HO-1004

Baughner Farm, site

Maryland Historical Trust Maryland Inventory of Historic Properties Form

Inventory No. HO-1004

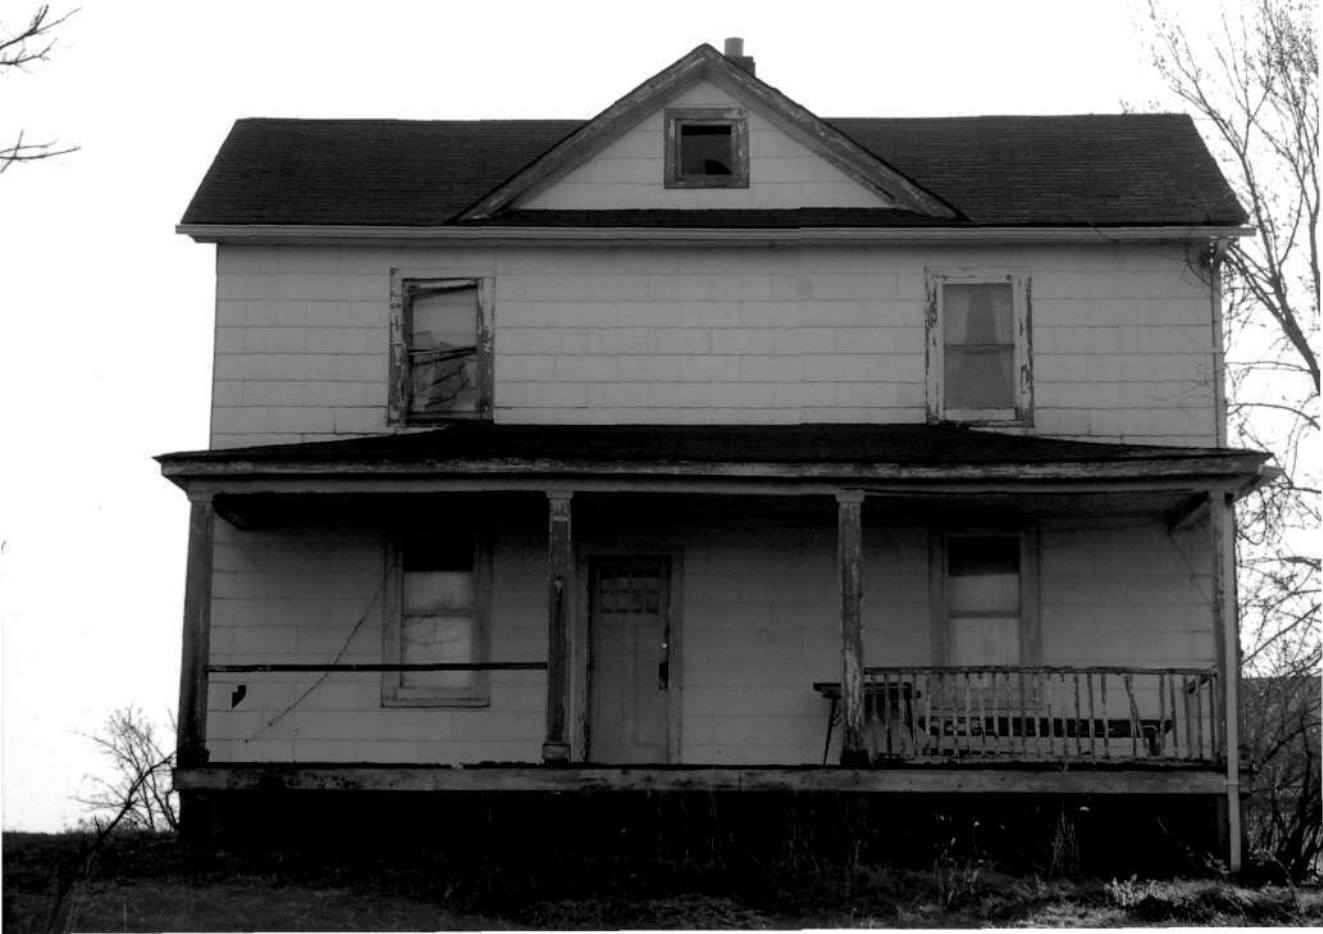
1/11

The northwest elevation has a door set north of center on the first story, with eight lights over two tall panels that are sunken and flat and have no panel moulds. There is a one-over-one double-hung sash to each side of the doorway, and all of the openings have head-cut trim. There is a one-story, three-bay porch set on concrete piers, with plywood laid over top of tongue-and-grooved boards on the deck. The porch has four boxed posts with capitals that have a cavetto over an ovolo, and it has a wood box cornice and hipped roof with asphalt shingles. The second story has typical one-over-one sash in the

House northwest elevation

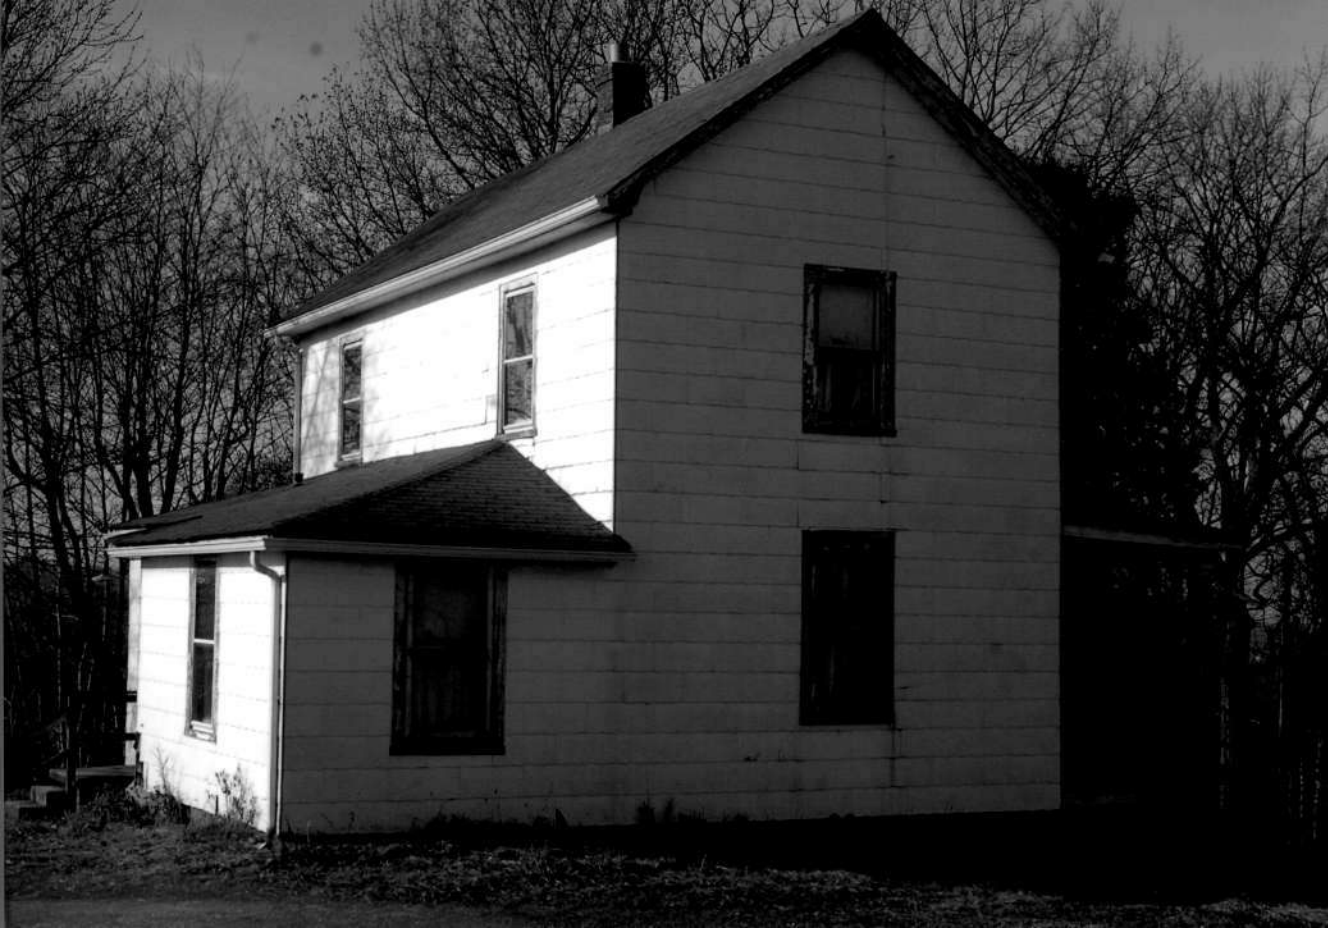
2/11

On the southeast elevation the first story of the enclosed porch has an aluminum storm door to the south and a one-over-one sash in a mitered frame in the center bay of the house, which is the east bay of the porch. The ell has a large one-over-one double hung sash. The second story, on the main block, has two typical one-over-one sash, one in each end bay. There is no opening in the center bay. The northeast elevation of the ell has a large one-over-one sash. The main block has a three-light sash in the foundation and a typical one-over-one sash on both the first and second stories. The gable end has no opening.

House, Southeast & Southwest Elevations

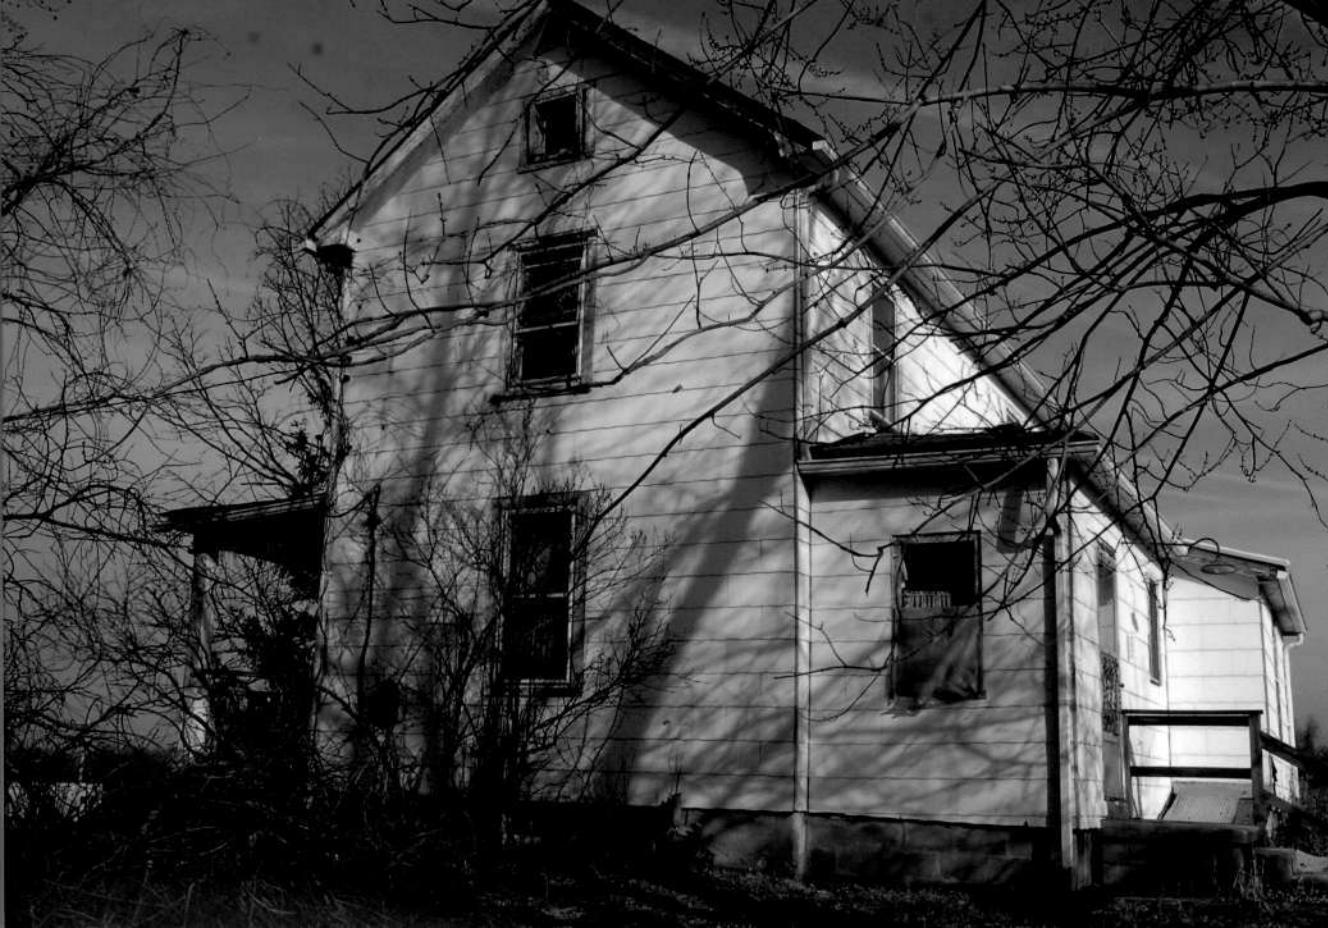
3/11

The southwest elevation of the main block has a three-light sash in the foundation and a single typical one-over-one sash on both the first and second stories. The gable end has a one-light sash. The southwest elevation of the enclosed porch has a fixed two-light wood storm window.

House, southwest & Southeast Elevations

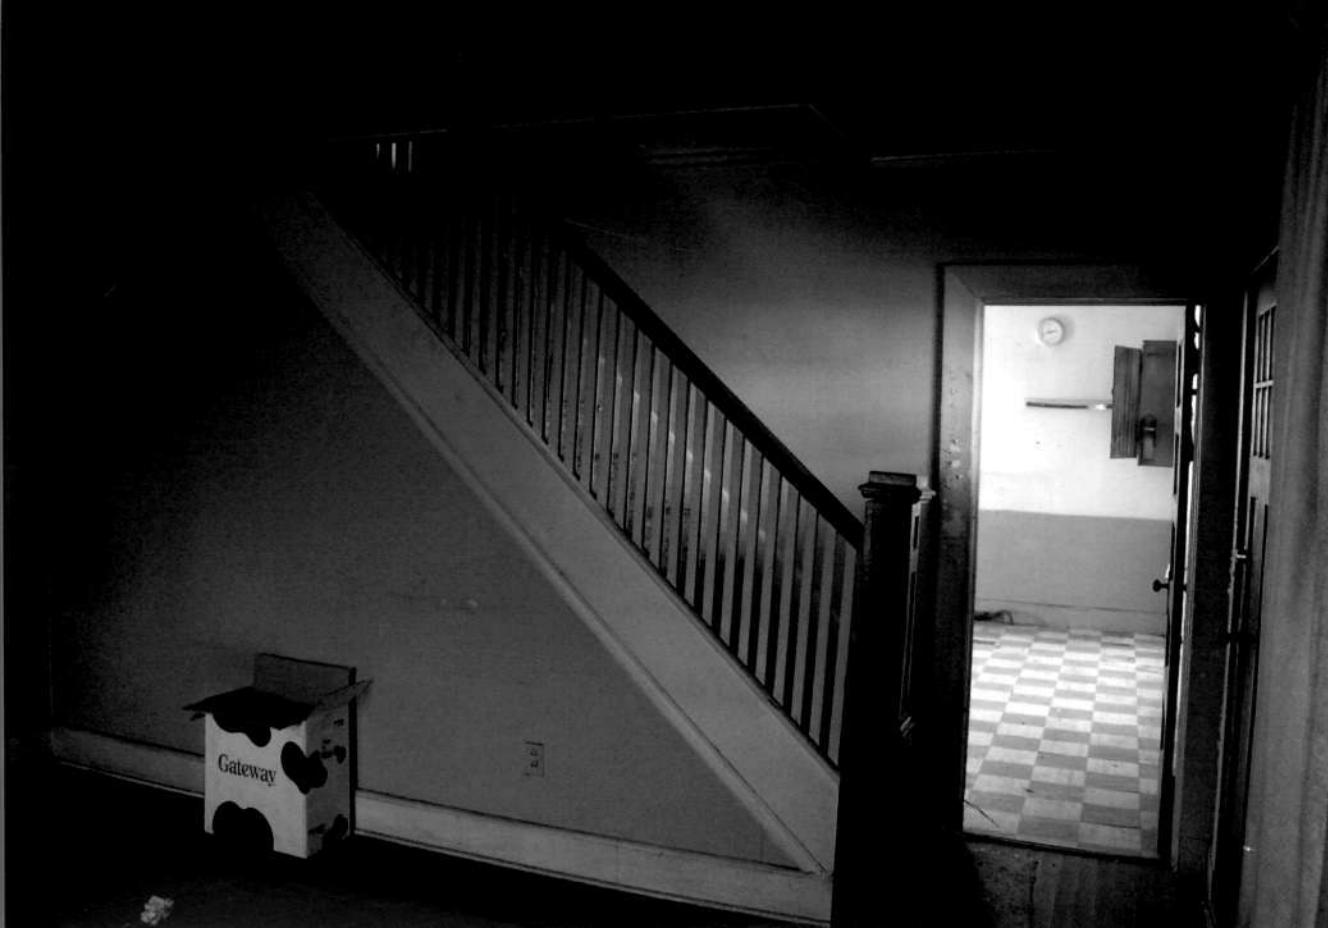
4/11

The first story has a hall-parlor plan with a centrally-located stairway in the parlor, one room in the ell, and two small rooms in the porch. The northeast room has 2 ½-inch tongue-and-grooved pine flooring that runs northeast-southwest. The baseboard has a quarter-round moulding on top, and there is plain mitered architrave that is typical of the early 20th century. The front door interior matches the exterior side, and it is hung on butt hinges with ball finials and has a mortise lock. There is an open straight-run stairway on the southwest elevation, and it ascends to the southeast. It has a closed stringer, and the space below the stairs is walled off. It has a boxed newel post that is paneled, and a moulded toad-back handrail, with square balusters. These features are also typical of the early 20th century. To the west of the stairs is a door that leads to the southwest room; it has five-lying panels, butt hinges with ball finials, and a mortise lock with metal knobs. The sash are hung on cords and have parting beads. There is a small wood cornice in this room that has an ovolo above a cavetto. There is a large heating grate in the floor near the stairway, set south of center, with a small grate in the ceiling above it.

House, interior North east room,
view South

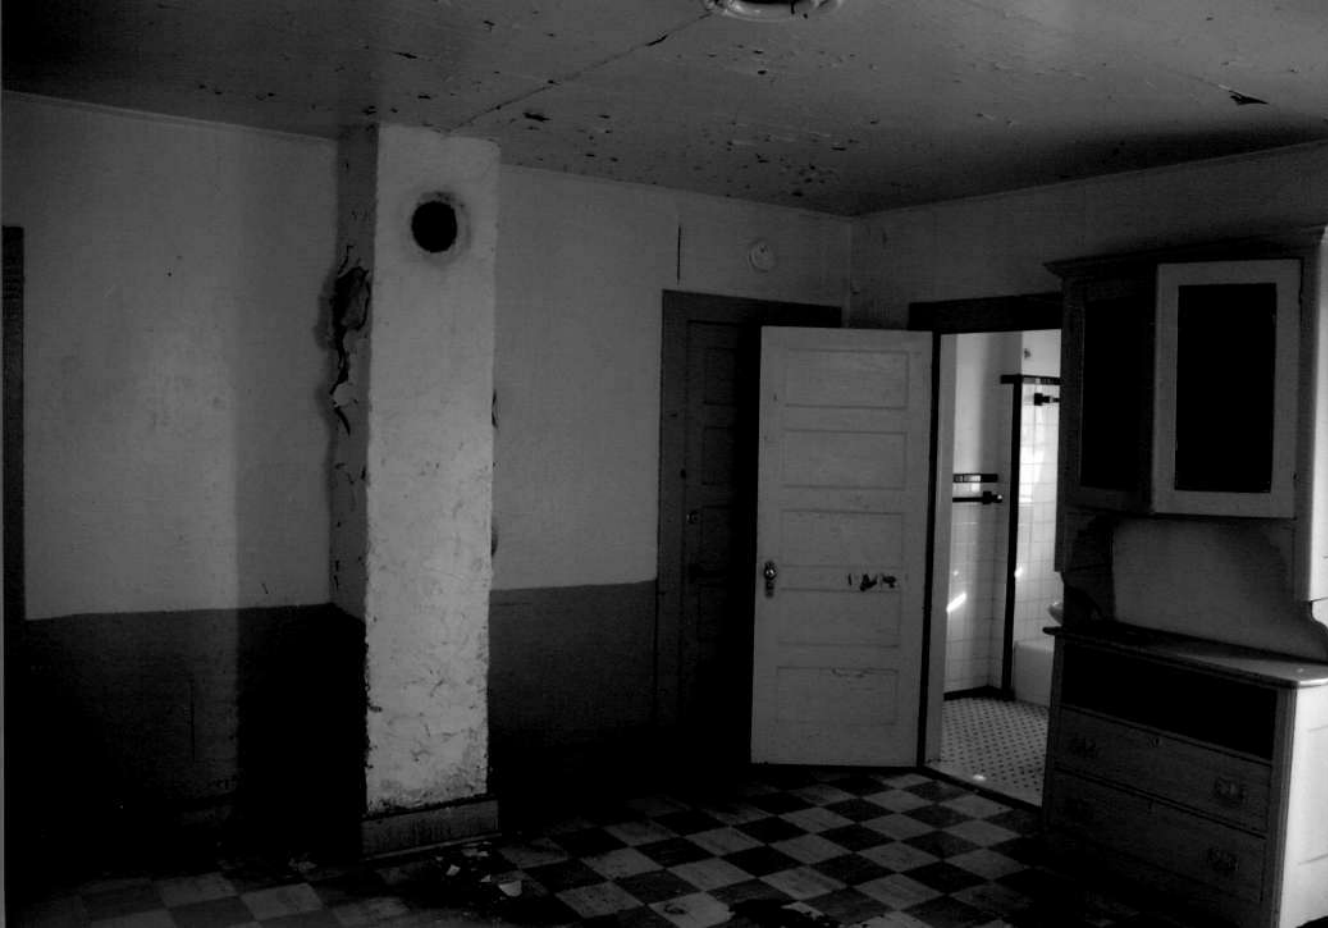
5/11

The southwest room has tile on the floor, typical baseboard, architrave, and doors on the northeast and the southeast, set to the east. The sash are also typical. The walls and ceiling are drywall. There is a stove chimney on the northeast elevation. The southeast door, set to the south, has six lights over three lying panels and is hung on butt hinges with ball finials. It has a mortise lock with metal knobs. On the southeast elevation, set between the two doors, is a wood cabinet on the wall with ogee brackets below it. The cabinet has two doors that have one light each, and a cornice with an ogee above a cavetto. The cabinet has rounded corners, and three shelves inside it. Below the cabinet is an old bedroom dresser.

House, interior, southwest room, view east

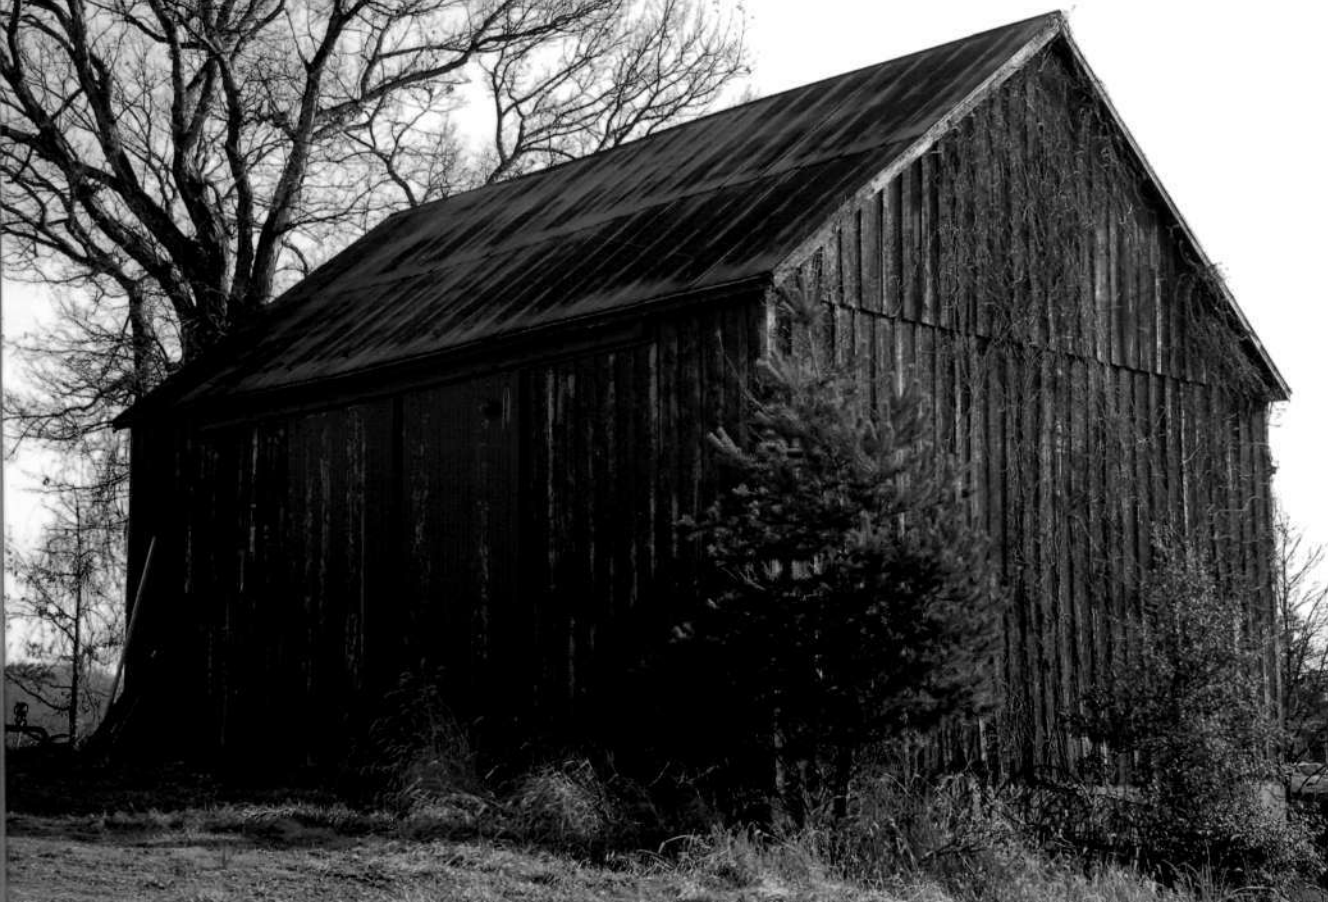
6/11

There is a bank barn located about 100 feet southeast of the house, and it has a forebay that faces southeast. It is a three-bay by one-bay frame structure with a concrete foundation, board-and-batten siding, and a gable roof of corrugated metal with a northeast-southwest ridge. The northwest elevation is banked into a slight hill, and the lower story is not exposed. The upper story has beaded-edge-and-center vertical-board wagon doors on rollers in the center, and no openings in the end bays. On the southwest elevation the lower story has a boarded-up opening to the west and a six-light sash to the south. The upper story has no openings. The southeast elevation has a board-and-batten wall on the lower story with three doors that match the siding. The end bay doors are Dutch doors, and they are all hung on T hinges. The forebay is set on three posts with bolsters. The upper story has a board-and-batten door in the center. On the northeast elevation the lower story has a six-light sash in the east bay that is partly below grade. The upper story has no openings.

Barn, Northwest & Southwest elevations

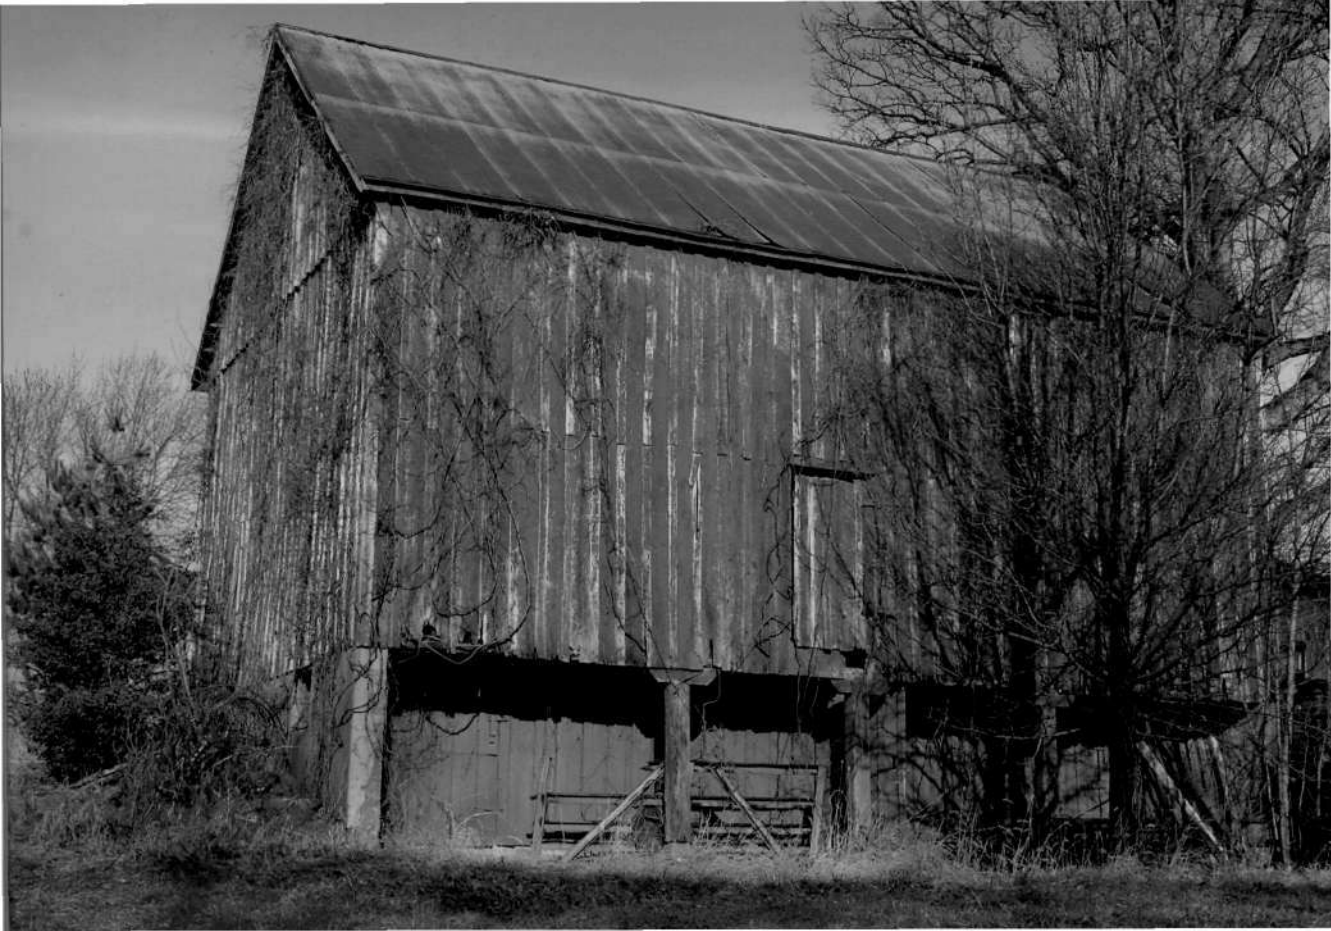
7/11

Barn, Southwest & Southeast Elevations

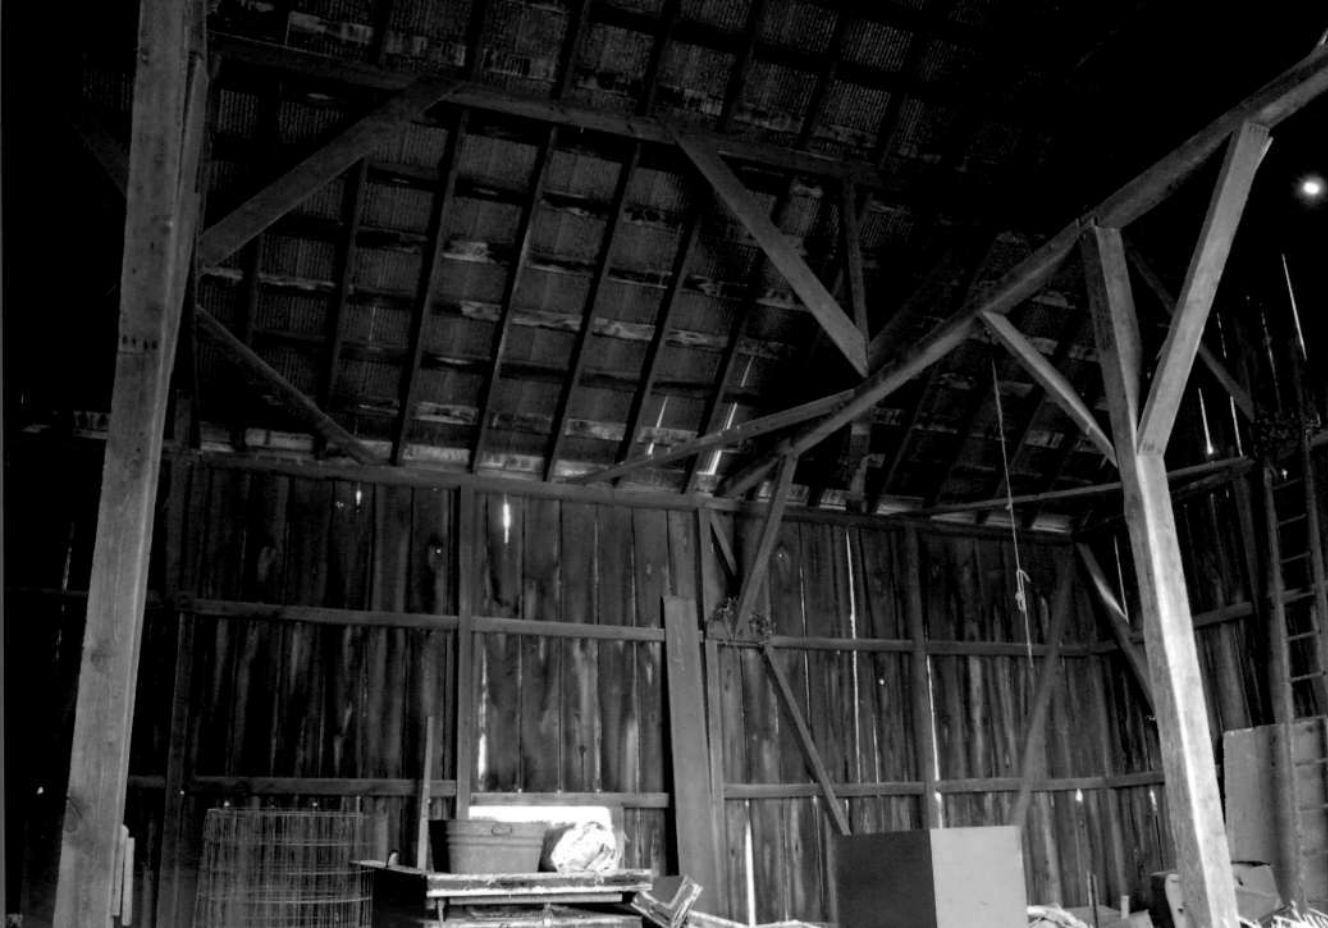
|| 8/11

The lower story of the barn has pens on the northeast and northwest sides and several horse stalls on the southwest. The southeast-center has a large square feeding aisle with a feed bin on the southwest side of it. The joists above are circular-sawn 2 by 10s spaced 16 inches on centers, with cross-bracing fastened with wire nails. A summer beam runs northeast-southwest, and it is constructed of four ganged-together

2 by 10s fastened with wire nails. It is supported by two posts with bolsters. The southeast wall is constructed of 4 by 4s that are wire-nailed. The upper story has a center wagon floor with a hay mow to each side. The bents have one post in the center with up-braces, a lapped girt, and braces between the girt and plate. There are also dragon ties and corner braces between the end girts and plates. There are braced purlin posts (queen posts) on the girts. The corner posts have down-braces that extend from the top of the post to the sill. All of the joints are nailed. There are 2 by 8 rafters with a ridge pole and collar beams, and they support wide board lath.

Barn; Interior, view Southeast

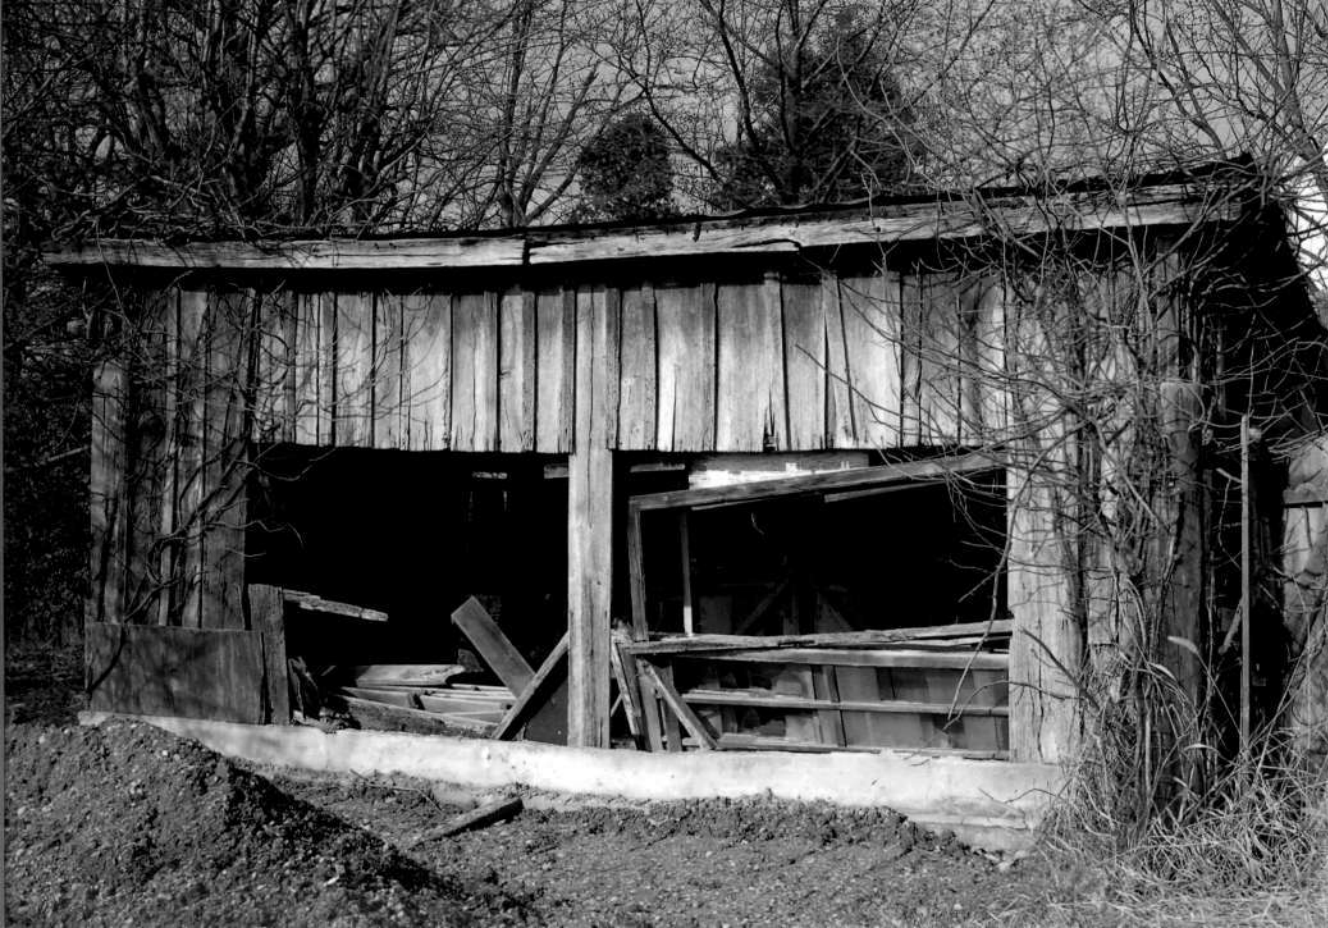
9/11

About 60 feet south of the house is a poultry house. It is a one-story, two-bay by one-bay frame structure with board-and-batten siding, a concrete foundation, and a shed roof with inverted-V-seam metal that slopes down to the north. The south elevation has two large openings that are much deteriorated. The west elevation has a six-light sash and the north elevation has no openings. The east elevation has a vertical-board door hung on T hinges, and set to the south. There is a dirt floor, and the framing is circular-sawn 2 by 4s and 4 by 4s that are wire-nailed together.

Poultry House, Southeast Elevation

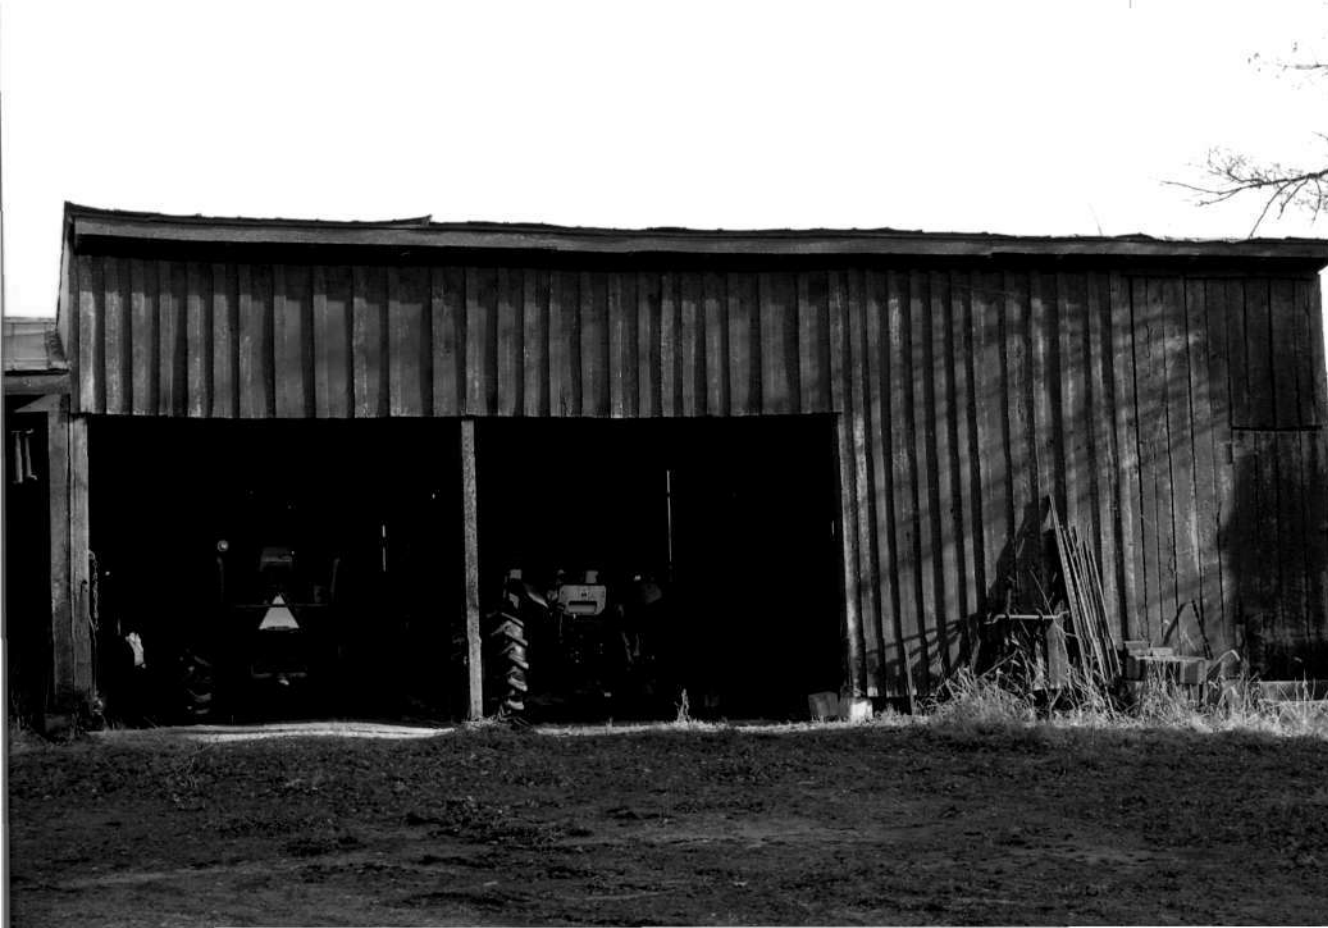
10/11

There is a tractor shed about 12 feet north of the barn. It is a three-bay by one-bay, one-story shed-roofed structure with a concrete foundation, board and batten siding, and inverted-V-seam metal roofing that slopes down to the northeast. The southwest elevation has open bays on the west and center bays and a vertical board door at the south end. The southeast elevation has a hatch that is set high on the wall in the center. There are no openings on the northeast end or the northwest elevation. The tractor shed is constructed of circular-sawn, ganged-together material that is wire-nailed. The southeast end has a corn crib with hardware cloth on the interior. The northwest end has a five-bay CMU tractor shed added to it.

Wagon Shed, Southwest Elevation

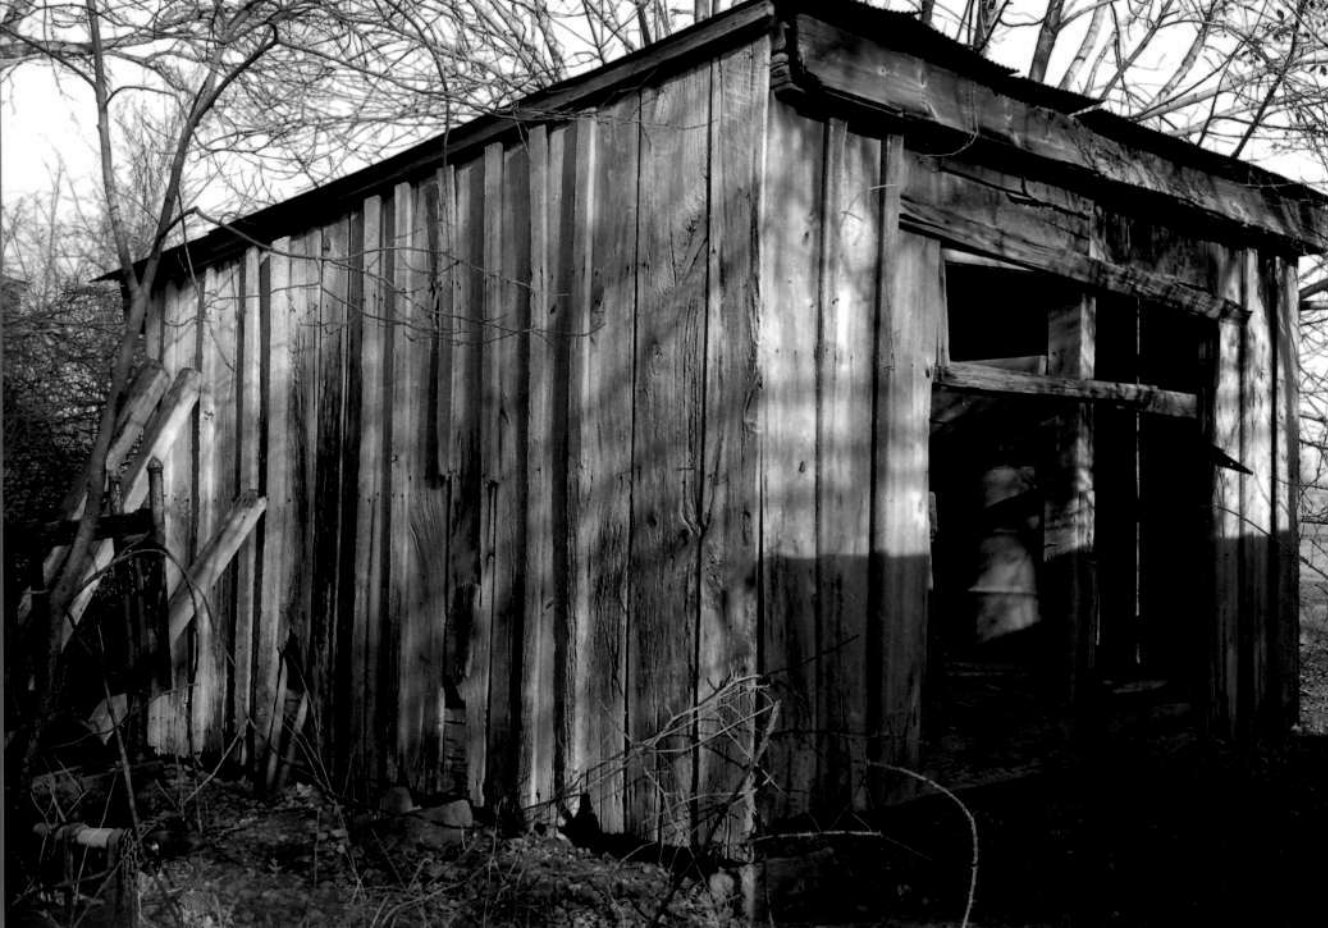
11/11

About 75 feet southeast of the barn is a one-story, one-bay by one-bay frame structure that could have been a hog pen. It has concrete piers, board-and-batten siding, and a shed roof with corrugated metal that slopes down to the northwest. The southeast elevation has a large opening in the center, and there are no openings on the other three elevations. The building is constructed of 2 by 4s and 4 by 4s that are wire-nailed, and has a 2-inch plank floor. It is divided into two pens by a center wall that runs northwest-southeast and there is a gate in this partition at the southeast end.

Hog Pen, Southwest & Southeast Elevations
