HO-145

Mt. Joy (Santa Fe, Montjoy)

Architectural Survey File

**MARYLAND HISTORICAL TRUST
DETERMINATION OF ELIGIBILITY FORM**

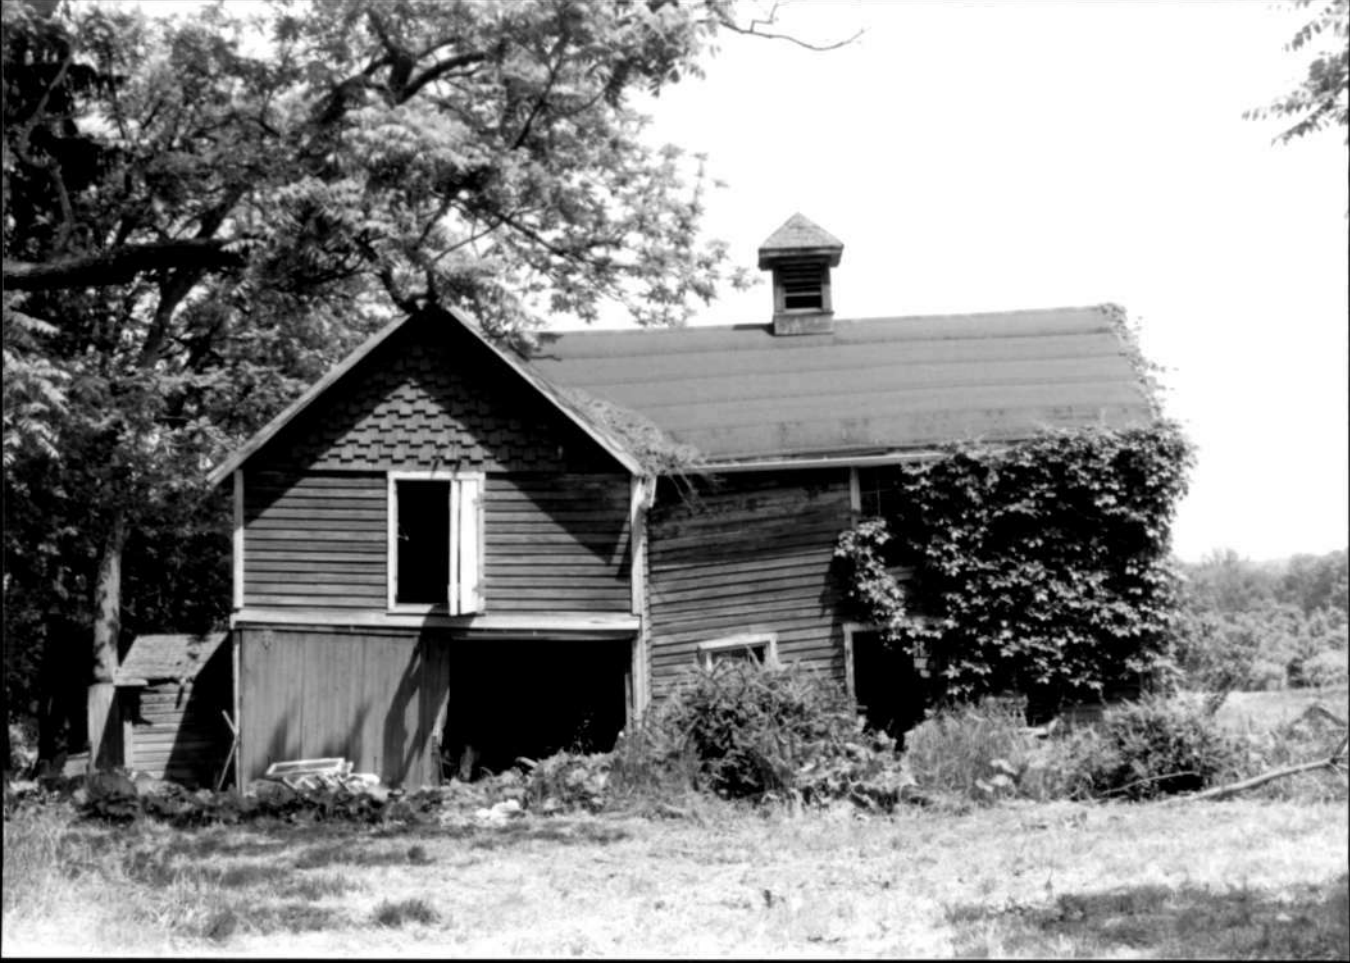
32/46

The general condition of the building is poor, with a compromised foundation and unstable envelope. Winchester Homes proposes to demolish the building.

Garage/workshop, ^{39 21+01 NNNNN 357} front (south) elevation

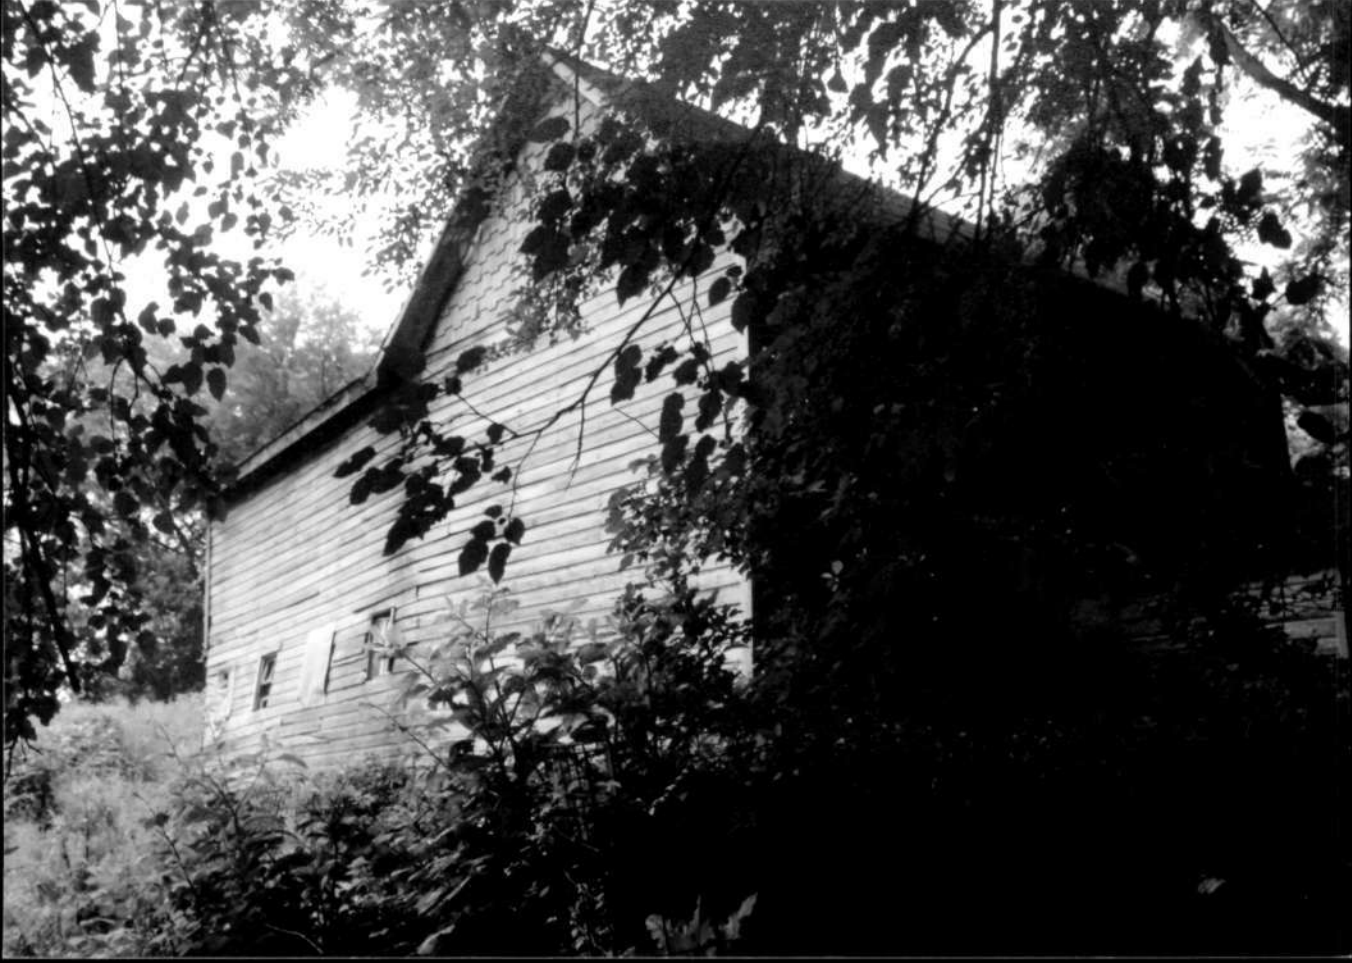
33/46

Garage/workshop, northwest elevation

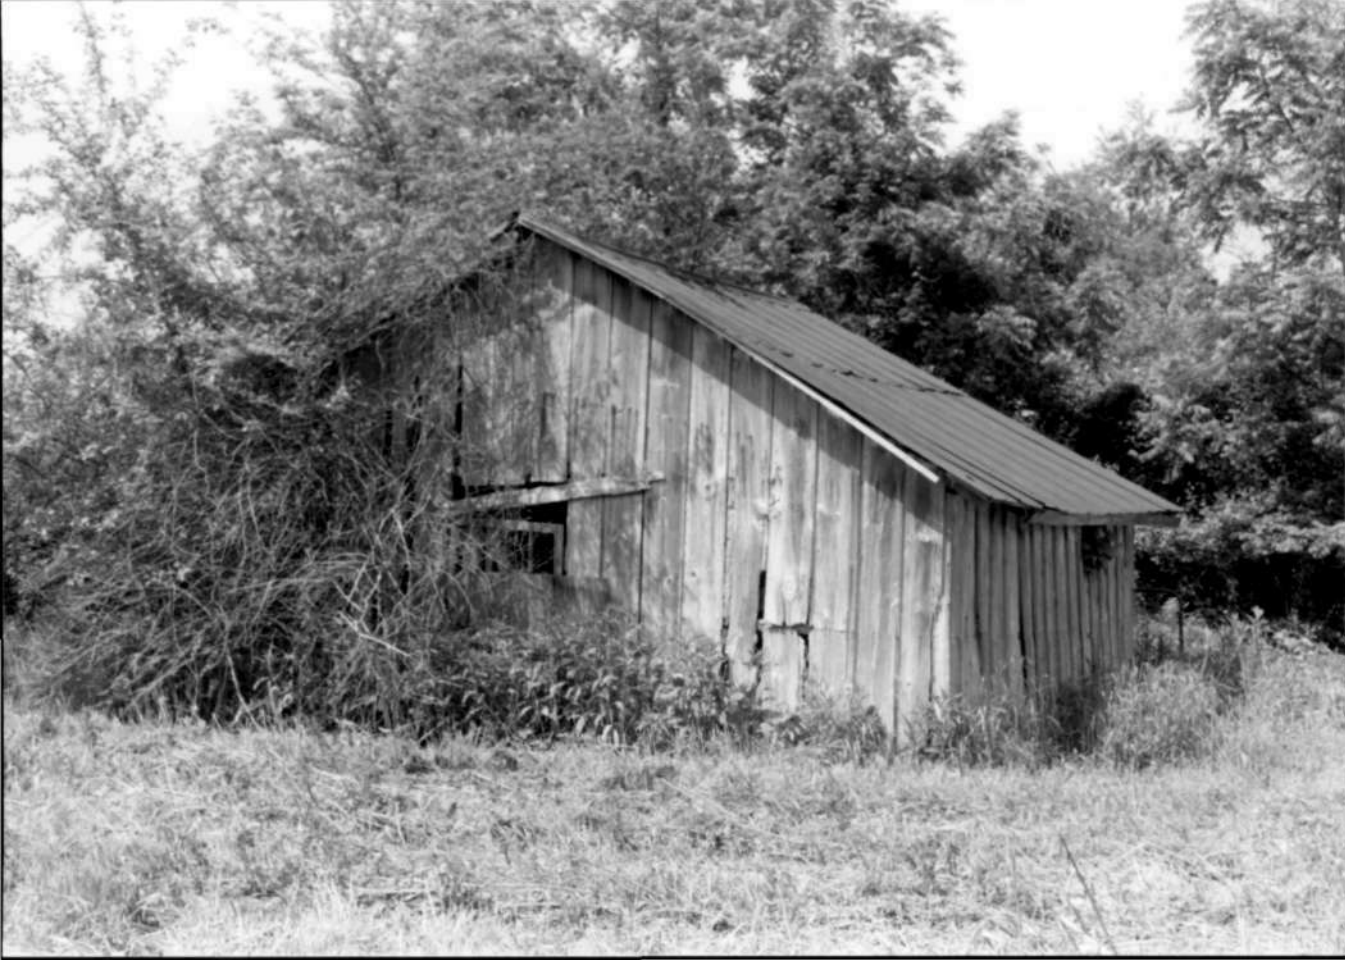
44/46

Settlement has caused cracks in the foundation and the slight dipping of the north wall. Wire nails tie the circular-sawn wood framing together. Remnants of white paint is evident on the exterior cladding, and faded white paint coats all interior wood, including the diagonally suspended wood-pole perches spanning the northern interior wall that indicate the previous agricultural function of the now unused structure.

The general condition of the building is fair due to missing wall elements and foundation settlement.

Chicken coop- NE corner
