AL-I-A-083

## Bridge 1036 (SHA)

### **Architectural Survey File**

Name: US 40 over Fifteen Mile Creek

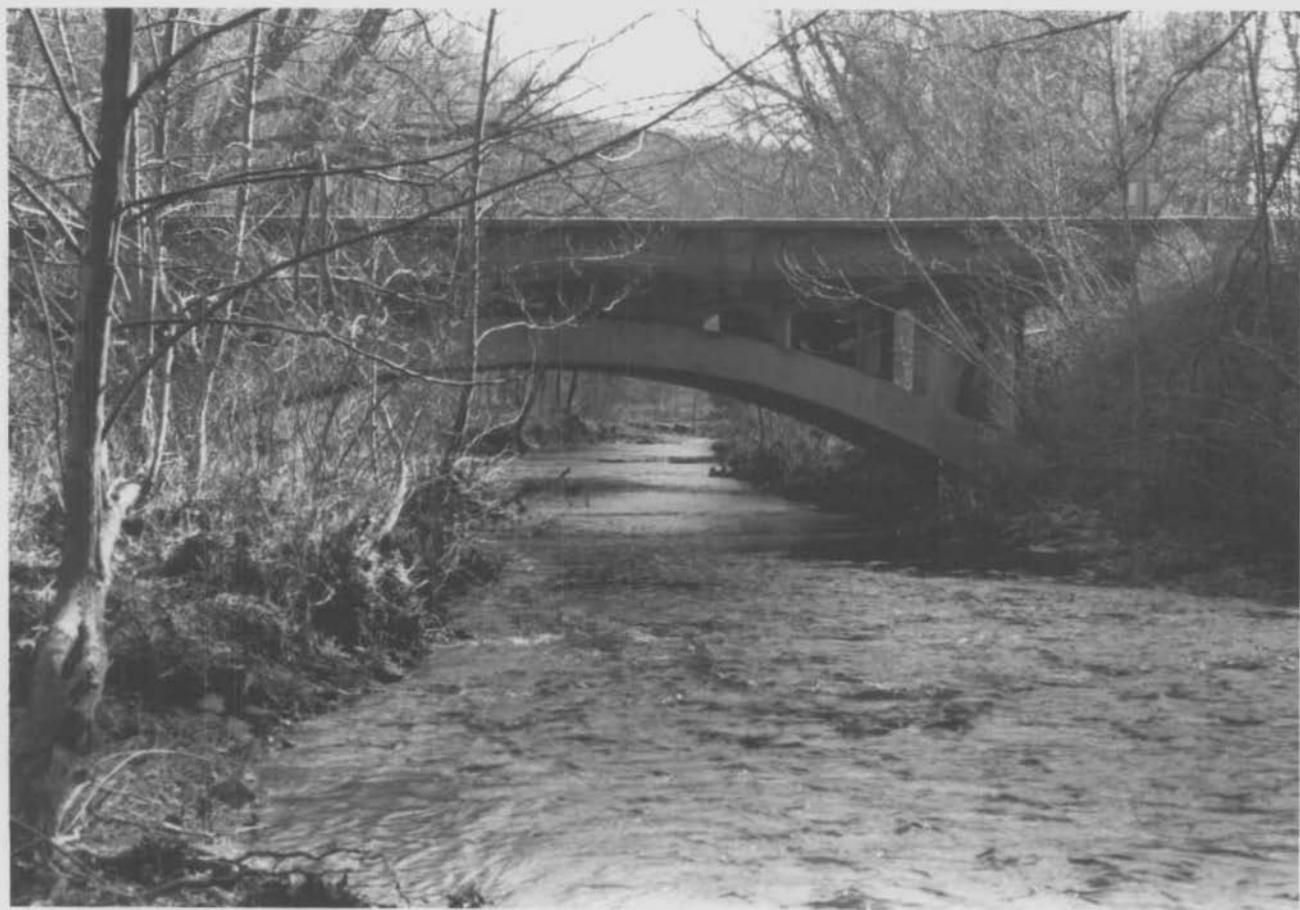
1. AL-1-A-083
2. US 40 over Fifteen Mill Creek
3. Allegany Co., MD
4. Wallace, Montgomery & Assoc.
5. 12/97
6. MD SHPO
7. Elevation looking downstream
8. 10 F 4

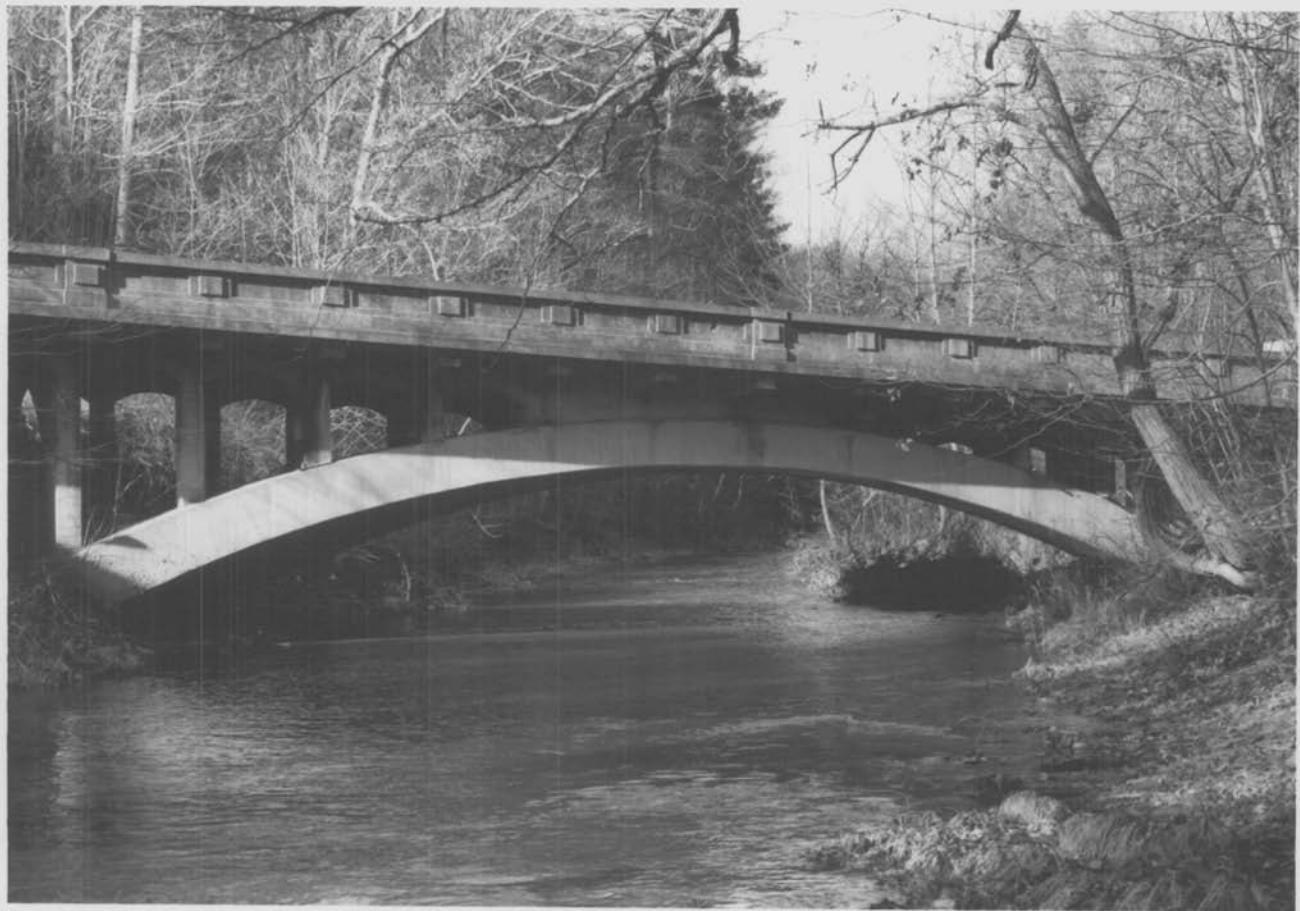
1. AL-1-A-083
2. US 40 over Fifteen Mill Creek
3. Allegany Co., MD
4. Wallace, Montgomery & Assoc.
5. 12/97
6. MD SHPO
7. Elevation looking upstream
8. 2 of 4

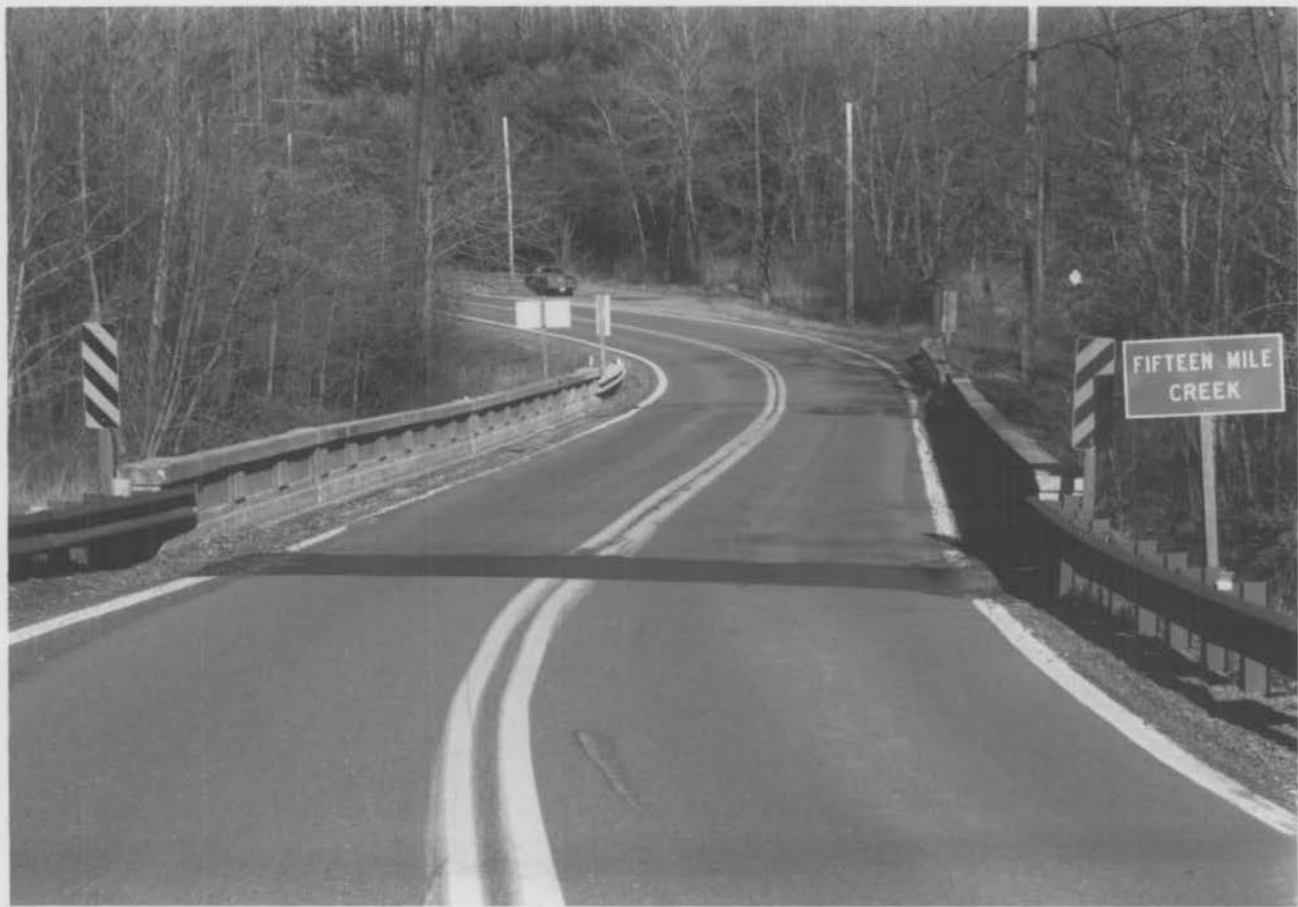
1. AL-1-A-083
2. US 40 over Fifteen Mill Creek
3. Allegany Co., MD
4. Wallace, Montgomery & Assoc.
5. 12/97
6. MD SHPO
7. Looking East
8. 3 of 4

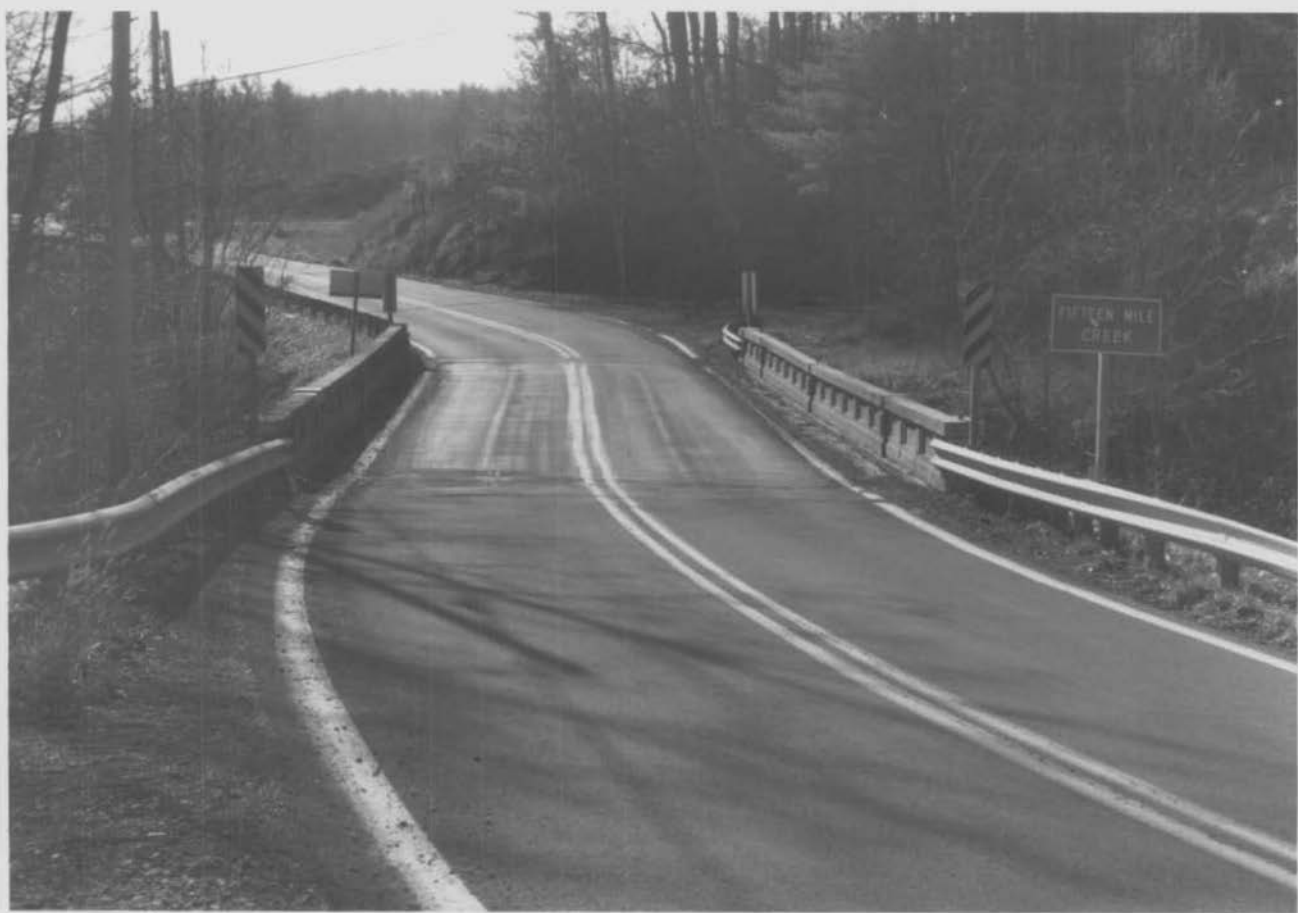
1. AL-1-A-083
2. US 40 over Fifteen Mill Creek
3. Allegany Co., MD
4. Wallace, Montgomery & Assoc,
5. 12/97
6. MD SHPO
7. Looking West
8. 4 of 4
