Tipton Airport

Architectural Survey File

MARYLAND HISTORICAL TRUST
DETERMINATION OF ELIGIBILITY FORM

Property Name: Tipton Airport Inventory Number: AA-2380
Address: 81 General Aviation Drive (MD 198) Historic district: ___ yes no
City: Odenton Zip Code: 21113 County: Anne Arundel
USGS Quadrangle(s): Laurel
Property Owner: Anne Arundel County, Tipton Airport Authority Tax Account ID Number: 4-000-90213642
Tax Map Parcel Number(s): 12 Tax Map Number: 20
Project: MD 198 from MD 295 to MD 32 Agency: SHA
Agency Prepared By: EHT Traceries, Inc.
Preparer's Name: Elizabeth Breiseth Date Prepared: 8/21/2007

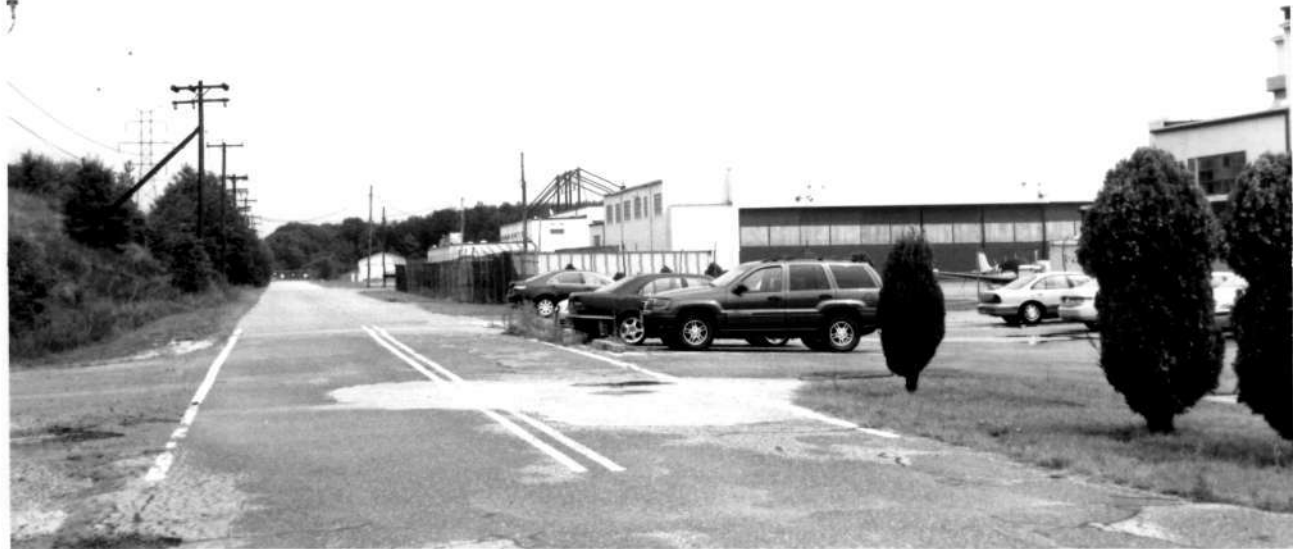
#1 of 11

Hangar #84, Tipton Airport

Looking east down General Aviation Drive

Constructed circa 1960, this two-story, one-bay hangar is set on a concrete foundation with steel-beam framing. The structure is mainly clad in corrugated metal panels with sections of the second story clad in concrete blocks. A low-pitched front-gabled roof covers the hangar. The roof features a raked cornice. Both the east and west side elevations of the hangar feature six sliding metal doors with corrugated metal panels. The doors run the full height of the first story. Fenestration on the first and second stories of the north elevation is a combination of single, paired, and tripled 6-light metal-sash awning windows with interior storm windows. First-story windows are set on a concrete sill course, while each second-story window opening has a concrete lug sill. A one-story enclosed projecting entry bay is located on the first story of the north elevation. The entry bay is concrete-block construction covered by a shed roof. The entry bay has a 12-light metal-sash window and a single-leaf door. The interior of the hangar was not accessible at the time of the on-site survey.

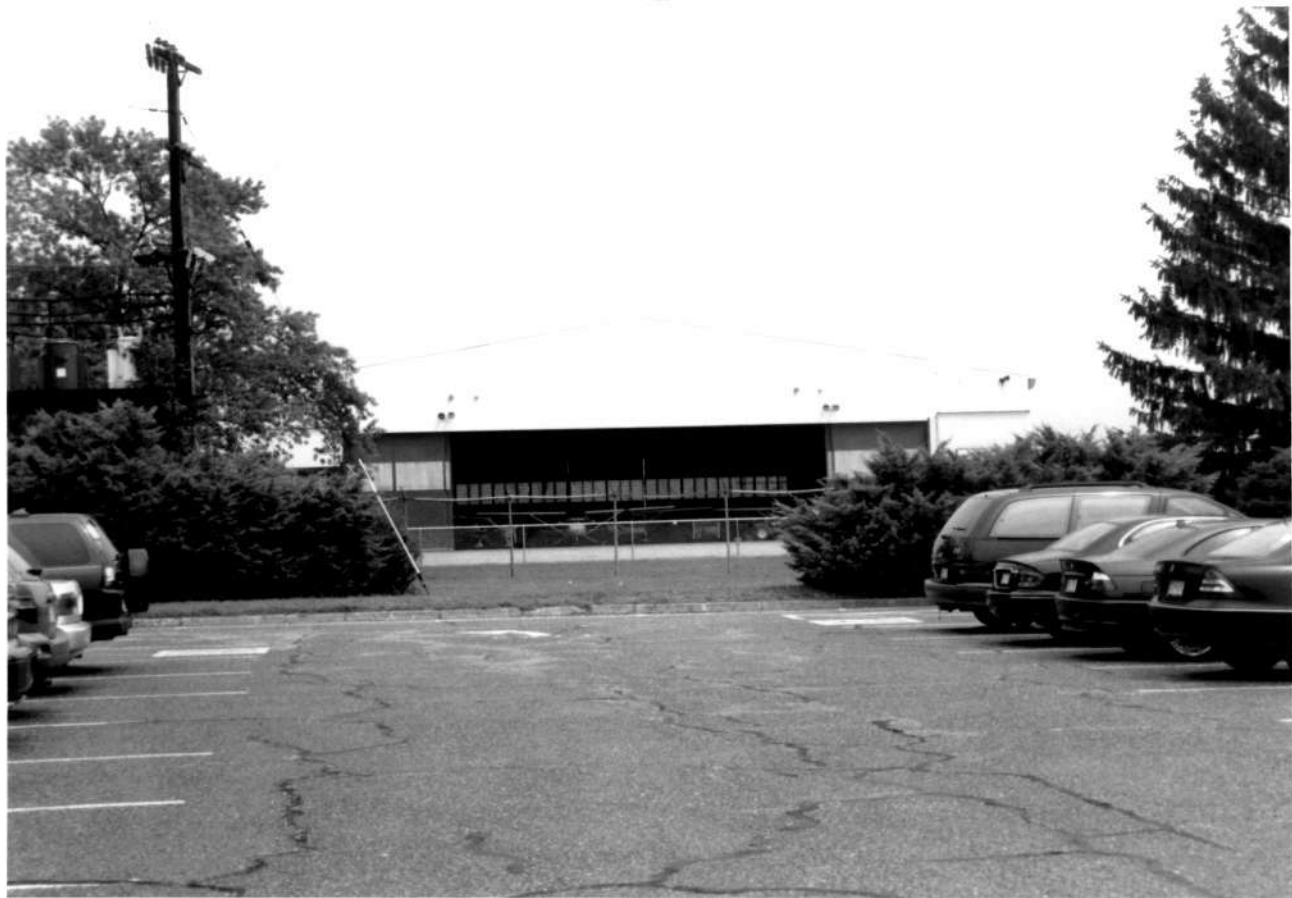
#2 of 11

Hangar #80, Tipton Airport

West elevation

Constructed circa 1960, this two-story, one-bay hangar is set on a concrete foundation with steel-beam framing. The structure is mainly clad in corrugated metal panels with sections of the second story clad in concrete blocks. A low-pitched front-gabled roof covers the hangar. The roof features a raked cornice. Both the east and west side elevations of the hangar feature six sliding metal doors with corrugated metal panels. The doors run the full height of the first story. Fenestration on the first and second stories of the north elevation is a combination of single, paired, and tripled 6-light metal-sash awning windows with interior storm windows. First-story windows are set on a concrete sill course, while each second-story window opening has a concrete lug sill. A one-story enclosed projecting entry bay is located on the first story of the north elevation. The entry bay is concrete-block construction covered by a shed roof. The entry bay has a 12-light metal-sash window and a single-leaf door. The interior of the hangar was not accessible at the time of the on-site survey.

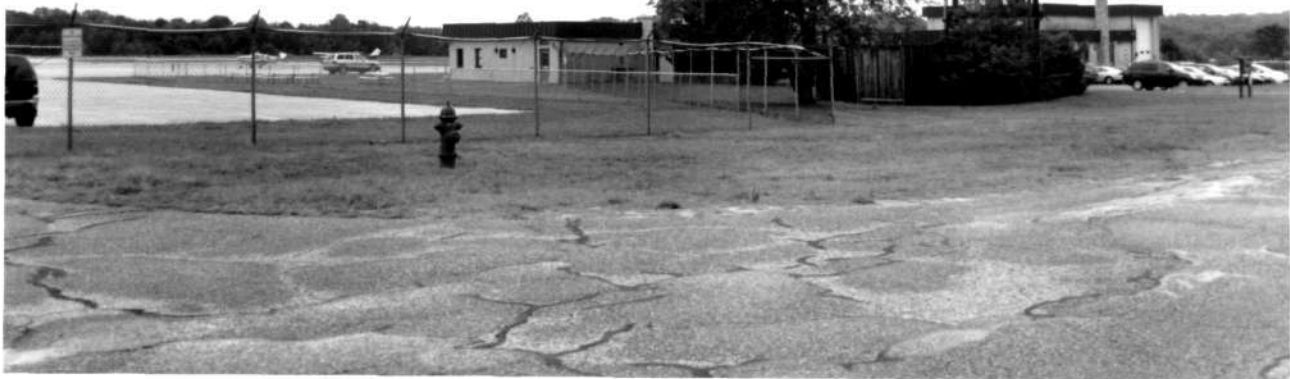
#4 of 11

Building # 81, Tipton Airport

Looking Southeast towards Building # 81

This one-story, six-bay airport operations building was constructed circa 1960. It has a rectangular plan with a two-story control tower on its west elevation. The building, which is concrete-block construction, is clad in stucco. A flat roof covered with standing-seam metal caps the main block of the building. The standing-seam metal forms a parapet. The building has an exterior-front chimney clad in stucco that is located adjacent to the entrance. The entrance has a single-leaf metal door with lights. Five window openings are placed along the façade (north elevation). The openings have 1/1 metal-sash windows set on metal-clad sills. The two-story tower has a pyramidal roof with overhanging eaves. The tower's roof is covered in standing-seam metal. The control tower has a ribbon of four 1-light fixed metal-sash windows on each elevation; each 1-light metal-sash is set above a 1-light sliding metal-sash window. The interior of Building #81 was not accessible at the time of the on-site survey.

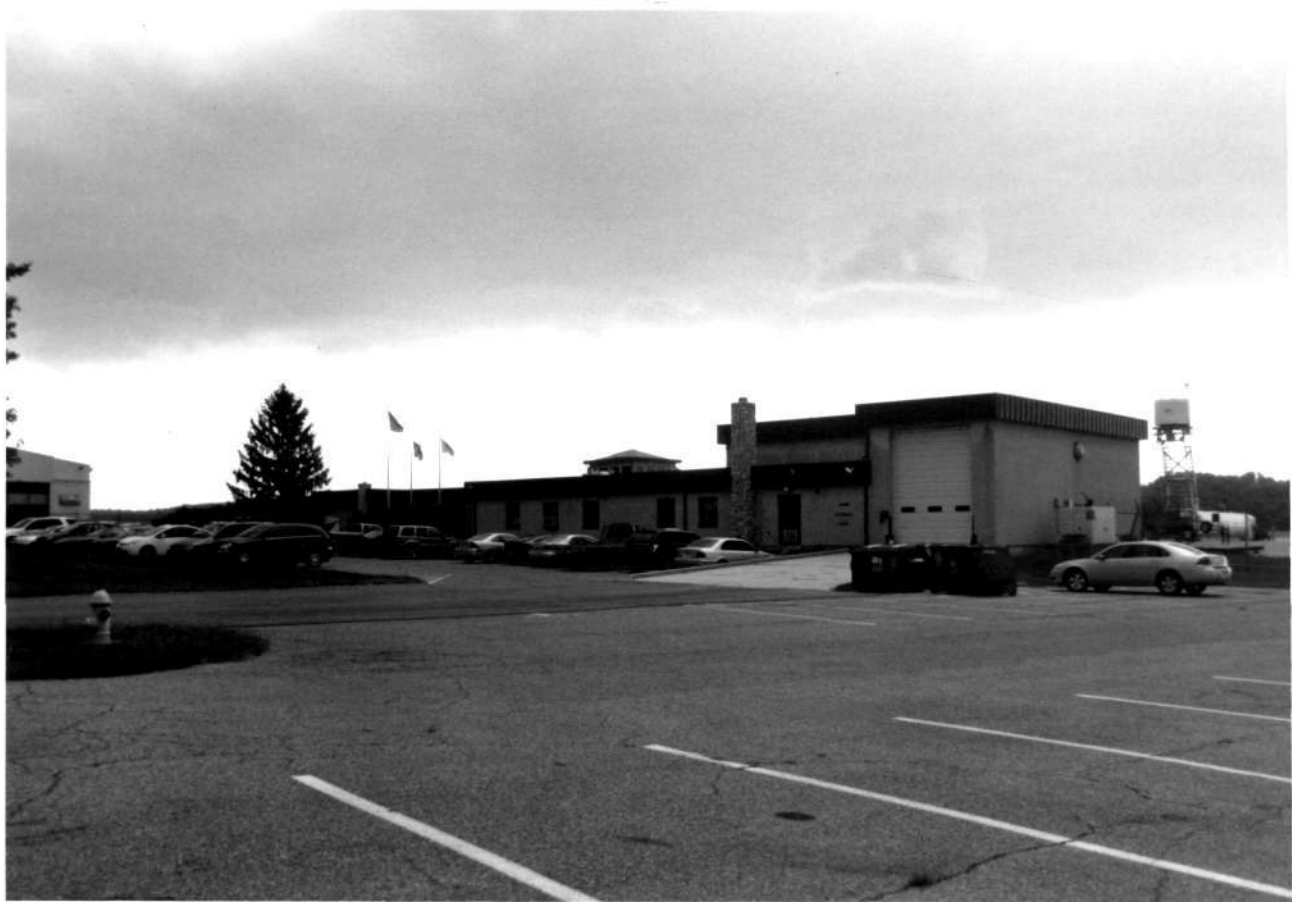
#5 of 11

Administrative Building, Tipton Airport

Northwest corner

The administrative building was constructed circa 1960. This two-story, seven-bay administrative building is constructed of concrete blocks. The foundation is rock-faced concrete block, while the structure is clad in stucco. The western bay of the building

is an attached garage that is two stories in height. A roll-up metal door provides access to the garage, and a concrete ramp leads to the vehicular opening from the parking lot. The main block of the building is one story in height. A flat roof of standing-seam metal covers both the one- and two-story portions of the building. The roof has a standing-seam metal parapet. An exterior-front chimney faced in coursed stone is located on the façade (north elevation), just east of the main entrance. The main entrance has a single-leaf metal door. There are five window openings on the façade. Each opening features a 1/1 metal-sash window set on a metal-clad sill. The interior of the building was not accessible at the time of the on-site survey.

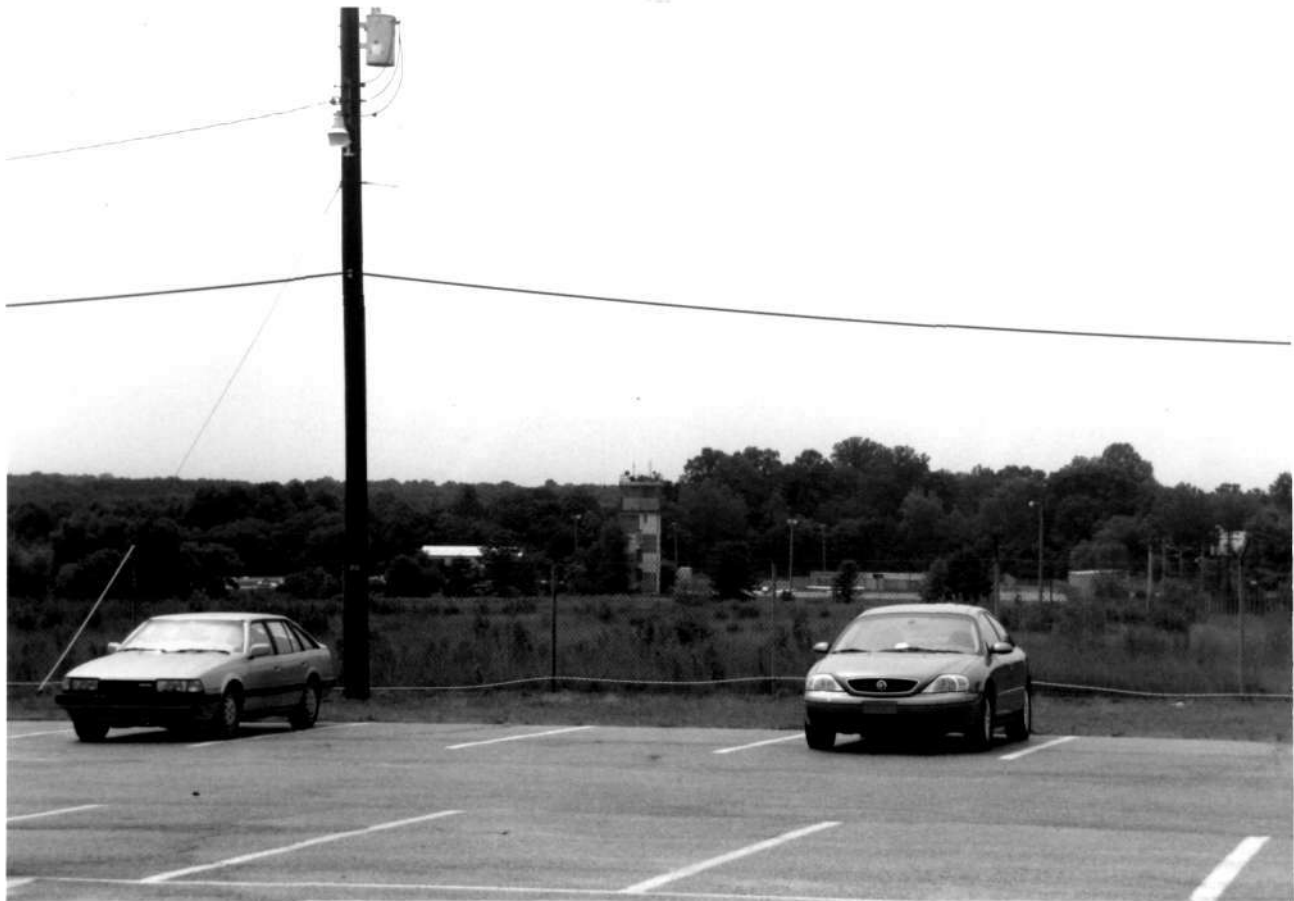
#6 of 11

control tower, Tipton Airport

Looking west towards control tower

The control tower was built circa 1960. The building, which has a hexagonal shape, is constructed of cast concrete with two window openings on the west elevation. The windows are 4-light metal-sash casements set on concrete sills. A single-leaf door on the north elevation provides access to the tower. A flat roof with a metal balustrade caps the building. The glass-paneled control room is situated on top of the flat roof. The control room has a continuous ribbon of 1-light fixed metal-sash windows. A flat roof with a metal balustrade covers the control room. The control tower is no longer in use and the interior was not accessible at the time of the on-site survey.

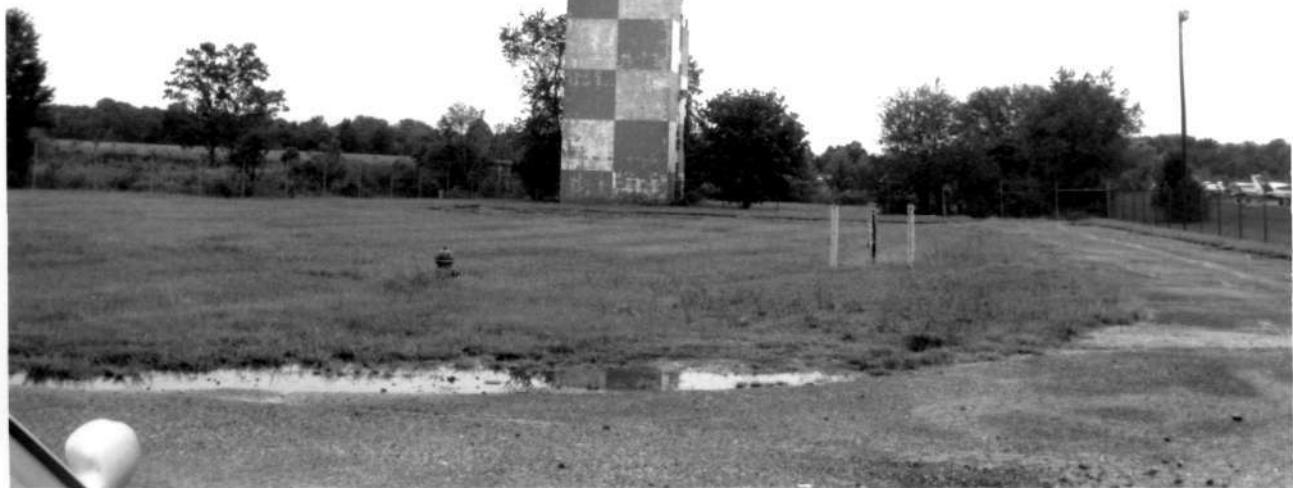
#7 of 11

Control tower, Tipton Airport

Looking south towards control tower

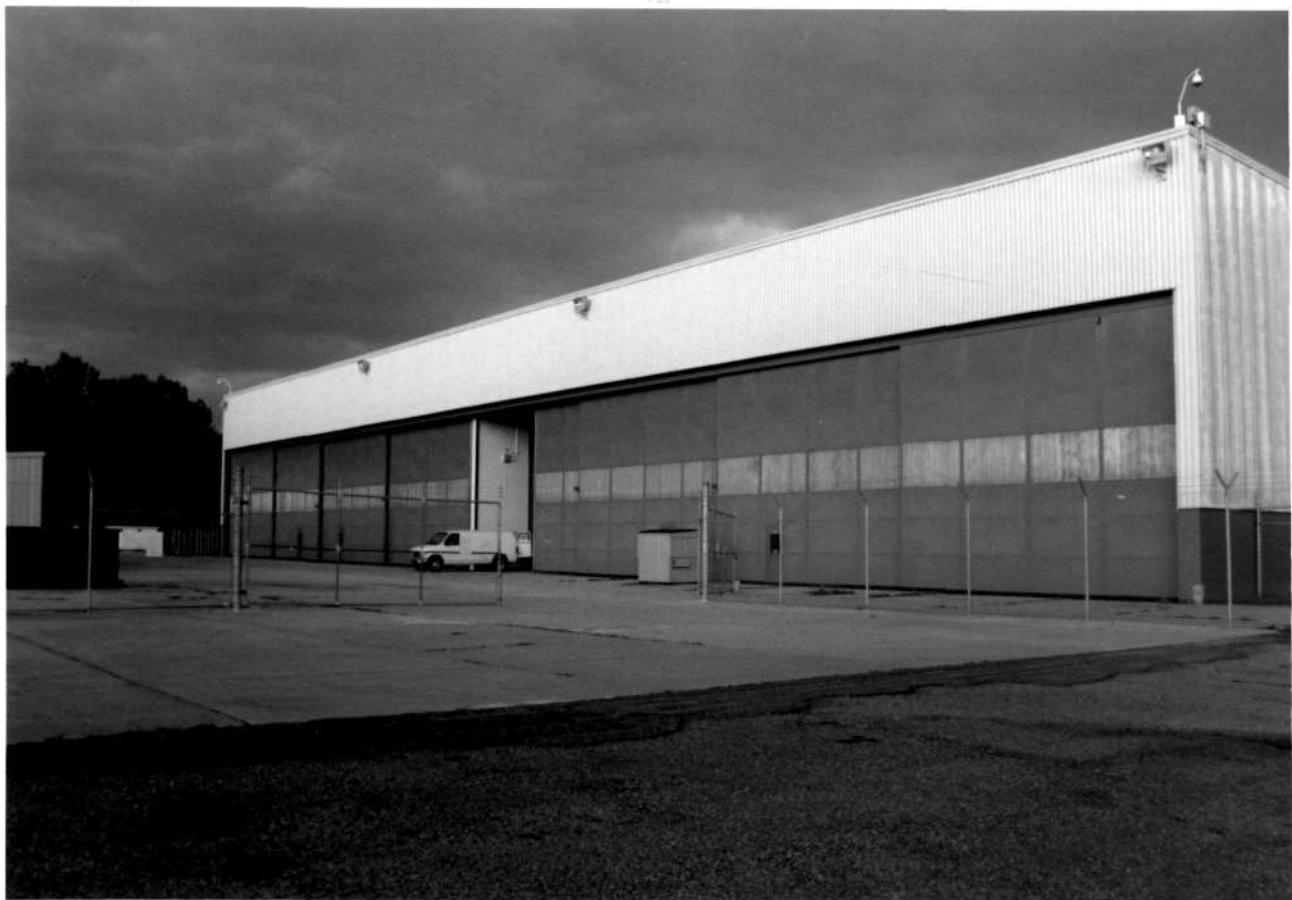
#10 of 11

Hangar #90, Tipton Airport

Southwest corner

This two-story hangar was constructed circa 1960. The building is set on a concrete-block foundation and constructed of steel-beam framing. The first story is clad in concrete blocks, while the second story is clad with corrugated metal. The hangar has a flat roof with metal coping. An exposed steel-beam structure is situated on the roof. The structure is topped with lights and braced with smaller steel beams. The south elevation has nine sliding doors of corrugated metal. A set of double-leaf metal doors and two paired 1-light metal-sash awning windows are located on east elevation of the hangar. The north elevation has paired 1-light metal-sash awning windows set on concrete sills and a roll-up metal door. The interior of the hangar was not accessible at the time of the on-site survey.

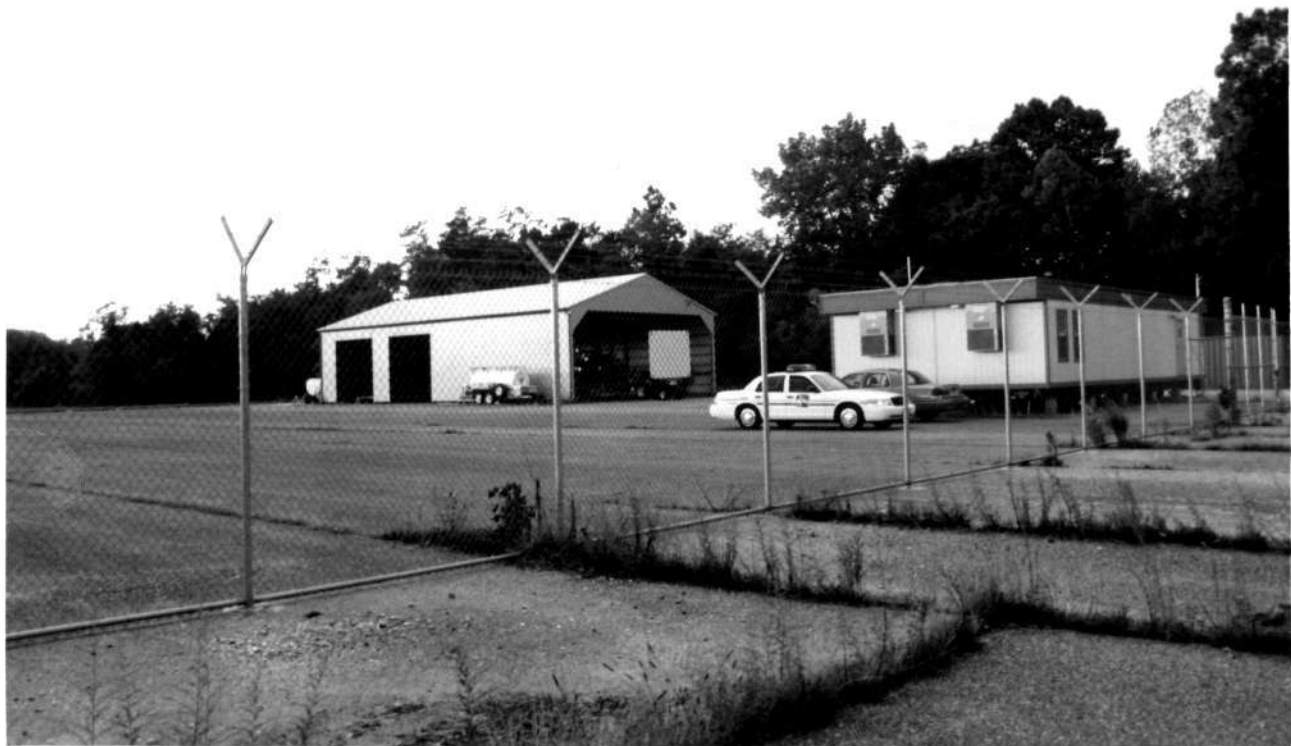
Shed #1, Tipton Airport

Constructed circa 1980, this shed is one story in height and one bay in width. The structure is built of steel-beam framing. The structure, capped by a front-gabled roof, is clad in corrugated metal. The north elevation of the shed has a large opening with no door. Two smaller entry openings are located on the east elevations. These openings have roll-up metal doors. The interior of the shed was not accessible at the time of the on-site survey.
