**MARYLAND HISTORICAL TRUST
DETERMINATION OF ELIGIBILITY FORM**

Property Name: Baltimore Greyhound Bus Terminal Complex Inventory Number: BA-1953 B-1953
 Address: _____ City: Baltimore Zip Code: _____
 County: Independent City USGS Topographic Map: _____
 Owner: _____ Is the property being evaluated a district? yes
 Tax Parcel Number: _____ Tax Map Number: _____ Tax Account ID Number: _____
 Project: _____ Agency: _____
 Site visit by MHT Staff: no yes Name: _____ Date: _____
 Is the property located within a historic district? yes no

Summary: The Baltimore Greyhound passenger station and service building were built in 1941-42 during the height of the growth of the bus transportation industry. The two terminal structures were built as a cohesive ensemble of station and service building, and were cited at the time of their construction as an example of the ideal bus terminal plan. The complex was designed by William Arrasmith, one of the most prolific and prominent architects in the field of bus terminal design.

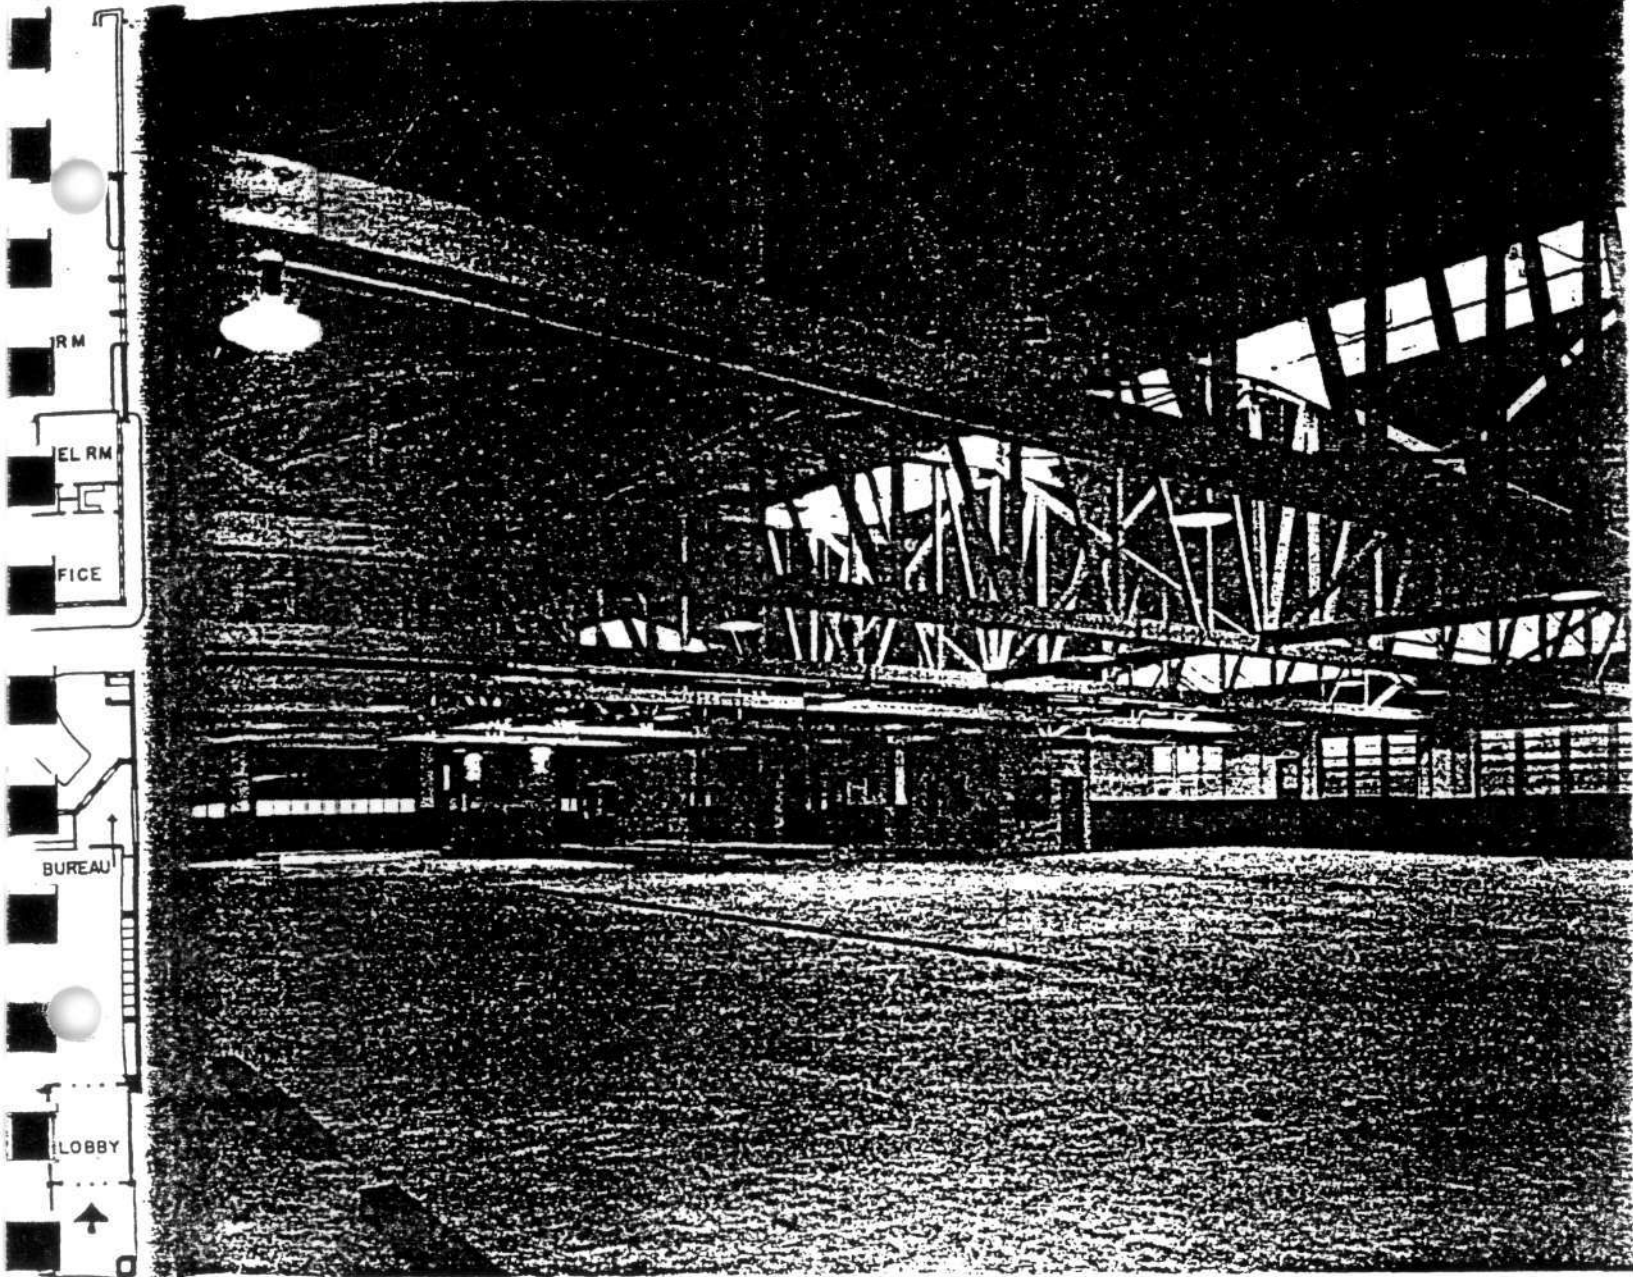
One great advantage of the on-site garage and Service Building (shown on this page) is the operational flexibility (without waste motion) it gives to coping with peak periods of travel. Without the near-by garage, efficient handling of unforeseen peak loads would require twice the docking space (often unused), costly delays (while busses come from a distant garage), or both.

and handling of equipment, and permits use of extra busses required on short notice with very little waste movement or time. Furthermore, the garage reduces the traffic load on crowded city streets.

The site is quite regular in outline; grades are not a serious problem, and the property value was considered in reasonable relation to anticipated operating revenue. The corner location of the terminal provides almost ideal lanes for bus movements in a clockwise direction—entering the lot from the front street, easing into the platform area, and exiting on the side street. When servicing or repairs are needed, a "trip" to the garage is simply a matter of a few feet.
