BA-1582

Warfield Farm Complex

Architectural Survey File

Maryland Historical Trust Maryland Inventory of Historic Properties Form

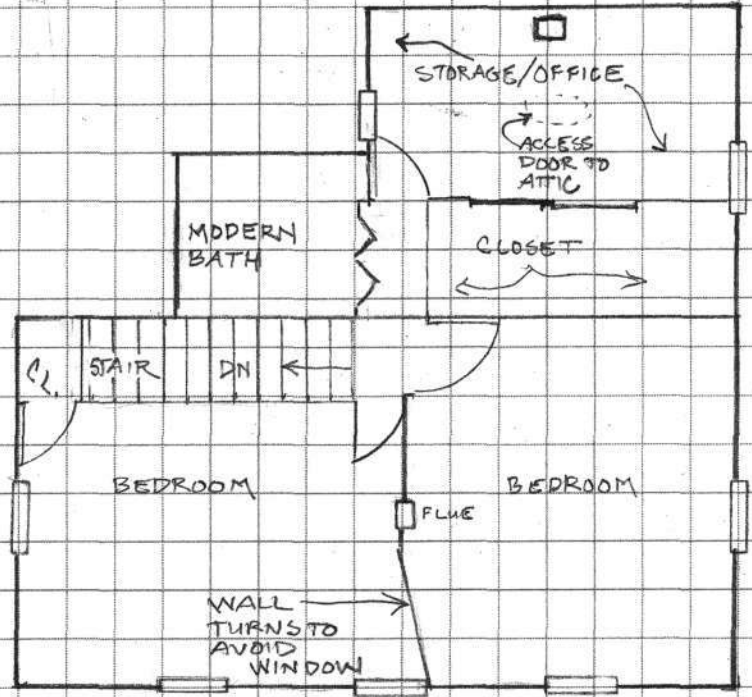
HOUSE - 1st + 2nd FLOOR PLANS
1/8" = 1' - SCALE
WOODSTOCK VIC. BALTIMORE CO.

The two story T-shaped gable roofed house, located approximately 40 feet north of the corncrib, dates from the late 19th - early 20th century. The house faces the road in a direction that is unlike the barn and corncrib in its plan/ orientation and may post date the barn and corncrib. While massing, location and setting are intact, certain character defining features have been altered/ removed. These include: replacement of 2/2 double hung sash windows with vinyl double hung sash windows; enlargement and replacement of front and rear exterior doors/transoms; removal and replacement of turned and bracketed front entry porch; original German wood horizontal siding replaced/ covered by vinyl horizontal siding; replacement of wood window shutters with plastic; alteration of first floor front rooms to open floor plan/ expose chimney. Of significance is the retention of the following: exterior gable end fishscale shingle, interior enclosed staircase, second floor plan and woodwork, interior door and window architraves with turned bulls-eye corner blocks.

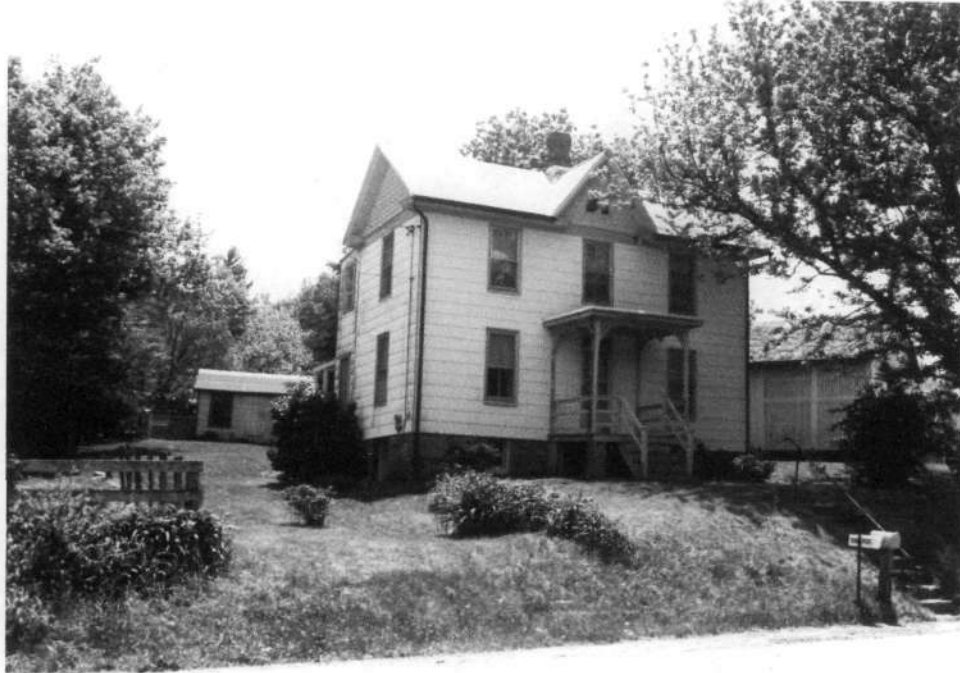
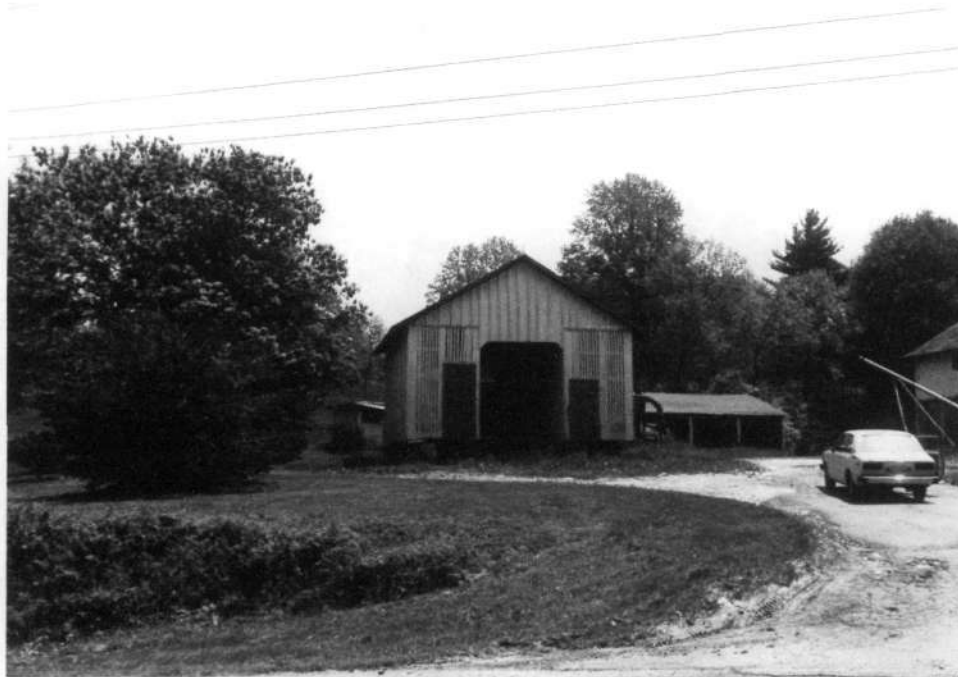
**WARFIELD FARM COMPLEX, BA-1582, C. 1978-79. 1- HOUSE AND 20TH C. SHED
PRIOR TO ALTERATIONS, 2- MACHINE SHED & CHICKEN SHED EAST OF CORN CRIB,
PRIOR TO DEMOLITION, & NORTHEAST SECTION OF BANK BARN**

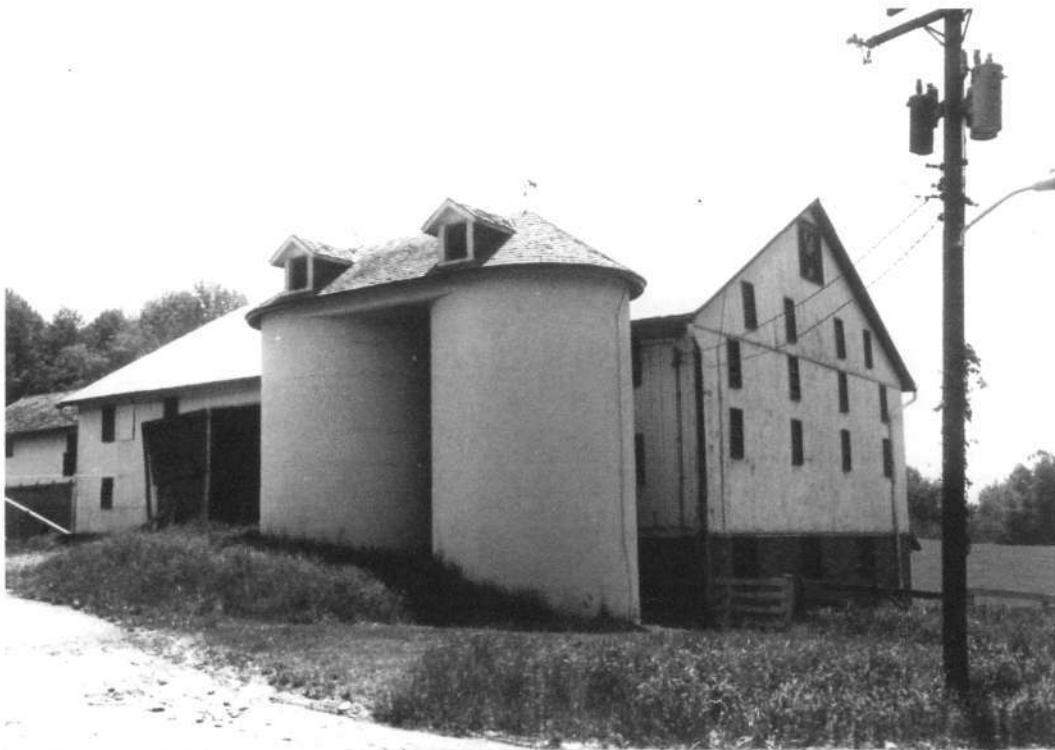
WARFIELD FARM COMPLEX, BA-1582, 1- BANK BARN, INTERIOR, C. 1993 PRIOR TO CURATORSHIP OCCUPANCY, 2- BANK BARN, 1998, UNDER ALTERATION / CURATORSHIP
ALL PHOTOGRAPHS COURTESY DNR

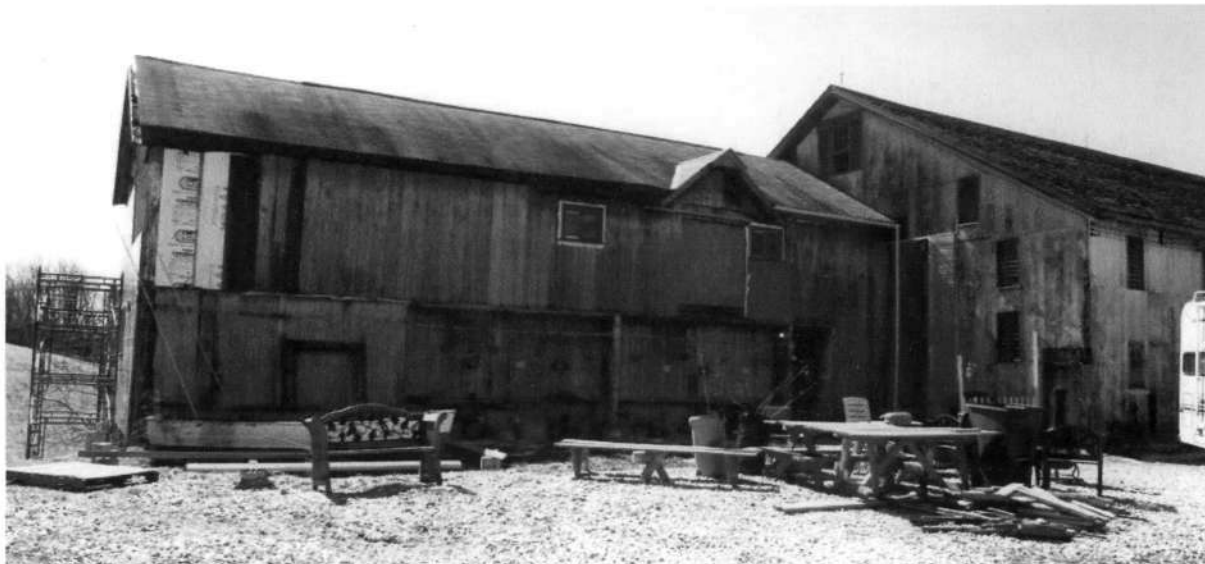
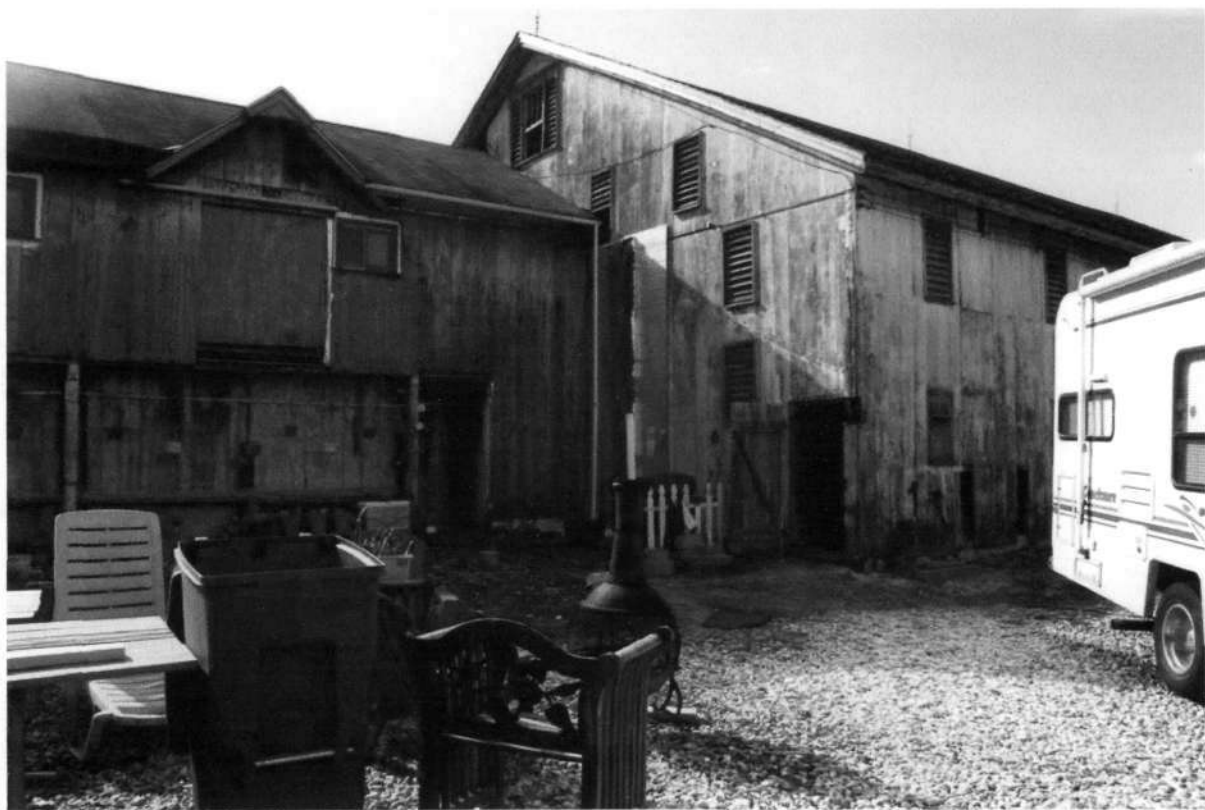
WARFIELD FARM COMPLEX, BA-1582, BANK BARN, EXTERIOR VIEWS 2007-2008
ALL PHOTOGRAPHS COURTESY DNR

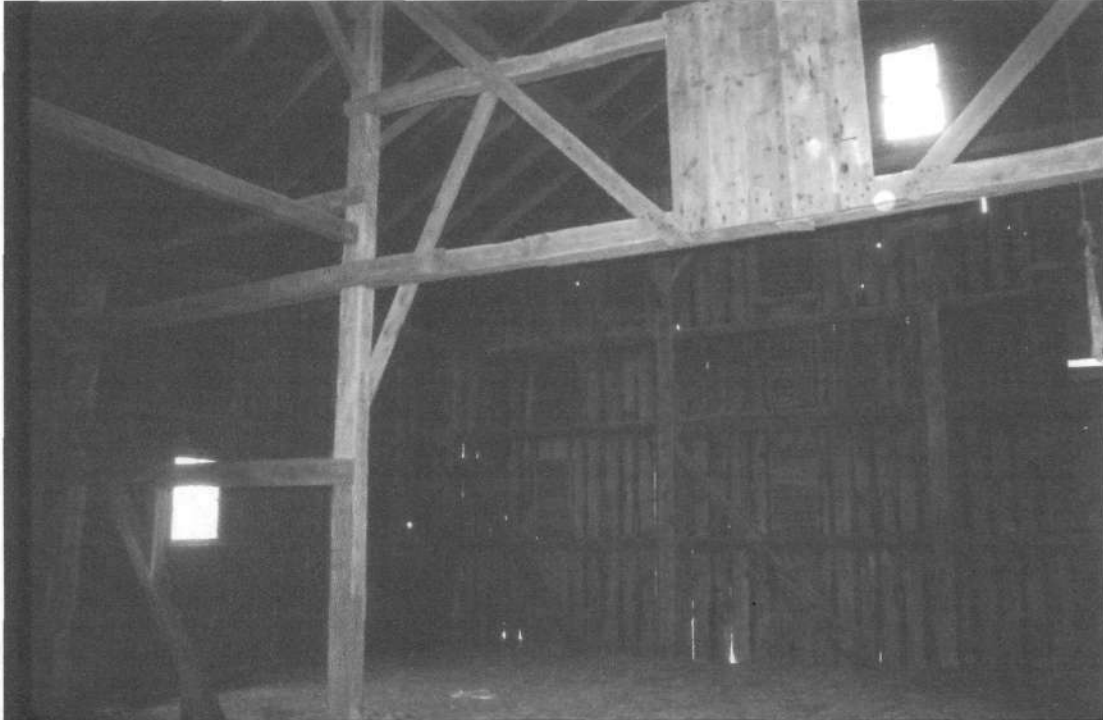
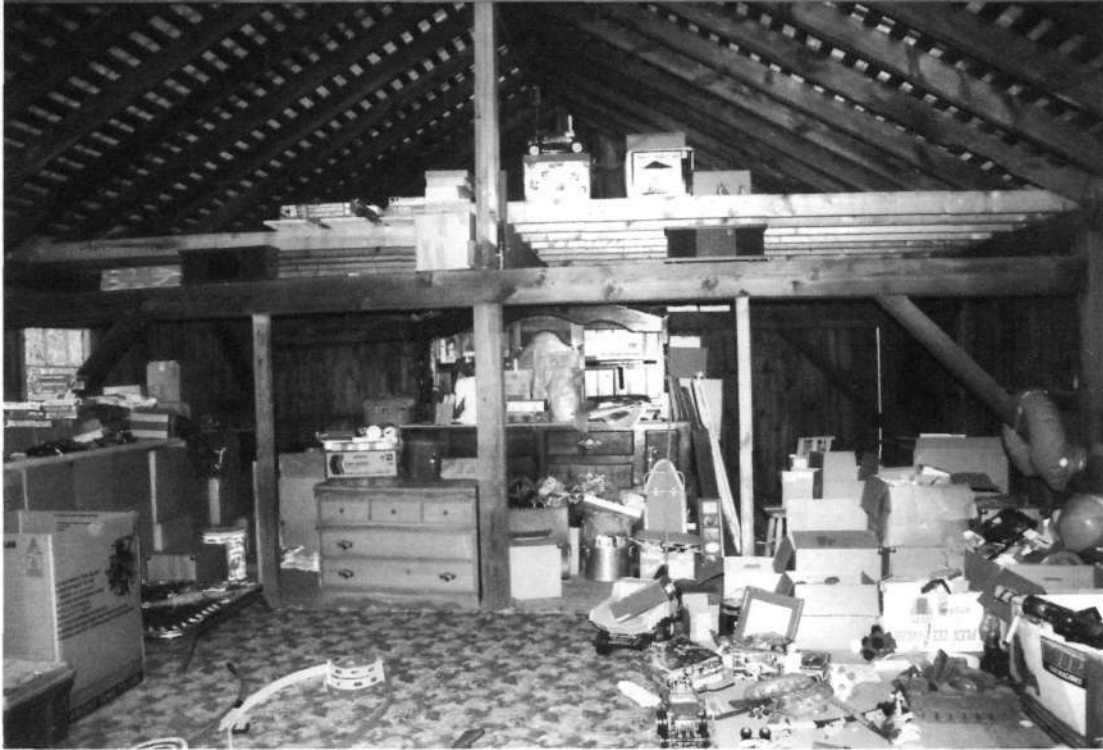
WARFIELD FARM COMPLEX, BA-1582, BANK BARN, INTERIOR VIEWS 2007-2008
ALL PHOTOGRAPHS COURTESY DNR

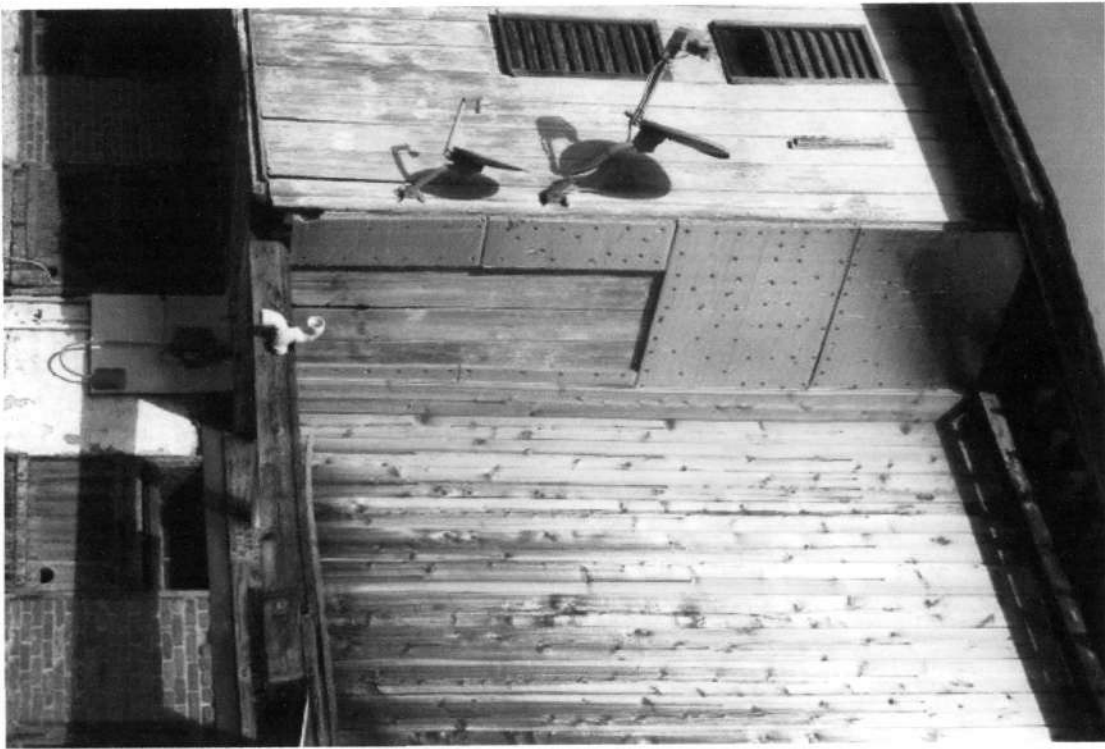
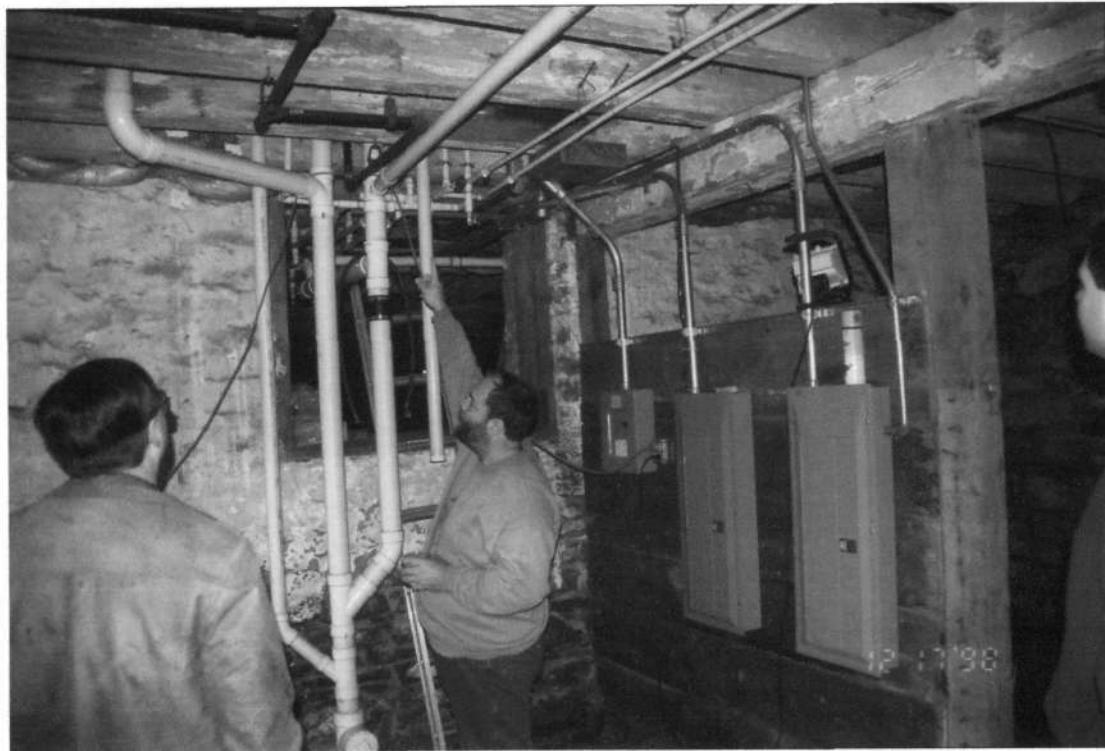
PHOTOGRAPHS OF WARFIELD CORNCRIB, MACHINE SHED AND BANK BARN,
WOODSTOCK. TOP- COURTESY OF PATAPSCO VALLEY STATE PARK, UNDATED.
BOTTOM- MIHP FORM, 1978-79.

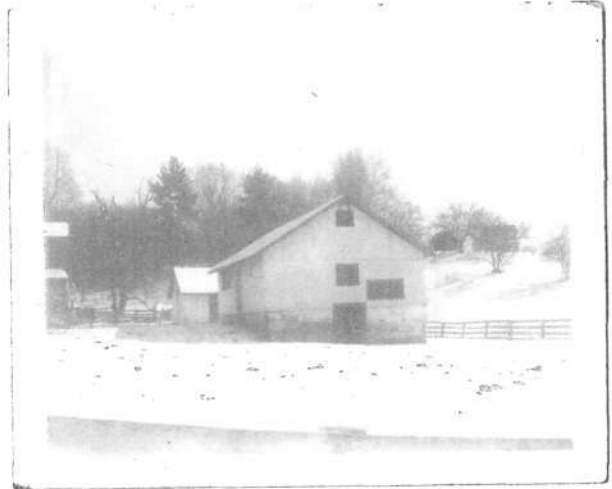
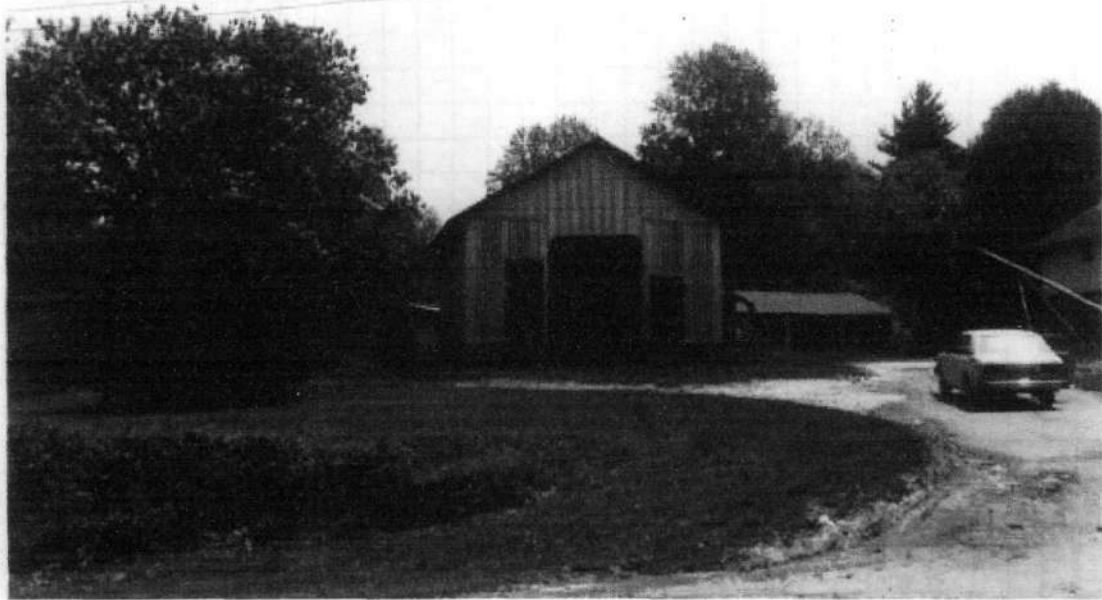
PHOTOGRAPHS FROM THE COLLECTION OF JOE WARFIELD,
PREVIOUS OCCUPANT OF WARFIELD FARM COMPLEX, c. 1940's - 1950's
SHOWING HOUSE, CORNCRIB AND MACHINE SHED

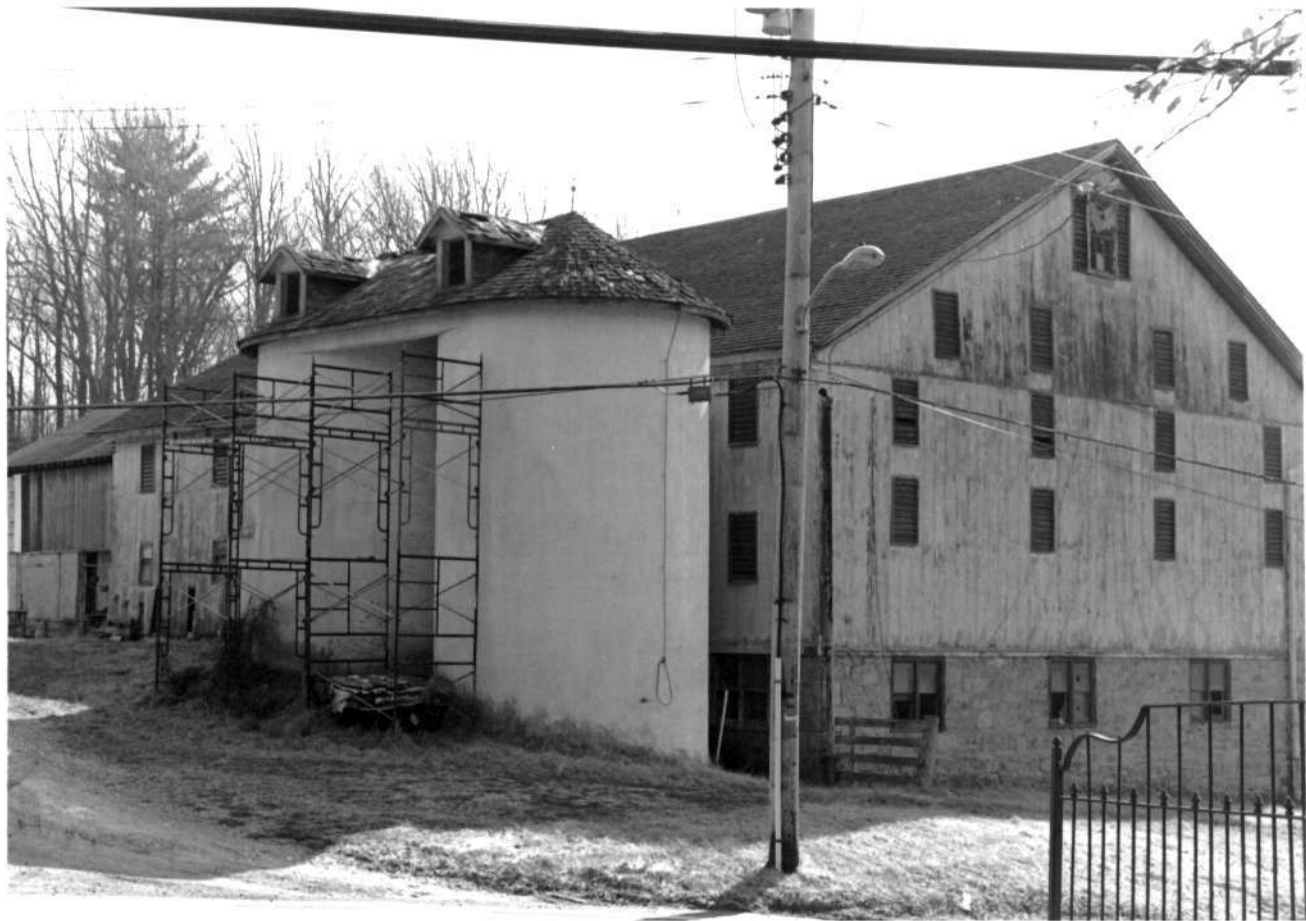
BA-1582
WARFIELD FARM COMPLEX
PATAPSCO VALLEY SP
WOODSTOCK, BALTIMORE CO,
BANK BARN - N. + W. FACADES
C.A. MASEK

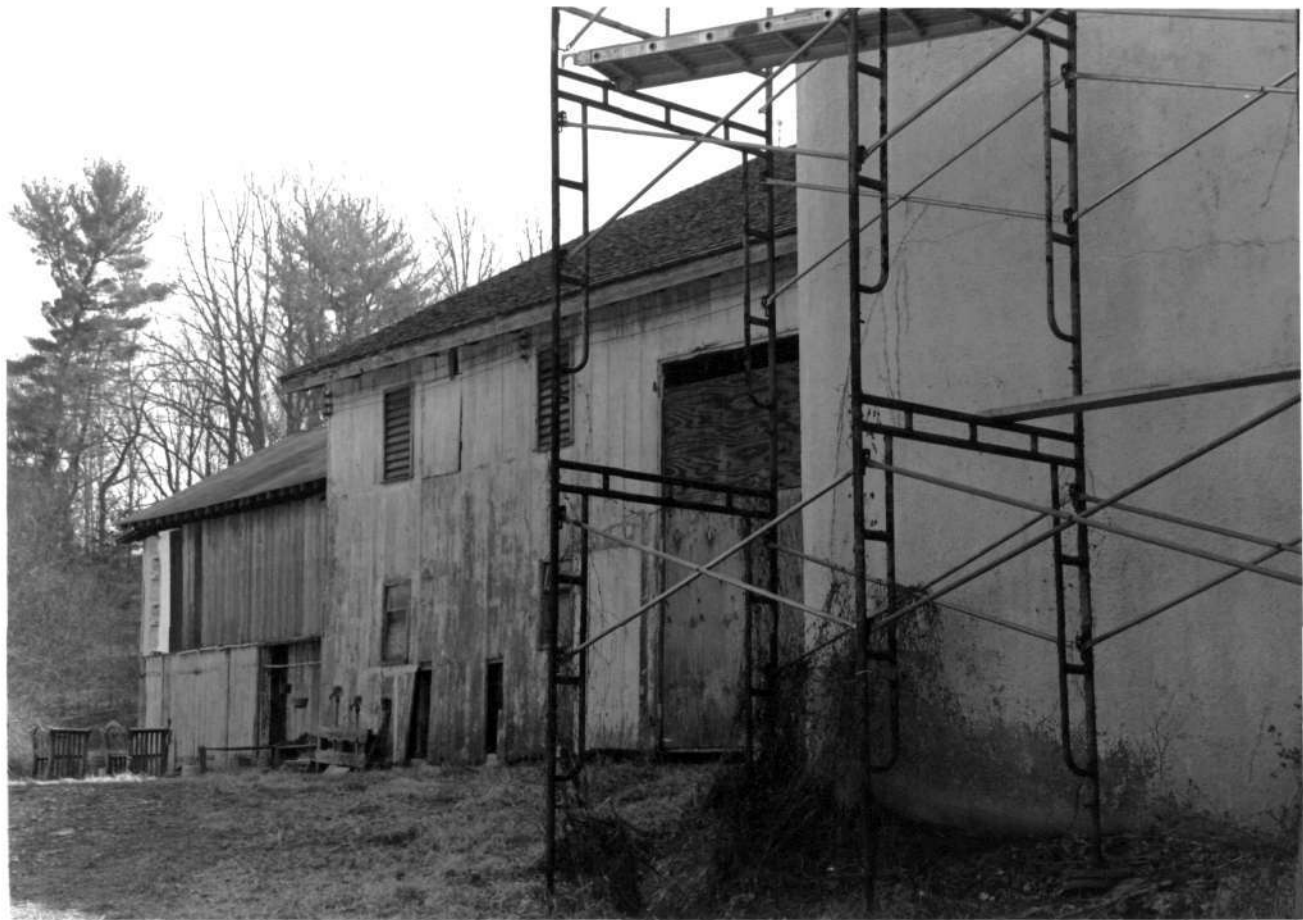
BA-1582
WARFIELD FARM COMPLEX
PATAPSCO VALLEY SP
WOODSTOCK, BALTIMORE CO.
BANK BARN - DETAIL - N. FACADE
C.A. MASEK
2/09
MD SHPO
7 of 8
