# Maryland Historical Trust

## State Historic Sites Inventory Form

historic Wilson Farmand/or common N/A

Survey No. PG 72-44

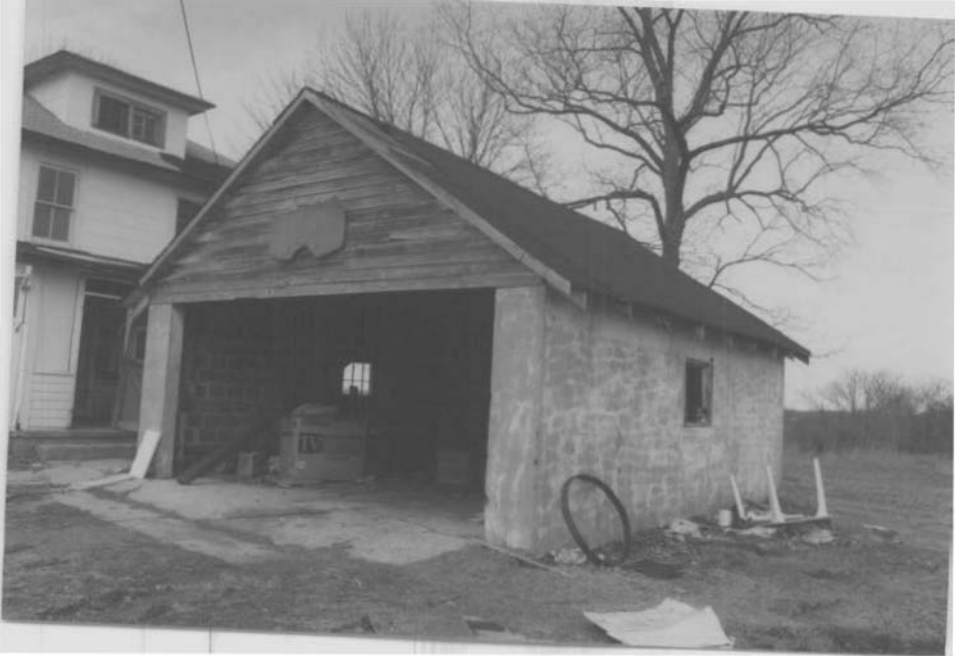
PG 72-44  
Wilson Farm  
Pr. Georges Co., MD  
Eliza Burden  
Feb. 1996  
View NW, Bldg. 4  
3 of 14

Building 4, erected ca. 1950, closely resembles Building 2. The building is a two-bay, concrete block garage constructed on a concrete slab (Figure 5). The garage is located directly behind Building 3 and faces south. On the exterior, the concrete walls are sheathed in a smooth coat concrete stucco. The gable peaks are clad with wood clapboards. A single window opening is located on each side elevation. A fixed four-light wood sash remains on the west elevation; no sash remains in the east elevation opening.

The building is in fair condition. The stucco exterior walls are cracking and the roof and clapboards are deteriorating.

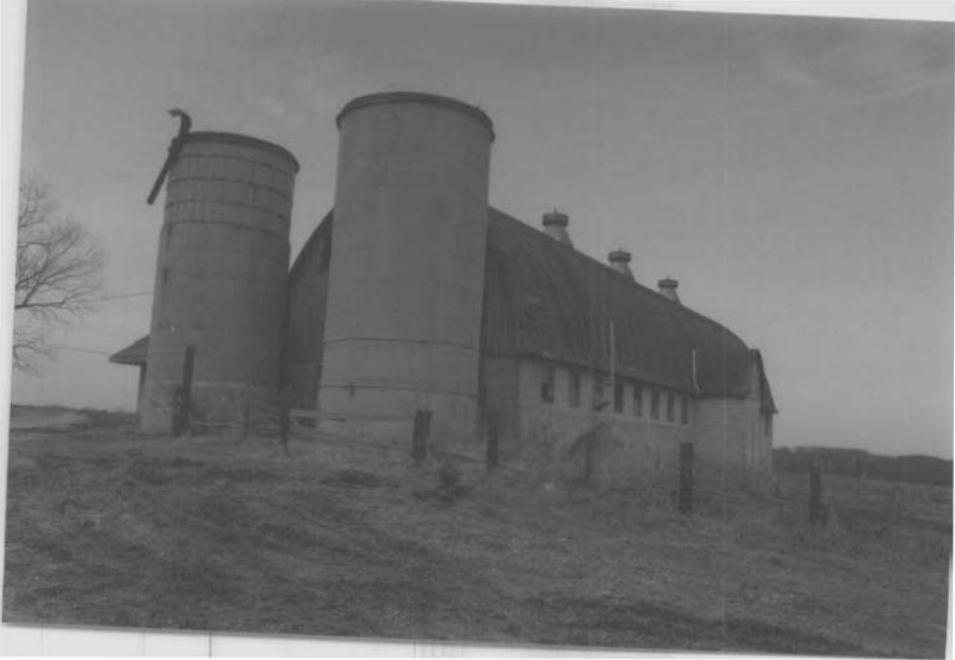
PG 72-44  
Wilson Farm  
Pr. Georges Co., MD  
Eliza Burdett  
Feb. 1996  
View NE, Bldg. 5  
4 of 14

The Dairy Barn, constructed ca. 1950, is the largest building in the Wilson Farm complex. It consists of two sections: the main barn and the creamery. The main barn is a rectangular, two and one-half story building that terminates in a gambrel roof (Figure 6). The creamery is a smaller, one-story building projecting from the south end of the barn's west elevation (Figure 7).

The main barn is oriented on a north-south axis. The walls of the barn are concrete block; the ends of the building are clad in standing seam metal siding. The roof is sheathed in composition roll roofing; four ventilators are located along the roof ridge. The two primary entrances to the barn are located on the north and south ends of the building. A wood sliding door is located at each opening. Windows on the barn are metal sash. Lintels are concrete and sills are red brick. The interior floor of the main barn is poured concrete. Feeding troughs extend along the walls.

Two small, two-story projections are located on the east and west elevations of the main barn. These gambrel roof projections link the first and second floors of the barn. They were used as a means for hay from the second floor of the barn to be delivered to the first floor feeding areas.

The creamery on the barn's west elevation occupies a rectangular footprint and terminates in a side gable roof. This three-bay by one-bay structure faces south and, like the main barn, is constructed of concrete block. A single door is located along the structure's south and east elevations. A broad overhanging eave on the south and east elevations shelters the doorways and forms a breezeway to the main barn. The roof of the creamery is sheathed in asphalt shingles. A single metal ventilator is centered on the roof ridge. Glazed tiles cover the interior walls of this structure. The building is in fair condition.

Though deterioration has altered the appearance of the Wilson dairy barn and creamery, it is apparent that these structures were constructed to adhere with the standards of sterility that were promoted during the 1920s and 1930s.

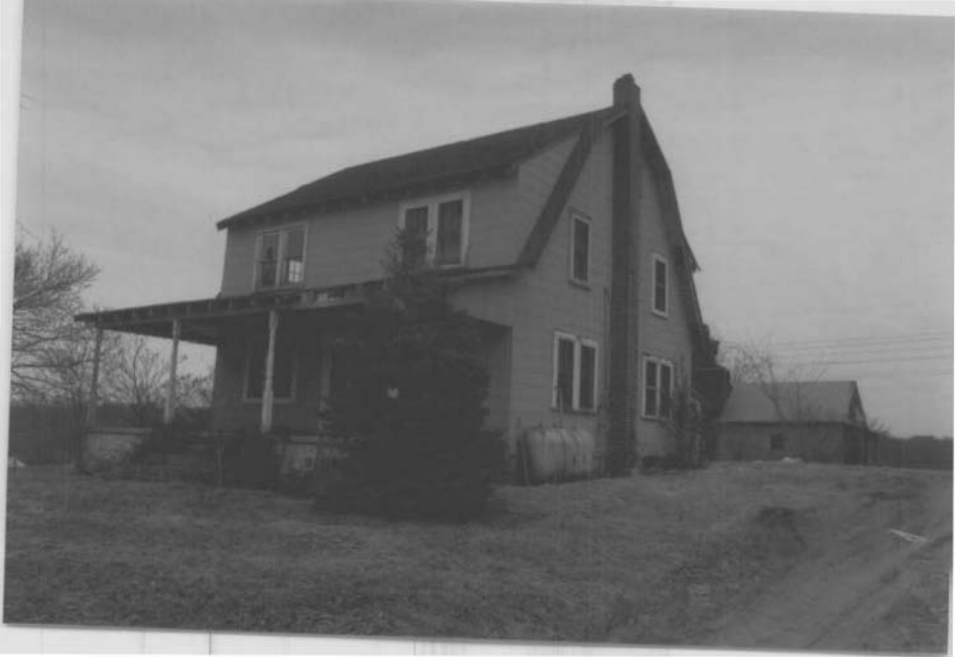
1 of 14

Building 1, constructed ca. 1930, is a two-story wood frame house terminating in a side gambrel roof (Figure 3). The three-bay by two-bay building is constructed on a concrete block foundation and faces west. The exterior walls of the building are clad with synthetic shingles. The roof is sheathed in asphalt shingles. An exterior brick chimney is centered on the building's south elevation. Windows in the building are six-over-one light double-hung wood sash.

The front elevation is characterized by a full-width shed dormer and an open porch. The front three-bay porch extends the full-width of the west elevation. It terminates in a shed roof and is supported by simple turned wood posts. The primary entrance is centered along the front facade. A single rear entrance is sheltered by a similar two-bay shed roof porch. The building is in fair condition.

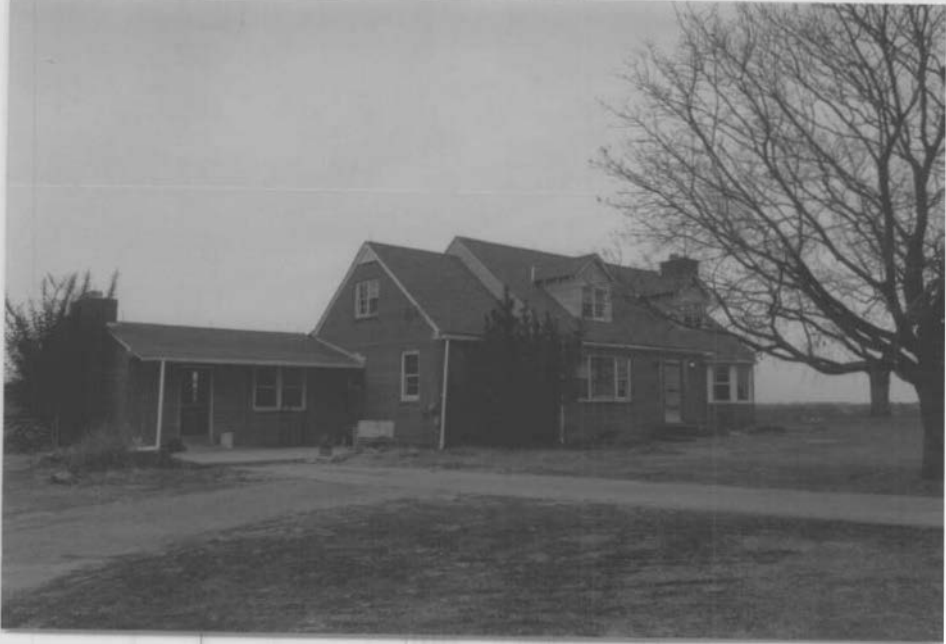
8 of 14

Building 8 is a one and one-half story, brick house that adopts a "Cape Cod" form (Figure 10). The dwelling faces east. The building was erected ca. 1950. The principal block of the building is a rectangular, three-bay by one-bay dwelling that terminates in a side gable roof. Two gable dormers are located along the front elevation; a full-width shed dormer is located on the rear elevation. The dormers are clad with synthetic shingles. The primary entrance to the dwelling is centered on the front facade. Glass block sidelights flank the doorway. A bay window is located on both the front and rear elevations of this principal block.

Two gable roof extensions project from the south end of the building's principal block. A secondary entrance is located on the southernmost projection.

The windows throughout the building are two-over-two light double-hung wood sash. A brick exterior chimney is located at both the north and south ends of the dwelling. The building is in fair to good condition.

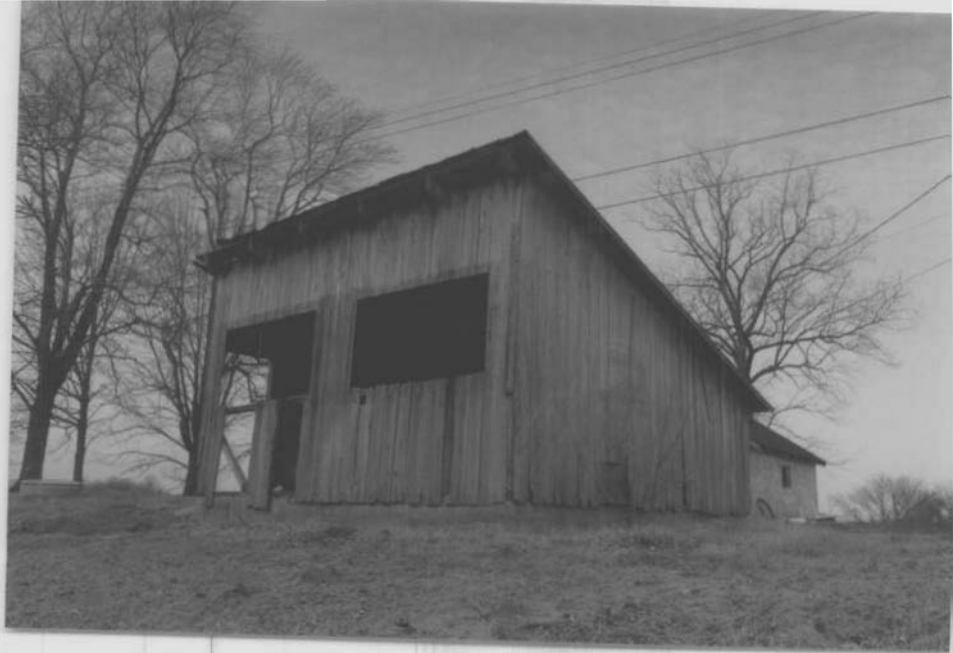
7 of 14

Building 7 is a one-story, wood frame chicken coop that terminates in a shed roof (Figure 9). The structure was built ca. 1950 and faces south. The roof slopes to the rear (north) and is sheathed in standing seam metal. The walls of the structure are clad with vertical wood siding. Two rectangular cutouts on the south elevation are enclosed with chicken wire. A single door opening is located on the west elevation; no door remains. The building is in fair condition. The vertical wood is deteriorating.

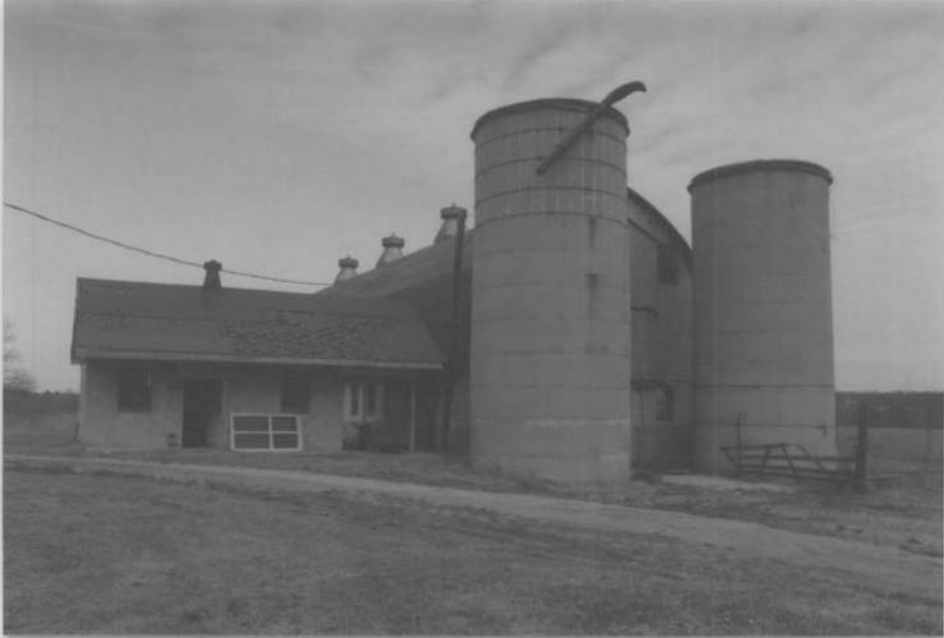
5 of 14

View northeast, Dairy Barn & Creamery  
(Bldg. 5)

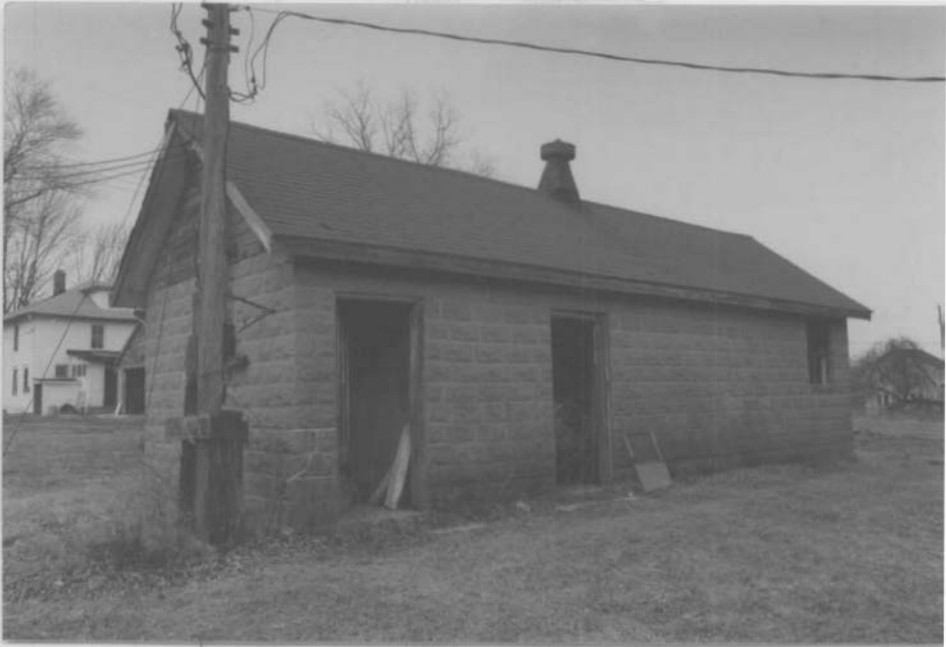
6 of 14

Building 6 is a rectangular, one-story structure located southwest of the Dairy Barn and facing east (Figure 8). The building dates from ca. 1950. The two-bay by one-bay building is constructed of concrete block on a concrete slab and terminates in a side gable roof. Wood clapboards occupy the gable peaks. The roof is sheathed in asphalt shingles.

An interior brick chimney is located near the south end of the structure. A metal ventilator is centered on the roof ridge. The two entrances to the building are on the east elevation. One of the doors is missing. The door that remains is a 12-light wood door. The building contains a combination of metal sash and wood sash windows. The metal sash windows are four-light hoppers; the wood sash windows are four-light fixed sash. The building is in fair condition.

View northwest, Bldg. 6

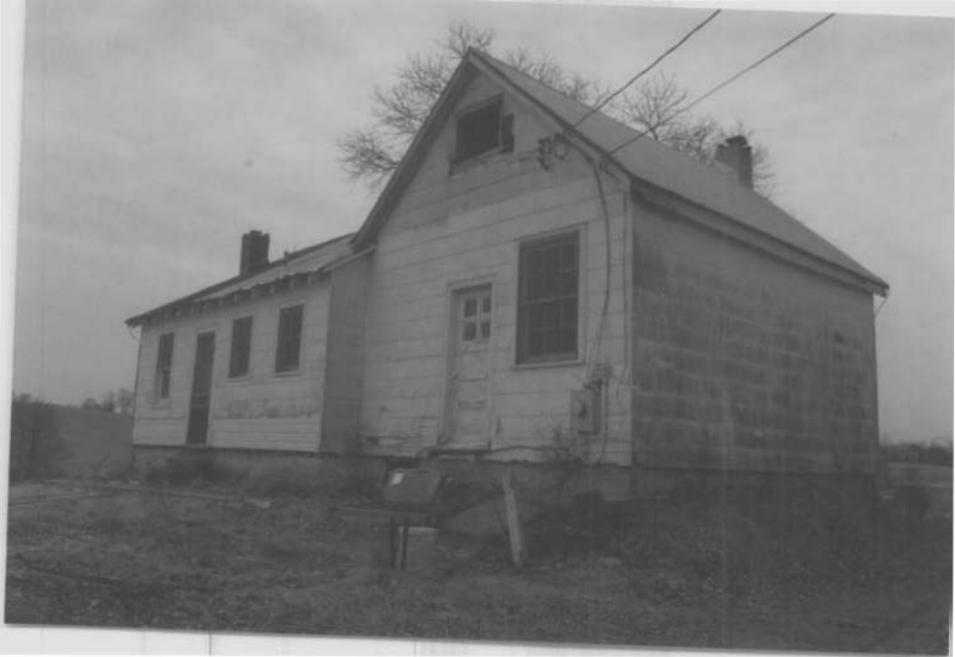
9 of 14

Building 9 is a one-story, wood frame house constructed in two phases, ca. 1930 and ca. 1950 (Figure 11). The earlier part of the house occupies a rectangular plan and is oriented on an east-west axis with a front gable roof. A single door entry is located on both the east and west elevations. Both doors are original to the dwelling. The door on the east elevation is a four-light panelled wood door; the door on the west elevation is a six-light panelled wood door. The windows in this earlier section are six-over-six light, double-hung wood sash. A poured concrete interior chimney is located at the west end of the dwelling.

The second part of the house is rectangular in plan, faces east, and terminates in a side gable roof. The rear elevation is flush with the west elevation of the earlier section. A single wood door with a diamond pane is located on the east elevation. Windows in this section of the building are six-over-one light, double-hung wood sash. An interior brick chimney is located at the south end of this section.

Synthetic shingles cover the original wood clapboards on the exterior walls of the dwelling. The roof of the earlier section is sheathed in corrugated metal; the roof of the later section is sheathed in standing seam metal. The dwelling is in fair condition.

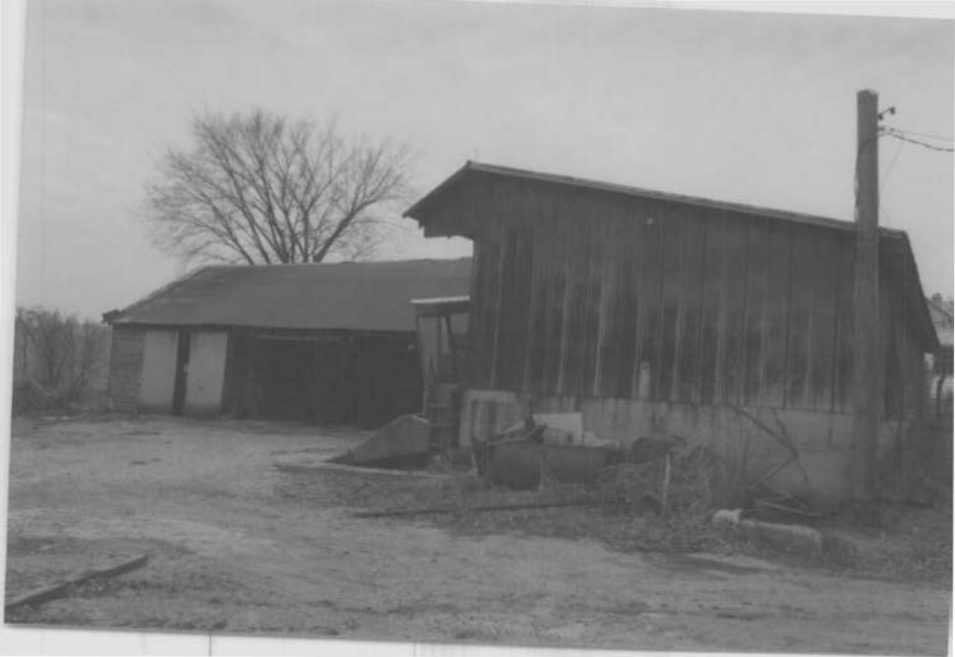
10 of 14

Building 10 is an L-shaped structure constructed in two phases, ca. 1930 and ca. 1950 (Figure 12). The first section is a five-bay open shed facing south. It is constructed of wood on a poured concrete foundation. The walls are clad with metal panels and terminate in a standing seam metal shed roof.

The second section also is five bays wide but faces east. This section is constructed of concrete block and terminates in a standing seam metal gable roof. This section is open with the exception of the southernmost bay, which is enclosed. Corrugated metal sliding doors provide entry into this bay. The only windows are located in the enclosed portion of this structure. These are eight-over-eight light wood sash. The barn is in fair condition.

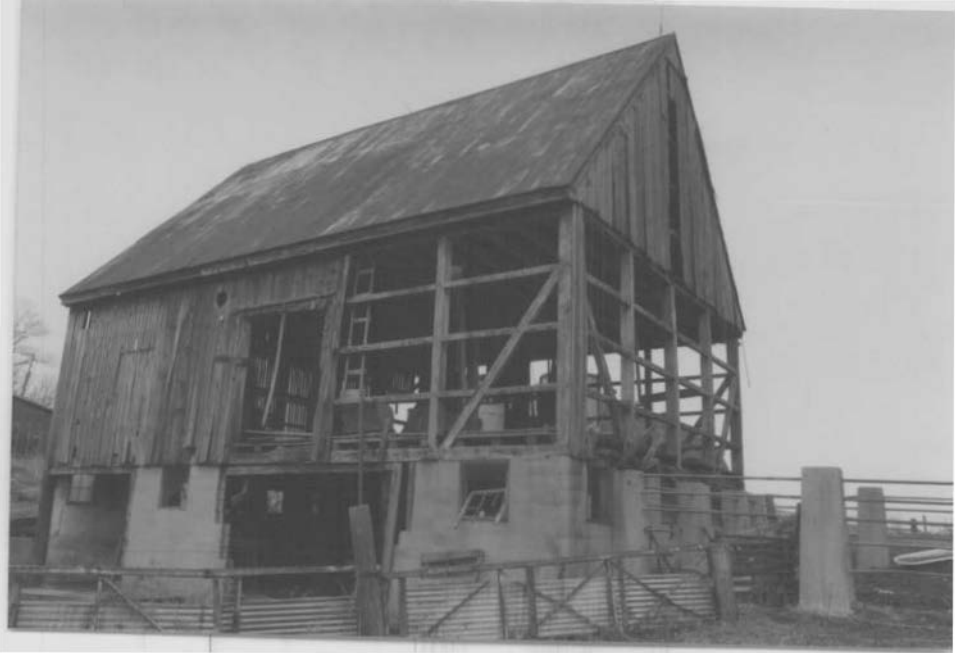
11 of 14

Building 11 is a two-story timber frame barn constructed ca. 1930 (Figure 13). The barn is rectangular in plan and terminates in a side gable roof. It is built into the hillside and opens to the south. The building sits on a concrete block foundation. The walls are clad with vertical wood siding. The roof is sheathed in corrugated metal.

The building was designed with feeding areas at ground level and hay storage on the upper level. Two wide openings are located on the south elevation at ground level. Six-light fixed wood sash windows along the foundation walls provide light into the feeding areas of the barn. A fenced-in area is situated east of the barn.

The building is in poor condition. The metal roofing is corroded and much of the wood siding is missing, particularly along the east end of the barn.

View northwest, Bldg. 11

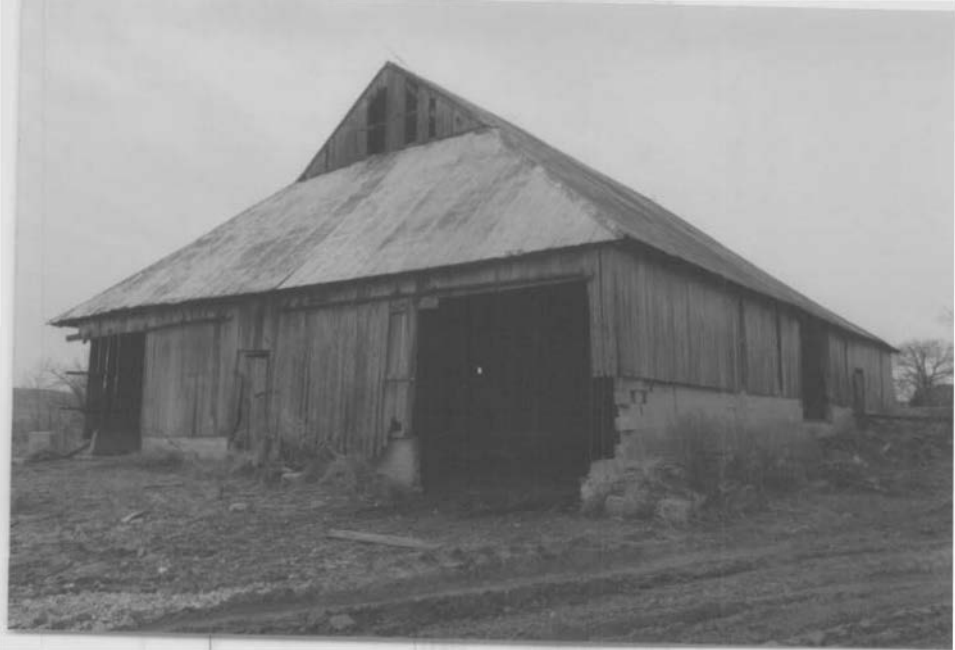
12 of 14

Building 12 is a one-story, wood frame barn constructed ca. 1930 (Figure 14). The building faces east. The barn occupies a rectangular plan and terminates in a gable-on-hip roof. The barn is clad with vertical wood siding and the roof is sheathed in corrugated metal. The barn sits on a concrete block foundation. Two wide openings with sliding wood doors are located on the east elevation. A smaller single wood door is centered between these wider openings. Secondary entrances are located on the north elevation; no doors remain.

The barn is in poor condition. The corrugated metal roofing is corroded and much of the wood siding is missing.

View southwest, Bldg. 12

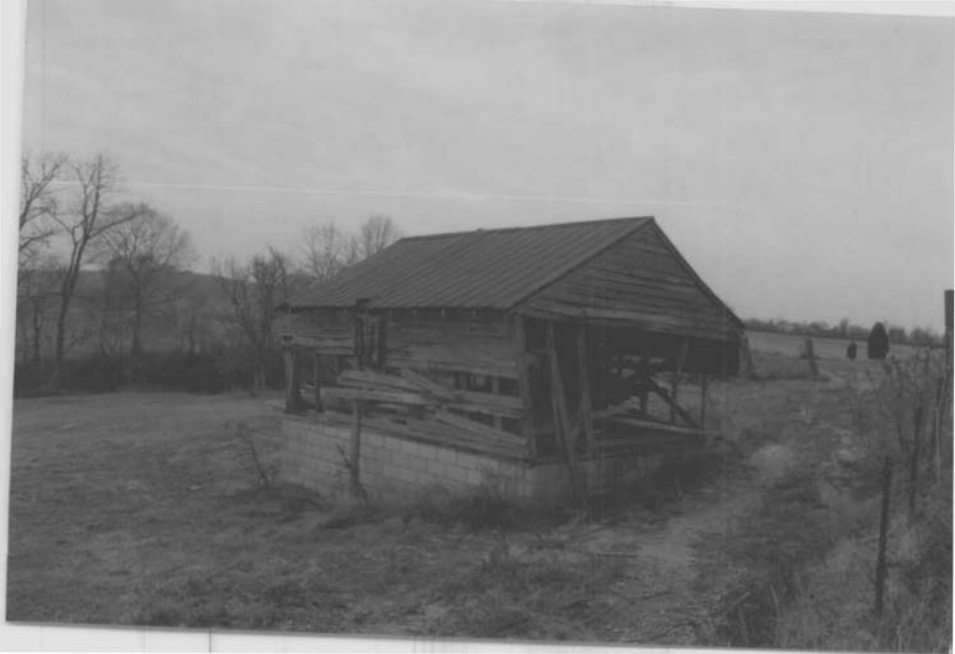
13 of 14

Building 13 is a one-story, wood frame shed constructed ca. 1930 (Figure 15). The building is rectangular in plan and faces south. It is constructed on a concrete block foundation and terminates in a front gable roof. The walls of the shed are clad with horizontal wood siding. The building is in poor condition. Most of the wood siding is missing and the wood frame is deteriorating. The deteriorated condition of the structure made it difficult to identify the original locations and number of openings.

| Photograph 13. | Building 13, facing southwest |

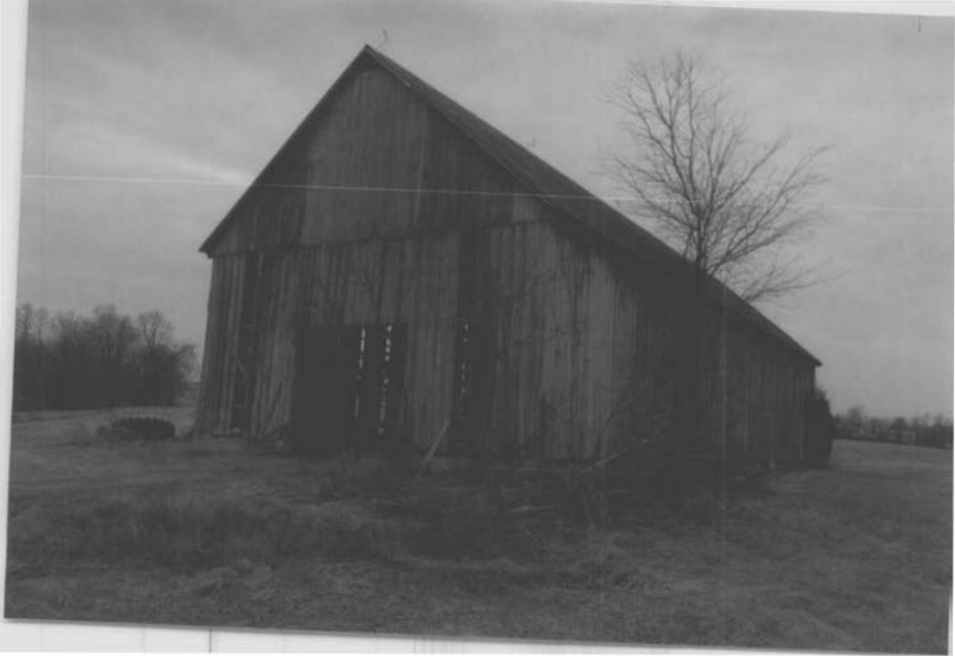
Building 14 is a tall, one-story, wood frame barn located southwest of the main cluster of buildings in the Wilson Farm complex (Figure 16). The building occupies a rectangular plan and is oriented on an east-west axis. The barn terminates in a front gable roof. The structure is clad with vertical wood siding and sits on a poured concrete foundation. The roof is sheathed in standing seam metal. A wide opening is located on both the east and west ends of the building. No doors exist. The interior of the barn is open with no partitions.

The structure is in fair condition. The building's frame is intact and most of the vertical siding is in place.

| Photograph 14. | Building 14, facing southwest |
