## Quindocqua Methodist Episcopal Church

### **Architectural Survey File**

National Register of Historic Places  
Registration Form

historic name QUINDOCQUA UNITED METHODIST CHURCH

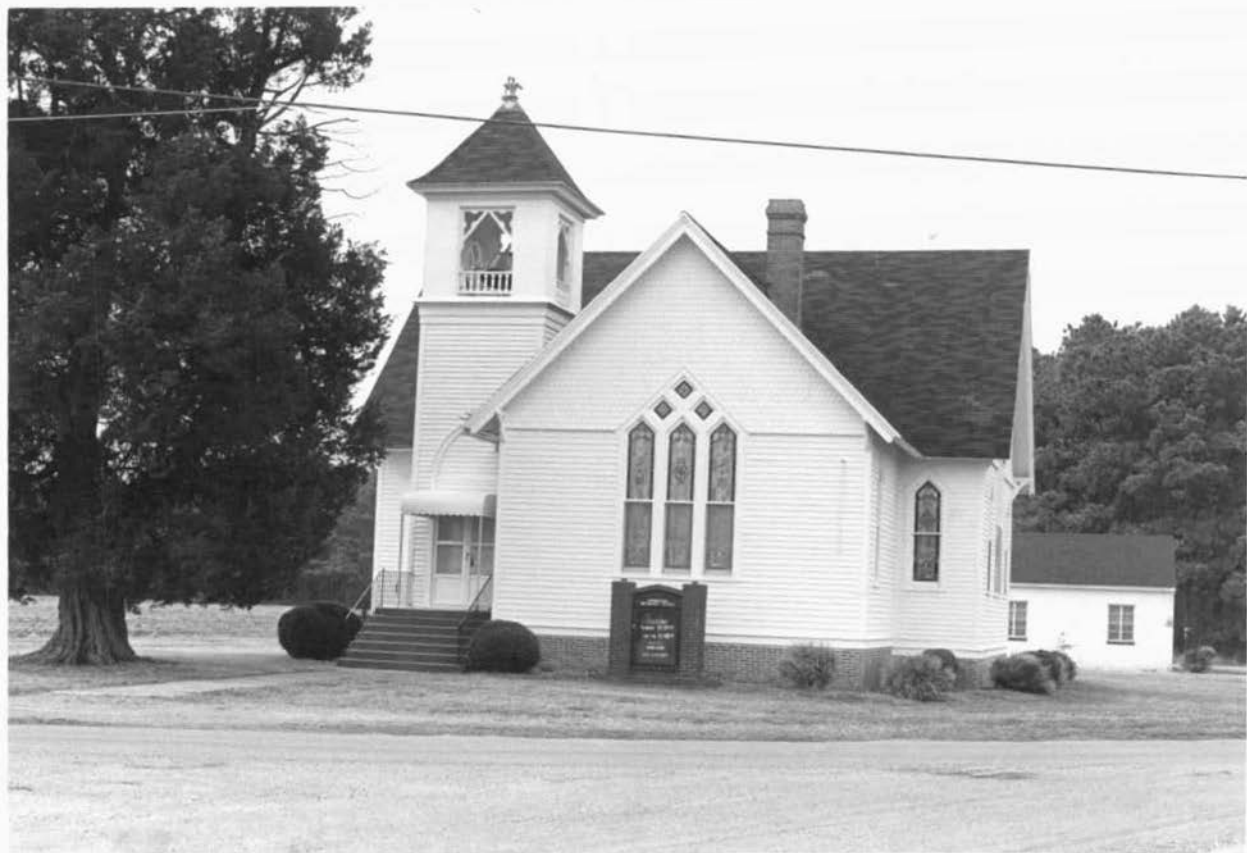
Quindocqua Methodist Church S-123  
Near Tulls Corner, Somerset County  
South Elevation  
4/85, Photographer, Paul Touart  
Neg./MD. Historical Trust

The principal elevation faces south. Centered in the gable-front wall is a tripartite colored glass window with three diamond panes above three lancet windows, which together form a large pointed arch. An interior brick stove chimney rises through the east slope of the roof. A marble cornerstone in the southwest corner of the brick foundation is inscribed with the dates 1829, 1847, and 1913.

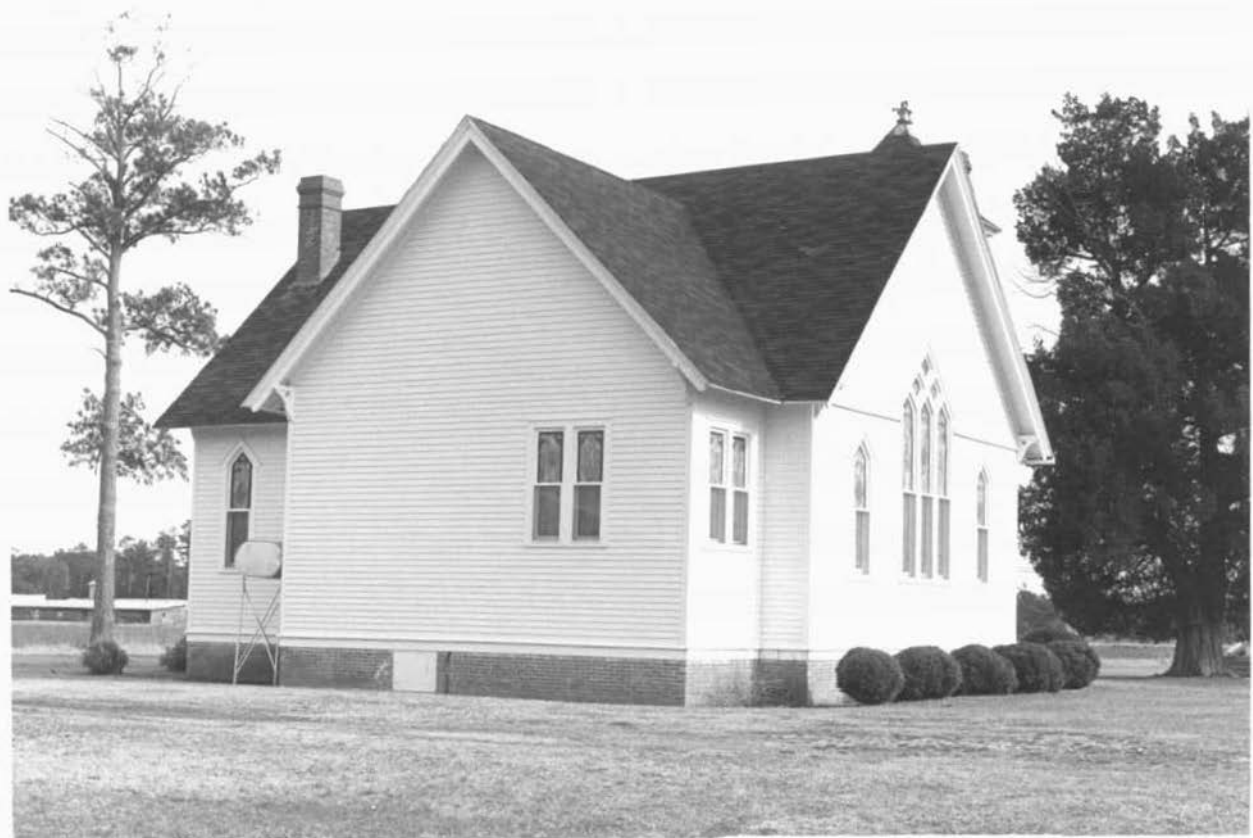
Quindocqua Methodist Church S-123  
Near Tulls Corner, Somerset County  
North Elevation  
4/85, Photographer, Paul Touart  
Neg./MD. Historical Trust

The north wall of the rear arm of the cruciform plan is unfenestrated, except for a pair of small colored glass windows offset to the west lighting the choir loft. The west wall has an identical pair of windows.

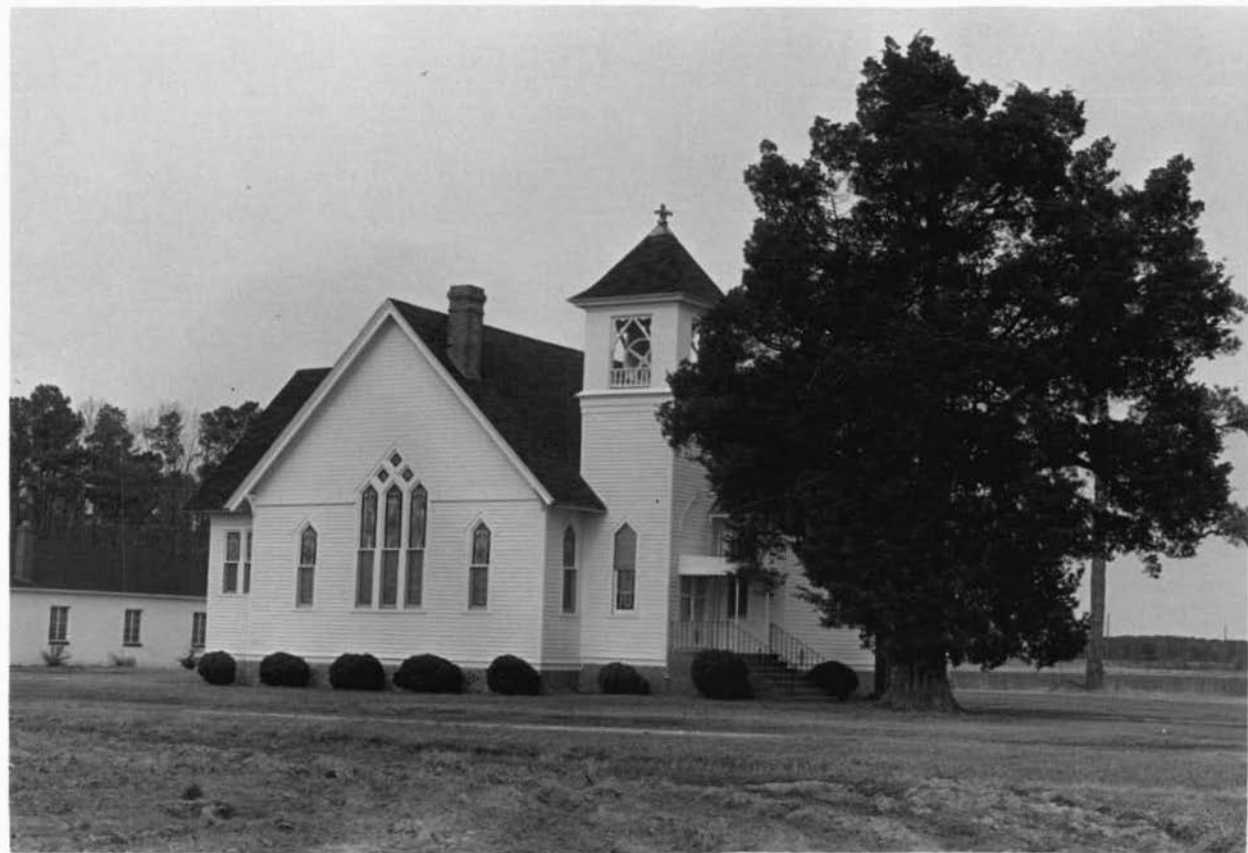
Quindocqua Methodist Church  
Near Tulls Corner, Somerset County  
Southwest Elevation  
4/85, Photographer, Paul Touart  
Neg/Md. Historical Trust

The south face of the tower is marked by a Gothic-arched double-door opening, now partially obscured by a metal awning. The second level of the tower is a plain weatherboard wall, while the third level is an open belfry. Each of the four open sides of the belfry has a turned post balustrade and corner brackets. The pyramidal roof of the tower is flared at its base, and it is topped by a three-dimensional fleur-de-lis metal cap.

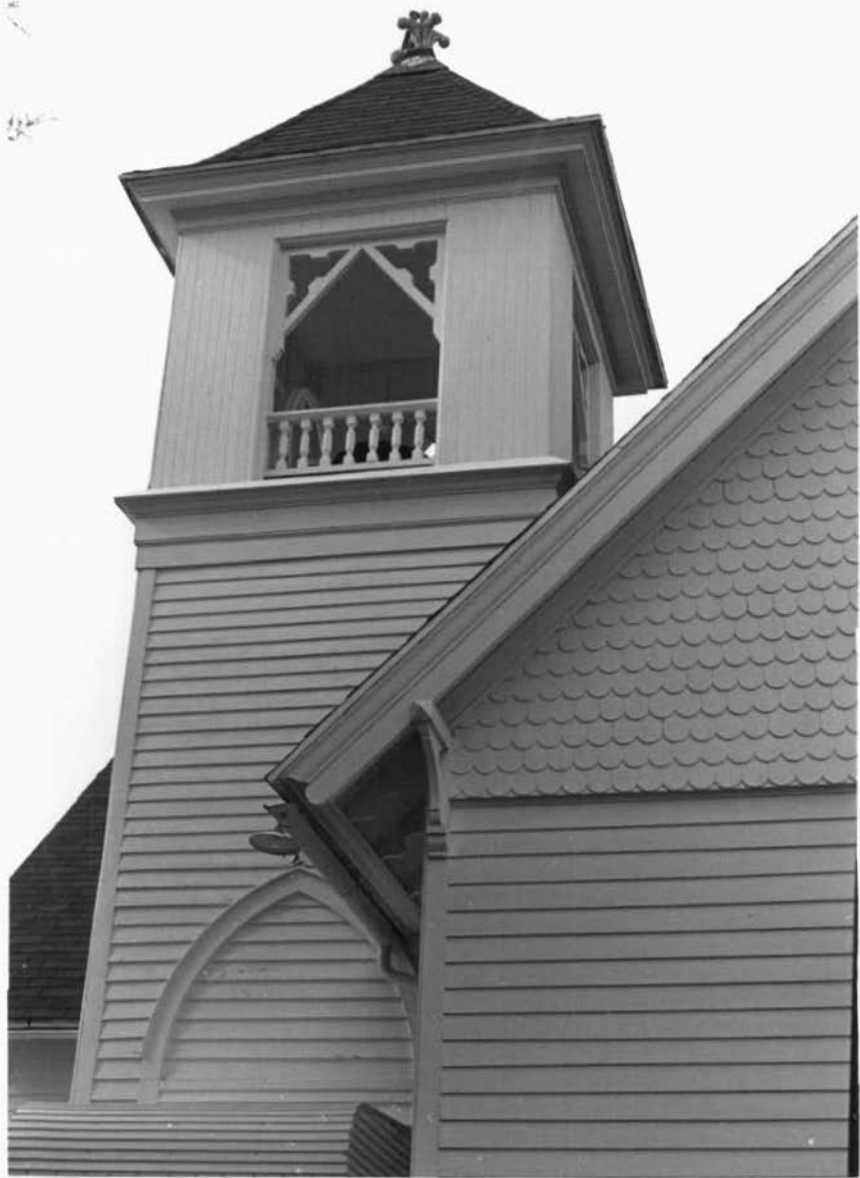
Quindocqua Methodist Church                    S-123  
Near Tulls Corner, Somerset County  
Bell Tower  
4/85, Photographer, Paul Touart  
Neg/Md. Historical Trust
