## Forest View (Roland Maxwell Farmhouse, Carl R. Myers House)

### **Architectural Survey File**

Forest View (HO-191)  
Name of Property

Howard County, MD  
County and State

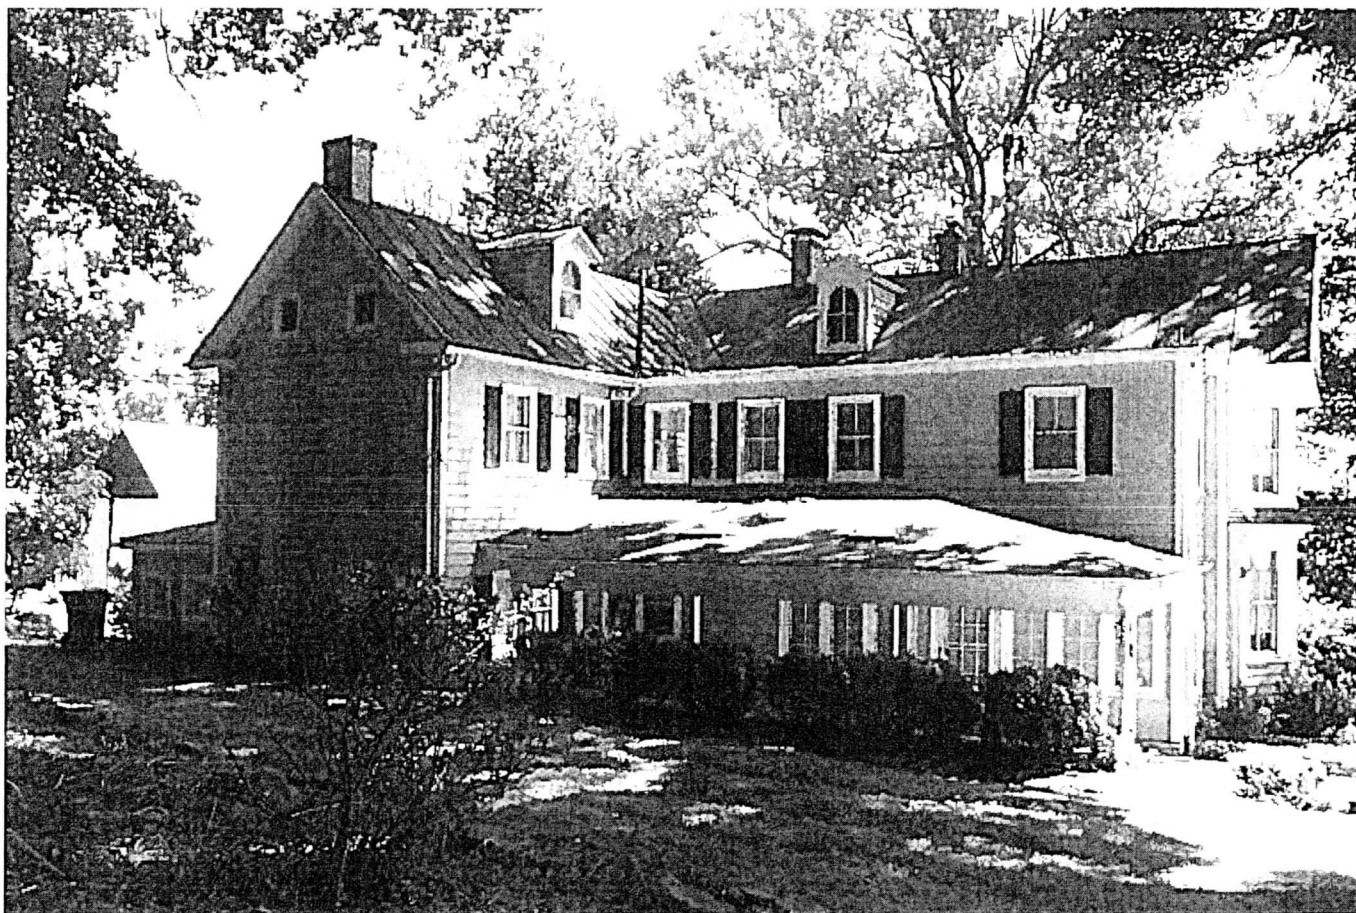
MD\_HowardCounty\_ForestView\_0003.tif  
House, south elevation (September, 2013)  
3 of 15

The south elevation of the ell has paired two-over-two sash to the west on the first story and a door to the east that has six lights over two lying panels. The second story has two two-over-two sash with blinds. There is a box cornice with returns and a dormer in the center that matches the end dormers on the east elevation. The west elevation of the ell has no openings on the first or second stories. There are two small one-light sash in the gable end. The foundation is parged.

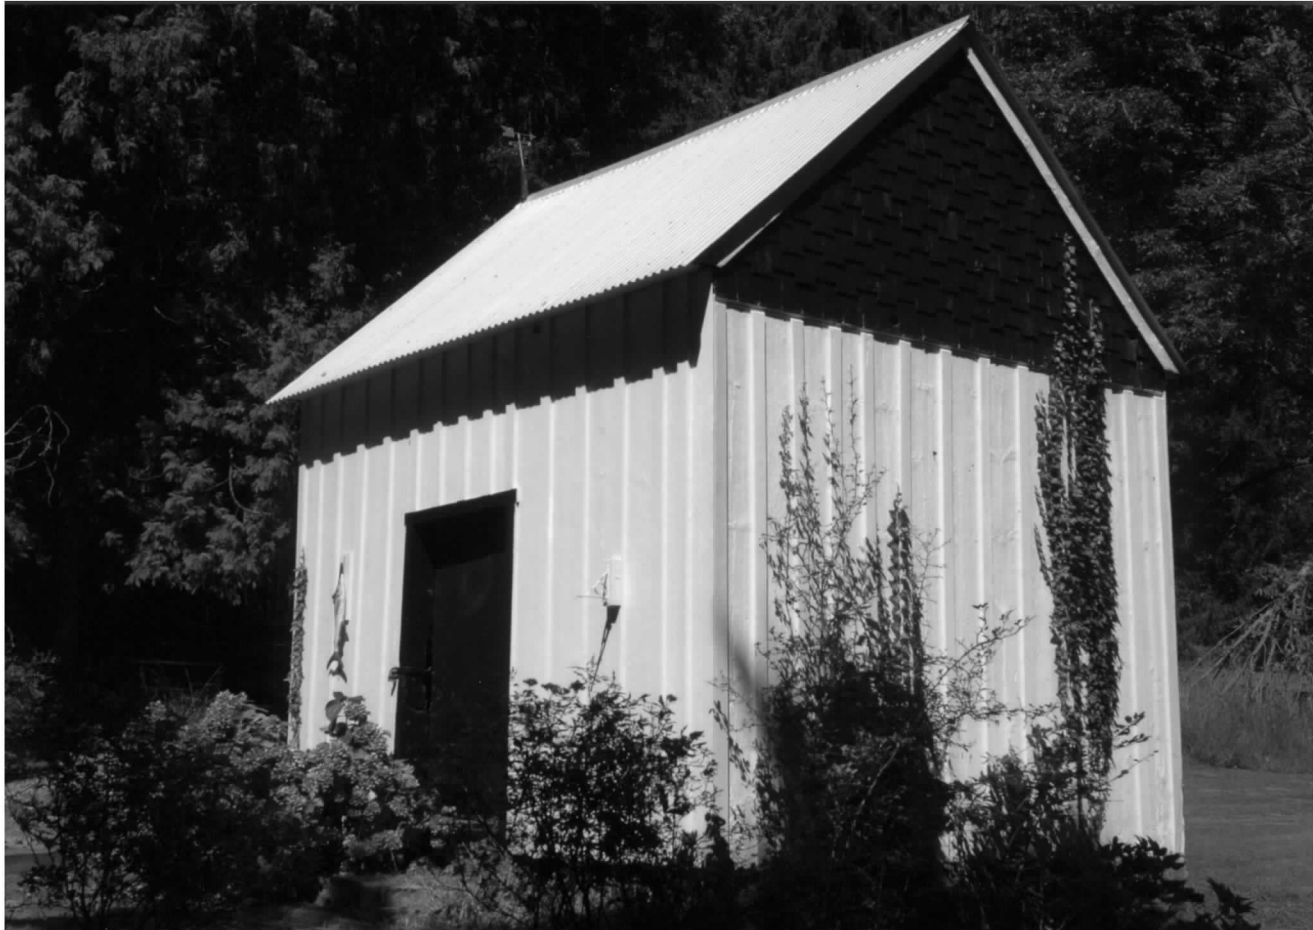
Smokehouse, south + east elevations

The smokehouse is located about 30 feet north of the house. It is a one-story, one-bay square frame building with a rubble stone foundation, board-and-batten siding, staggered-butt wood shingles in the gable ends, and a gable roof with corrugated metal and an east-west ridge. The south elevation has a vertical-board door hung on strap hinges with lima bean cusps. The east, west, and north elevations have no openings.

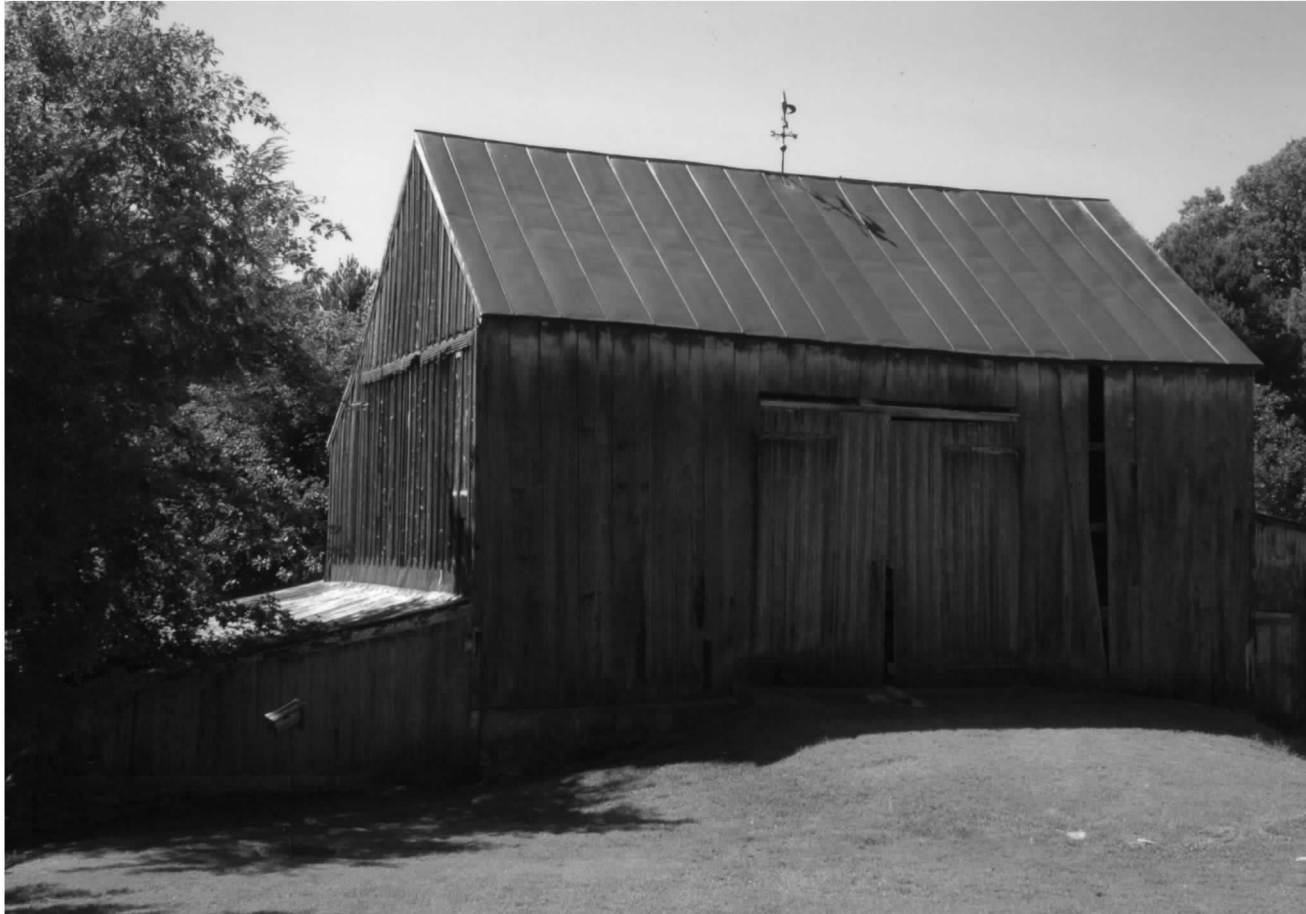
Barn, east + north elevations

The north elevation has a concrete repair to the east bay of the foundation, with a ramp in the center bay. The upper story center bay has wagon doors with beaded-edge-and-center vertical boards, hung on strap hinges that have lozenge ends. The siding is fastened with cut nails and has traces of red paint below traces of white paint, and the hinges have green paint below traces of white paint. The eaves are open.

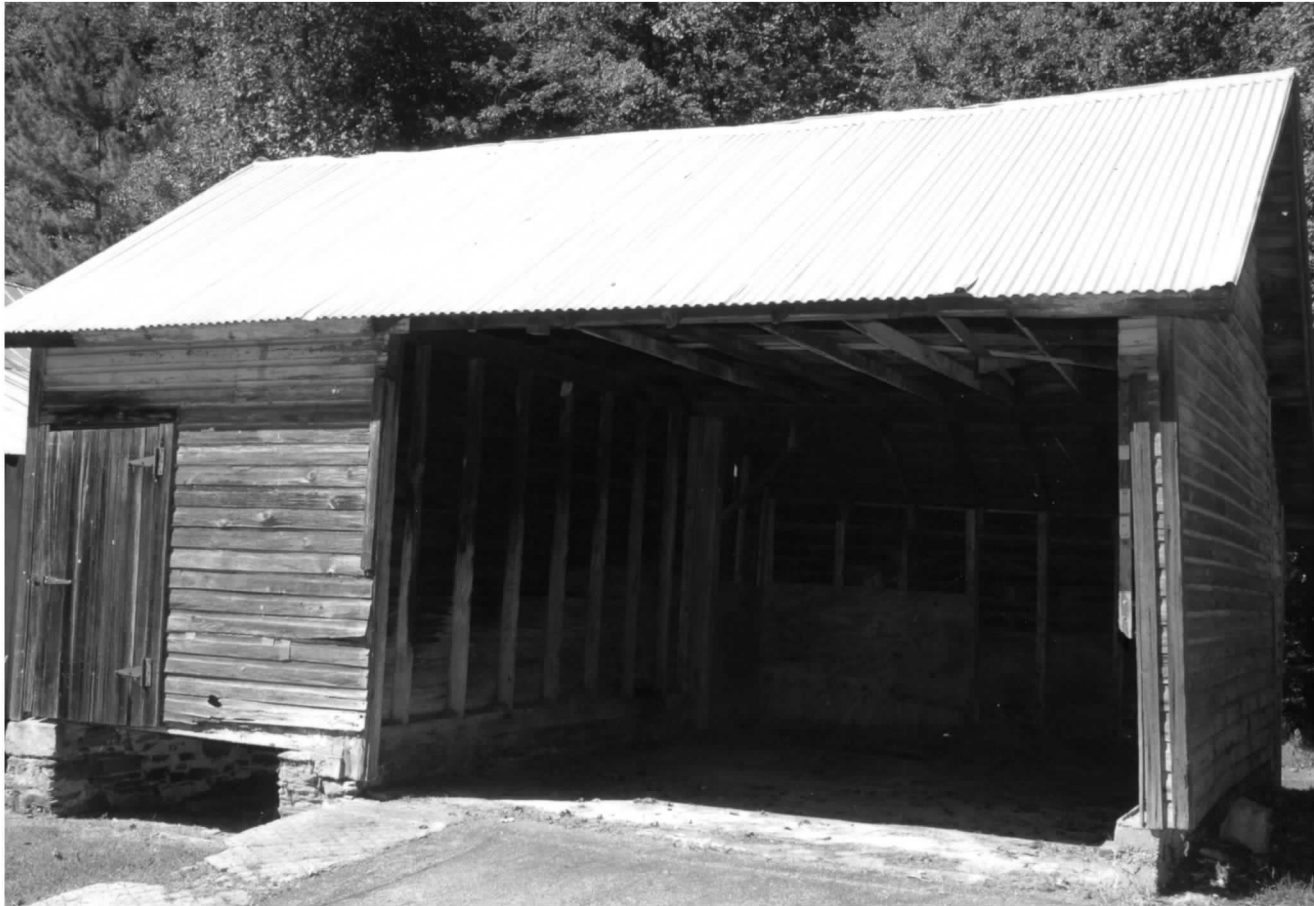
Tractor Shed, east + north elevations

The tractor shed is located just north of the wagon shed and corn crib. It is a one-story, two-bay by one-bay frame structure with German siding and a gable roof with a north-south ridge and metal roofing with raised battens. The eaves are open. The foundation is rubble stone under the south and center walls and concrete under the north wall. The east elevation has a vertical-board door on "T" hinges in the south bay. The north bay is open for a tractor. The north elevation has no openings. The west elevation also has no openings. There is a shed-roofed addition on the northern two-thirds of the building, with a CMU foundation. The south elevation has no openings, and the addition has vertical beaded-edge-and-center board siding on the south wall. The siding was painted red, and later painted over in white.

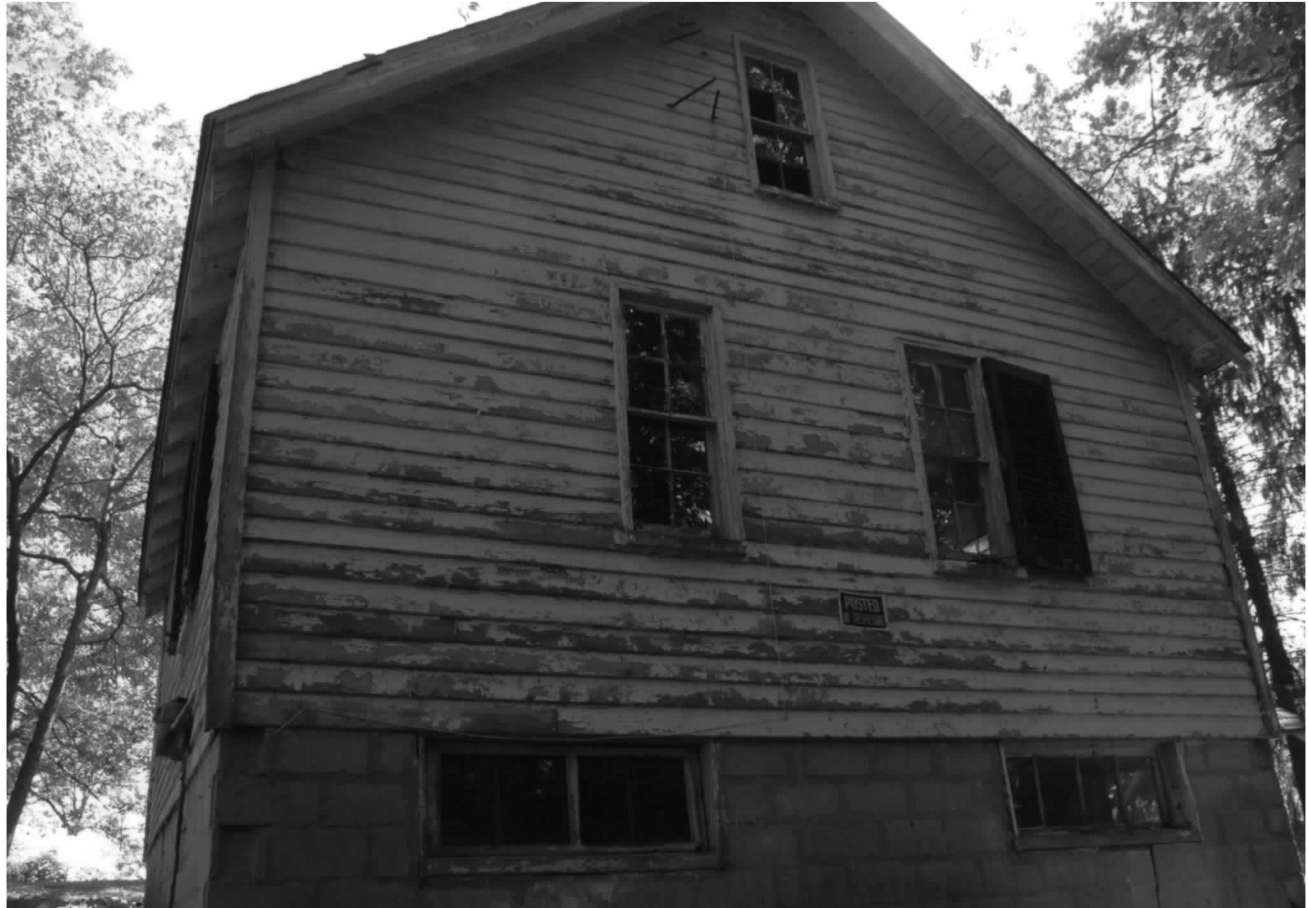
Cottage, west elevation

The west elevation has two four-light horizontal wood sash in the exposed foundation. The first story has two four-over-four double-hung sash with blinds, and the gable end has a smaller four-over-four double-hung sash.
