HO-259

Daisy I.O.O.F. Building, site

Architectural Survey File

historic IOGT Hall
 other _____

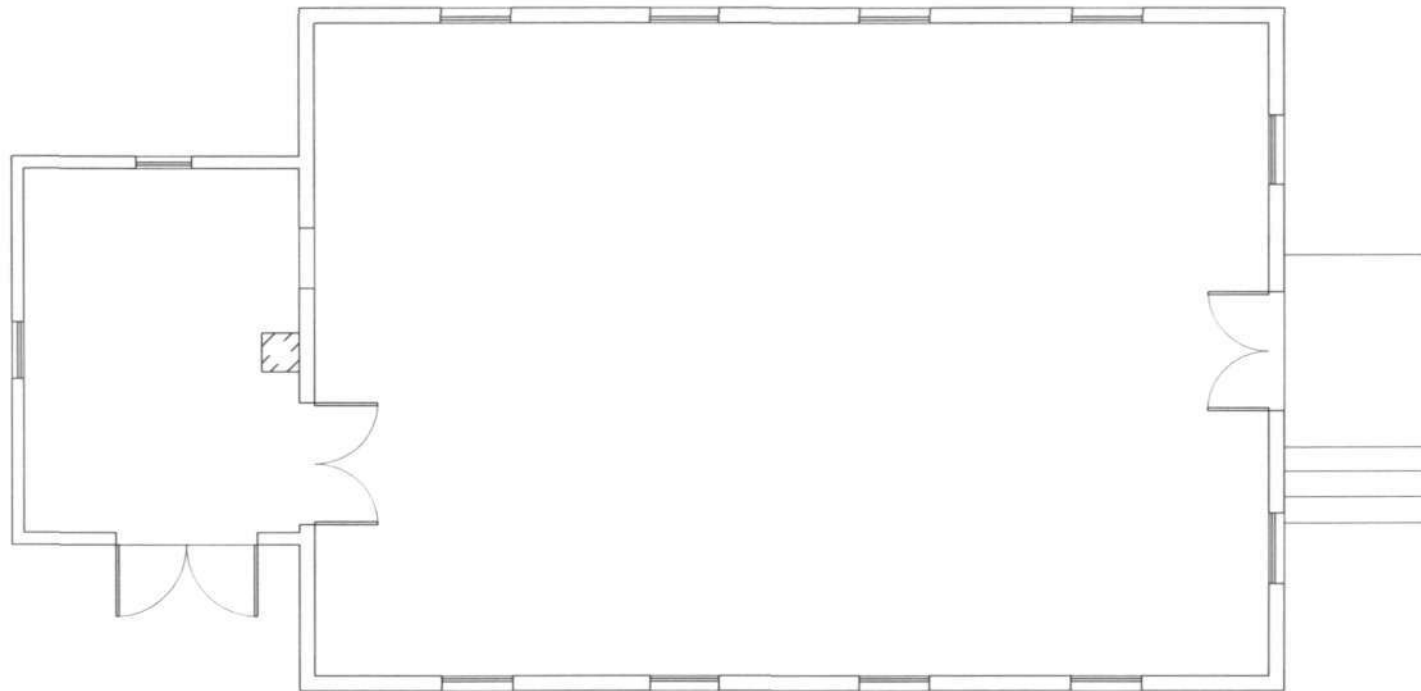
HO- 259 IOGT HALL 15905 UNION CHAPEL ROAD

FIRST FLOOR PLAN - MEASURED AND DRAWN BY KEN SHORT - AUGUST 2006

The interior of the hall has one large open room in the main block and one room in the wing. The main room has 3-1/4 inch pine flooring that runs north-south, and wood baseboard that is 12 inches high and has a quirked ogee and bevel on the top. The architrave has a quirked ogee and bead inside of a fascia on the back band, and has a bead on the inner edge. There are also bulls-eye corner blocks. The walls have a pressed metal wall covering with a decorative pattern of long hexagons that contain paired anthemion inside of them, the bottom anthemion being set upside down. There is a metal frieze that contains Gothic revival cusps with fleur de lies on top of them, and the cusps alternate between large and small ones. The background of the frieze has a pebbled finish. Above the frieze is a metal cove cornice decorated with anthemion topped by bellflowers, and there is a rope moulding in metal above the cornice. The ceiling follows the rafters and collar beams, and is also covered in pressed metal, with squares that have Anthemion in each corner. There is a rope moulding at the break between the rafters and collar beams. The gable ends have foliate pattern pressed metal containing patera that have four lobes each. There is a large, square ceiling medallion in the center, and it has anthemion in the four corners. The north windows match those on the east and west, and there is a three-light transom above the door. In the center above the door is a frieze that is patched or finished with a short piece of the cove cornice material. The window sash were hung on cords, have parting beads, and are not pinned. The south end of the room has a stovepipe hole in the gable end that has since been closed off. There are flush double doors to the east of the chimney and a small pass-through in the wall west of the chimney.

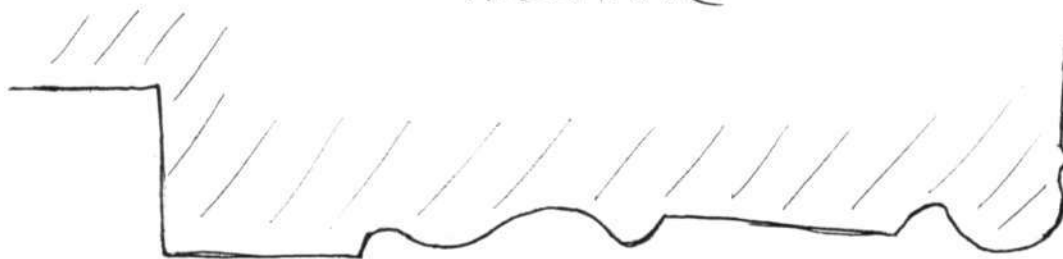
IOGT Hall HO-259
Moulding profile

Architrave

The wing has the same flooring as the main room, and it runs east-west. The baseboard is shorter and is plain, though one piece has an ogee and bevel on top of it. The walls have the same pressed metal as in the main room, and this covers the chimney, as well. There is a stovepipe hole with a terra cotta thimble on the south side of the chimney. The room has an egg and dart moulding on the cornice, and the ceiling has long hexagons with a single rosette in the center. The architrave matches the main room, but there is a plain board over top of the door and the window architrave has plain head-cut trim. There is a hatch cut in the

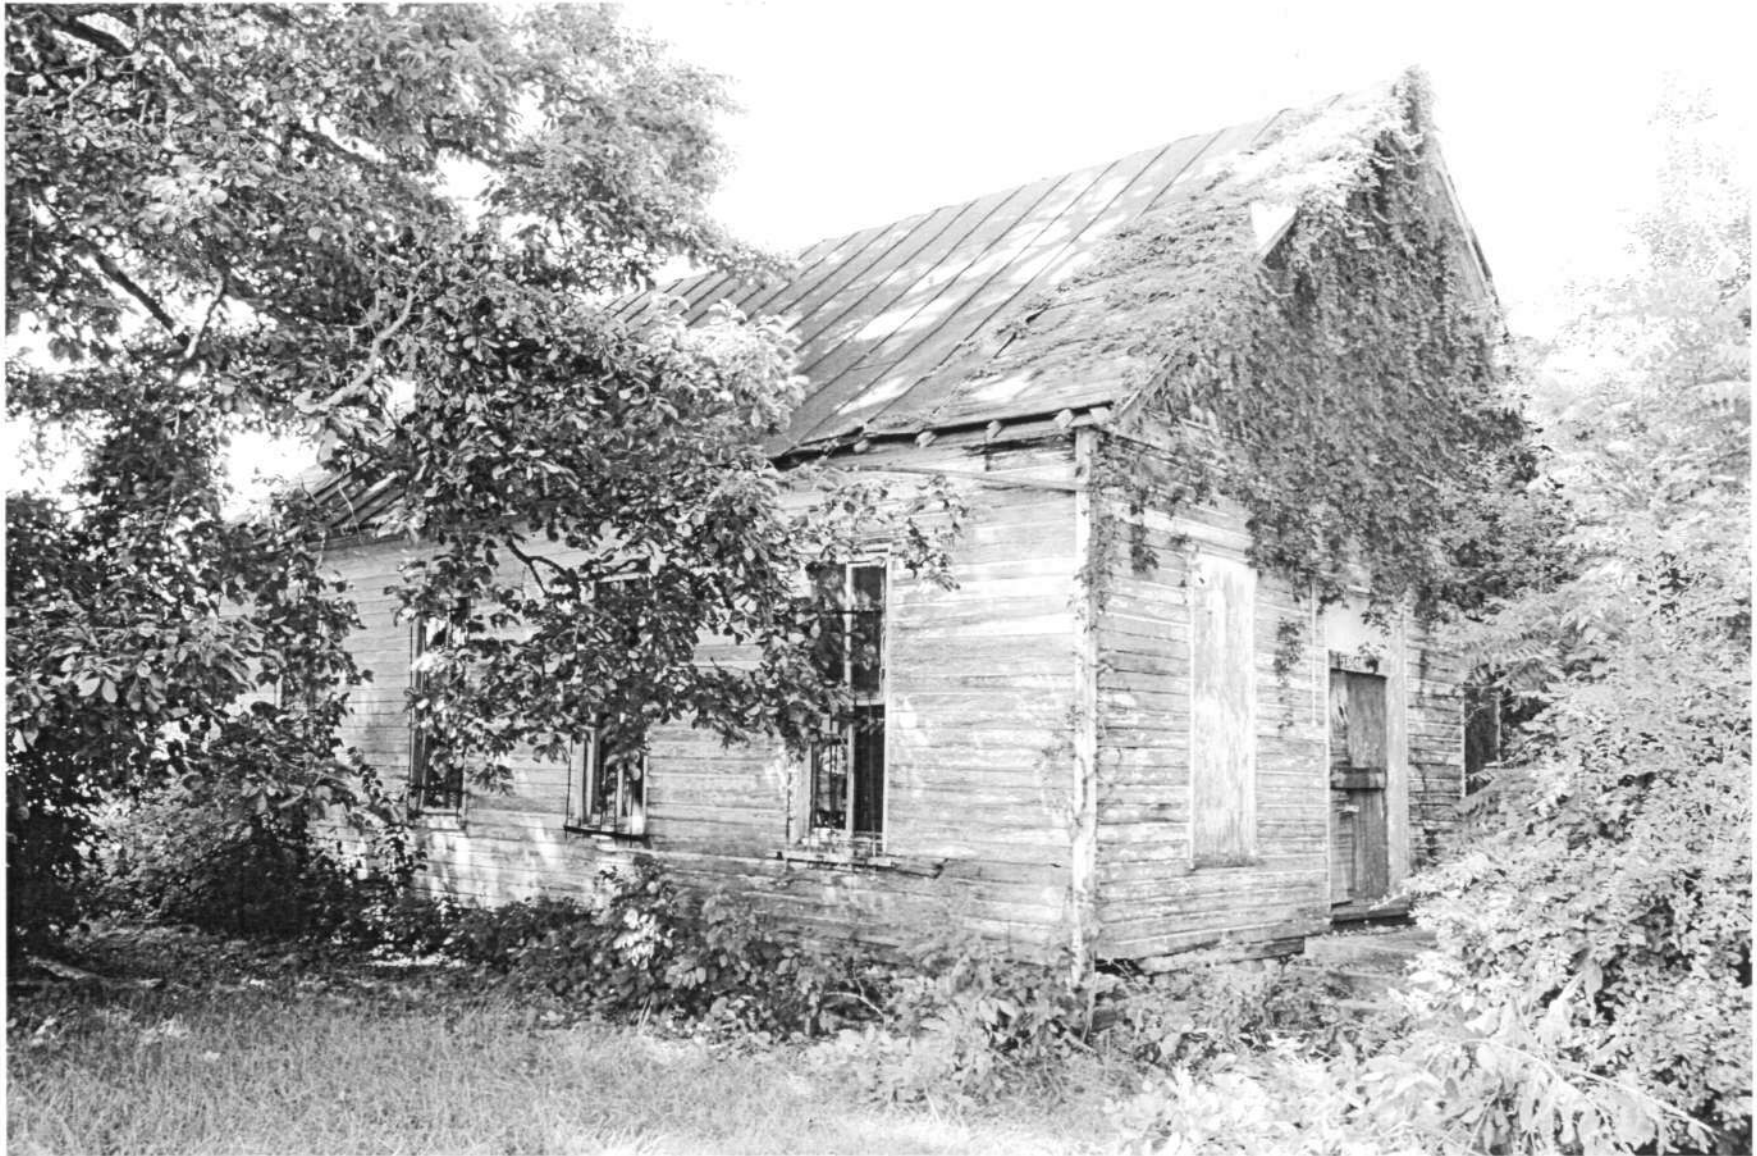
HO-259 International Order of Good Templars Hall 15905 Union Chapel Road East & north elevations
Ken Short, August 2006 1/13

The north elevation has flush double doors and a boarded-up transom in the original center opening, and there is a beaded-interior-edge frame. There is a boarded-up window to each side with an identical frame and a wood sill. The gable end has a moulded cornice below fish scale shingles. There is a center window with wire mesh in it, and it has a pedimented surround with rounded dentals and a keystone motif in the center. The east elevation has four two-over-two double-hung sash with typical frames and sills. There are iron bars over the windows, most of them made of rebar, and there is a stovepipe hole with a thimble between the north and north-center bays.

The east elevation of the south wing has double doors made of butcher block, hung on T hinges. There is an exterior brick chimney on the south end of the main building, centered on the ridge. The south elevation of the wing has no openings. The west elevation of the wing has a boarded-up window opening with a typical frame and sill. The west elevation of the main block has four two-over-two sash that match the east elevation.

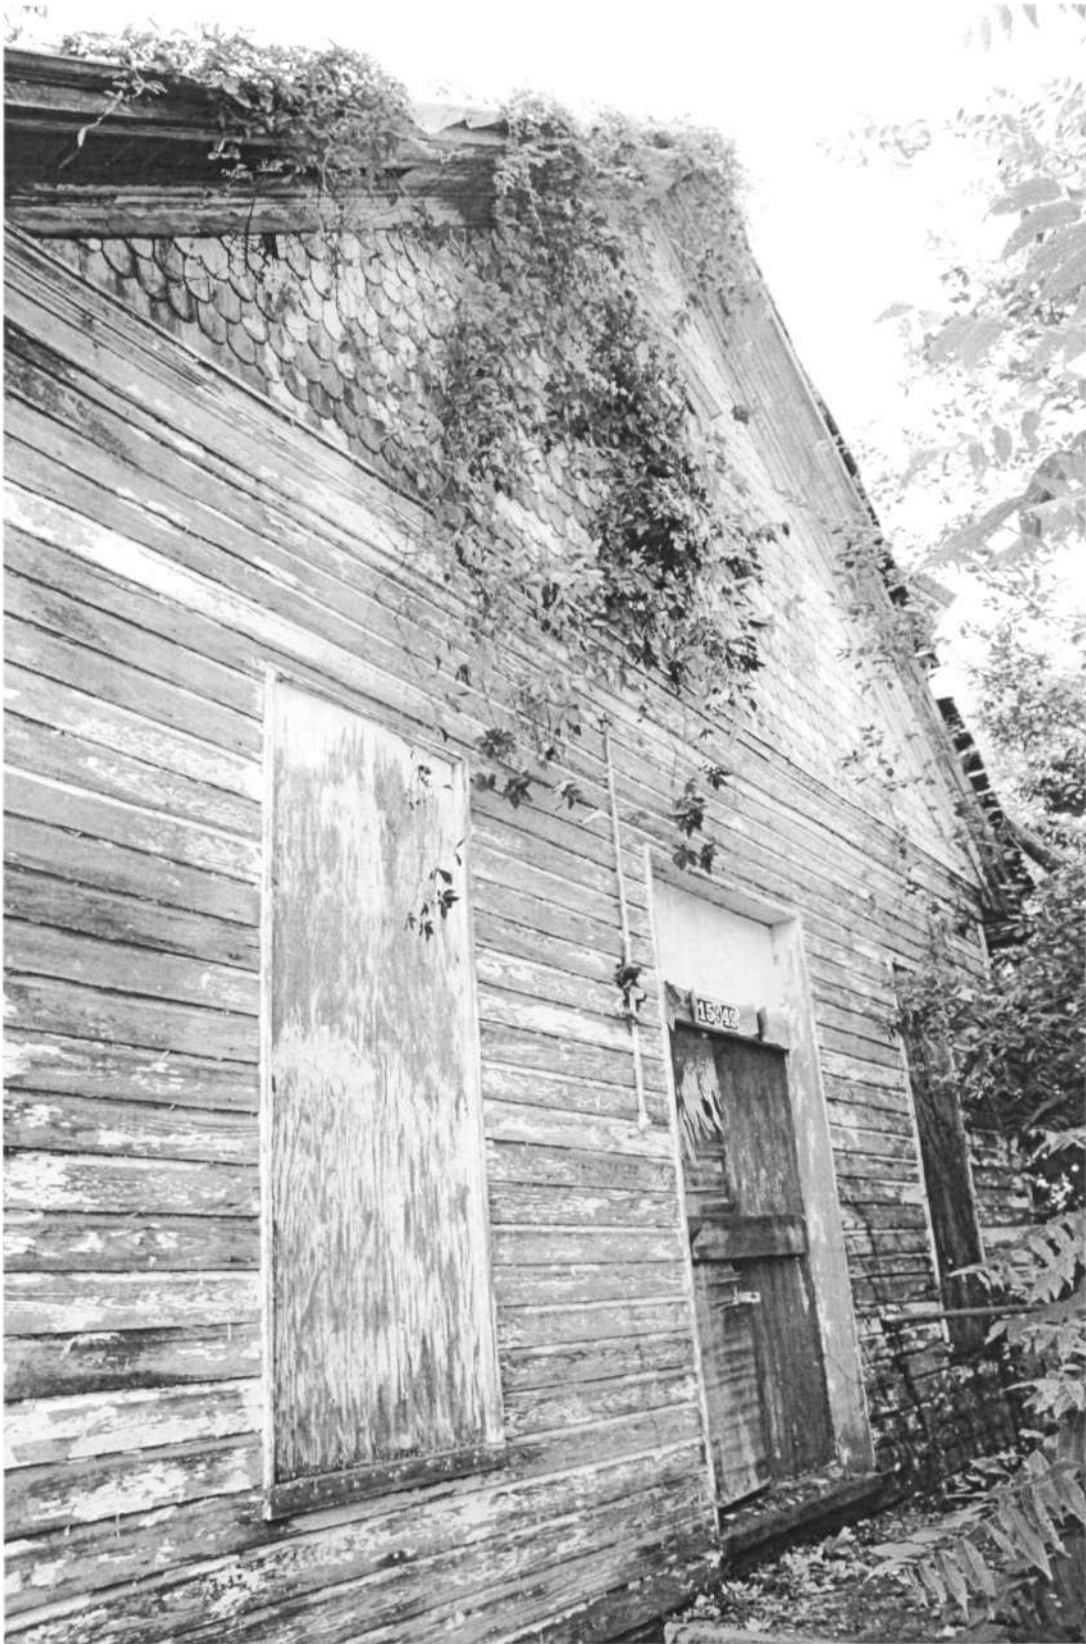
HO-259 International Order of Good Templars Hall 15905 Union Chapel Road North elevation
Ken Short, August 2006 2/13

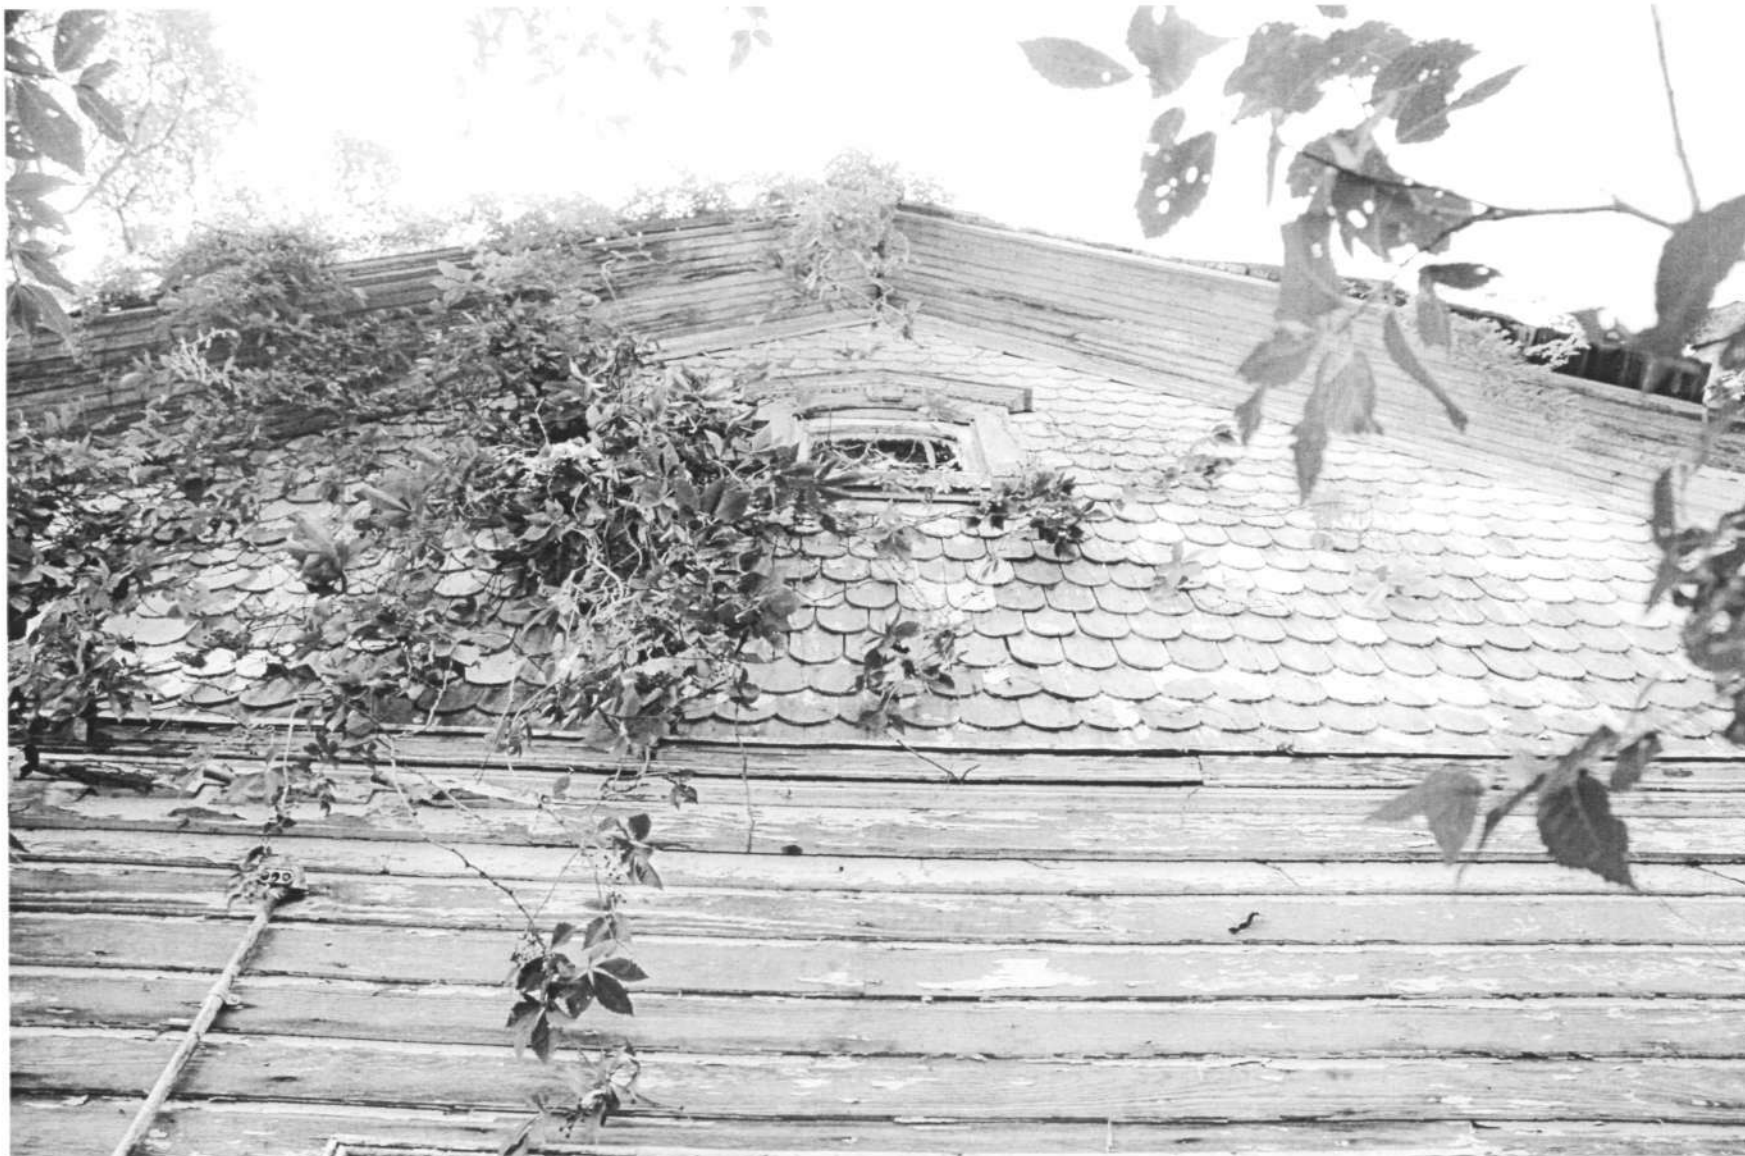
HO-259 International Order of Good Templars Hall 15905 Union Chapel Road North elevation, gable
Ken Short, August 2006 3/13

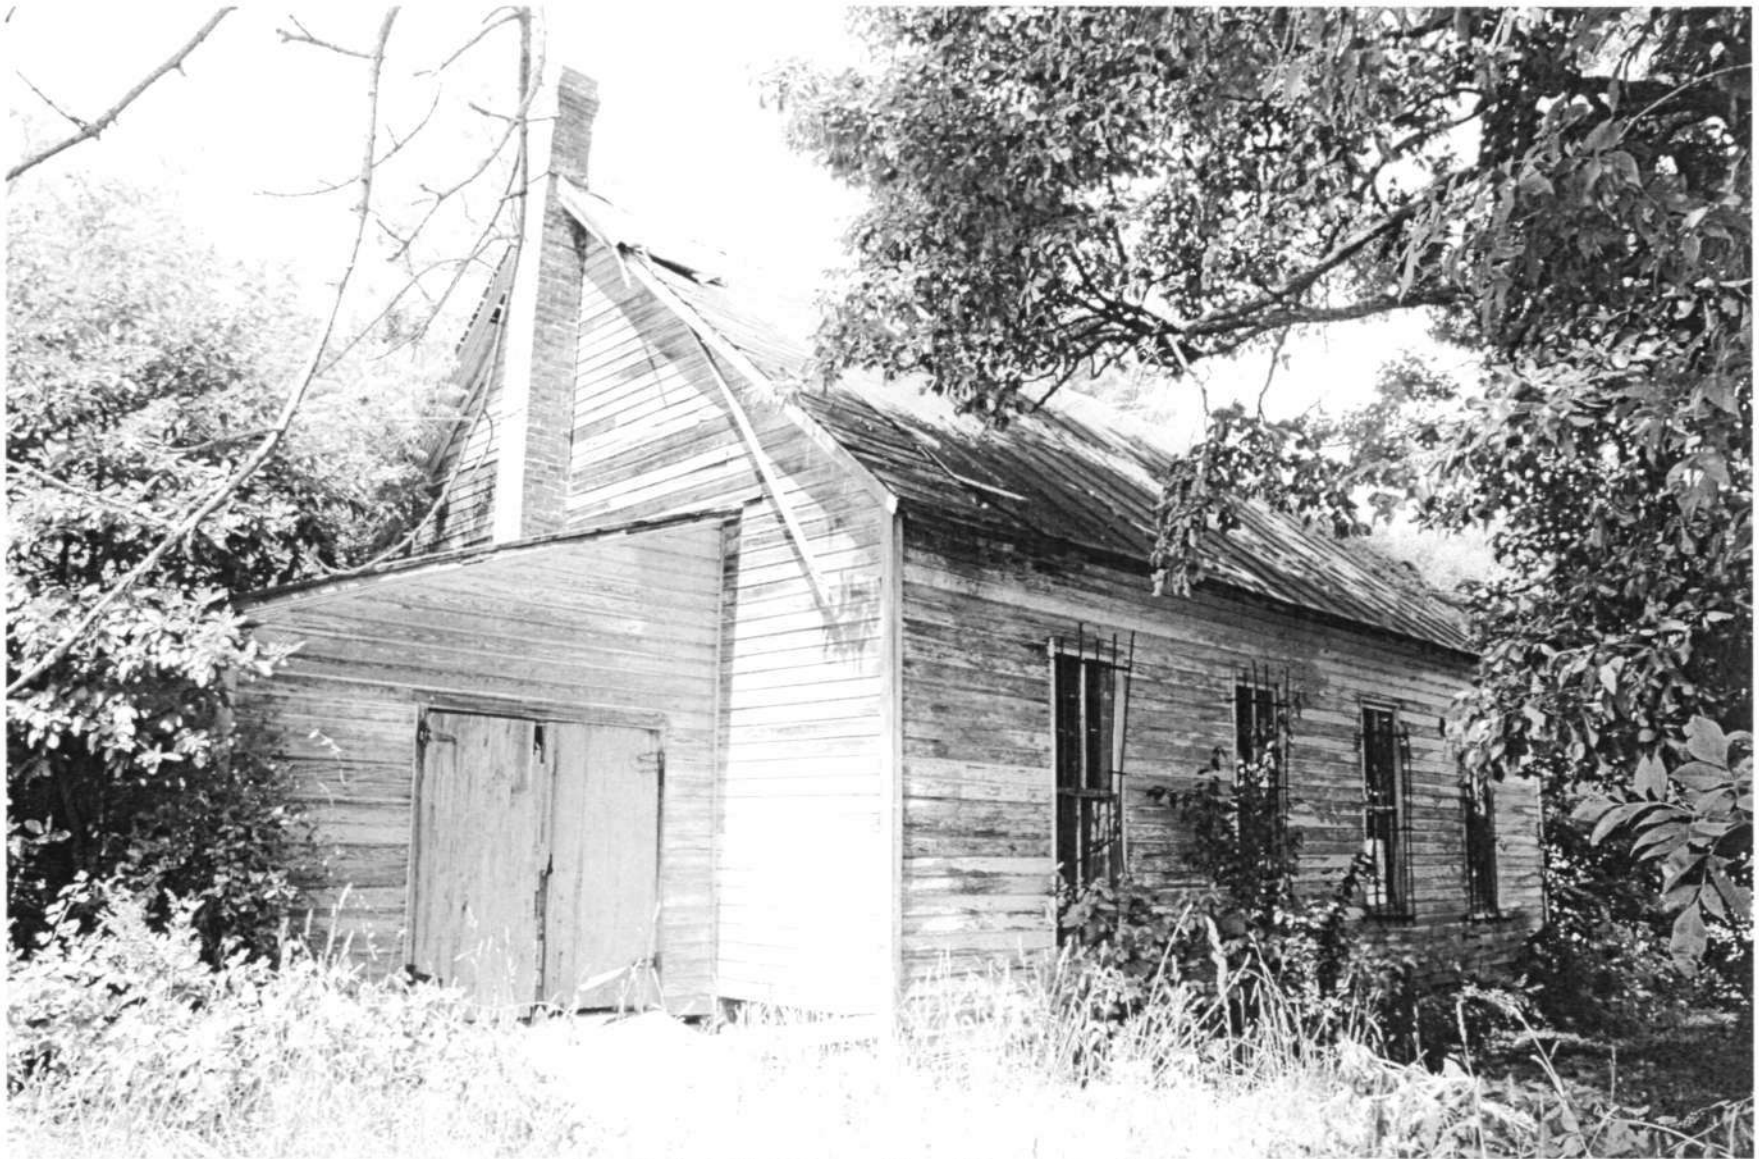
HO-259 International Order of Good Templars Hall 15905 Union Chapel Road South & east elevations
Ken Short, August 2006 4/13

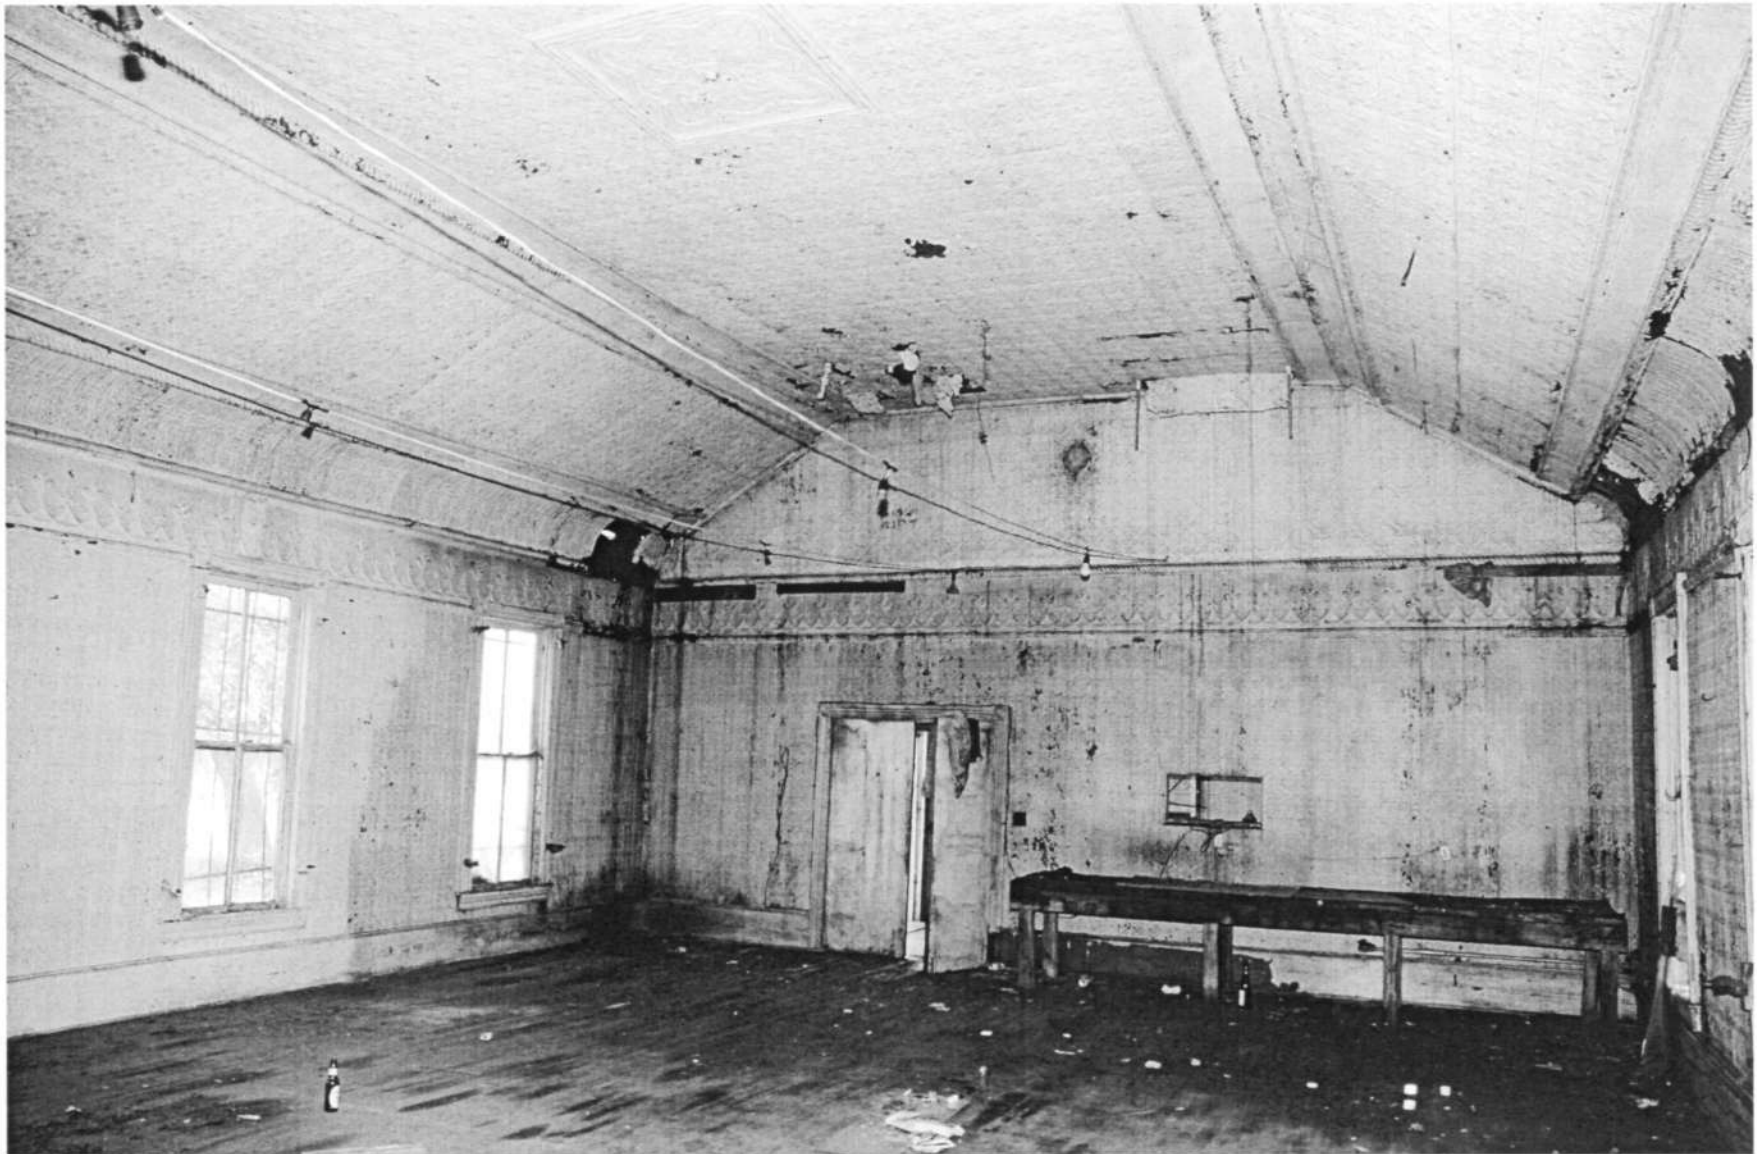
HO-259 International Order of Good Templars Hall 15905 Union Chapel Road Interior, vw. northwest
Ken Short, August 2006 5/13

The rafters are approximately 2 by 6s with pieces nailed to the sides at a flatter angle than the metal ceiling is nailed to, and appear to probably be scissor braces. The roof is rotted, and missing some of its metal roofing; the pressed metal interior is very rusted, with some of it missing, and the floor is soft. The building is very deteriorated.

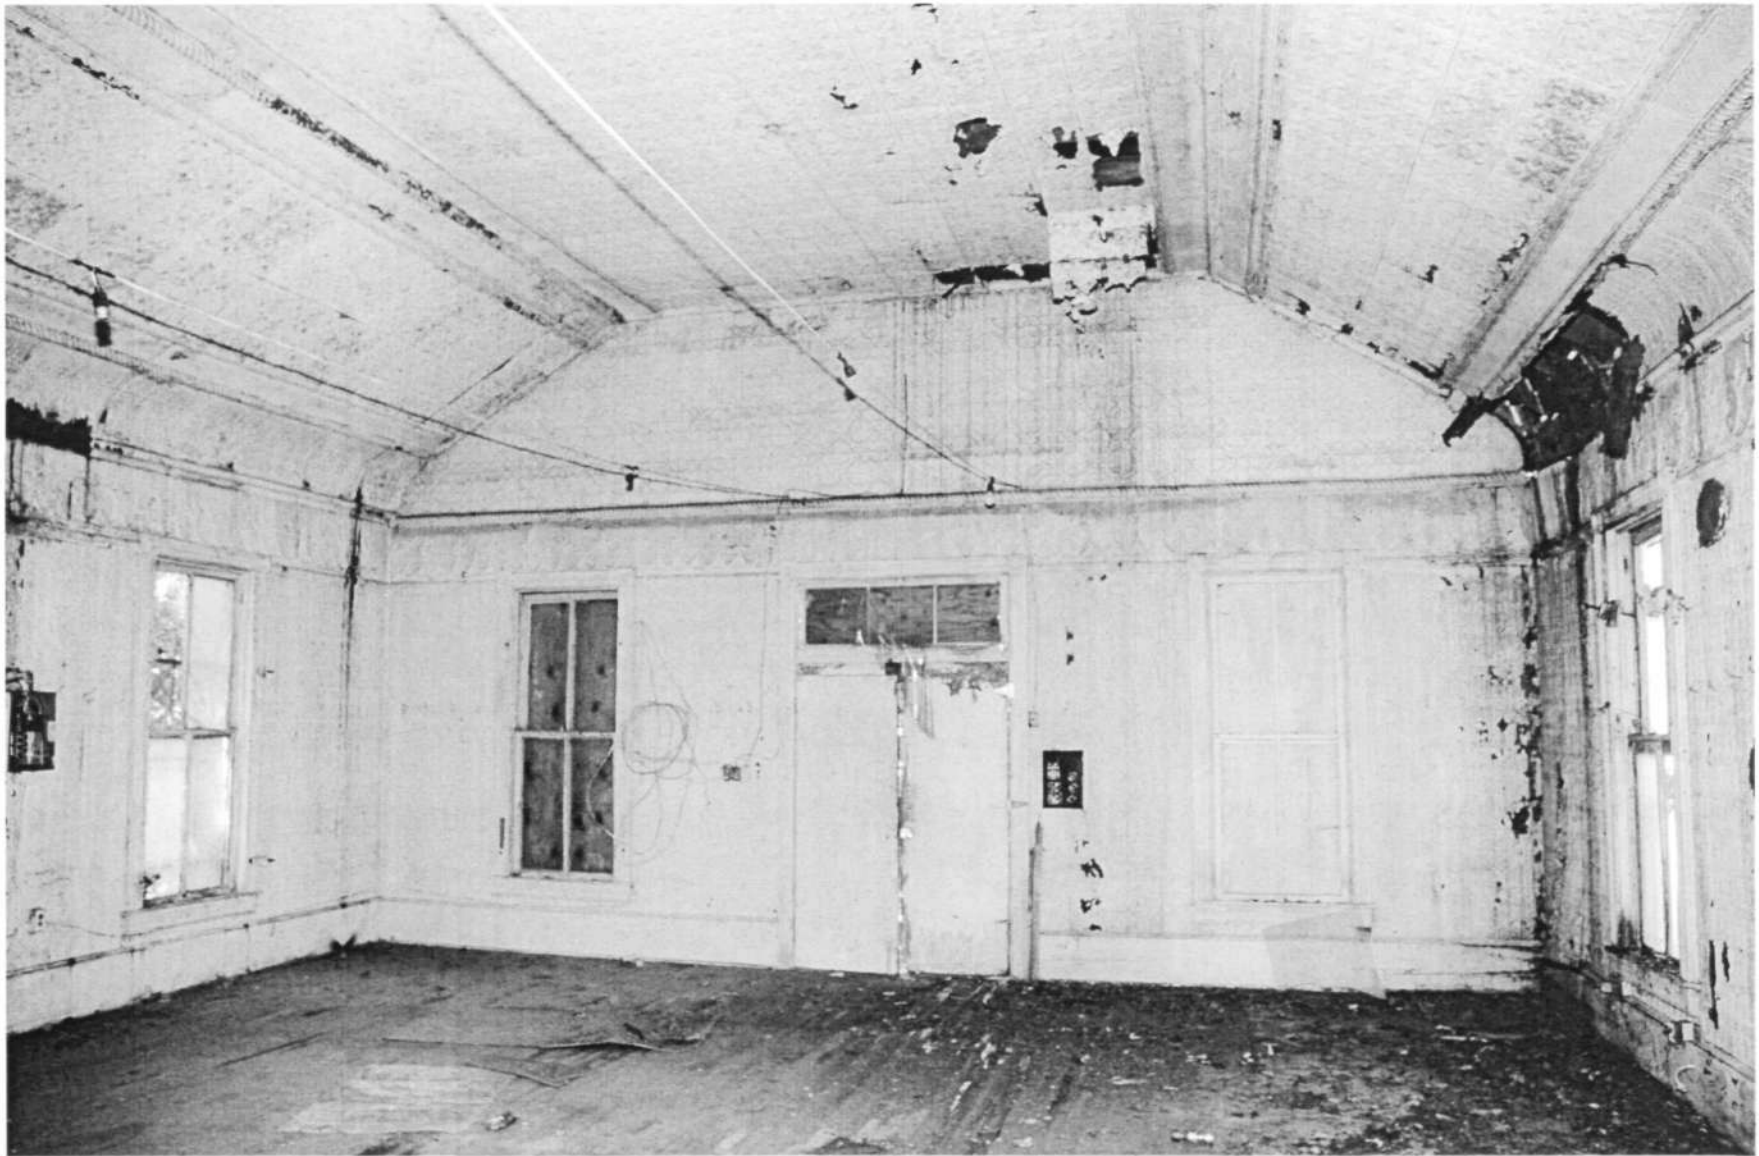
HO-259 International Order of Good Templars Hall 15905 Union Chapel Road Interior, vw. southeast
Ken Short, August 2006 6/13

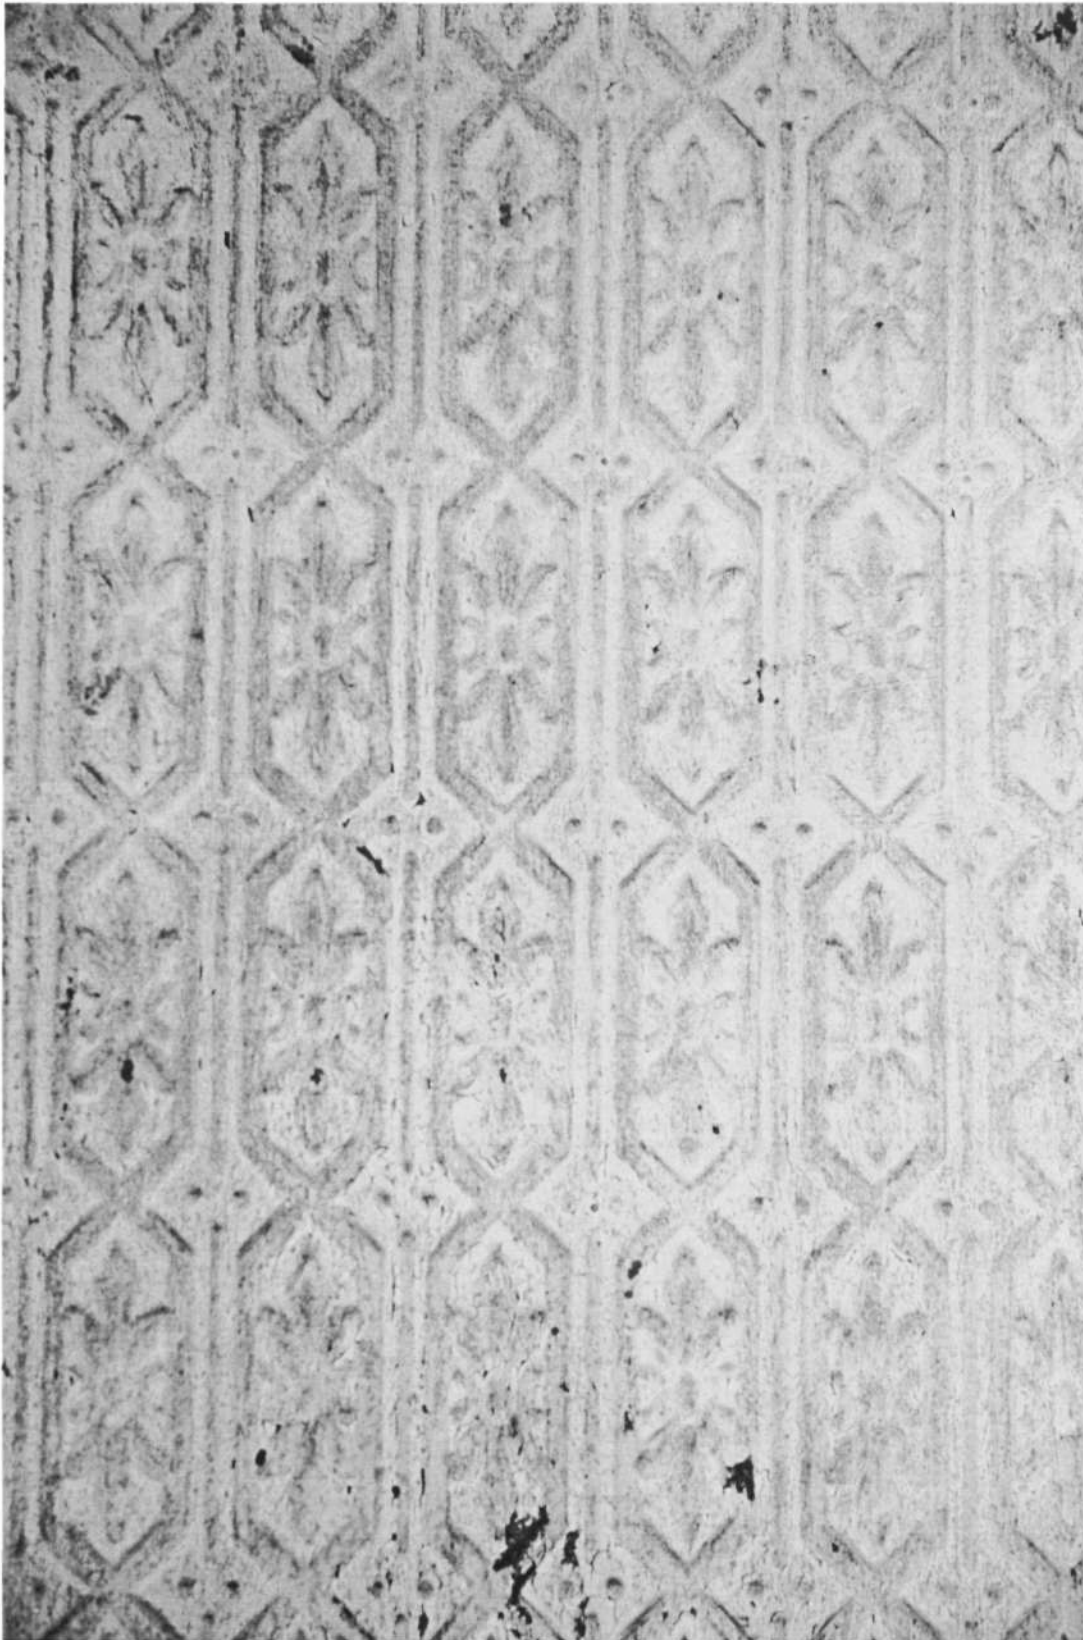
HO-259 International Order of Good Templars Hall 15905 Union Chapel Rd. Interior, wall panel detail
Ken Short, August 2006 7/13

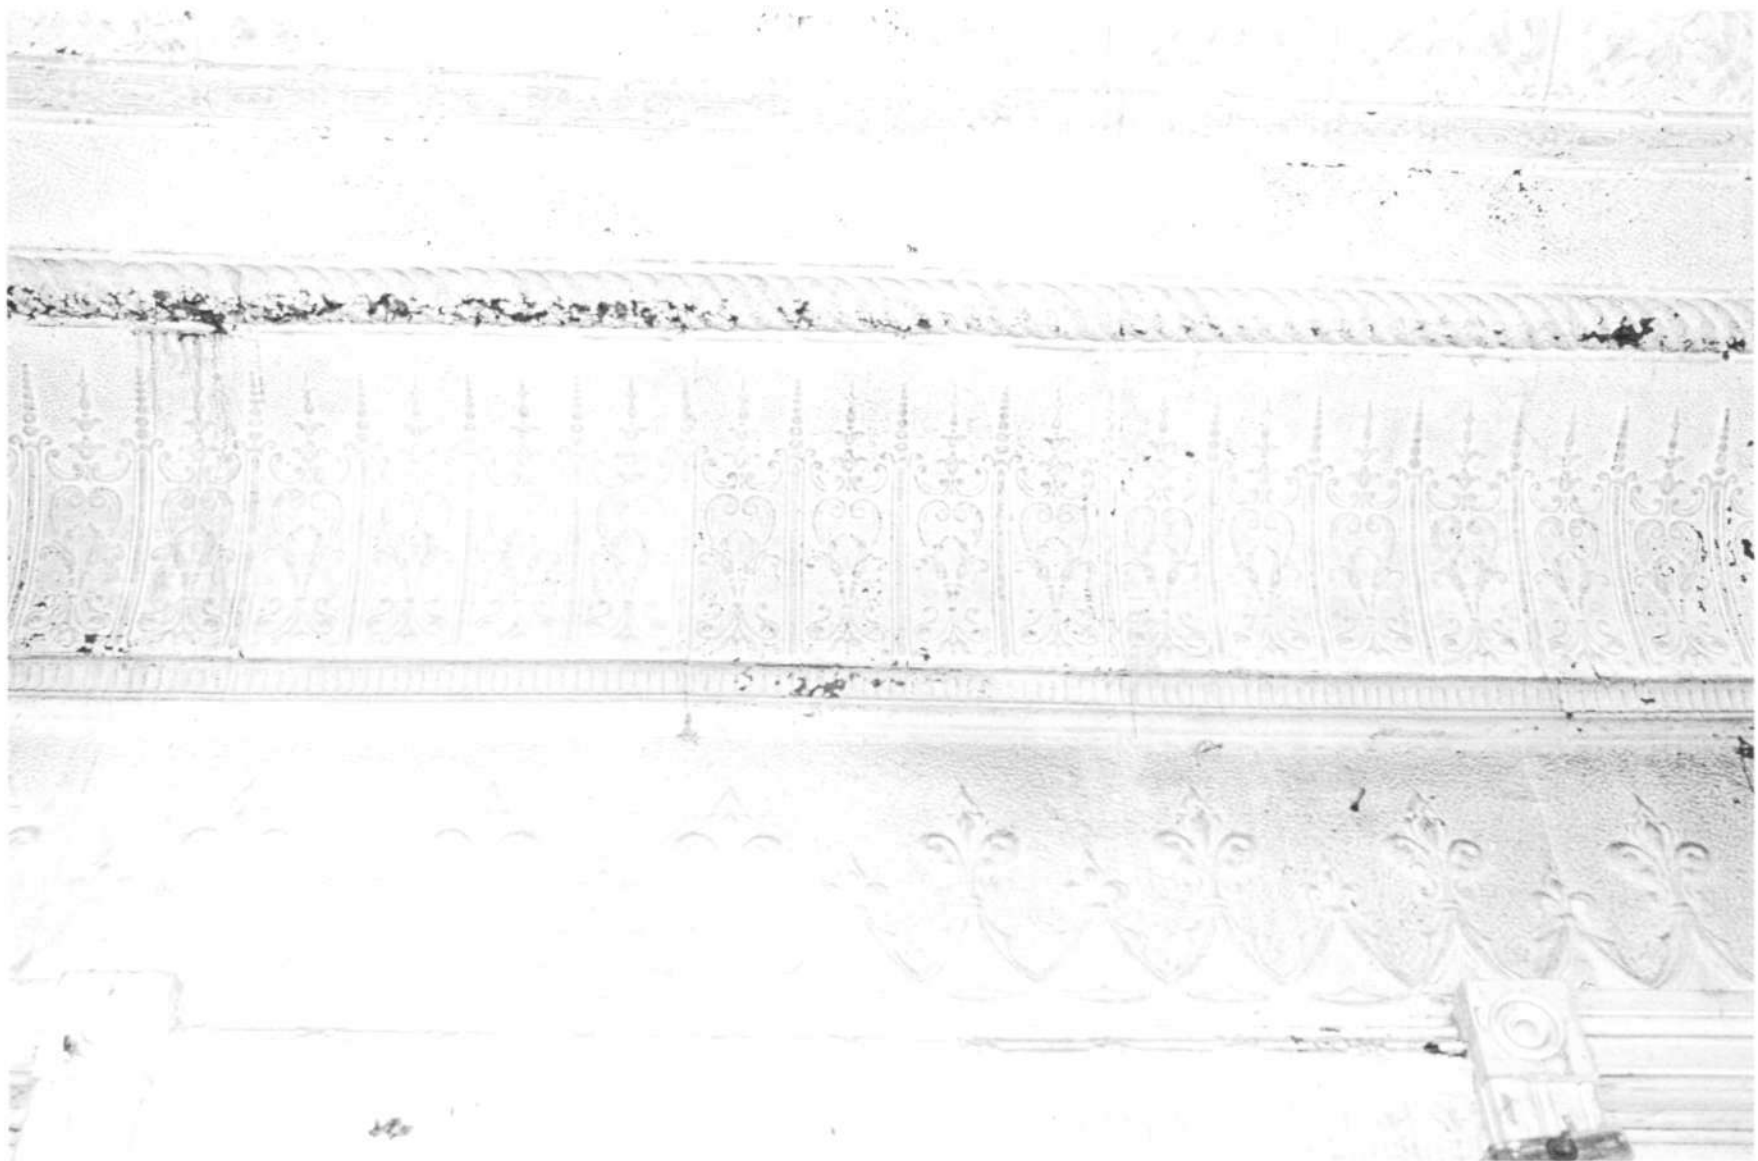
HO-259 International Order of Good Templars Hall 15905 Union Chapel Road Interior, cornice detail
Ken Short, August 2006 8/13

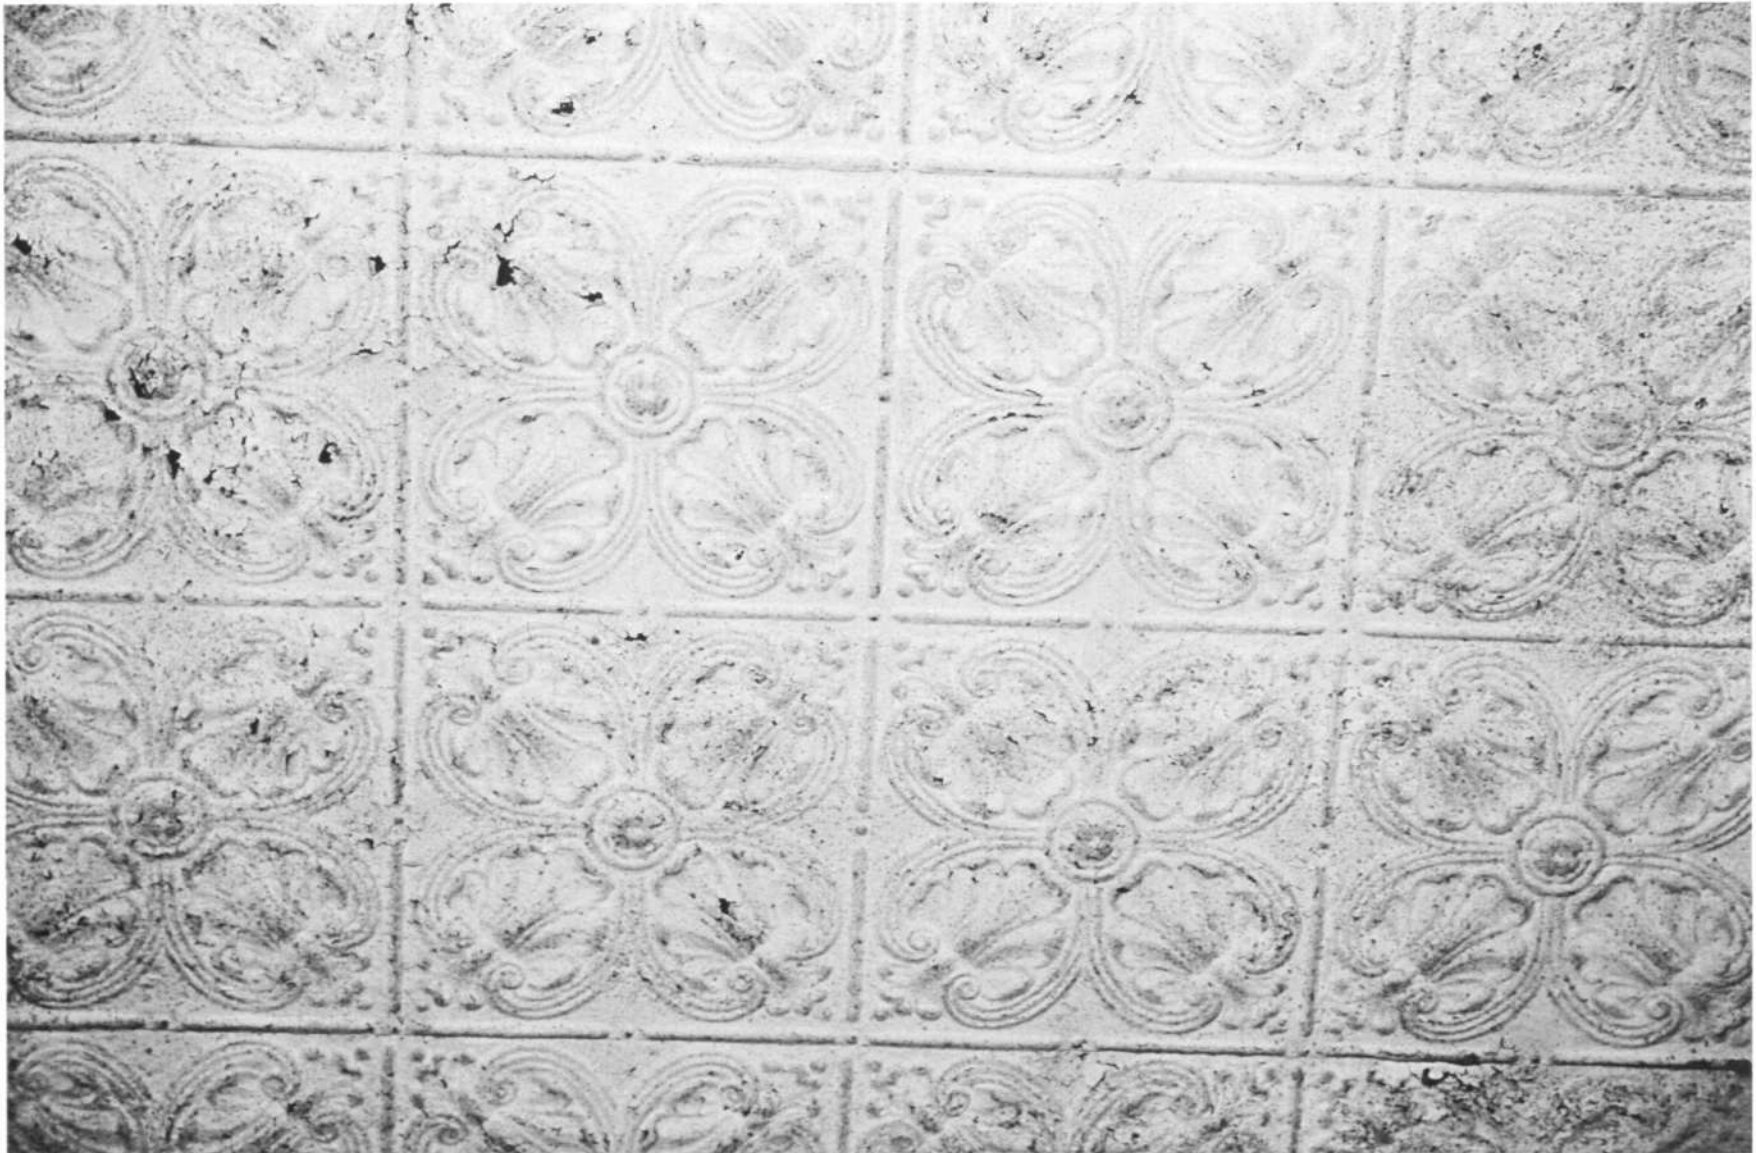
HO-259 International Order of Good Templars Hall 15905 Union Chapel Road Interior, ceiling panel detail
Ken Short, August 2006 9/13

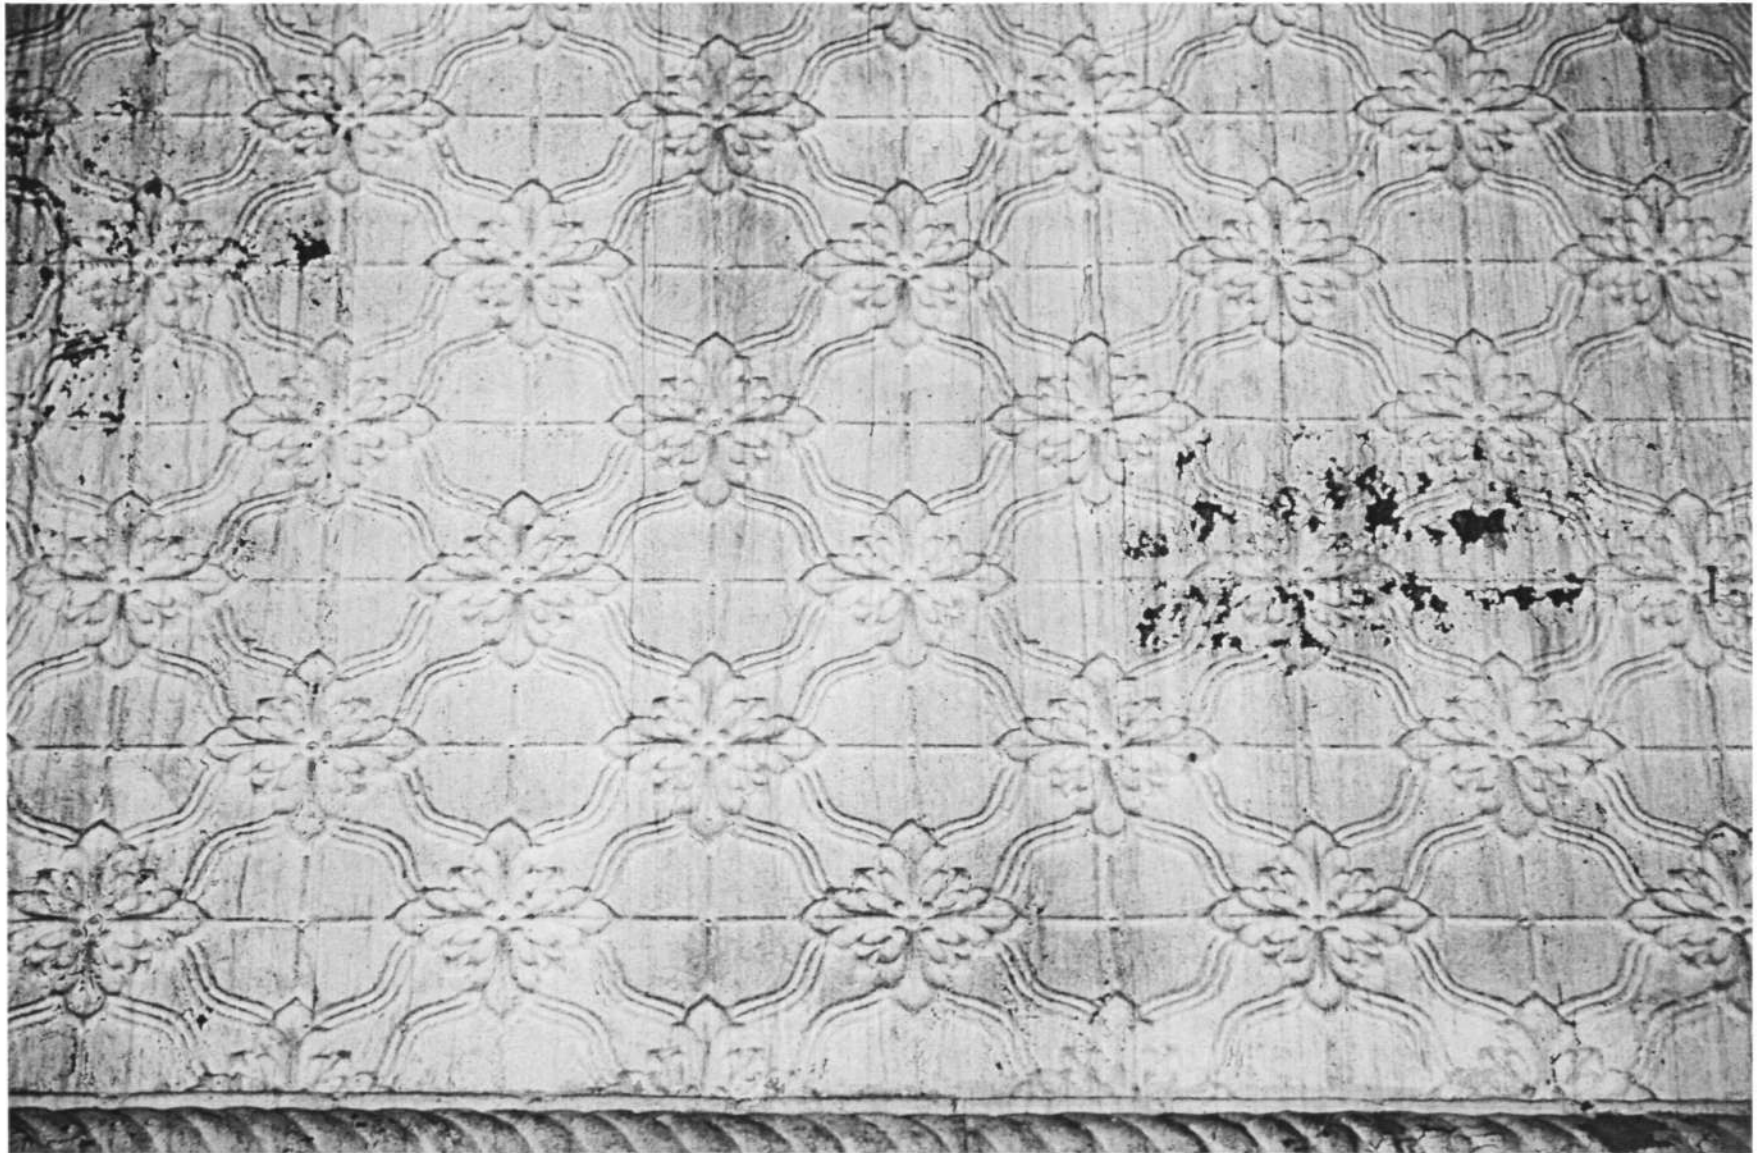
HO-259 International Order of Good Templars Hall 15905 Union Chapel Road Interior, gable wall panel detail
Ken Short, August 2006 10/13
