HO-259

Daisy I.O.O.F. Building, site

Architectural Survey File

historic IOGT Hall
 other _____

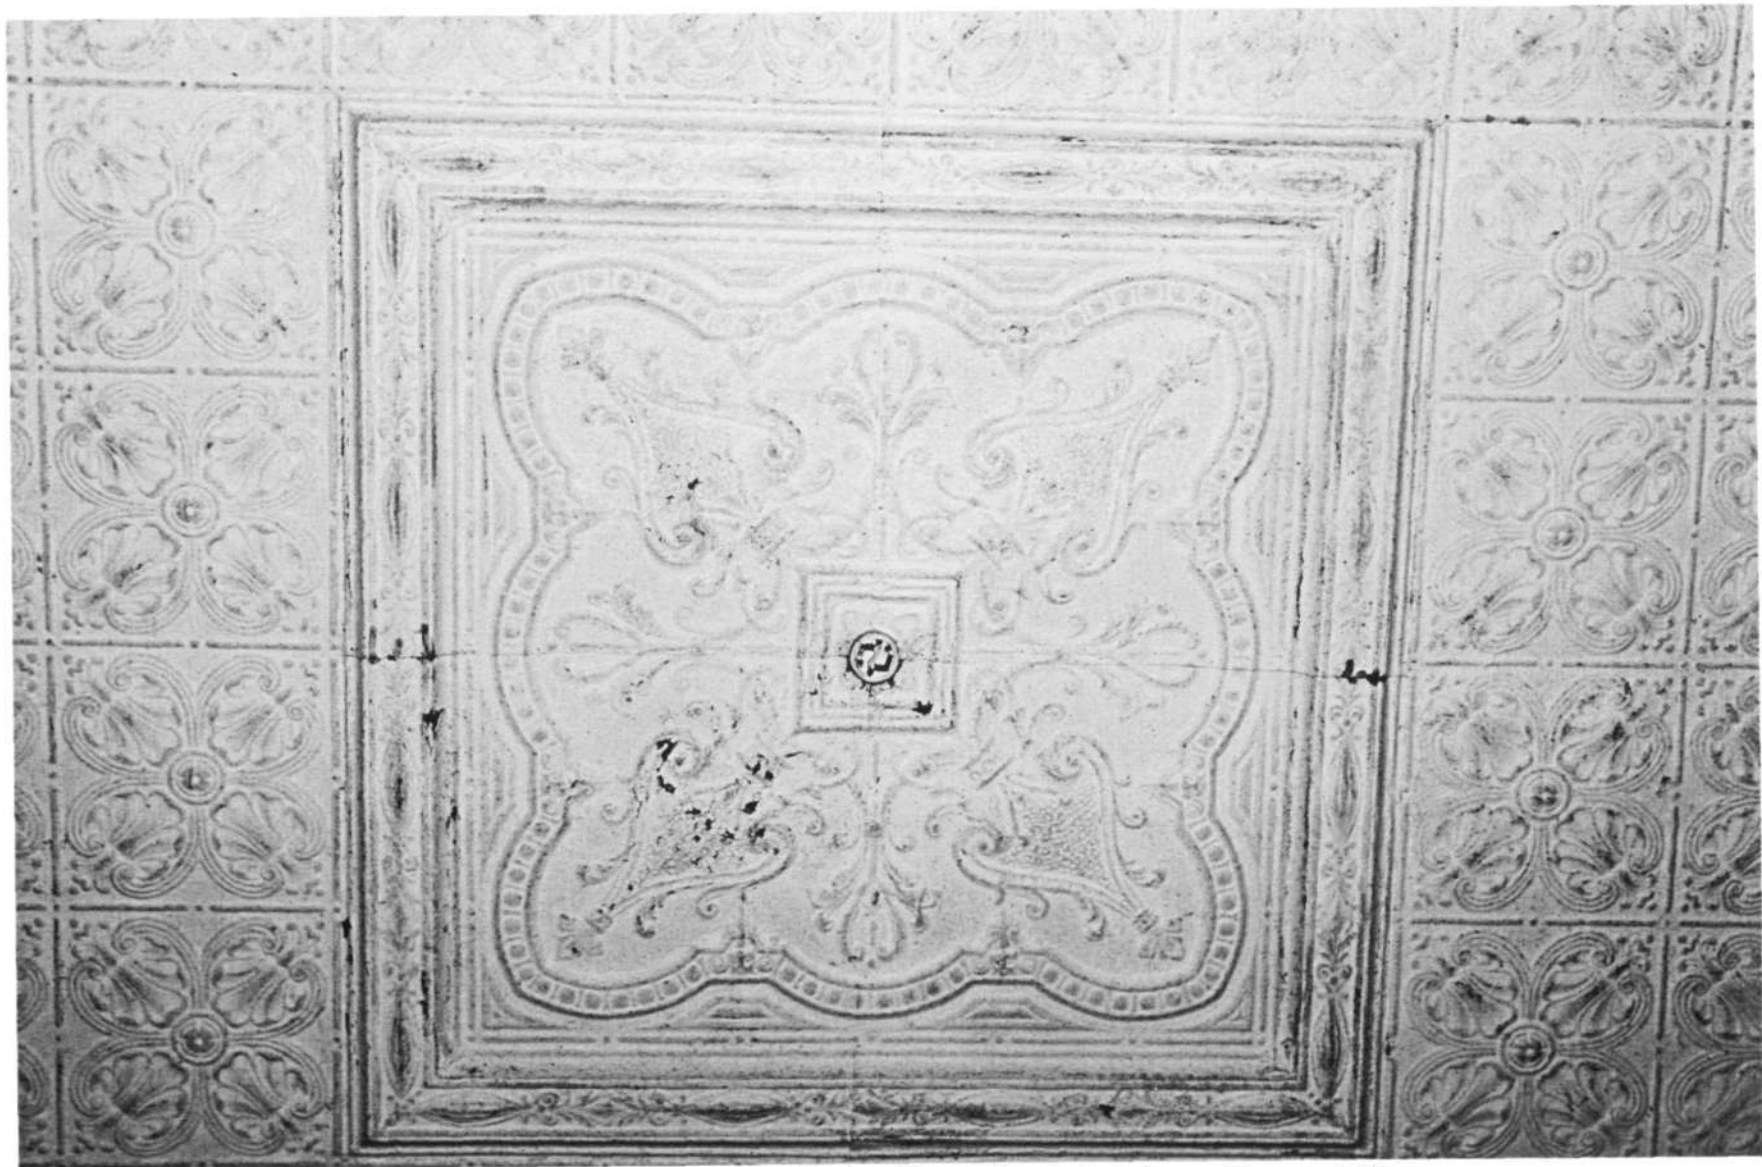
HO-259 International Order of Good Templars Hall 15905 Union Chapel Road Interior, ceiling medallion
Ken Short, August 2006 11/13

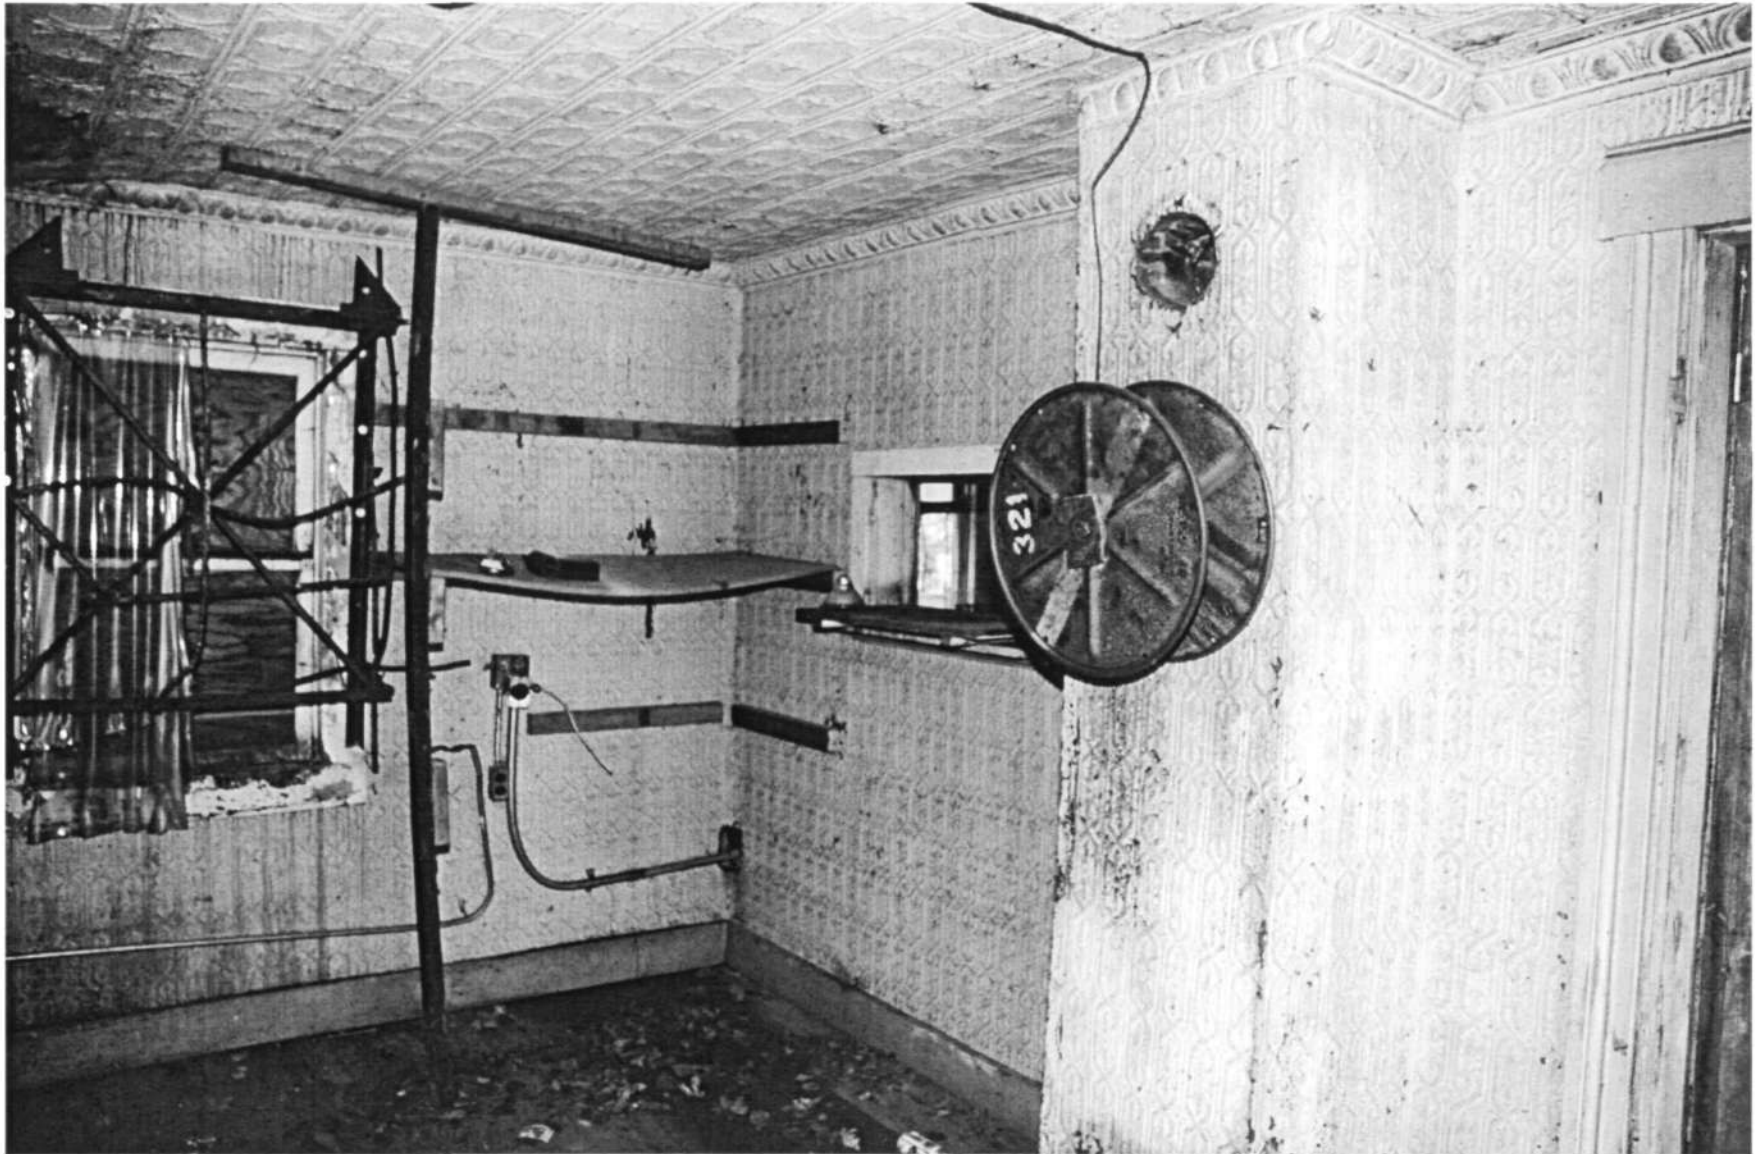
HO-259 International Order of Good Templars Hall 15905 Union Chapel Road Interior, south wing, vw. northwest
Ken Short, August 2006 12/13

The wing has the same flooring as the main room, and it runs east-west. The baseboard is shorter and is plain, though one piece has an ogee and bevel on top of it. The walls have the same pressed metal as in the main room, and this covers the chimney, as well. There is a stovepipe hole with a terra cotta thimble on the south side of the chimney. The room has an egg and dart moulding on the cornice, and the ceiling has long hexagons with a single rosette in the center. The architrave matches the main room, but there is a plain board over top of the door and the window architrave has plain head-cut trim. There is a hatch cut in the

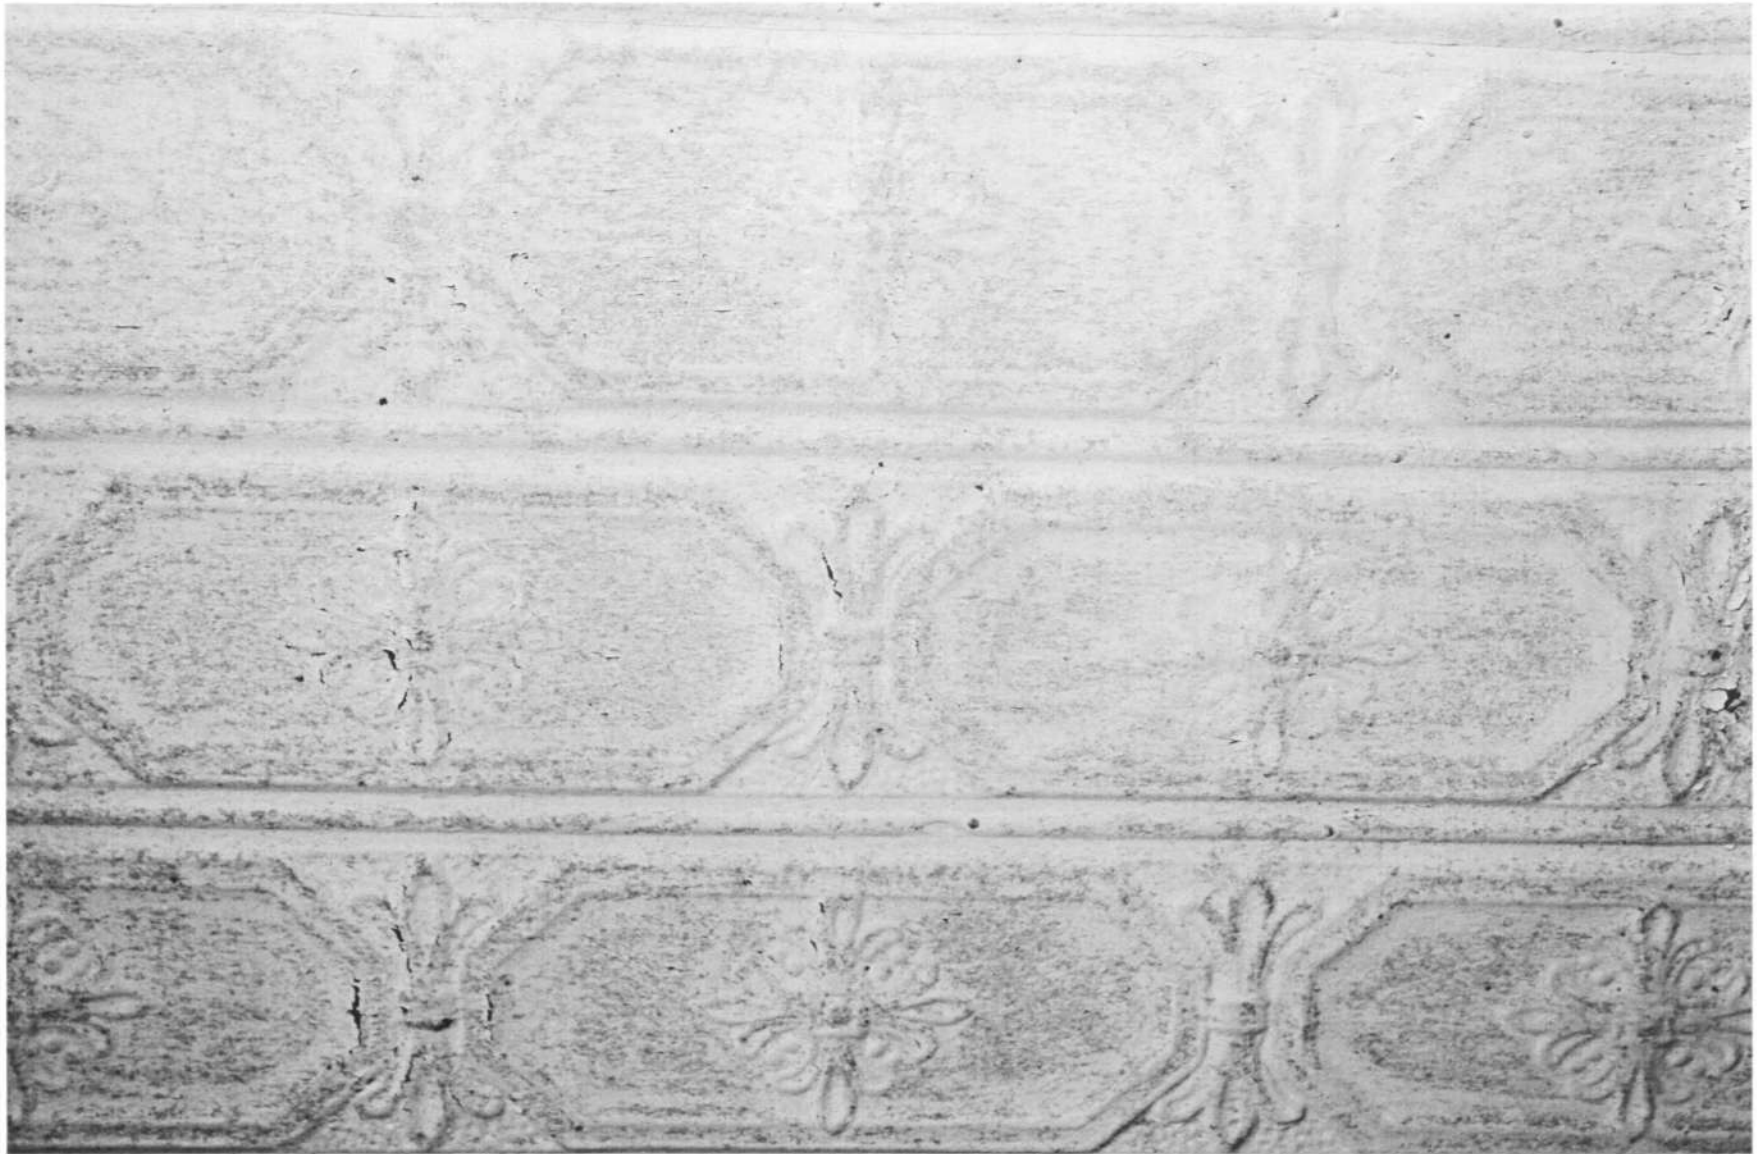
HO-259 International Order of Good Templars Hall 15905 Union Chapel Road Interior, south wing, ceiling panel detail
Ken Short, August 2006 13/13
