HO-329

Howard Lodge #101 Masonic Building

Architectural Survey File

HO-329, Howard Lodge No. 101 Masonic Building
5814 Main St., Elkridge
Surveyed by: Kristin Hill
April 2003

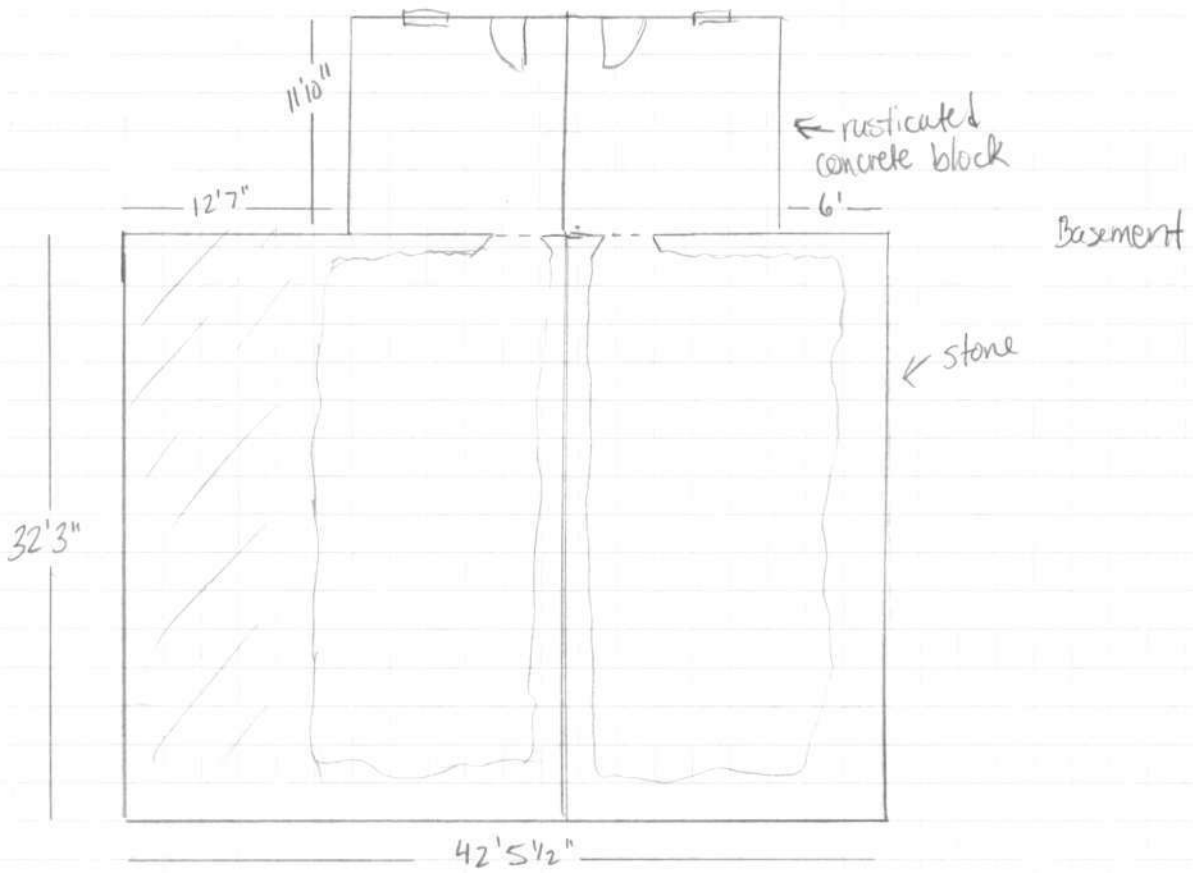
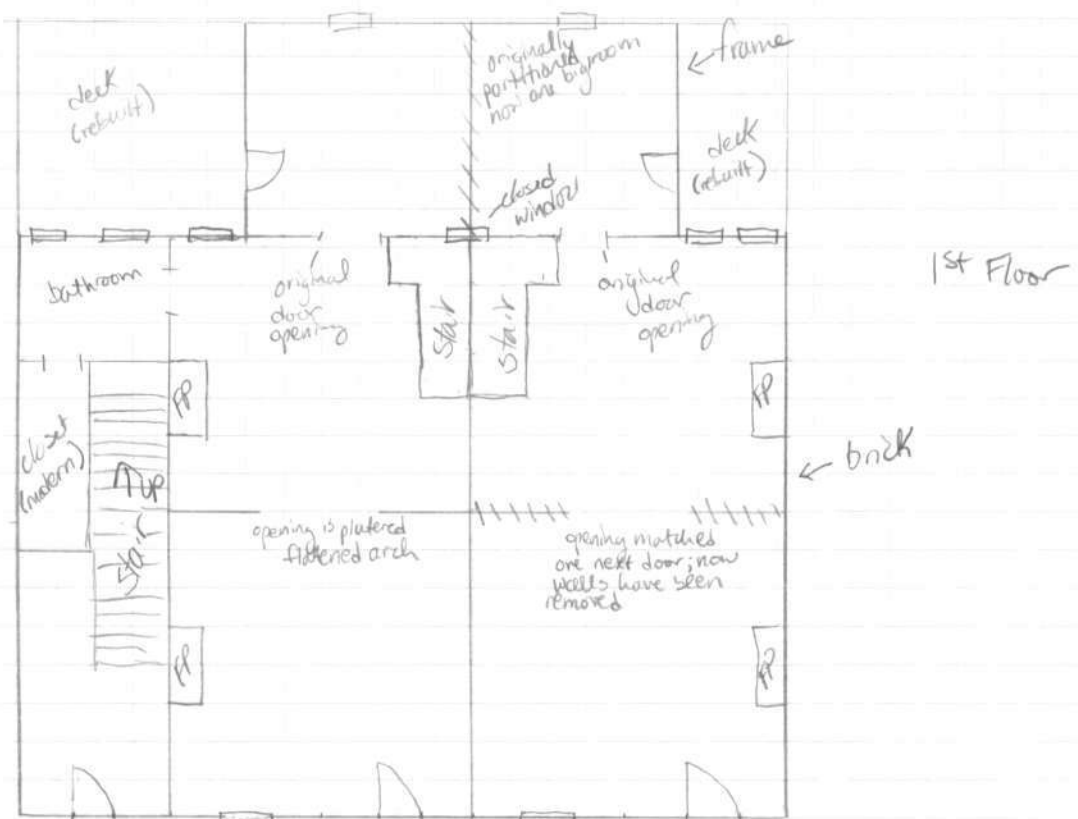
Ho-329
 Howard Lodge Masonic Building
 5814 Main St., Elkridge
 Howard County
 Drawn 4/03, by Kristin Hill

Exterior dimensions drawn at 3/32 scale
 Interior dimensions/details NOT drawn to scale

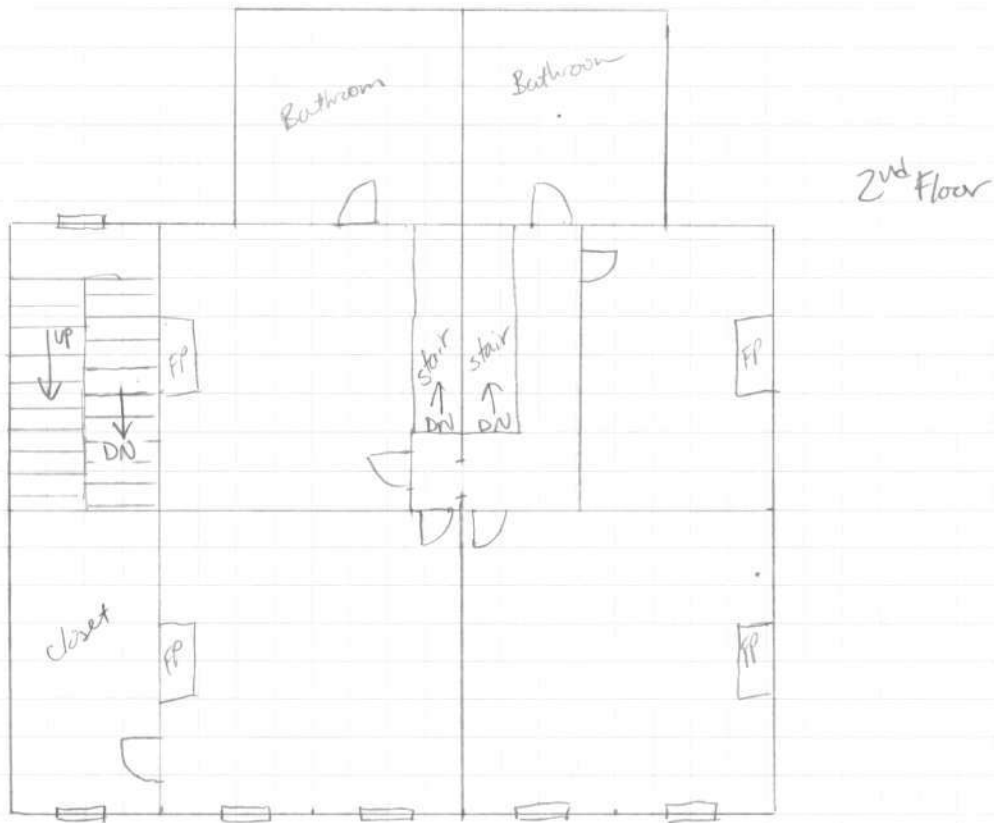
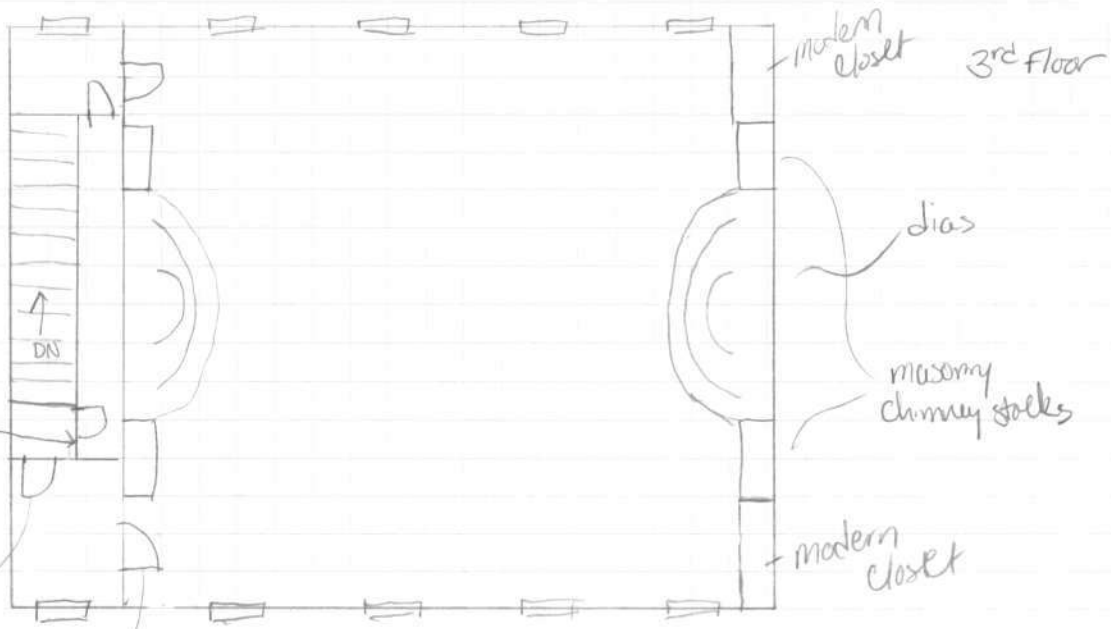
H0-329
 Howard Lodge Masonic Building
 5814 Main St., Elkridge
 Howard County
 Drawn 4/03, by Kristin Hill

modern partition and door

doors have hole w/ speaking tubes on exterior

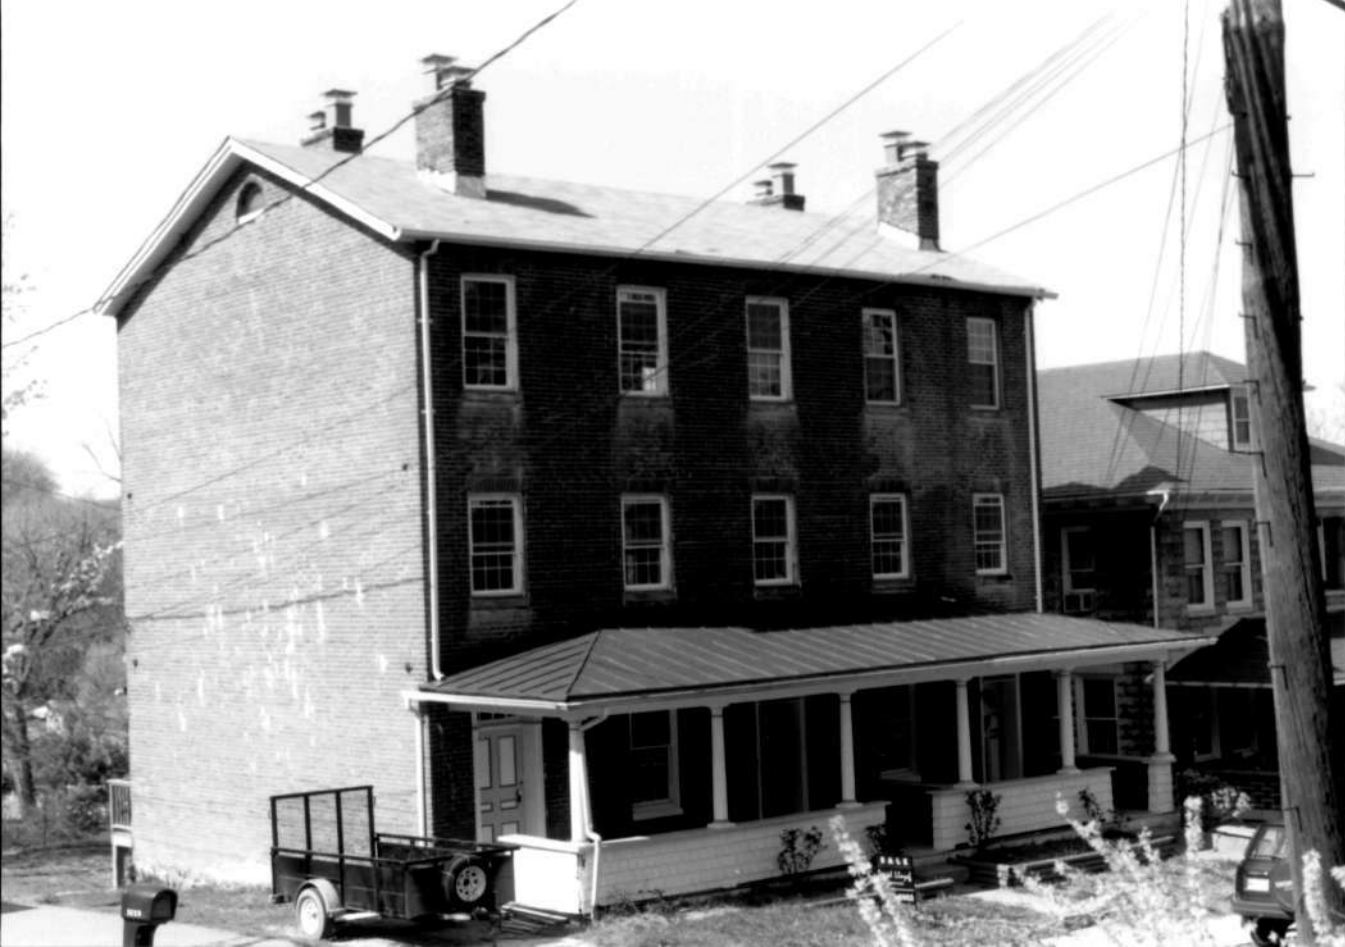
#1 of 11

Southwest elevation

This fascinating building faces south on the north side of Main Street and is the third building west of the intersection with Brumbaugh Street. The three story, five bay, double pile brick building is built of 5:1 common bond and rests on a stone foundation. A low pitched side gabled roof is pierced by four massive interior brick chimneys. Both the front and rear facades have matching corbelled brick cornices and jack arches over all window and door openings. The building is in the process of being renovated and is currently for sale. As a part of this renovation, all of the original windows were unfortunately removed and replaced with vinyl units with snap in muntins but the sizes of the window openings were not altered. Three entrances are located on the first floor of the front façade, one in the central bay and one in each end bay. The door in the west end bay may be an original paneled door with a four light transom. This door leads into a narrow hall which contains the original stair running up to the third floor Masonic/ Temperance Hall. The doors in the central bay and the other end bay are glazed and paneled and not original. Both have transoms and while the existing windows are not original, both the door and transom openings are original. The second and third floor windows are vertically aligned above the first floor openings and it is unusual that the third floor window openings are larger (and were originally so) than the second floor openings. A single story full width hipped roof front porch is not original to the building and confuses the simplicity of the façade. The porch currently has a solid balustrade

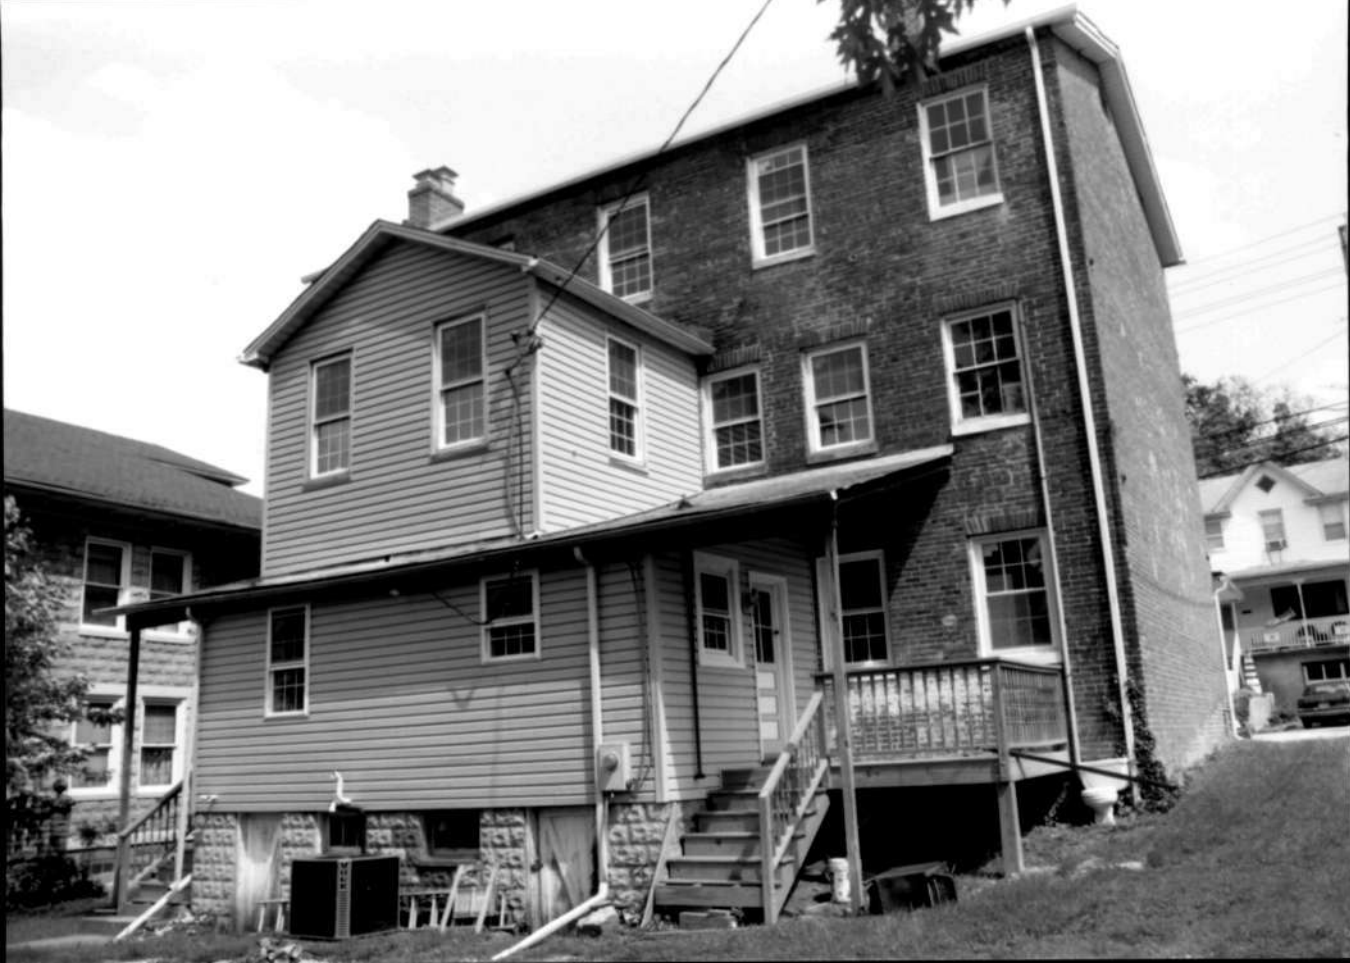
2 of 11

North (rear) elevation

The rear façade of the building probably originally closely mirrored the front façade but sometime in the early 20th century a two story two bay frame addition was made. The addition projects from what is approximately the middle of the eastern-most two thirds of the building and rests on a rusticated concrete block foundation which contains a substantial crawl space. There are two windows and two batten doors located in the north façade of the rusticated concrete block foundation. The fenestration of the rear façade of the brick part of the building was altered to accommodate the frame addition as both window openings and their accompanying jack arches were shifted to either side.

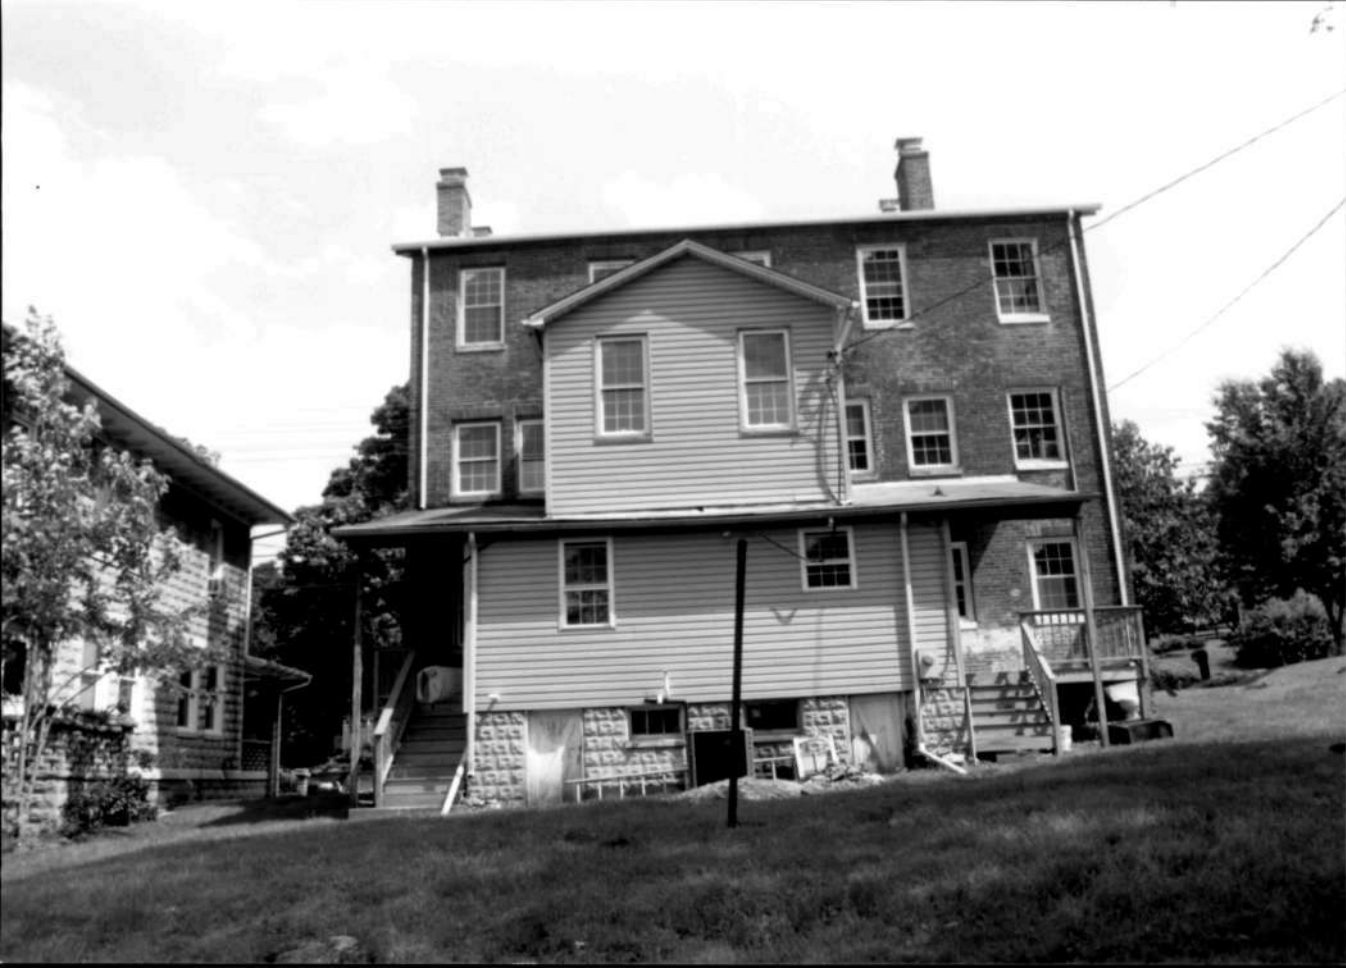
3 of 11

North (rear) elevation

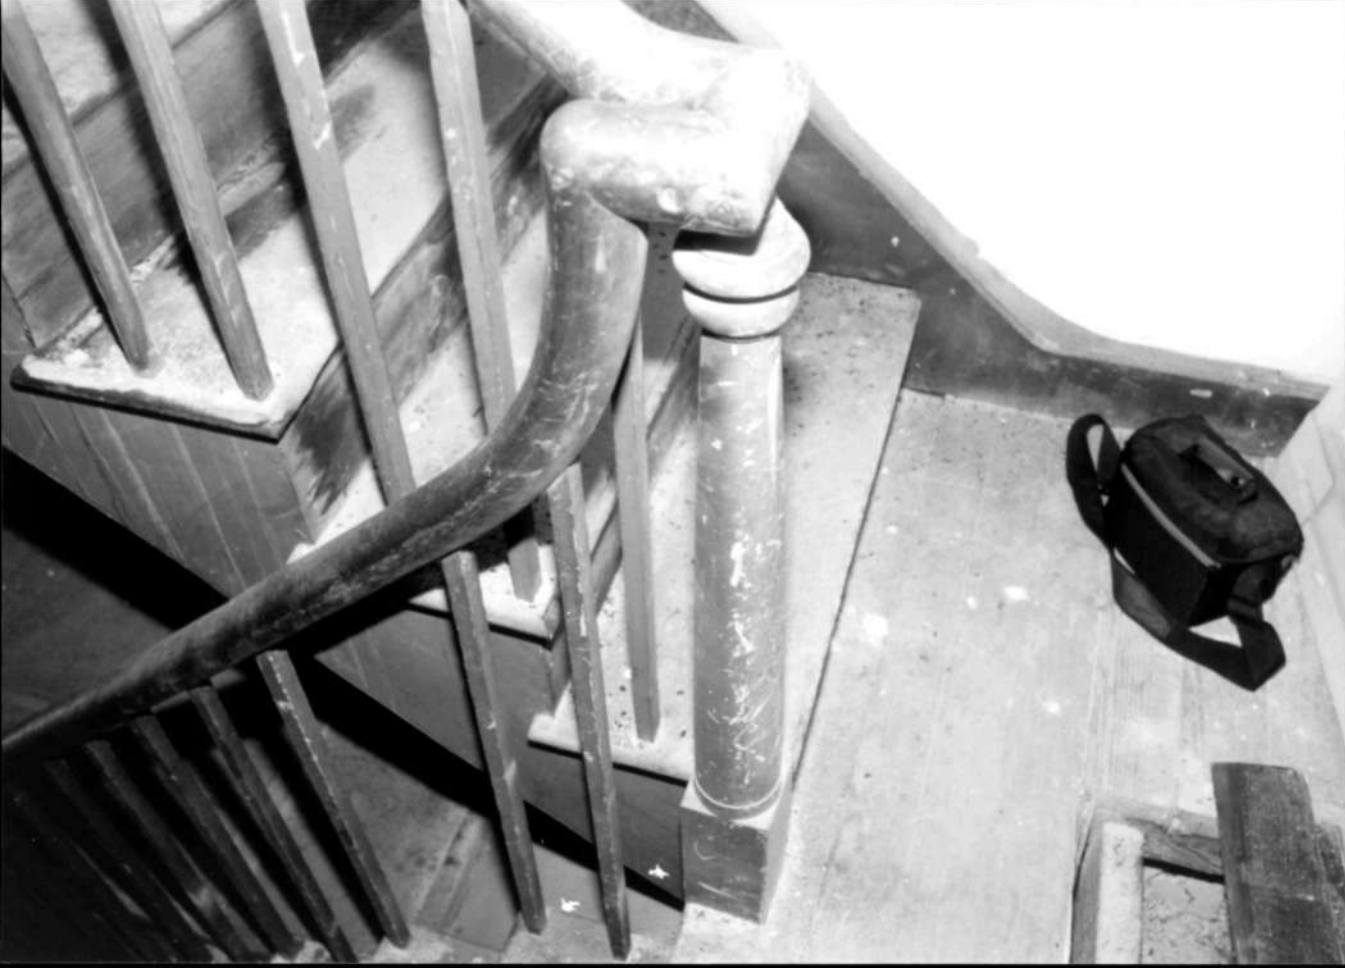
6 of 11

Newel post and ramped handrail at 2nd floor landing
of stair to the 3rd floor hall.

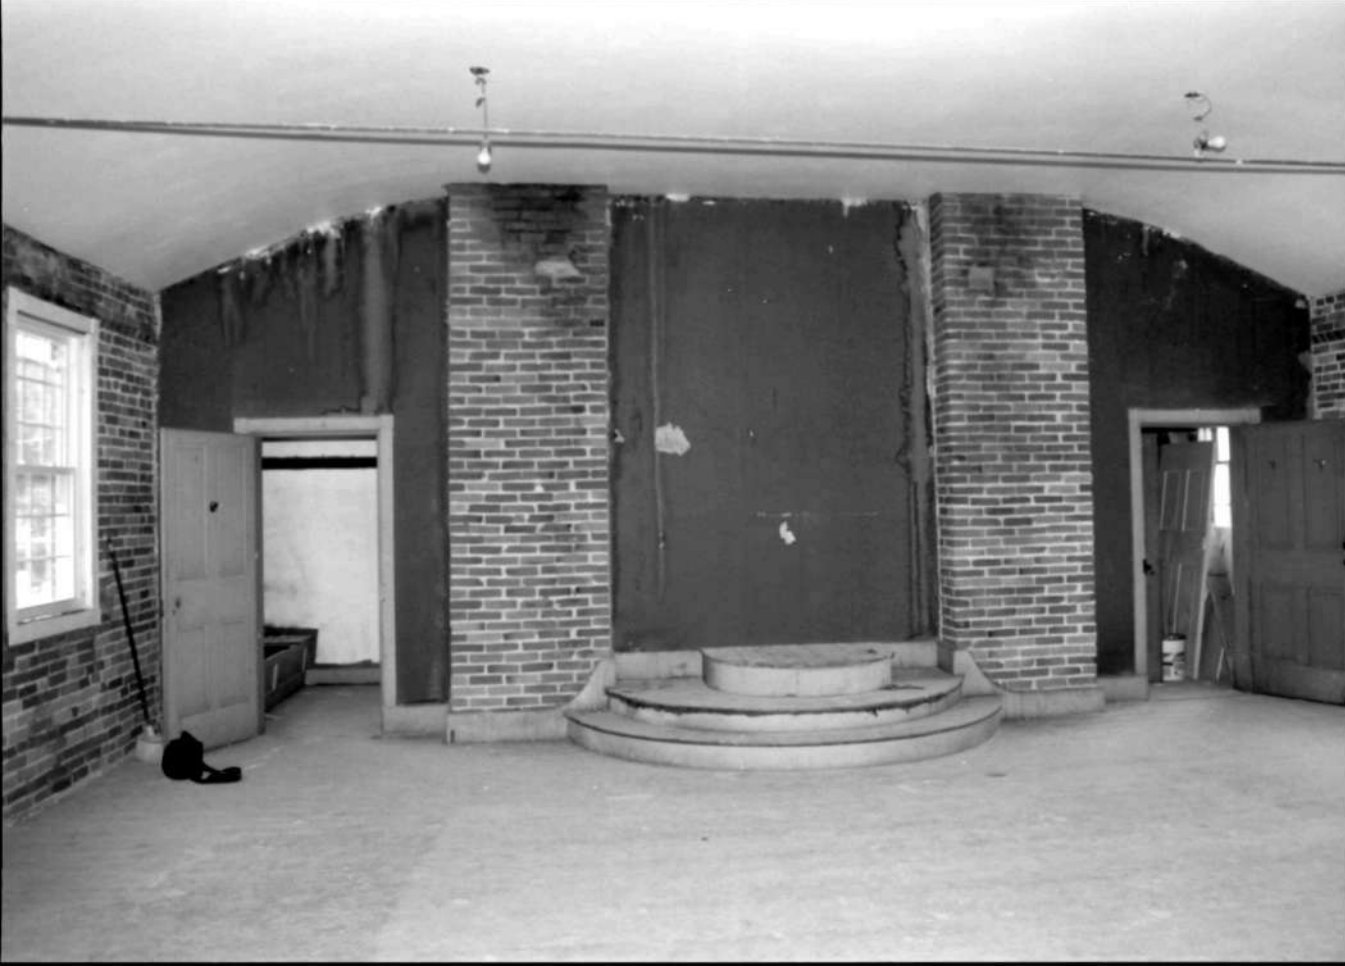
7 of 11

West end of 3rd floor hall/meeting space.

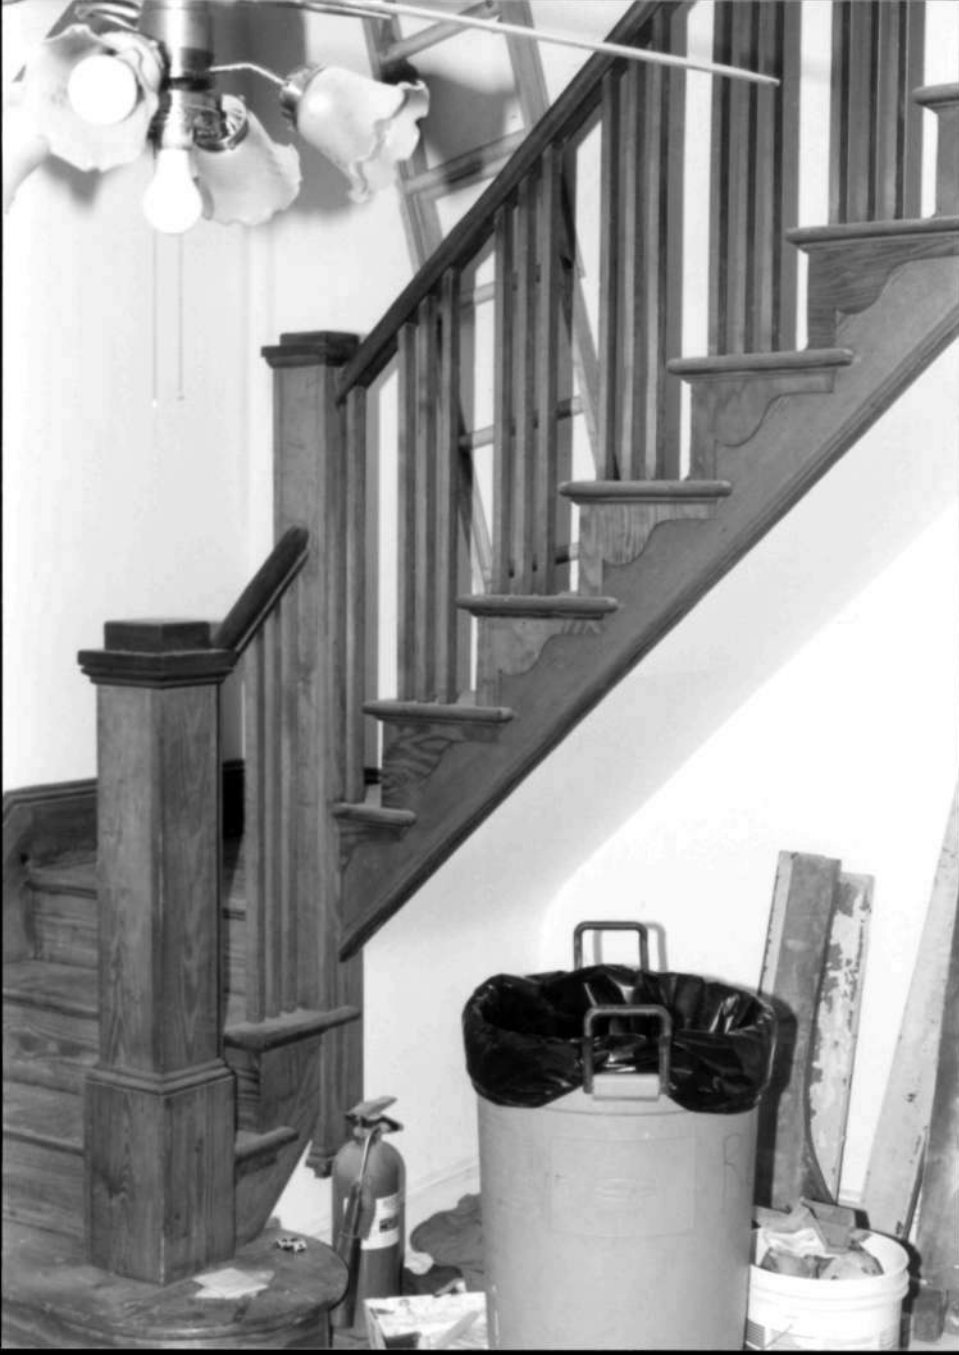
10 of 11

Stair in the center dwelling unit.

stair in the middle unit does have scroll decoration on the stair ends that may be original, and there is no reason to believe that the staircases themselves are not original. The other stair in the east end unit is currently lacking a balustrade and newel post, but the back of the stair has been opened up during the current renovation revealing that the boards are all sash sawn and the stair is constructed with machine headed cut nails.

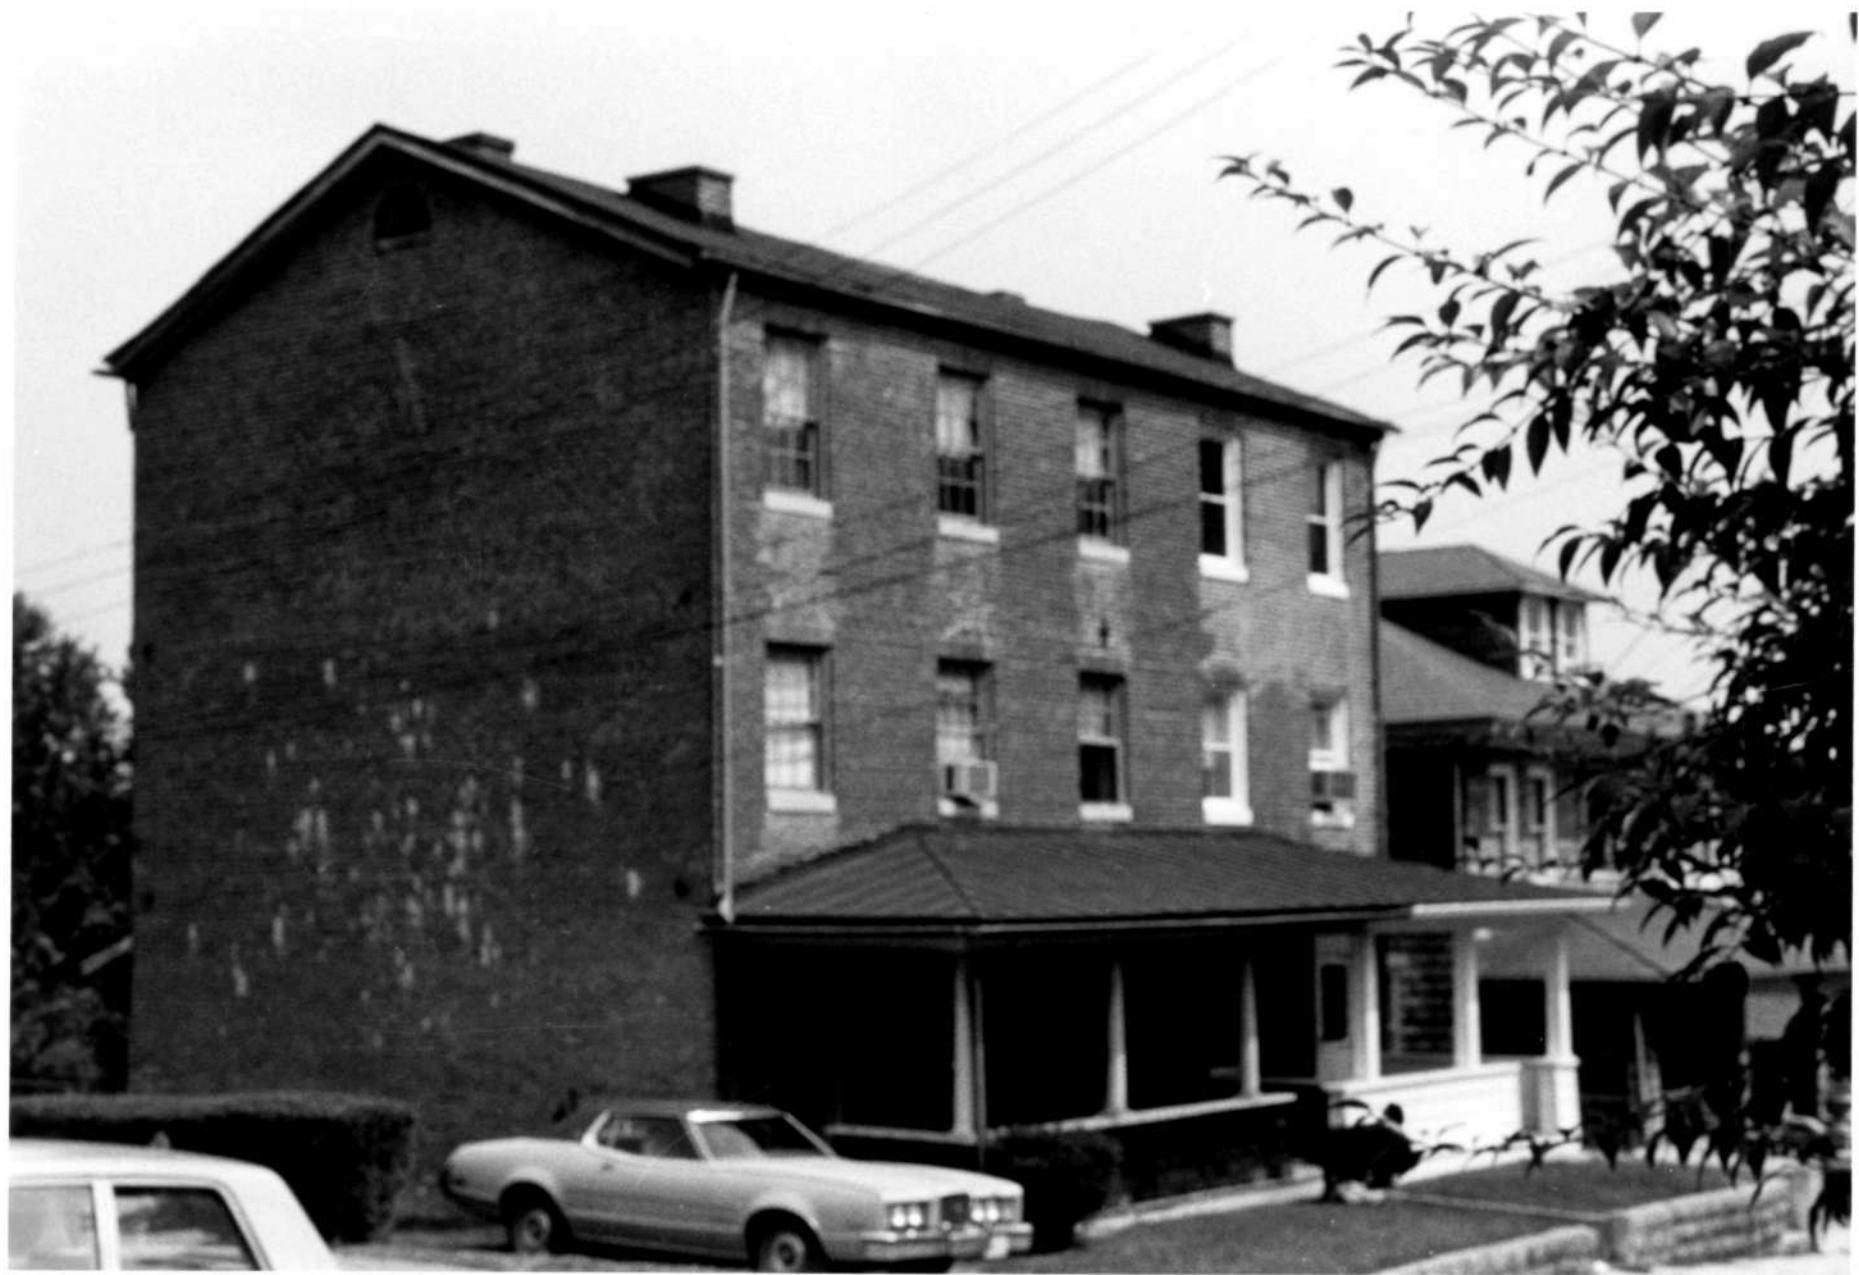
H0-329
The Howard Lodge #101
Masonic Building
5814 Main St - Elkridge
Southwest
CB Thompson, ACP
December - 1978
