HO-357

Jones-Mayfield-Kirkwood Building

8129 Main Street, Ellicott City

Maryland Inventory of Historic Properties Form

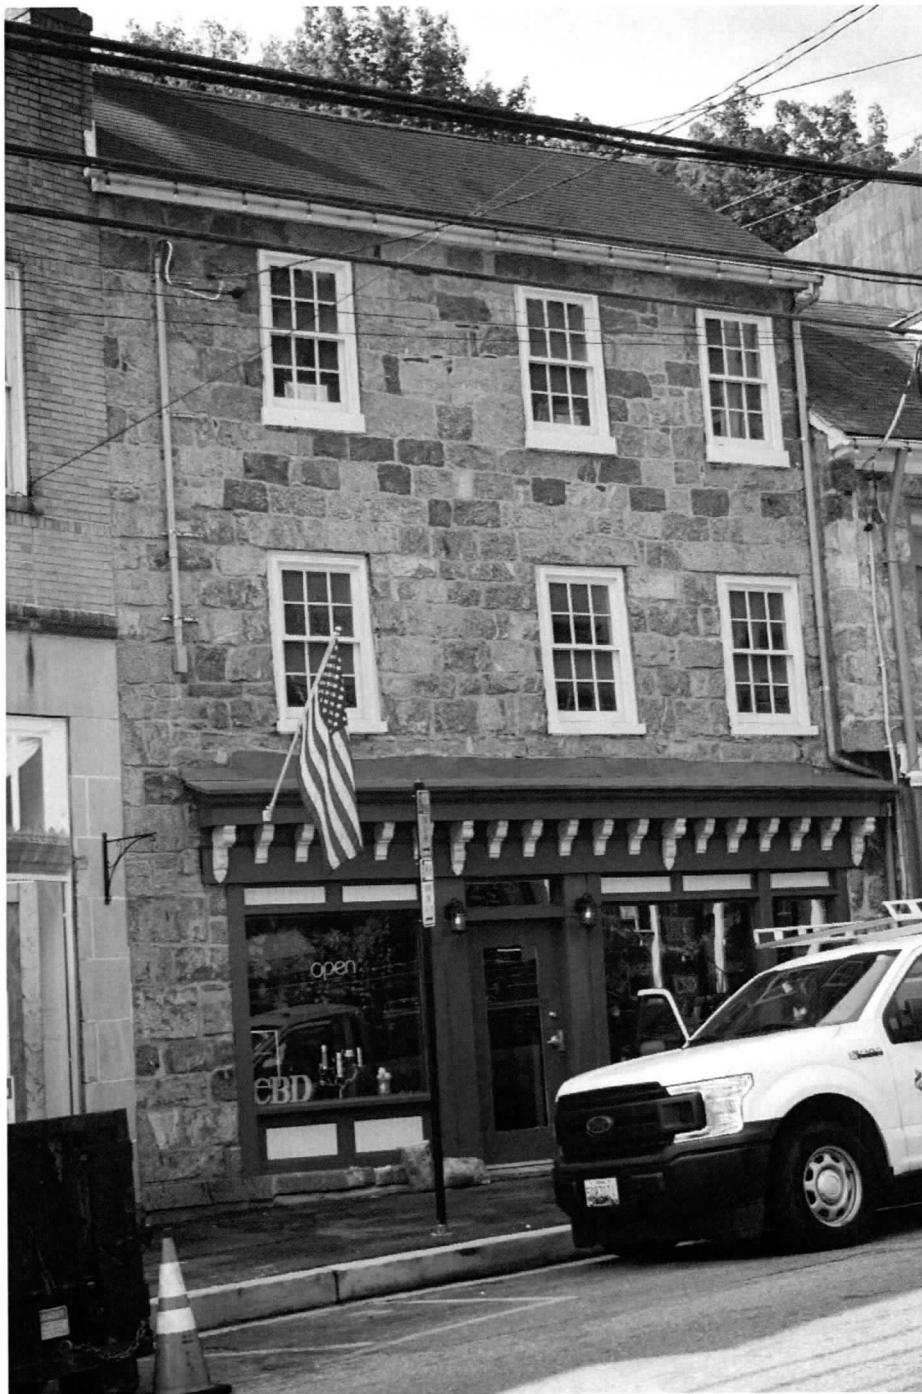
Photo 1 of 10: North elevation. 8/25/2020

This is a three-story, three-bay by one-bay rubble stone structure with a gable roof that has asphalt shingles and an east-west ridge. The north elevation stonework is partially dressed and brought to course. There is a wooden commercial storefront on the first story that has a doorway set just east of center. The door has one large light, and there is a one-light transom. Flanking either side of the door is a wide plate-glass storefront window of one light with two panels below and two narrow panels above. All of the panels are filled with vertical bead-board. The top panels read as transoms or frieze windows that have been infilled. The western-most bay is only half as wide as the other storefront windows, with only one panel above and below the light. There is a bracketed wood storefront cornice that has four larger brackets and 15 smaller ones, five each between each pair of larger brackets. The second and third stories each have three six-over-six windows with wood sills and stone lintels. The west bay windows are set close to the west wall; this partition wall projects to the north on the second and third stories, with the stone cantilevered over the storefront cornice. There is a simple wood box cornice, and an interior brick chimney on the east gable ridge.

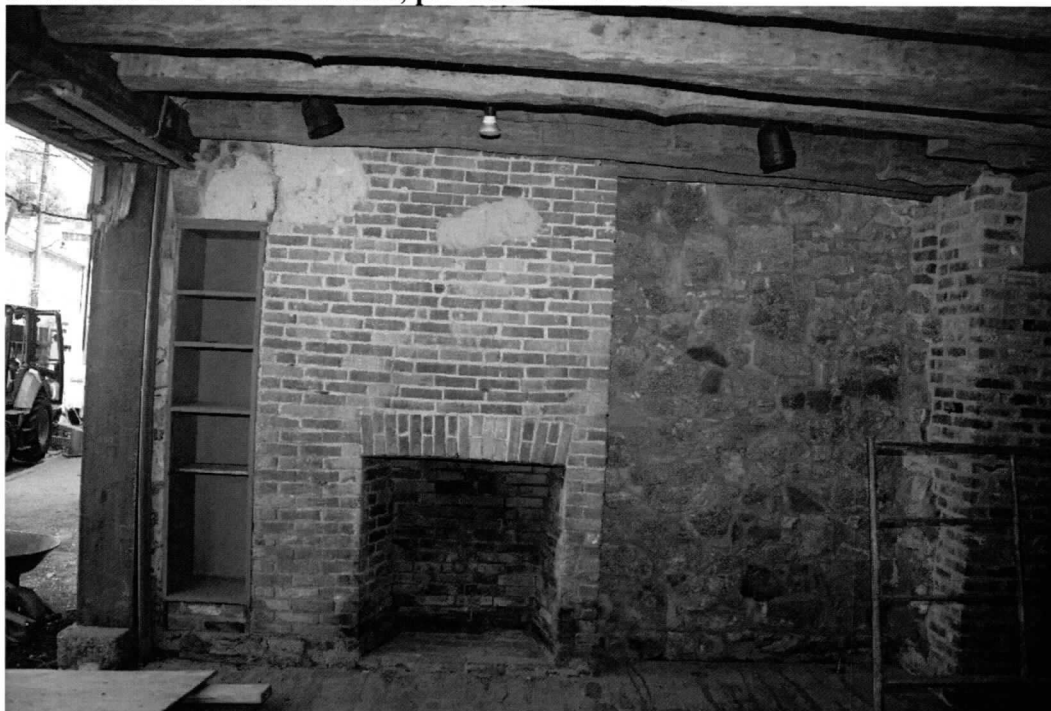
Photo 3 of 10: First story, east elevation. 9/15/2016

The southern section is all-new construction, though there was something here earlier, but not as deep. The west wall of Caplan's Department Store, on the east, has a section 7 feet, 5 inches long, running from the stone wall to the south, where the mortar was pressed up against German siding when the brick was laid c. 1926.

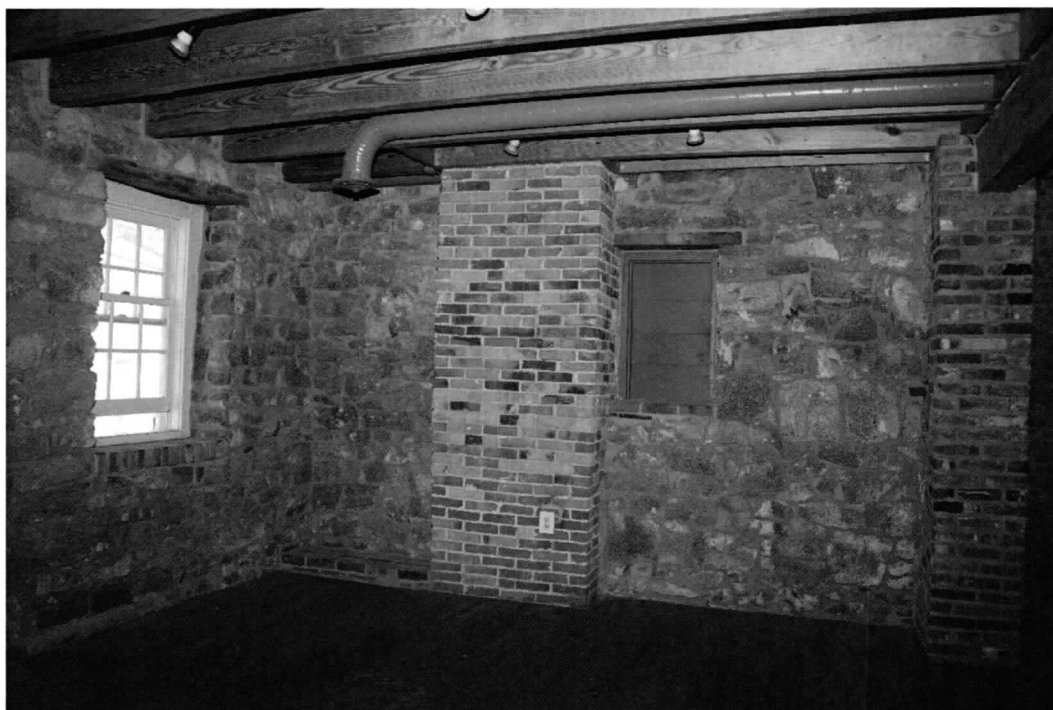
Photo 4 of 10: Second story, east elevation. 9/15/2016

The addition on the south is of all-new construction. The brick wall of Caplan's on the east, like on the first story, was clearly built up against something, but on this story it was not clearly German siding. On the west wall the rear corner of the adjoining building (George Ellicott's Tenant House/Fissell's Store, 8133 Main Street, HO-358) is exposed, and it is 3 feet, 1 inch deeper than this building and overlaps it at least 6 ½ inches. The bottom third of the stone wall appears to be missing, although it is possible that the wall was built this way because the bottom-most stone is set into the south wall of 8133 and is cantilevered the 6 ½ inches to the east. This stone is topped by one large stone that runs to the north and appears to pass into the wall of 8129. The stones above this alternate between a short stone at the corner with a longer stone running to the north into the wall, and one large stone spanning this whole width and also passing into the wall.

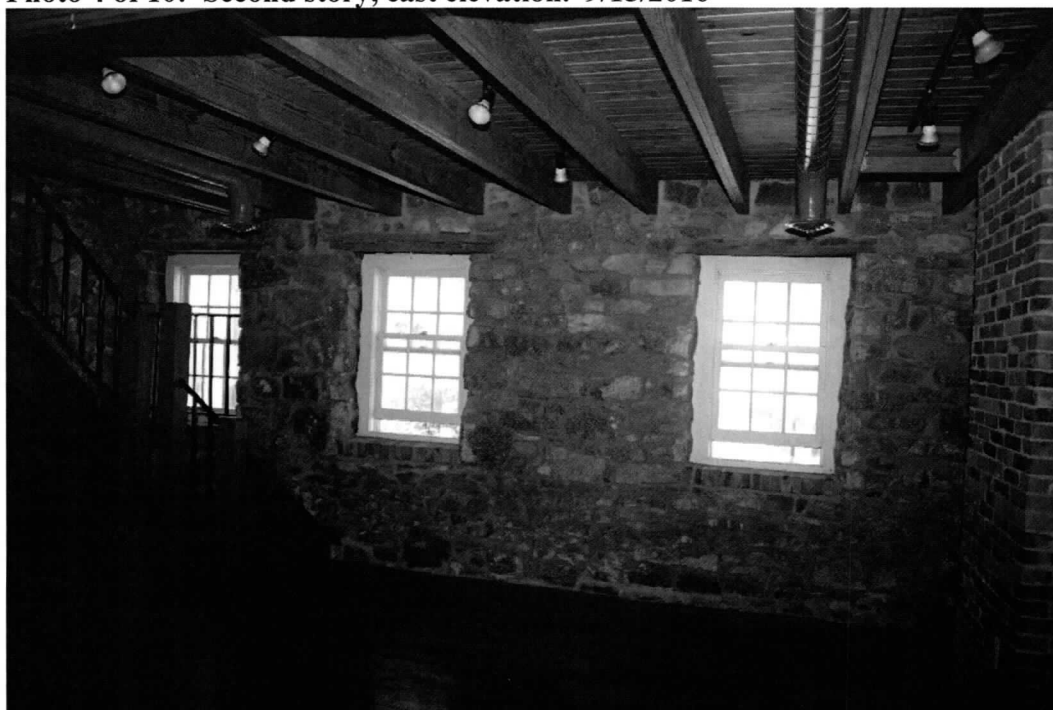
Photo 5 of 10: Second story, south elevation. 9/15/2016

The second story was probably one room and has all-new pine flooring and new third-story joists. The walls are exposed stone and the south wall has been blown out, with brick at the east and west ends of the wall. There is a ganged-together wood beam that supports the floor joists above. The east wall has a brick chimney with a small patch, possibly for a stove pipe, though the hole was smaller than is typical. To the south of the chimney and hard up against the south side of it, is an original window opening with a wood lintel that has plaster burns on the bottom of it. It has a new brick sill on the interior, but the frame could be original. There is board infill on the exterior side of the opening. The opening in the stone is 25 inches wide by 38 inches high from the wood sill; the latter is sloped to the exterior. The opening of the frame is 21 inches wide by 36 inches high. The frame is 2 inches wide, with marks on it

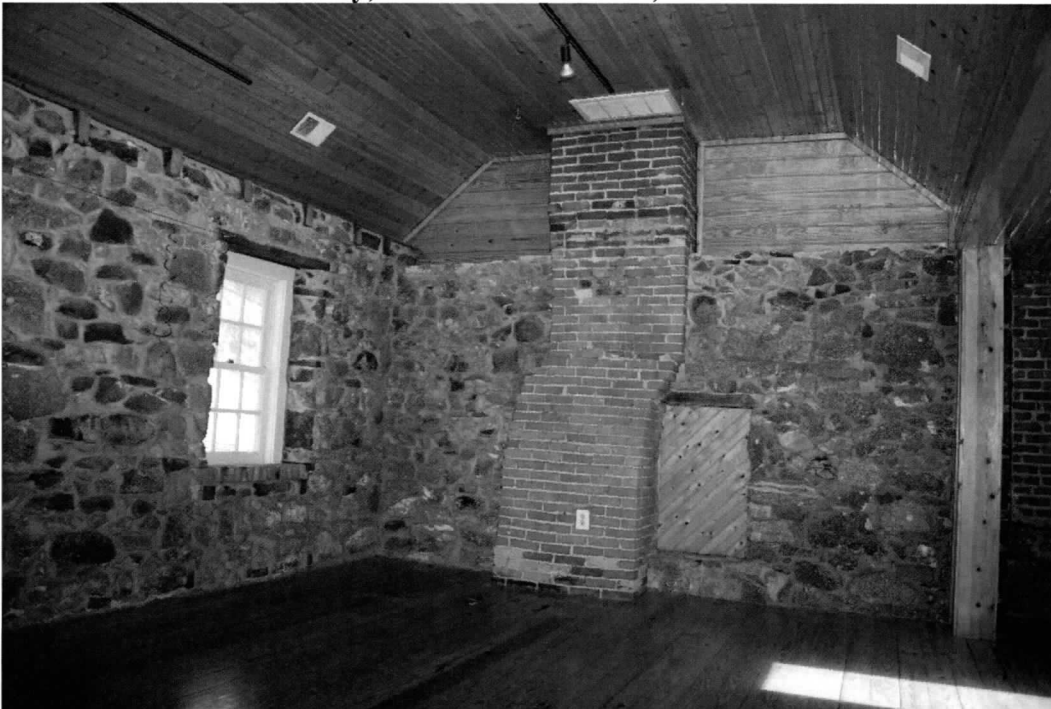
Photo 7 of 10: Third story, view northeast. 9/15/2016

The third story has all-new pine flooring and the attic floor and joists above have been completely removed, with the rafters and collars being covered with new bead-board. The south wall has mostly been removed and what little remains is brick. On the east elevation the brick chimney begins to step back about three feet above the floor, and then about four courses are corbeled to the south above the window lintel. The stone wall on the east ends just below the eave line, with the gable end being frame with new wood horizontal siding on the interior. At the top of the stone wall the brick of the chimney changes in color, being darker, and corbels out to the west for several courses. The change in color may simply reflect the fact that the third-story brick was plastered, and then this was removed and probably took some of the brick with it, while the attic was exposed to dirt and the environment for much of its existence. To the south of the chimney is a window opening like that on the second story, set tight against the chimney. It has a wood lintel with whitewash on the soffit and has straight jambs. It is infilled with bead-board. It is set lower on the wall than the windows on the north elevation. There is considerable blank wall to the south of the window opening, but there is no incontrovertible evidence that the wall was raised. There are nailing blocks in the north wall, just above the floor level; some are set vertically and appear to be cut-off joists, but others are set horizontally, and they do not align with the cut-off joists of the attic. The windows in this wall have straight jambs with narrow nailers set into the jambs, and three larger nailing blocks under each sill. These appear more like something structural that has been cut off, but if so, it is unclear what they may have been. The west wall steps back to the west about 3 inches just below the level of the nailing blocks. The top of the wall is boxed in, with German siding on the interior that follows the pitch of the building to the west and the bottom of the western-most attic floor joist, which appears to be the only one that remains (though it is now hidden from observation). On this wall is a large triangular ghost of what appears to be plaster residue

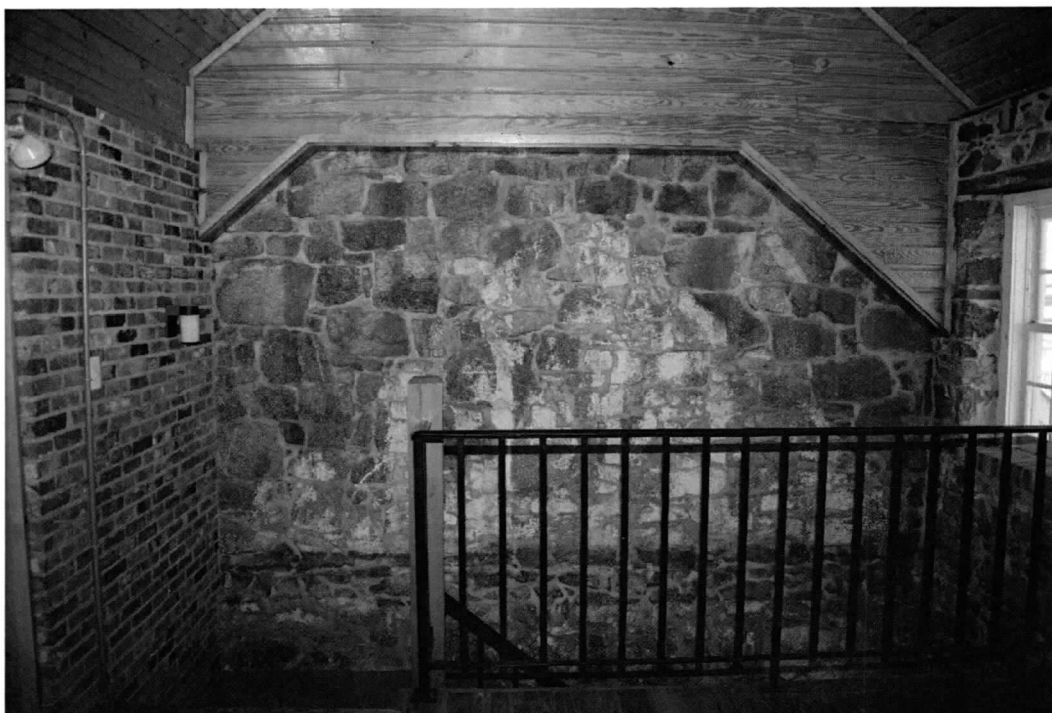
Photo 8 of 10: Third story, west elevation. 9/15/2016

beginning at floor level at the north and south walls and reaching its peak in the center of the wall at about the height of the north window lintels.

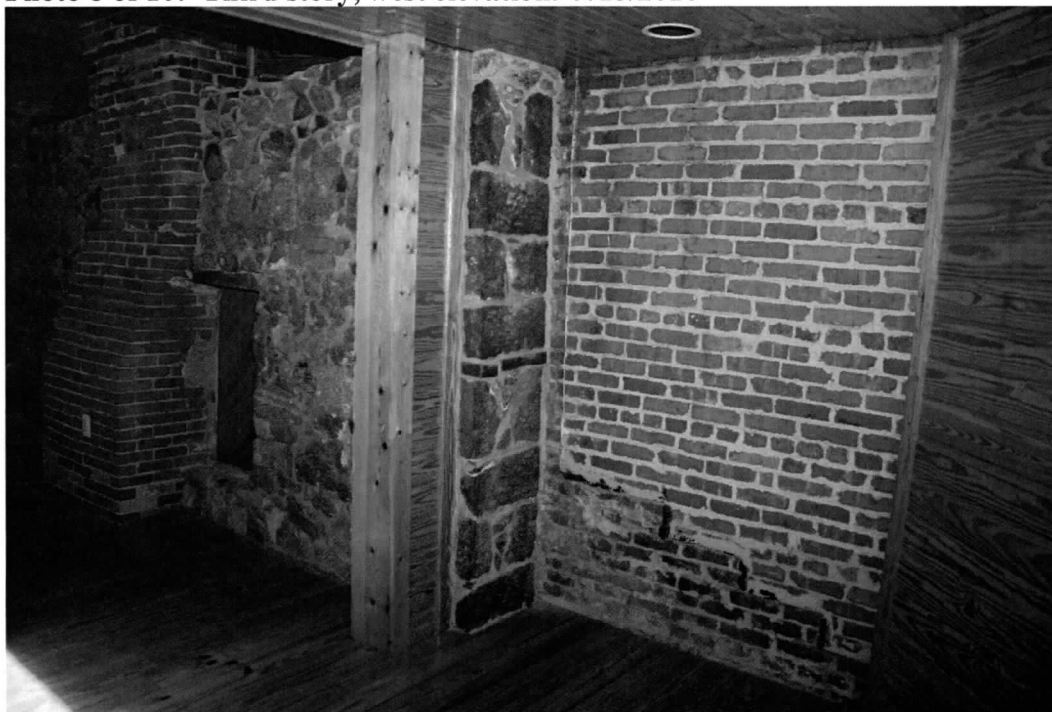
Photo 9 of 10: Third story, south and east walls, view northeast from addition. 9/15/2016

The south addition on the third story is all new. The east wall is the brick wall of the building to the east and it has the ghost of stepped flashing for the shed roof of the earlier southern section of 8129 Main Street. Above the roof-line ghost is a vertical ghost against the stone wall that appears to be a post, though might only have been a downspout. On the south side of the eastern section of remaining stone rear wall there is old wood set into the stonework, similar to bond timbers. It is set 3 feet, 6 inches above the floor and is 2 inches tall. The western edge of this stone section appears to be a good, sharp corner from the floor to the ceiling.

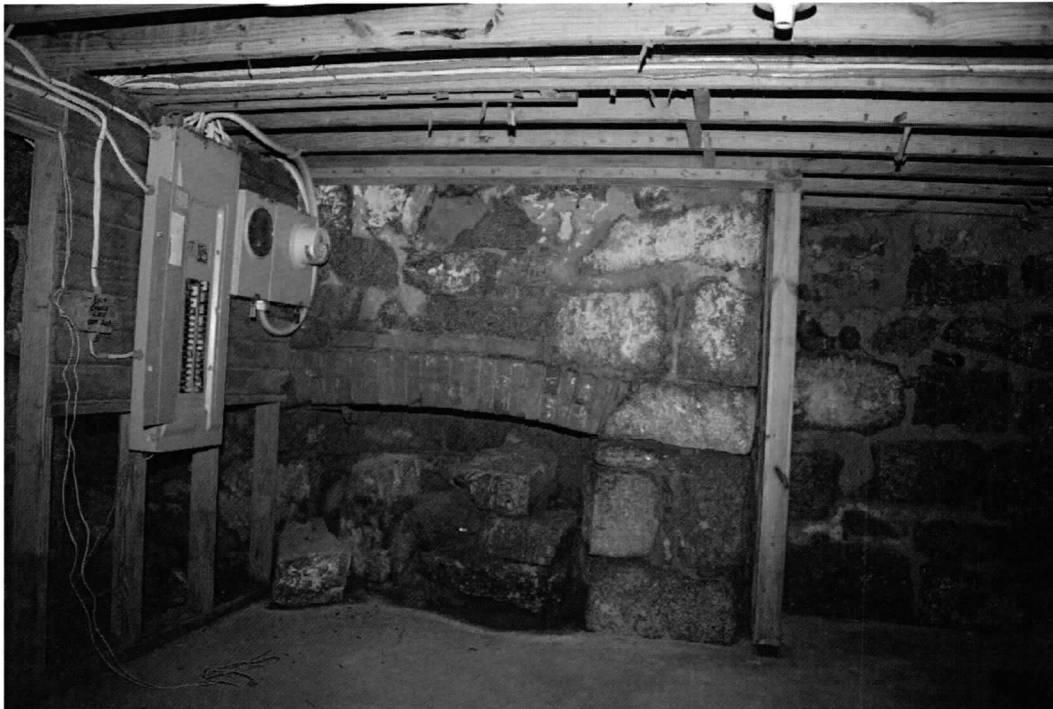
Photo 10 of 10: Basement, east elevation. 9/15/2016

The basement has a concrete floor and the level has probably been raised because the ceiling level is low. The first-story joists are all new. The walls are granite, with some of it roughly dressed and most of rubble; there are some traces of lime wash or paint. The east elevation has a fireplace with splayed stone jambs and a brick jack arch with a slight arch to it. There were two iron lintels below it, but they are mostly rusted out now. The north end of the lintel is set into the north wall, right at the corner of the building. There may be the rusted end of a broken-off crane eye in the back corner of the north jamb. The north elevation has an original opening in the wall at the east end for a cellar entrance. This opening is right next to the fireplace. The west jamb of the opening has been infilled with stone and brick, reducing the opening from 4 feet, 7 inches wide to 3 feet, 1 ½ inches wide. The south wall has brick infill supporting steel I-beams. Sections of the wall were apparently cut out when the rear section was added.
