HO-358

Ellicott's Tenant House/Fissell's Store

8133 Main Street, Ellicott City

# Maryland Historical Trust Maryland Inventory of Historic Properties Form

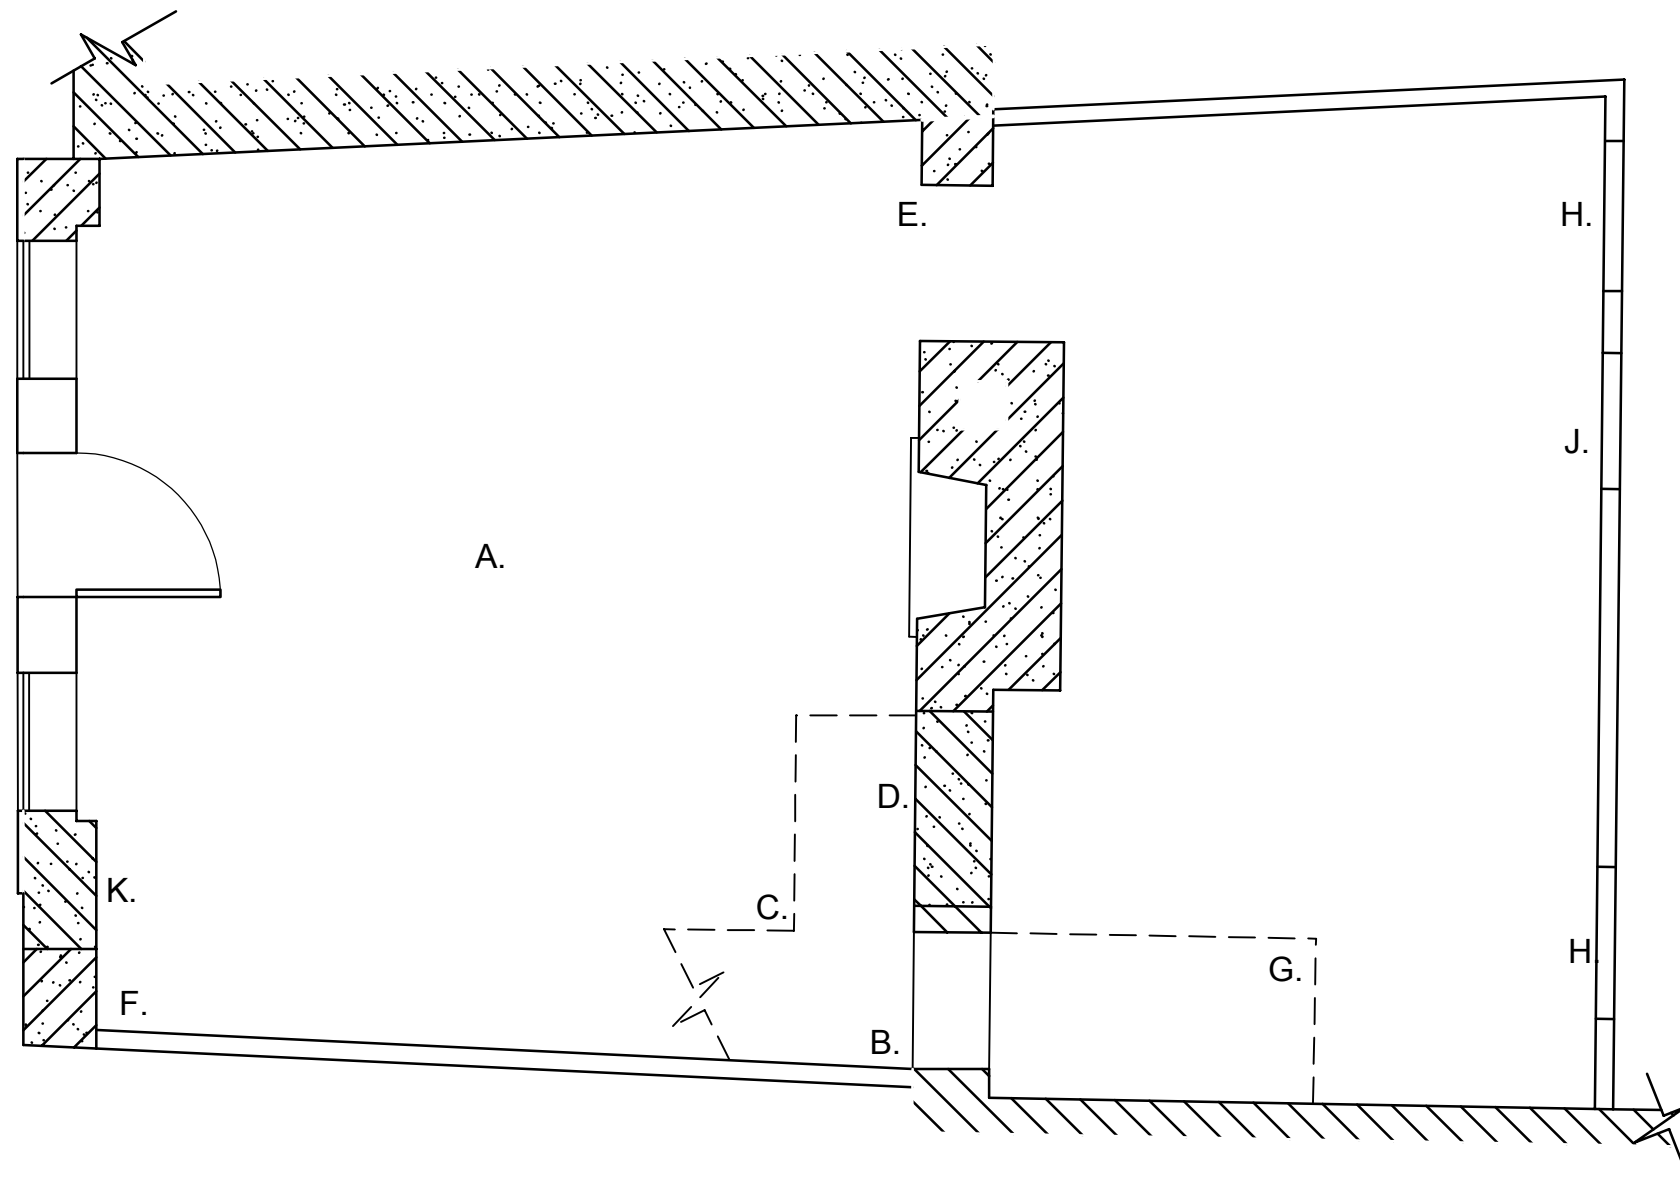
- A. FLOOR LEVEL DROPPED 2 FEET FOR STOREFRONT CONVERSION.
- B. DOORWAY CUT THROUGH WITH STOREFRONT CONVERSION. SILL IS 4 FEET, 6 INCHES ABOVE CURRENT FLOOR LEVEL.
- C. APPROXIMATE LOCATION OF ORIGINAL STAIRWAY. MODERN STAIRWAY NOT SHOWN.
- D. ORIGINAL WINDOW OPENING INFILLED WHEN DOORWAY CUT THROUGH.
- E. ORIGINAL DOORWAY -- SILL DROPPED.
- F. ORIGINAL STUD AND RIVEN LATH PARTITION WALL WITH NO OPENINGS.
- G. LOCATION OF EARLIER STAIRWAY.
- H. ORIGINAL WINDOW OPENING CLOSED OFF AND SASH REMOVED.
- J. ORIGINAL DOORWAY CLOSED OFF AND DOOR REMOVED.
- K. ORIGINAL WINDOW INFILLED FOR STOREFRONT CONVERSION.

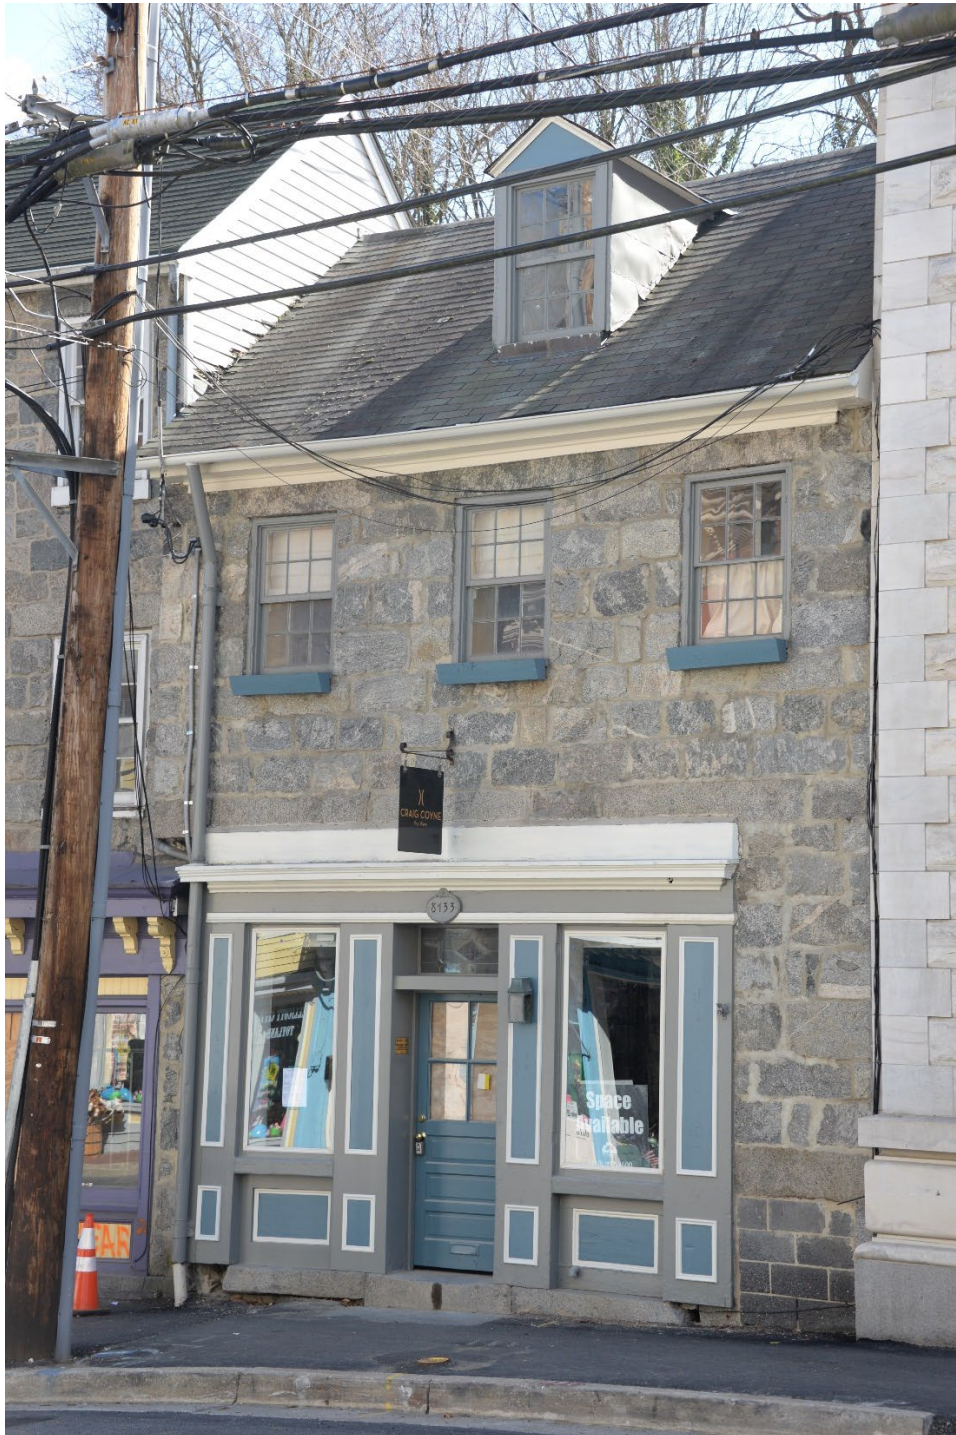
**Photo 1 of 19: North elevation. 3/2/2017**

The north elevation has a storefront set just above grade, with a center entrance that has a wood door with four lights over three lying panels, and with a new transom. There are one-light plate glass

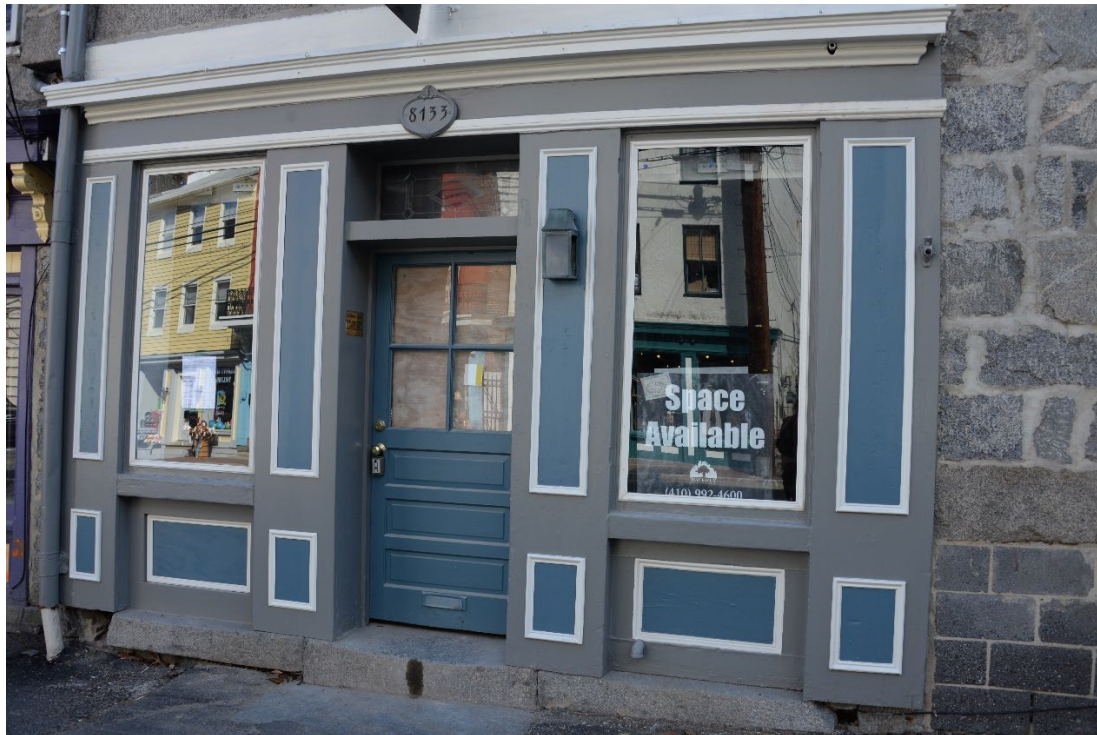
**Photo 2 of 19: North elevation, storefront. 3/2/2017**

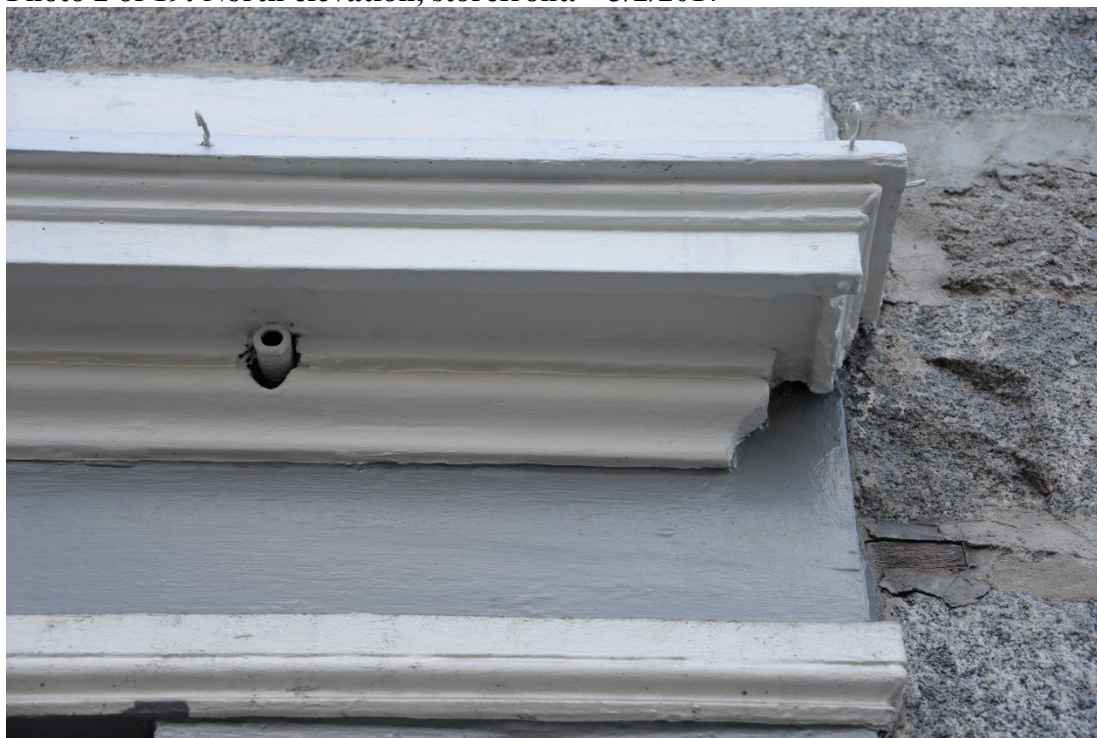
**Photo 3 of 19: North elevation, storefront cornice detail. 3/2/2017**

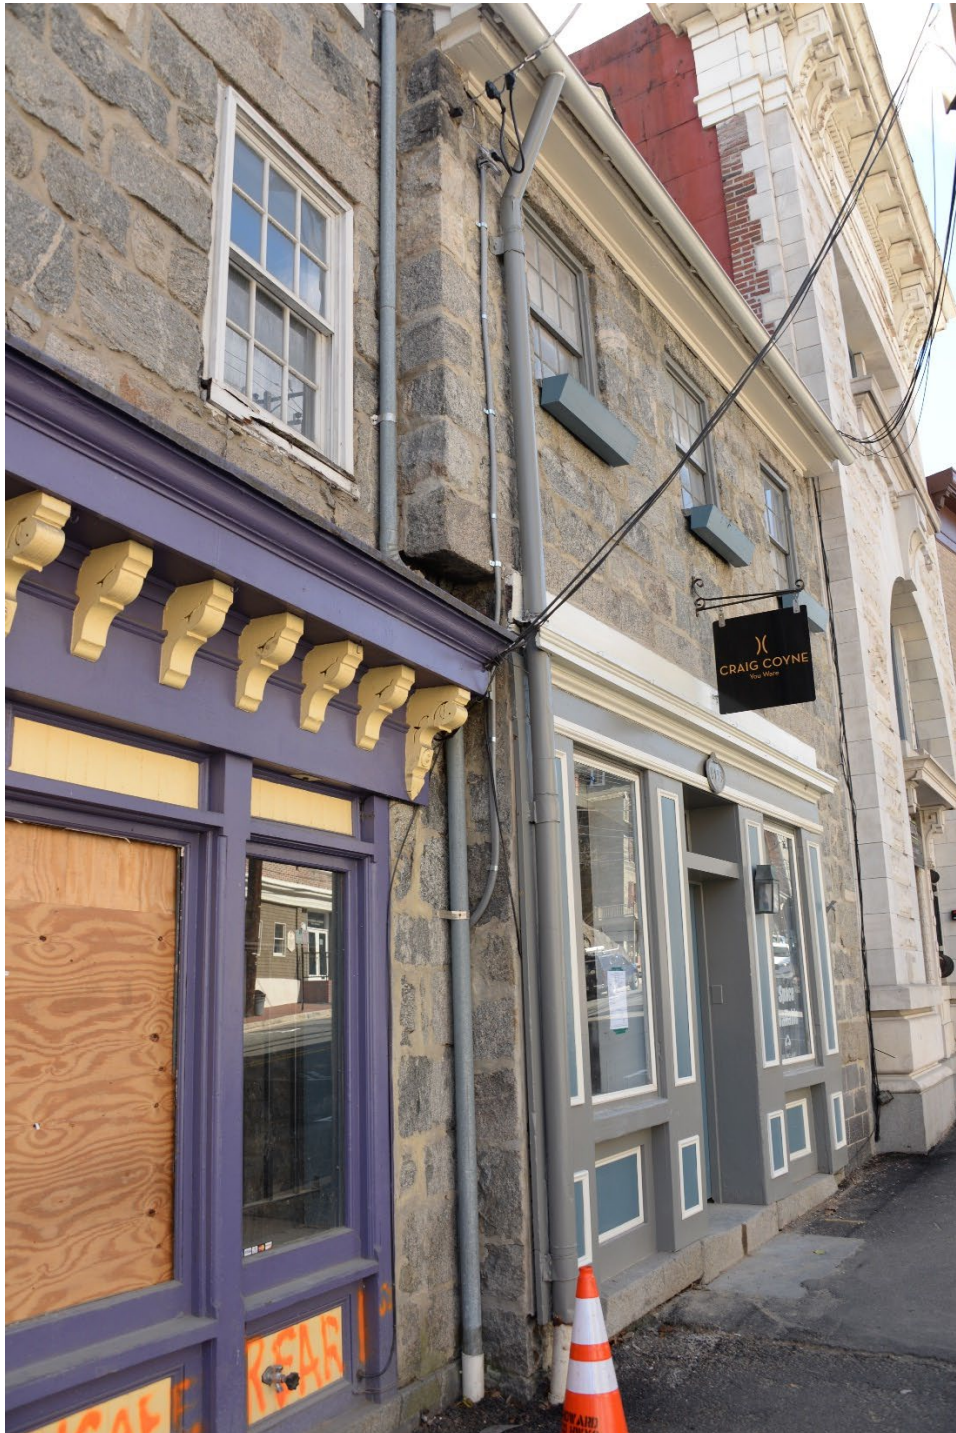
Photo 4 of 19: North elevation from east showing building overhang at 2<sup>nd</sup> story. 3/2/2017

A curious feature of the building is the overhang of the northeast corner at the second story. As the plan of the building shows, the first story was built up against an existing stone wall that must have been David Jones' building. This wall must have been built over the property line, and the structure must have been only one story, originally. Since Ellicott intended a two-story and attic building, he must have taken down parts of the gable end of Jones' building and rebuilt the wall. Since he built the front wall of his structure closer to the street than had Jones, he either would have had to build his front wall more than a foot further east on the first story, or failing that, cantilevered the east end of the second story forward to reach the plane of the front of his building. Since any wall added in front of the existing partition wall could not have been tied into the existing wall without taking parts of that wall down, Ellicott (and probably with Jones' input) chose the latter solution. The use of stone for rental buildings was not unusual in Ellicott City and probably reflects both the availability of the material from quarries along the river, within a few hundred feet of this site, that the Ellicotts were Quakers, who tended to build with a desire for durability, and the urban character of the town, where fire was an ever-present threat.<sup>3</sup>

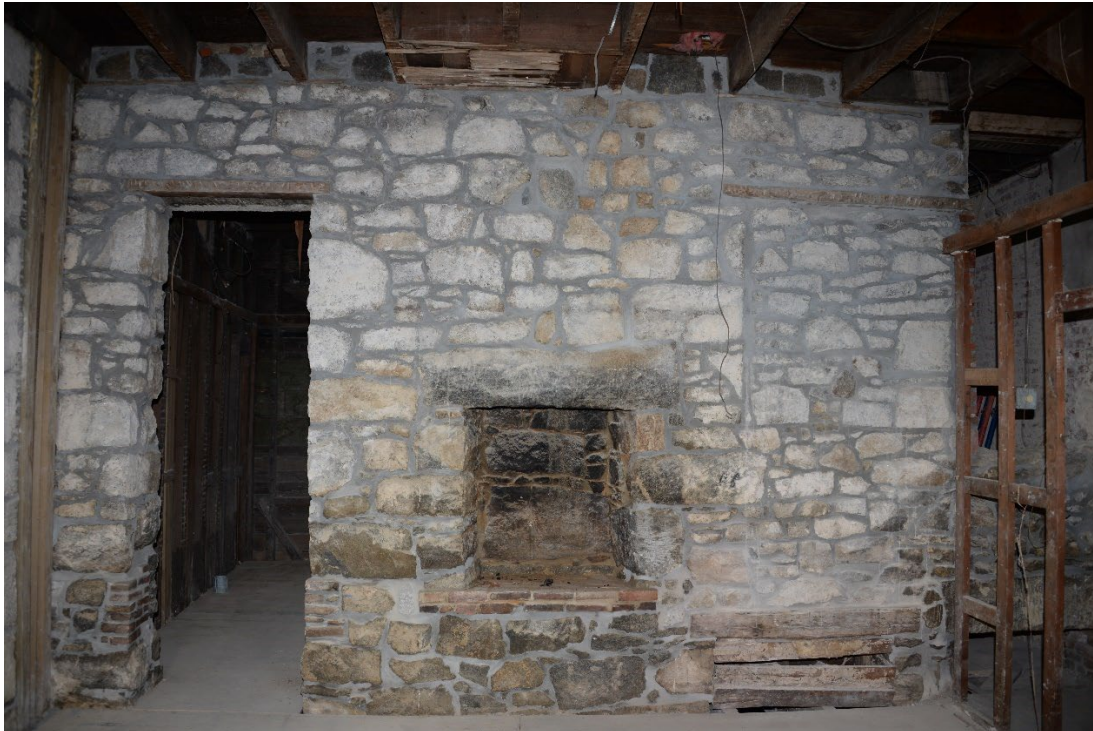
**Photo 5 of 19: First story, main block, south wall. 2/15/2017**

The south wall has a doorway to the east with a wood lintel, and the stone at the bottom of the opening looks cut through, with brick infill on both of the jambs where a sill was removed. In the center of the wall is a fireplace with the brick floor of the firebox set 26 inches above the floor. It has two courses of brick, with the top of the bottom course at 24 inches above the floor, suggesting that the floor has been dropped by about that amount. The firebox has splayed stone jambs and a single large stone lintel. To the west of the fireplace is a longer wood lintel with stone infill in what must have been a window opening. The sill height of the opening is just below the top of the firebox opening. Beneath it is a deep wood lintel, probably for a window opening in the basement. It has wood infill that retains one piece of circular-sawn lath nailed to it. At the west corner is a door opening cut through at the edge of the stone window-opening infill, with brick and plaster on both jambs. The bottom of this opening is set about 3 feet above the floor. Below the door opening is a large stone lintel, apparently for a doorway in the basement. The bottom of this lintel is about 13 ½ inches above the present floor. The south wall in this area appears to have a diagonal ghost on the stone like a stairway ascended to the west along the south wall, to a landing under the south doorway. There are traces of plaster on the stone to the east of this ghost, and none to the west of it, under the doorway. On either side of the brick hearth is a white stone that is probably infill for a joist pocket. There is a similar stone at the same vertical height near the southeast corner. The brick infill on the doorway to the east could also be joist pockets. It appears that there was one pocket over the basement window lintel, but to the west of it there are no clear pockets, suggesting the possibility that there was an interior stair here to the basement. At the southwest corner there is the end of a beam or joist in the west wall, up against the south wall, that may have originally run to the east. The southwest corner of the floor has 2 ½-inch tongue-and-grooved flooring that is blind-nailed and laid over diagonal sub-floor. This probably dates to when the floor level was lowered.

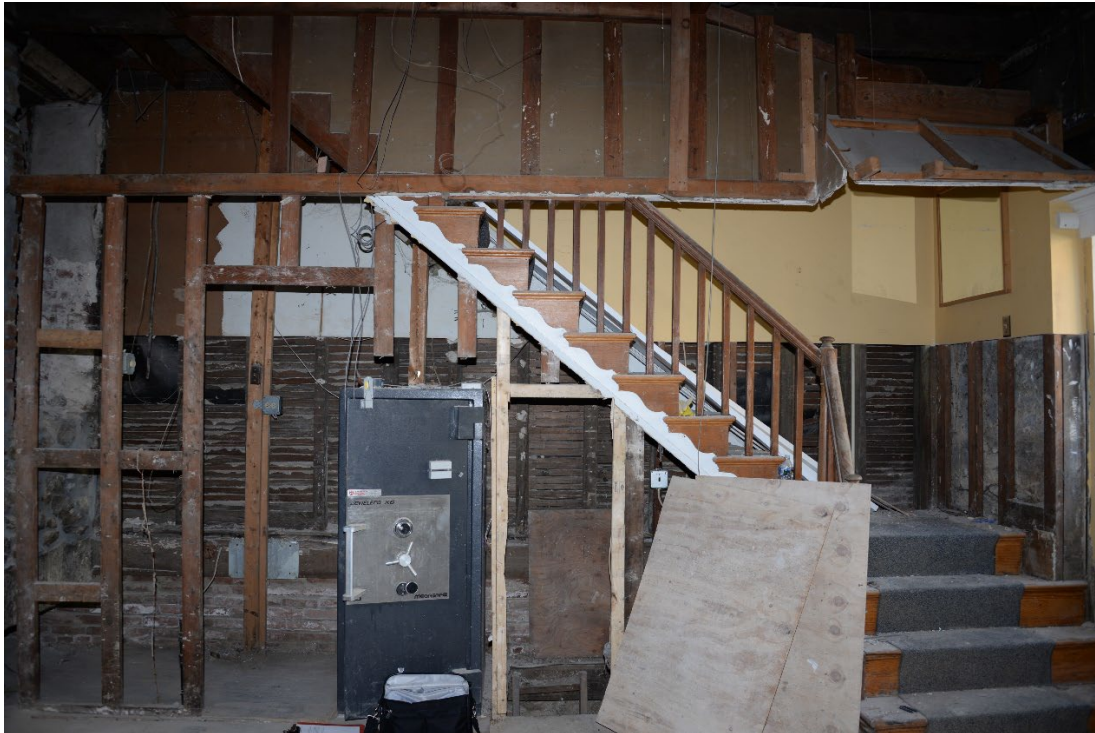
**Photo 7 of 19: First story, main block, view west. 2/15/2017**

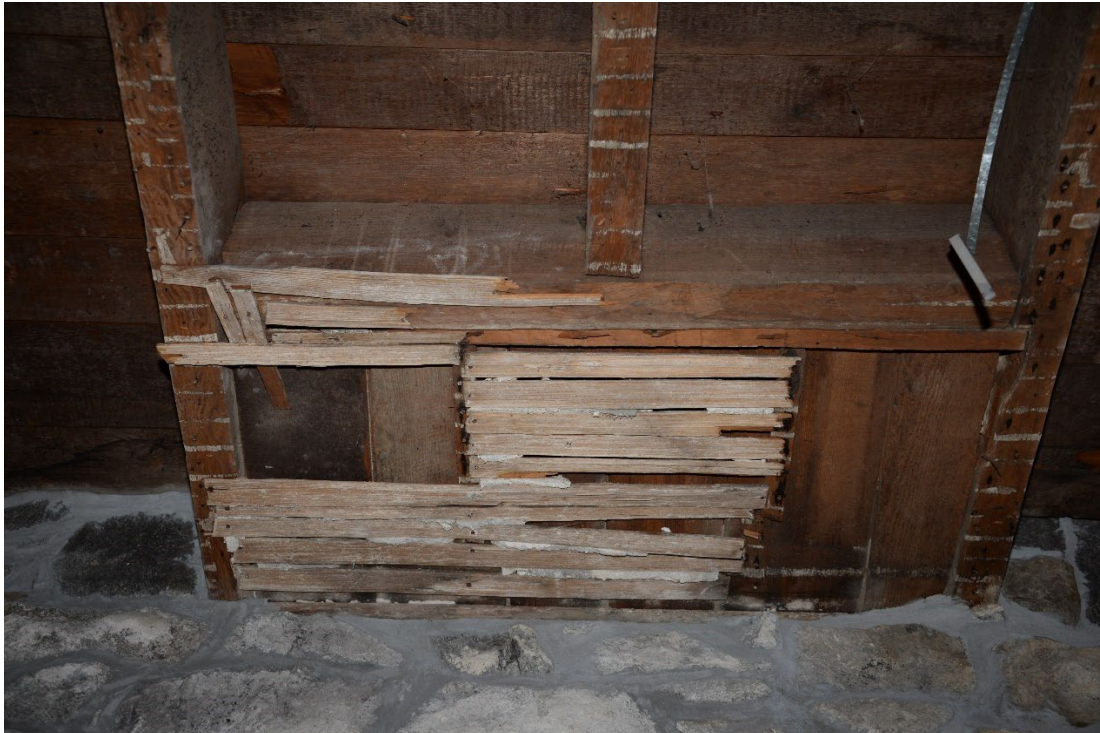
**Photo 9 of 19: First story, main block, second story hearth framing. 2/15/2017**

The ceiling had been dropped but is now opened. The second-story joists are about 3 by 10 inches, run north-south, and are set in pockets in the stone wall, on top of 1-inch boards. There are no breaks in the joists, suggesting that the stairs had to be at the west end, but there is no clear evidence of a stringer on the west studs. The second-story hearth is framed-in on the south side, with a joist flanking the east and west sides, and a header with through tenons between them picking up one joist end. The hearth bricks are supported with boards, and there is still riven lath nailed to the joists and to nailers on these boards. There are strips of lath nailed to the bottom face of some of the joists as shims, and the ceiling was always plastered.

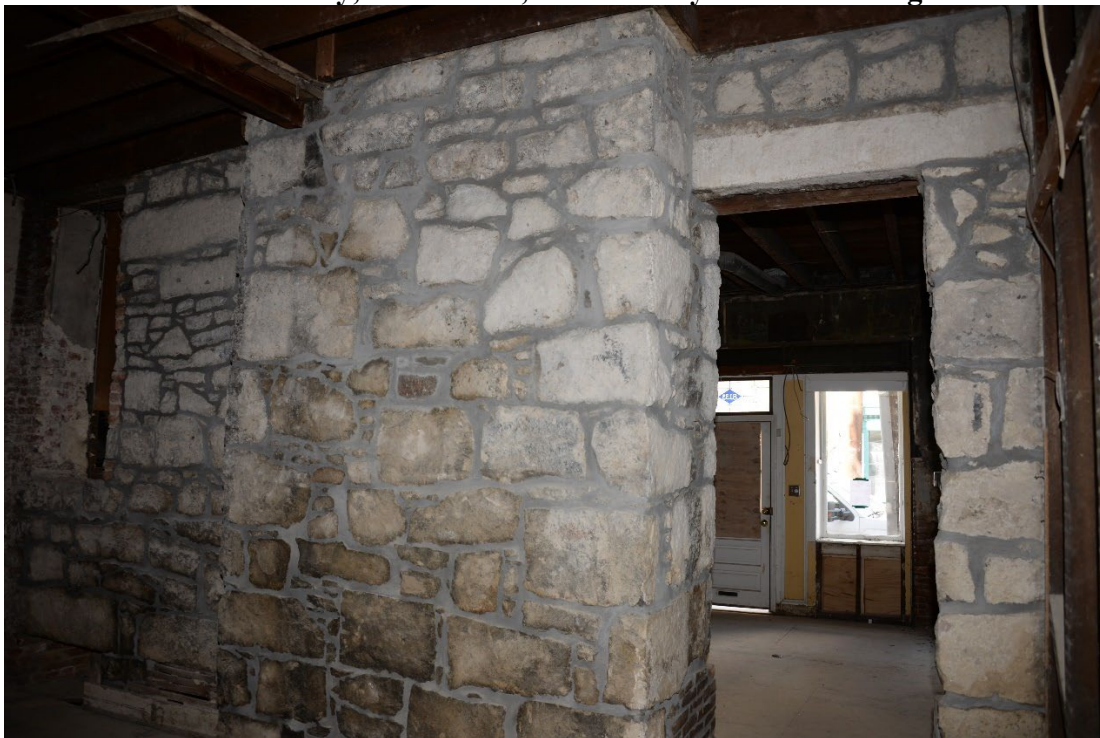
**Photo 10 of 19: First story, main block, south elevation captured by addition. 2/15/2017**

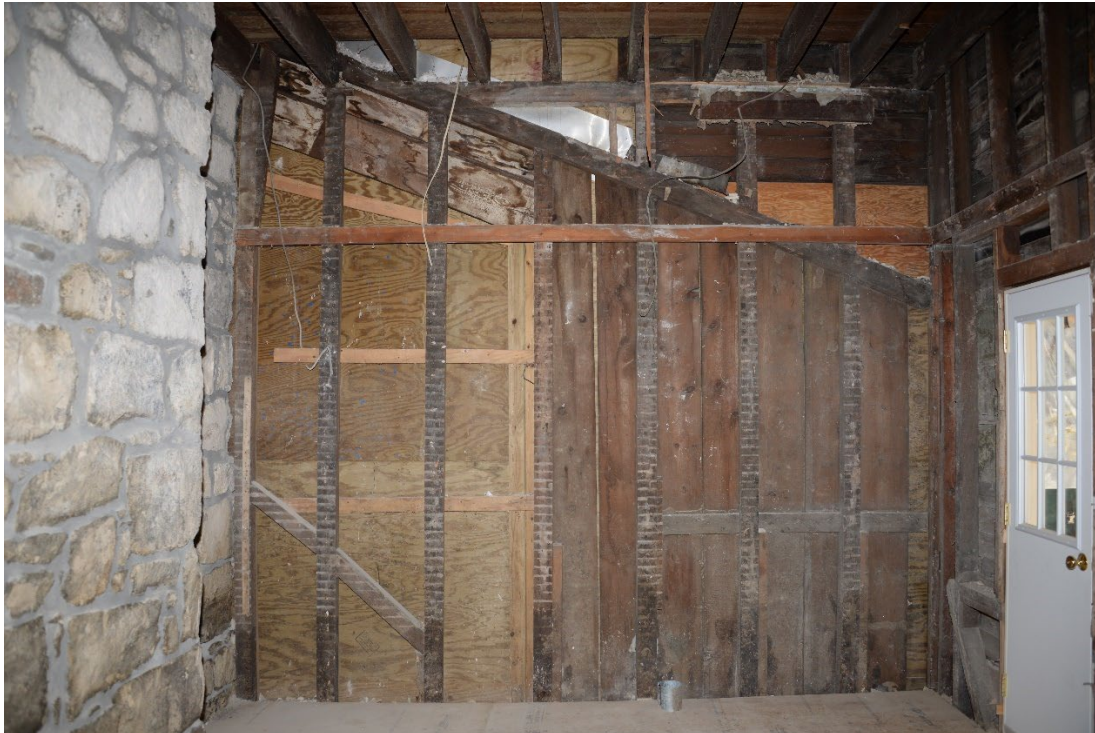
**Photo 11 of 19: First story, addition, east wall. 2/15/2017**

The east wall studs are 4 inches wide by 3 inches deep, are circular-sawn, have plaster burns on their interior face, and have cut lath nails. The north end has a crippled brace running down to the south. The south end of the wall has sash-sawn vertical boards on the exterior face. There is a diagonal running from the top of the wall at the north end down to 6 feet, 11 inches above the floor at the south end, suggesting the rear room was originally a one-story, shed-roofed structure. Several of the studs are notched for a horizontal 1 by 4 in the middle that acts as a stiffener for the siding. There are short studs added on top of the diagonal to raise up the wall; most of them are 4 by 3 inches, and they may be reused. At the north end the diagonal has either been raised slightly or has pivoted up if the south end started to drop.

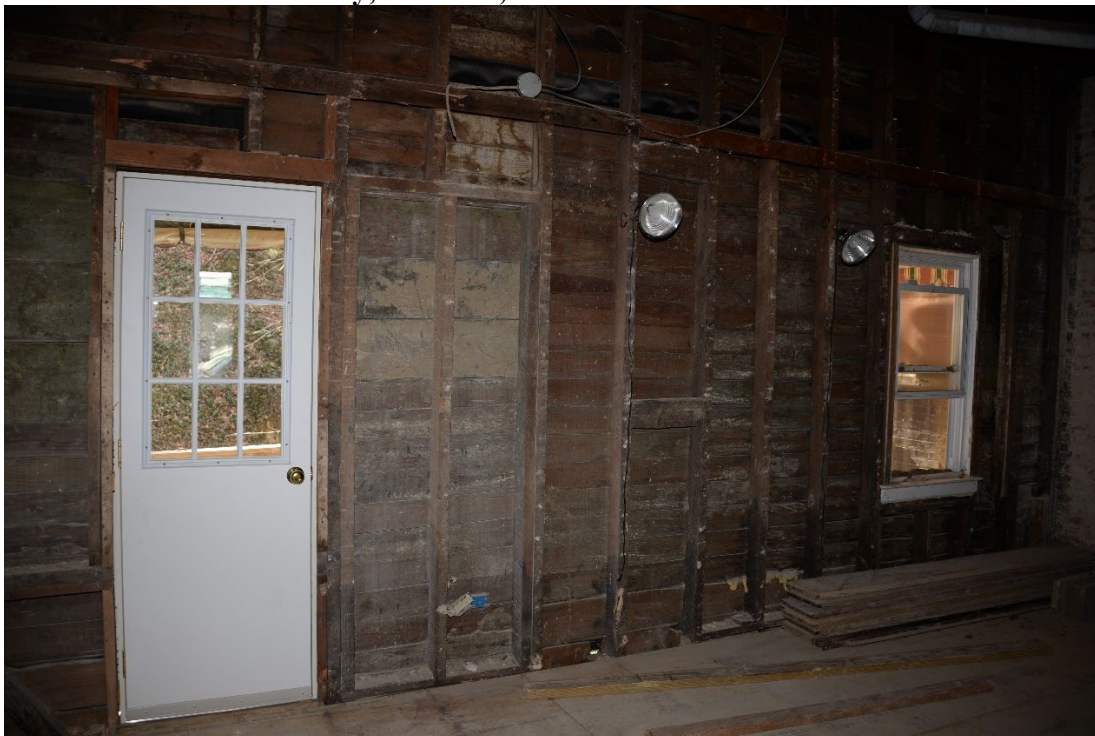
**Photo 12 of 19: First story, addition, south wall. 2/15/2017**

The south wall is mostly 2 by 4 studs with some plaster burns, and with many wire lath nails. There is a window opening to the east that is now infilled with reused boards, some of them painted green. This is partially cut through by the existing doorway to the exterior, which has a modern door. Just west of the existing door is an earlier doorway that is also infilled with reused boards. There was also a window opening to the west that is now infilled and mostly obliterated by the existing west bay window; this opening was moved slightly east of the original window opening. In the east corner, near the bottom of the wall, is a crippled stud that is 3 inches wide by 4 inches deep, with a like-sized down brace that is cut short of the corner. There is a piece of corner post that is cut off and topped by another piece of post. It is set at the end of the east wall diagonal, not under it, and the end of the diagonal seems to be cut flat on the bottom. There is a notch in the bottom piece of corner post that pretty much aligns with the brace, and this suggests that the corner post has been moved. The south wall is balloon-framed, with the studs spanning two stories. The ceiling joists are circular-sawn, run east-west, and are approximately 2 by 10s. There are two new glue-lams added underneath of them. The second-story flooring runs north south and is about 2 ¼ to 2 ½ inches wide.

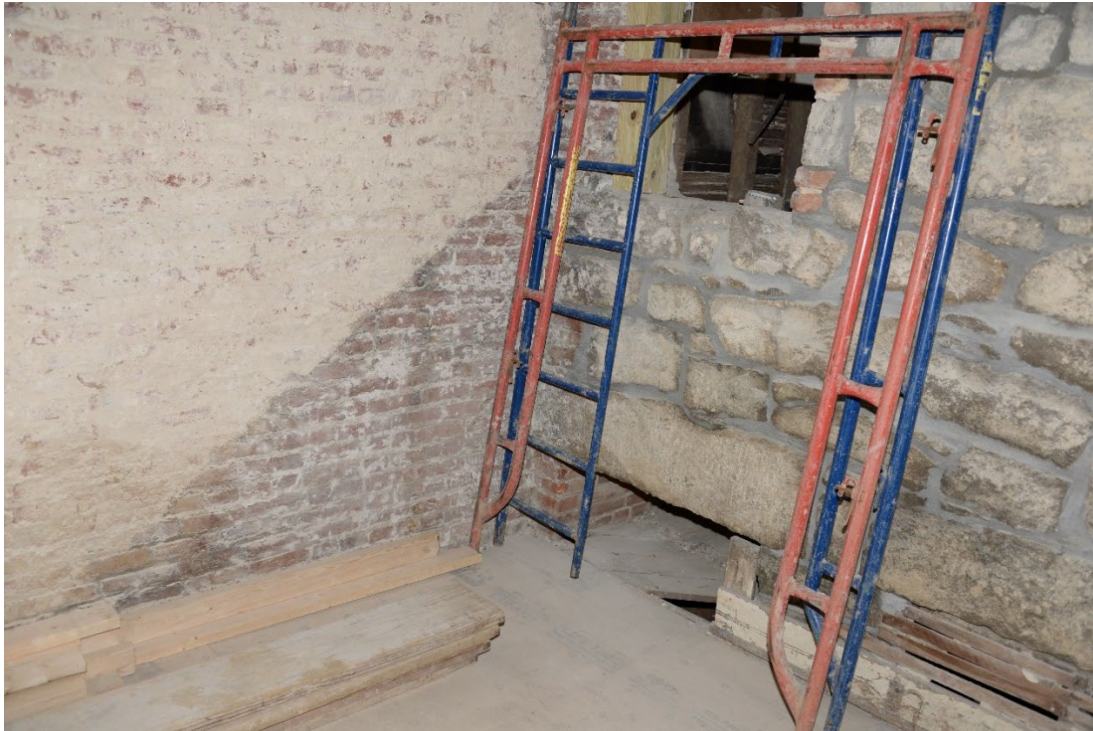
**Photo 13 of 19: First story, addition, northeast corner with ghost of stair. 2/24/2017**

The west wall is brick with plaster traces on it. There is a clear diagonal ghost on the north end, running up to the base of the doorway opening, indicating that there was a stairway here coming down from the doorway.

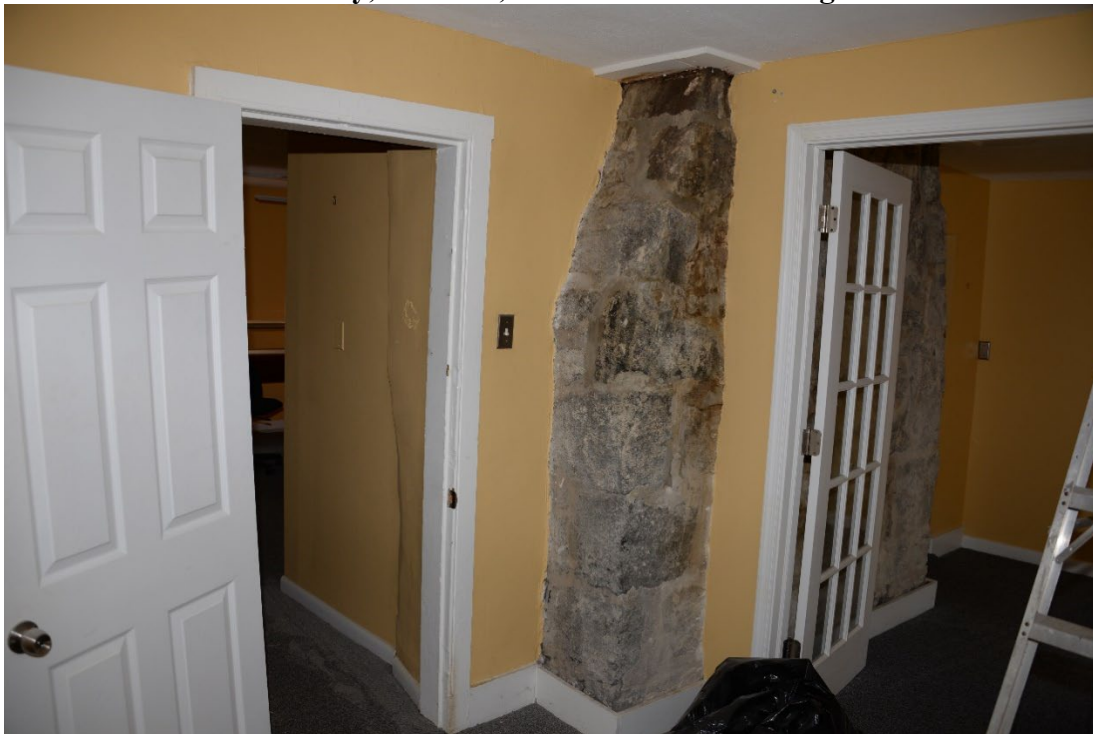
**Photo 14 of 19: Second story, south elevation now captured by addition. 2/15/2017**

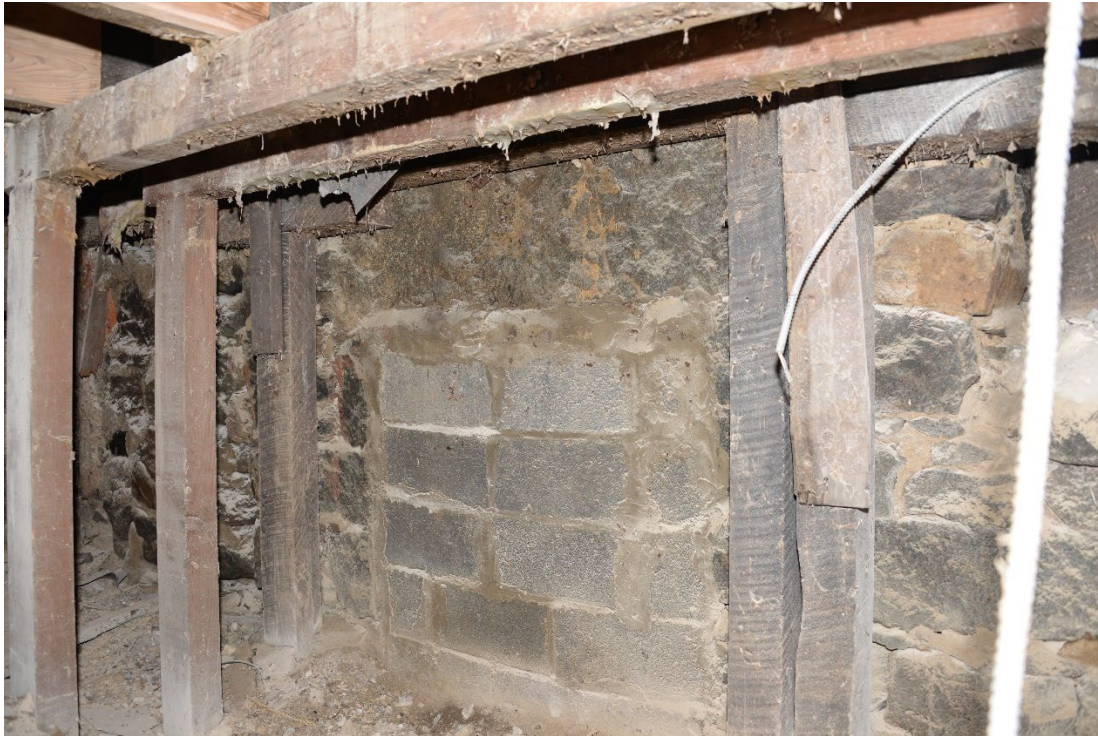
**Photo 15 of 19: Basement, main block, fireplace on south wall. 2/24/2017**

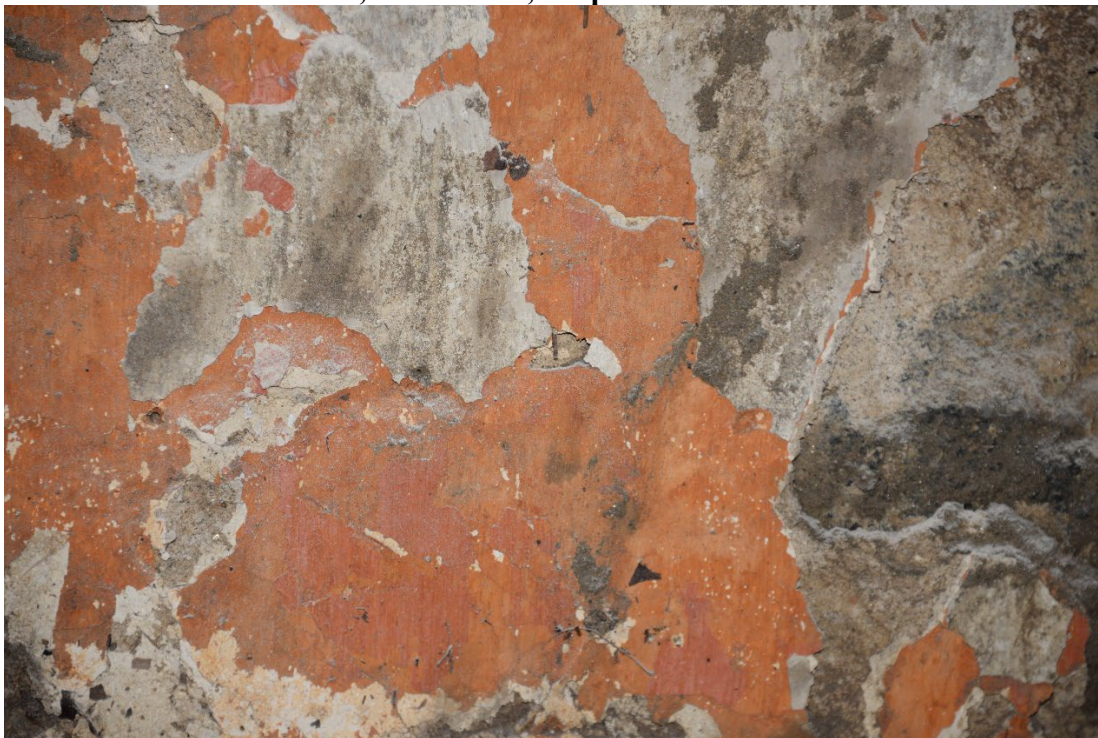
**Photo 16 of 19: Basement, main block, traces of plaster and paint on east wall. 2/24/2017**

but the north jamb is rough, and this was probably a small window opening that has since been widened. At the east end is the main basement space. The east wall has traces of plaster with the same orange-brown paint found on the first story east wall. The south wall has a fireplace in the center that has been closed off with CMUs. The firebox has a stone lintel and the stonework has traces of orange-brown paint. To the east of the fireplace is a doorway to the rear, closed off with stone. The eastern jamb was plastered and painted with the orange-brown paint prior to be infilled. To the west of the fireplace is a window opening that is closed off with horizontal boards. The north wall has what appears to be a doorway at the west end; it now has a window in the top of the opening, closed off with CMUs, and stone infill below. The first-story floor joists are sash-sawn, are 3 ¼ by 8 ¾ inches, and are spaced 24 to 25 inches on centers. They run north-south and have some lath nail holes in the bottom face. At the south end there is a header around the fireplace that is tenoned and pegged into the trimmers and is mortised for a tenon on the end of the joist. The original floor framing was apparently cut loose from the pockets and lowered and supported with horizontal beams with wood posts underneath of them. These have been augmented with additional posts and beams. After the 2018 flood the first-story flooring and floor framing was removed and the basement filled with concrete prior to any further recording and measuring of the space.

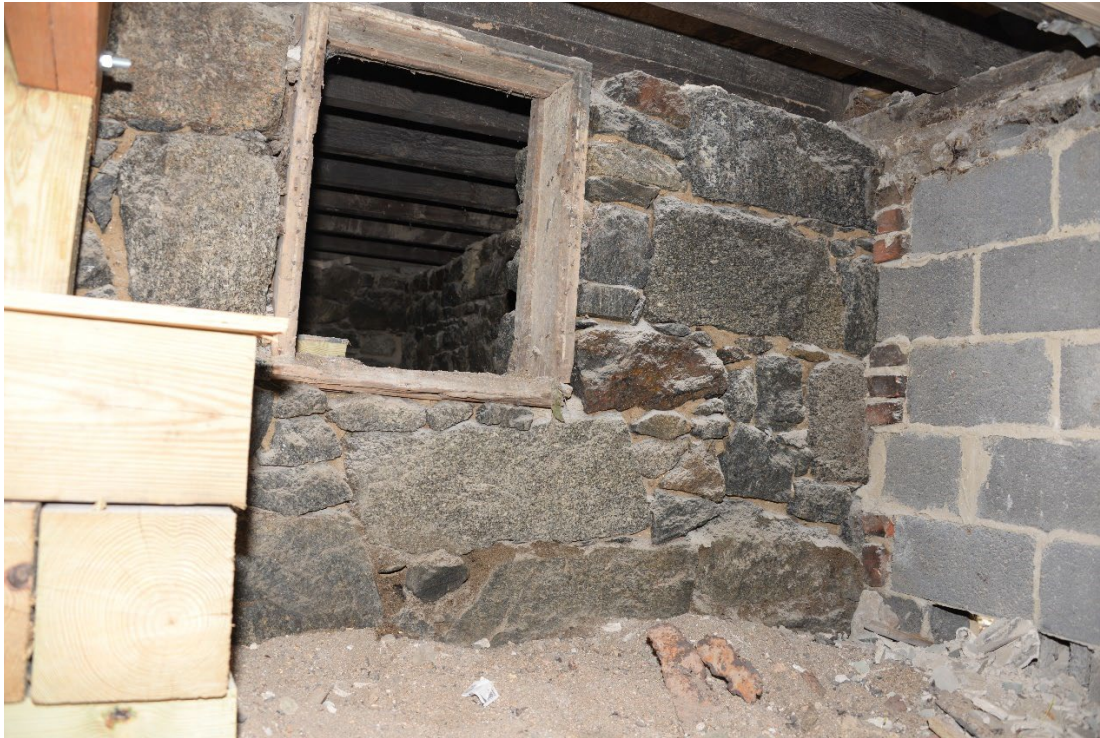
**Photo 17 of 19: Basement, addition, west elevation. 2/24/2017**

There are stone foundation walls to the rear for a two-bay wide building, and the southern doorway at the east end must have provided access to this space. The west wall of this space has a window opening to the south and a doorway to the north, both with beaded-interior-edge frames. The first-story joists here are circular-sawn.

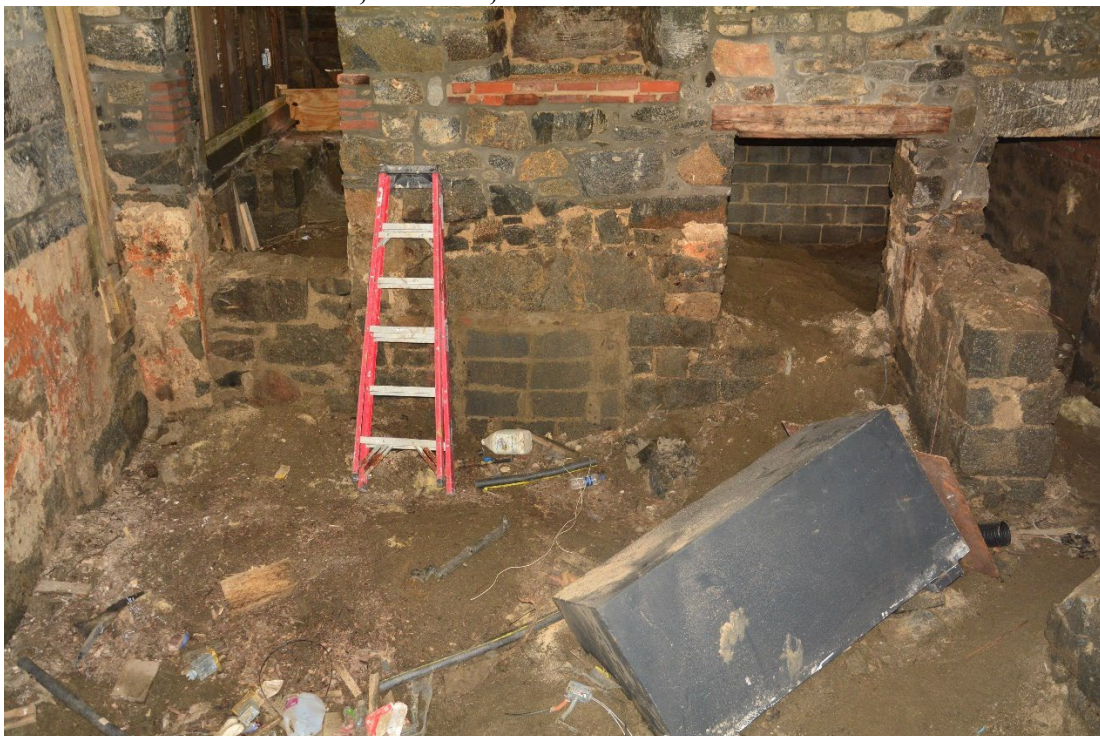
**Photo 18 of 19: Basement, main block, view south after floor was removed. 8/18/2018**

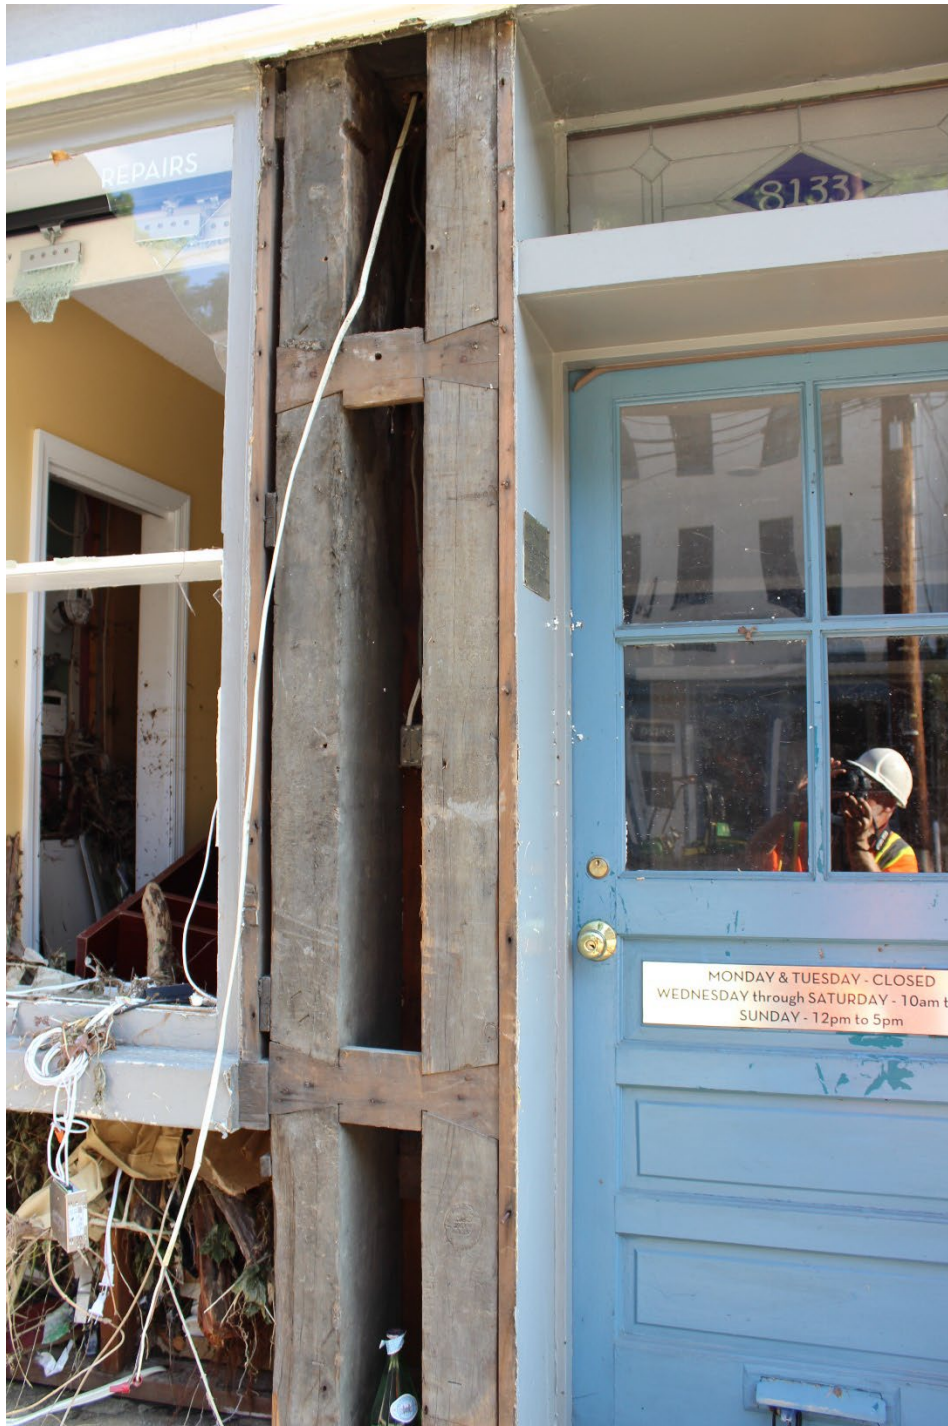
**Photo 19 of 19: North elevation showing post construction exposed after 2016 flood. 8/2/2016**

windows to each side, with a panel below them and two panels on the posts flanking each side of the windows. The fascia board on one of the paneled posts was knocked off by the flood, revealing the post to be two planks about 4 inches thick and spaced about 4 inches apart. They are joined by a block that is set in the gap between the two posts and has a dovetail on each end that is lapped and nailed to each post. It has granite sills in three pieces. The center piece is worn in the center and the end pieces are shorter than the storefront windows in the end bays. The storefront has a wood cornice with a quirked-ogee bed mould, a plain frieze, and an ogee-and-bevel moulding at the bottom of the frieze. There is a pipe passing through the bed mould near the west end that may be an old gas pipe. Above the cornice are three stone lintels for the original openings. The east end of the eastern lintel sits on top of the west wall of the building to the east, and projects forward of this wall about one foot. The east wall on the second story is in line with the eastern end of this lintel. To the west of the storefront is a stone lintel at the height of the storefront window sills, with CMU infill below. The western jamb of the original western bay opening is visible at the edge of the lintel above, and this was clearly a window originally. The second story has three six-over-six sash in beaded-interior-edge frames that have hinge mortises for blinds. There is a wood box cornice with a quirked bead and fascia bed mould. There is a single dormer in the center, with a six-over-six sash. Most of the trim and finish work appears to be new.

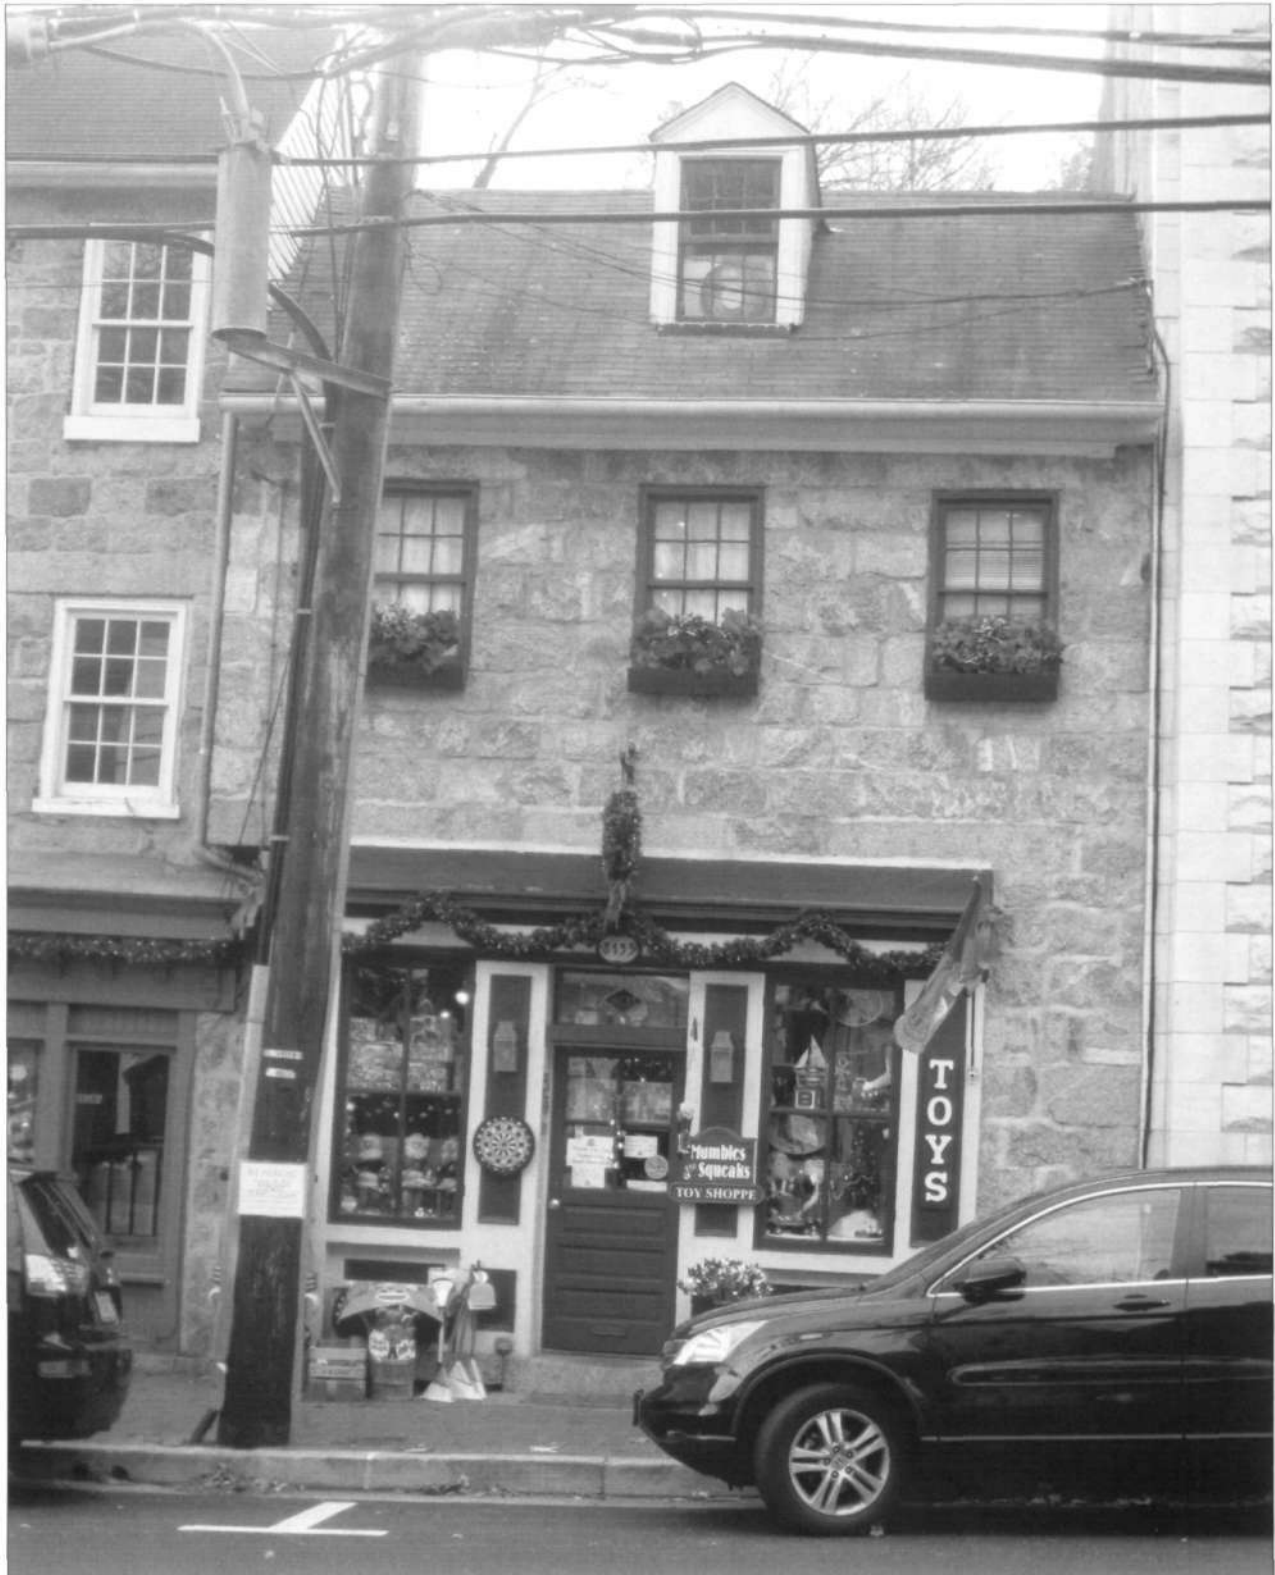
HO-358  
Fissel's Stone Shop (Mumbles and Squeaks)  
8133 Main Street (MD 144), Ellicott City  
Photo by Jennifer K. Cosham, 12/5/2012  
North elevation
