HO-360

Partington-Collier-Kraft Store and Dwelling

8081 Main Street, Ellicott City

## Maryland Inventory of Historic Properties Form

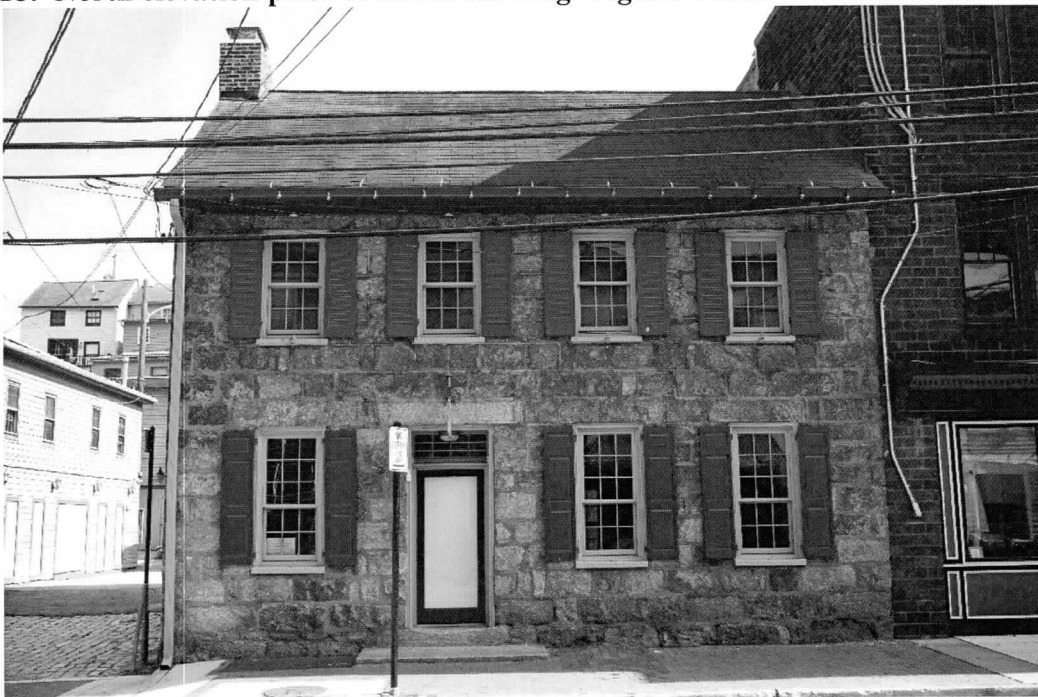
**Photo 2 of 18: North elevation after floods showing replacement windows and shutters. 8/25/2020**

**North elevation after floods showing replacement windows and shutters.**

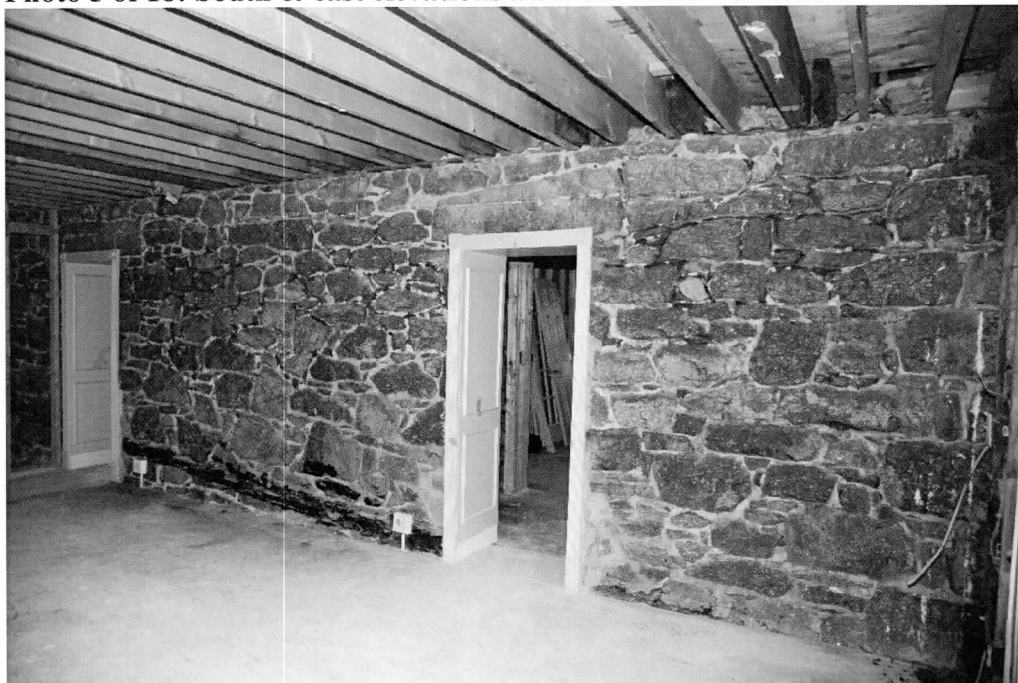
The south side of the south wall is stone with traces of early pointing, a raised V that is painted black. Both doorways have stone lintels and sloppy Portland cement pointing on the bottom three feet, indicating that these were both windows, originally. Local tradition states that there was a porch here in the 1970s; it is now a modern addition.

**Photo 6 of 18: South elevation of original stone building. 11/5/2019**

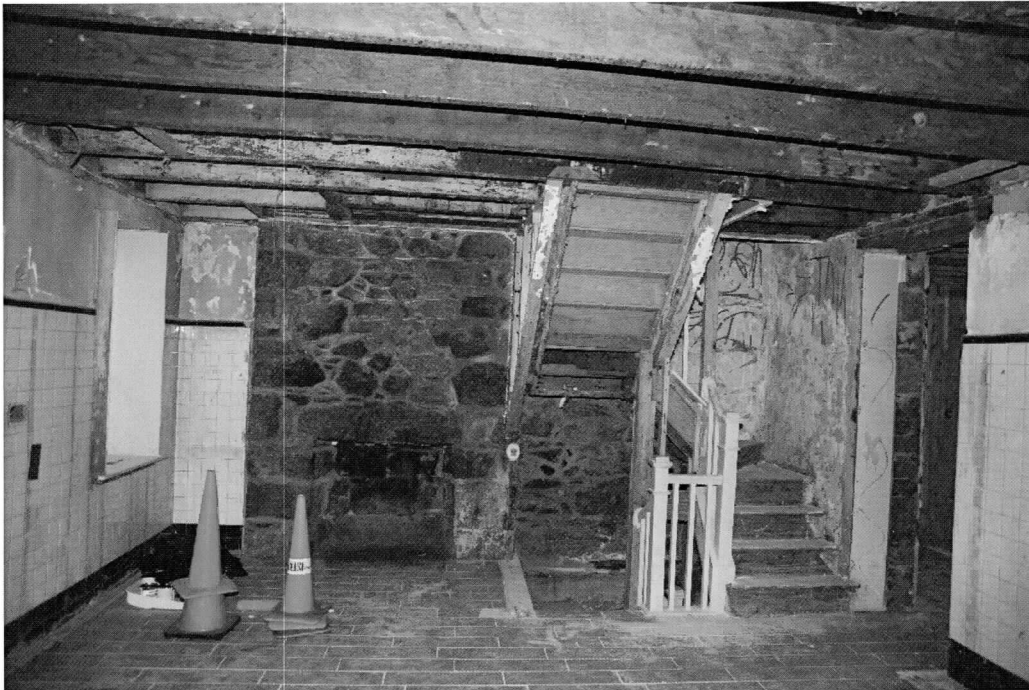
**Photo 7 of 18: First story east wall after removal of most later additions, with rebuilt stair. 11/5/2019**

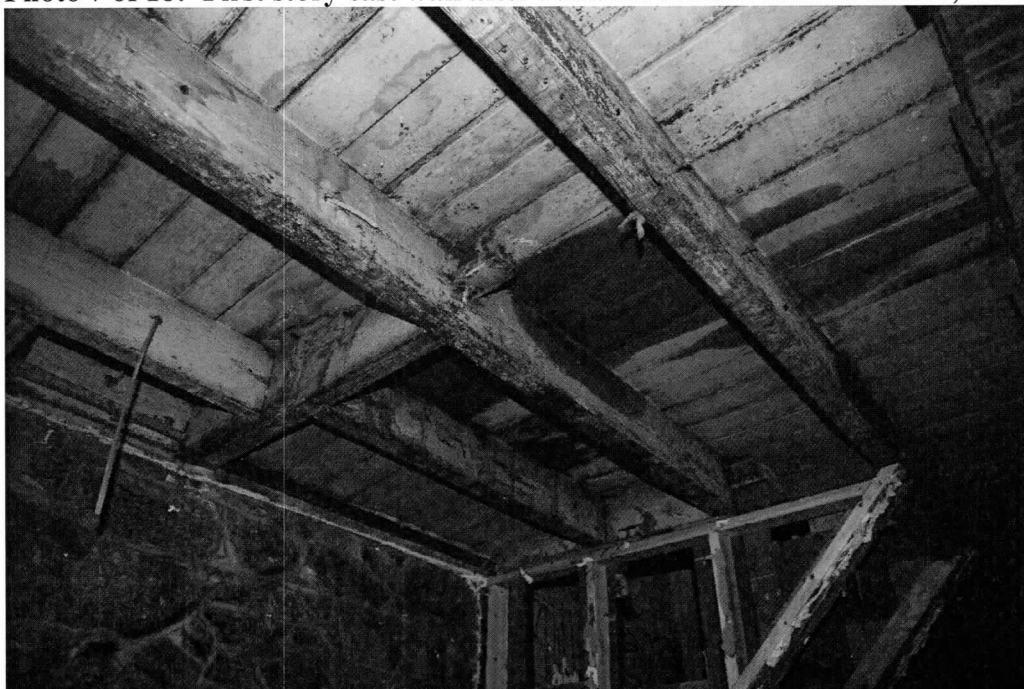
The original east room was originally not ceiled, and the exposed joists and floorboards are whitewashed. The second-story hearth trimmer and stair trimmer have through tenons with exposed pegs. The stairwell has been enlarged and the stair rebuilt in the late twentieth century, with the original trimmer cut through. It appears that there was a doorway in the partition wall that aligned with the stairs. The whitewashing of the east room ceiling ends about 4 feet north of the south wall suggesting that this room was closed off, creating a vestibule at the bottom of the stairs and inside the south (rear) doorway. There is no clear evidence of whether there was a door in this wall giving access to the east room from the vestibule, or whether there was a doorway between the east and west rooms. However, the access to the basement was only from the east room.

**Photo 8 of 18: First story ceiling framing at east end. 11/5/2019**

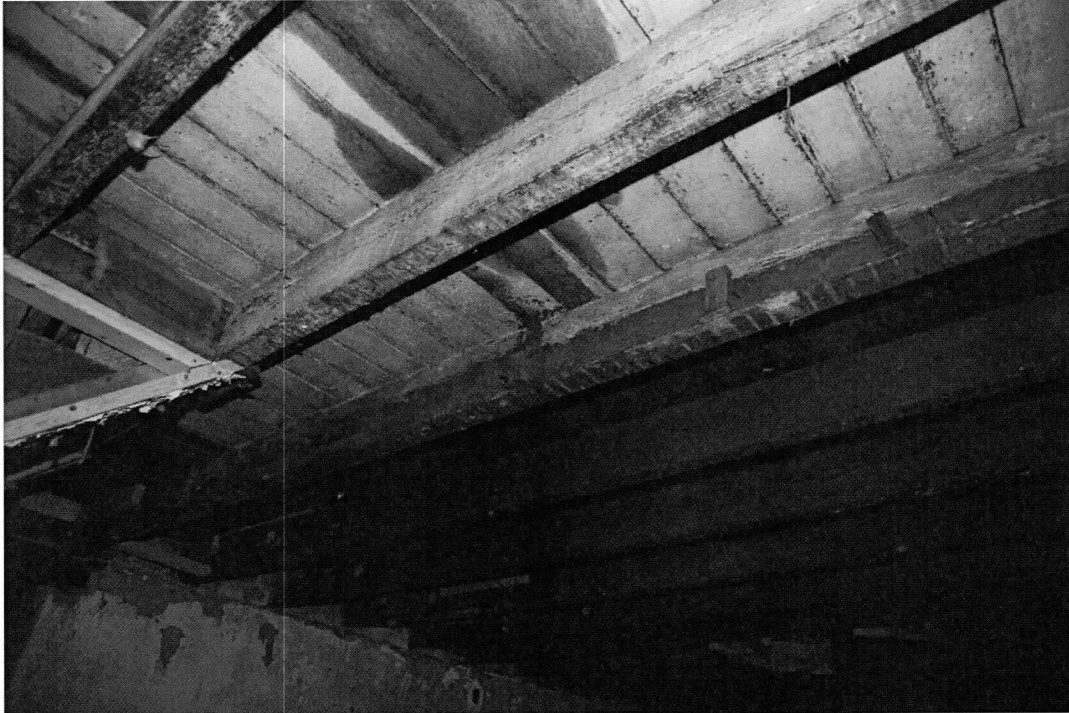
**Photo 9 of 18: First story ceiling framing showing evidence of missing partition wall. 11/5/2019**

First story ceiling framing showing evidence of missing partition wall.  
HO-0360\_2019-11-05\_09.tif

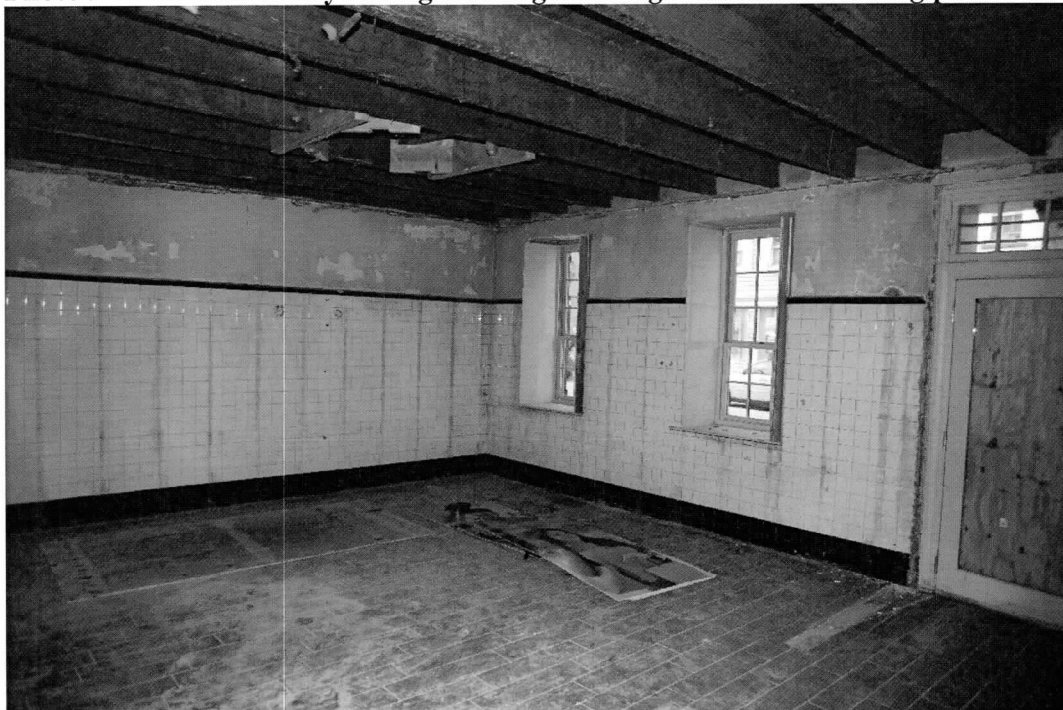
**Photo 10 of 18: First story, view northwest. 11/5/2019**

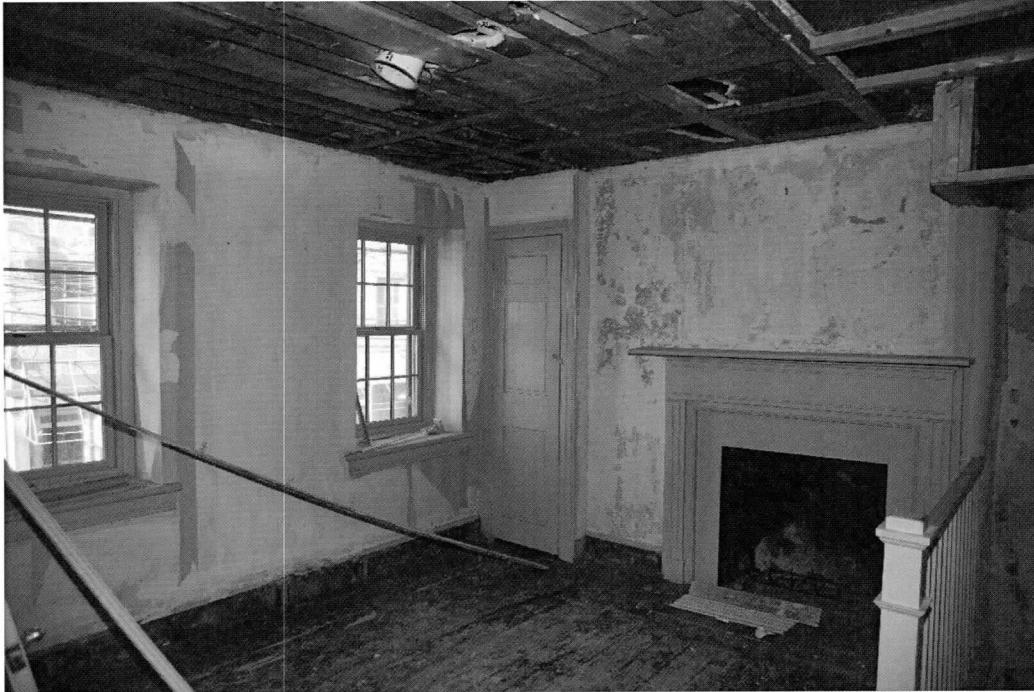
**Photo 11 of 18: East chamber, view northeast following removal of most later material. 11/5/2019**

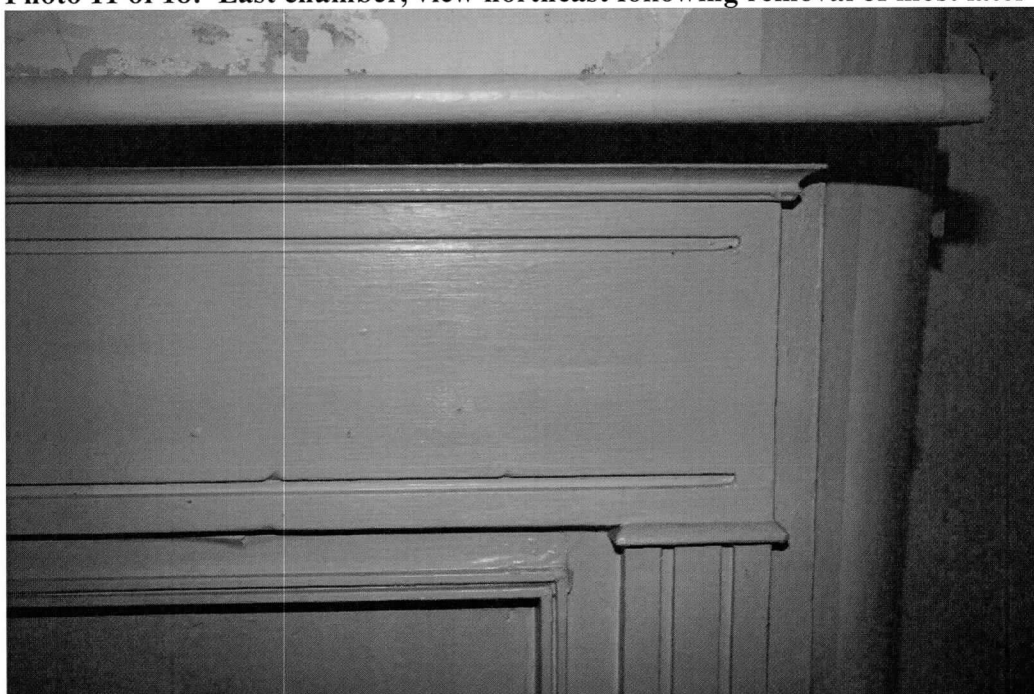
**Photo 12 of 18: East chamber mantel detail. 11/5/2019**

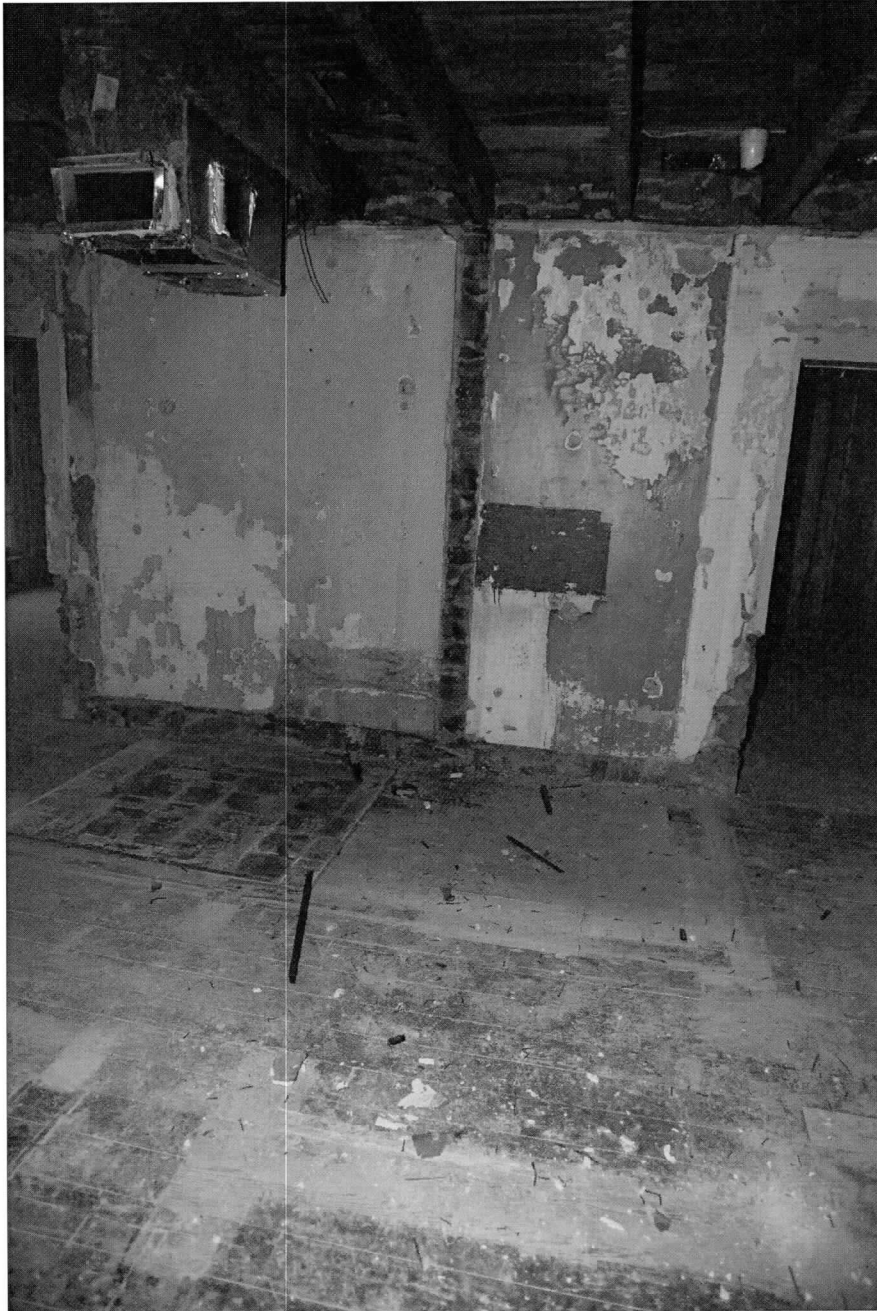
**Photo 15 of 18: Second story, view south showing ghosts of missing partition walls on floor and wall following removal of later material. 11/20/2019**

Second story, view south showing ghosts of missing partition walls on floor and wall following removal of later material.  
HO-0360\_2019-11-05\_15.tif

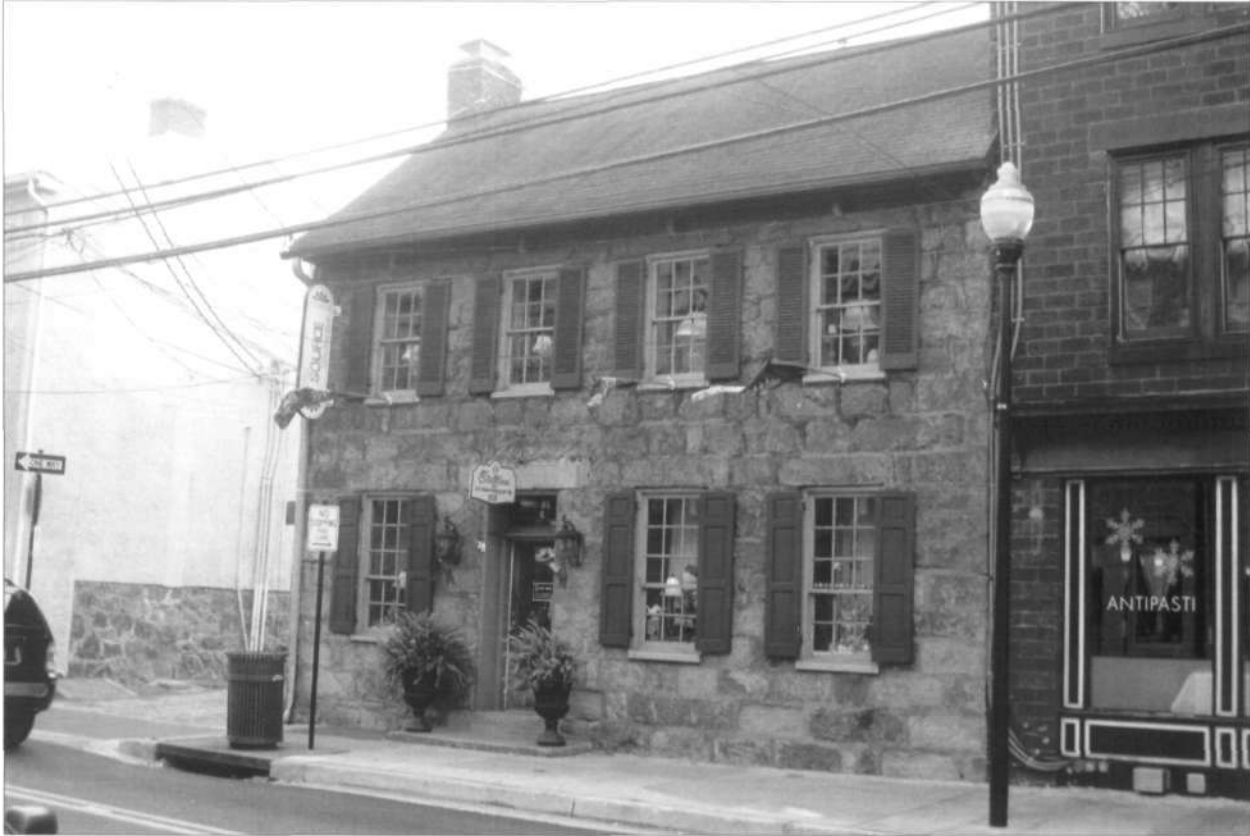
HO-360  
Boone Stone Shop  
8081 Main Street (MD 144), Ellicott City  
Photos by Jennifer K. Cosham, 12/5/2012  
North facade

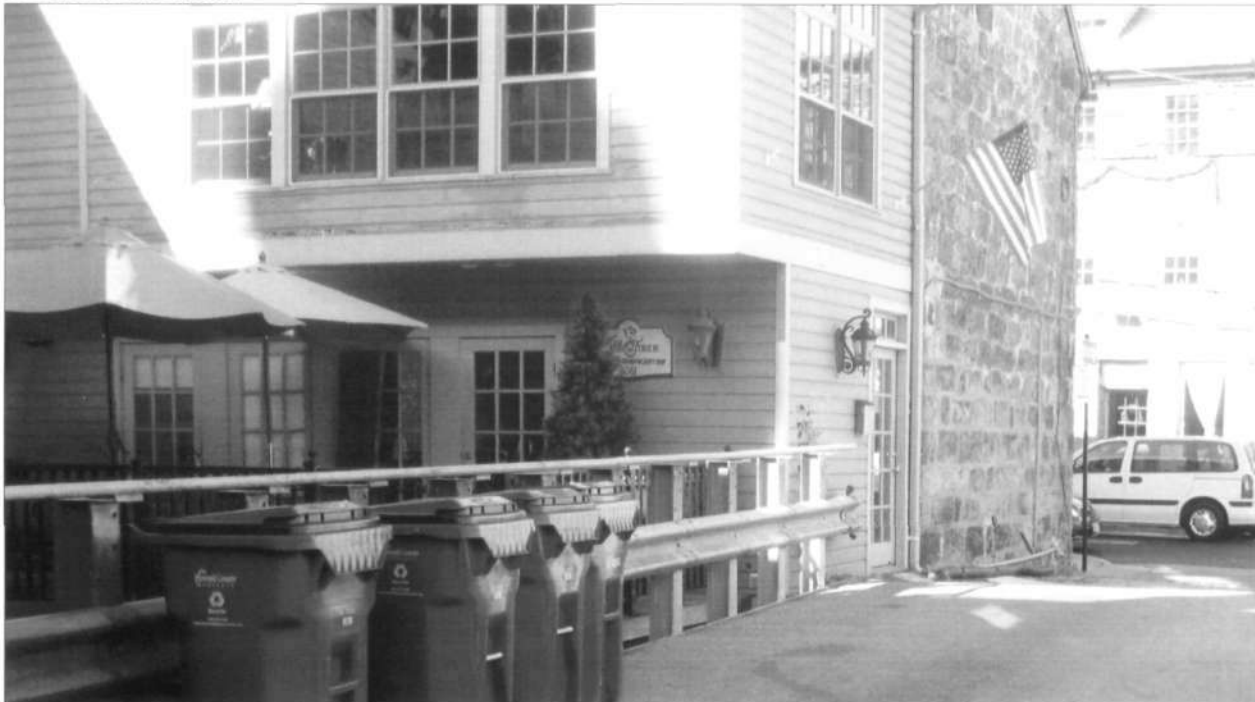
Southeast elevation

The south facade of the building has a one-story concrete block addition covering the first floor, and two 6/6 sash windows on the second floor.
