HO-411

## Woodlawn Slave Quarters Complex

### **Architectural Survey File**

Woodlawn Slave Quarters

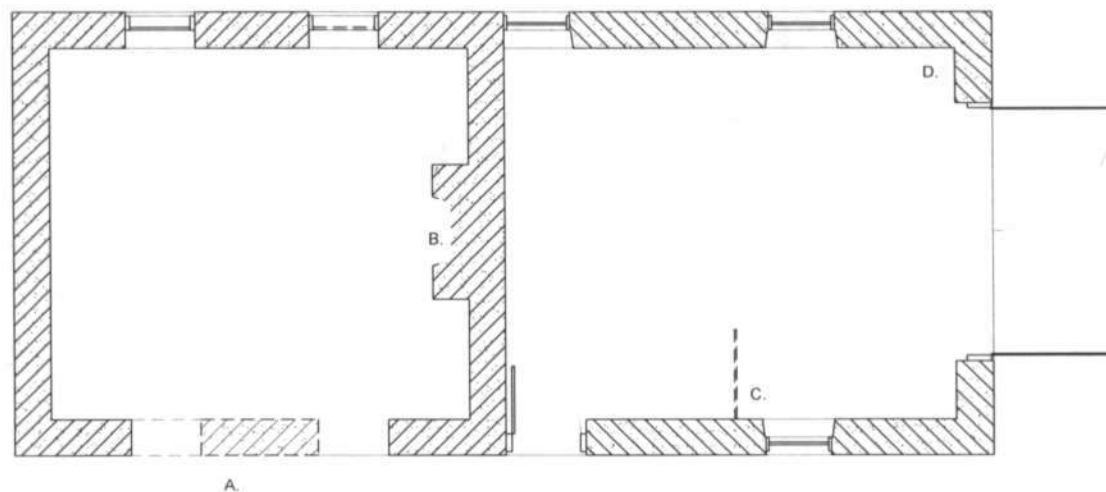
- A. WALL PARTIALLY COLLAPSED HERE, BUT ORIGINAL CONFIGURATION DECIPHERABLE.
- B. FIREPLACE COMPLETELY FILLED WITH DEBRIS.
- C. PLASTER CONTAINS GHOST OF WALL HERE, BUT PLASTER DOES NOT SURVIVE ON OPPOSITE WALL.
- D. MARKS ON WALL INDICATE POSSIBILITY OF STAIRWAY HERE.

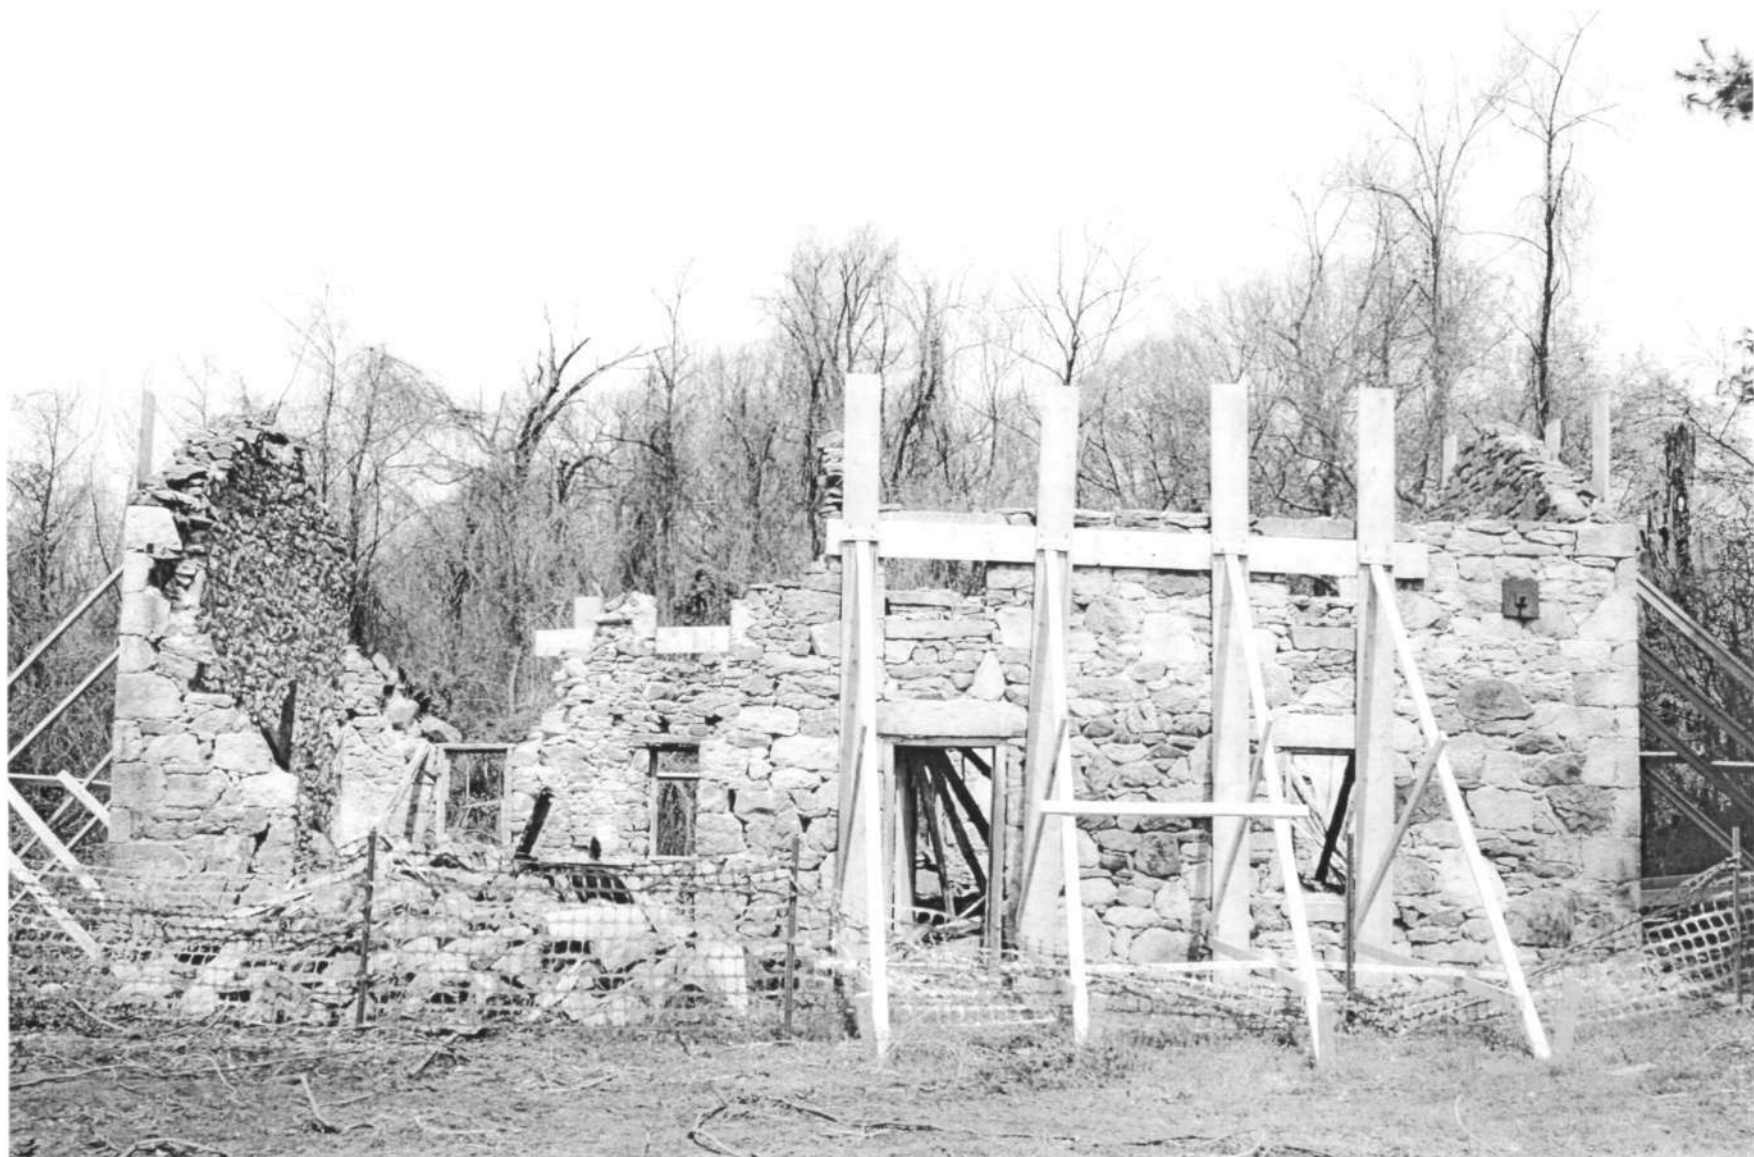
The Slave Quarters faces south and is a two-story, four-bay by one-bay rubble stone shell in ruinous condition. It formerly had a gable roof and the ridge ran east-west. On the south elevation the two west bays have collapsed, and it appears there was a window in the west bay and a doorway in the west-center bay of the first story. The corners and openings have quoins. The east-center bay has a doorway on the first story that has a beaded-interior-edge frame, beaded-edge vertical-board door, and a stone lintel with quoins below and above that continue up along the west side of the window opening above but not on the east side. The second story opening has a stone sill and lintel, and the arrangement of the stonework indicates that the two east bays were added. A quoin was cut out of the earlier building to the west, to give a bearing for the door lintel. The east bay has a window opening with a stone sill and lintel on the first story, and there is a beaded-interior-edge mitered frame with cut nails. The window had a fixed top sash and no parting beads. There were exterior blinds, and the hinged mortises still contain some screws, but they are too rusted to be removed. The second story window opening also has a stone still and lintel. There is a tie rod with a large square plate near the east corner of the second story.

HO-411 Woodlawn Slave Quarter 9254 Old Annapolis Road south elevation  
Ken Short, April 2006 1/14

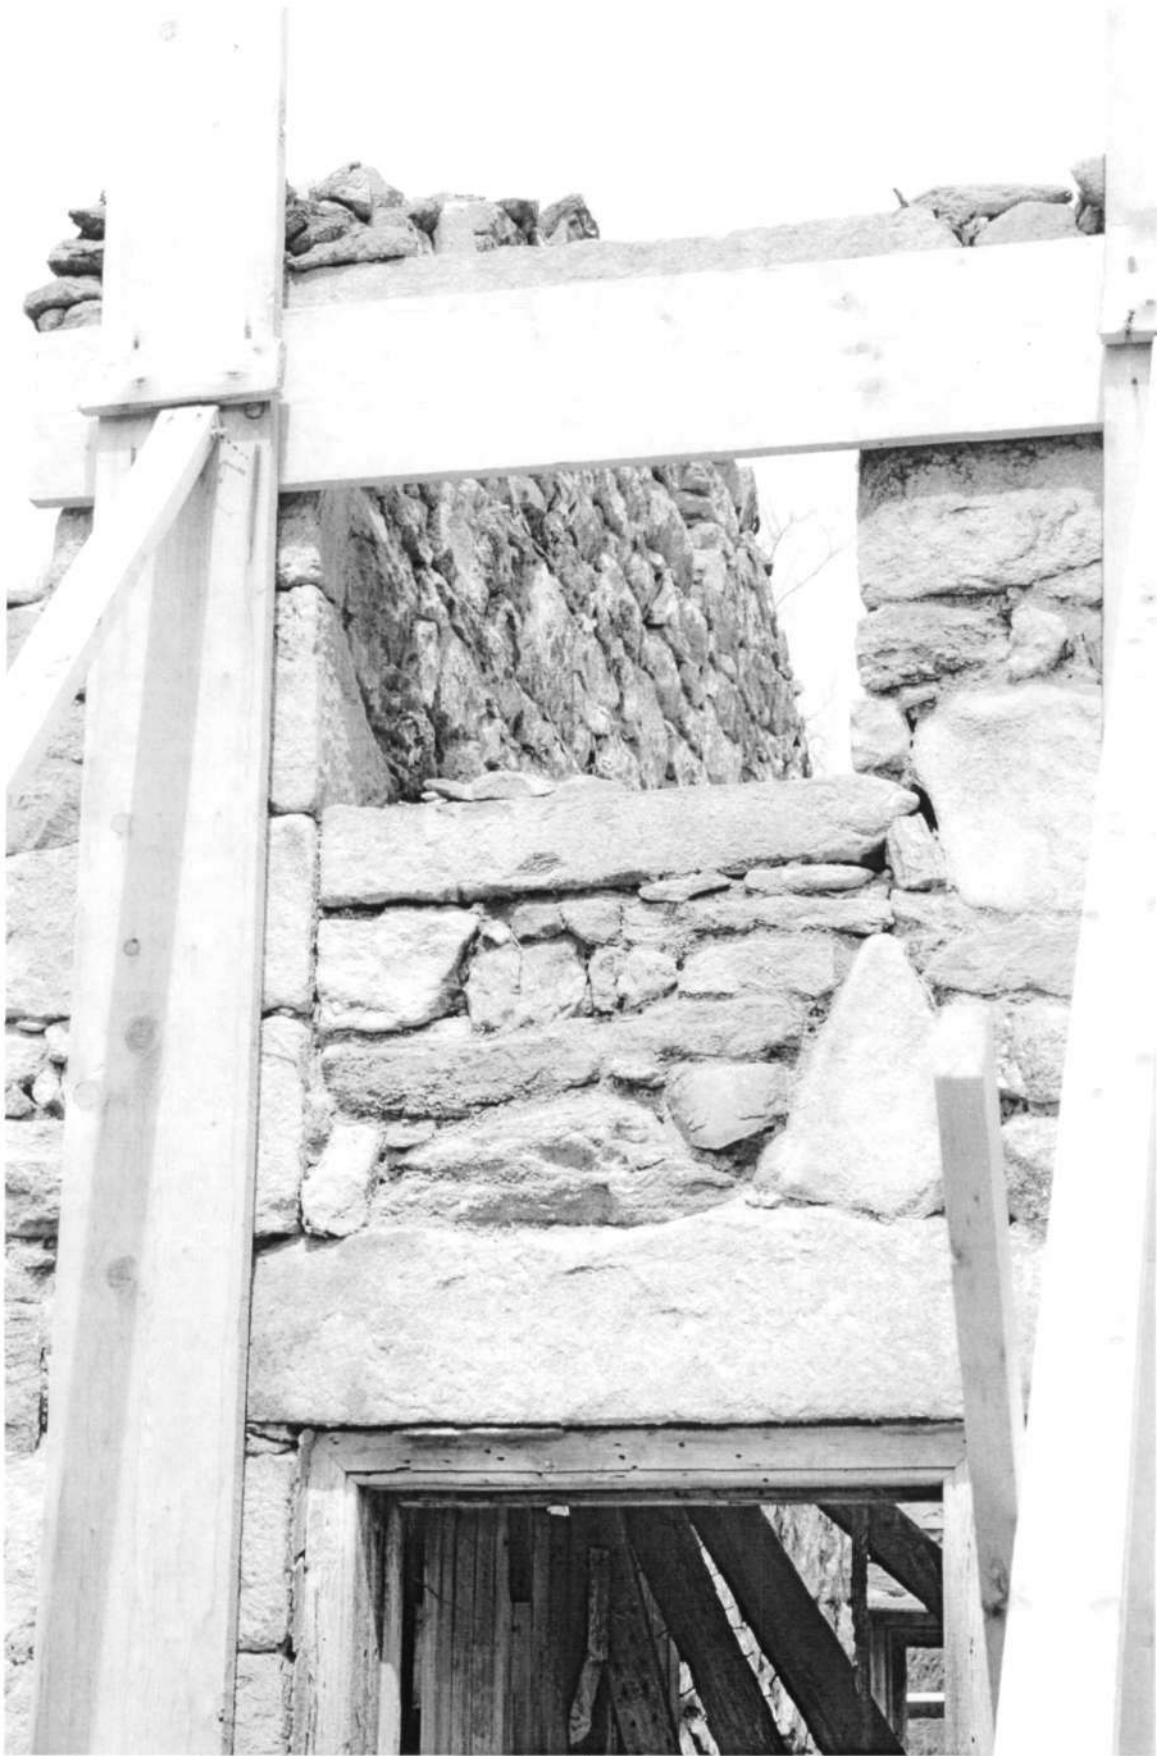
The stone building known as the slave quarter was built in two stages, with the western section having been constructed first. It was a one-room, 1 1/2-story structure, with the upper story having three-over-three sash, and the ceiling likely following the profile of the roof rafters and collar beams. The walls were plastered, and there is a heating fireplace on the first story that is original to the building, since the masonry is tied into the east wall. The firebox is small and has splayed jambs typically used for heating, not cooking, though at present it is buried in debris and cannot be examined closely. The window frames are constructed with mature cut nails that are exposed now, but had to have been assembled before the walls went up, and could not have been altered afterward. The window sash, which could have been replaced (though this is unlikely), were constructed with pinned joints at the corners only. This marks a simplification of the construction from a time when the muntins were also pinned, and generally dates after c. 1830. There is little left with which to date the building beyond these fragments, but the nail evidence is sufficient to conclude that the slave quarter is a nineteenth-century building, and a date after 1830 is most likely. A similar single-cell, 1 1/2-story rubble stone structure was appended to the east side of the earlier building, and may have had a winder stair in the northeast corner. The stonework was butted against the east corners of the earlier building, with the corners serving as window and door jambs for openings in the addition. Some of the quoins in the original building were taken out and moved to the west in order to create a bearing for the west end of window and door lintels. No connection was cut through

HO-411 Woodlawn Slave Quarter 9254 Old Annapolis Road south elevation, joint between east & west sections  
Ken Short, April 2006 2/14

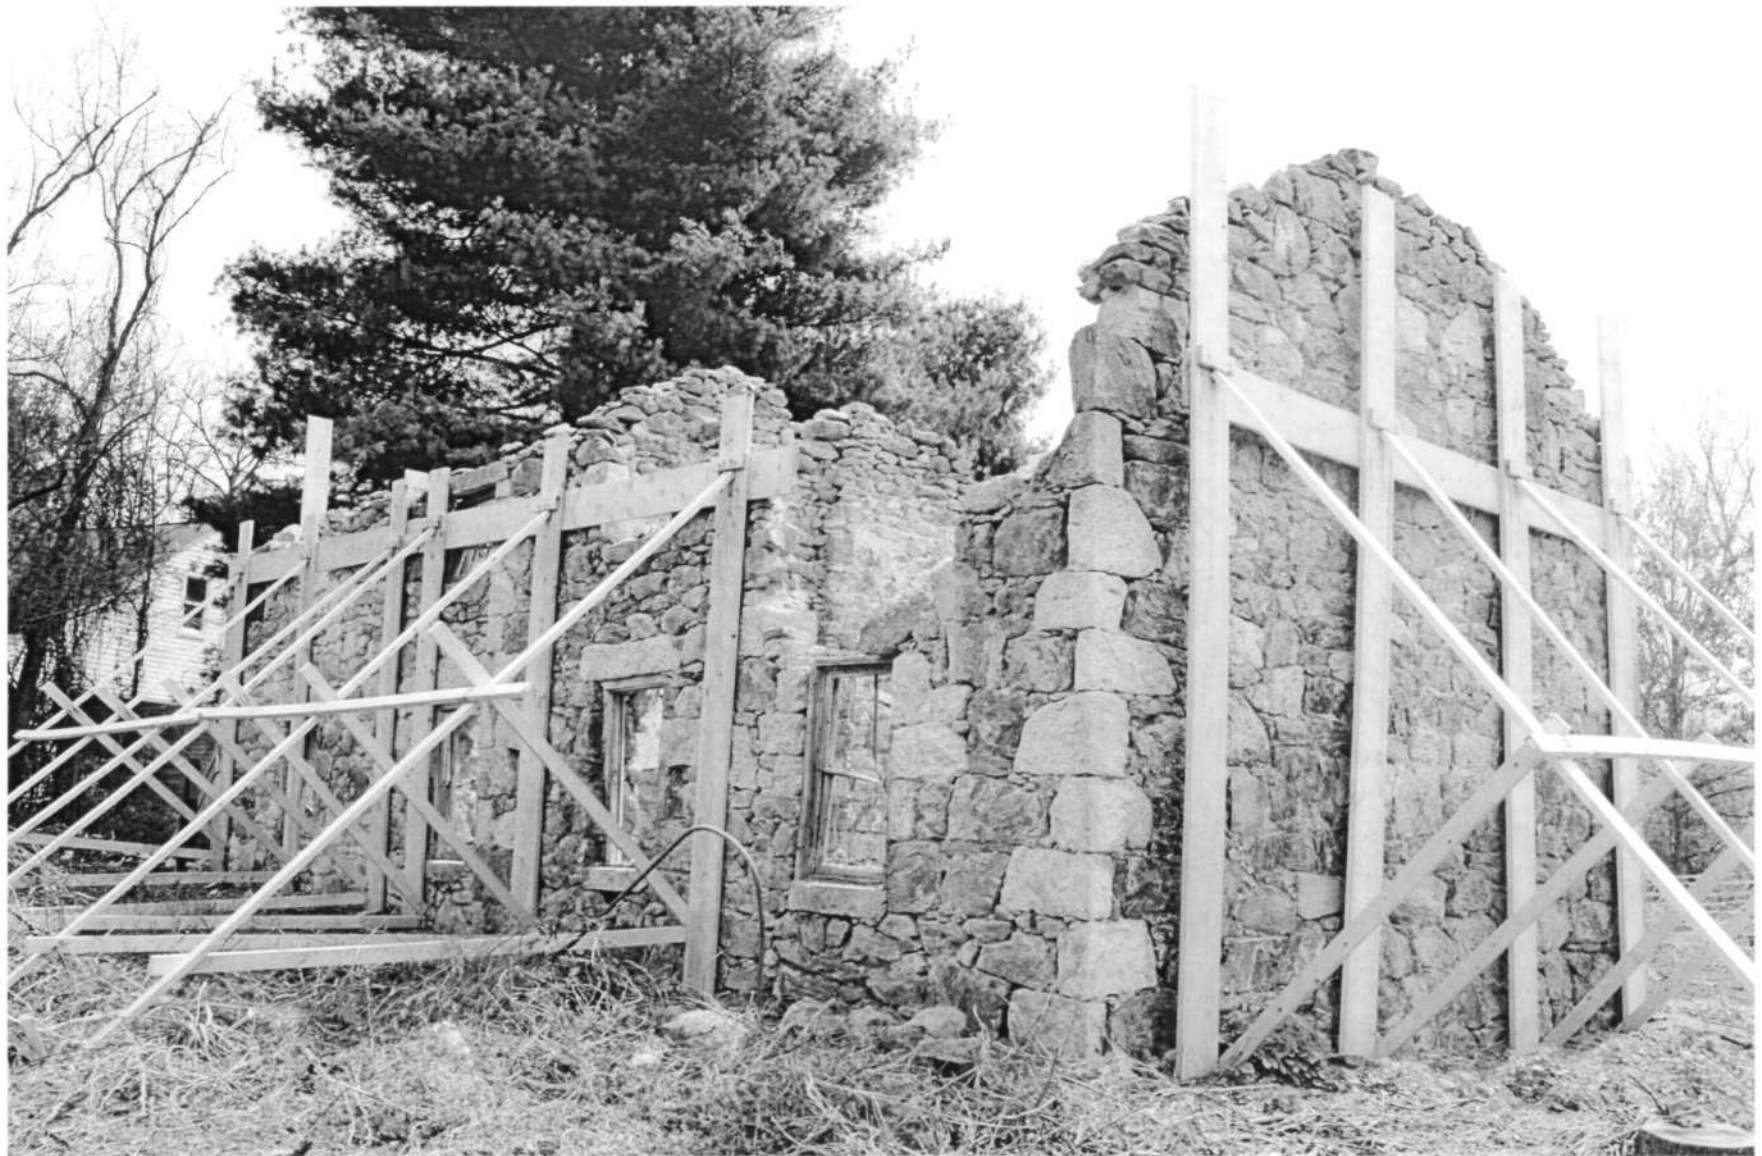
The west elevation has no openings at all. The north elevation has a tie rod at the east corner of the second story. The east bay of the first story has a window with a stone sill and lintel and a beaded-interior-edge mitered frame like that on the south elevation east bay. There are the remains of a six-over-six double-hung sash, with the muntins tenoned into the rails and stiles, and only the corners are pinned. The second story of the east bay has a window opening with a stone sill, but the lintel is gone. The opening contains the remains of a three-light sash that is mortised and tenoned and pinned at the corners. Based on the surviving frame, this window had a three-over-three sash. The east-center bay has a window opening on the first story, with a stone sill and lintel. The stone wall beneath the sill butts against the wall to the west, while the lintel is set slightly into the wall on the west. The opening contains a beaded-interior-edge frame that is mitered at the corners and has the remains of a six-over-six sash. The sash mortise for the muntins appears to be hand cut and not cut with a mortising machine. There are cast-iron butt hinges for blinds on the east jamb and mortises for hinges on the west jamb. On the second story only the lintel is tied into the wall on the west, and the windowsill and stones below it all abut the quoins to the west. There is a three-over-three double-hung sash that is mortised and tenoned and pinned at the corners.

HO-411 Woodlawn Slave Quarter 9254 Old Annapolis Road North & west elevations  
Ken Short, April 2006 3/14

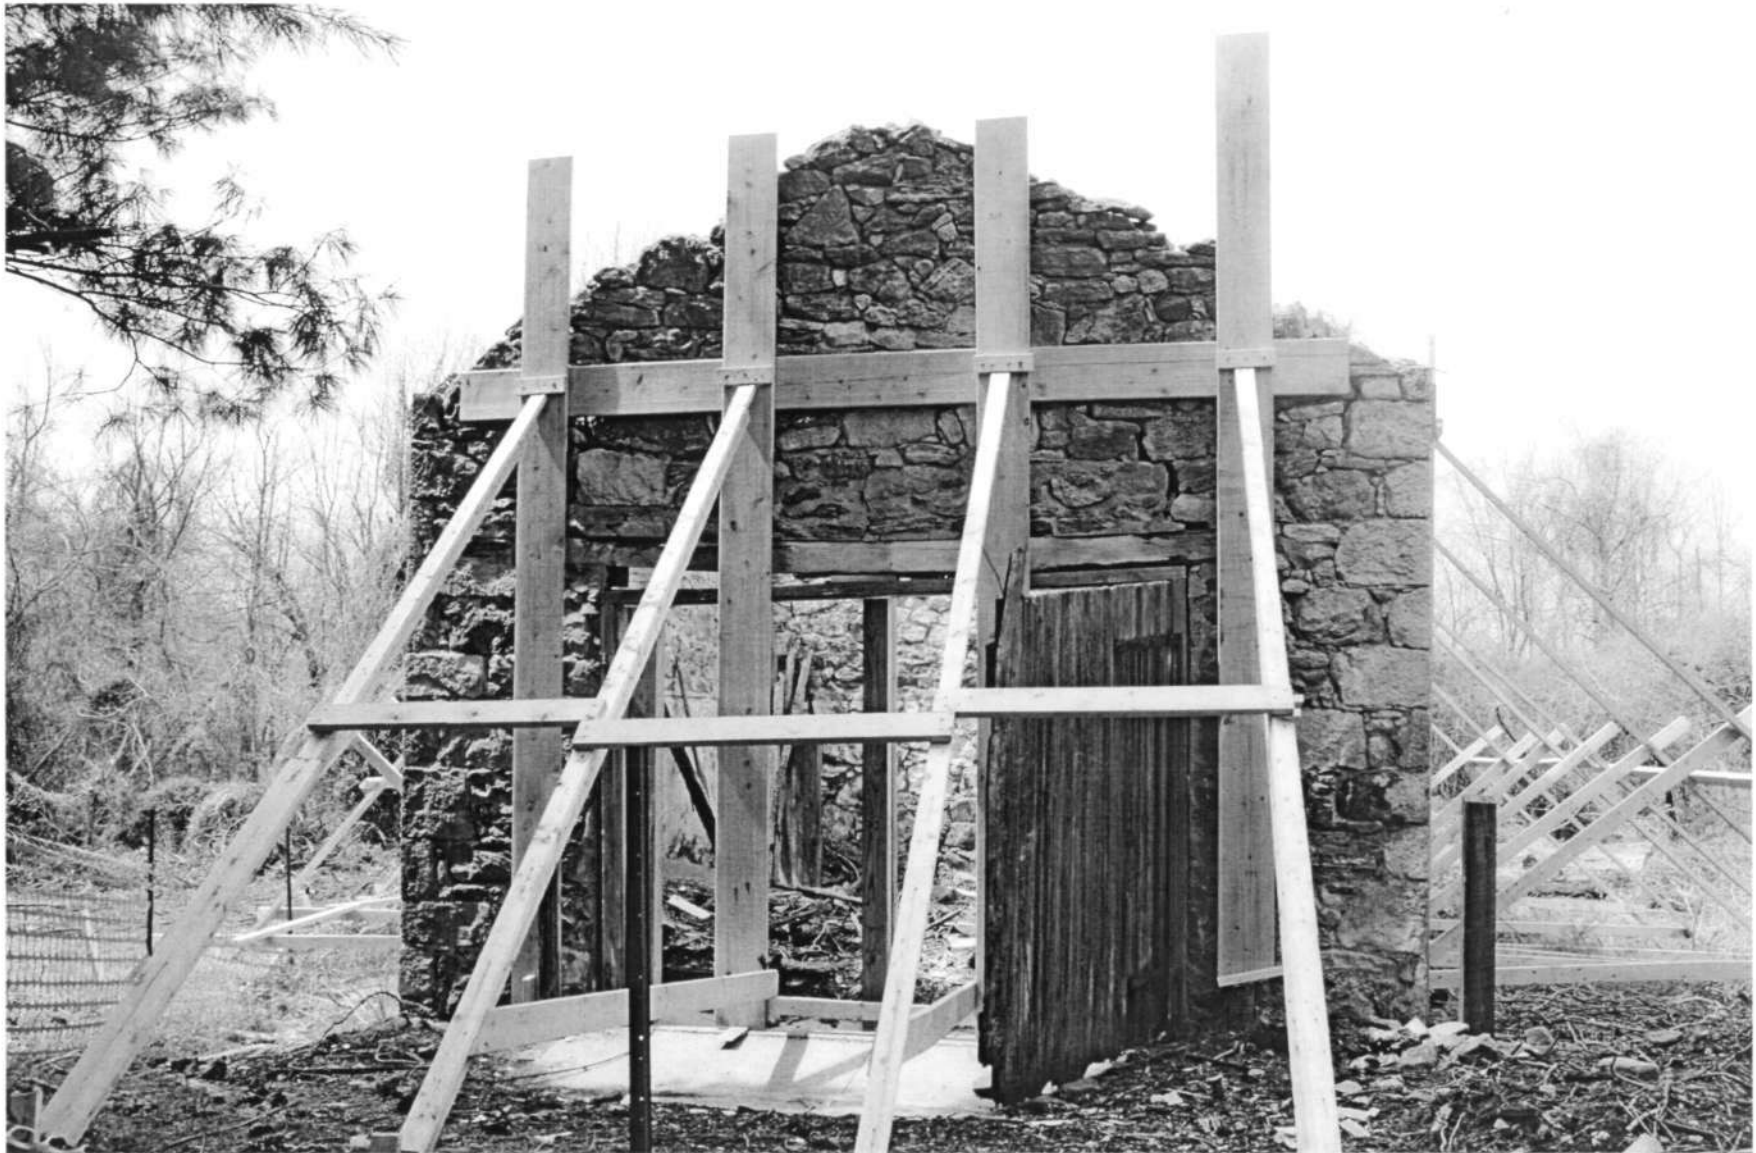
The east elevation has a wide opening that had double doors, and has a circular-sawn wood lintel. There is concrete patching around the opening that indicates that it was added later. The north door survives and has beaded-edge tongue-and-groove vertical boards with screwed battens, and it is hung on machine-made strap hinges. The doorframe is sawn and is weathered but appears to be sash-sawn. There are pintels on the south jamb for the other door, which is lying on the ground nearby. The wall has sagged and cracked in the center, probably because the frame and lintel are rotted and termite-eaten.

HO-411 Woodlawn Slave Quarter 9254 Old Annapolis Road East elevation  
Ken Short, April 2006 4/14

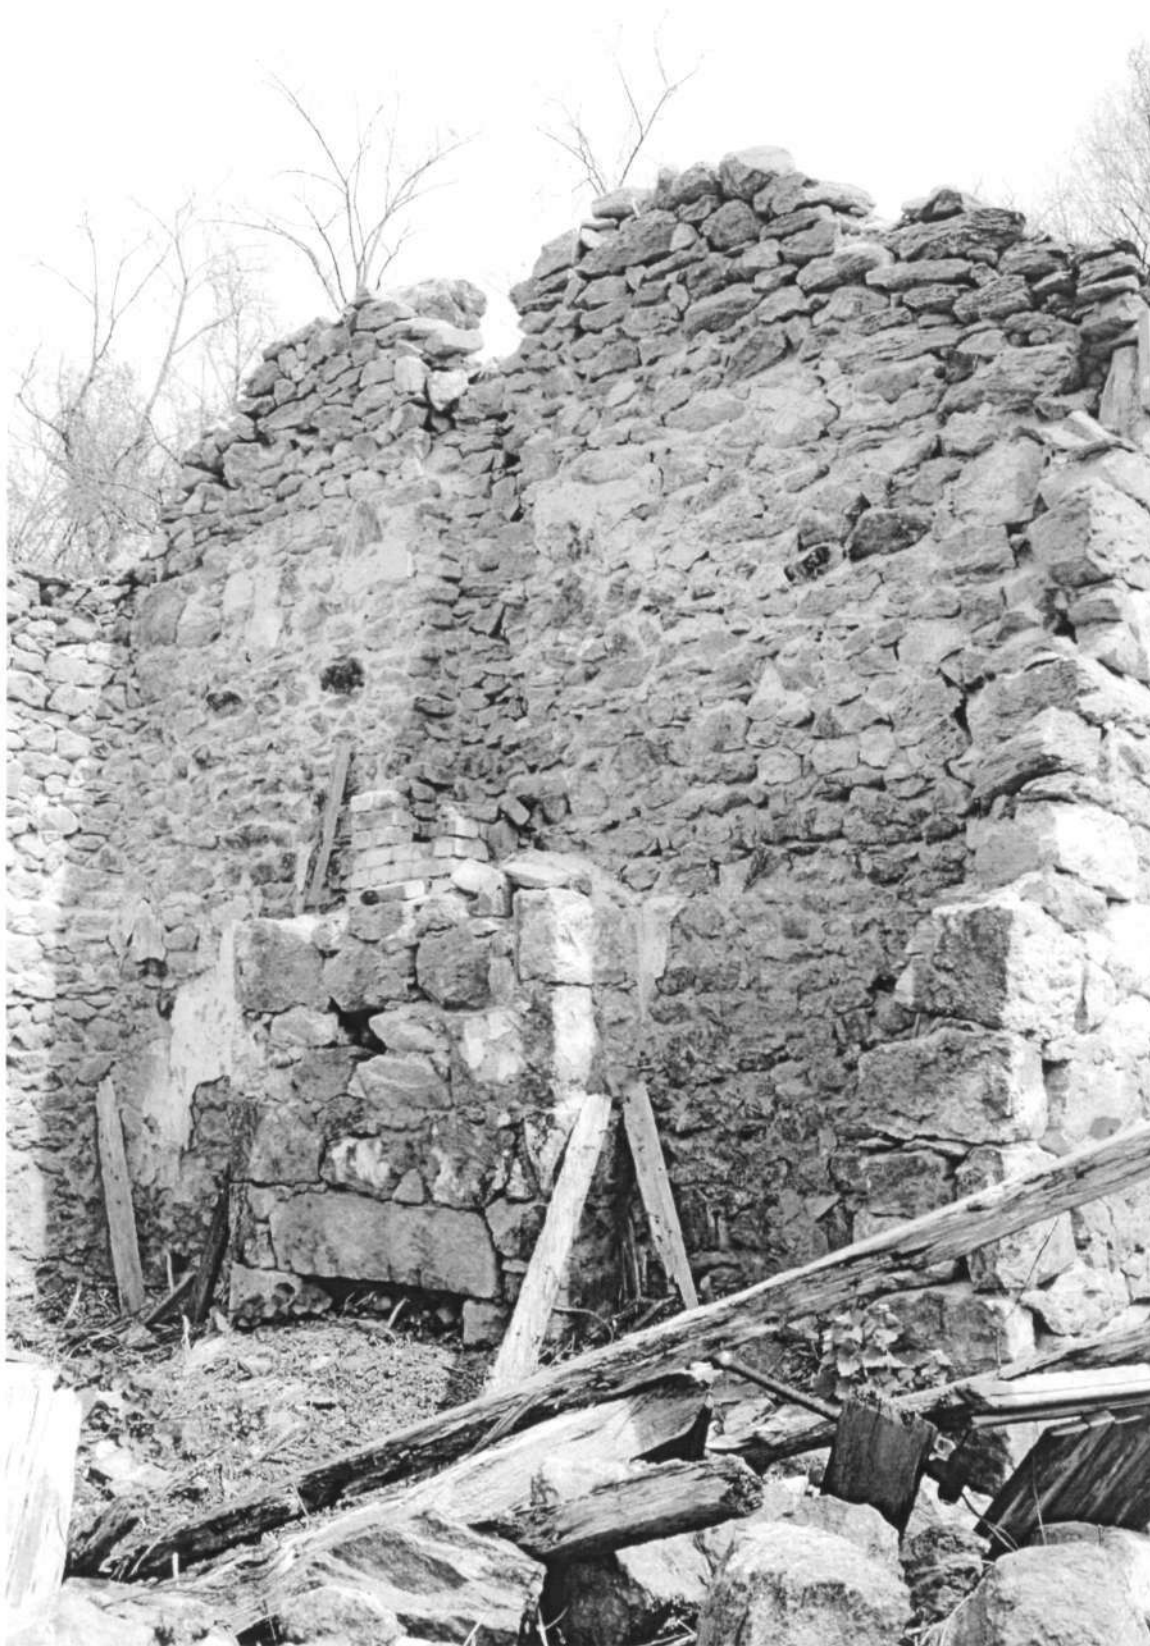
The west room floor is also covered with dirt and debris, especially stone, wood, and brick. There is a stone fireplace on the east elevation, and it is filled with debris to just below the stone lintel. This lintel has quarry drill holes. The stone stops at the second story joist level, and then a small brick chimney rises from that point. The flue was built partly into the stone wall, with the bricks tied in. There are some 20th century bricks and mortar, and the chimney was probably rebuilt at the top once. The lower bricks are hand moulded and are softer. Some plaster survives on the interior walls of this room. There are joist pockets on the north wall, just above the wood lintel of the west-center bay. The pockets are roughly 3 inches by 6 inches. The remains of the joists lying on the floor appear to be sawn. The soffit of the wood lintel has riven lath with cut nails. The debris includes sash-sawn timber that is 2-1/2 inches by 3-1/2 inches and has cut nails. This could be either joists or rafters. There are also beaded-edge tongue-and-groove boards that are 8 to 9 inches wide and could be part of a vertical-board partition wall. One of the timbers is notched and must be a rafter. It is 3 inches by 4 inches and has cut lath nails, suggesting that the attic ceiling must have been finished. There is another similar timber in the southeast corner of the east room. The north elevation west bay window frame is constructed with cut nails, and the wood sill and header are set into the walls and had to have been built in as the stone walls were constructed. It is not possible to make a similar determination about the east room windows because the jambs still have plaster on them. In the west room, the east wall, north of the fireplace, has the plaster extending up above the level of the bottom of the joist pockets, suggesting a stairway was here. The fireplace appears to have splayed jambs and is much too small to cook in.

HO-411 Woodlawn Slave Quarter 9254 Old Annapolis Road West section, interior, east elevation  
Ken Short, April 2006 5/14

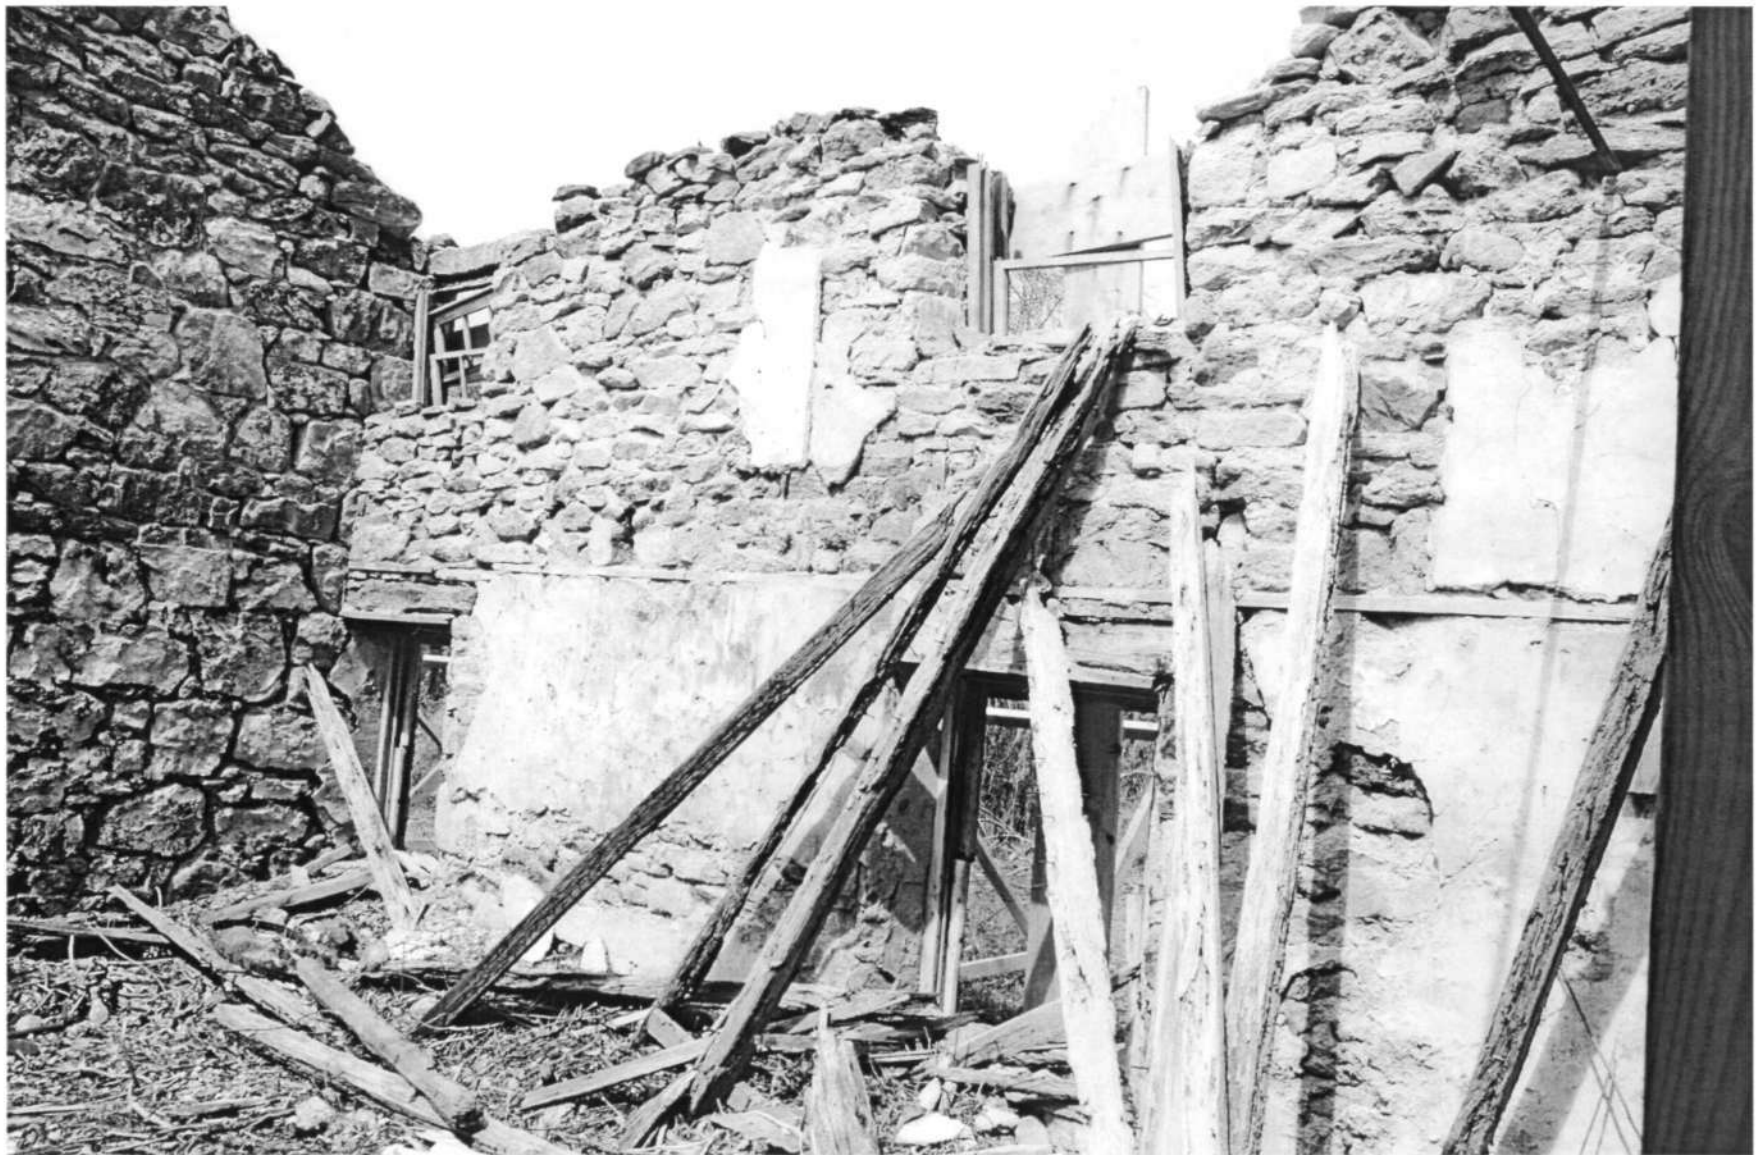
debris covering the floor, with numerous sawn timbers that appear to be the rotted second story floor joists and rafters. These timbers contain cut lath nails on one side indicating that there was a finished ceiling here. The joists had to be removed when the east door was added because the lintel is higher than the joist pockets, and the joists may actually come from the attic floor. The walls are plastered. There is a one-inch-wide board set into the north and south walls just above the wood lintels. There was a narrow partition that was probably a board wall running north-south just west of the east bay window. There is no evidence of it on the north wall plaster, but it is clear on the south wall. There are two sets of pockets on the north and south walls, and several are set on the board in the wall. There are also several pockets just above these and they still have wood that is probably nailing blocks for baseboard. One of these pieces of wood has a cut nail in it. The second story in the east half has a ghost in the plaster of the north indicating a board wall just west of the east bay window. No plaster survives on the south wall across from this. The northeast corner of the east room plaster does not have an even break in it, and there may have been a winder stair located here. There is an octagonal post lying on the ground in the east room that could be from a winder stair. The west elevation is whitewashed below the level of the boards that are set into the north and south walls. There is a hole, probably for a stovepipe, in the center near the top of the first story whitewash. The second story also has whitewash. Several stones have quarry drill holes, as does the south elevation second story east bay lintel. The east elevation has a ghost on the wall at the south corner that may indicate peg rail here. The south door has a cast-iron rim lock with a decorative band on the outer edges and a mineral knob. There is a T hinge at the top of the door, and the bottom of the door and its hinge are buried beneath debris.

HO-411 Woodlawn Slave Quarter 9254 Old Annapolis Road East section, interior, west & north elevations  
Ken Short, April 2006 6/14

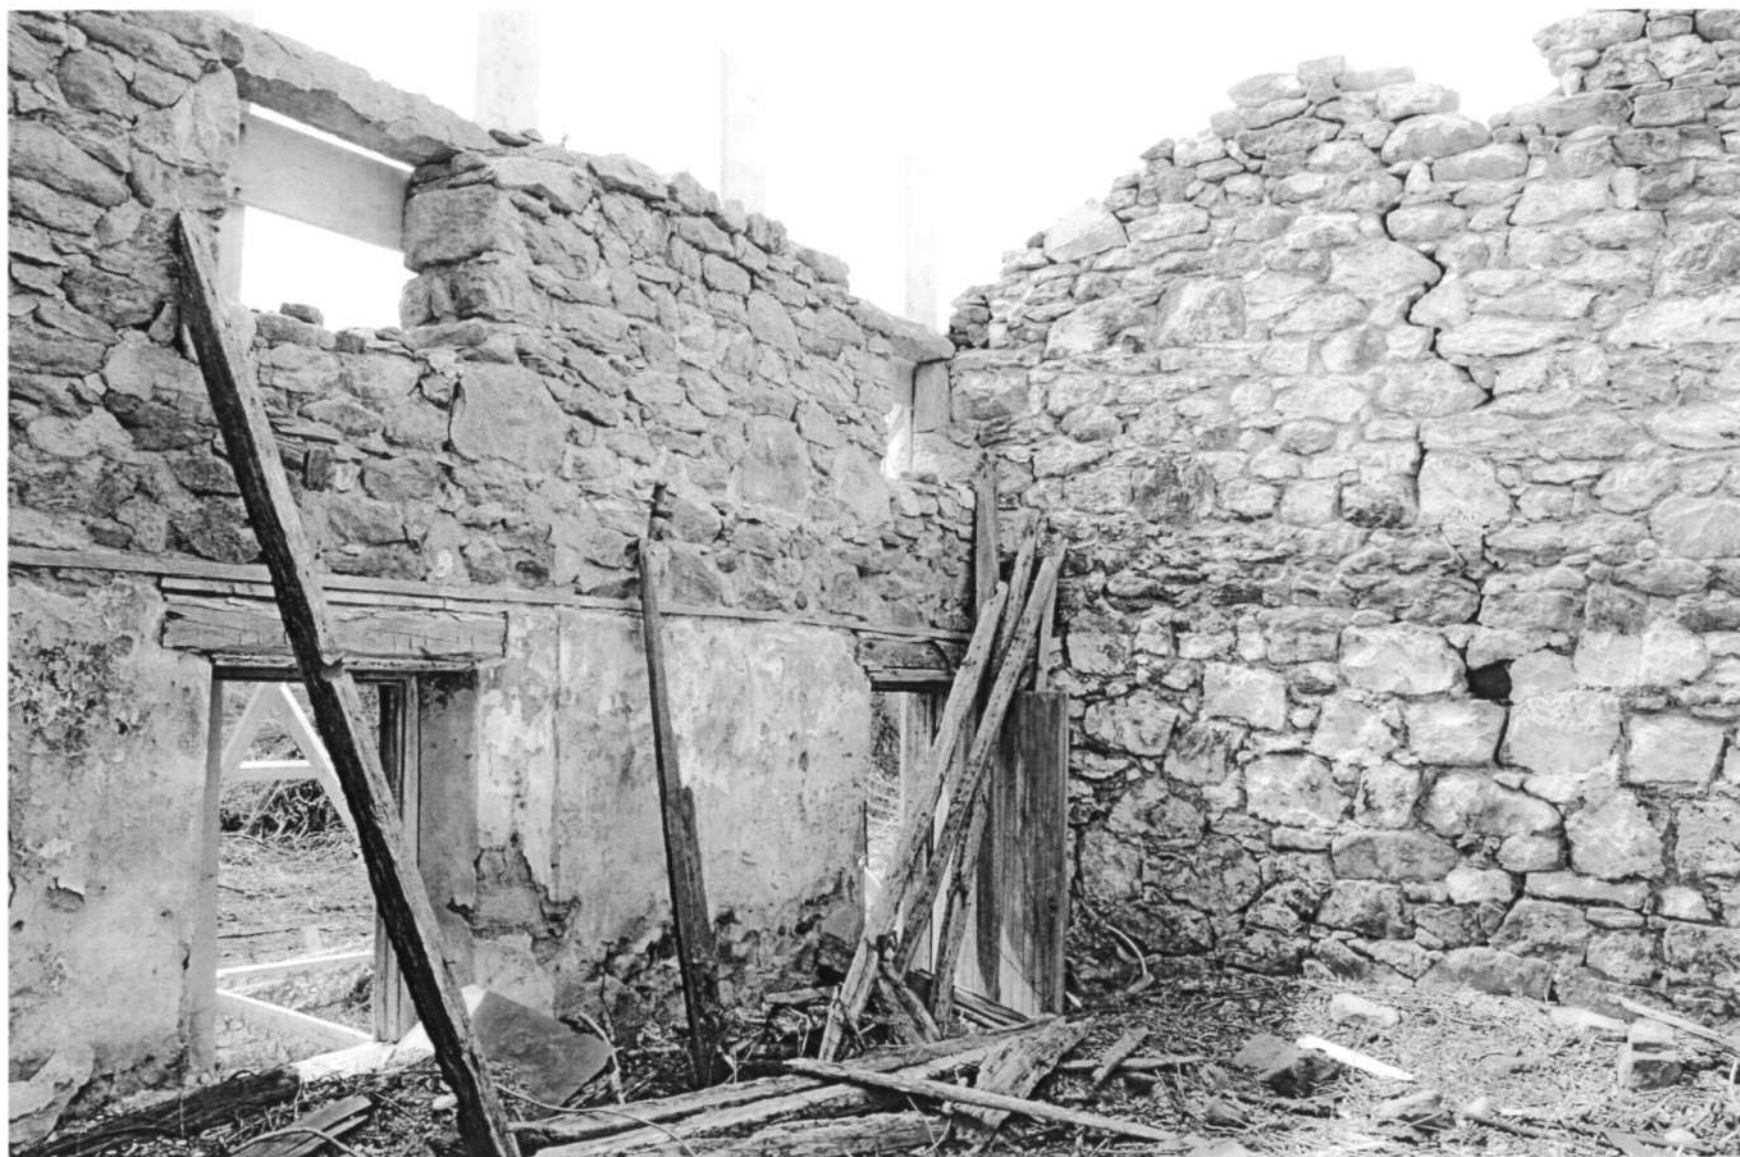
HO-411 Woodlawn Slave Quarter 9254 Old Annapolis Road East section interior, south & west elevations  
Ken Short, April 2006 7/14

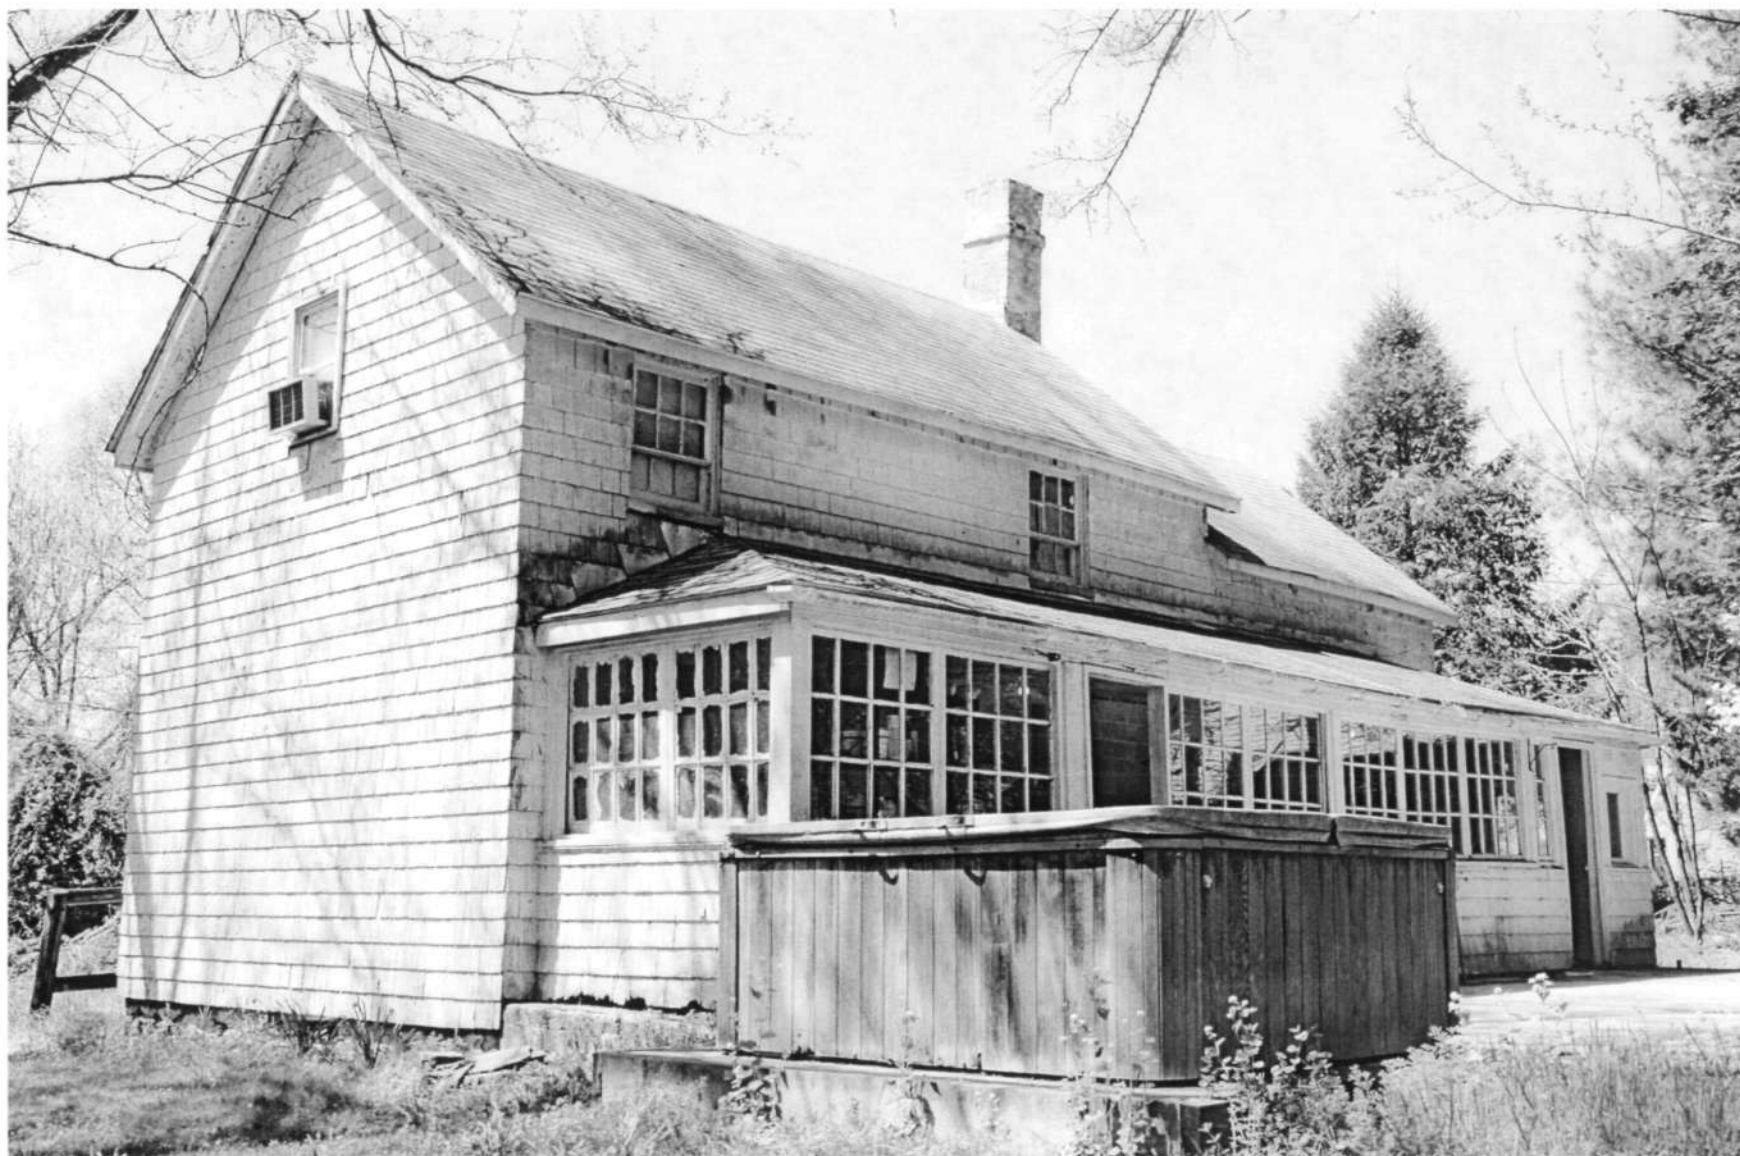
The Cottage is located about 70 feet south of the Slave Quarters. It is a two-story, three-bay by one-bay frame structure with a 1-1/2-story, one-bay by one-bay wing on the north end. The building has a rubble stone foundation, wood shingles, and a gable roof with asphalt shingles and a north-south ridge. There is a parged chimney between the main block and the wing, on the ridge, and it is sitting in the wing attached to the main block. The east elevation has an enclosed one-story porch on the first story that has a hipped roof with asphalt shingles, and a wood shingle wall below the sash. From south to north the porch has a 16-light fixed sash, another 16-light sash, a doorway, five 6-light sash, a post, a 6-light sash, a doorway, and a sash with one large light. Inside the porch is a six-over-six double-hung sash in a beaded-interior-edge mitered frame in the south bay. There is a door with three lying lights over three lying panels and the same frame in the center bay. The north bay has a typical six-over-six sash. The wing has a door that matches the center door, and it is set near the north corner. The porch has a concrete deck, beaded-edge vertical boards below the sash, and narrow slats on the soffit with spaces between them. The second story of the main block has a six-over-three sash in the north and south bays. The eaves are open.

HO-411 Woodlawn Slave Quarter 9254 Old Annapolis Road Cottage, south & east elevations  
Ken Short, April 2006 8/14

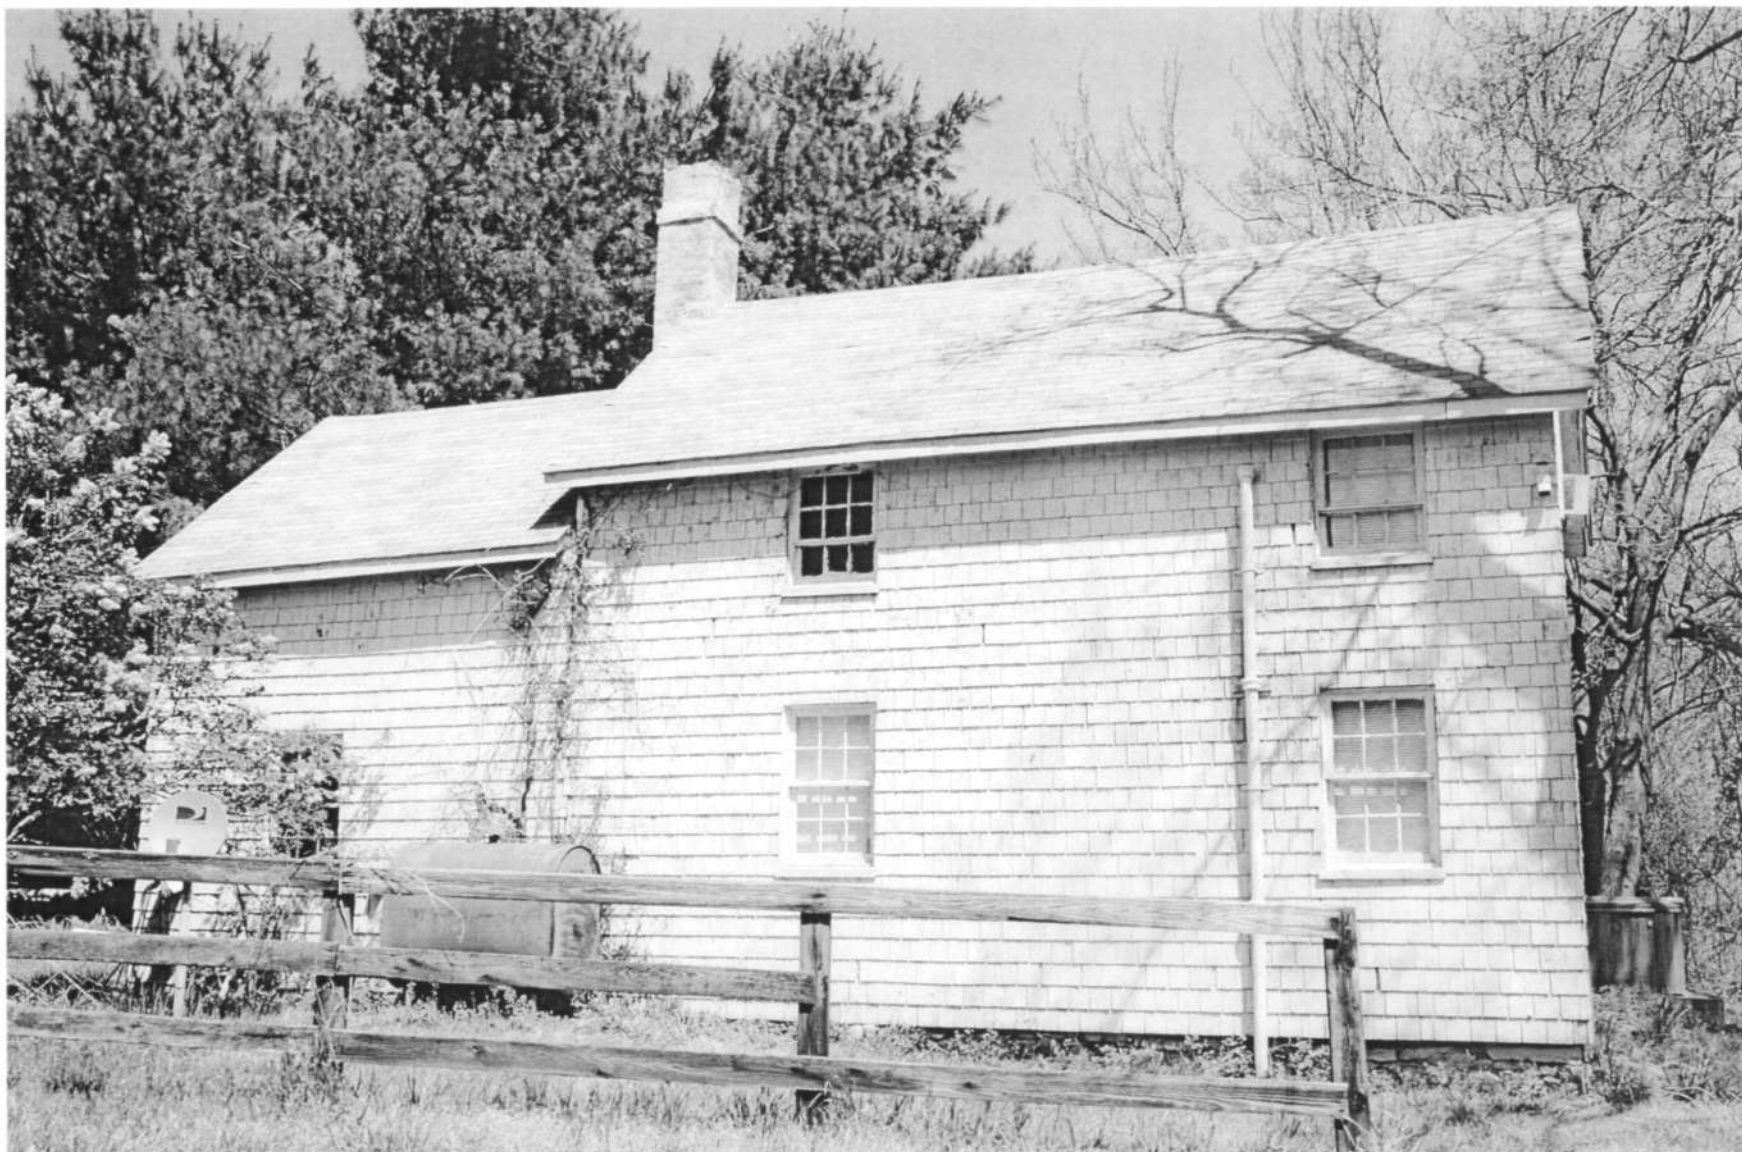
HO-411 Woodlawn Slave Quarter 9254 Old Annapolis Road Cottage, west elevation  
Ken Short, April 2006 9/14
