HO-411

## Woodlawn Slave Quarters Complex

### **Architectural Survey File**

Woodlawn Slave Quarters

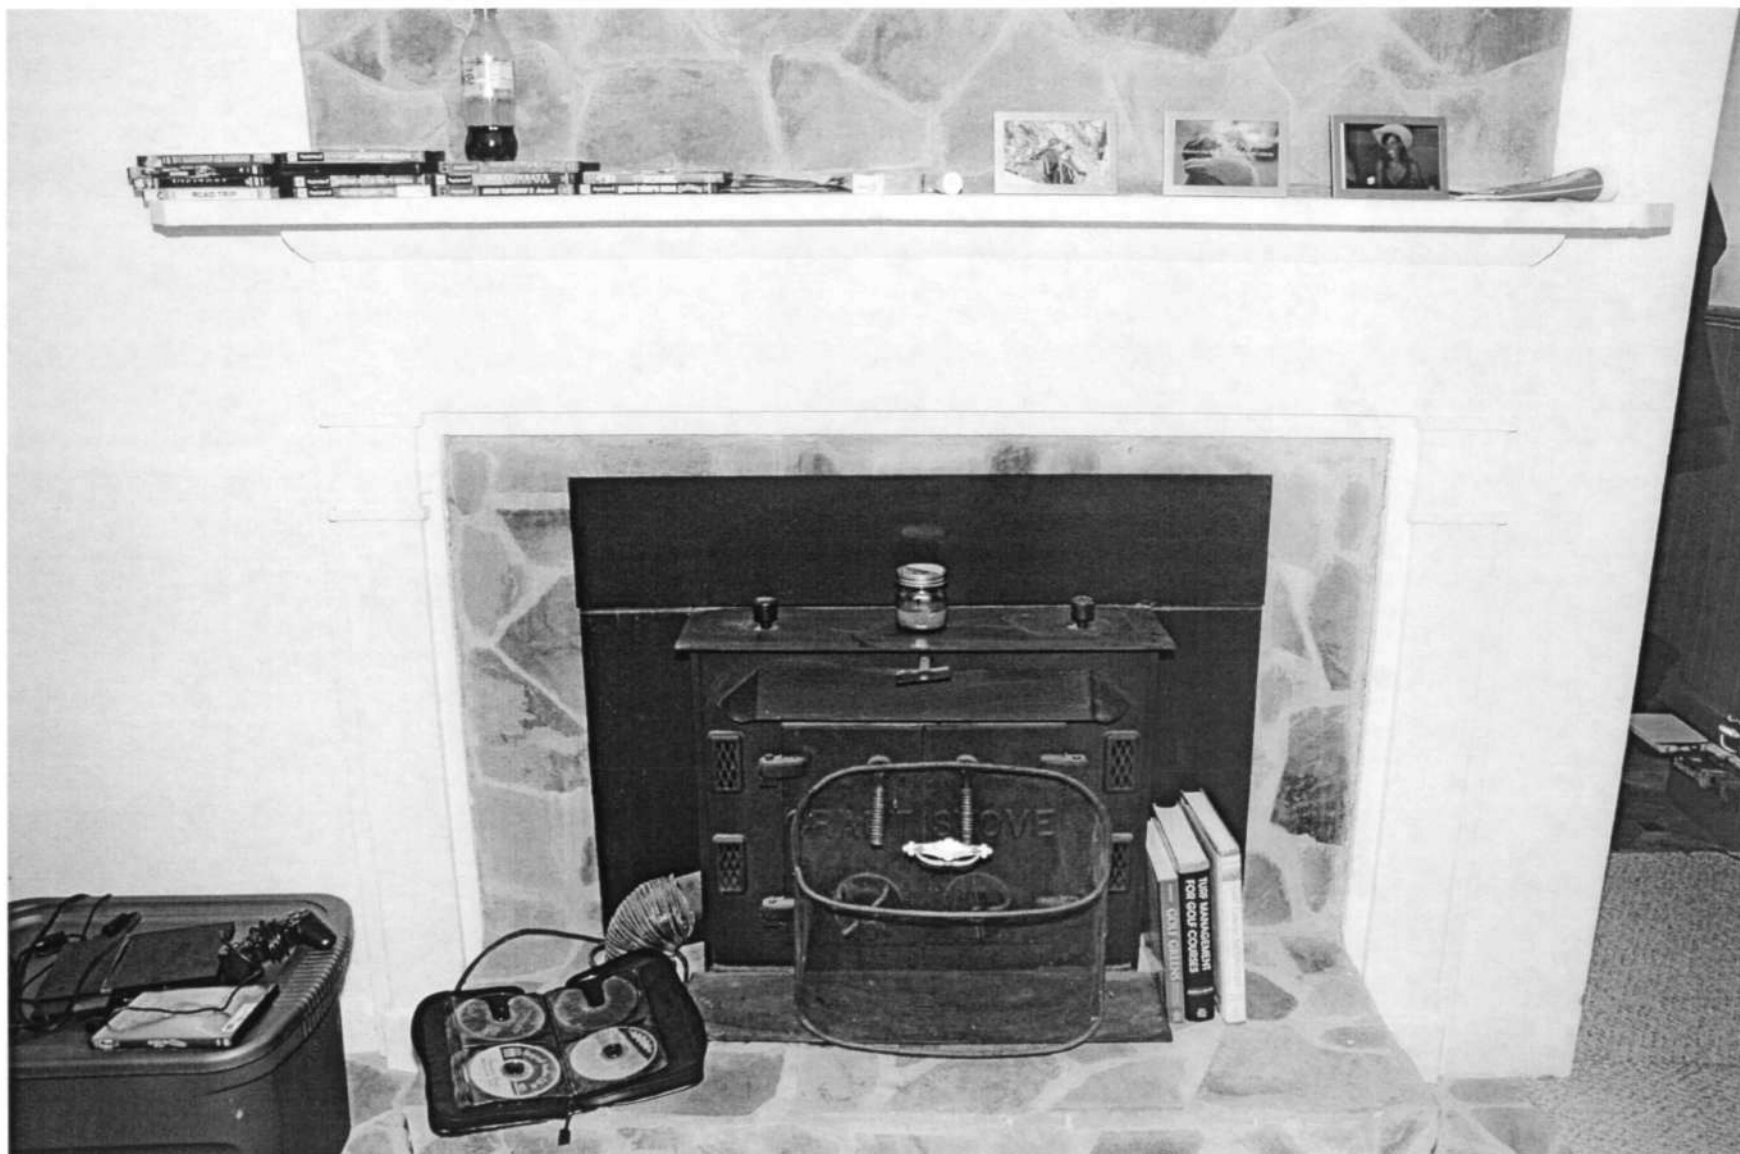
The interior has a hall-parlor plan with one room in the north wing. The north room has carpeting, plain baseboard, and mitered architrave that has a beaded interior edge. The sash have ovolo muntins, are mortised and tenoned and pinned with two pins at the corners and large pins on the muntins. They have 8-inch by 10-inch lights and parting beads. The fireplace on the north elevation has been rebuilt, with the wood mantel probably taken off and put back. This mantel has plain pilasters and a plain frieze, and a large ovolo bed mould. There is a winder stair in the southwest corner that was originally enclosed with beaded-edge vertical boards that have been cut off at the tread level in order to open it up. There is a door to a closet below the stairs that also has beaded-edge vertical boards. It is hung on cast-iron butt hinges with three knuckles, and they are heavily painted. There is horizontal flush tongue-and-groove bead-board siding on the south wall inside this closet. The bottom of the stairs are plastered and have sash-sawn lath with cut nails. There is drywall on the walls and ceiling. On the south elevation is a doorway with typical architrave, but the door is missing. The south room is now divided by a partition wall that runs north-south and has plain trim and a two-panel door. The east half has carpet, paneling, and a drop ceiling. The west half has plaster. The second story has sash-sawn joists that run east-west, are 3 inches by 7 inches and are spaced 25 inches on centers. Above the joists is sash-sawn flooring that runs north-south and ranges from 4-1/4 to 5-1/4 inches wide.

HO-411 Woodlawn Slave Quarter 9254 Old Annapolis Road Cottage, north room mantel  
Ken Short, April 2006 10/14

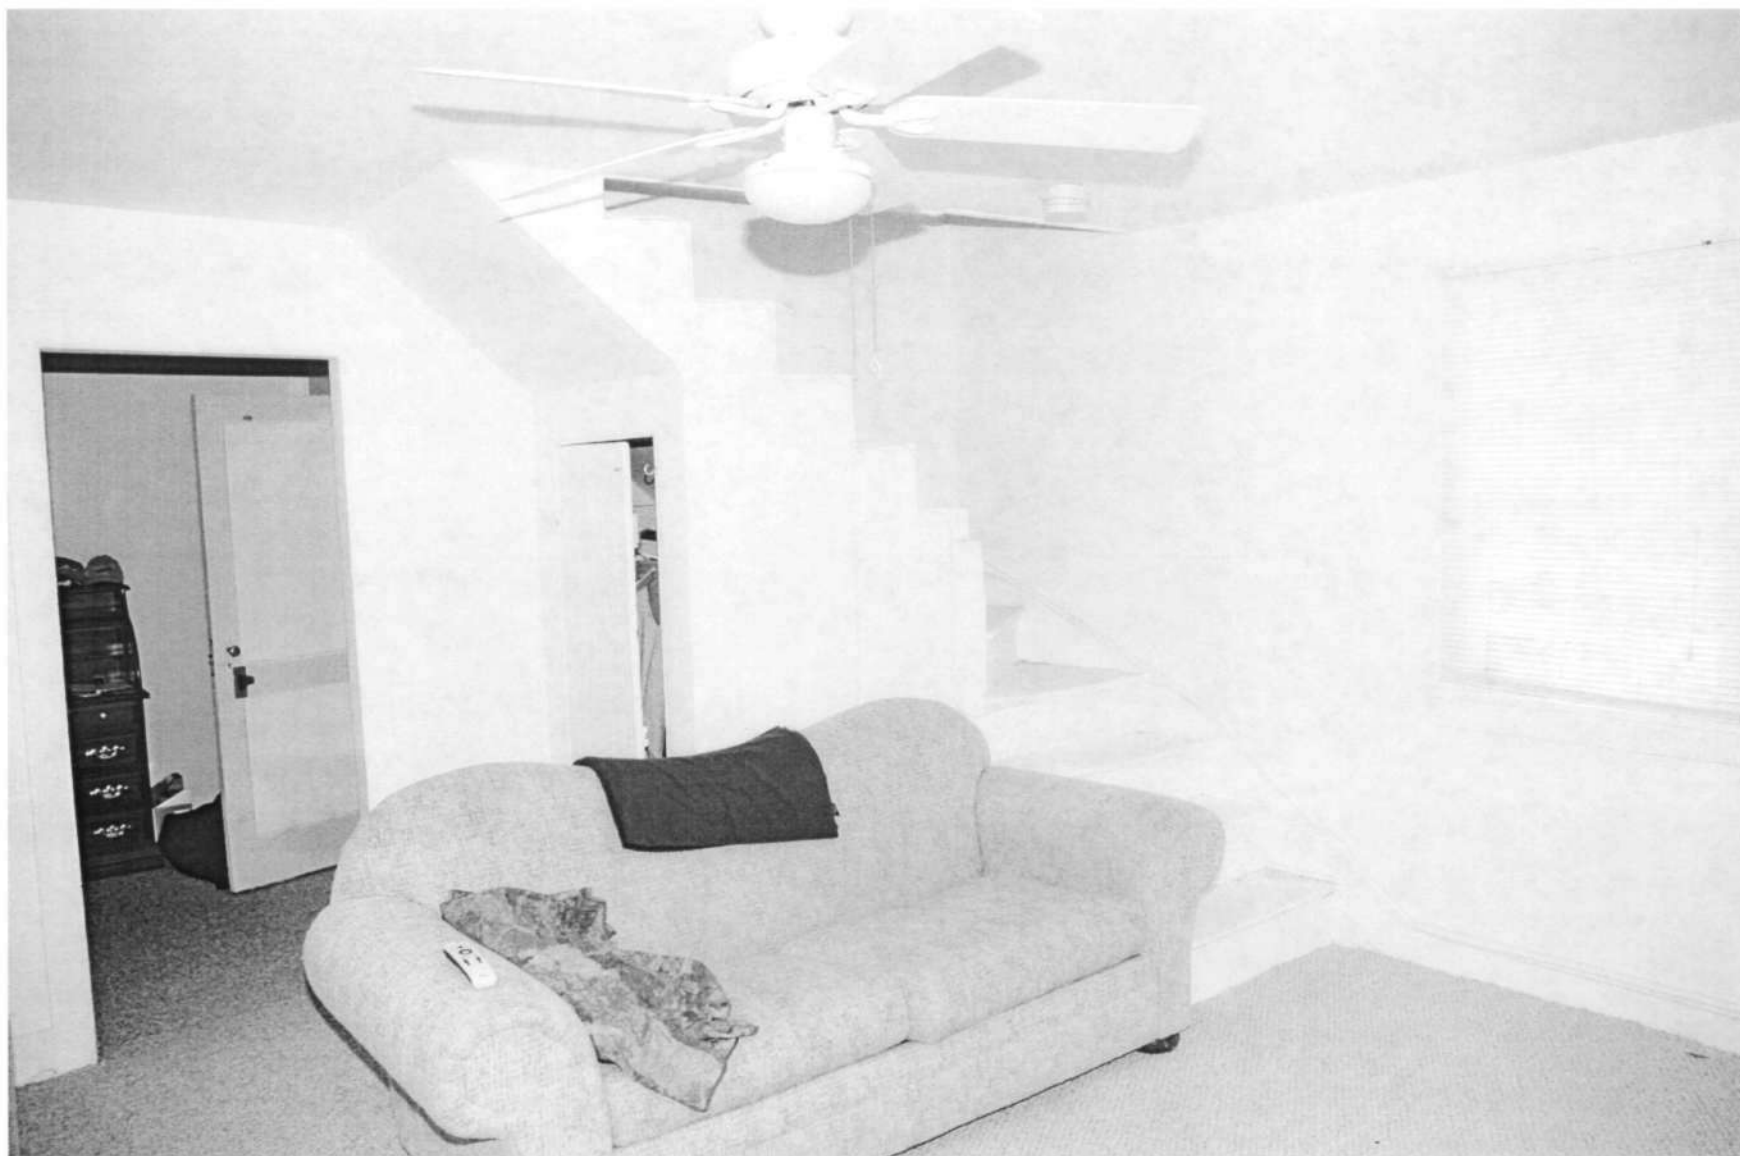
HO-411 Woodlawn Slave Quarter 9254 Old Annapolis Road Cottage, north room, vw southwest  
Ken Short, April 2006 11/14

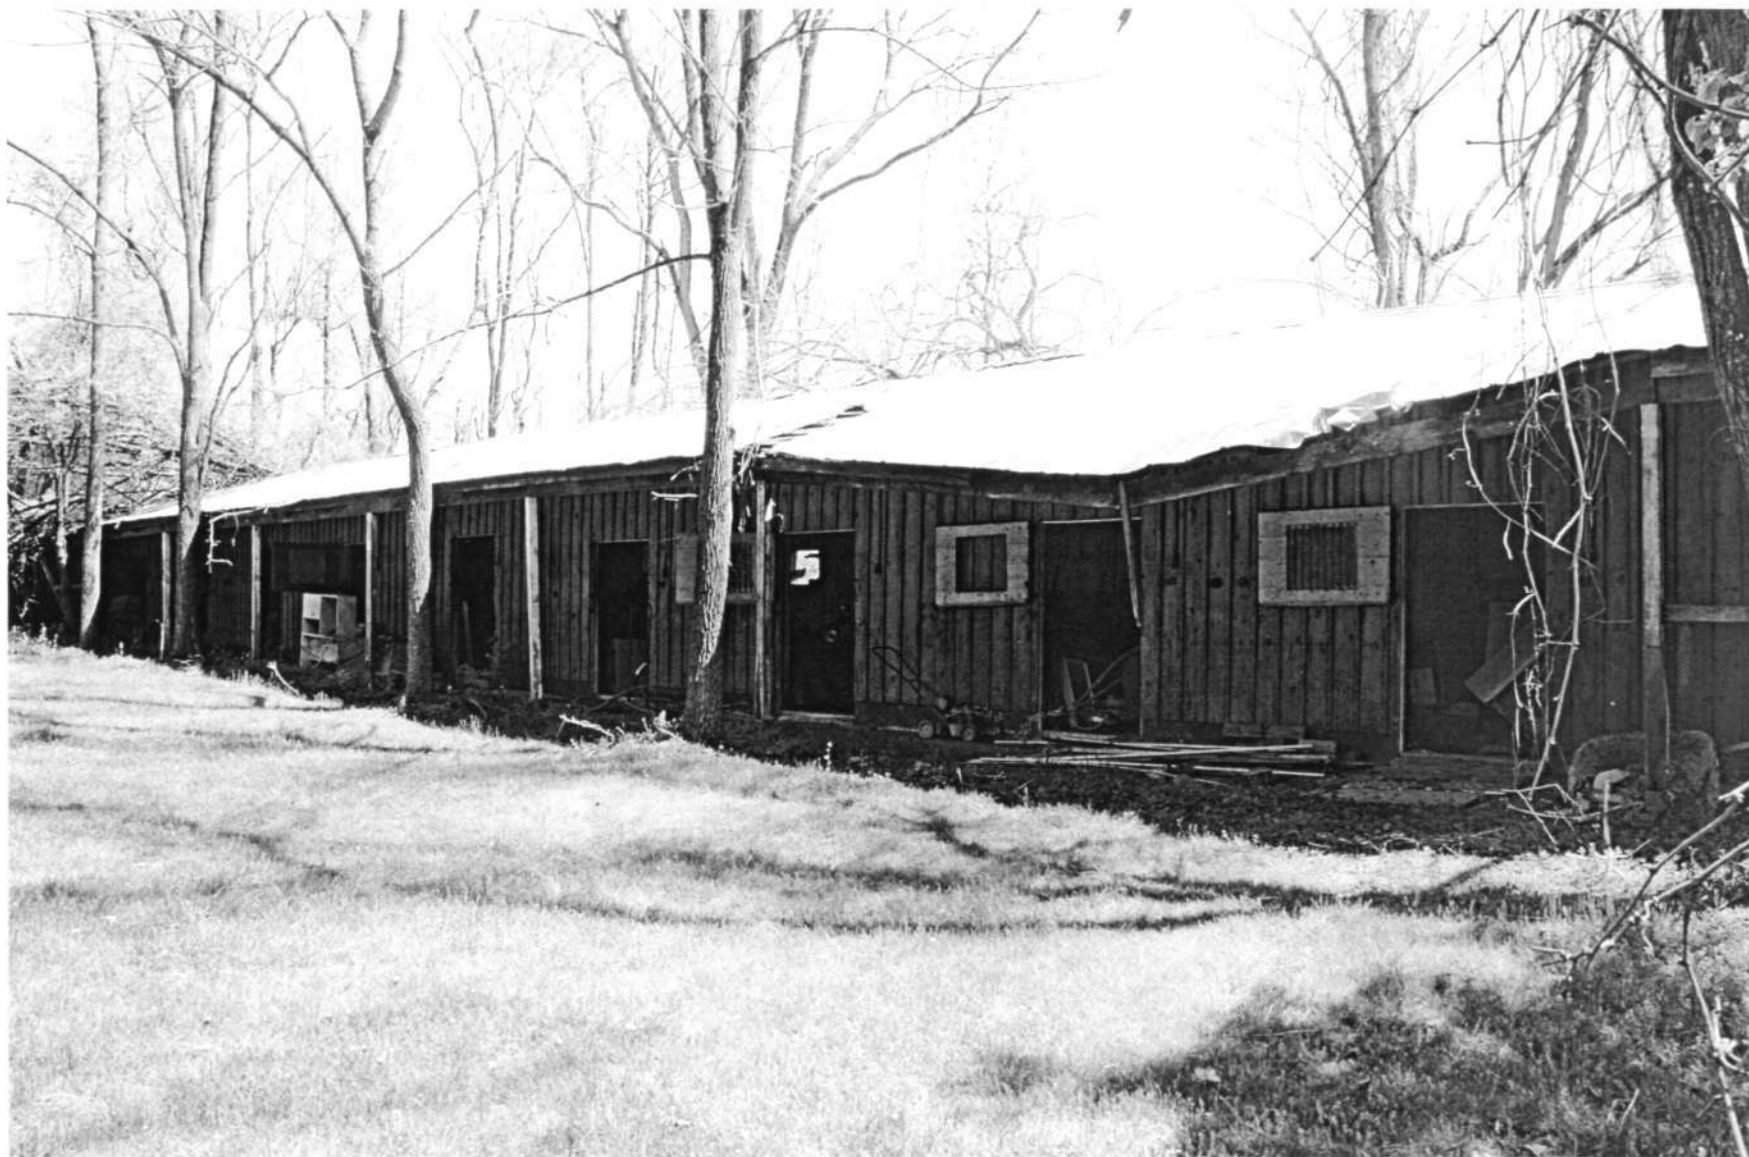
A stable is located about 40 feet south of the barn foundation. It is a one-story, ten-bay by one-bay structure with a CMU foundation, framing with board-and-batten siding, and a gable roof with inverted-V-seam metal and an east-west ridge. The roof overhangs on the north side and has posts supporting it between each bay. Each bay on the north has a doorway with Dutch doors, and the top halves of most of them survive and are hung on machine-made strap hinges. The roof has partially collapsed in several places. There is a small window opening on the south elevation opposite of each door. The interior is divided into a seven-bay room to the west with vertical-board siding inside it. This area was originally individual stalls, but the partition walls have been cut out. The three eastern stables survive and have wire nails. There are also wire nails in the siding. The rafters are 2 inches by 6 inches and have a ridge board.

HO-411 Woodlawn Slave Quarter 9254 Old Annapolis Road Stable, north elevation  
Ken Short, April 2006 12/14

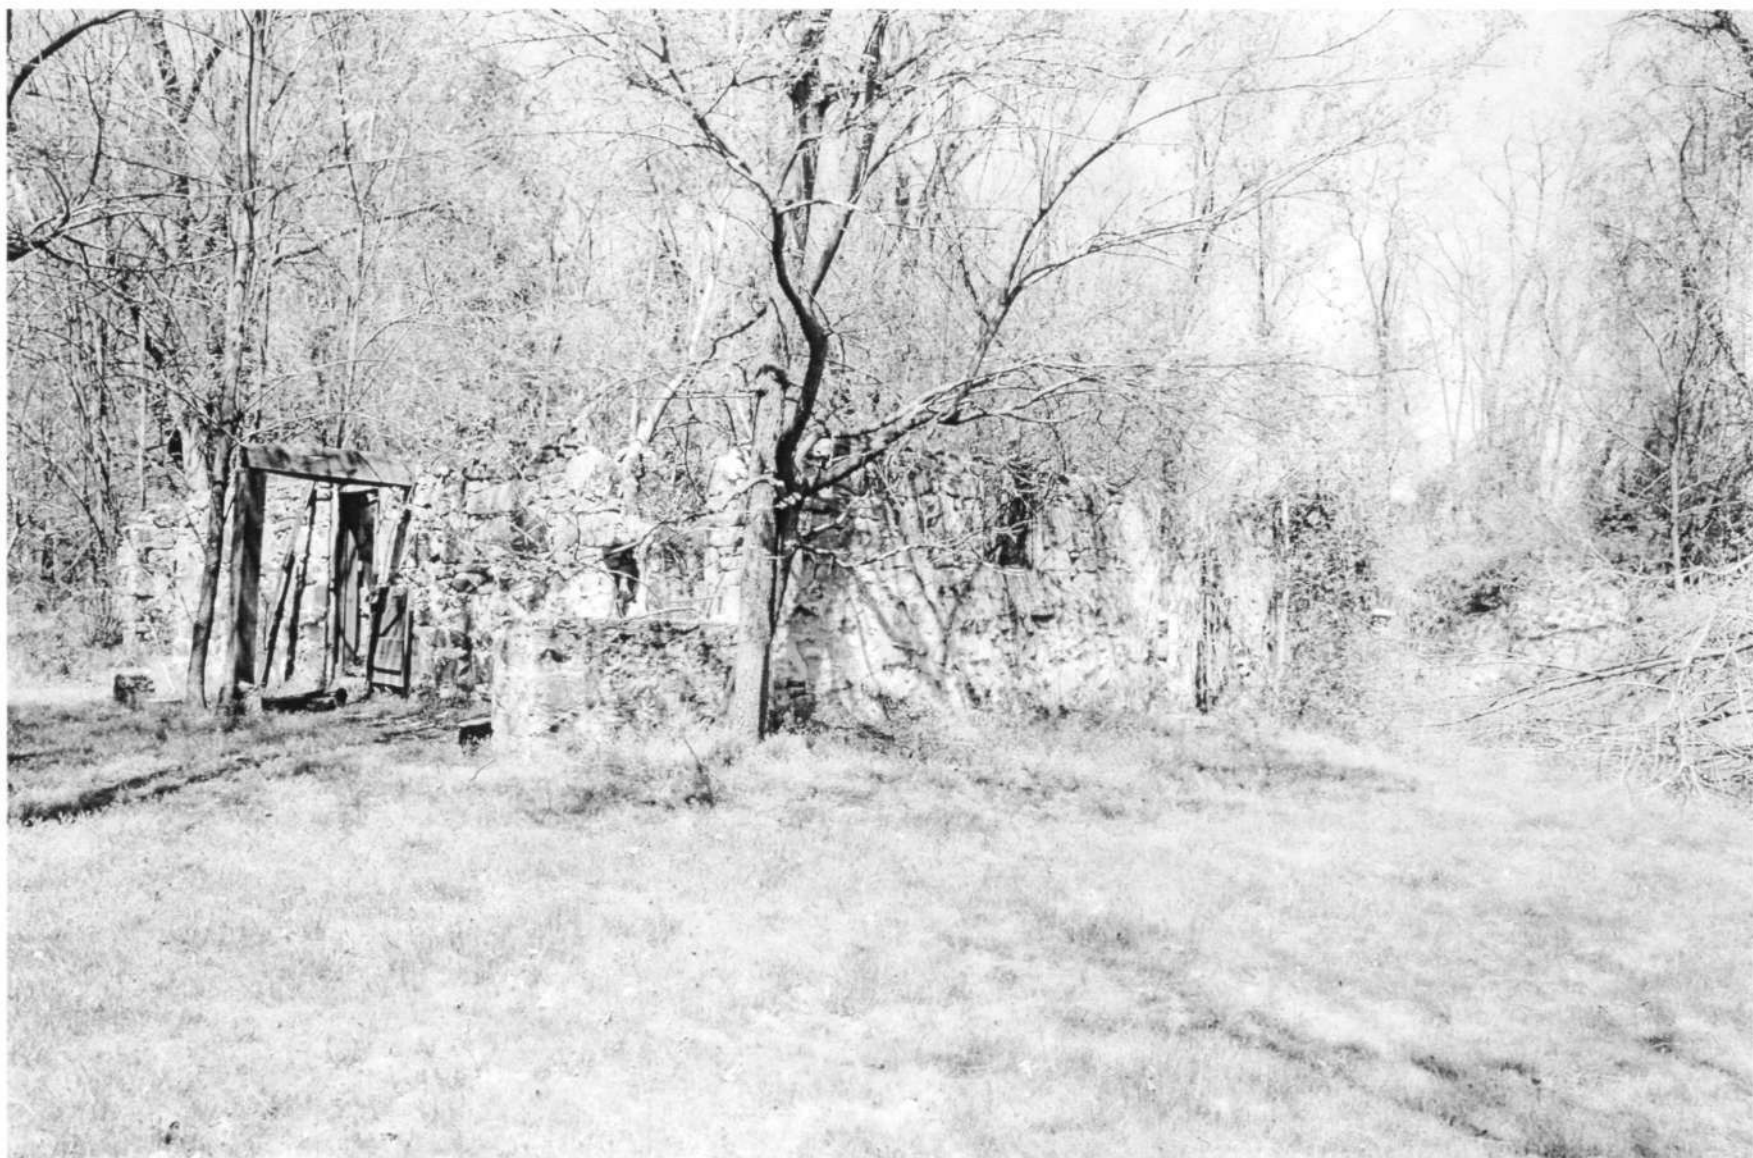
There is a rubble stone bank barn foundation located about 25 feet east of the well house. It is banked on the north side. The west elevation has three doorways, the center with circular-sawn framing and still containing the bottom half of a vertical-board Dutch door on machine-made strap hinges. There is a stone sill. There are the remains of a summer beam south of the center door, and it extends to the west of the foundation about 6 feet and rests on a circular-sawn post sitting on a stone plinth. There is another stone plinth to the north of this doorway in line with the pocket for another summer beam. This plinth has a hole in the top where a pin on the bottom of a post could have been. It is not clear what these summer beams, posts, and plinths were used for. There is a short stone wall at the southwest corner of the foundation, and it has concrete on top that has a square hole where a post sat in line with the other two.

HO-411 Woodlawn Slave Quarter 9254 Old Annapolis Road Barn foundation, view from southwest  
Ken Short, April 2006 13/14

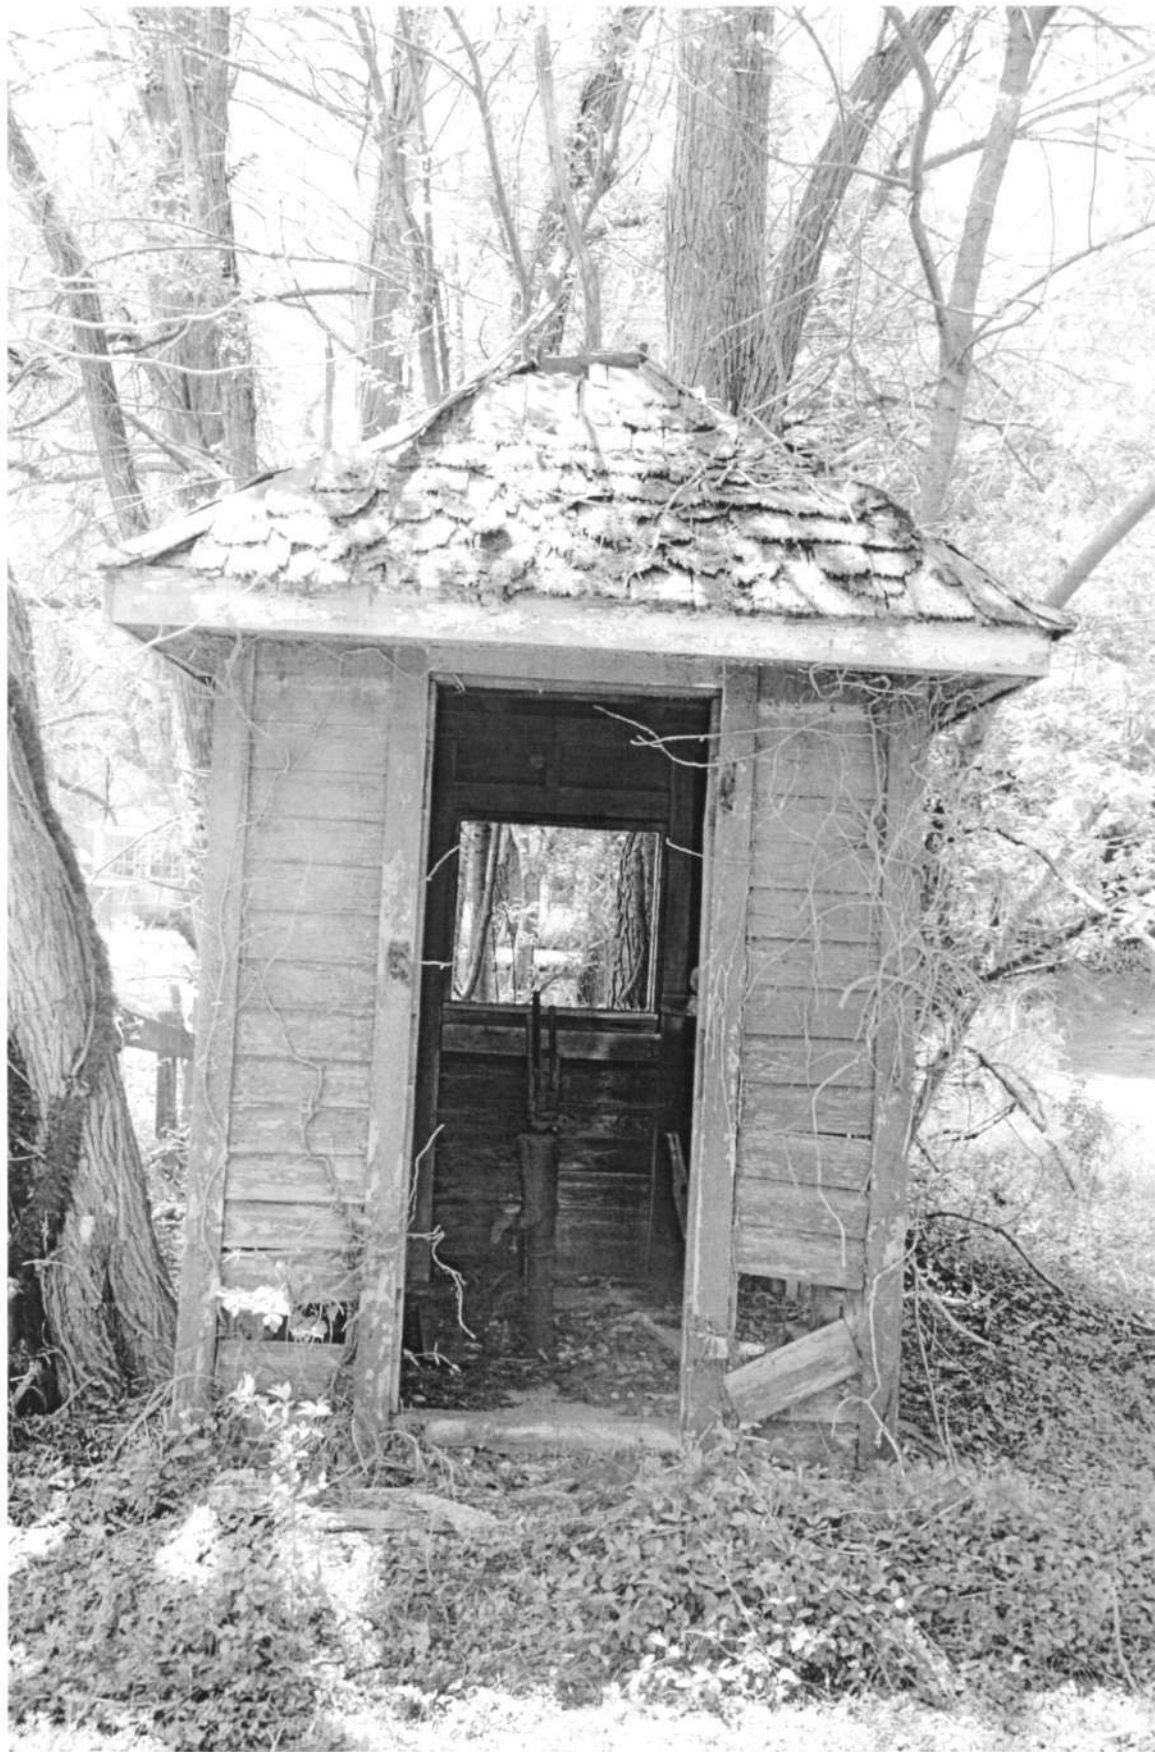
About 100 feet east of the cottage is a well house. It is a one-story, one-bay square frame structure with German siding and a hipped roof with wood shingles. The east elevation has a doorway, and the west elevation has a window opening. There is a low hatch or doorway on the north elevation, set to the west. The interior has a concrete floor with a steel pump in the center, and a wood floor around it. The building is constructed with 4- x 6-inch corner posts, 2 by 4 studs, and 4- by 4-inch posts flanking the window and door. The framing is circular-sawn and toe-nailed with cut nails. The rafters have 2 by 4s with an opening in the center of the roof. The door was hung on T hinges. About 3 feet south of the building is a concrete trough.

HO-411 Woodlawn Slave Quarter 9254 Old Annapolis Road Well house, east elevation  
Ken Short, April 2006 14/14

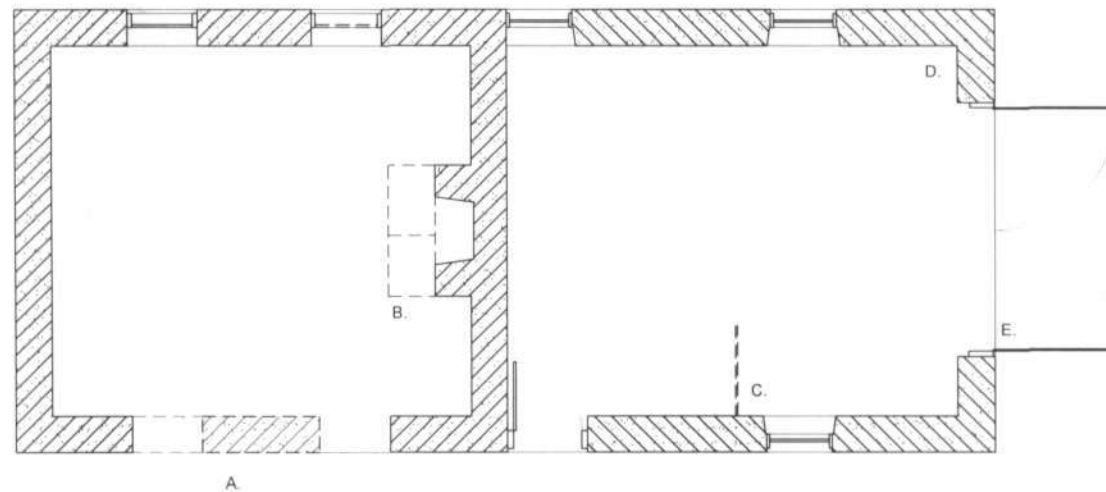
FIRST FLOOR PLAN - MEASURED AND DRAWN BY KEN SHORT - APRIL 2006

- A. WALL PARTIALLY COLLAPSED HERE, BUT ORIGINAL CONFIGURATION DECIPHERABLE.
- B. HEARTH CONJECTURAL BASED ON TWO STONES FOUND IN THE RUBBLE.
- C. PLASTER CONTAINS GHOST OF WALL HERE, BUT PLASTER DOES NOT SURVIVE ON OPPOSITE WALL.
- D. MARKS ON WALL INDICATE POSSIBILITY OF STAIRWAY HERE.
- E. DOORWAY CUT THROUGH IN 20TH C.
