HO-430

## Felicity II (Oakland Mills Blacksmith House and Shop)

### **Architectural Survey File**

National Register of Historic Places  
Registration Form

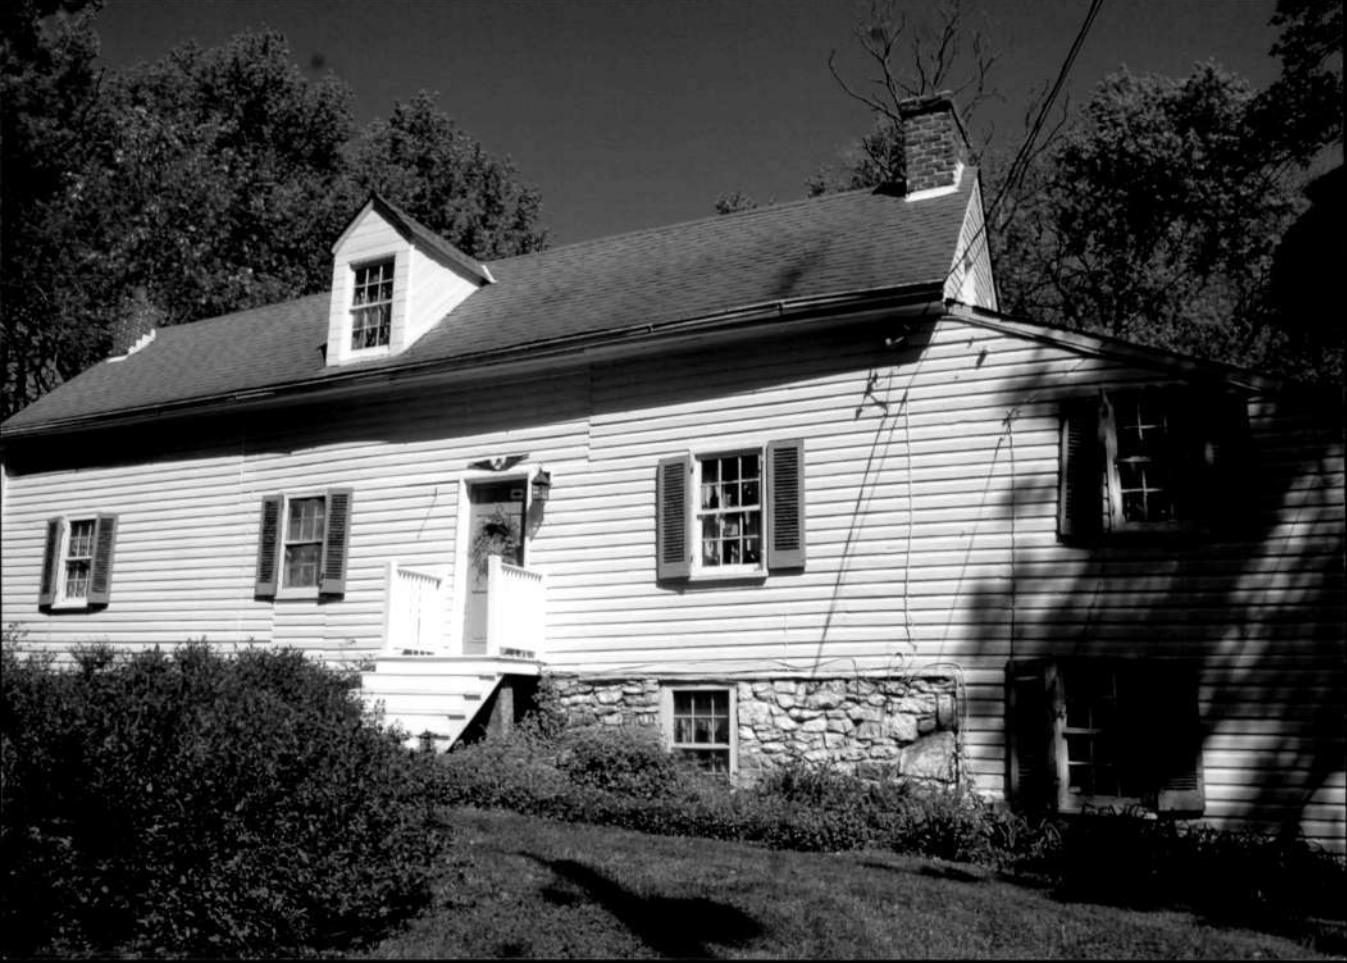
1 of 16

House, west elevation

On the main block the northwest elevation foundation has no seam in the stonework and contains traces of whitewash. The north-center bay has a window with a rotted frame and sash and the west bay has a six-over-six double-hung sash in a beaded-interior-edge frame. On the first story the north bay has a six-over-six double-hung sash in a beaded-interior-edge frame, and there are blinds with mortised-and-tenoned-and-pinned joints. This window is typical for the house. There is a seam in some of the German siding between the north and north-center bays. The north-center bay has a typical six-over-six sash. The siding below the windowsill is patched, indicating that this was once a door. The west-center bay has a six-panel door that has sunken fields and quirked Greek ogee panel moulds. It is set in a beaded-interior-edge frame. There is a rebuilt wood porch set on two granite posts, each post being of one piece of stone and containing

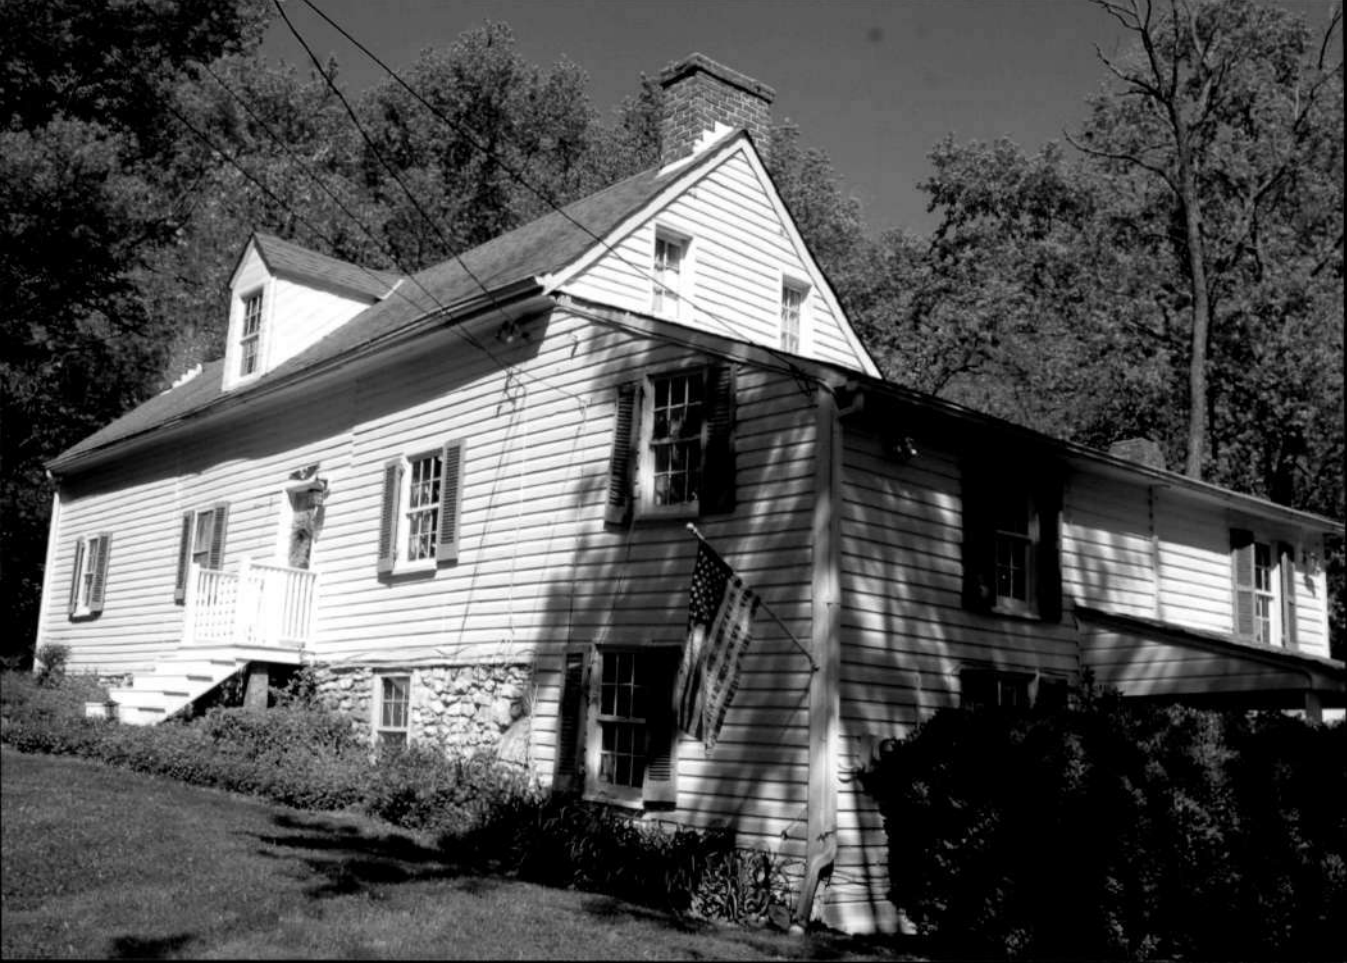
2 of 16

House, west and south elevations

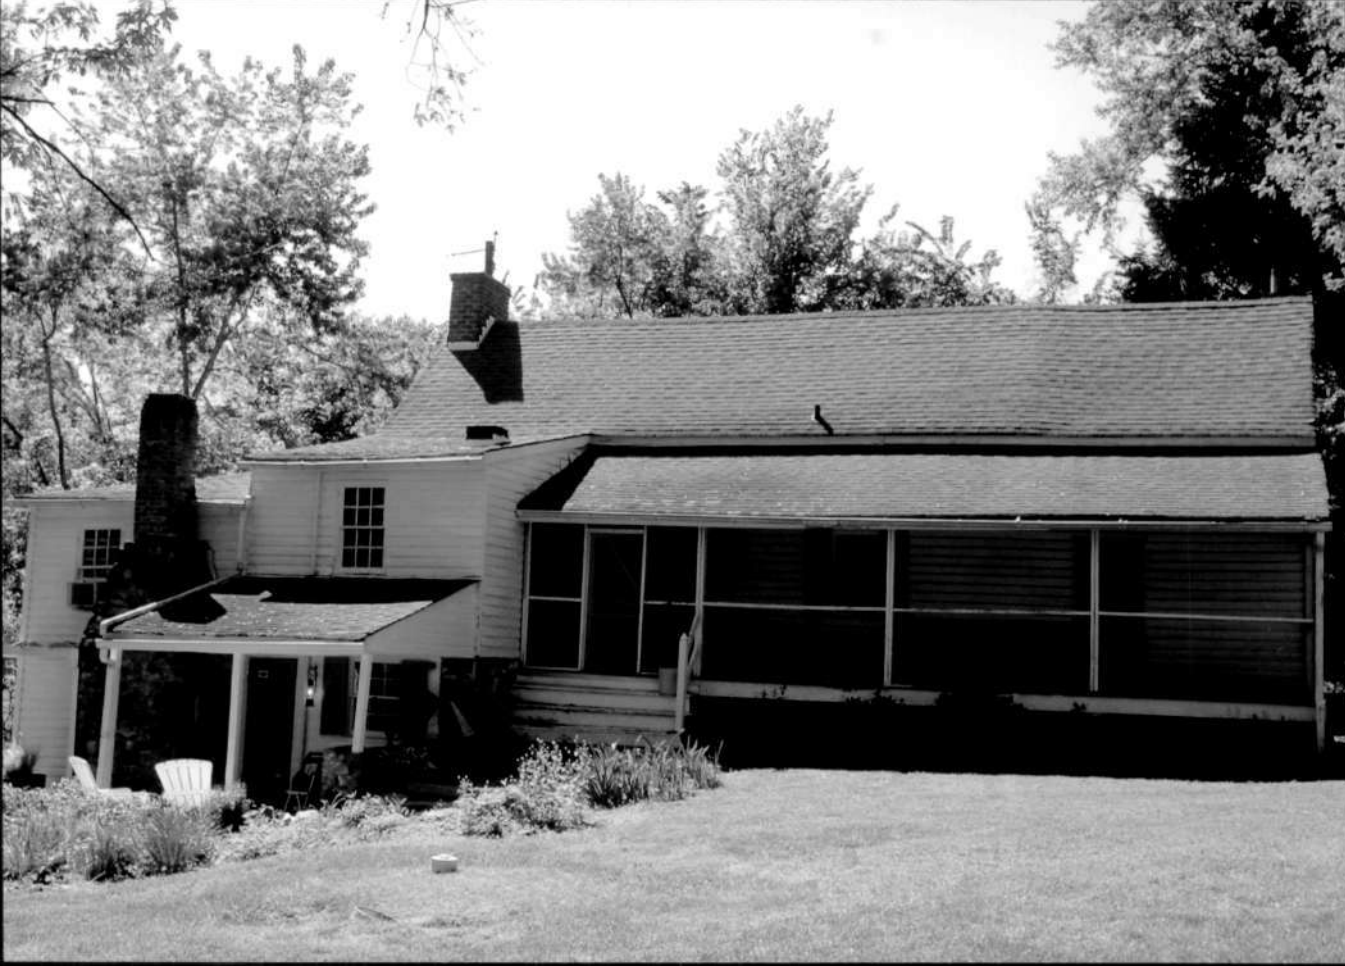
3 of 16

House, east elevation

On the northeast elevation of the main block the first story has a six-over-six sash in a modern frame, with fake shutters. The second story has a typical six-over-six sash, but no blinds. There are plain rake-boards that appear to be new. On the southeast elevation the south bay is covered by the ell. The south-center bay has a door with nine lights over two panels that have sunken fields and no panel moulds. The door has a beaded-interior-edge frame with a larger bead than what is found on the windows. The east-center bay has a typical six-over-six sash and blinds. The blinds have shutter dogs that are round on the bottom half and flattened on the top half, and they are attached to plates that are screwed to the siding. The east bay has a door that matches the south-center bay, but the muntins are thicker and the frame matches those on the windows. There is a three-bay porch across the main block, set on five stone piers. It has five 4 by 4 wood posts, dimensional lumber in the roof, and a shed roof that slopes down to the southeast.

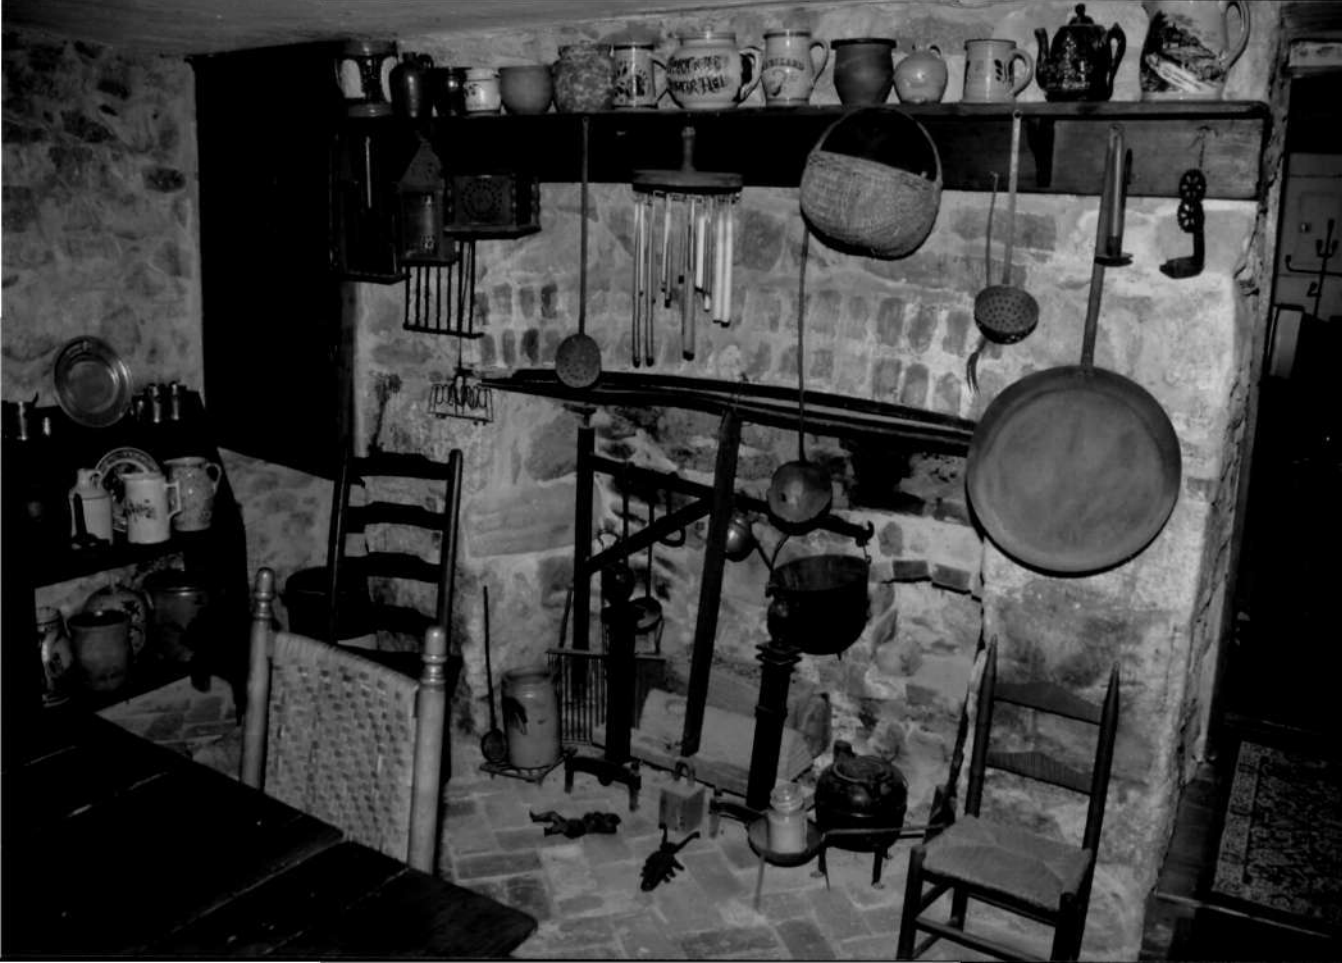
6 of 16

basement room, south fireplace

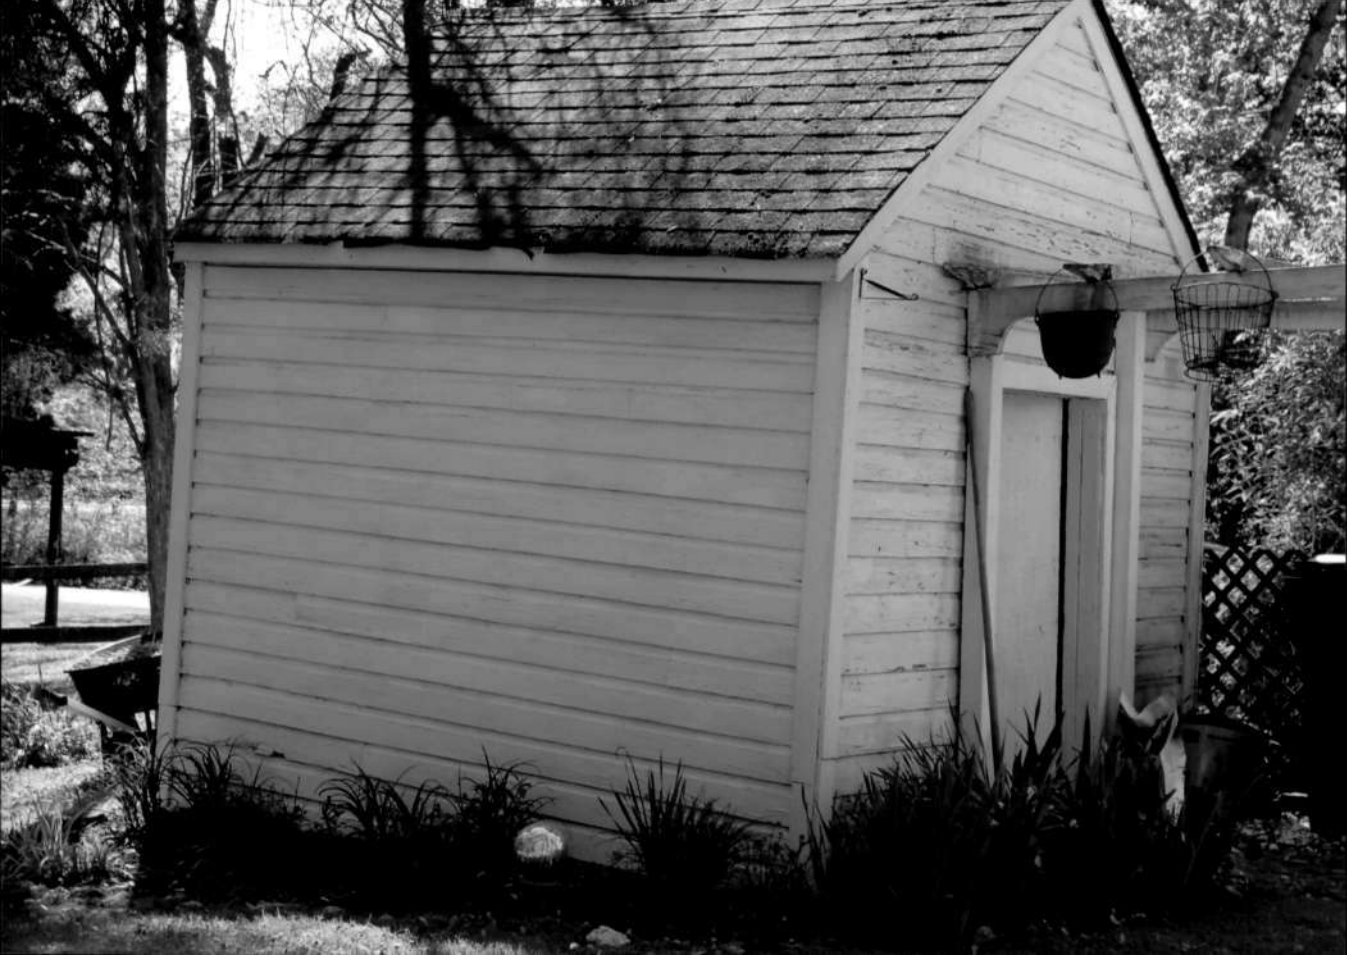
HO-430  
Oakland Mills Blacksmith House and Shop  
5471 Old Columbia Pike  
Howard County, Maryland  
Ken Short, photographer  
2010-04-30  
HO-0430  
Smokehouse, east and north elevations  
7 of 16

collar beams. There are nails in the sides of the rafters, collars, and purlin on which to hang meat, and there is much soot in the interior of this building. The rafters have an open-faced bridle and peg at the ridge. There are sash-sawn joists that run north-south and are set on the front and rear girts. They have no nails in them and little soot accumulation, and could be added later, though they do have the fuzzy deterioration commonly found in smoke houses.

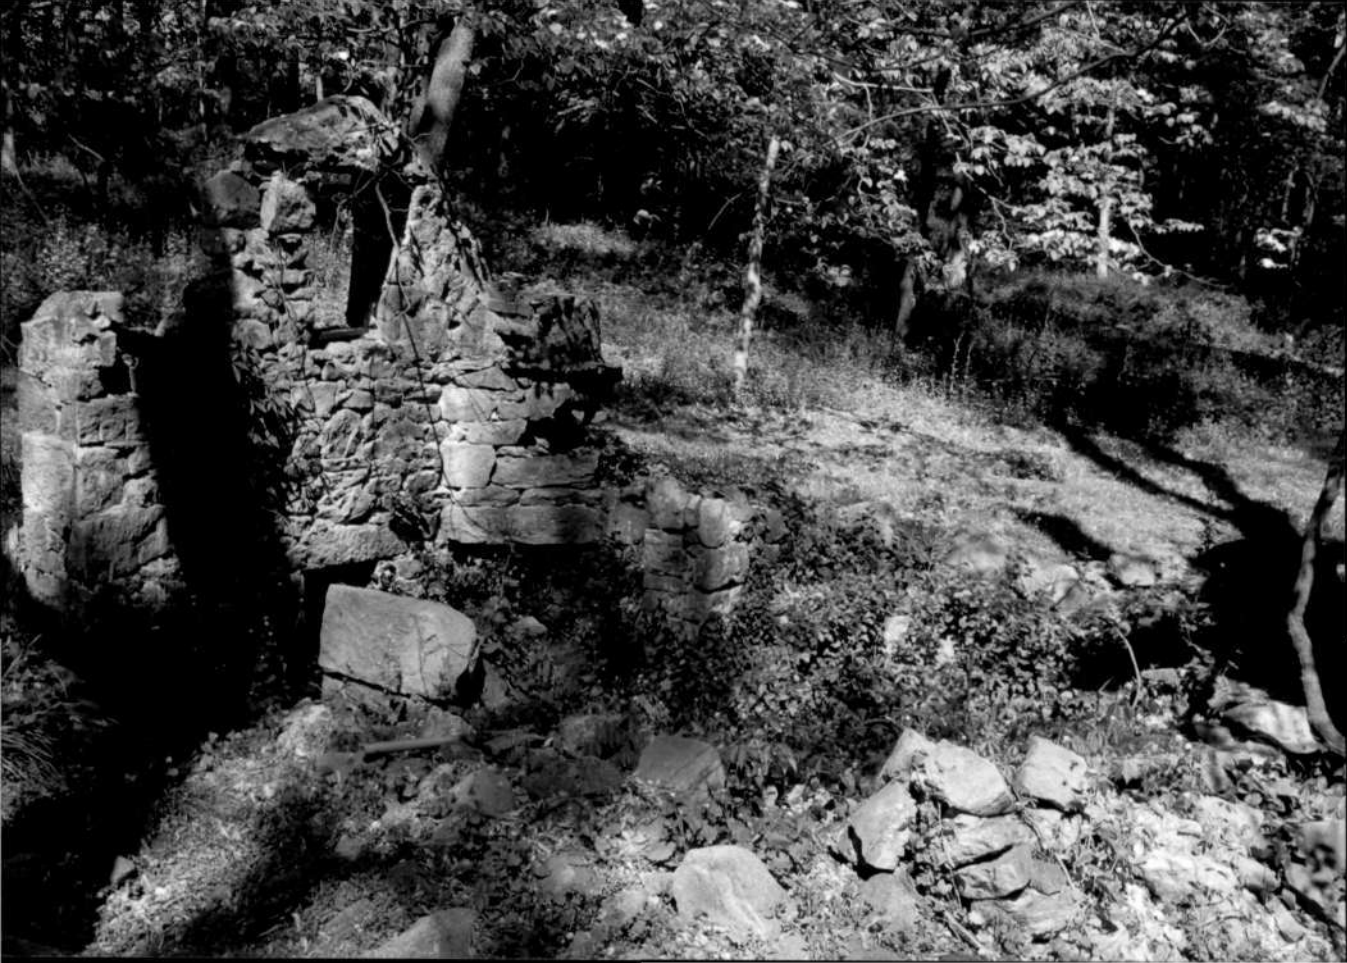
8 of 16

Springhouse, view northeast

=====  
springhouse that is now in a ruinous condition. All that remains of the springhouse is the north wall and a portion of the east wall. A single window opening pierces the north gable end wall. The springhouse is set within a low ravine.

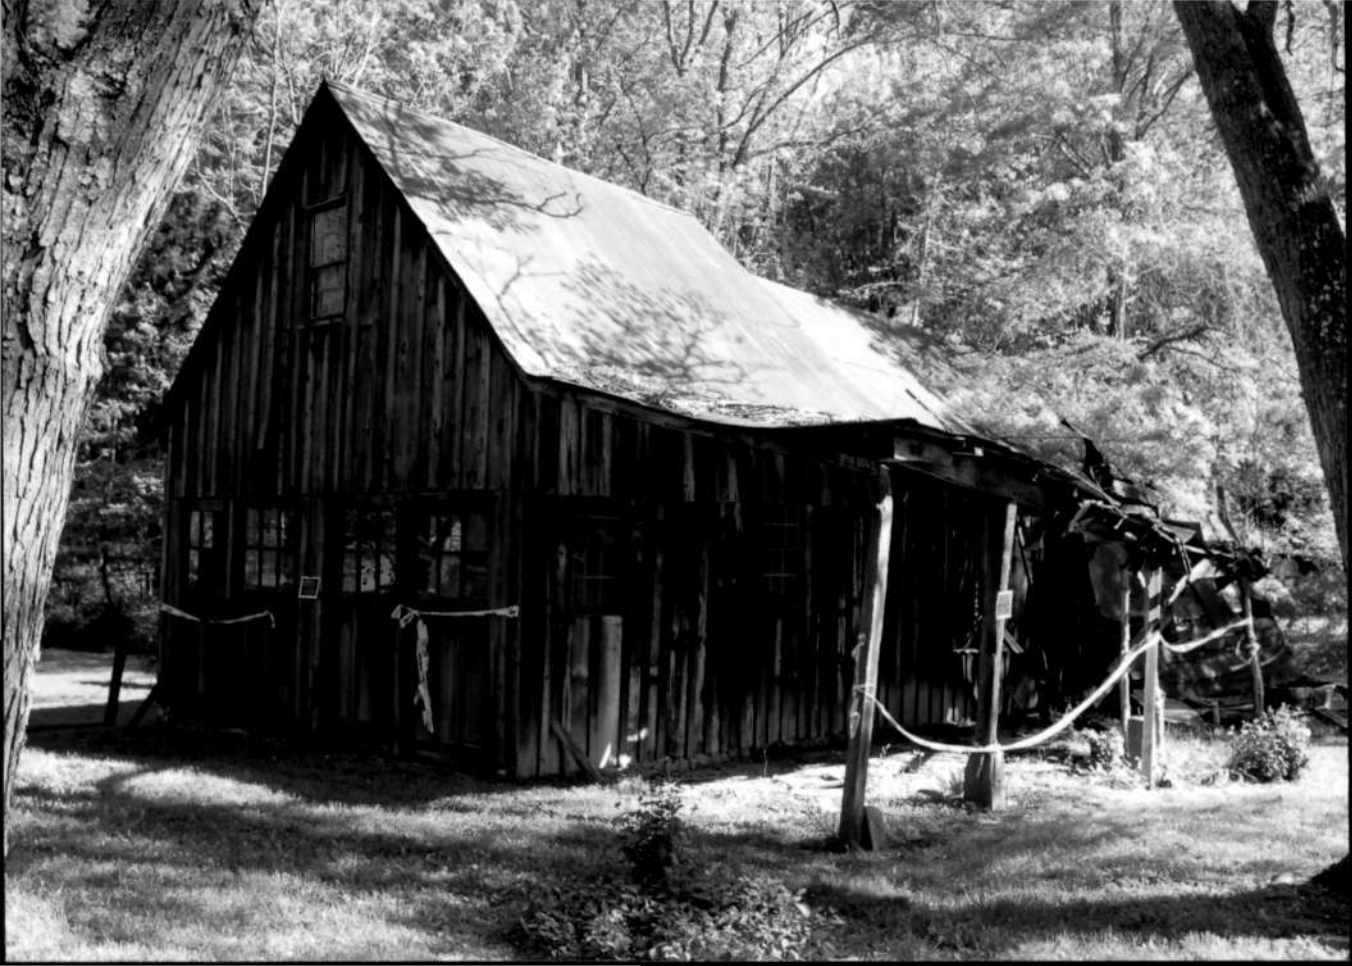
9 of 16

Blacksmith shop, north and west elevations

The blacksmith shop is located about 100 feet southwest of the house, along the road. It is built in two stages, with each stage containing a single room. Both sections of the shop are one story. The north section is two-bays by two-bays, and the south section is three-bays by one-bay. The building is set on a low rubble stone foundation and is framed with board-and-batten siding. It has a gable roof with corrugated metal, with a north-south ridge. The north section has a higher ridge and a slightly steeper pitch than the south section. There is an open shed-roofed porch on the west side, but the south half of the porch has completely collapsed.

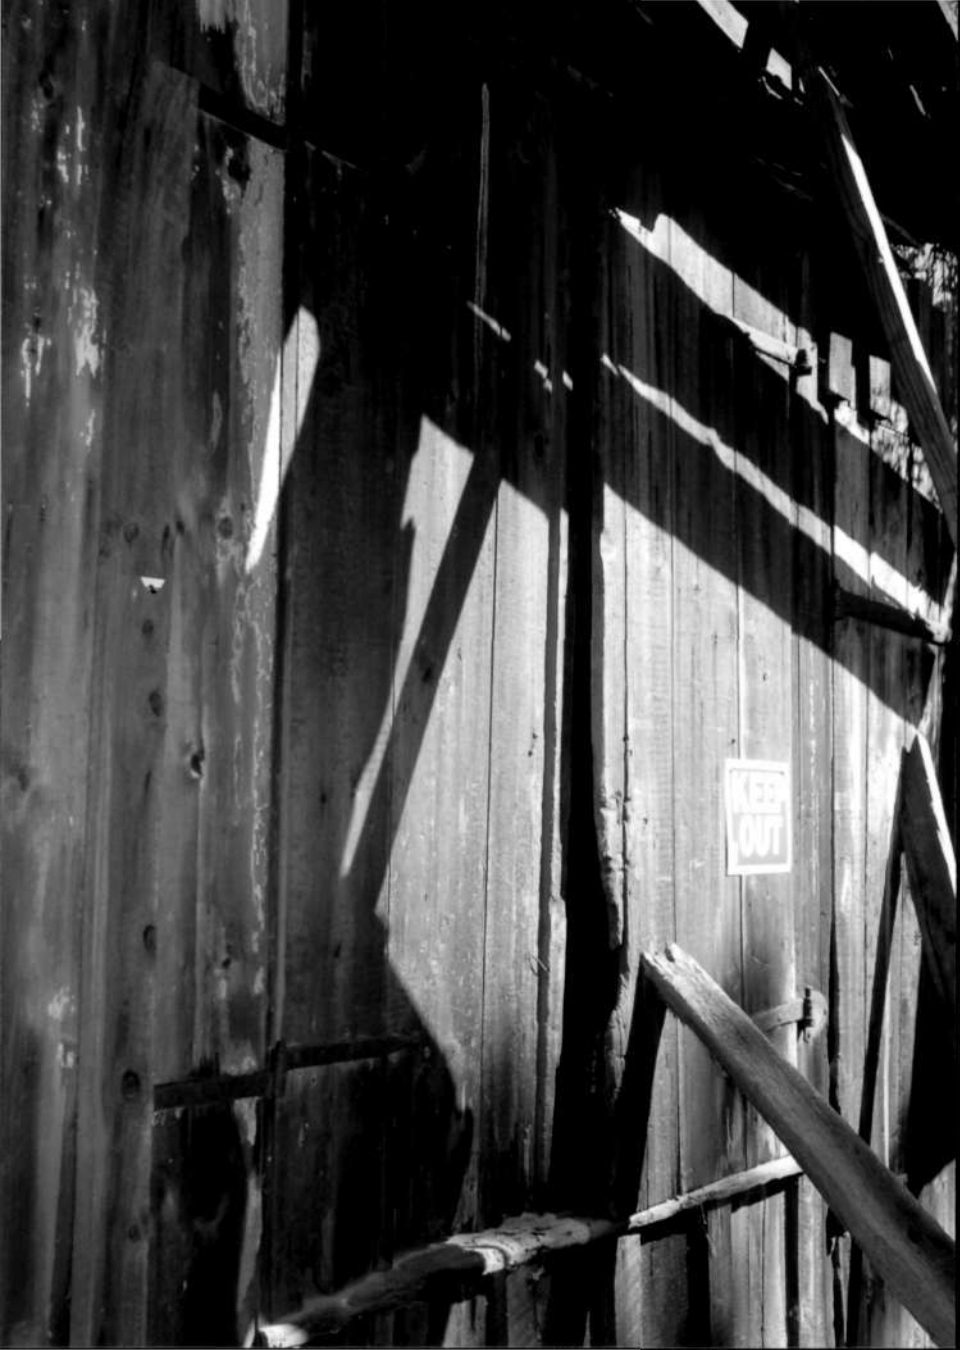
11 of 16

Blacksmith Shop, west elevation, shutters

The south end of the blacksmith shop has a dirt floor and a hewn heavy-timber frame with hewn down braces. The northwest elevation center bay has large board-and-batten double wagon doors, with a slide bolt at the top of the door that passes into the header. The north door bolt is large and old while the south door bolt has been replaced. The south door has a smaller door for people. The door header is mortised and tenoned to the posts, and these posts flanking the doorway have rings stapled to them. The west bay has a large window opening with an eighteen-light sash at the bottom and board infill at the top of the opening that replaces another eighteen-light sash. The sash has ogee muntins and 10-inch by 12-inch lights; it is mortised and tenoned and pinned at the corners. There are exterior shutters on this opening made of vertical boards with beads, and battens. The frame on the west side consists of only a 1-inch board set on top of the down brace and nailed to the end of a cut-off horizontal member. The north bay window opening matches the west bay but has no sash. It has exterior shutters with beaded-edge boards.

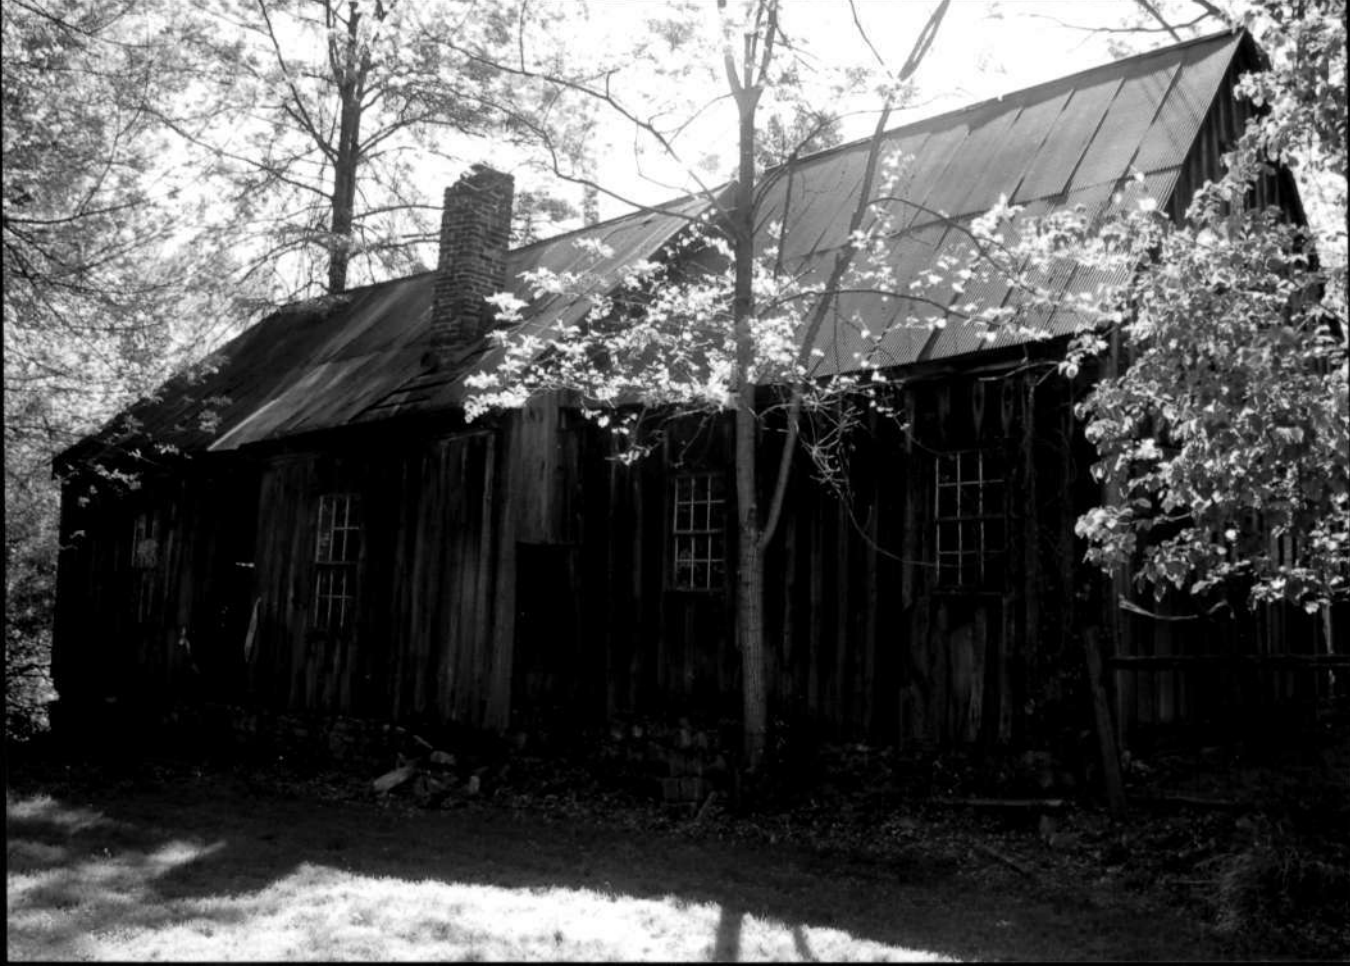
Blacksmiths shop, east elevation  
12 of 16

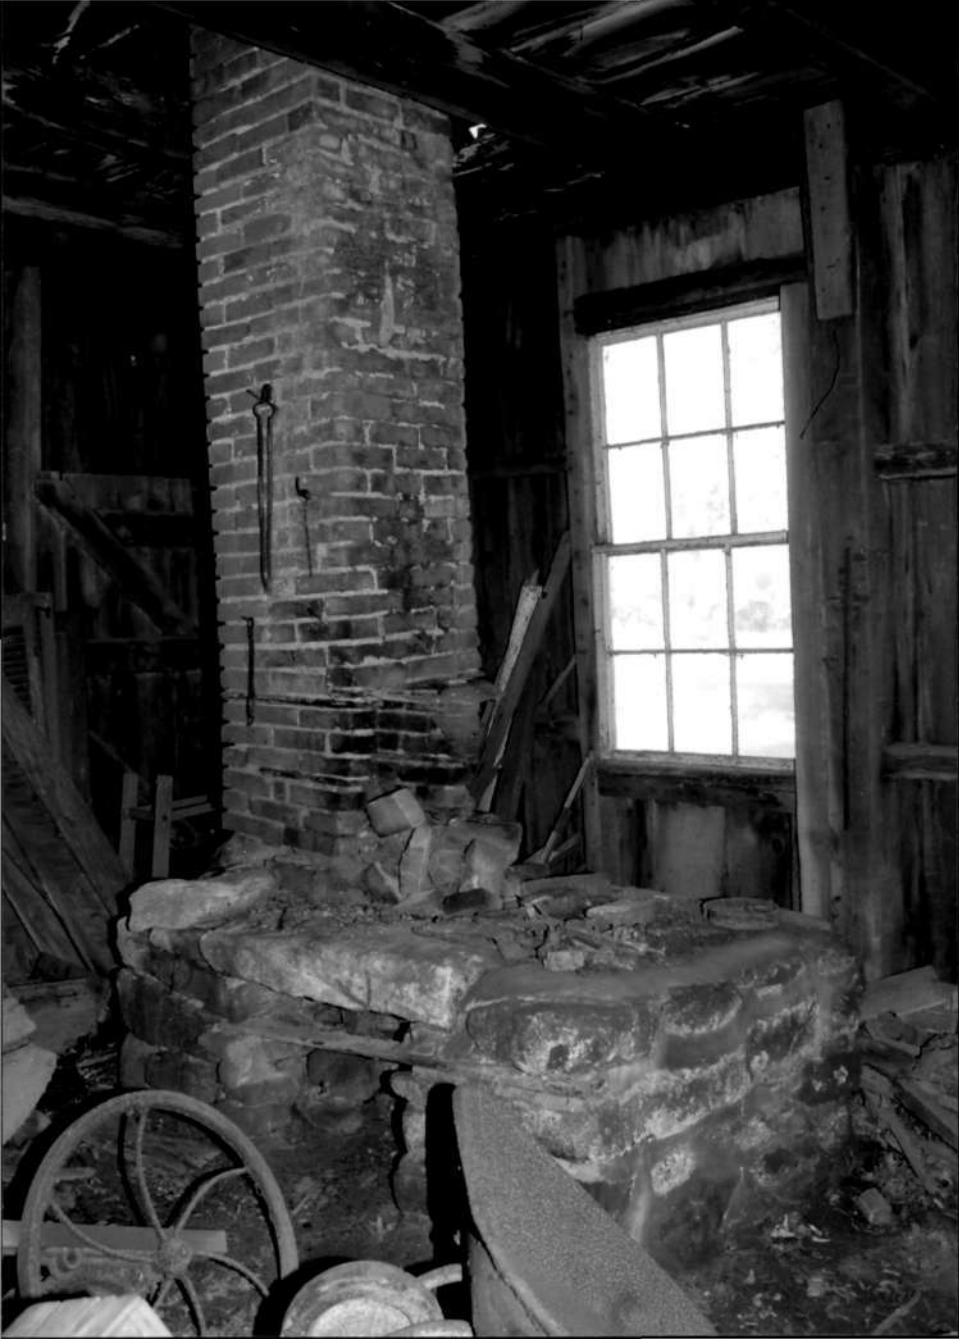
14 of 16

HD-0430  
Blacksmith shop, interior, south room,  
northeast forge

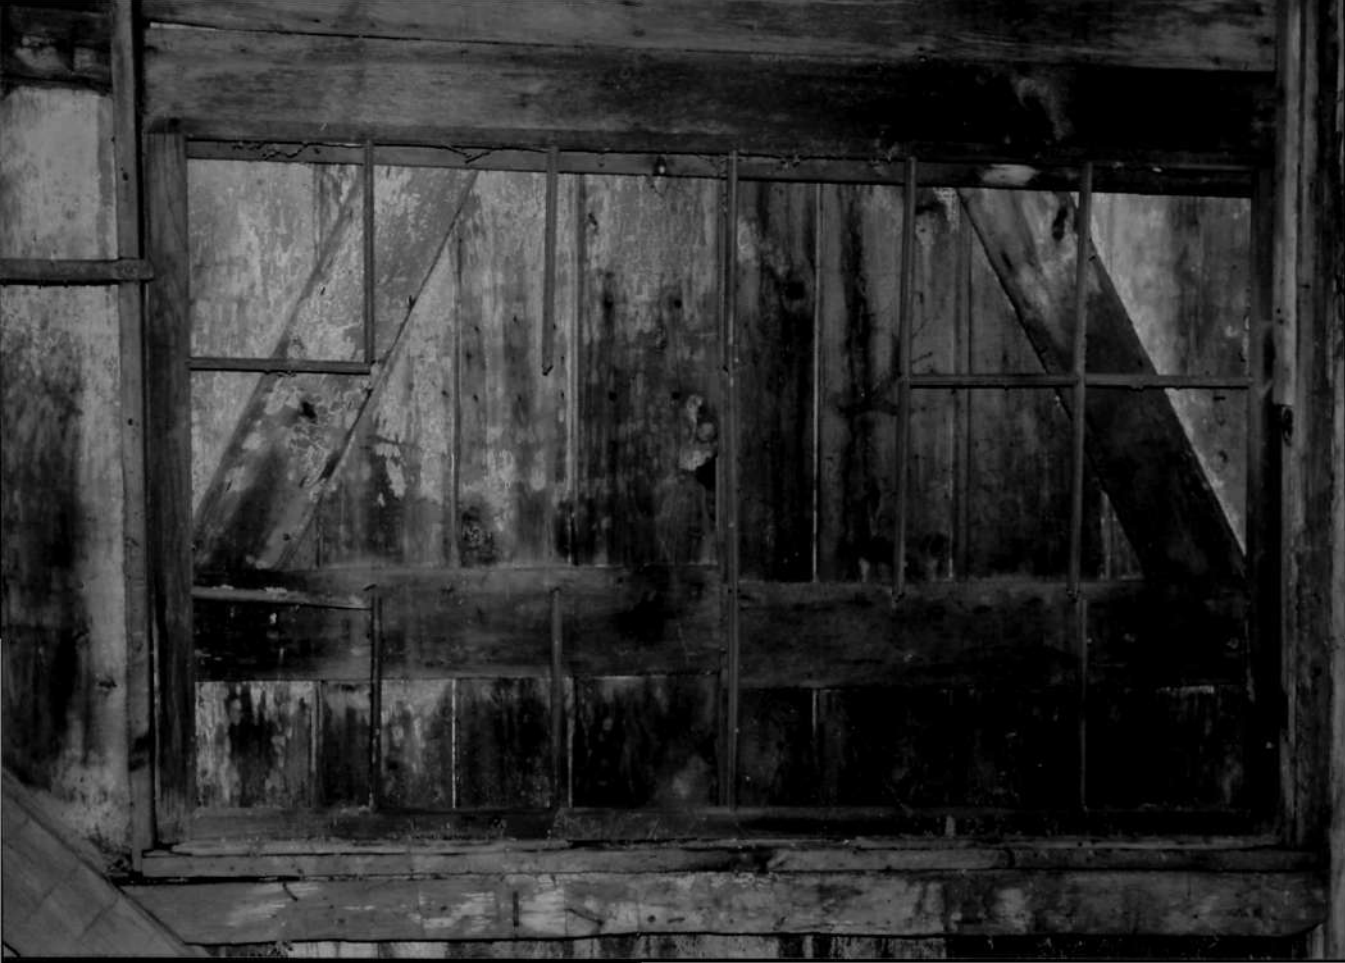
15 of 16

Blacksmith shop, interior, shop window

The southeast elevation center bay has the remains of the wide window opening with half of a header, and a rotted sill. The jambs are sash-sawn with some cut nails and some wire nails, and several stops survive. The window opening is potentially original, but is much deteriorated. The east and south bays each have an added six-over-six sash with sash-sawn framing and cut nails; these appear to be an early addition. The sash have beveled muntins that are narrow but deep, are mortised and tenoned and pinned at the corners, and have 10-inch by 14-inch lights.

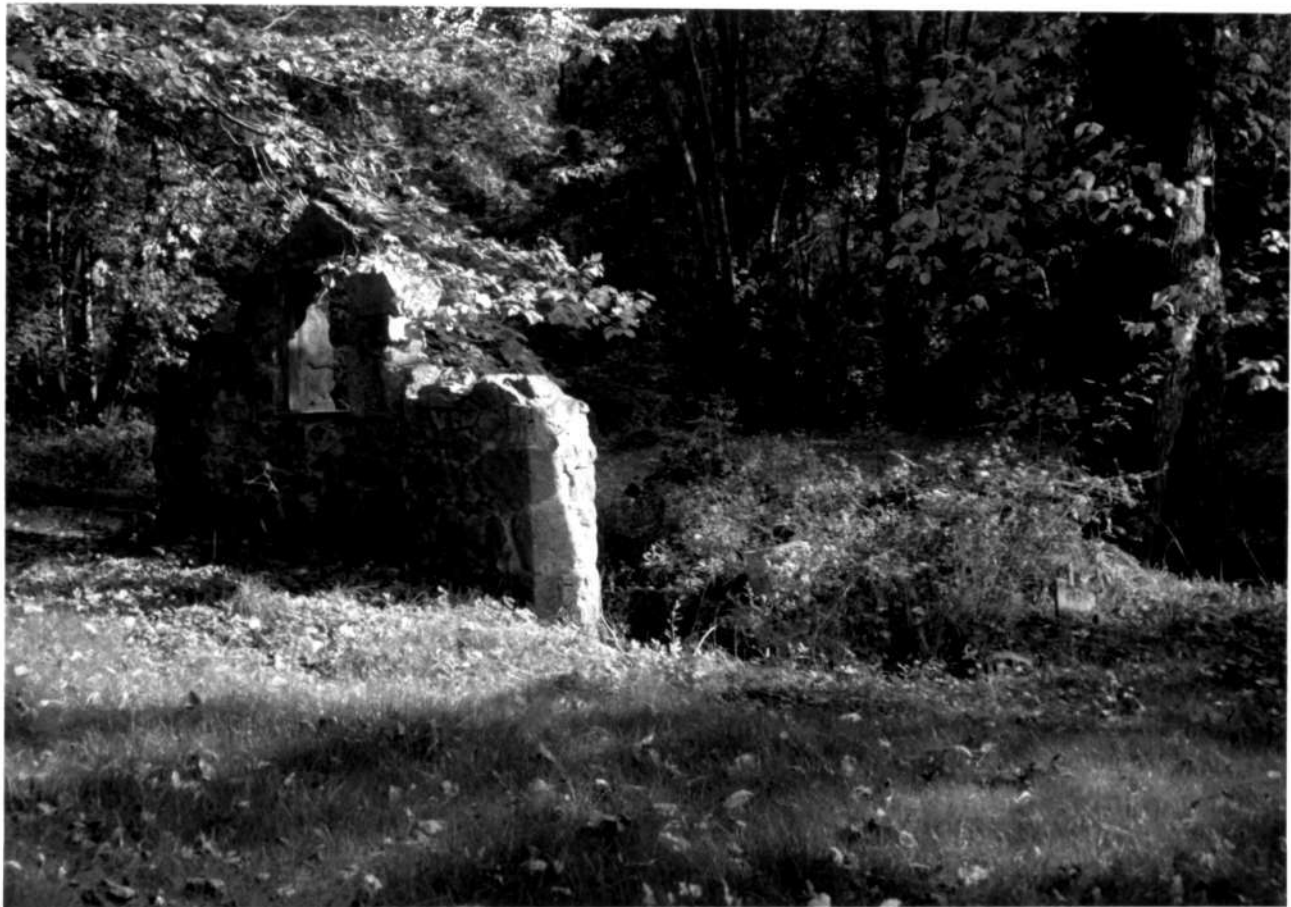
7 OF 12

Springhouse - Ruins looking South

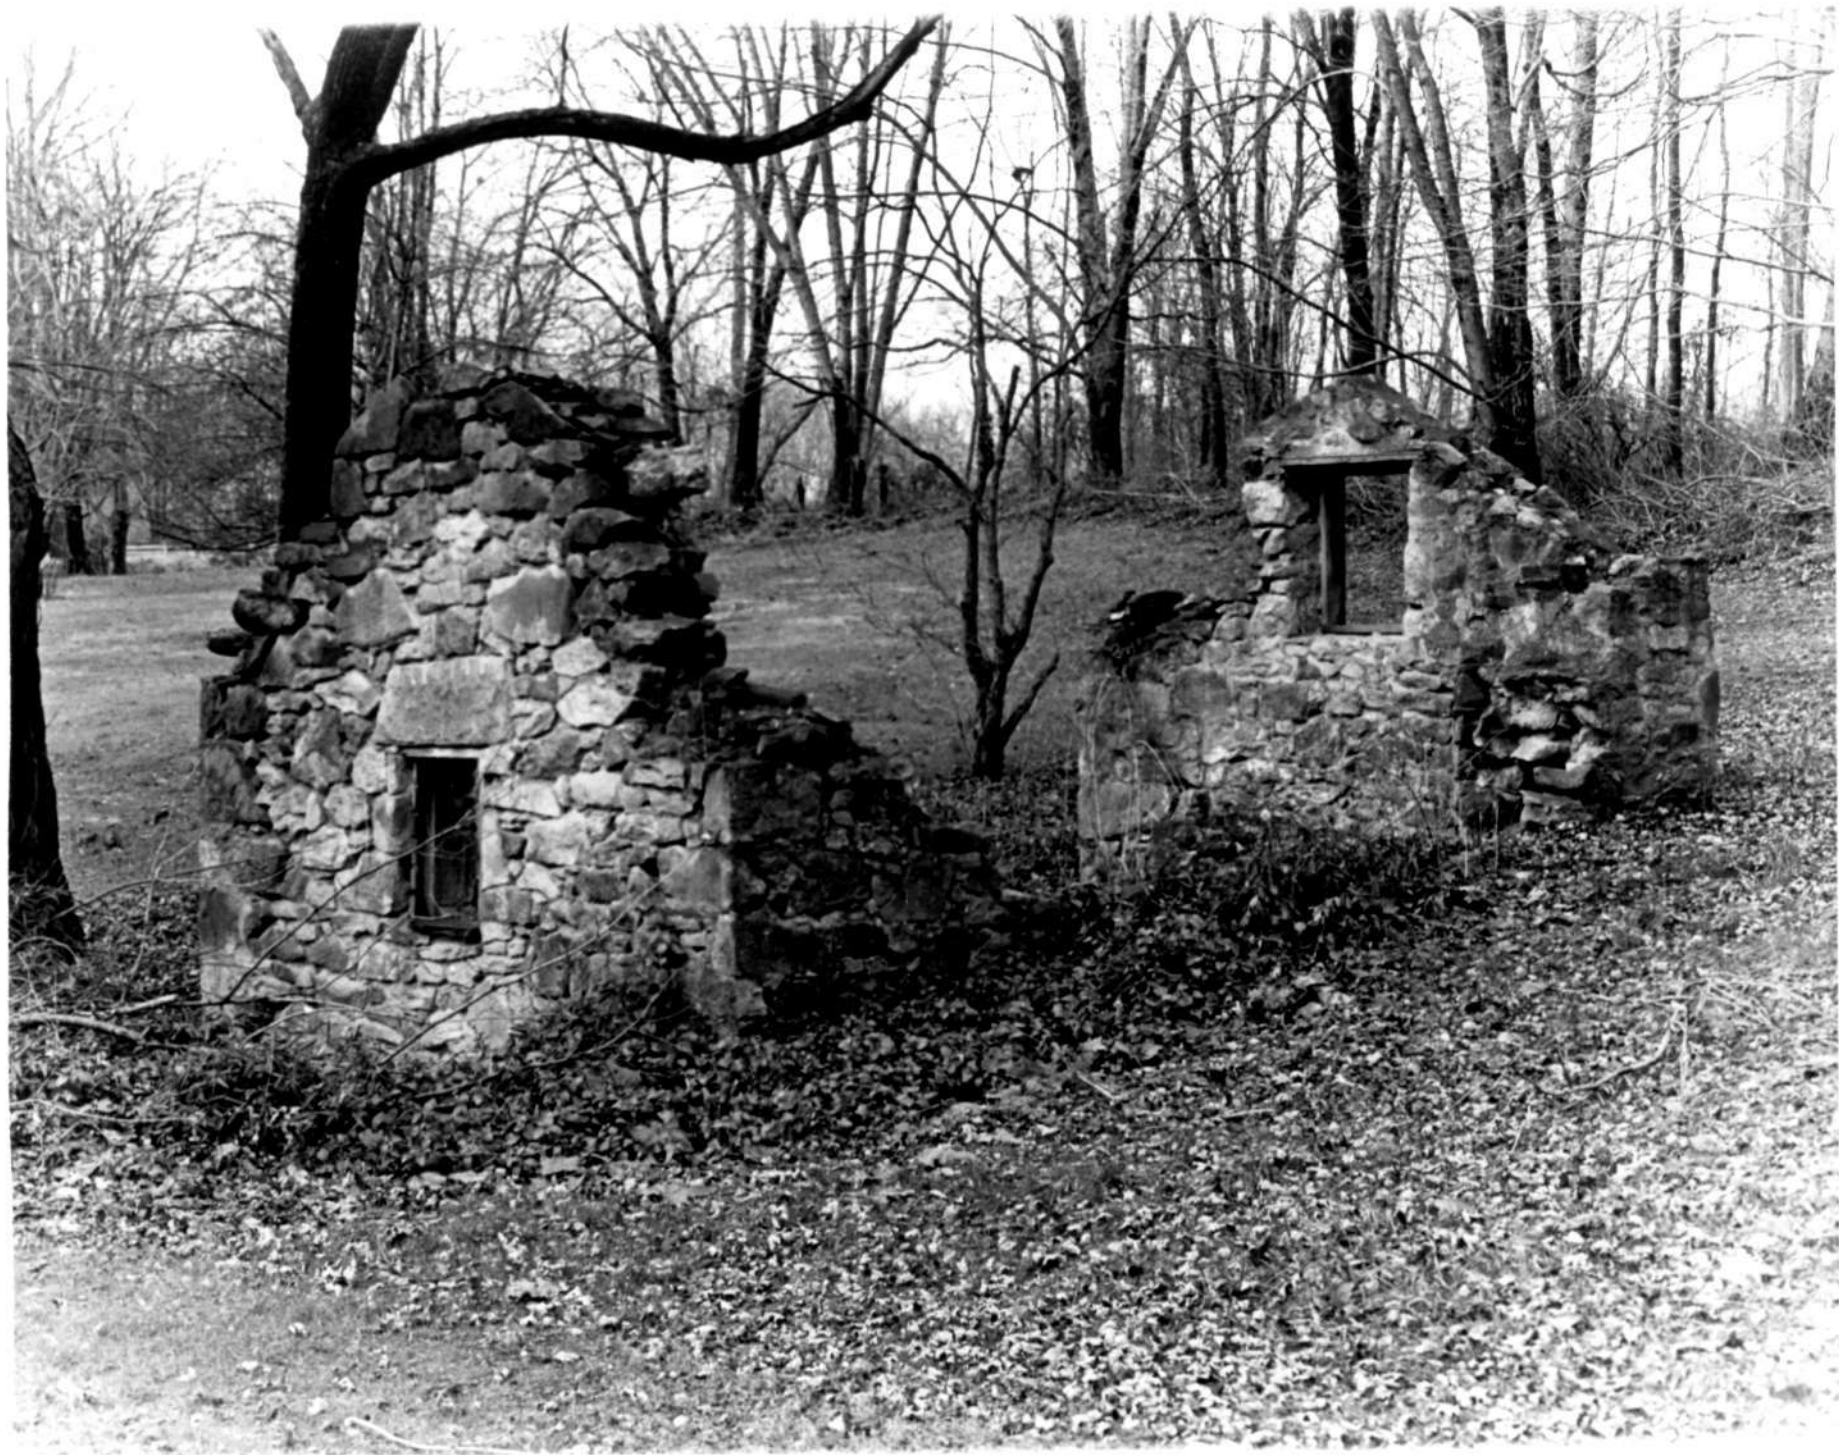
HO-430 Felicity  
Oakland Mills, Maryland  
Orlando Ridout V, Jan. 11, 1983  
Stone Springhouse ruin, from  
Southeast

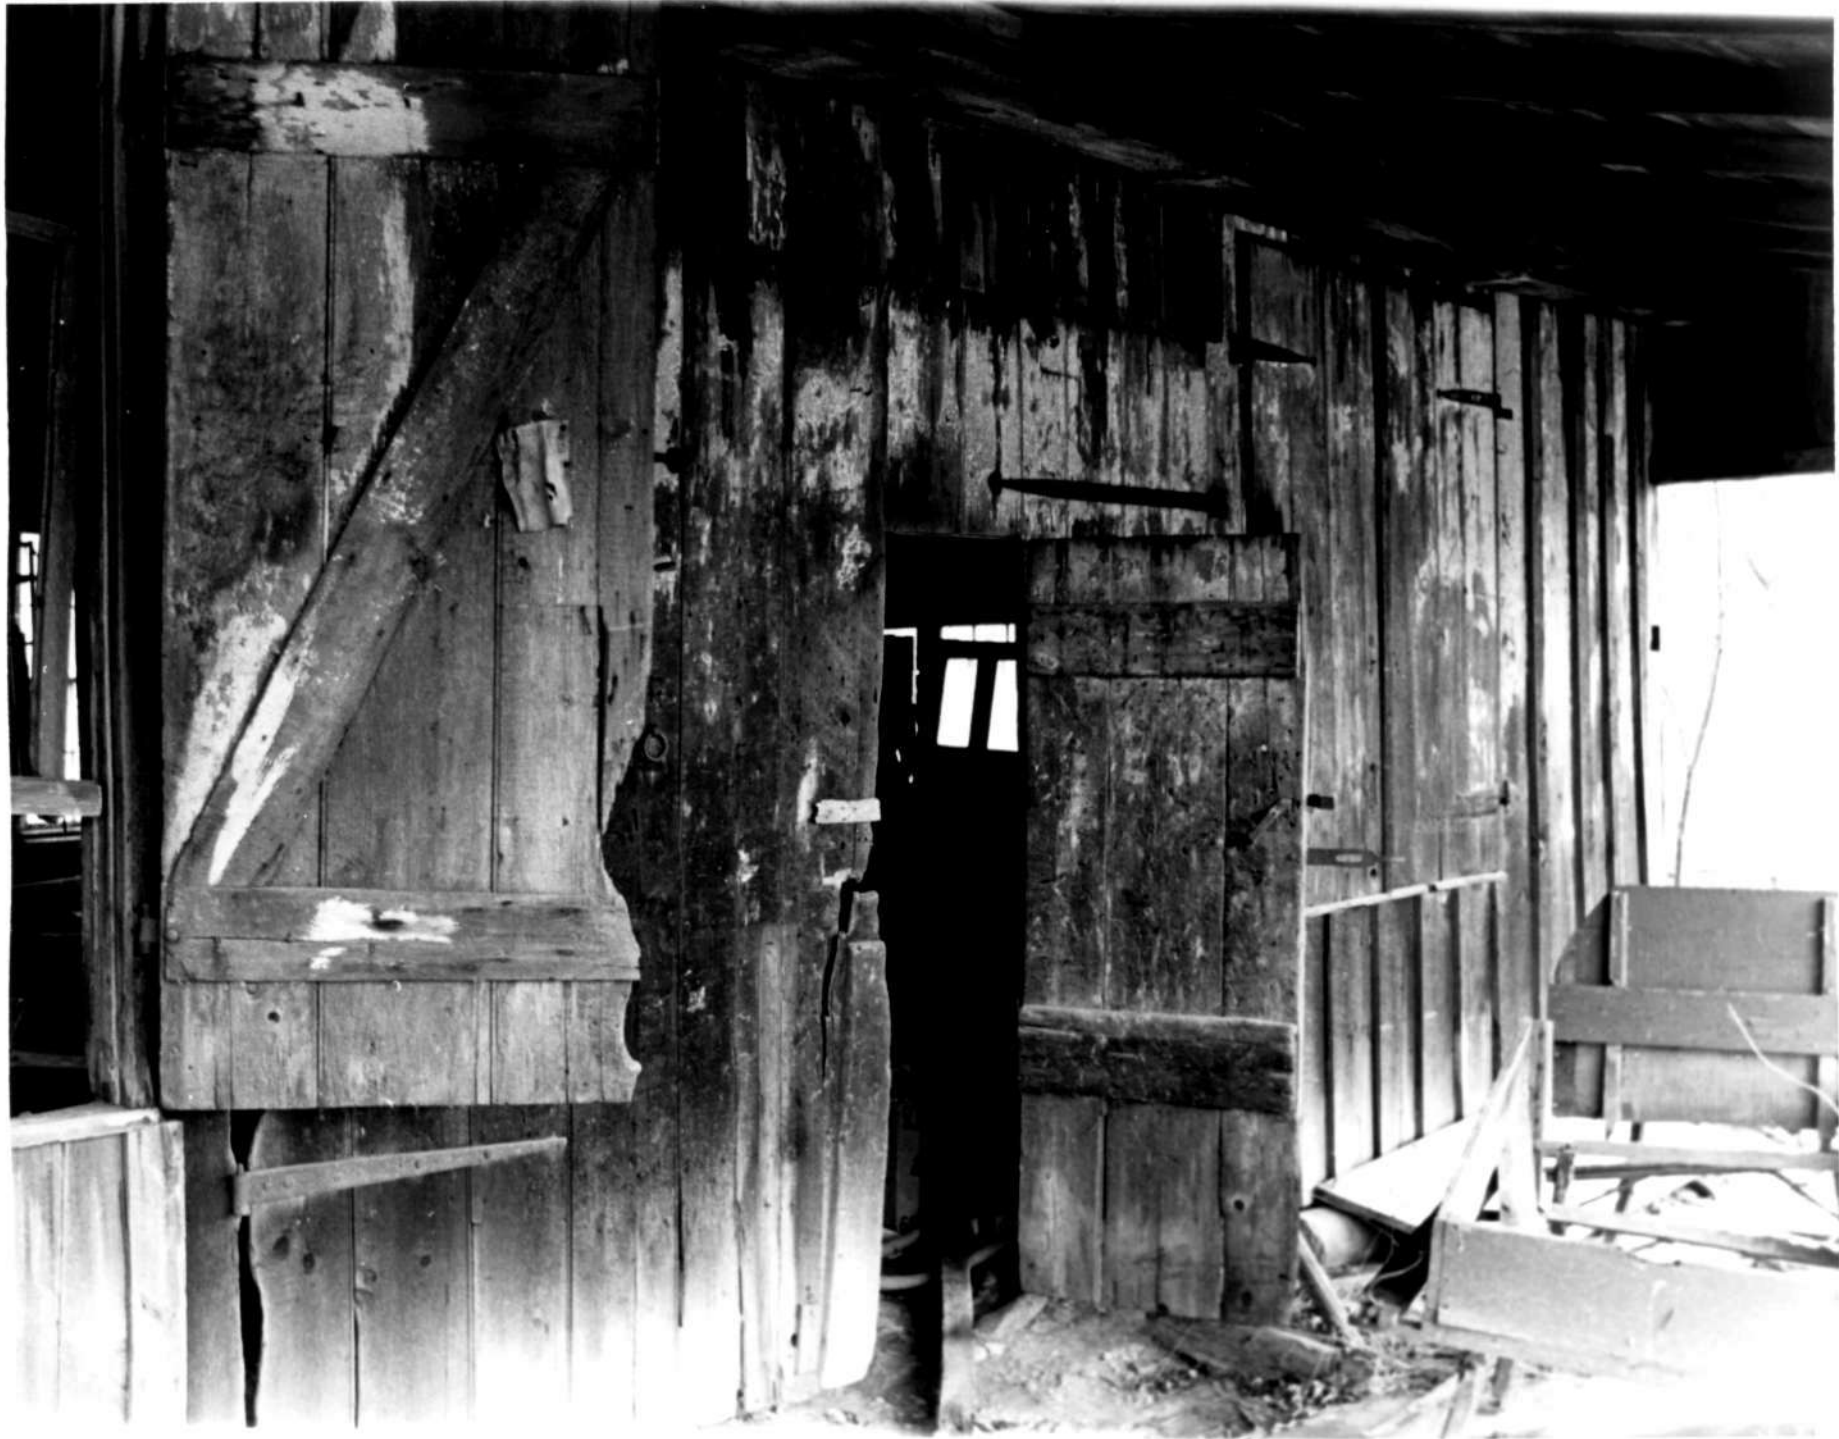
HO-430 Felicity  
Oakland Mills, Maryland  
Orlando Ridout V, Jan. 11, 1983  
Detail of double doors and  
shuttered windows in West facade,  
Period II.
