HO-430

## Felicity II (Oakland Mills Blacksmith House and Shop)

### **Architectural Survey File**

National Register of Historic Places  
Registration Form

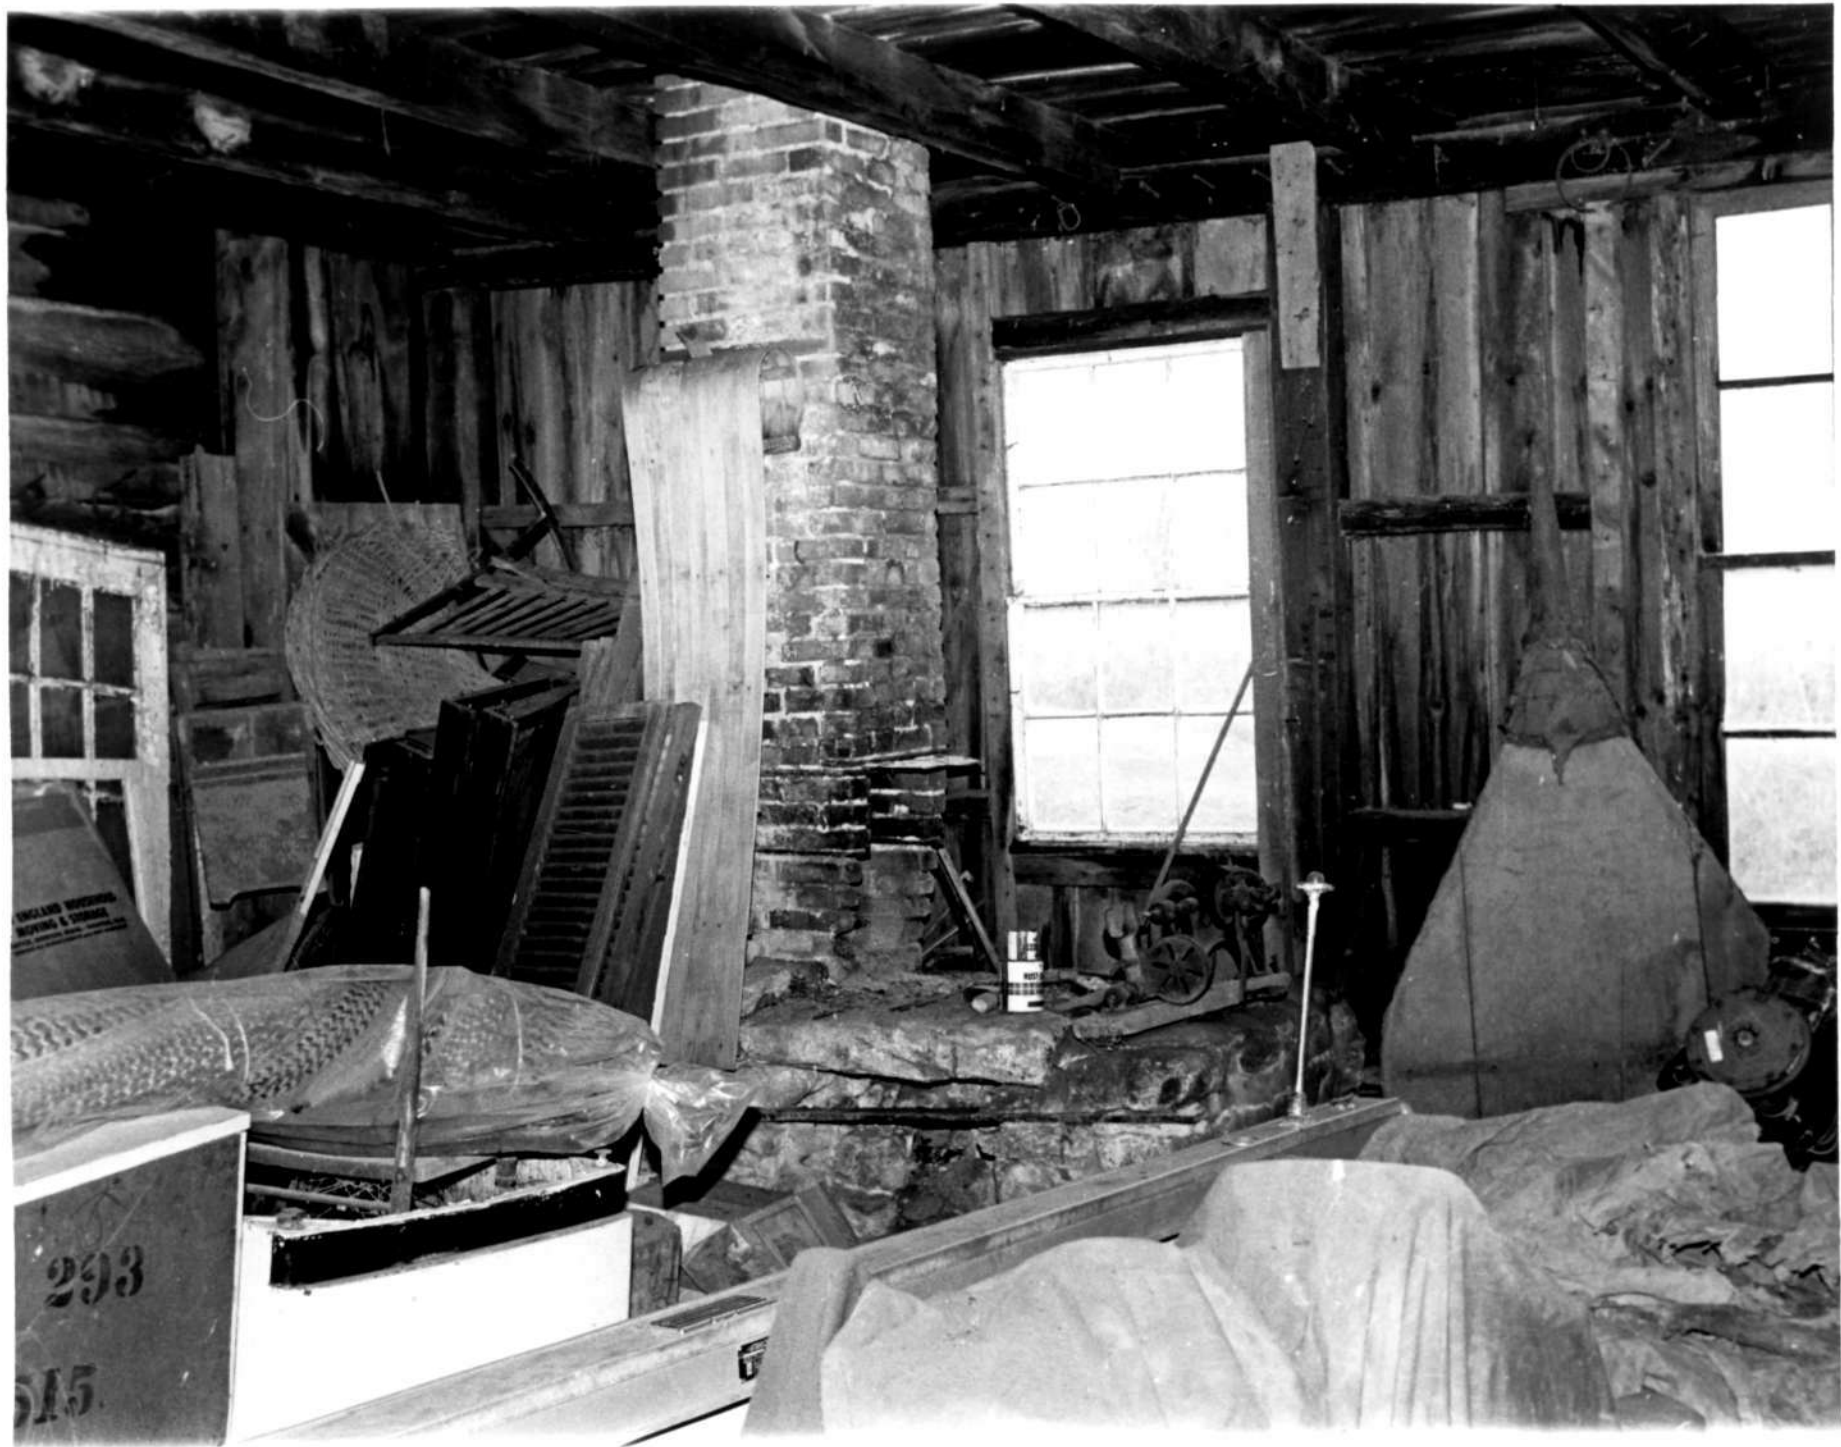
HO-430 Felicity  
Oakland Mills, Maryland  
Orlando Ridout V, Jan. 11, 1983  
Interior view facing East with one  
of two forges visible. Bellows to  
right is not original to this  
building.

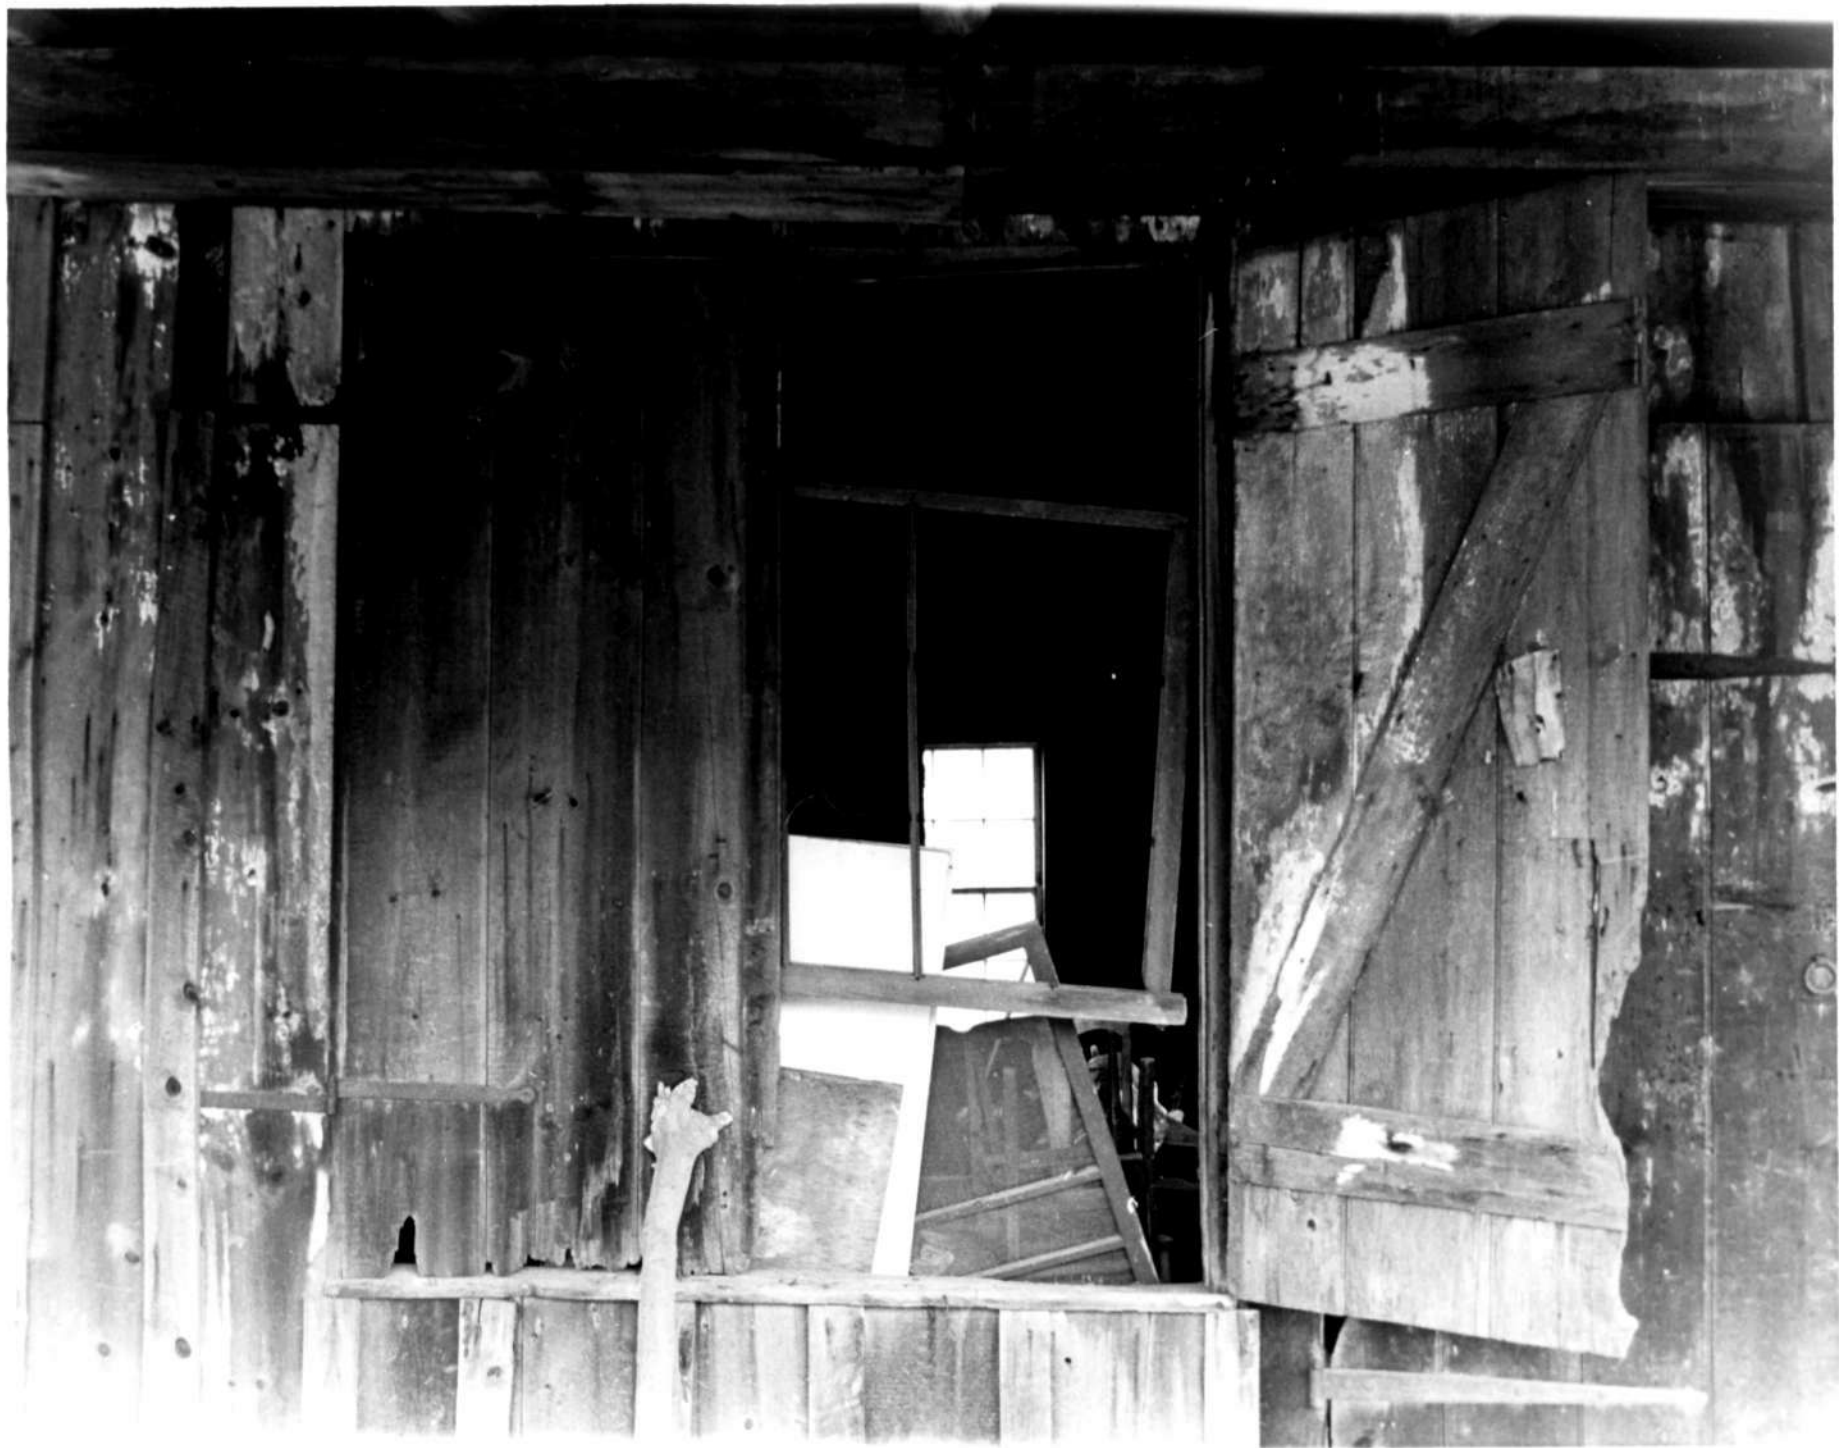
HO-430 Felicity  
Oakland Mills, Maryland  
Orlando Ridout V, Jan. 11, 1983  
Detail of shuttered 18/18 sash  
window in West facade, Period II.
