HO-570

Linnwood (Samuel F. Cobb House)

Architectural Survey File

National Register of Historic Places Registration Form

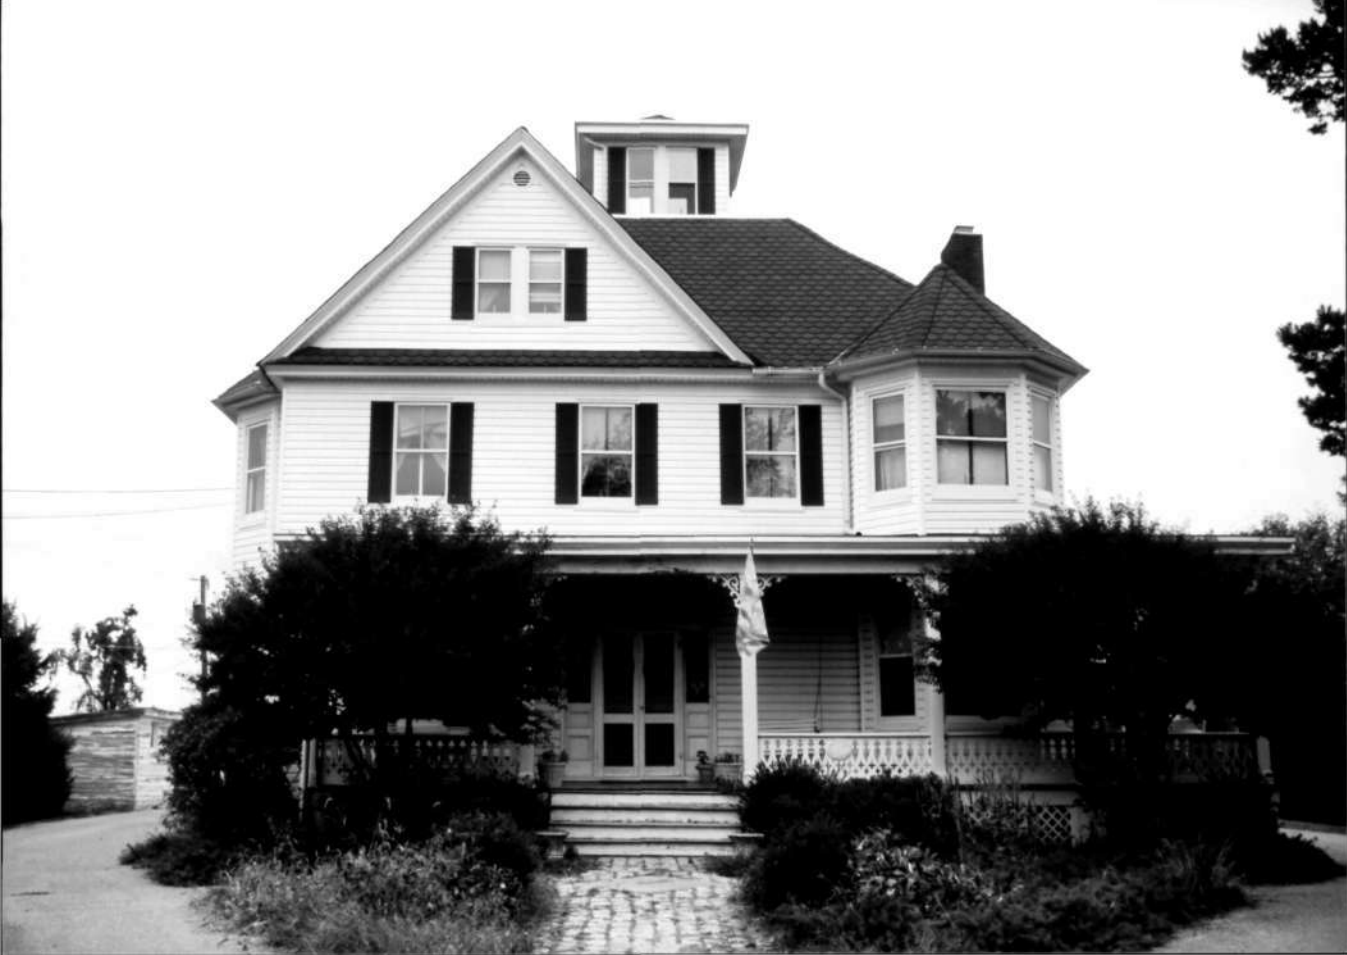
1/13

House SW elev.

The southwest elevation, on the first story, has a two-over-two sash in the west bay. There is a pair of three-panel doors, with bolection mouldings and the small panels in the center, in the west-center bay. There are sidelights with two stained glass lights over two bolection-moulded panels, and a transom with four stained glass lights. The jambs are chamfered, with run-on stops. There is nothing in the south-center bay, and the south bay has a three-sided bay window with a two-over-two sash flanked by a one-over-one on each side. There is a one-story porch that wraps around the southeast. It has six large square posts with rounded-off corners and a torus above an ogee creating a rudimentary capital. There are jig-sawn brackets, a plain frieze, and a box cornice with an ogee. The balusters are also jig-sawn. The second story has three two-over-two sash and a bay window that matches the first story. There is a gabled wall dormer with paired one-over-one sash that spans 2 ½ bays, and a turret roof on the south-bay window.

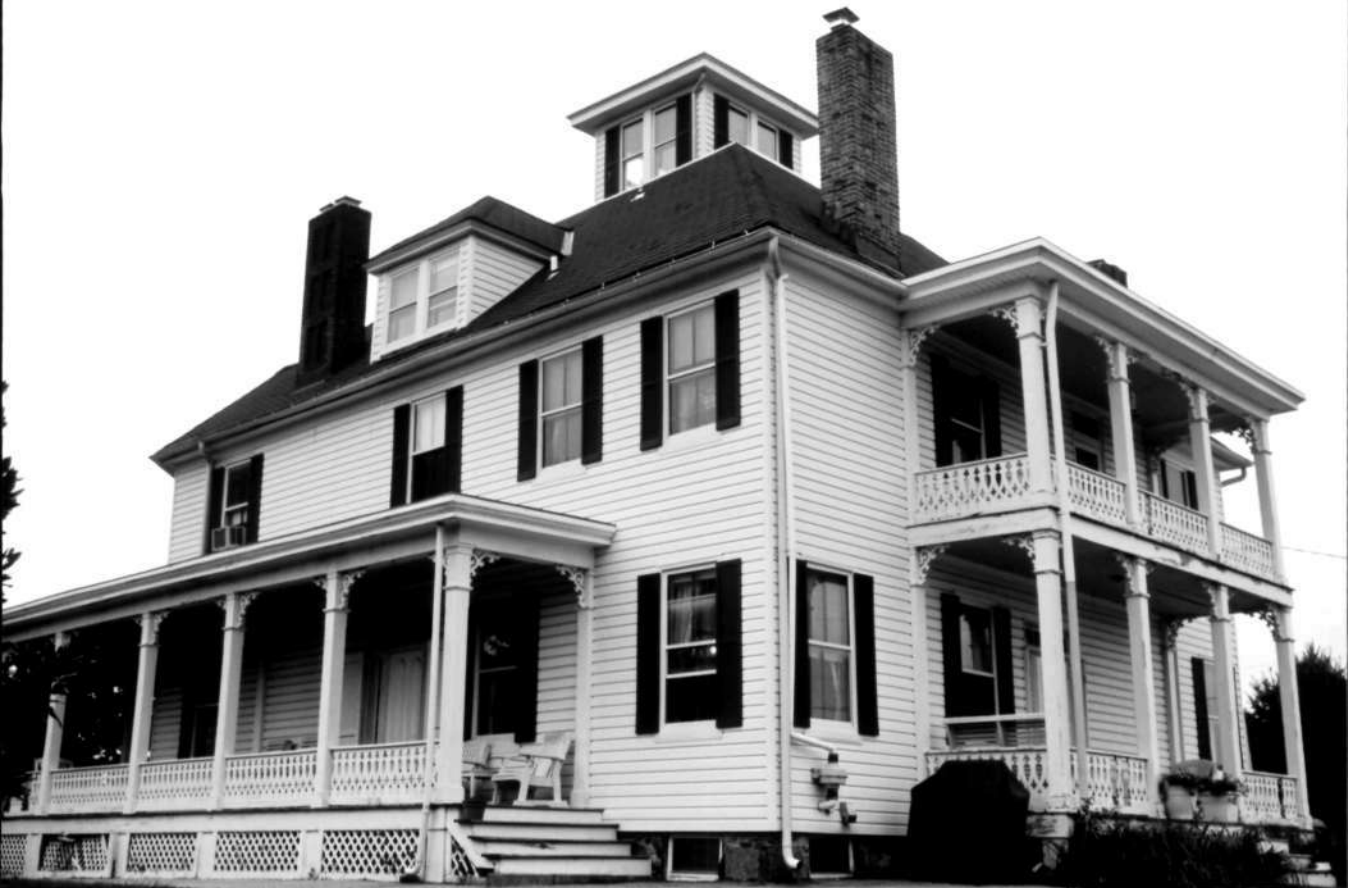
2/13

House - SE & NE e Lewis

On the southeast elevation, the first story has a two-over-two sash in the south bay. There is a four-panel door in the south-center bay that has round-arched top panels and bolection mouldings, and sidelights with three lights over one panel that has sunken fields and quirked Greek-ovolo-and-bead panel moulds. The jambs are chamfered, with lamb's-tongue stops, and there is a transom with three lights of frosted glass. The east-center and east bays each have a two-over-two sash. The porch stops short of the east bay. The second story has four two-over-two sash. There is a hip-roof dormer with a pair of one-over-one sash over the south-center bay, and a paneled interior brick chimney to the south of it.

The northeast elevation has a two-over-two sash in the east and east-center bays of the first story. The north-center bay has a four-panel door with square panels that have bolection mouldings. There are sidelights with two lights over one bolection-moulded panel, and a three-light transom. The north bay has a two-over-two sash. There is a two-story porch in the center, with four posts and details that match the front porch. The second story has no opening in the east bay, and a two-over-two sash in the east-center bay. There is a four-panel door in the north-center bay, set to the north of the door below, with a two-light transom that has vestiges of painted decoration in a diamond pattern. The north bay has a two-over-two sash. There are two paneled-brick interior chimneys set even with each end of the porch.

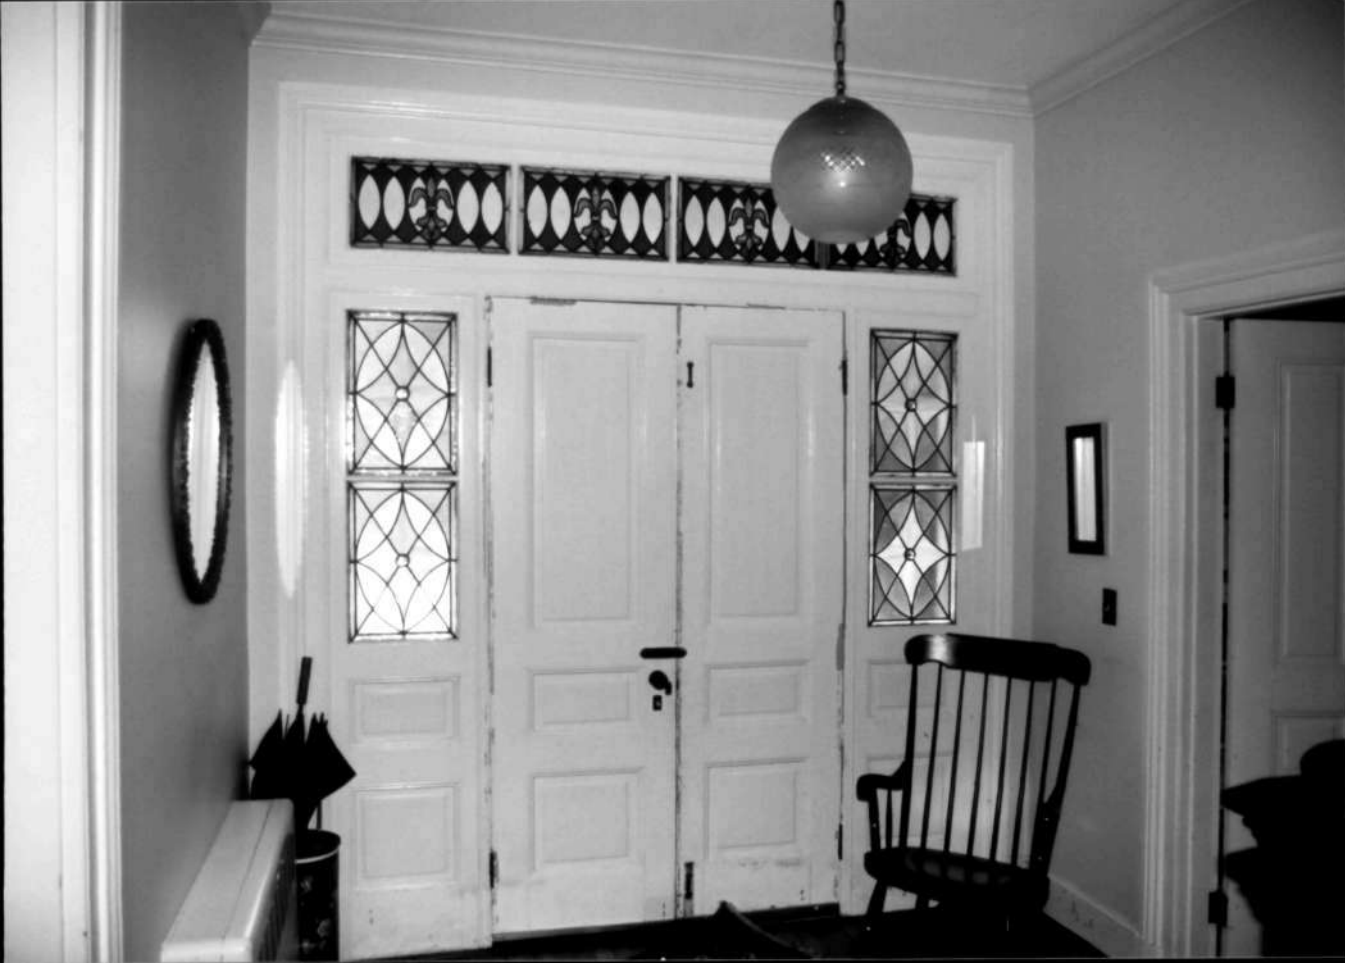
3/3

House - SW door, interior

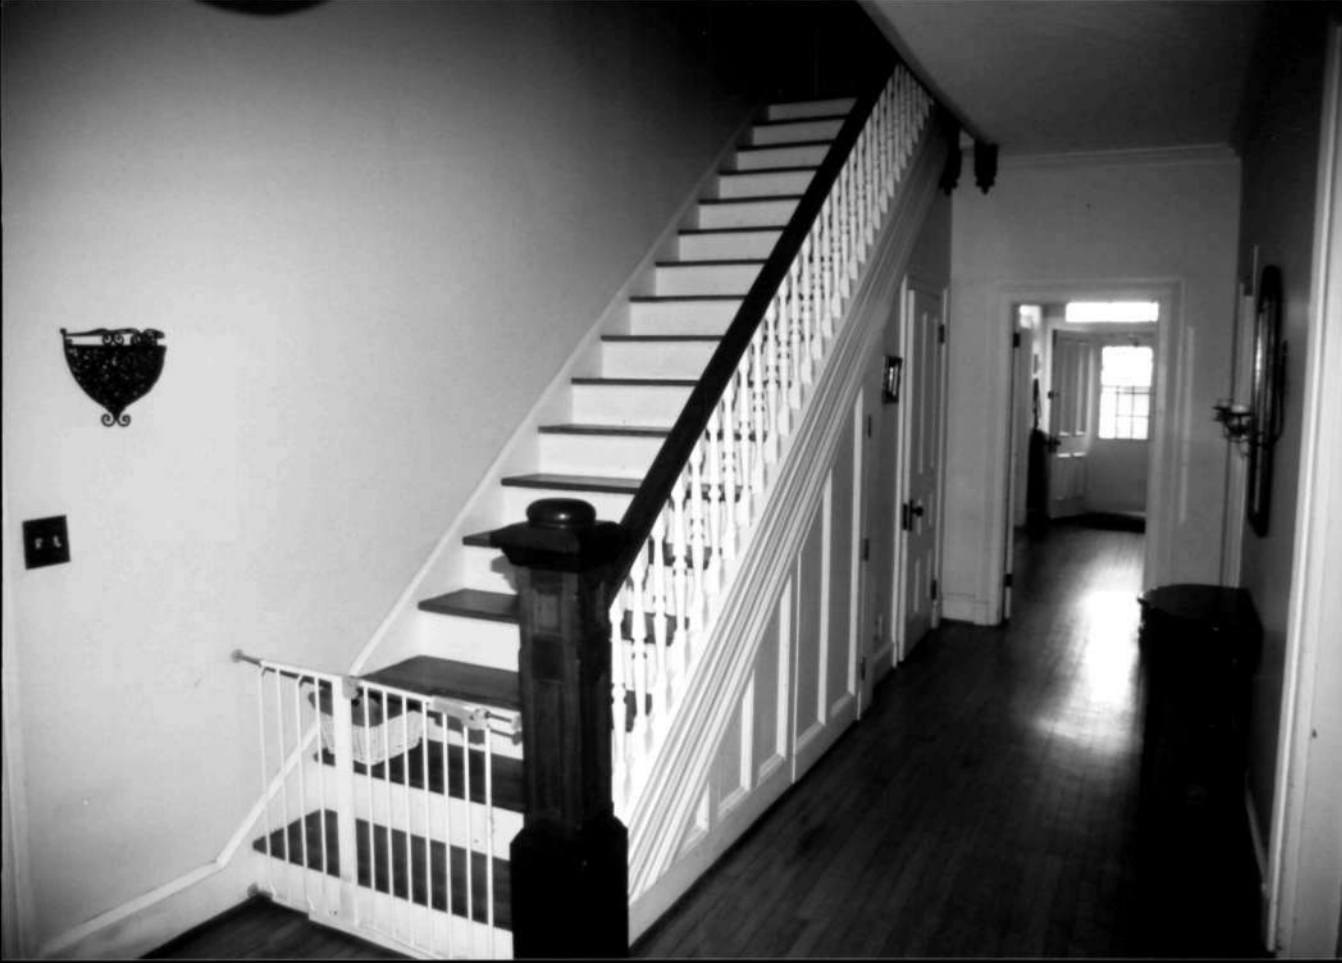
4/13

House - First story passage, view N.

The first story has a center-passage, double-pile plan with a cross-passage in the center, to the southeast, and a small room to the southwest, between the front and rear rooms. The passage has 2-¼-inch hardwood (ash?) flooring that runs southwest-northeast and is blind-nailed. The front (southwest) doorway has double doors with three panels each, having sunken fields and ogee-and-bead panel moulds. They are hung on butt hinges with ball finials, and there is a bronze foliate knob. There are sidelights of two stained glass windows above two panels that align with the door panels. The windows have a facet-cut roundel in the center with a light pink diamond surrounding it, a pale yellow oval surrounding that, dark yellow glass in the spandrels, and blue-green margins. The transom has four stained glass lights with a fleur de lis in blue and dark pink flanked by lozenge-shaped white glass, with

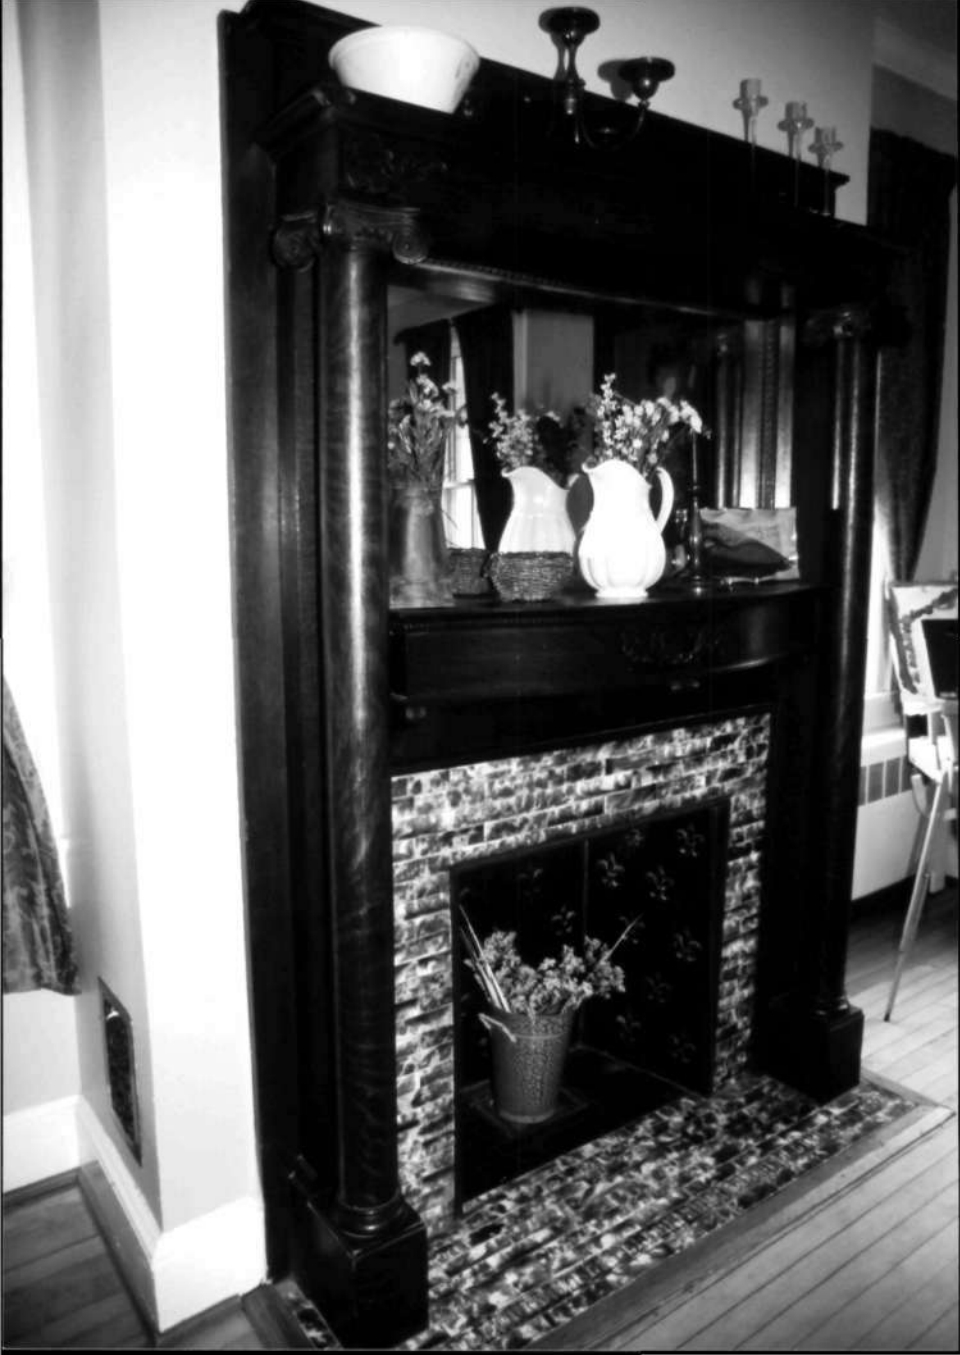
9/13

House - E. Rm. mantel

The east chamber has typical flooring that runs northwest-southeast, and typical baseboard and architrave. There is a fireplace centered on the northeast, with iron jambs in a basket weave pattern, rose tile hearth and surround, and a band of moulded tile with ovals on the hearth. The oak mantel has two scroll brackets that support a mantel shelf with an ogee on the edge. The oak overmantel has columns that are missing their capitals. These support a shelf with an ogee on the edge, and there is a beveled glass mirror with egg and dart moulding. To the east is a built-in closet with two two-panel doors that have sunken fields and no panel moulds. The bottom panels are very tall.

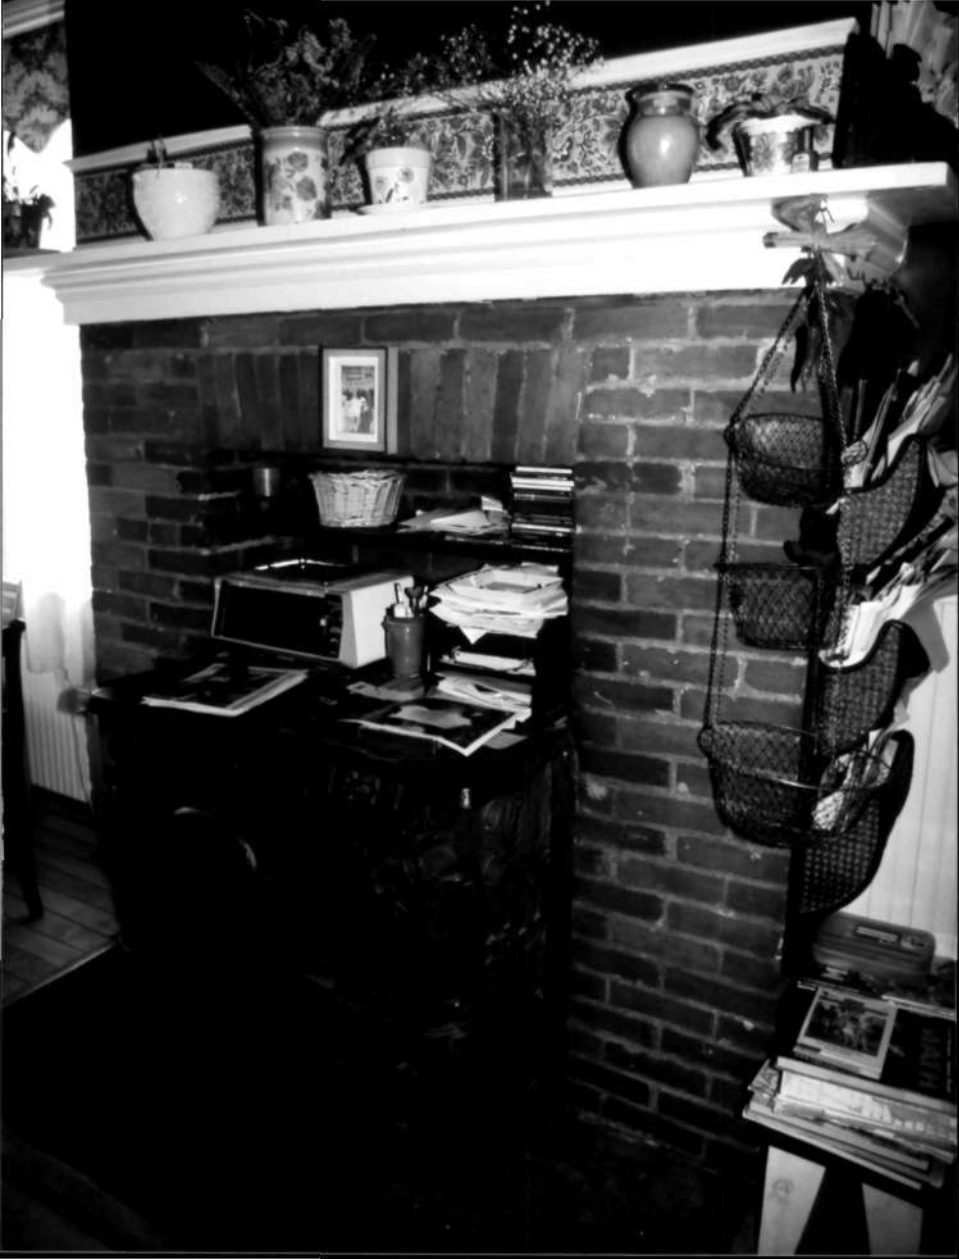
10/13

House - kitchen range

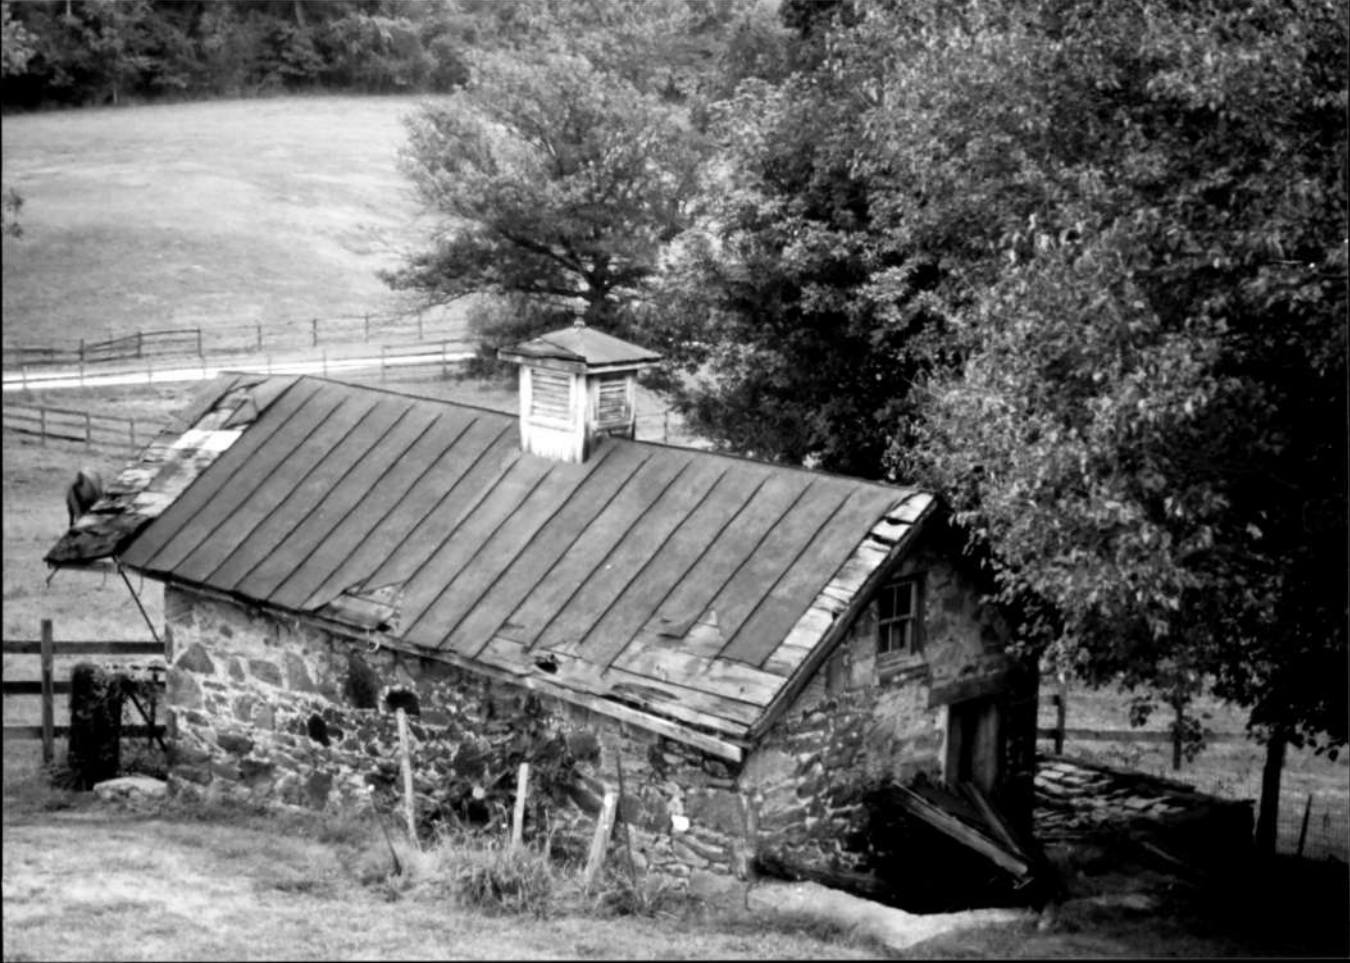
12/13

Springhouse / Greenhouse, NW & SW elevs

installed in mid-September, when Cobb could write that the building was all done "except a coat or two of paint, which we will apply next month when the flies and nats [sic] are gone." The diary never explains where the greenhouse was, but the remains of it exist. The stone building that was apparently originally a springhouse had the southeast wall of both rooms opened up and a foundation survives to the southeast, with the iron rods and wheel used to open the ventilators still hanging from the side of the stone building. Local lore calls this the greenhouse, and the physical evidence corroborates it.¹⁹

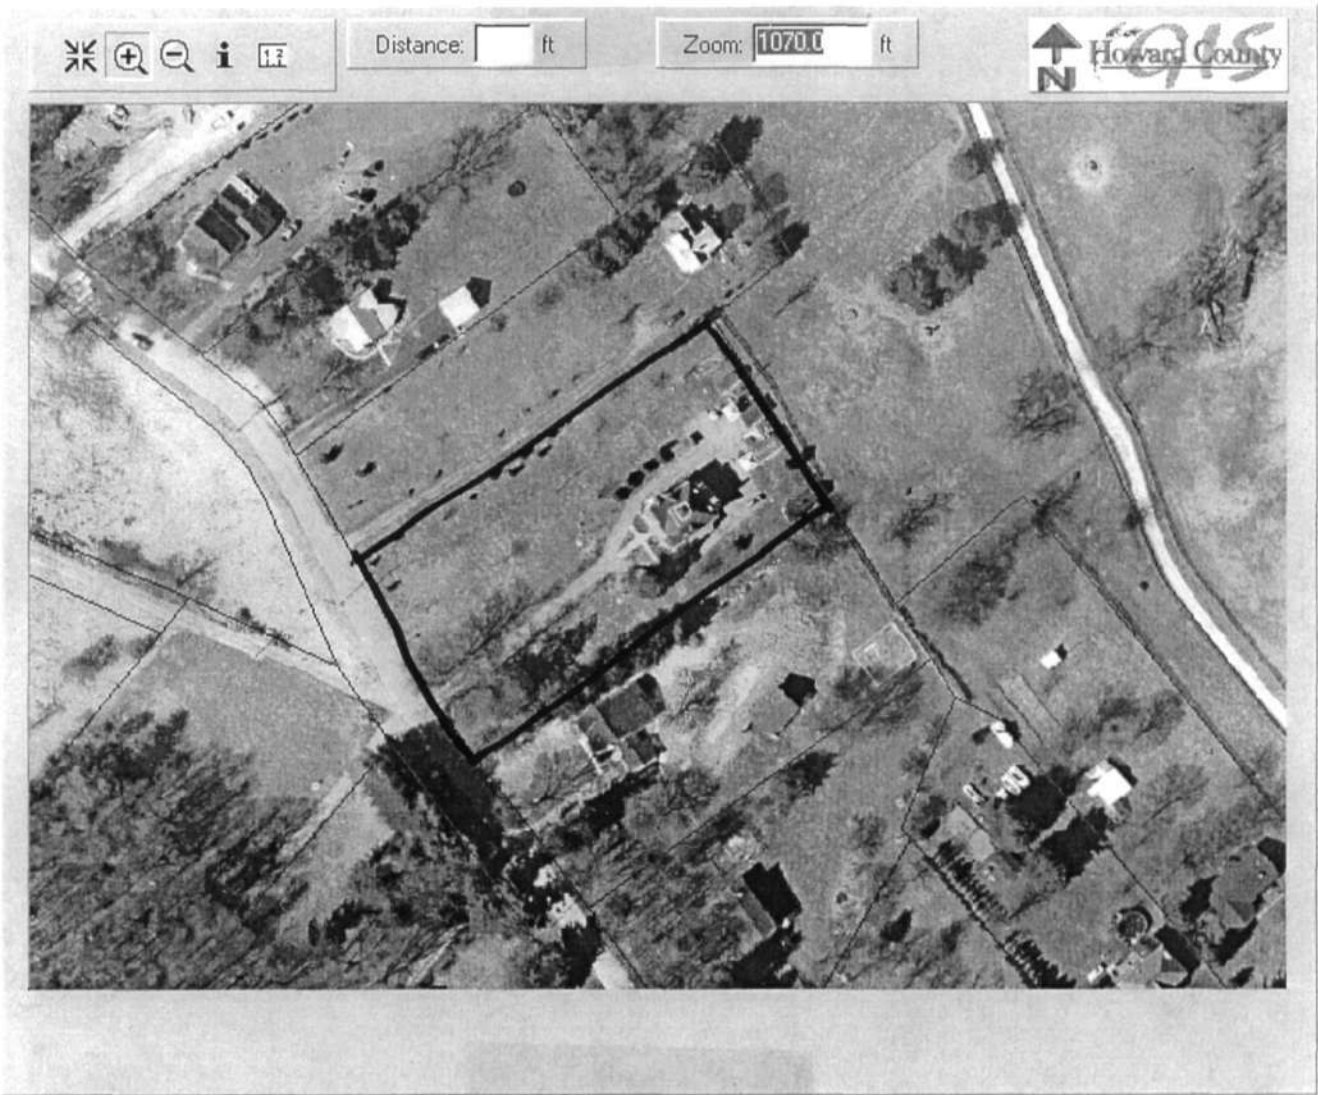
Linnwood (HO-570)
2327 Daniels Road, Ellicott City
Howard County
Site plan/Aerial photo

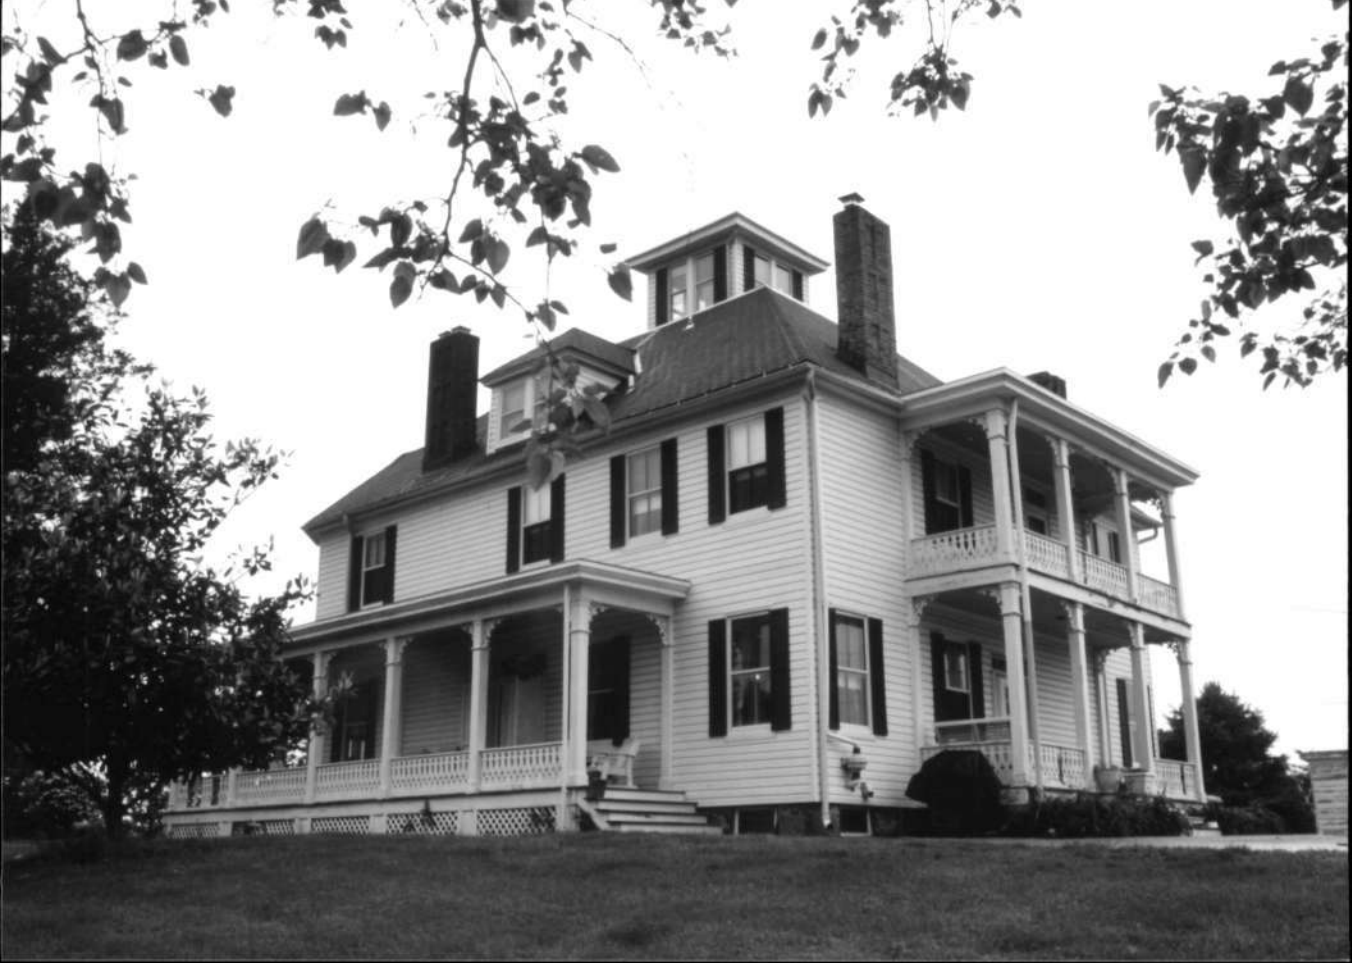
40619

View northwest. Shows side + rear facades
