HO-571

Marlow Family Farm House  
12975 Hall Shop Road  
Public

## Maryland Inventory of Historic Properties Form

historic Marlow Family Farm House

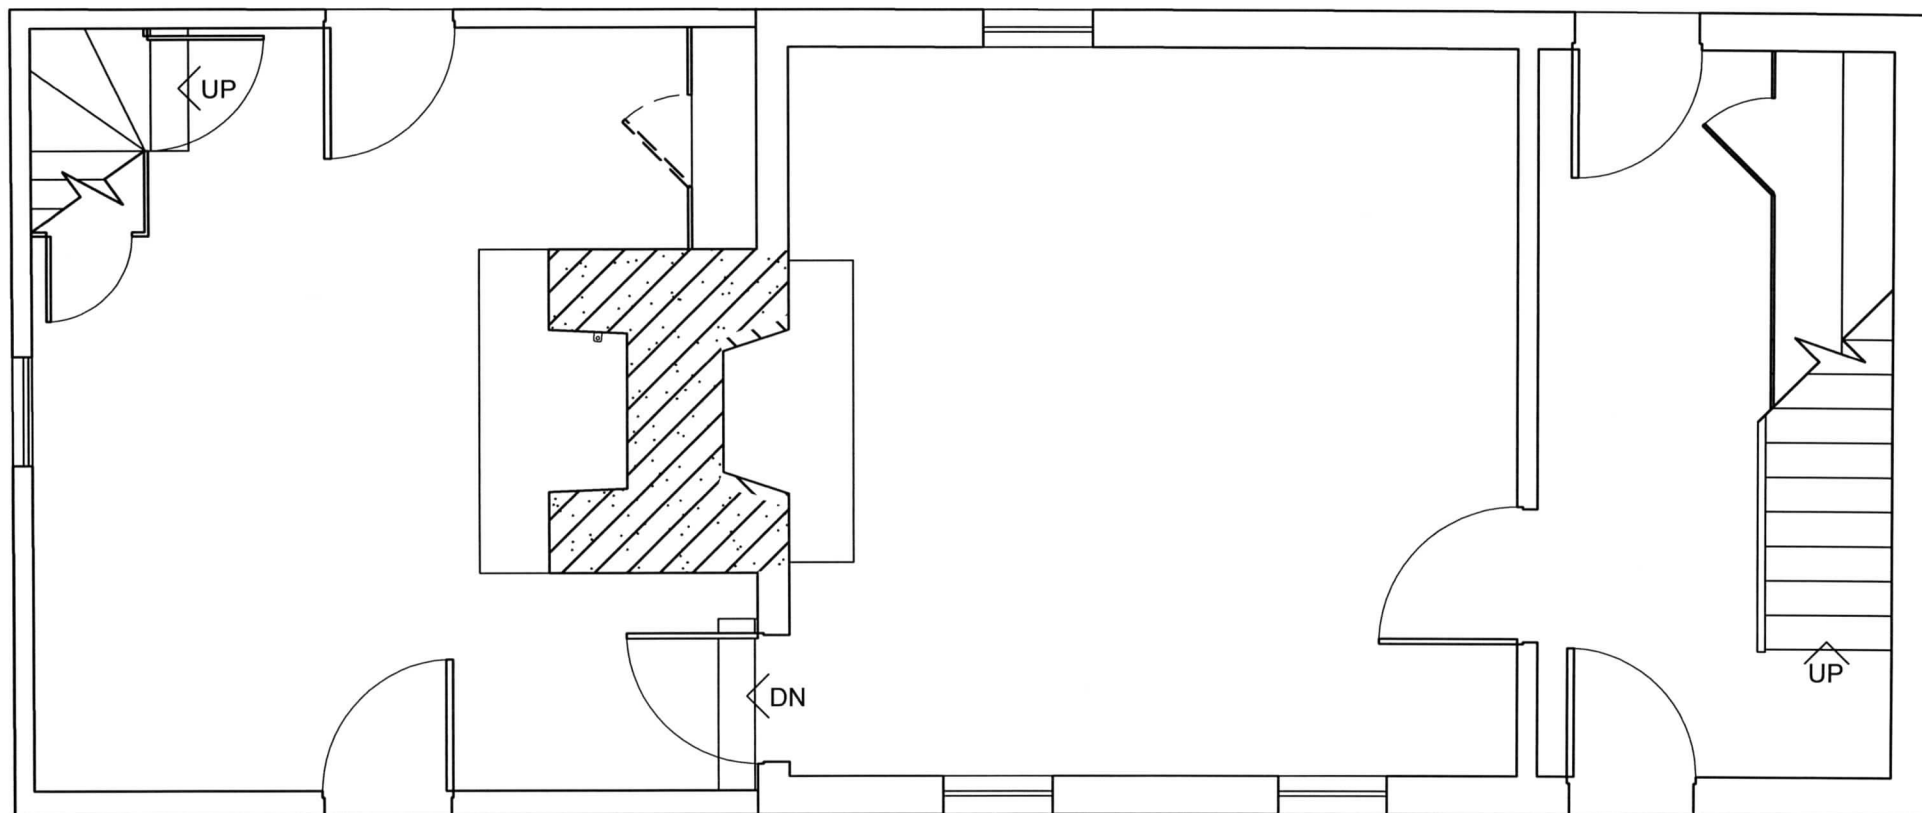
**HO-571 MARLOW FAMILY FARM HOUSE 12975 HALL SHOP RD**

FIRST FLOOR PLAN -- MEASURED AND DRAWN BY KEN SHORT -- APRIL 2017

This is a side-passage, single-pile plan with a one-room ell on the west.

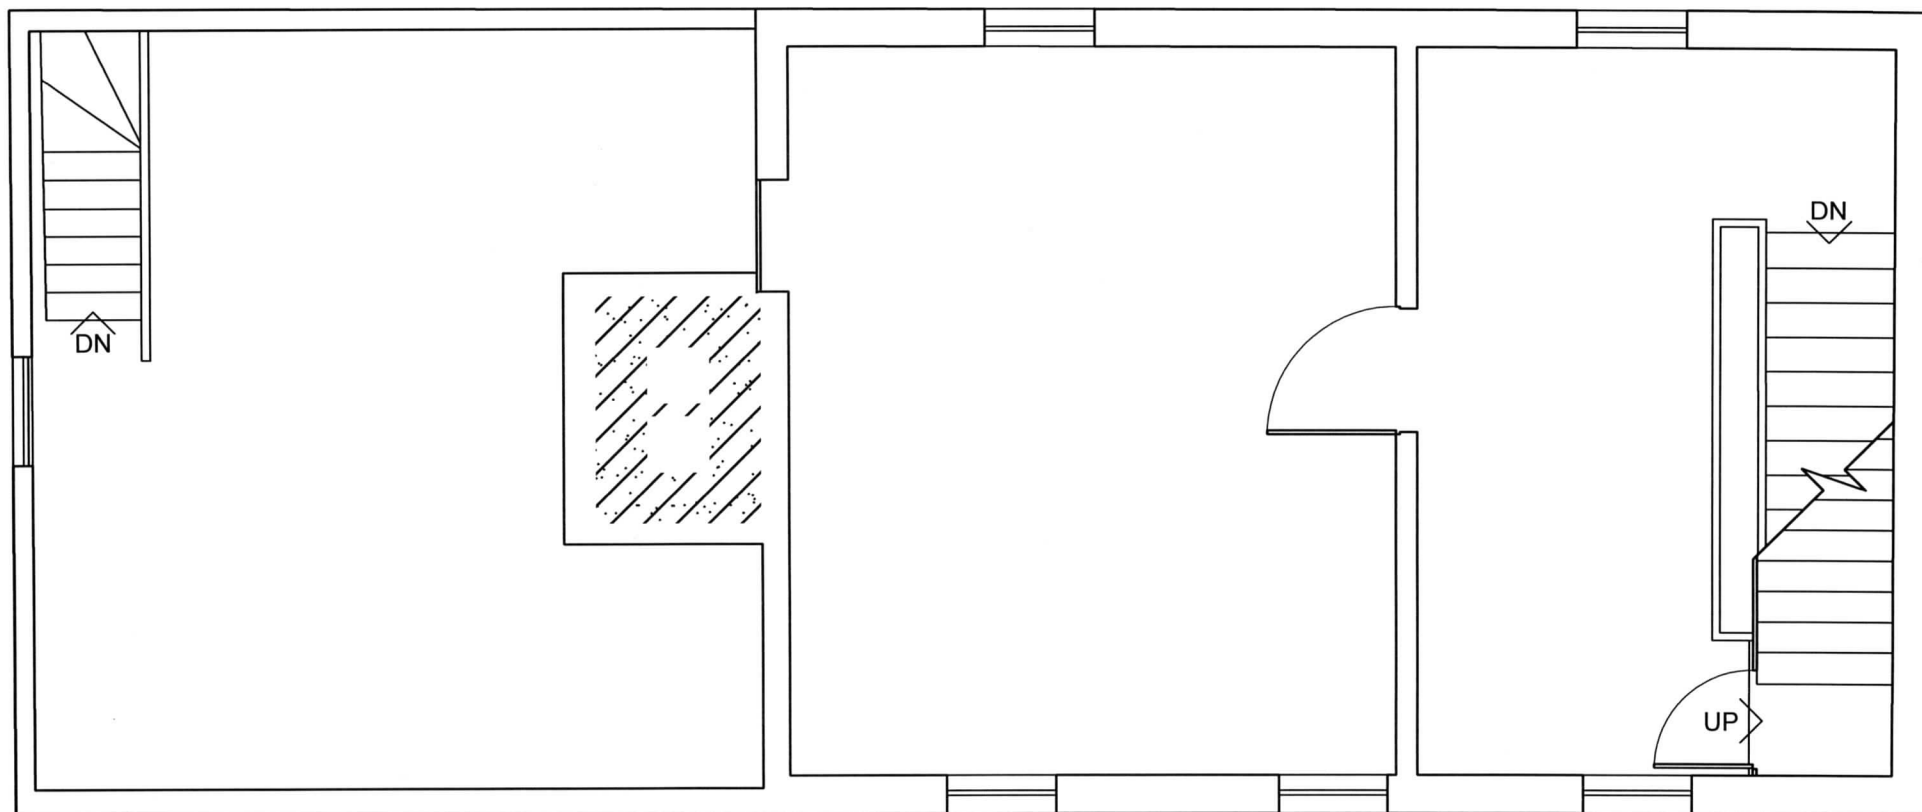
**HO-571 MARLOW FAMILY FARM HOUSE 12975 HALL SHOP RD**

SECOND FLOOR PLAN -- MEASURED AND DRAWN BY KEN SHORT -- APRIL 2017

The floor plan on the second story mirrors that of the first.

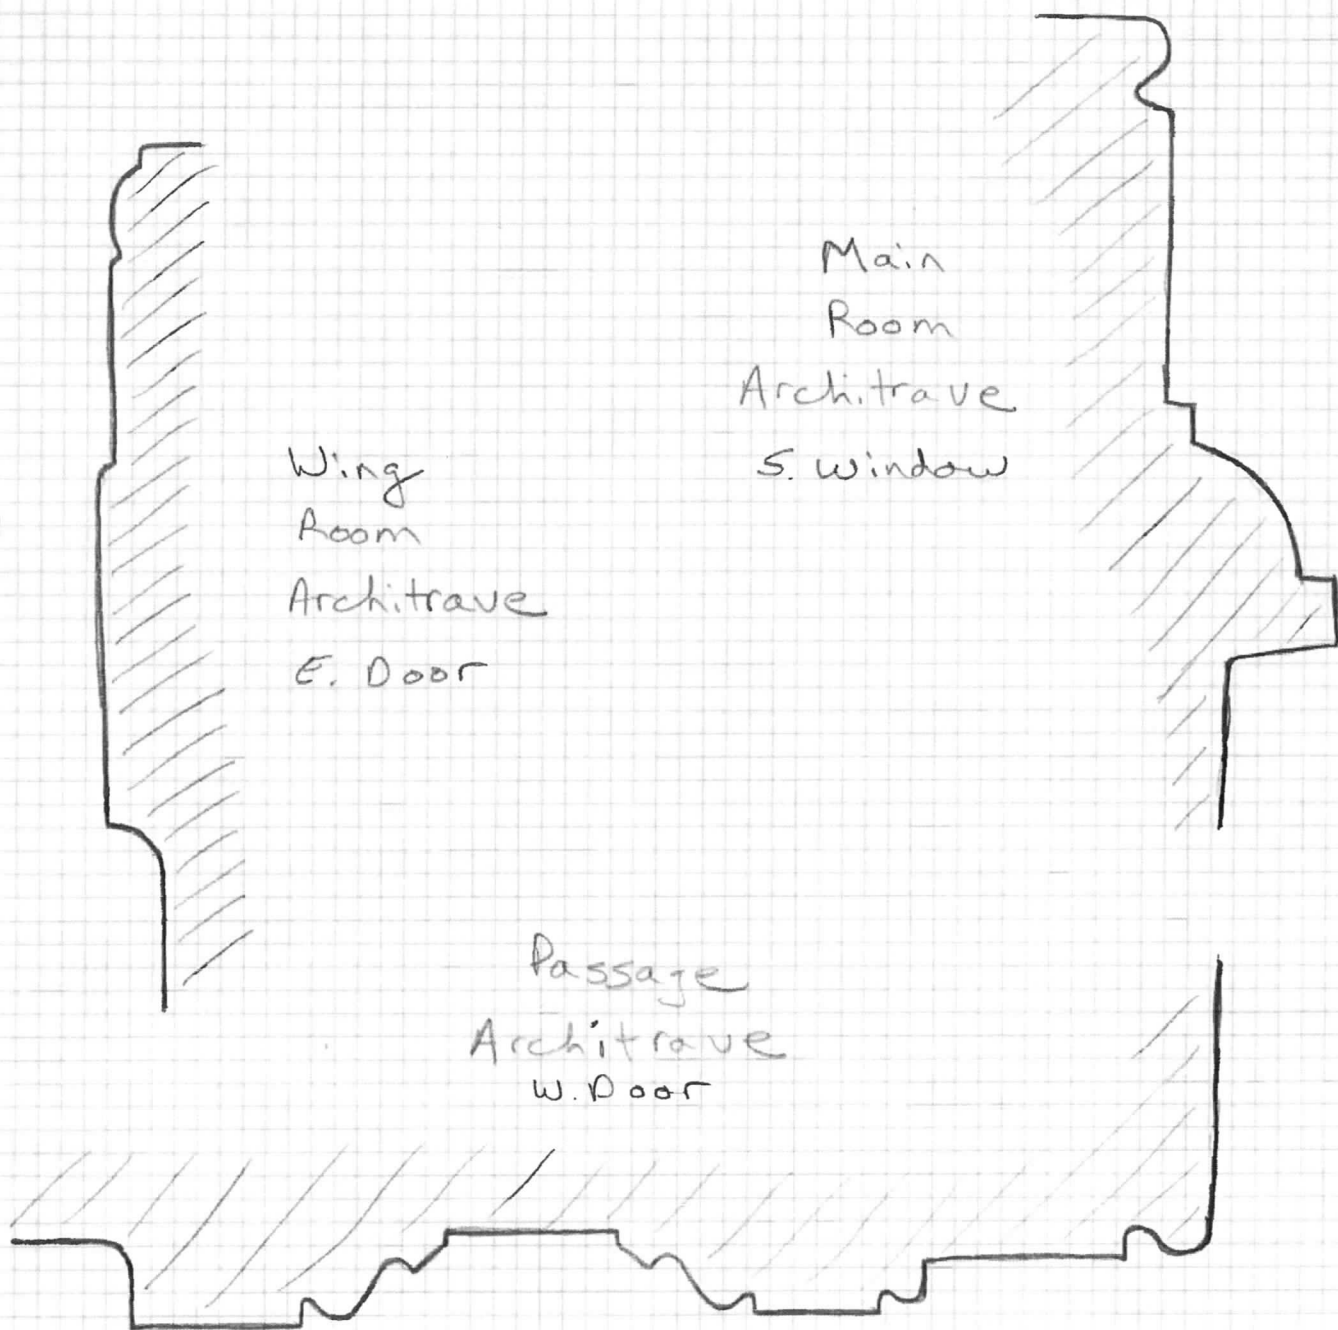
1/2 Marlow Family Farmhouse (HO-571)  
Moulding Profiles

The main room has plain baseboard and plaster walls and ceiling. The architrave has an ovolo backband, a beaded interior edge, and is mitered at the corners. The plaster is set about ¾ inch back from the top of the backband, as though it was added later, or skim-coated. The six-over-six windows have 8-inch by 10-inch lights, ovolo muntins, plain meeting rails, and no parting beads. The east door architrave has no backband, just a quirked bead on the inner edge that is miter-cut, while the field is head-cut. There is no evidence of a backband, but it also appears that the paint has been stripped, possibly destroying any such evidence. The west door architrave, leading to the wing, matches the windows; the mouldings are miter-cut, while the field is head-cut. There is an exterior fireplace centered on the west wall, with a brick hearth, splayed brick jambs, an ashlar stone back wall of the firebox, and a parged surround. It has a wood mantel with a wide architrave that has a quirked ogee-and-bead backband and a raised bead on the inner edge. There is a plain frieze that is mortised and tenoned and pinned to the side boards. The bed mould has two fillets below a Gothic bead, a fillet above that, and a large bead at the top. The edge of the mantel shelf is moulded with a quirked Greek ogee and bead.

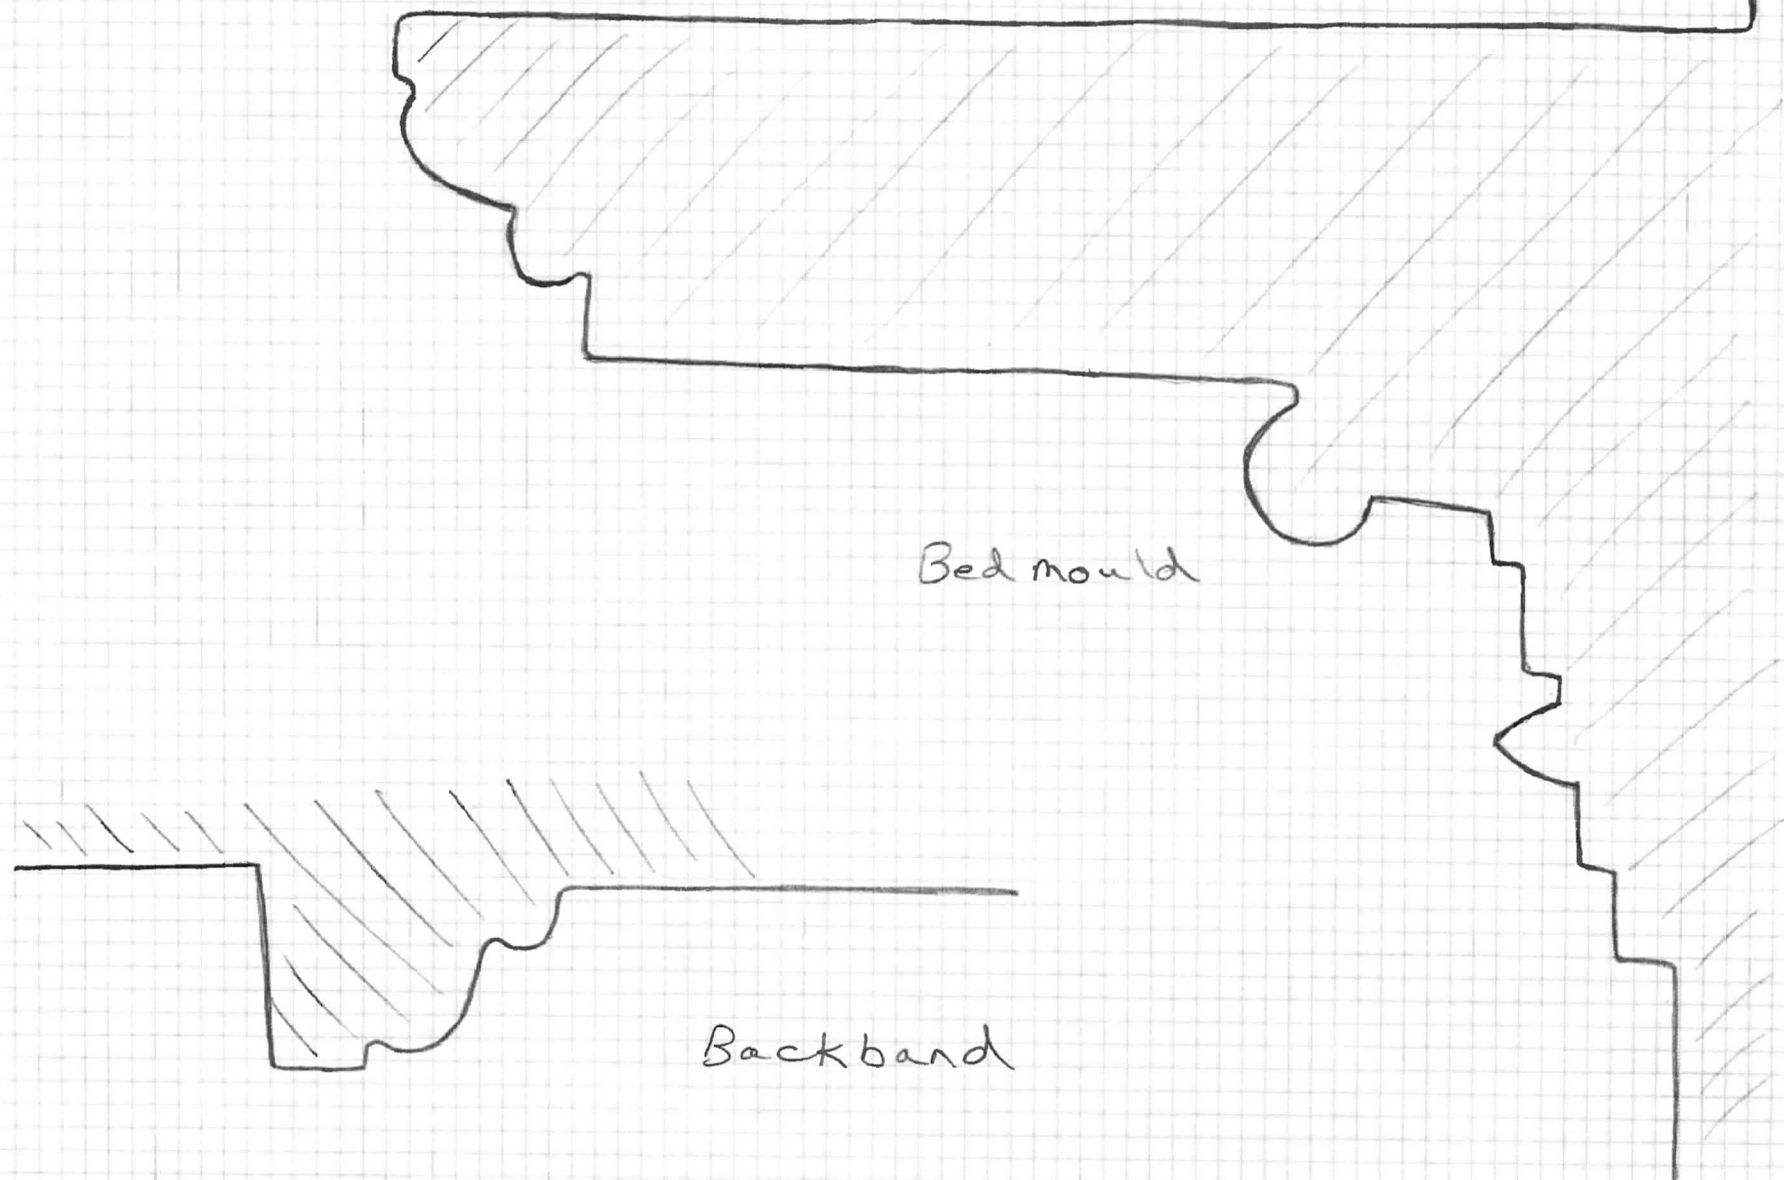
2/2 Marlow Family Farm House (HO-571)  
Main Room Mantel

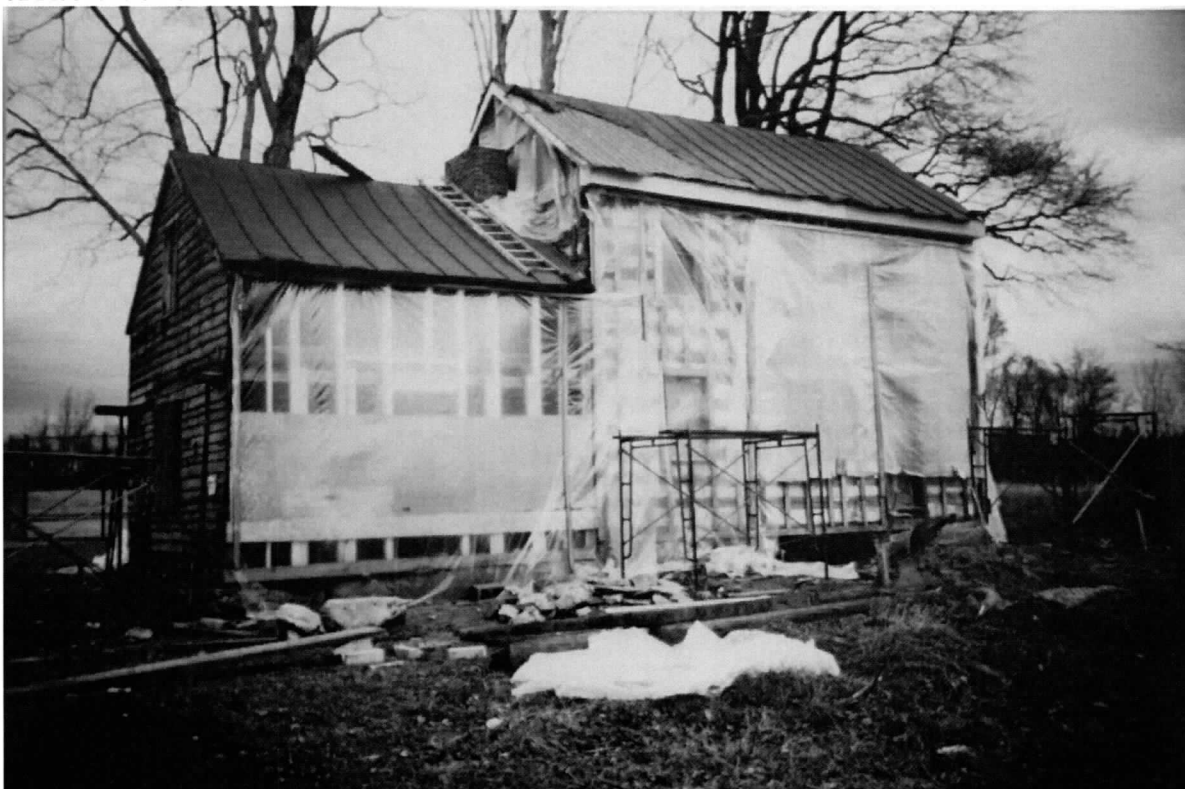
HO-571, Marlow Family Farm House, undated photo taken during initial restoration of the building c. 1991, in possession of Howard County Department of Recreation and Parks.

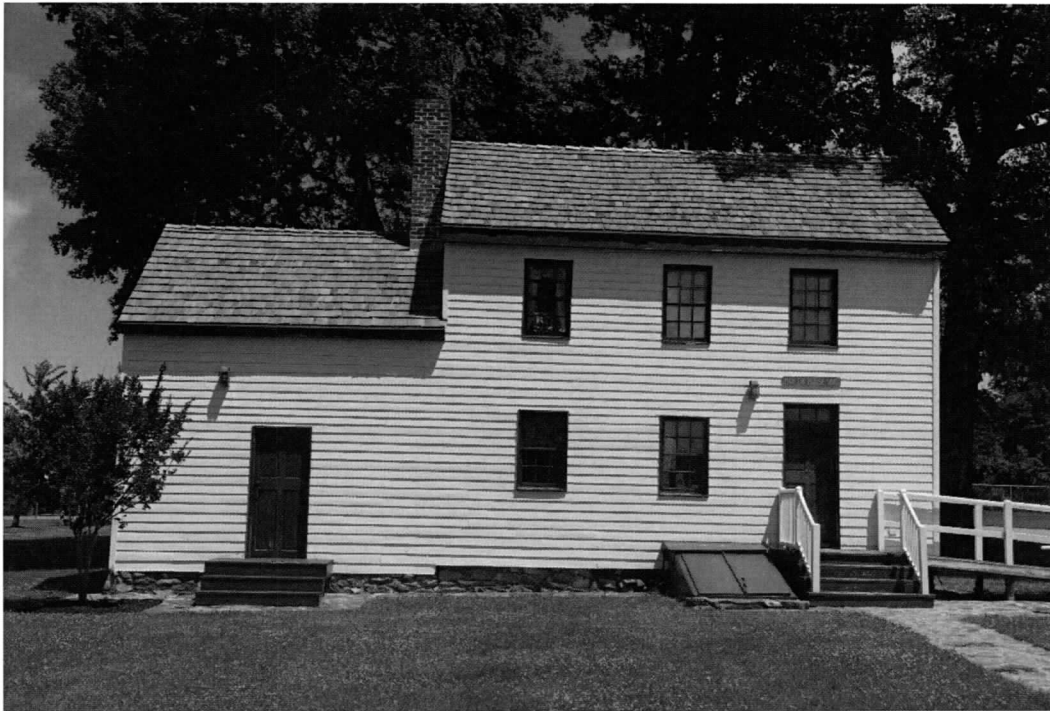
Photo 1 of 22: South elevation. 7/7/2017

The south elevation of the main block has two new wood six-over-six sash on the first story. The east bay has a new four-panel door with a three-light transom. There is a new wood porch and steps, with a

handicap ramp, and there are Bilco doors in the center. The second story has three new six-over-six sash and there is a wood box cornice. The south elevation of the wing has a new four-panel wood door in the center of the first story, with a new, open wood porch. There is a wood box cornice.

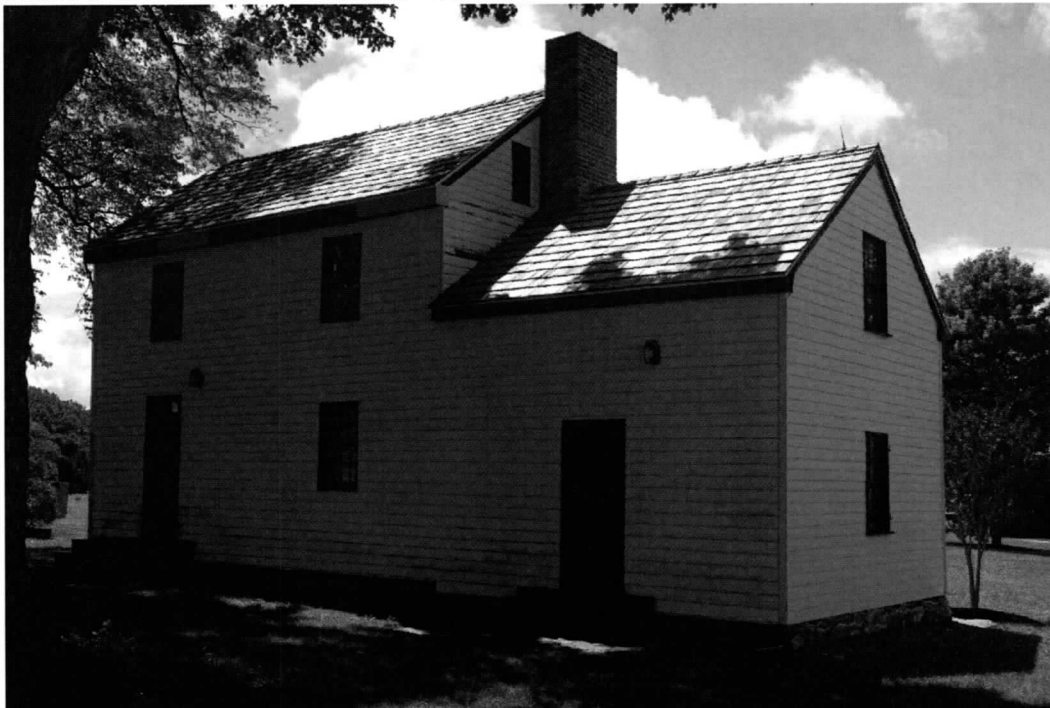
Photo 2 of 22: North & west elevations. 7/7/2017

The north elevation of the main block is only two bays. The first story has a new, wood four-panel door in the east bay, with a three-light transom, and a new wood porch deck and steps. The west bay has a new six-over-six sash. The second story has two new six-over-six sash. The north elevation of the wing has a new wood four-panel door on the first story.

The west elevation of the main block has a six-light casement window set north of the chimney in the gable end. The wing has a six-over-six sash on the first story and another in the gable end.

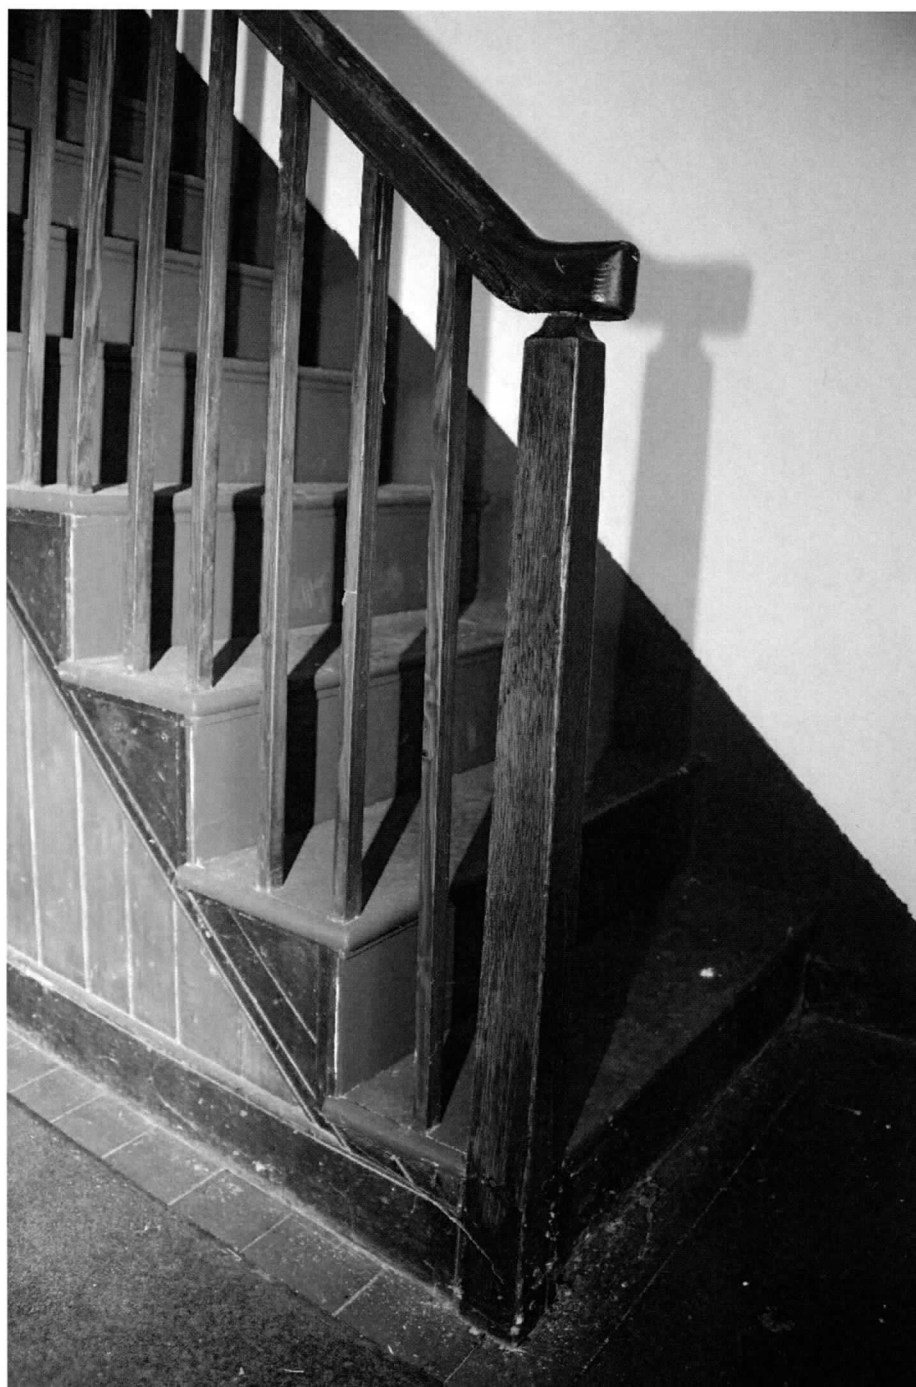
**Photo 3 of 16: First-story newel. 4/10/2017**

There is a straight run of stairs on the east wall that ascends to the north. It has an open stringer with a thin, narrow strip nailed vertically next to the riser, which sits proud of the stringer, and a similar strip that is fastened horizontally, under the tread. They are fastened with cut sprigs and appear to be original. The wall beneath the stringer is tongue-and-grooved beaded-edge vertical boards that are grained. There is a square, tapered newel and rectangular-in-plan balusters. The handrail is pine and has a semi-circular arched top profile, with a pin through the top into the newel. The handrail is ramped at the landing. There is a vertical-board door under the stairs, to a closet. It has a wood pull, a small cabinet lock, and plain cast iron butt hinges with three knuckles. The battens are fastened with cut nails. It is painted dark brown, and this is an early finish, if not original. The lock-side board has a hinge mortise at the top, with three screw holes, and three screw holes in line with the bottom batten, though with no hinge mortise here. There is no evidence of a lock on the hinge-side board. The door is constructed of four boards, while above the door header there are five boards. The door has been hung in this location for a long time, but whether it was miss-hung or moved here at a fairly early date is not clear. The closet inside has three shelf boards, each one set on two rails or large pegs driven into the wall. Some of these rails are in the round, some are riven and square, and all of them are in the round where they pass into the wall. They all also have lime wash or paint on the sides, but not on the end or on the bottoms of the shelf boards. The floor and baseboard in the closet are unpainted. The stair is constructed with cut nails. The west door, leading to the main room, has four panels and has a piece added to the hinge side, suggesting it was brought in during the original restoration of the building. It is mortised and tenoned and pinned, with sunken fields and no panel moulds. It has been painted to match the architrave, but this appears to be new work. The ceiling is 7 feet, 9 ½ inches high.

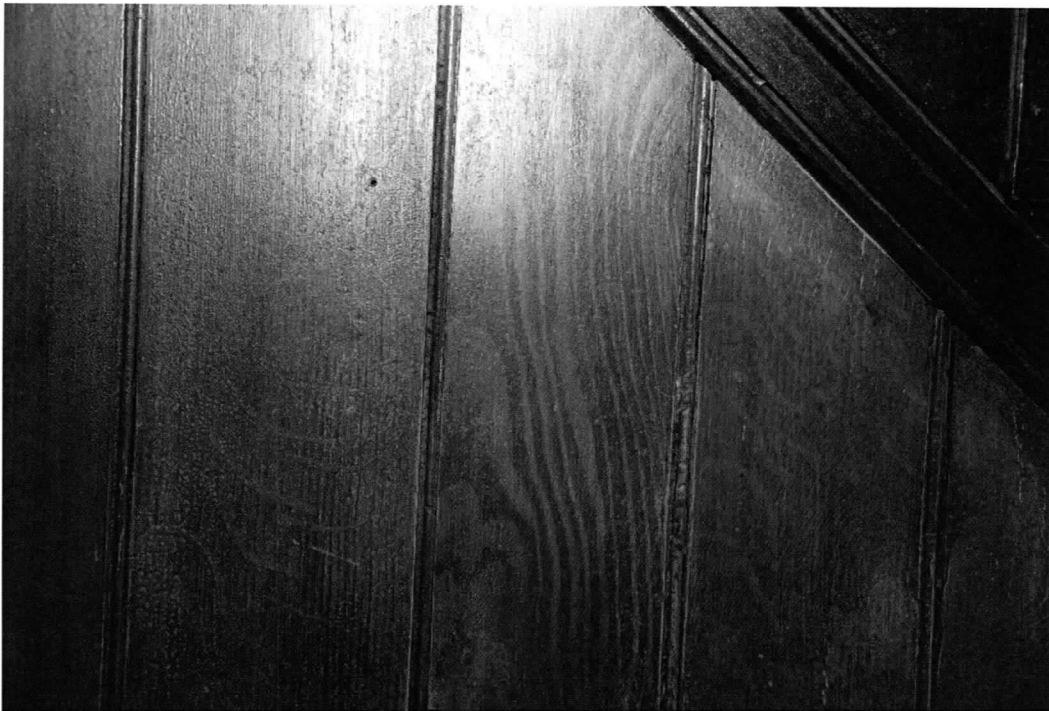
Photo 4 of 16: First-story passage, graining on boards under stair. 4/10/2017

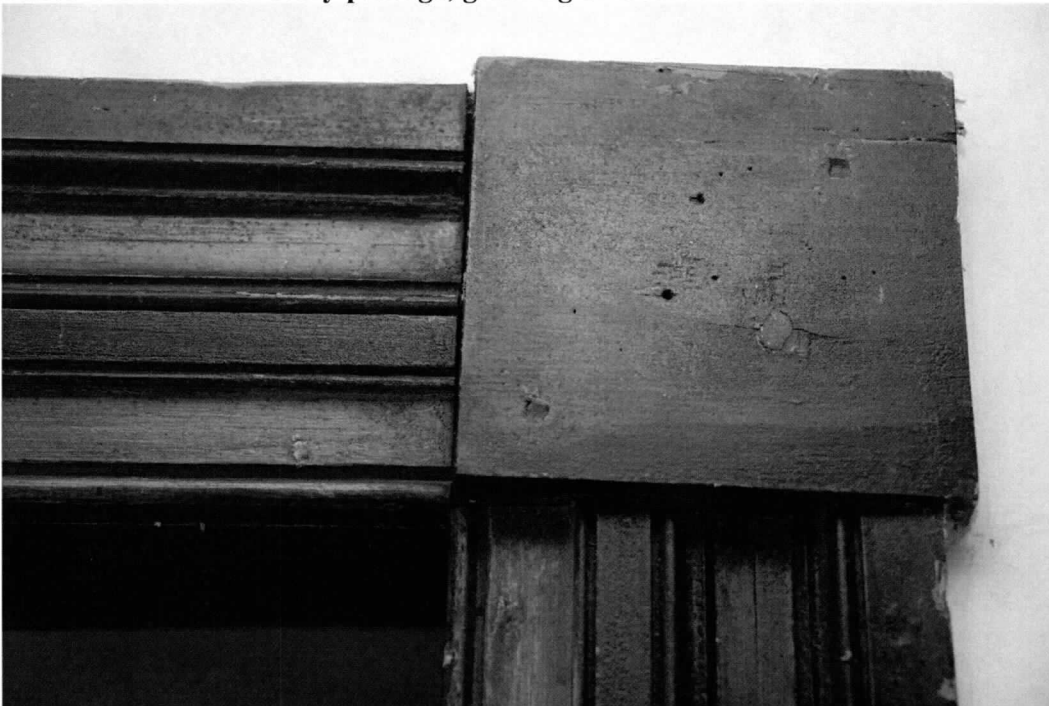
Photo 5 of 16: First-story passage, front door architrave with decorative paint. 4/10/2017

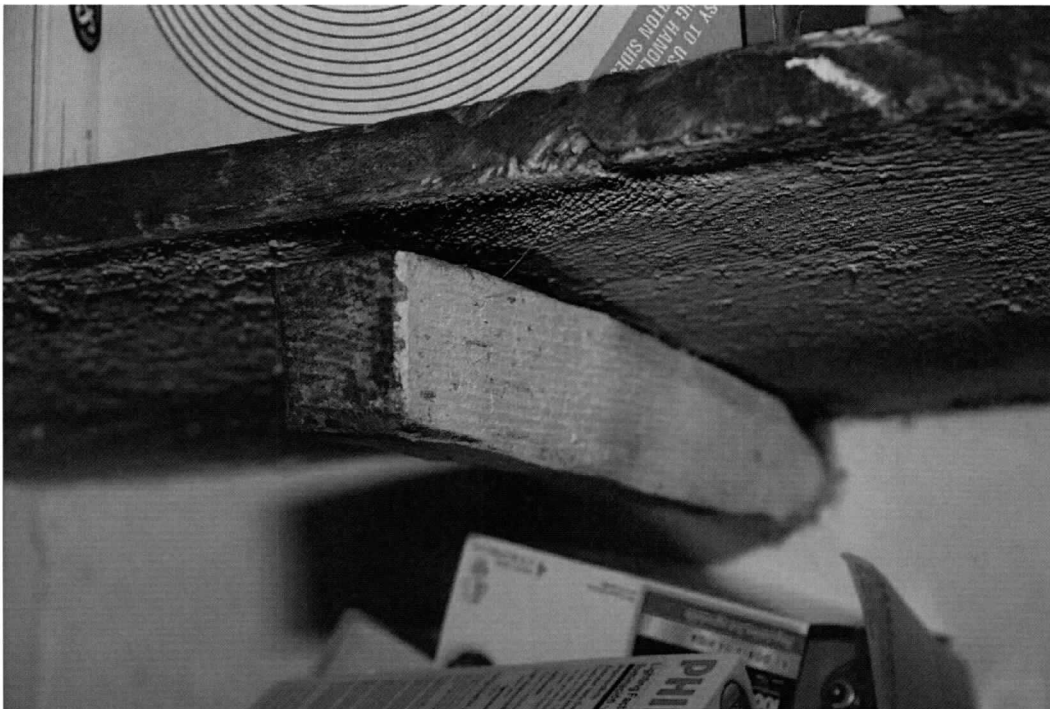
**Photo 6 of 16: First-story closet shelf support under stairs. 4/10/2017**

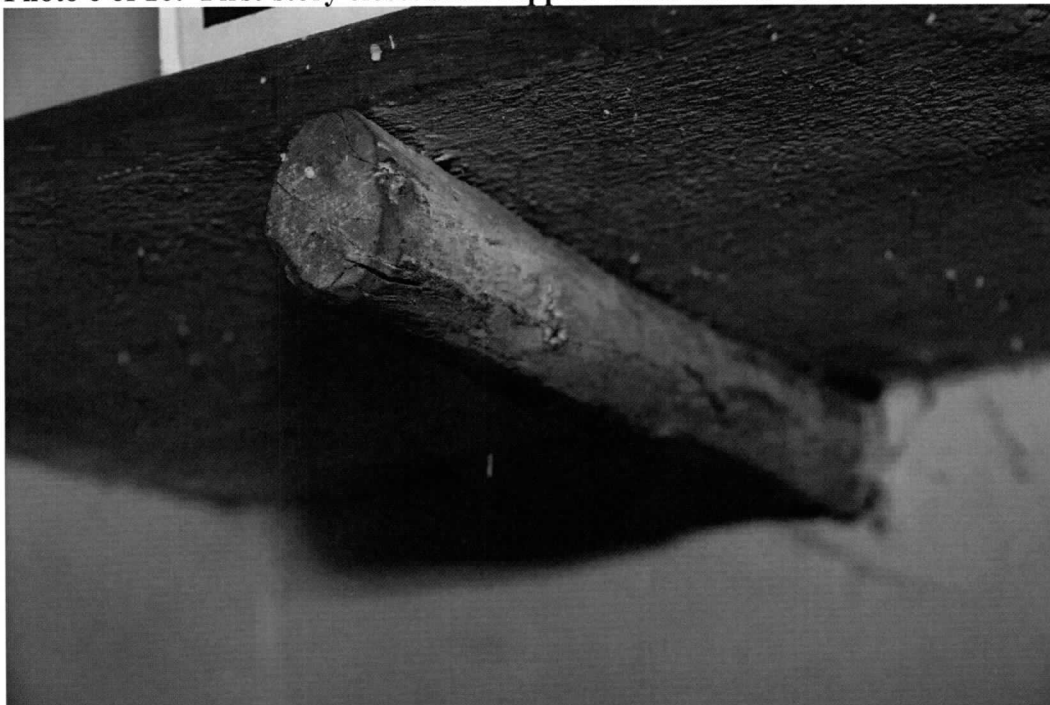
**Photo 7 of 16: First-story closet shelf support under stairs. 4/10/2017**

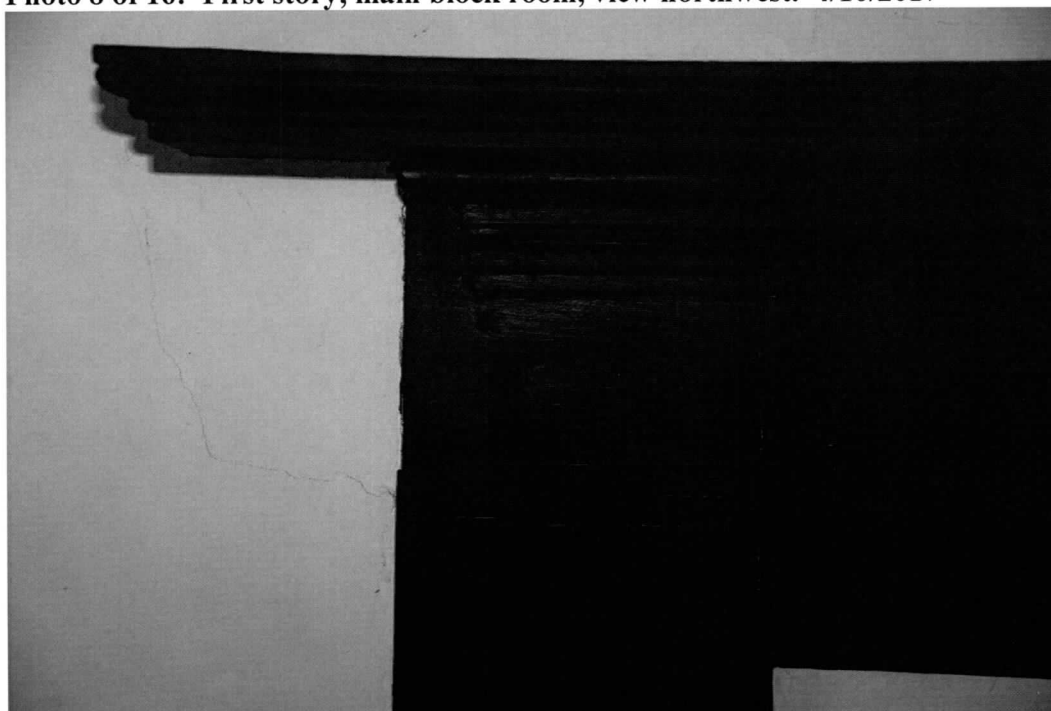
Photo 9 of 16: First story, main block room, mantel detail. 4/10/2017

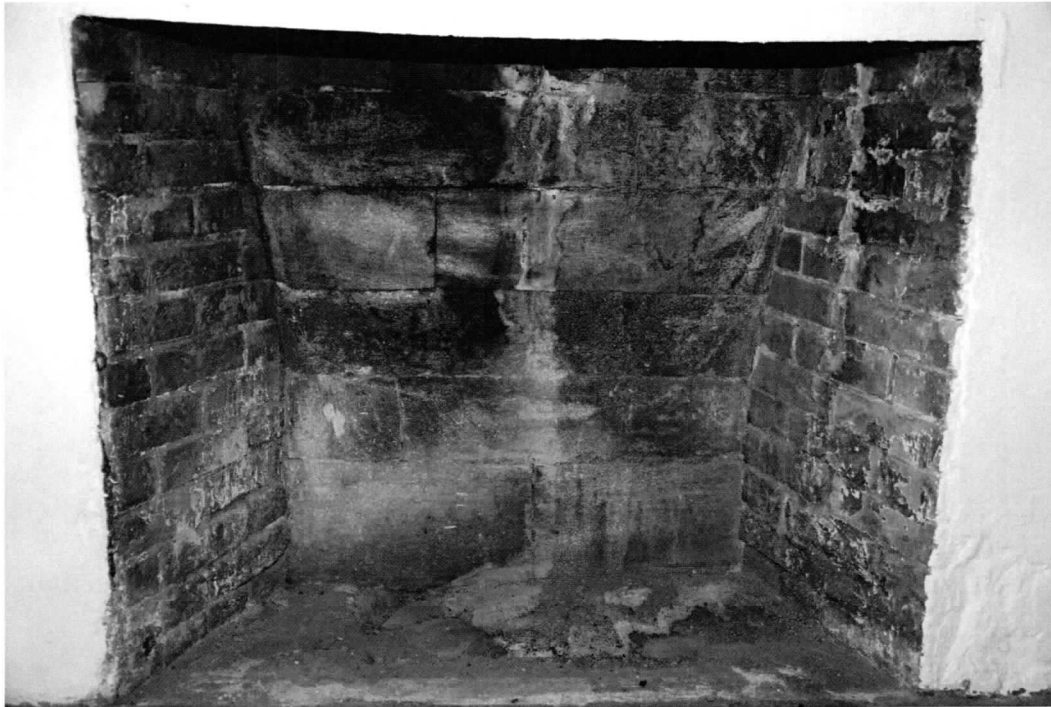
**Photo 10 of 16: First story, main block room, firebox detail. 4/10/2017**

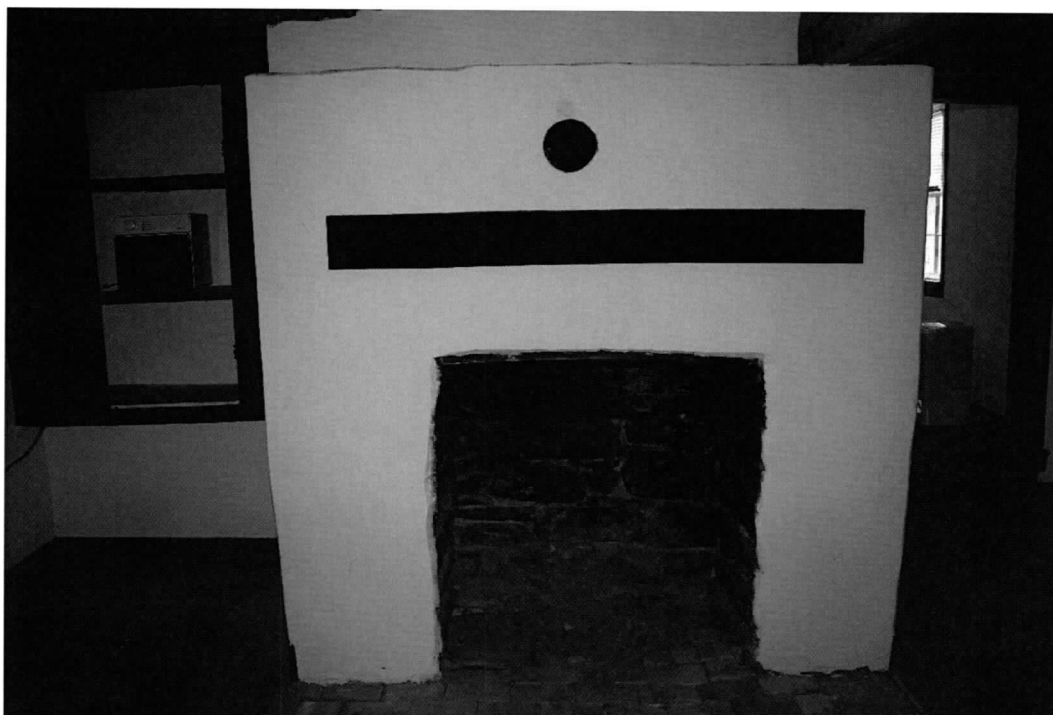
Photo 12 of 16: First story, ell, east elevation. 4/10/2017

and the architrave on the east doorway, which appears original, has a broken field with a bead on the inner edge. The door has four panels with sunken fields, no panel moulds, and new hardware; it is not original to this location and was probably brought in for the restoration. Both the north and south doors and their hardware were modern in 2017, were deteriorated, and were replaced the following year. There is a fireplace centered on the east wall, with a brick hearth, stone firebox with straight jambs, and a slight arch to the opening with two iron bars to support it. There are two iron eyes in the north jamb for a crane. There is a built-in cupboard to the north of the fireplace, and it sits 2 feet off the floor. It has three shelves, of old boards that appear original, and is enclosed with vertical boards with beads. There are new hinges, yet the door is missing. The second-story joists are hewn on all four sides and run north-south. They have plaster burns and lath nail holes on the bottom face. They are 3 ½ to 3 ¾ inches wide by 4 ¾ to 5 inches deep and are spaced 22 ½ to 26 ½ inches on centers and are supported by two circular-sawn and ganged together beams measuring 2 ½ by 9 ½ inches; they are fastened together with cut nails. The eastern-most joist contains traces of paint and wallpaper. The flooring above is wide circular-sawn boards that are probably new, except for those in the northeast corner; these do not align with the rest of the flooring, are also circular-sawn, and have traces of whitewash. There is an enclosed winder stair in the northwest corner leading to the upper story. It has beaded-edge vertical boards, with a door that matches and has a new latch. There are small, plain cast iron butt hinges with five knuckles and fast joints. The stair ascends to the west and south. There is a closet under the stairs, with a small vertical-board door that may be new and has new hinges. The boards are fastened with cut nails.

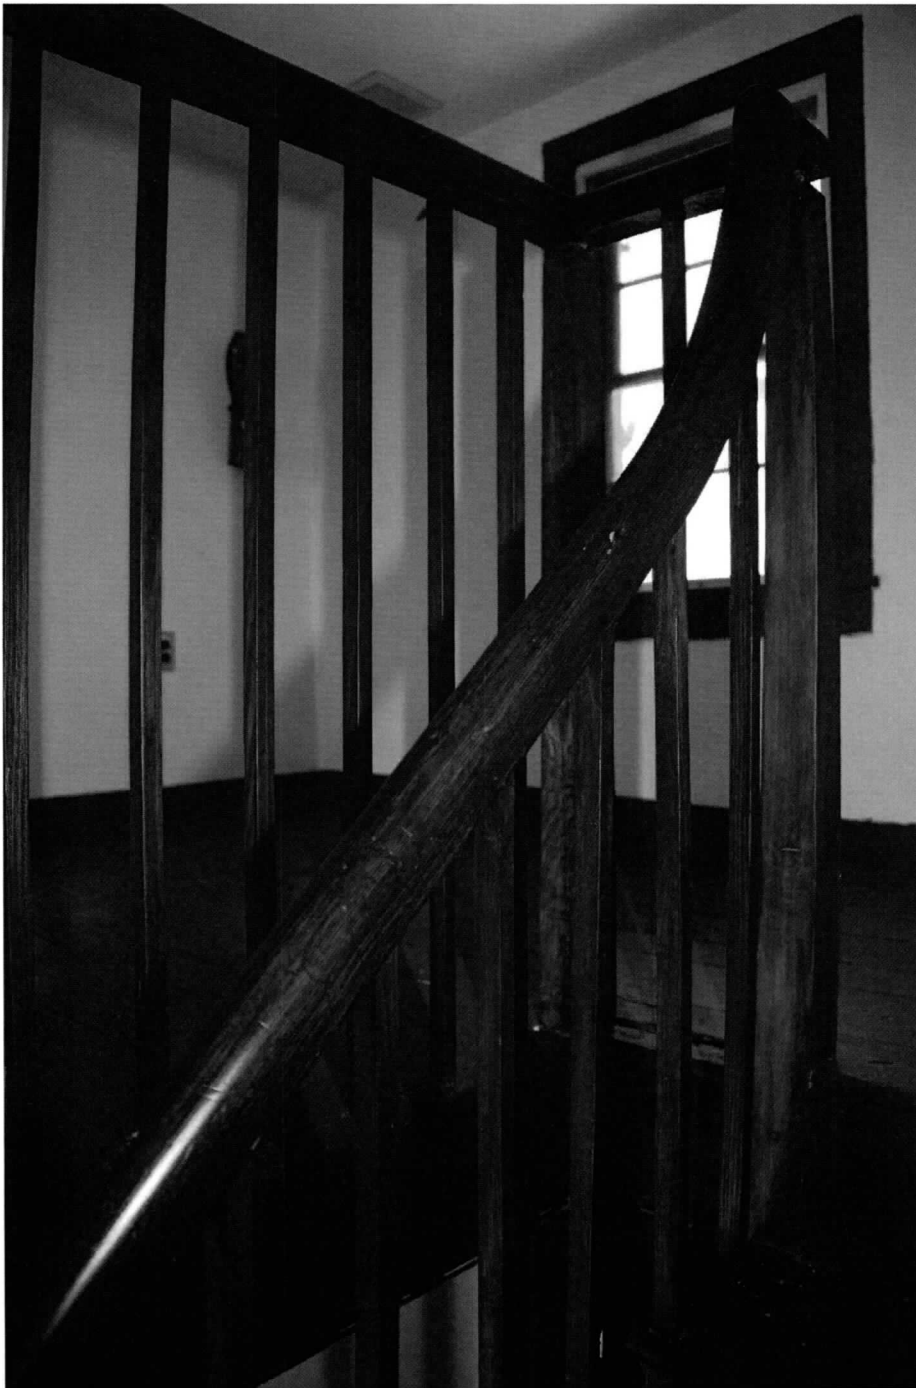
**Photo 14 of 16: Second-story passage, newels and railing. 4/10/2017**

The passage, however, is about 2 feet, 5 inches wider than that on the first story. There is random-width flooring that runs east-west and appears to be painted pine. It is tongue-and-grooved, is face-nailed, and varies between 4 ¼ and 7 ¼ inches. There are some new boards added in. The baseboard is plain and the walls and ceiling are plaster on lath. The ceiling height is 6 feet, 6 ¼ inches. The architrave is plain, with a quirked bead on the inner edge; the window architrave is miter-cut while the door has the bead miter-cut and the rest is head-cut. There are windows on the north and south, with sash that generally match the rest but appear to be new. The stairway has the same newels, balusters and handrail as the first story. The stairway to the attic is aligned above that to the second story but is enclosed with beaded-edge vertical boards fastened with cut nails. There is a door of matching boards, hung on new butt hinges with pins. The stair has a landing at the south end that is one step up, and it ascends to the north. The west door has beaded-edge vertical boards and the battens appear to have cut nails, though they are barely visible. The lock is new and the cast iron butt hinges have five knuckles and fast joints.

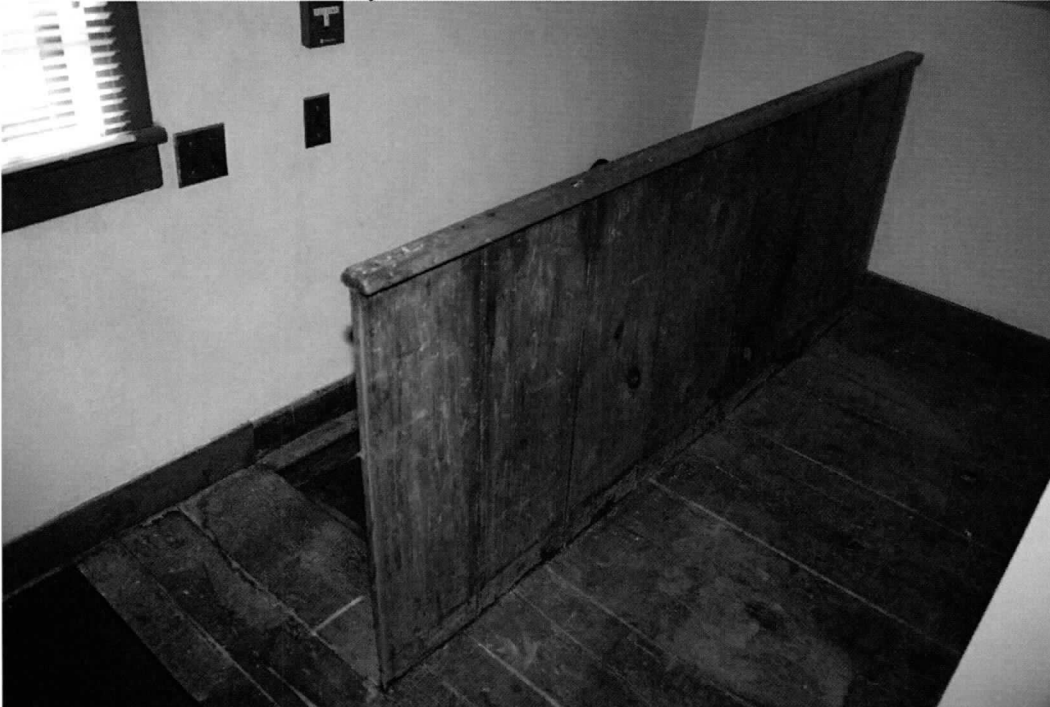
**Photo 16 of 16: Second-story ell, stair railing. 4/11/2017**

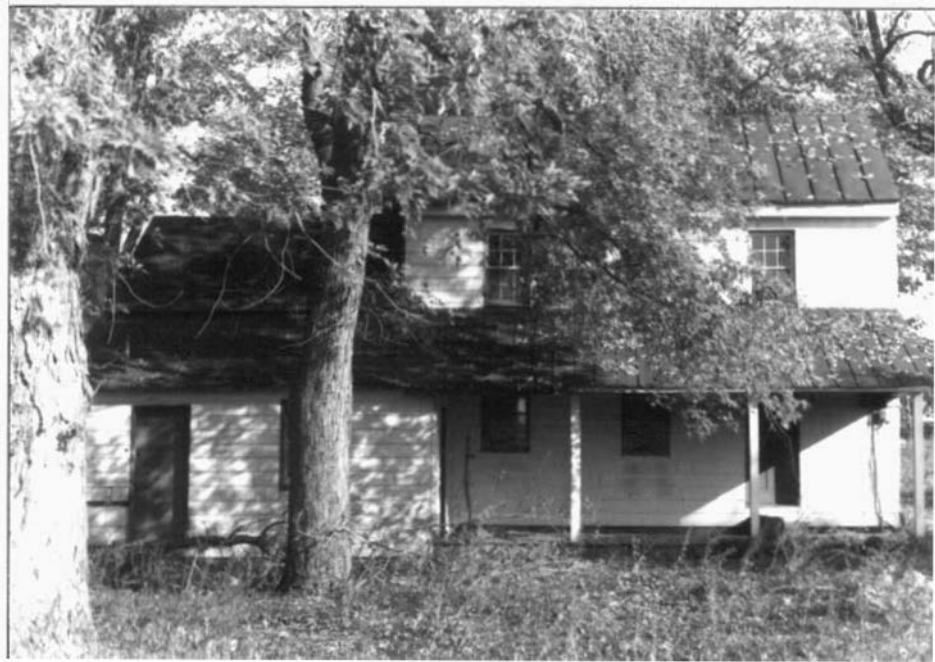
H0-571    Marlow House  
         Highland vicinity  
         Ed Shull 1981  
         South Facade

The south facade of the house appears to serve as the principal facade. The six-panel entrance door with three-light transom is located in the east bay, with two 6/6 windows to the west on the first story and three 6/6 windows ranged across the second story. The house rests on a stone foundation and is covered with horizontal weatherboards and a later covering of shingle siding. The eaves are enclosed with a plain box cornice; the roof is covered with standing seam metal. A one story open porch with plain posts and a standing seam metal roof extends across this facade of the main house.

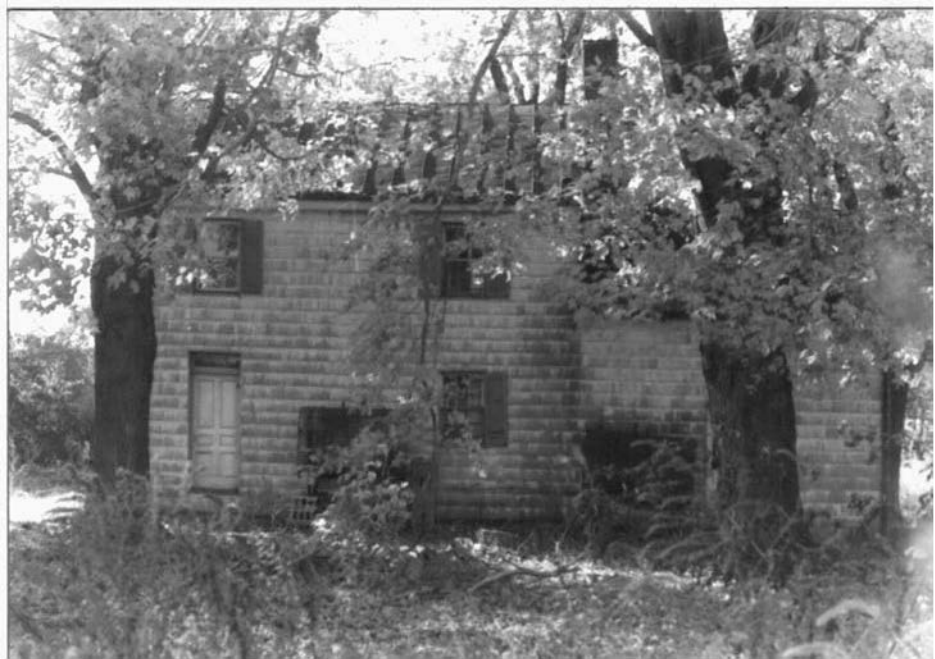
H0-571    Marlow House  
         Highland vicinity  
         Ed Shull    1981  
         North facade

A door in the center bay of the first story is the only opening in the north facade of the wing. The wing also rests on a stone foundation and is covered with wood shingle siding and a standing seam metal roof.

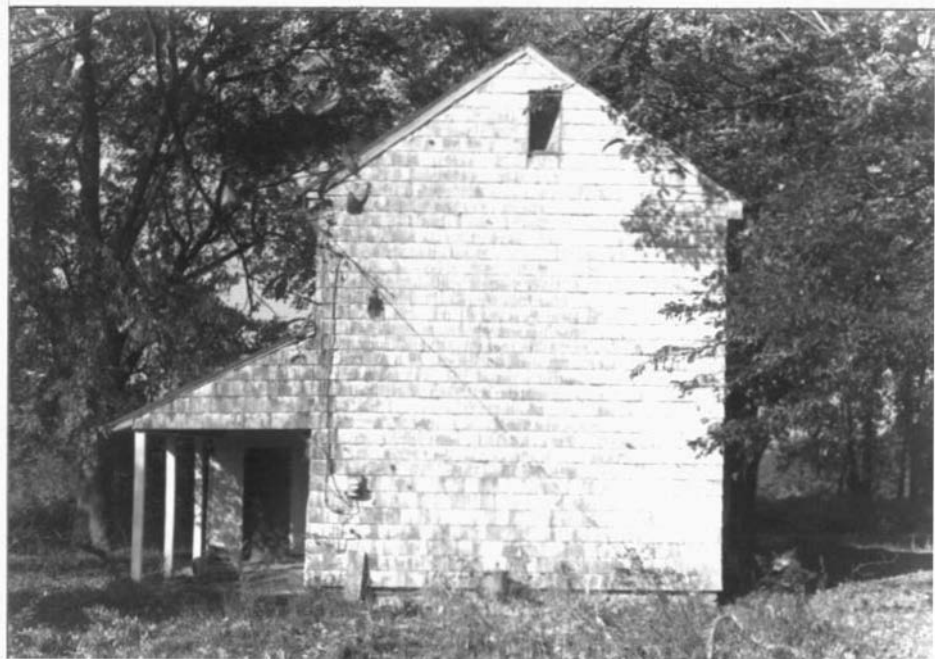
HO-571    Marlow House  
         Highland vicinity  
         Ed Shull    1981  
         East Gable

A small window offset to right of center in the upper gable is the only opening in the east gable wall. The stone foundation and wood shingle siding match the south facade; the rake-boards are plain.
