HO-571

Marlow Family Farm House  
12975 Hall Shop Road  
Public

## Maryland Inventory of Historic Properties Form

historic Marlow Family Farm House

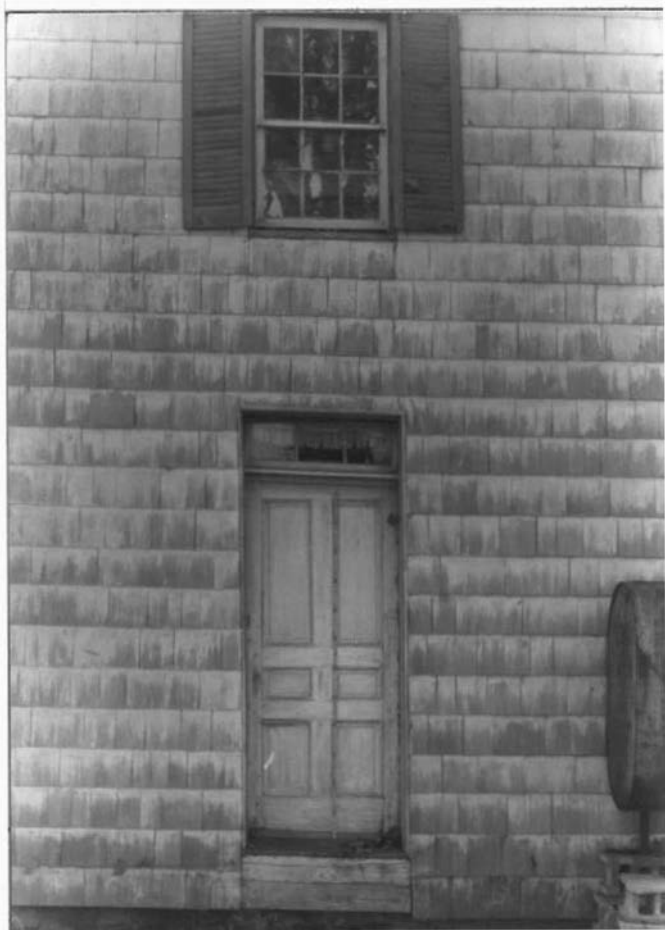
Marlow House  
Highland vicinity  
Ed Shull 1981  
North Door

Door - 4 Window - 9

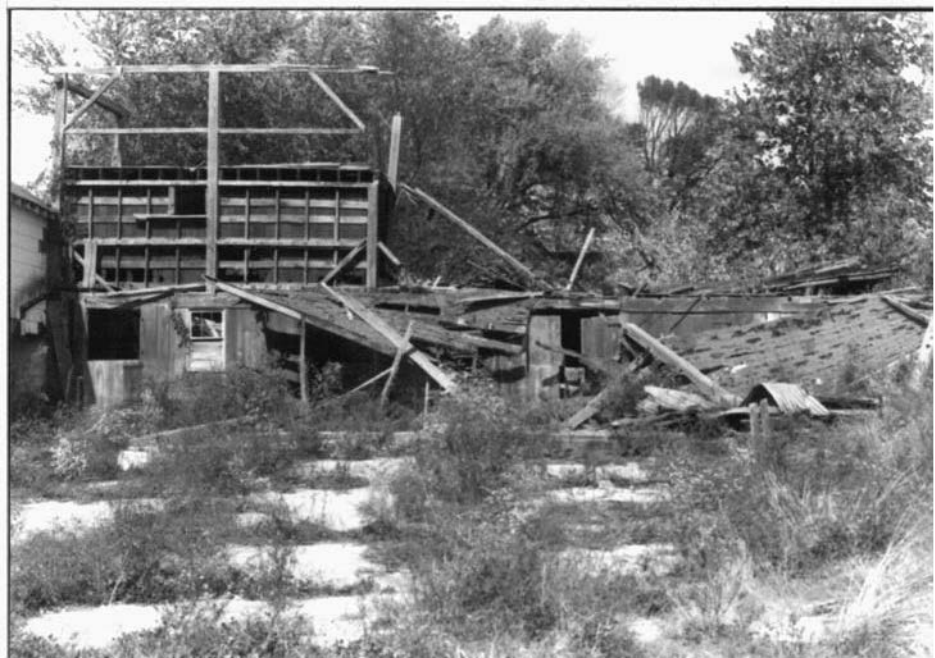
H0-571    Marlow House  
         Highland vicinity  
         Ed Shull 1981  
         Ruins of Barn

The house is sited on high ground along the south side of Hall Shop Road and is oriented on an east-west axis. A complex of late 19th and 20th century farm buildings is located to the south of the house. Most of these buildings are in very poor condition.

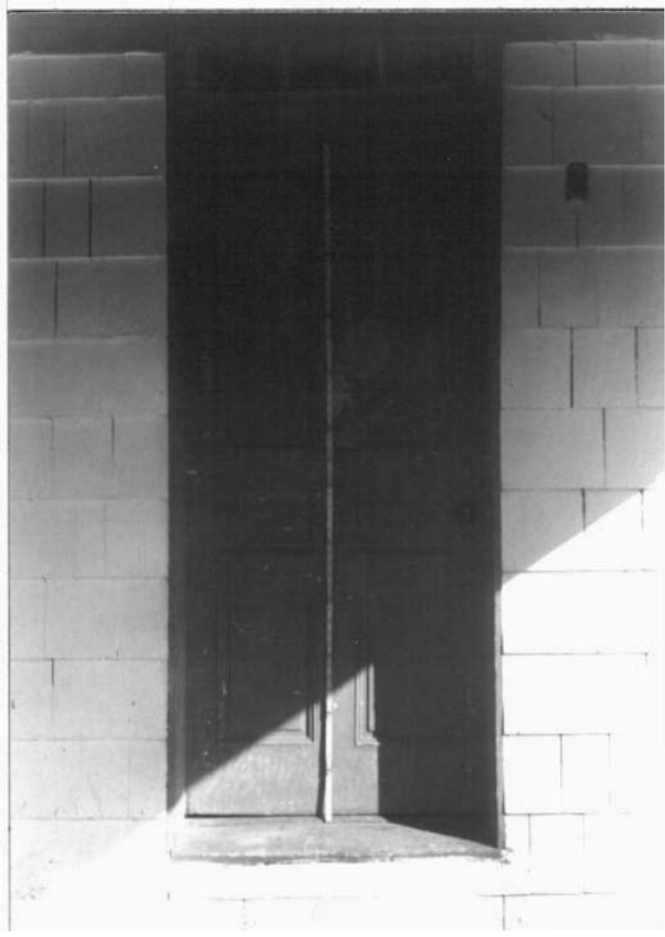
Marlow House  
Highland vicinity  
Ed Shull 1981  
South Door

South Facade Door 2

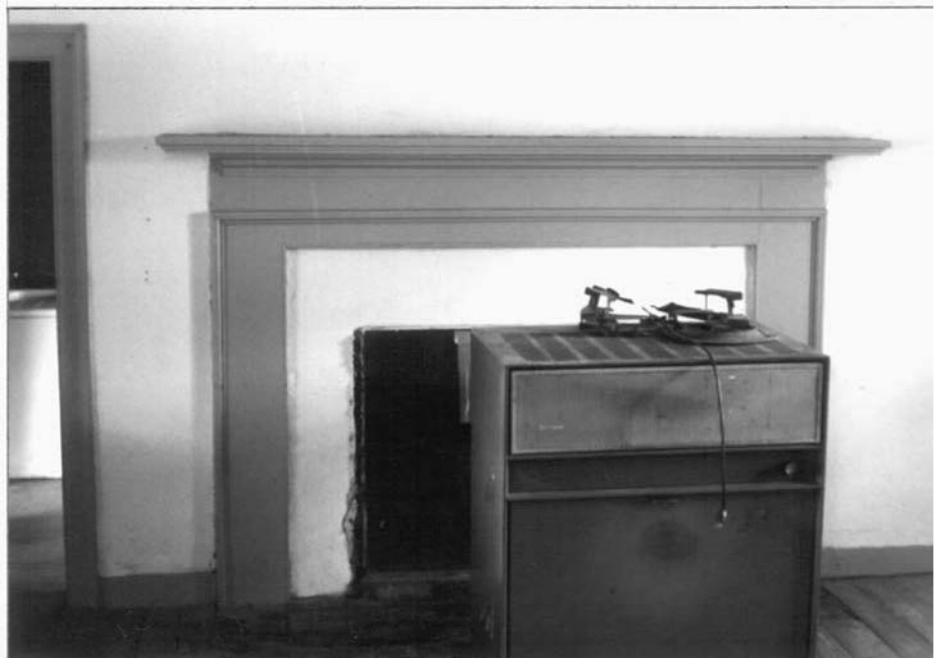
HO-571    Marlow House  
         Highland vicinity  
         Ed Shull 1981  
         Parlor Mantel

JAMES MARLOW HOUSE  
Mantle in Large  
Section
