Edward Talbott Clark Farm Buildings Complex, site

Architectural Survey File

INDIVIDUAL PROPERTY/DISTRICT
MARYLAND HISTORICAL TRUST
INTERNAL NR-ELIGIBILITY REVIEW FORM

The Edward Talbott Clark Farm Buildings Complex is a cluster of nine barns, dwellings, and utilitarian structures dating to the circa 1937-1955 time period. It was established following the purchase of the property by Edward Talbott Clark, a farmer, in 1936. These buildings are representative structures associated with middle 20th century farming operations in Howard County prior to the commencement of the suburbanization development that characterizes the county in the late 20th century. They reflect the local application of architectural styles and building technologies associated with rural farming structures and middle class dwellings of the 1937-1955 time period.

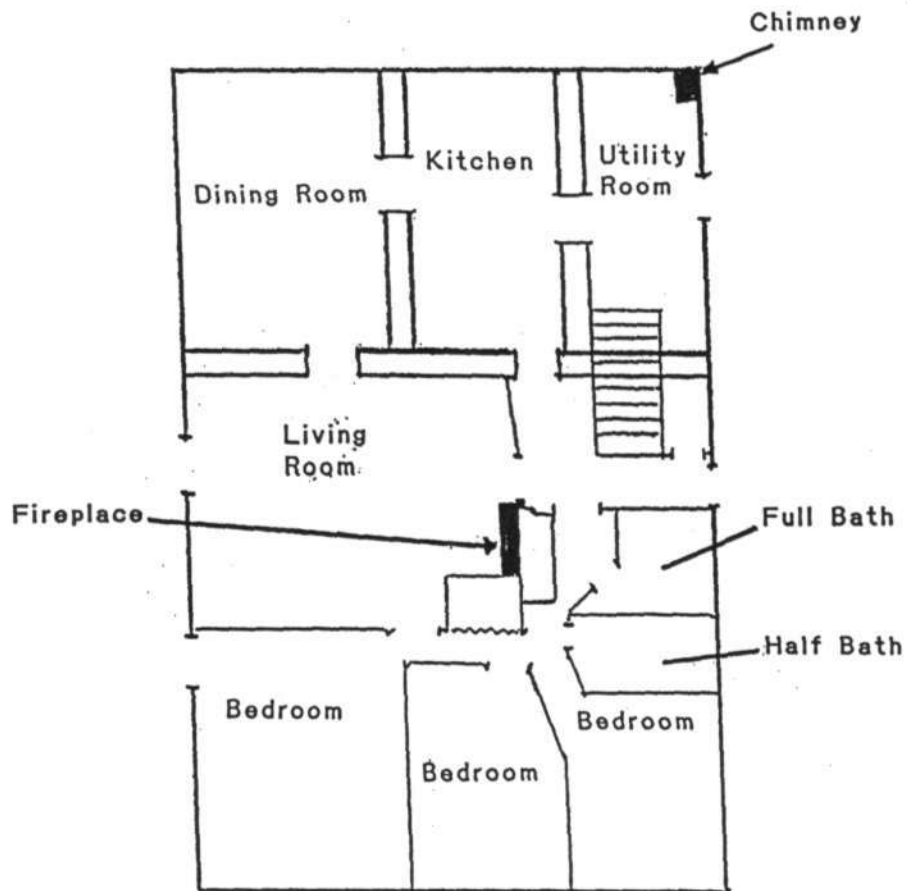
FLOOR PLAN
MINIMAL TRADITIONAL STYLE DWELLING
(STRUCTURE # 1)

This dwelling is rectangular in shape, 31 feet wide by 43 feet long. The long axis of the building is oriented along a 64 degree magnetic azimuth. This building is constructed of cement block and its exterior finish is stucco. There is a crawl space under the house. The windows are double hung, six over six. The exterior walls of the structure are in good condition. The interior of the building is deteriorated due to lack maintenance. The roof is of the gable type and is "T" shaped. Two brick chimneys extend through the roof, which is covered with asphalt shingles. The roof is severely deteriorated and partially collapsed.

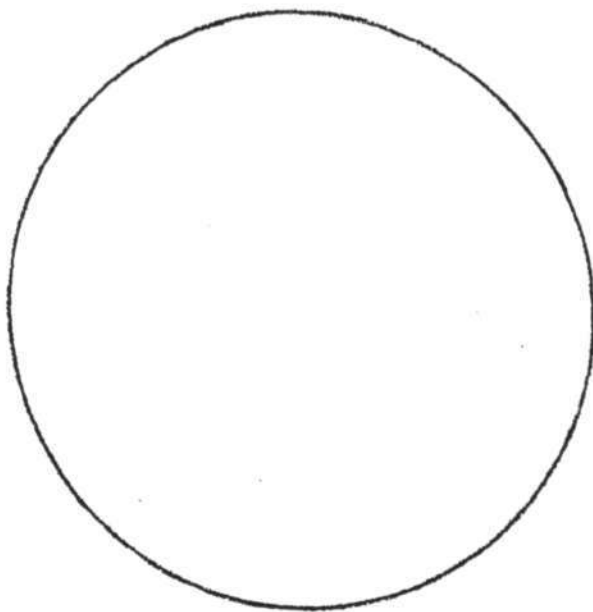
FLOOR PLAN
CONCRETE SILO
(STRUCTURE # 3)

Structure # 3 is located at the northeastern corner of Structure # 2 (dairy barn at 4296 Montgomery Road). It is a silo constructed of steel reinforced concrete with a concrete roof. The silo's diameter is 15 feet and its height is about 35 feet tall.

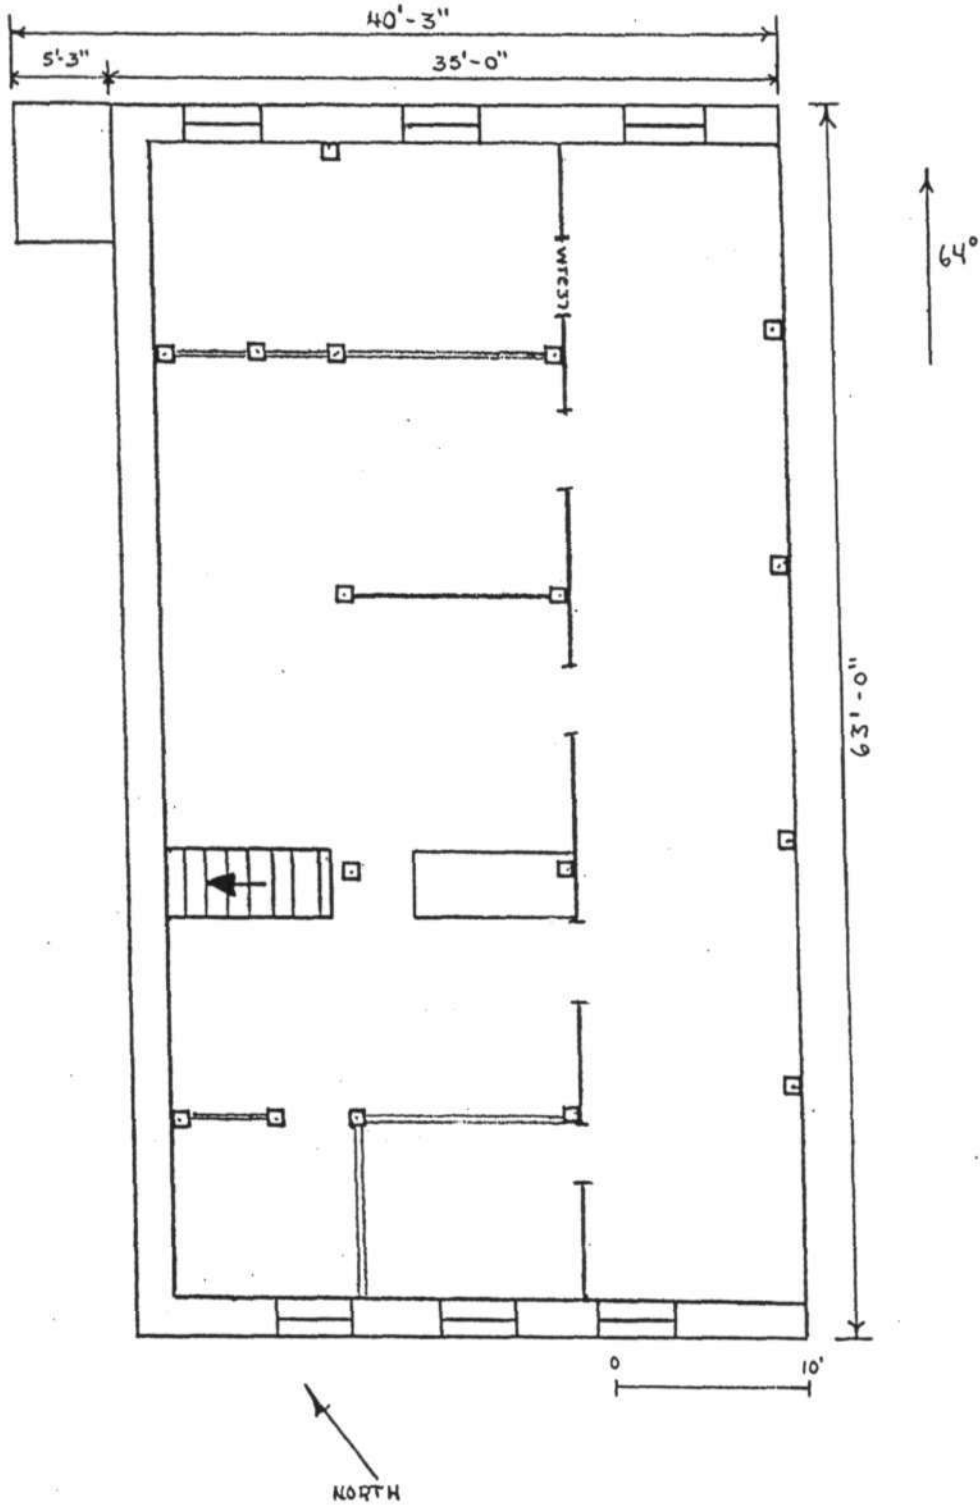
FLOOR PLAN - LOWER LEVEL
BANK BARN
(STRUCTURE # 4)

The building has two levels. The lower level has five bays and is enclosed on three sides by a stone rubble foundation bound with portland cement. No evidence was observed indicating that the cement was a later repointing application over earlier mortar. Repointing would have been indicated, for example, if mortar had been visible in seams between the rocks of the foundation. However, all the seams inspected both inside and outside the foundation were found to contain cement only.

The open side of the lower level includes four vertical wood posts spaced at 12- to 14-foot intervals. Those posts support a 7x12-inch timber beam consisting of five sections that vary in length between 12 and 14 feet. The sections are joined together using simple rabbeting, with the joints being directly over each of the four vertical posts.

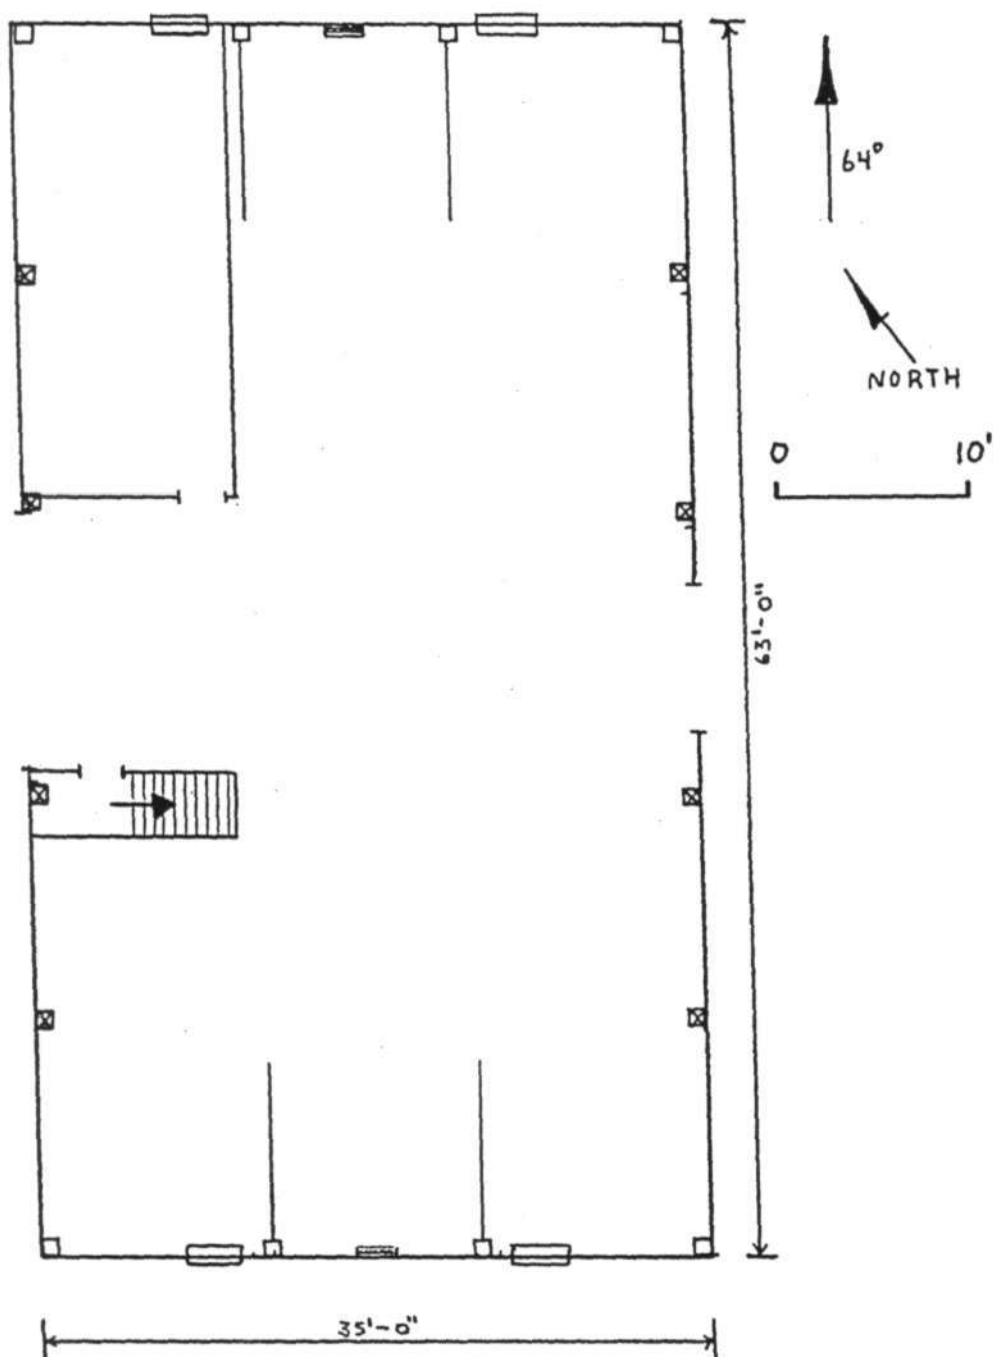
FLOOR PLAN - UPPER LEVEL
BANK BARN
(STRUCTURE # 4)

It appears that the bank barn's existing upper level was built at a later date than the lower level. While the barn's foundation and lower level exhibit an inscribed date and techniques consistent with a late 1930's construction vintage, the upper level and superstructure appear to be more recent. The bank barn's upper level frame superstructure and metal roof appear to date to circa 1945-1950. The roofing materials and ventilators are the same as those used in adjoining the dairy barn (circa 1945). Structure # 4 is in good condition. Its roof is in very good shape and has served to shield the building from the elements.

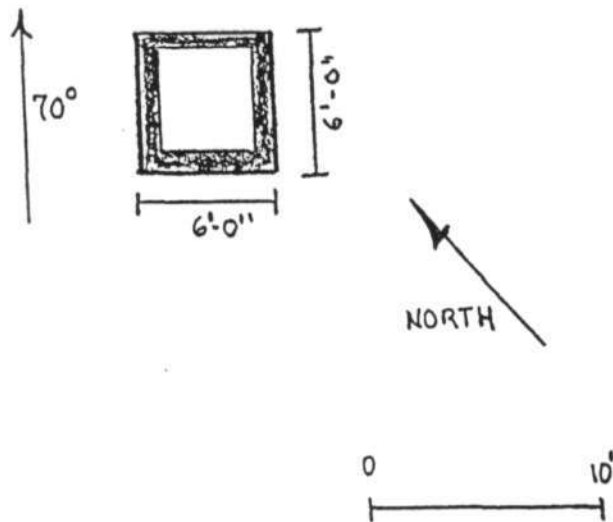
FLOOR PLAN
OUTBUILDING FOUNDATION
(STRUCTURE # 6)

To the rear of Structure # 5 there is a small rectangular concrete outbuilding foundation. It is designated Structure # 6. This feature measures 6 feet by 6 feet square. Its walls are 12 inches thick and rise to 18 inches above ground level. It has one bay.

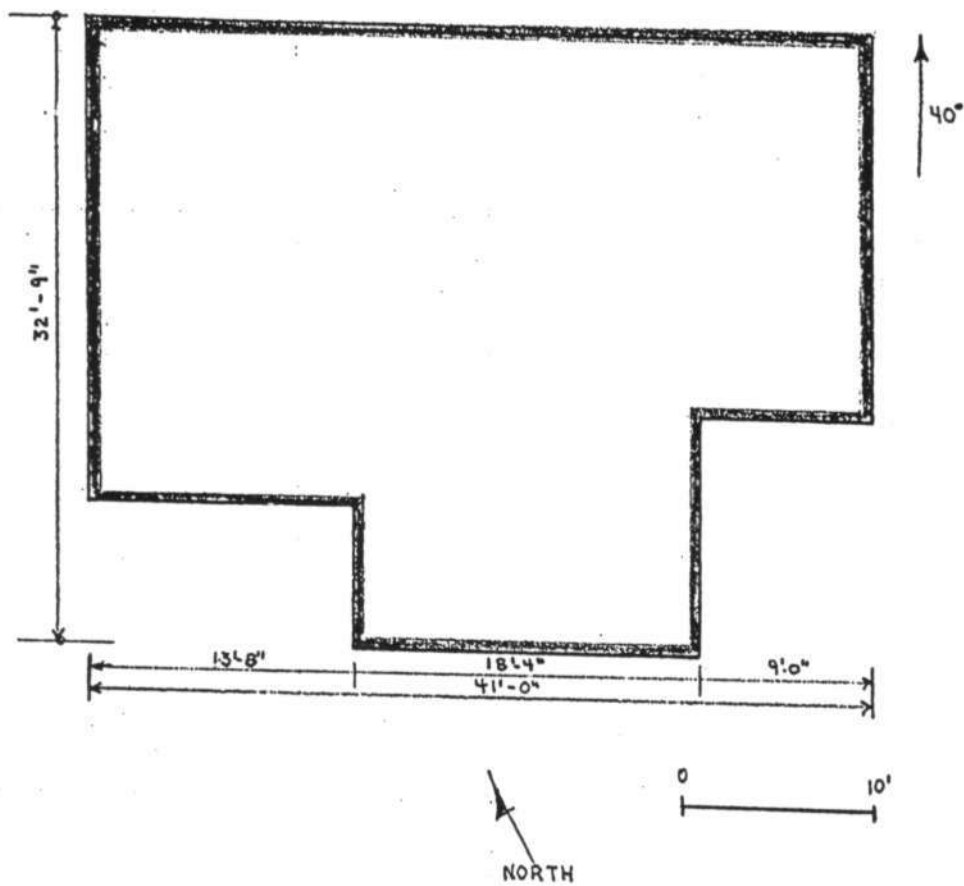
FLOOR PLAN
CAPE COD STYLE DWELLING
(STRUCTURE # 8)

Structure # 8 is a detached single family Cape Cod style dwelling at 4300 Montgomery Road. It is of frame construction on a poured concrete foundation. The overall dimensions of the house are 41 feet long by 32 feet 9 inches wide. The end walls of the house are oriented on a 40 degree magnetic azimuth. It is situated 90 feet from MD Route 103, and it has a driveway.

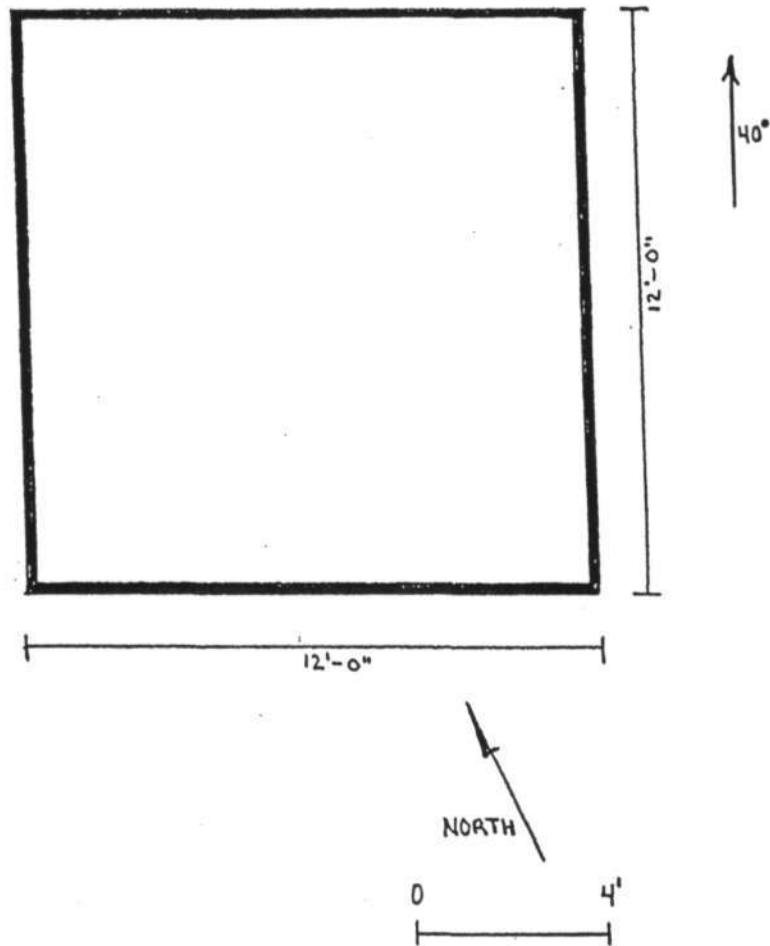
FLOOR PLAN
TOOL SHED
(STRUCTURE # 9)

Structure # 9 is a small rectangular shed on a concrete slab foundation located to the rear of Structure # 8. This feature measures 12 feet by 12 feet square. It is of frame construction with a corrugated metal shed roof.

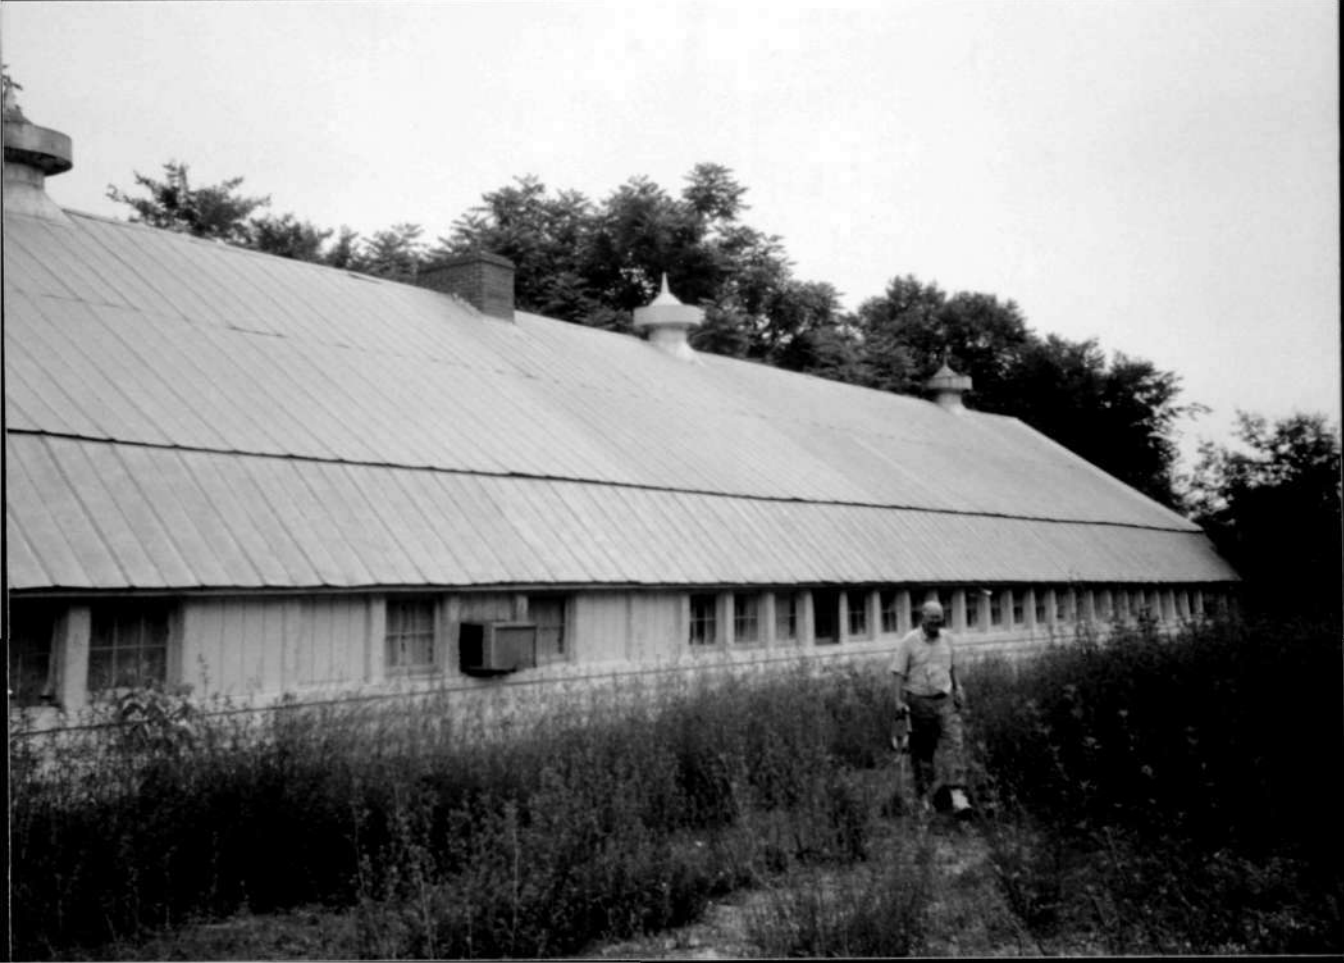
4 OF 13

STRUCTURE #2, DAIRY BARN, SIDE ELEVATION,
LOOKING SE.

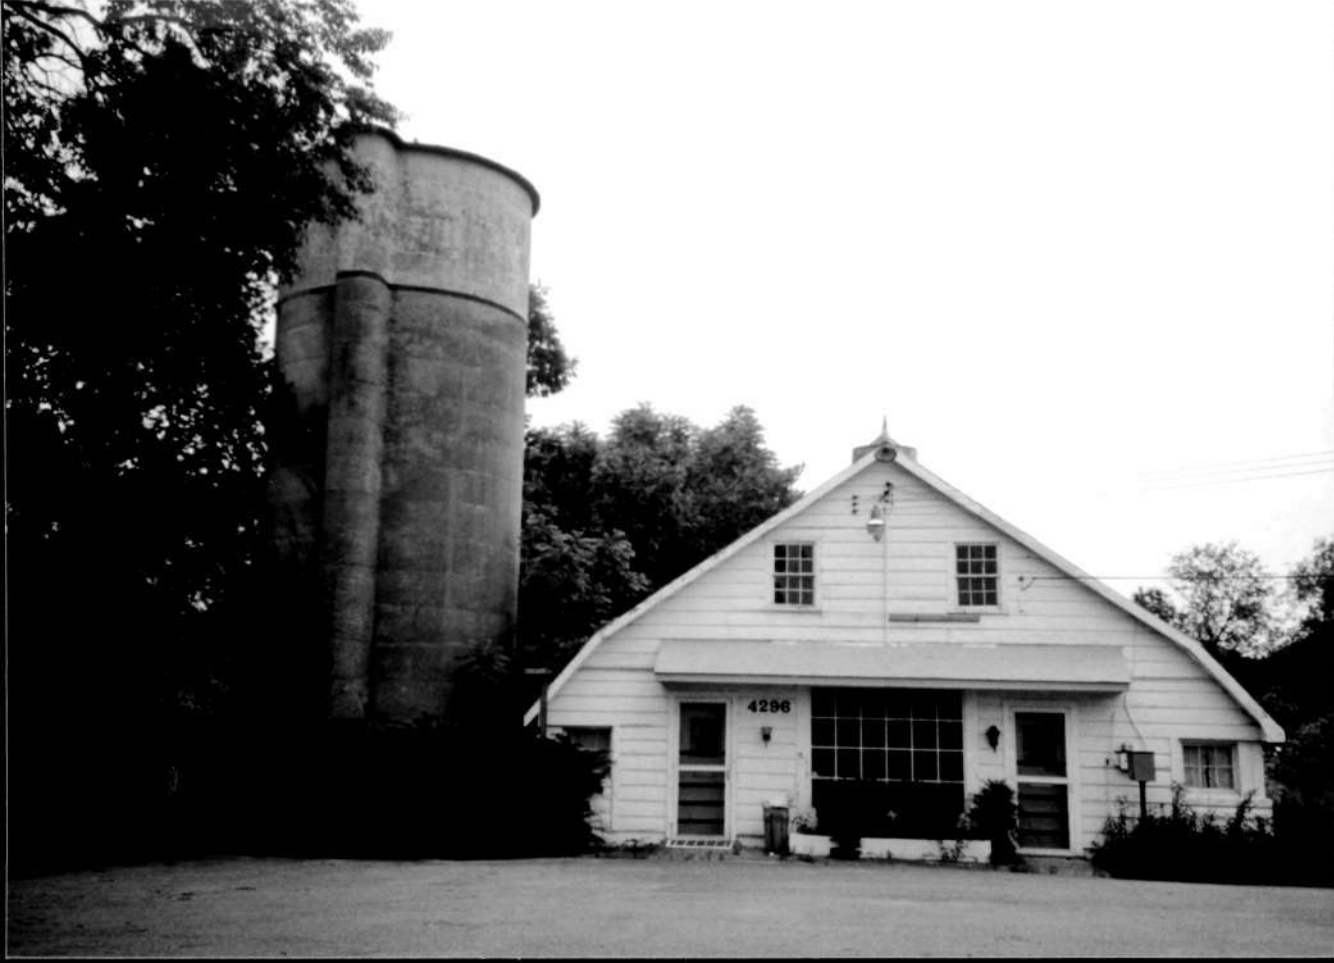
5 OF 13

STRUCTURE #3, SILO, AND STRUCTURE #2, DAIRY BARN
FRONT ELEVATION, LOOKING S.W.

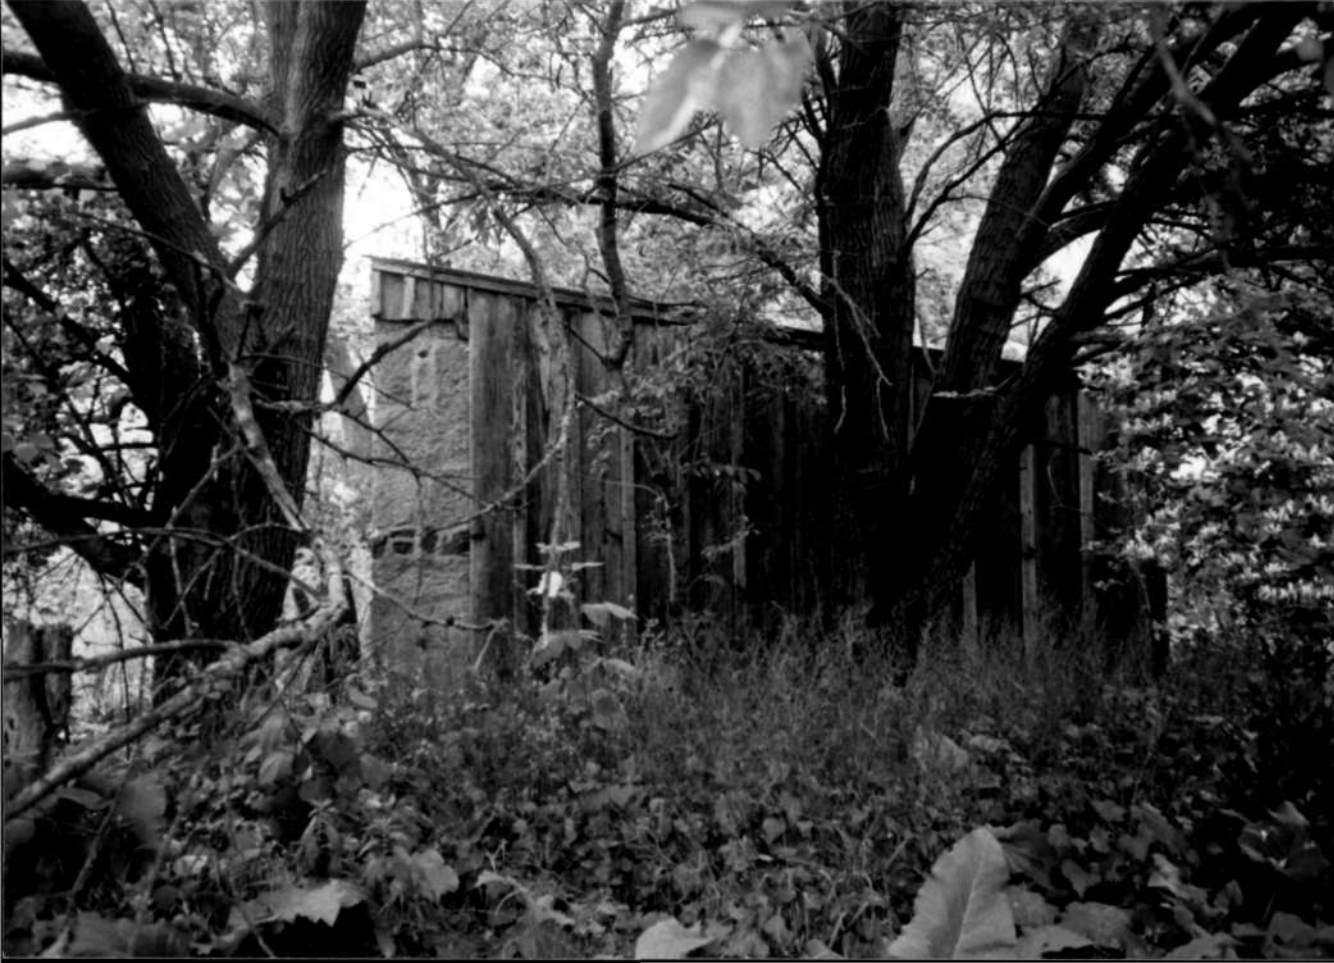
9 OF 13

STRUCTURE #5, FRAME SHED WITH STONE WALL,
SOUTHERN END, LOOKING NORTH.
