**MARYLAND HISTORICAL TRUST  
DETERMINATION OF ELIGIBILITY FORM**

Property Name: Howard Cotton Factory Inventory Number: HO-751  
 Address: 350 Route 32 City: Sykesville Zip Code: 21784  
 County: Howard USGS Topographic Map: Sykesville  
 Owner: Howard County, MD Is the property being evaluated a district?  yes  
 Tax Parcel Number: 54 Tax Map Number: 4 Tax Account ID Number:                       
 Project: South Branch Park Project Agency: Howard County Dept. of Recreation & Parks  
 Site visit by MHT Staff:  no  yes Name:                                      Date:                       
 Is the property located within a historic district?  yes  no

HO-751  
Howard Cotton Factory/B. F. Shriver Cannery  
350 Route 32  
Pictometry bird's-eye view of site looking west, 2017.

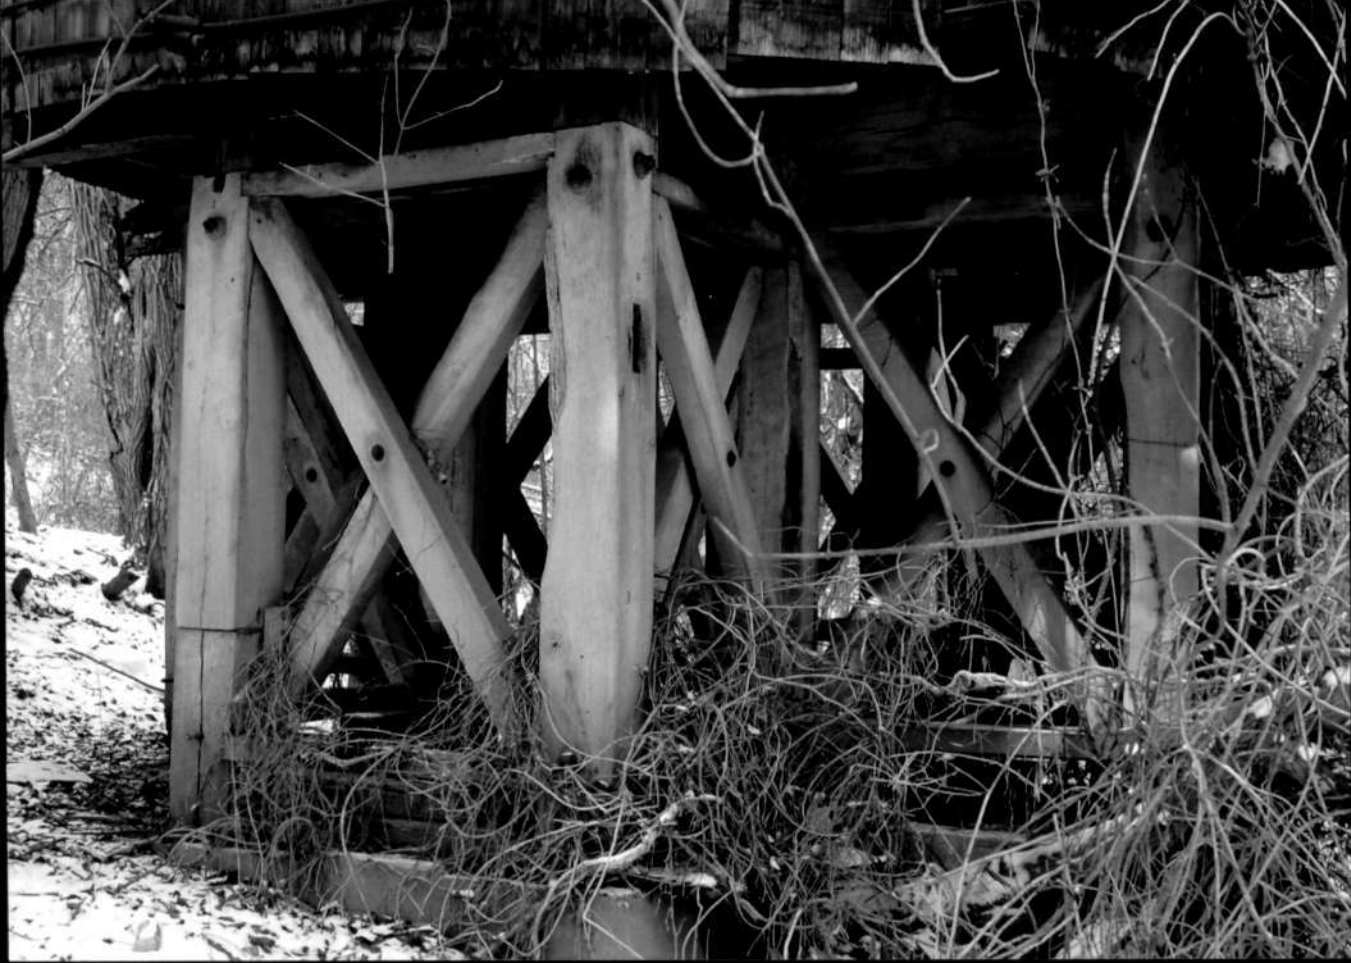
10 of 12

Water tank, view fr. southeast

**Note:** The water tower was heavily overgrown and was not described in the 2011 inventory of the property. In 2014 the Howard County Department of Recreation and Parks rented the site from the Town of Sykesville to use as a park and the water tower, which had not been maintained and was in a deteriorated condition, was dismantled for future renovation and re-erection. The immediate area was cleared, and the structure was examined, measured, and drawn prior to the dismantling. The following report is a result of that work. The pieces of the water tank were reportedly stored in the brick warehouse on the site and the water tank has not been re-erected as of late 2023.

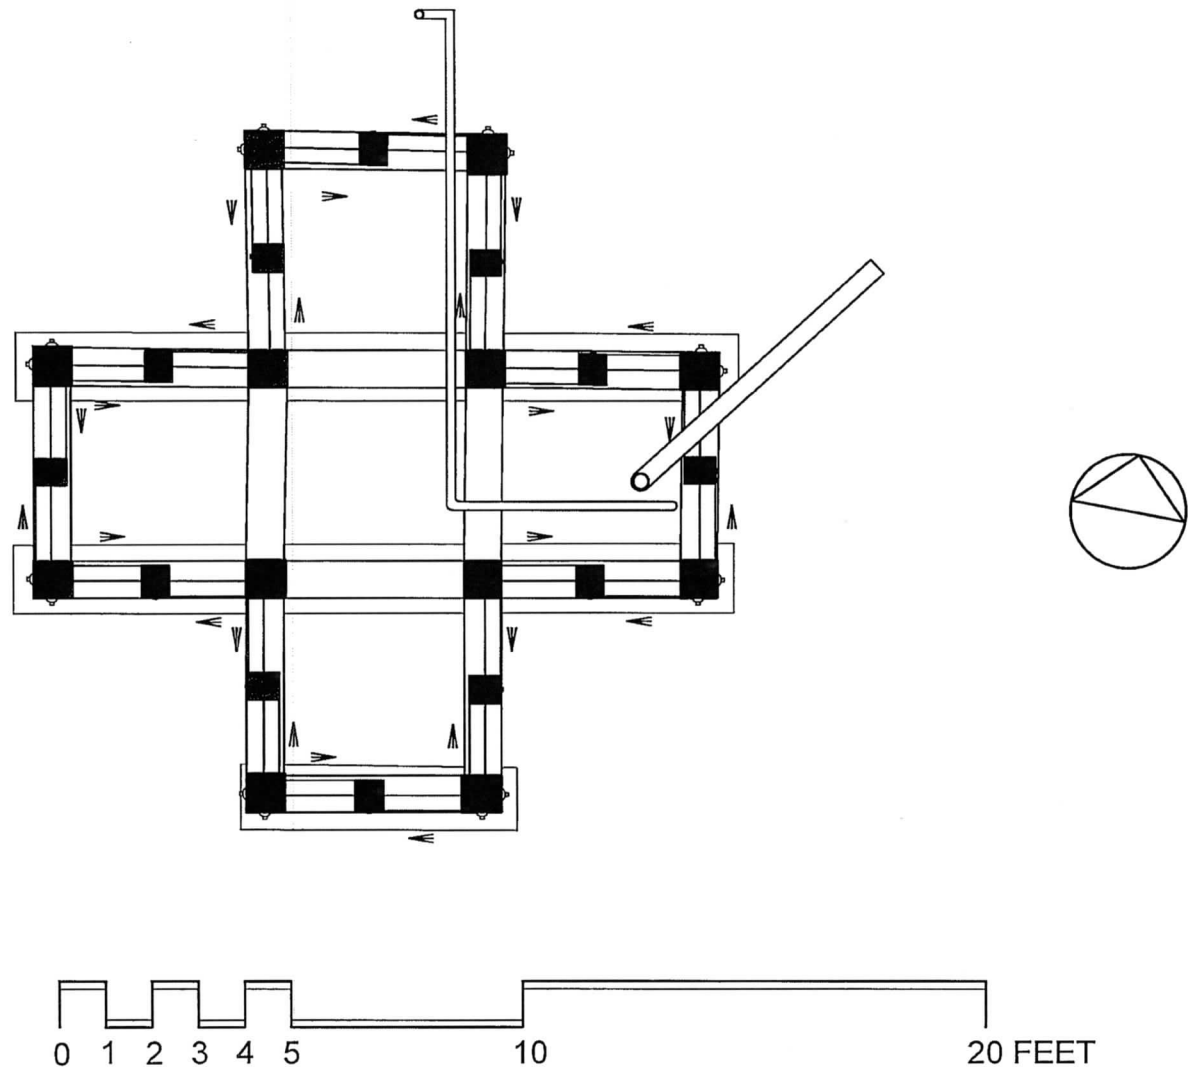
WATER TOWER PLAN -- MEASURED BY KEN SHORT & STEVE ROLLS -- DRAWN BY KEN SHORT -- MARCH 2014

During dismantling it was discovered that the staves of the tank were drilled through near the top, with long, thinner wood pegs driven through the holes to help guide and hold them in place, probably especially during erection. The edges of the staves are otherwise planed smooth to abut the adjoining staves.

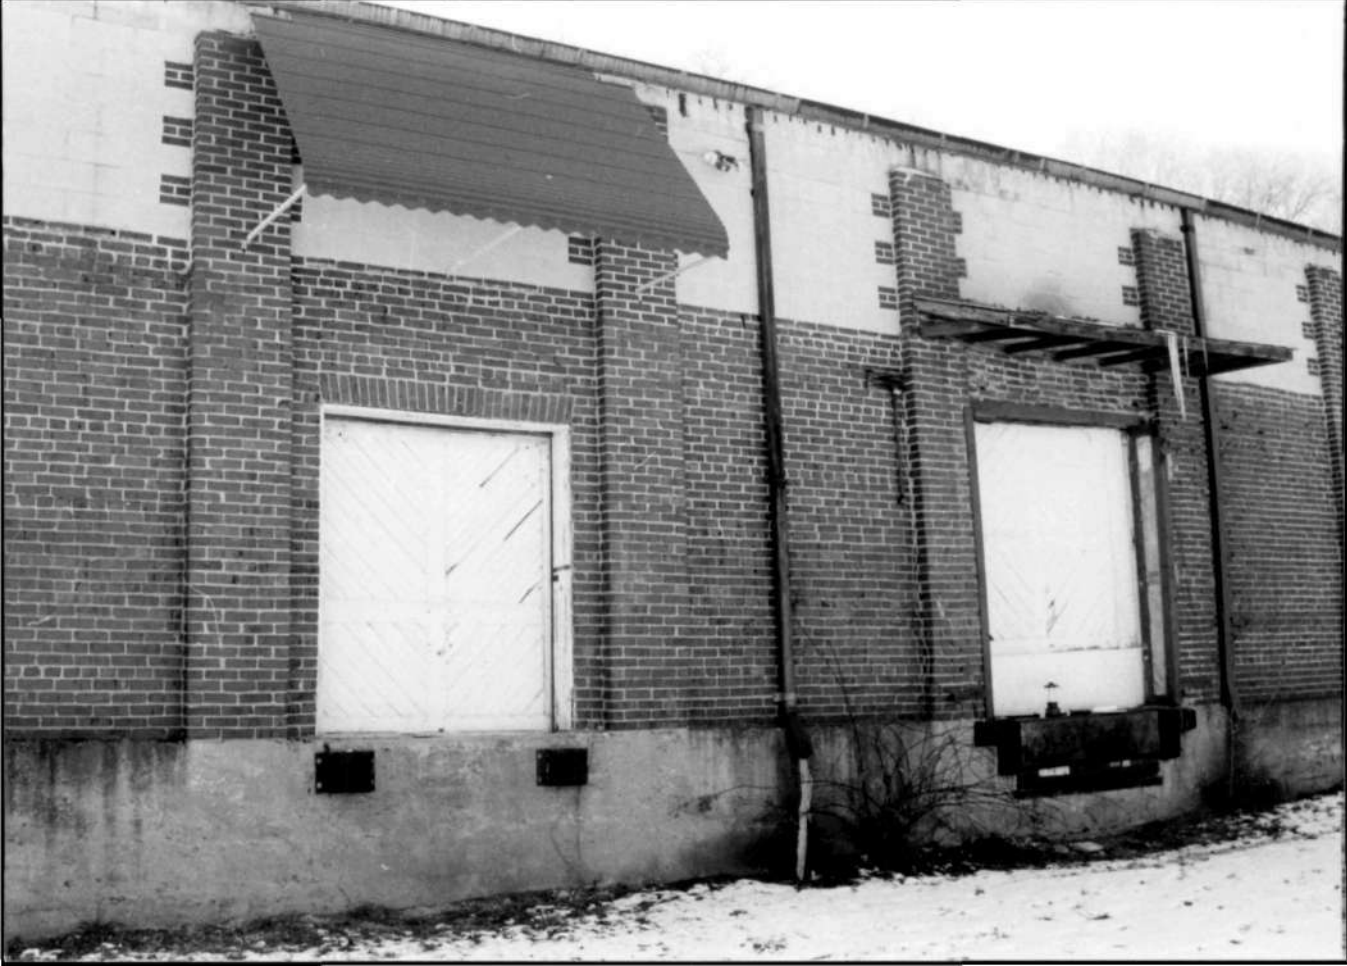
Brick warehouse, east facade, loading dock  
detail

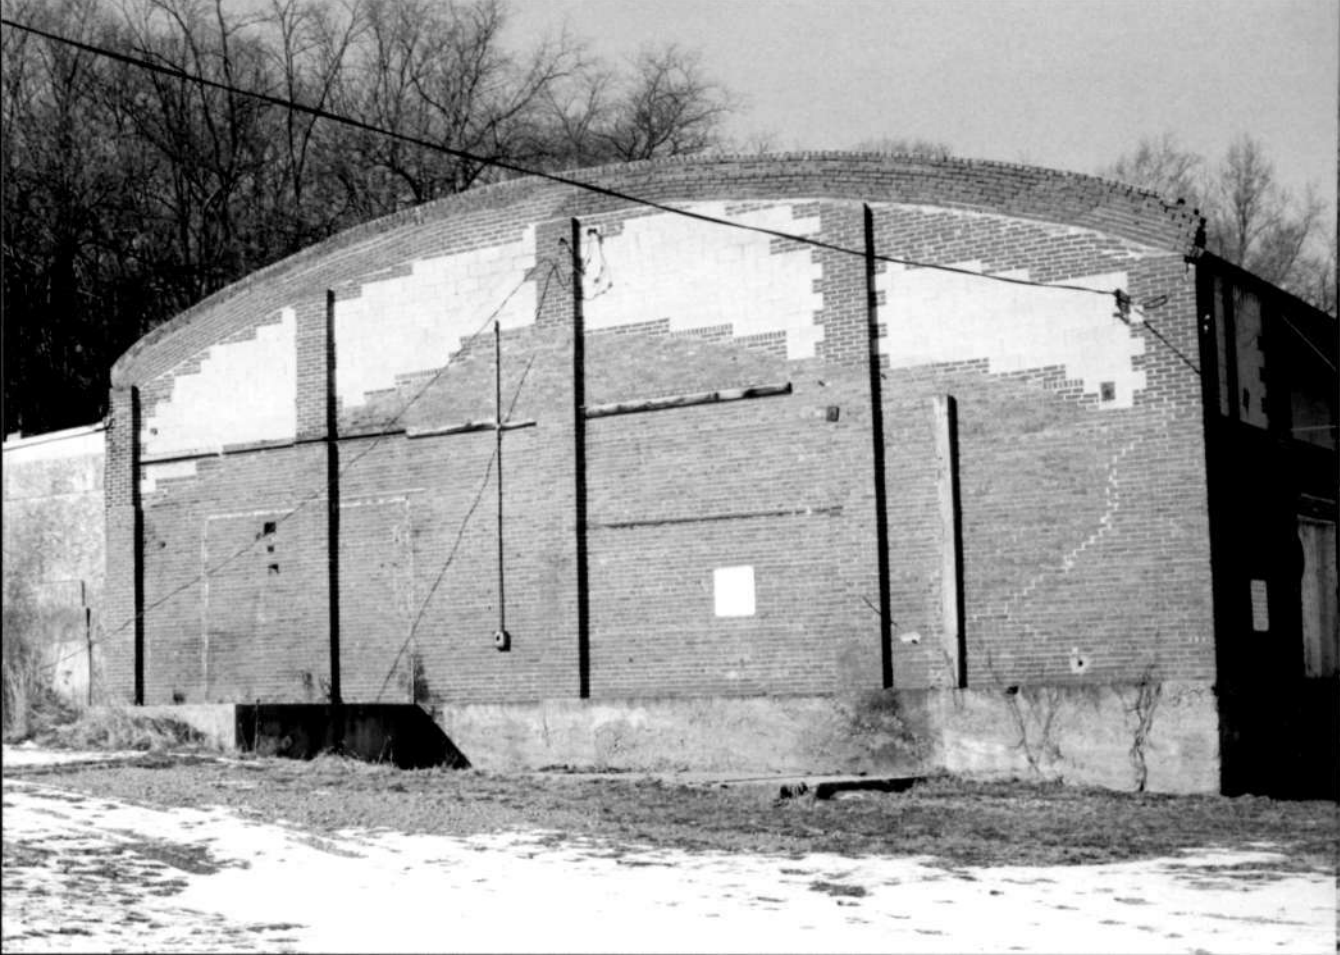
6 of 49

The south facade clearly shows the original gable roof form and the added arched parapet, which is two wythes in depth and laid in running bond with a top course of headers. This façade is four bays wide, again separated by brick buttresses. A projection of the concrete foundation at the west end and a bricked in opening indicate a former truck bay on this facade. Boards attached to the wall indicate where a shed or awning once covered the bay.

Brick Warehouse, South facade

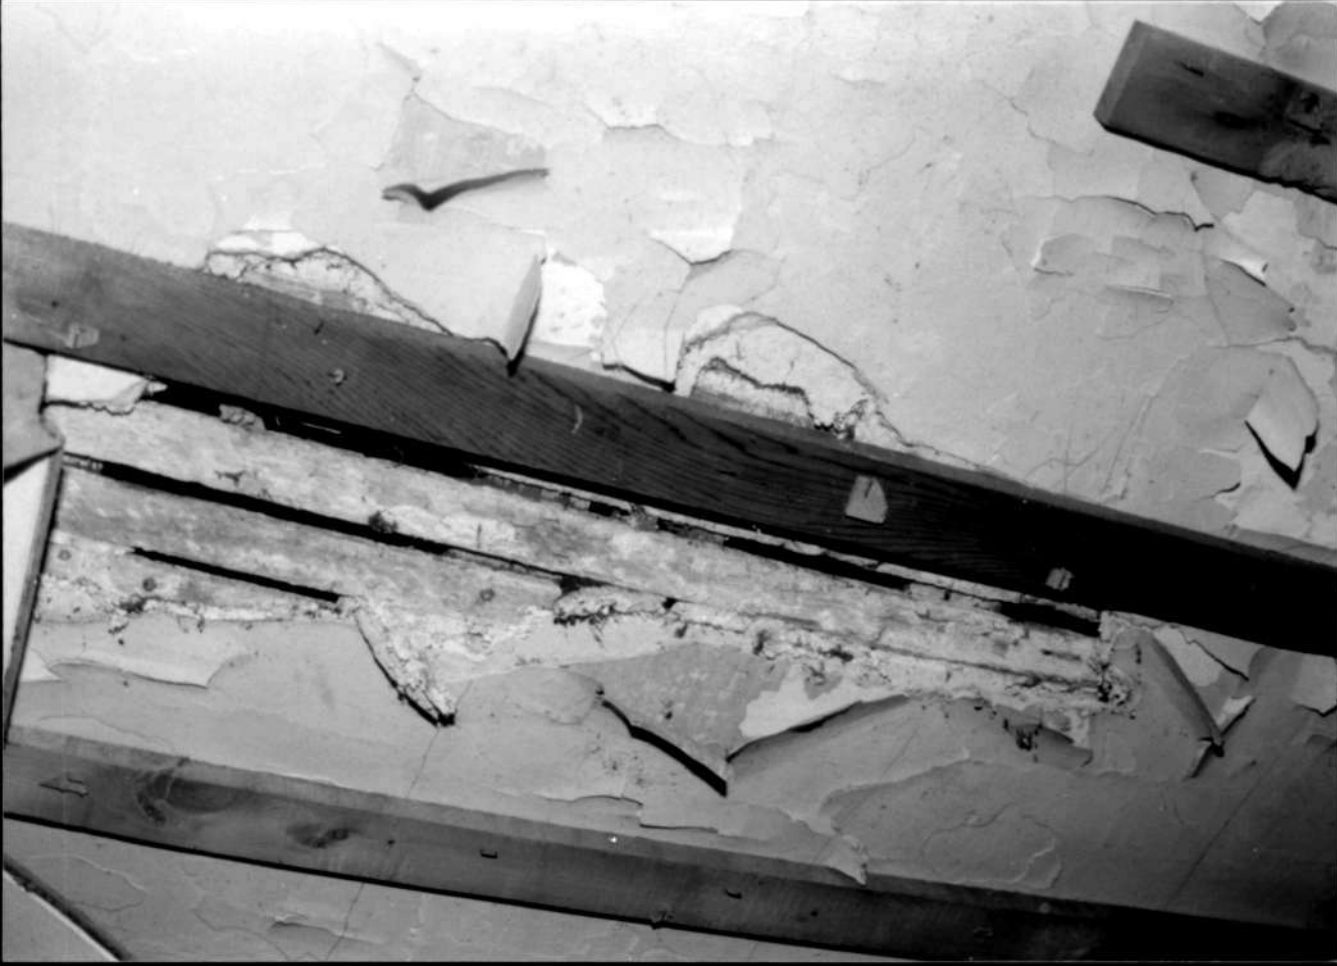
237 49

Stone house, interior view of plaster ceiling

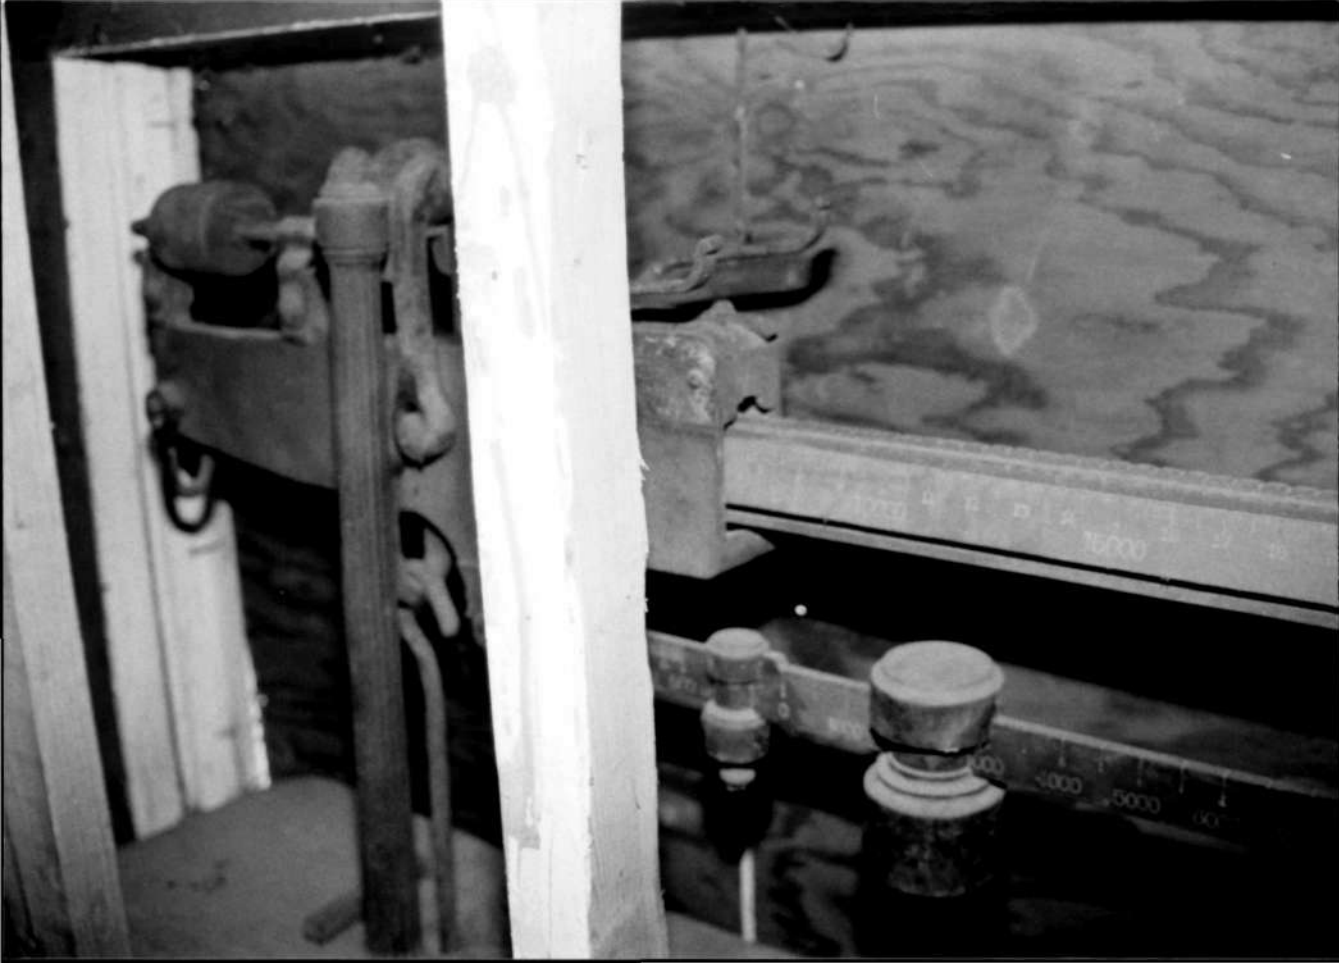
41 of 49

The entrance to the scale was from the south into the open space of the building. Long granite blocks in the ground extend southward from southwest and northeast walls, acting as guides for truck drivers entering the scale. The scale base is flush with the ground and constructed of wood planks within a concrete surround. The scale itself was located in an inset on the southwest wall of the office. Now covered from the exterior, the scale was visible behind the interior office wall. In good condition, the cast iron scale is model #7705 manufactured by the Howe Scale Company in Eastland, Vermont.

detail of scale inside west wall  
of office. Scale manufactured  
by HOWE SCALE COMPANY  
EASTLAND, VT.
