HO-798

## Claremont

### **Architectural Survey File**

"Claremont"

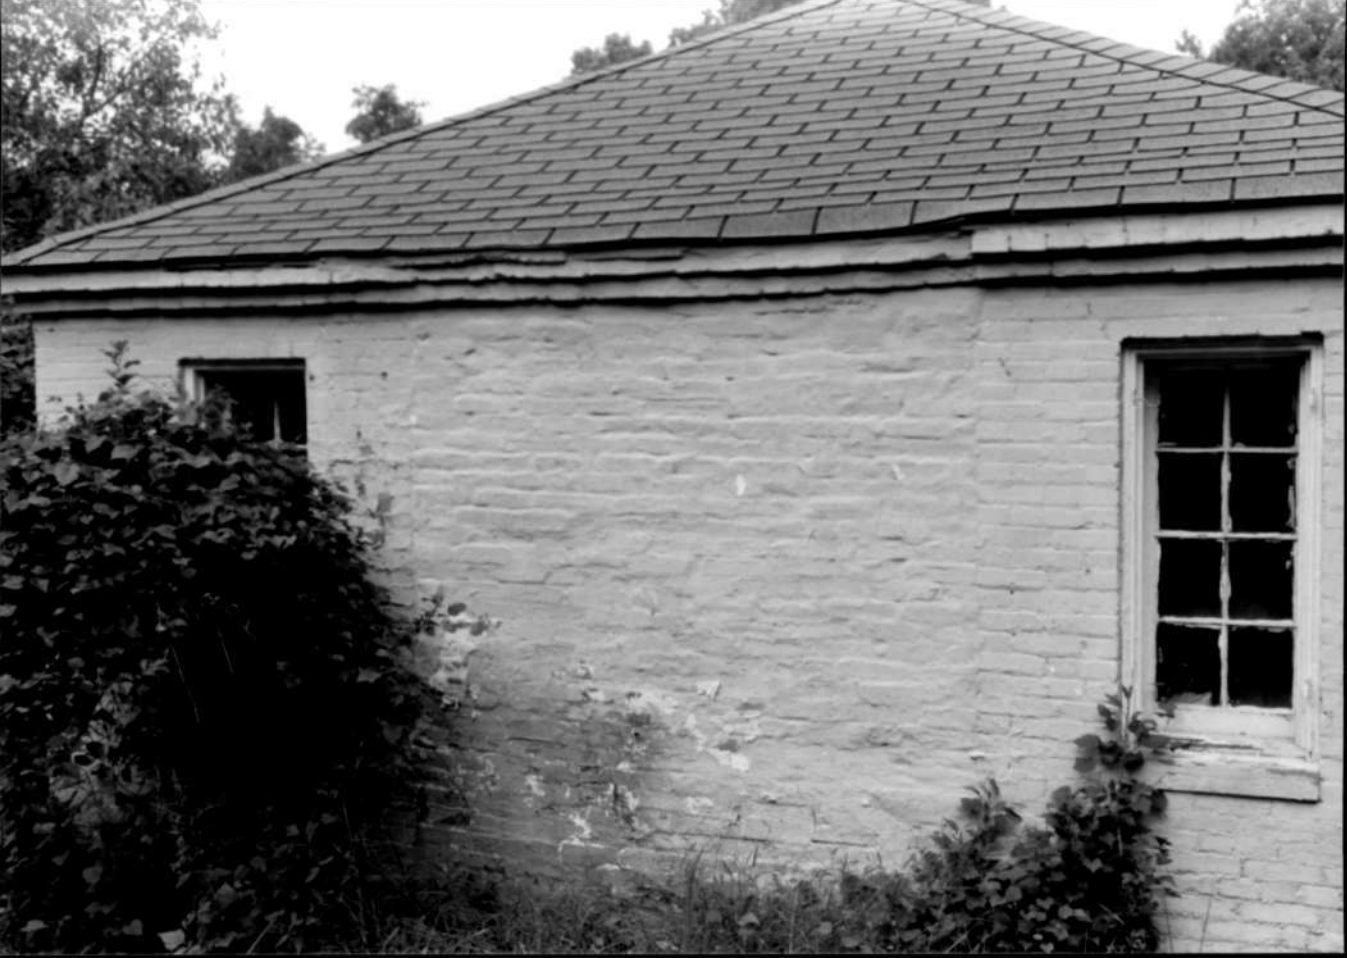
30134

Brick summer kitchen, NE elevation, notice patch on E wall

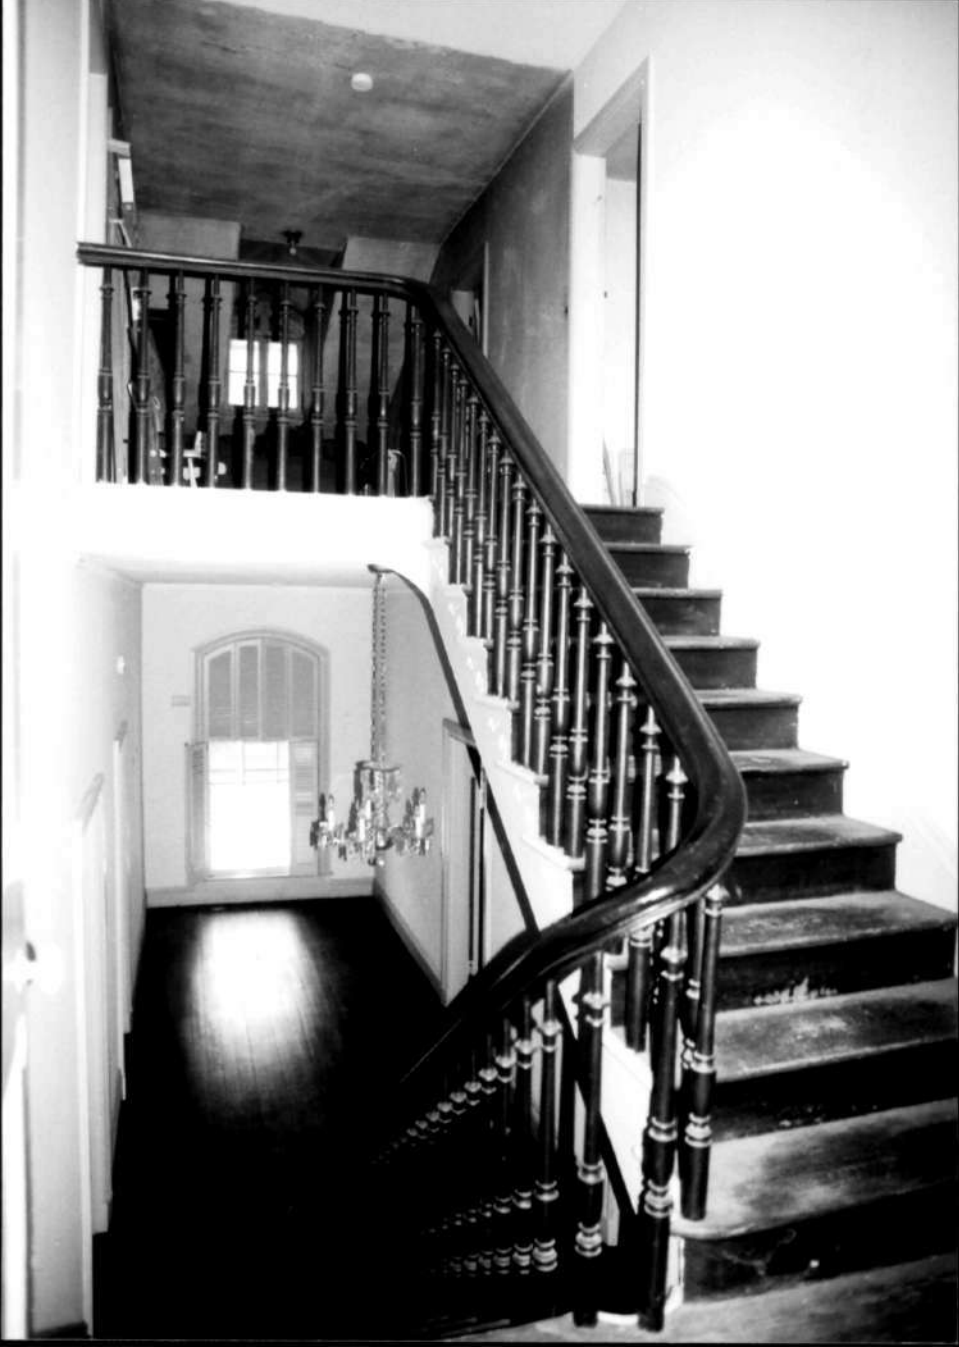
18/340

Board found in new post

The inscription was found on a board inside the newel post:

*Columns [on Anchors?] executed by John H. Pugsley, Baltimore.*

*Architect R. Snowden Andrews, Baltimore. Aug. 1858, finished Oct. 1858."*

A narrow wooden board found in the house has written on it: "This house owned by Dr. J. Hall of Baltimore. Built by Johnzee Selby, Carroll Co. and John S. Miller, Balt. Co. Painted by John Bowerson, Balt. Co. Collums [sic] on Anchors executed by John H. Pugsley, Baltimore. Architect R. Snowden Andrews, Baltimore. Aug. 1858, finished Oct. 1858." The date of completion, prior to the execution of the deed, is rare confirmation of a pattern seen frequently in the nineteenth century – that new owners would add to or replace buildings before actually having legal title to the property on which they sat. Johnzee Selby was listed in the 1860 census as a 54-year-old farmer, but was also a well-known builder in the area of Sykesville. Miller is listed in the 1860 census as a 50-year-old carpenter, and was living in southwestern Baltimore County, in the Soldier's Delight area. John H. Pugsley seems to have been a carpenter of questionable character. The New York native was arrested in 1851 on suspicion of arson, but could not be connected to the incendiary materials and was released. In 1859 he was arrested for brutally beating his 15-year-old daughter and was found guilty. The 1860 census lists the 47-year-old carpenter twice, in early July living at home in the eighth ward of Baltimore City, and by the end of the month residing in the city jail. Despite his deficiencies of character, Pugsley must have been a capable mechanic, if he was still being hired in 1858 to do specialty carpentry.<sup>2</sup>
