HO-895

Isaacs-Wright House (Eganor)

Architectural Survey File

Isaacs-Wright House
3866 Ivory Road
Private

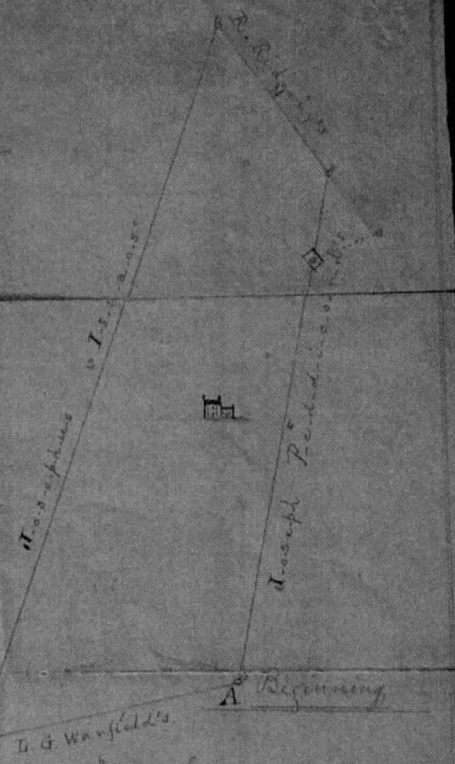
1870 plat of 1 1/4 acres in possession of Consuelo & Lawrence Alexander

⁵ Howard County Transfer Books, 1870 and 1871, Maryland State Archives. The owners possess a plat of the property from prior to 1870 which reportedly shows the house in its present configuration, and they surmise that the main block is much earlier than 1870. Unfortunately, this plat could not be located at this time, so this question must remain open, for now. However, no physical evidence of the main block having been altered was observed.

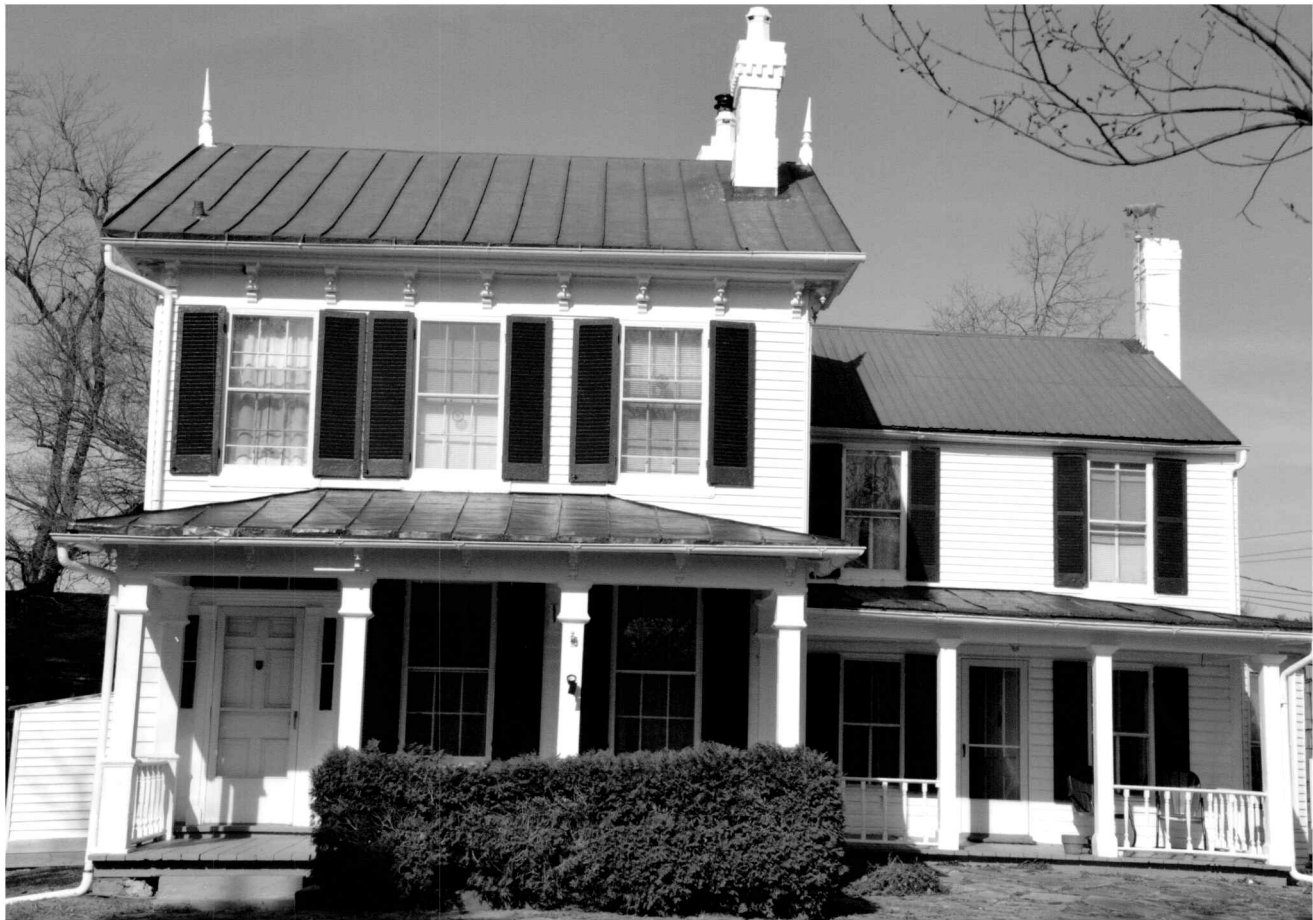
1 of 18

House, south elevation

On the south elevation, the main block first story has a door in the west bay with six belection-moulded panels, with a square engaged column to each side that has an ogee-and-bevel cornice. There are sidelights with two lights over one panel that has a sunken field and quirked ogee panel moulds. There is a three-light transom, with a quirked ogee-and-bevel on the transom bar. The center and east bays each have a six-over-six double-hung sash with a frame that has a beaded interior edge. There are wood blinds that are mortised and tenoned and pinned, have no center rail, and have cast iron shutter dogs with a shell pattern. There is a one-story, three-bay porch with a new wood deck and a new railing added by the current owners using old balusters that did not come from this house. There are four boxed wood posts that have an ovolo surbase moulding, a capital with an ogee above an ovolo, and an entablature block with a cavetto cap on the top. The porch ceiling is slats. There is a bracketed frieze with pendant drops on the brackets and small drops at the corners, and a semi-hipped roof with standing-seam metal. The second story has three six-over-six double-hung sash with wood blinds and a bracketed frieze with pendant drops that are larger and of a different pattern than those on the porch. The cornice has returns and larger drop pendants at the corners, with a large ogee on the cornice. There are two interior brick chimneys on the east side of the main block, with brick dentils and an octagonal chimney pot. The east and west ends of the ridge have a turned wood finial with a pendant drop on the bottom.

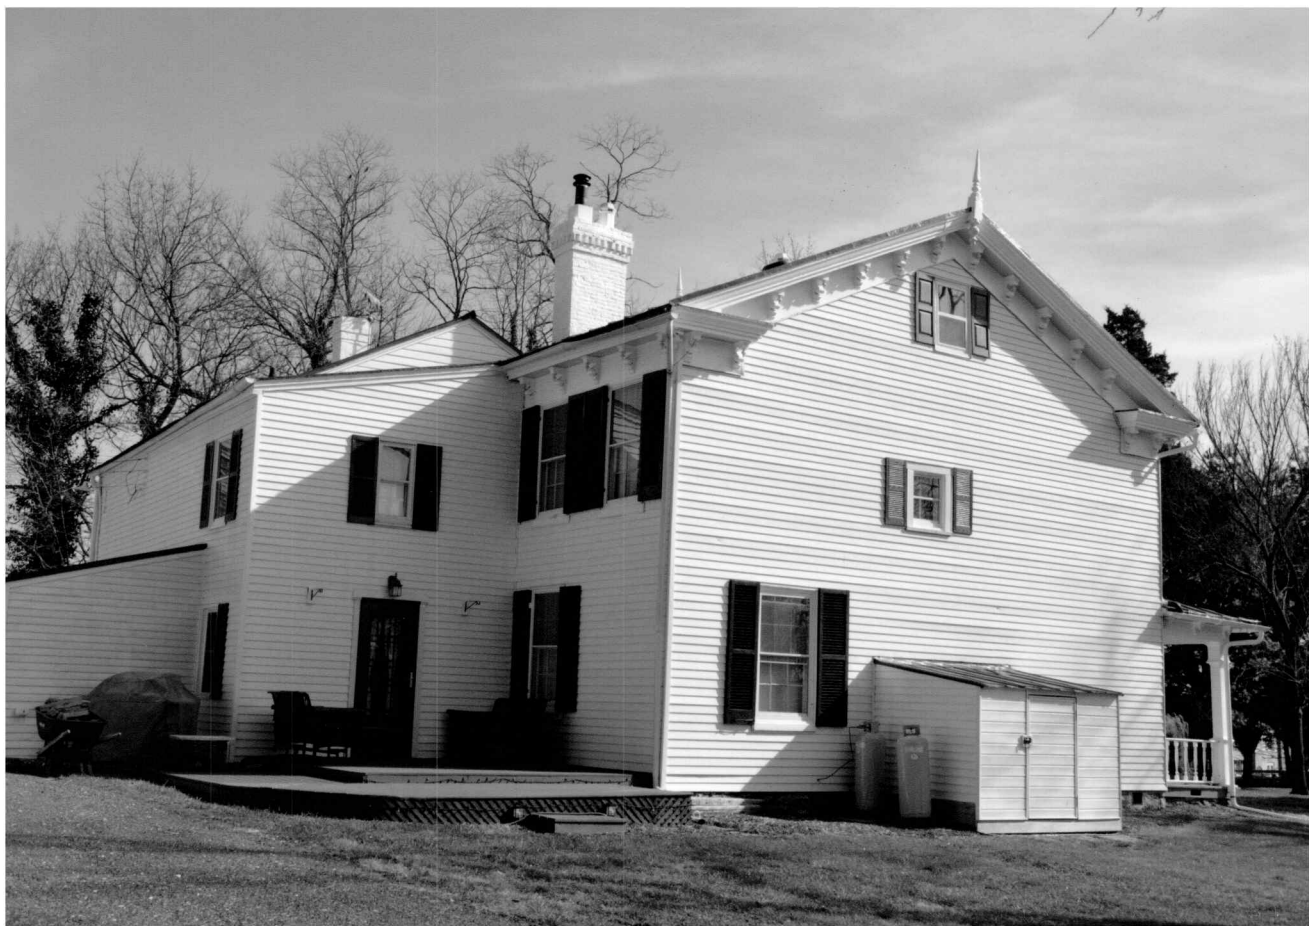
2 of 18

House, north & west elevations

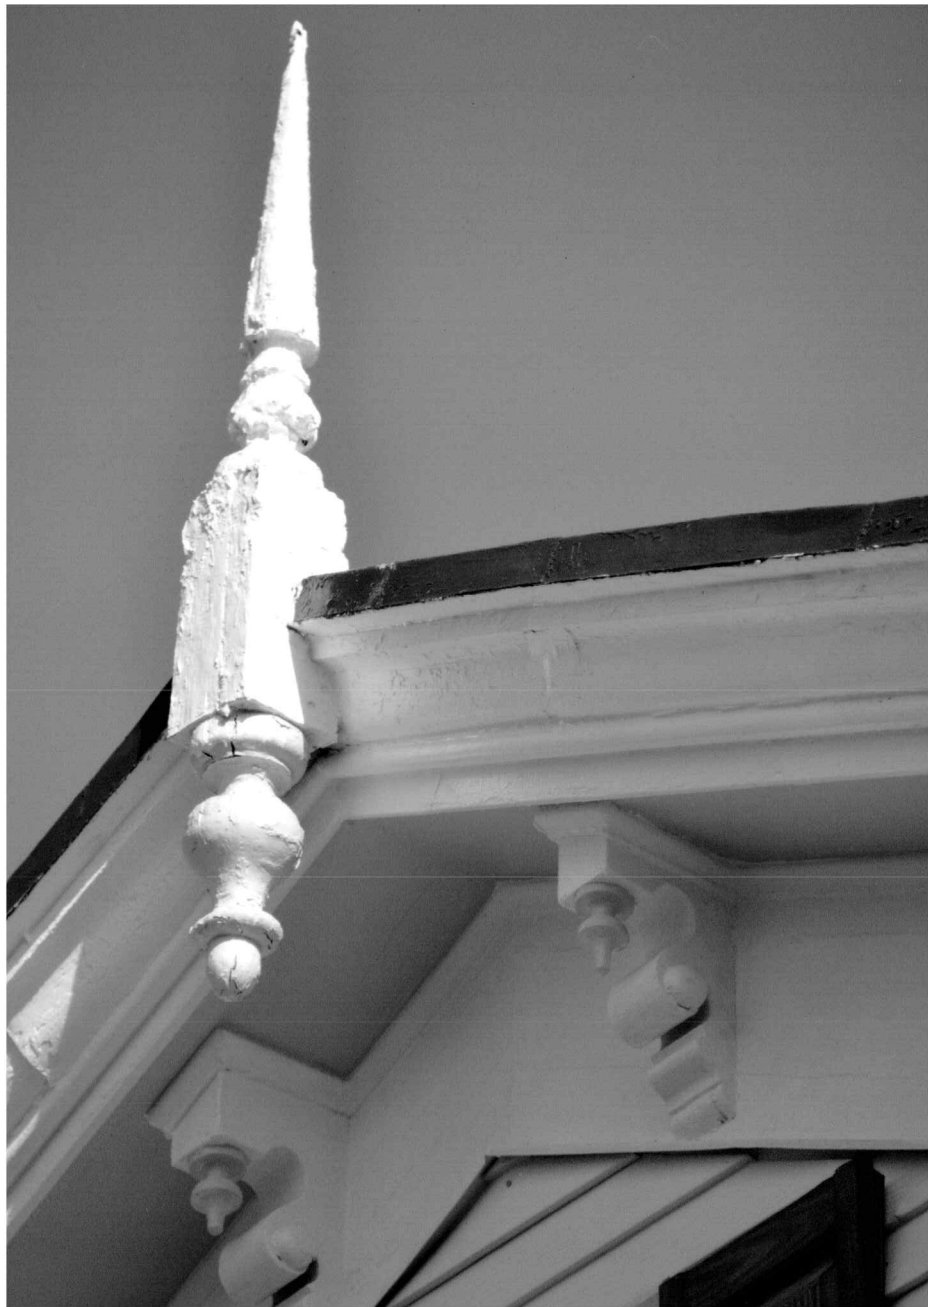
3 of 18

House, west elevation gable ridge

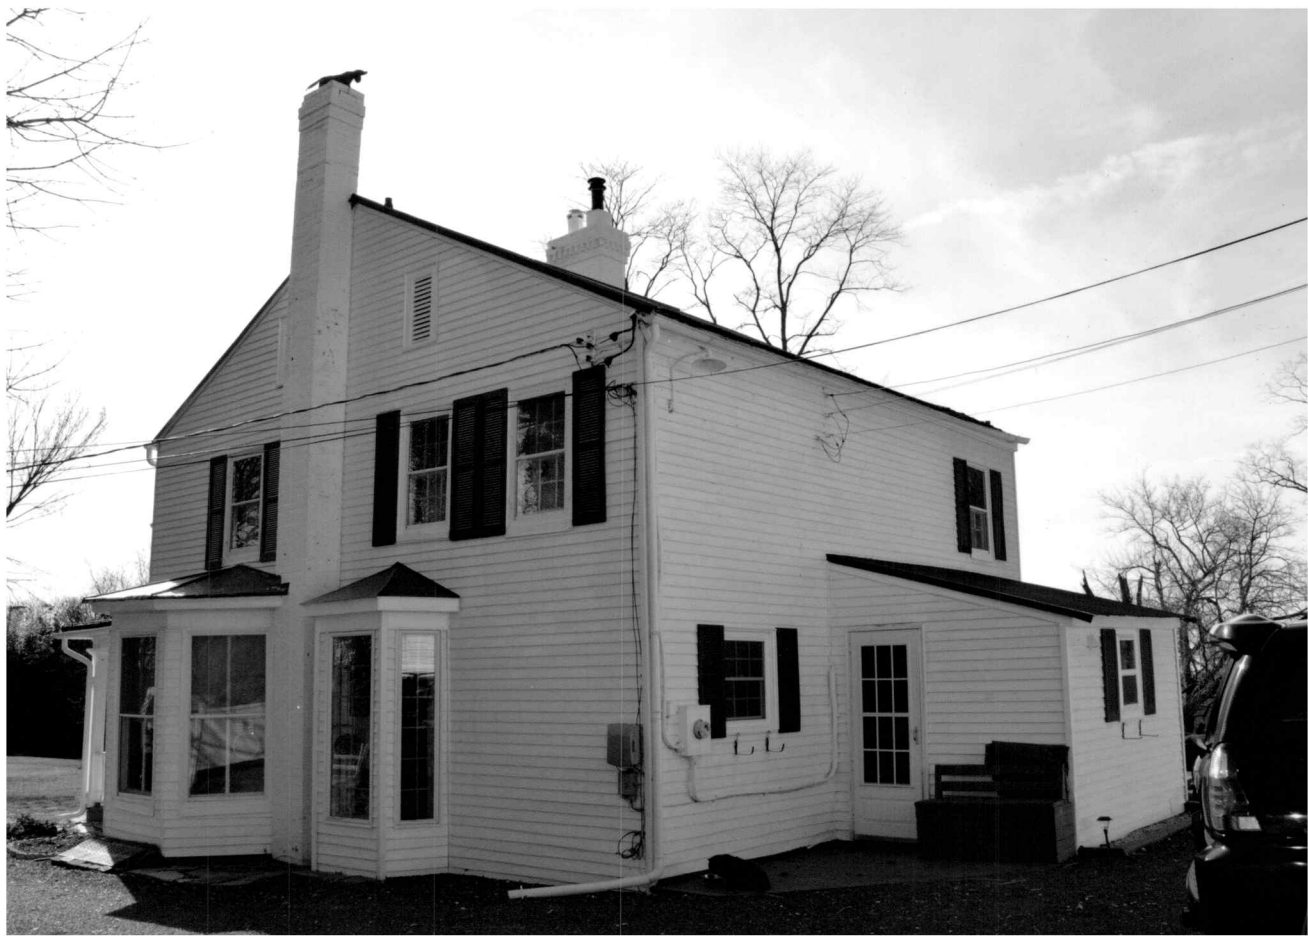
4 of 18

House, east & north elevations

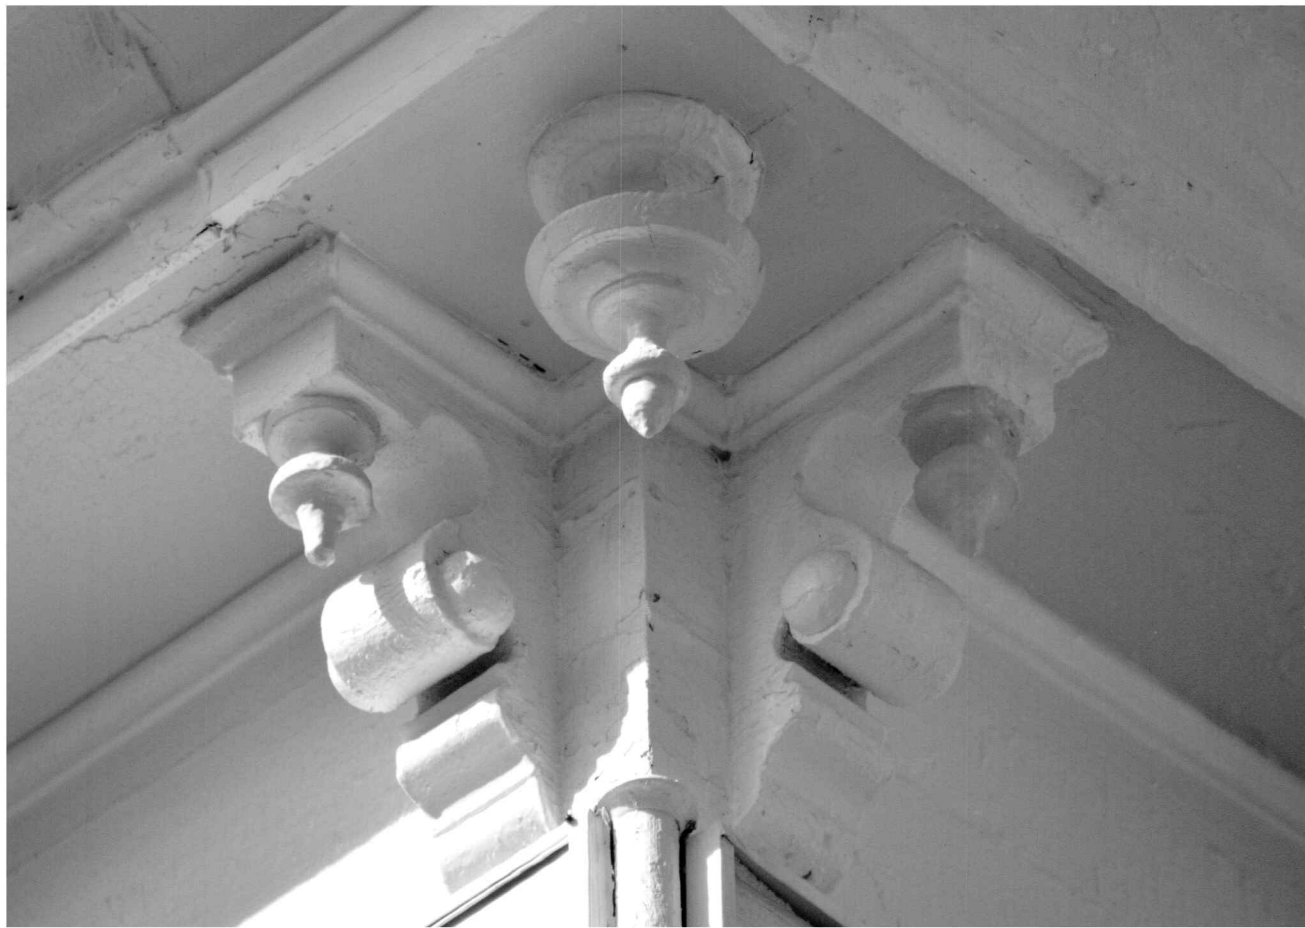
5 of 18

House, Southeast corner, cornice brackets,
pendant drop, & roll moulding

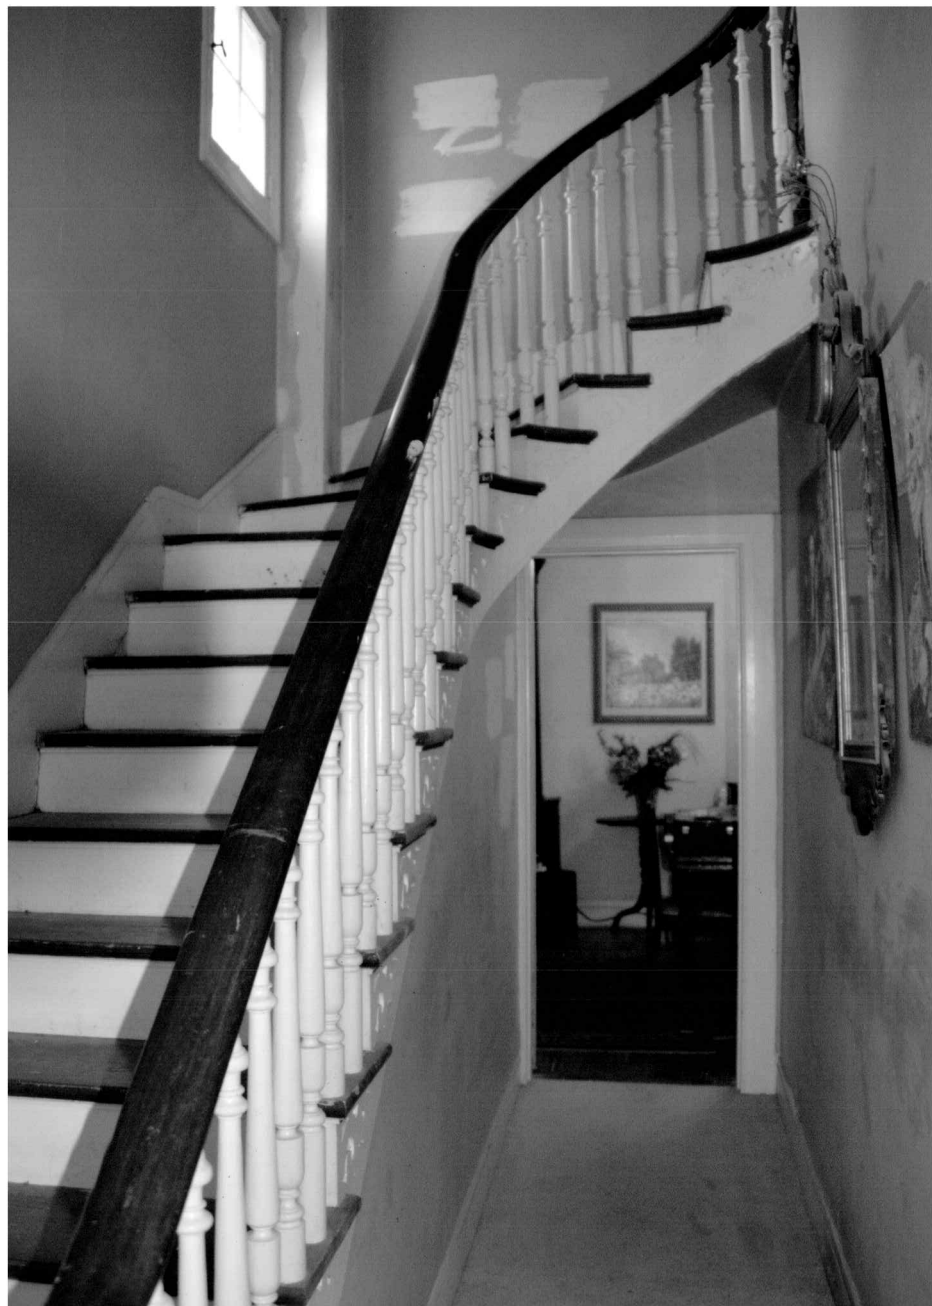
6 of 18

House, passage, view north

The passage flooring is random-width tongue-and-grooved pine that ranges between 3 ½ and 6 ½ inches, with most floorboards being around 5 inches wide. The baseboard has a broken field and no moulding on top. The architrave also has a broken field, with a bead on the inner edge. The front door has six panels with sunken fields and no panel moulds. It is mortised and tenoned and pinned. There is a cast iron rim lock with a new brass knob, and it is either not the original lock, or there was at least another lock above it. The door is hung on cast iron butt hinges with five knuckles. The sidelights have a sunken and flat panel with a quirked Greek ogee panel mould, and the rails and stiles are mortised and tenoned and pinned. The three-light transom is also mortised and tenoned and pinned, but has new colored glass. The door to the southwest room has four panels with sunken fields and quirked ogee-and-

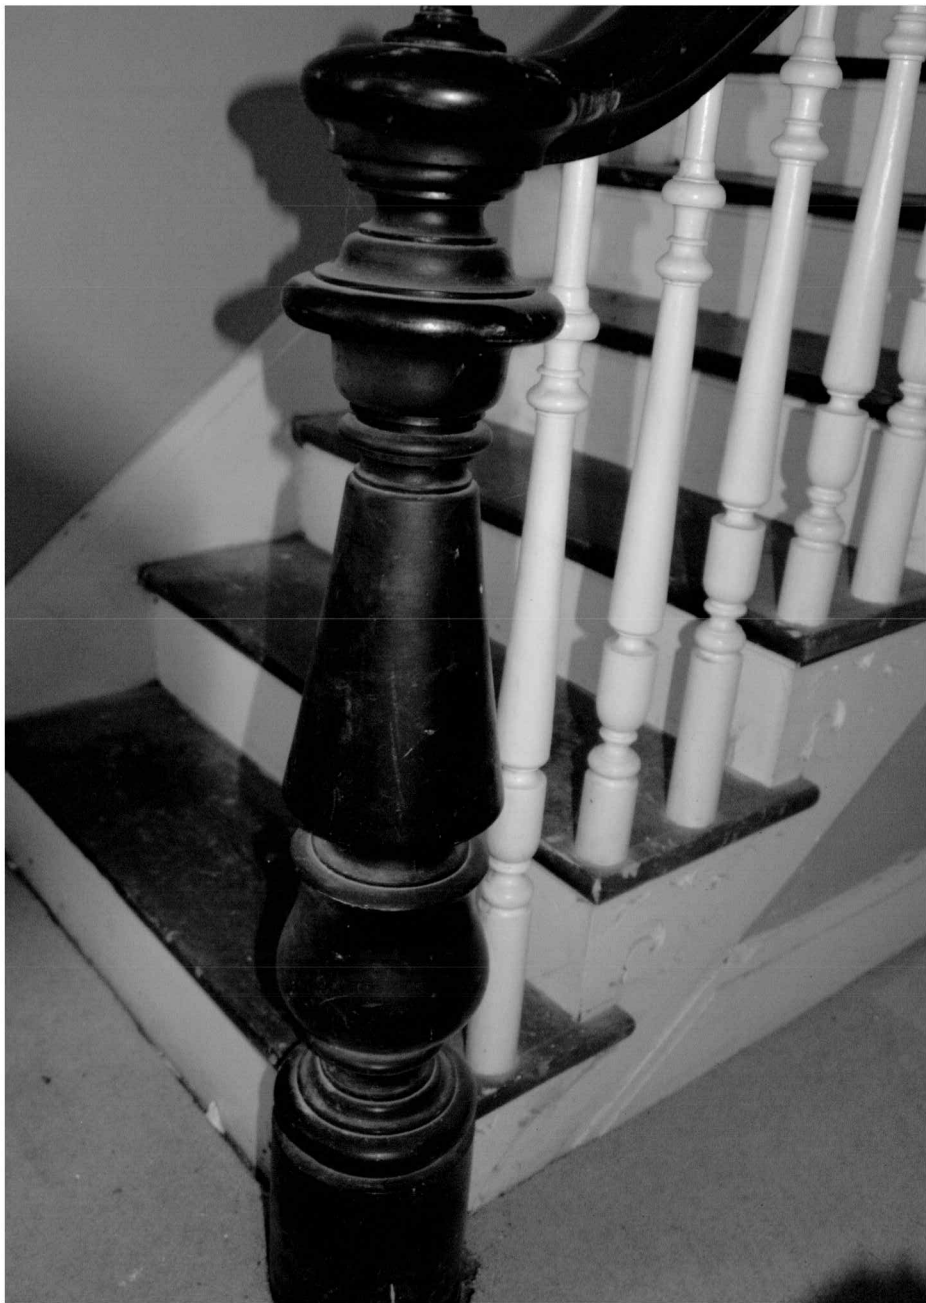
7 of 18

House, Stair newel

bevel panel moulds. It is mortised and tenoned and pinned, has a plain cast iron rim lock with brass knobs, and plain cast iron butt hinges with five knuckles. The door to the northwest room is identical to the door to the southwest room. There is a stairway on the west wall that ascends to the north, with winder stairs at the north end; the interior stringer and the handrail at the north end are curved. The open stringer has sawn, foliate brackets. The turned newel post appears to be walnut and is in an urn pattern, but with bold, heavy mouldings. The balusters are turned and tapered, with an urn profile, and are painted. The handrail also appears to be walnut and is ovoid in profile.

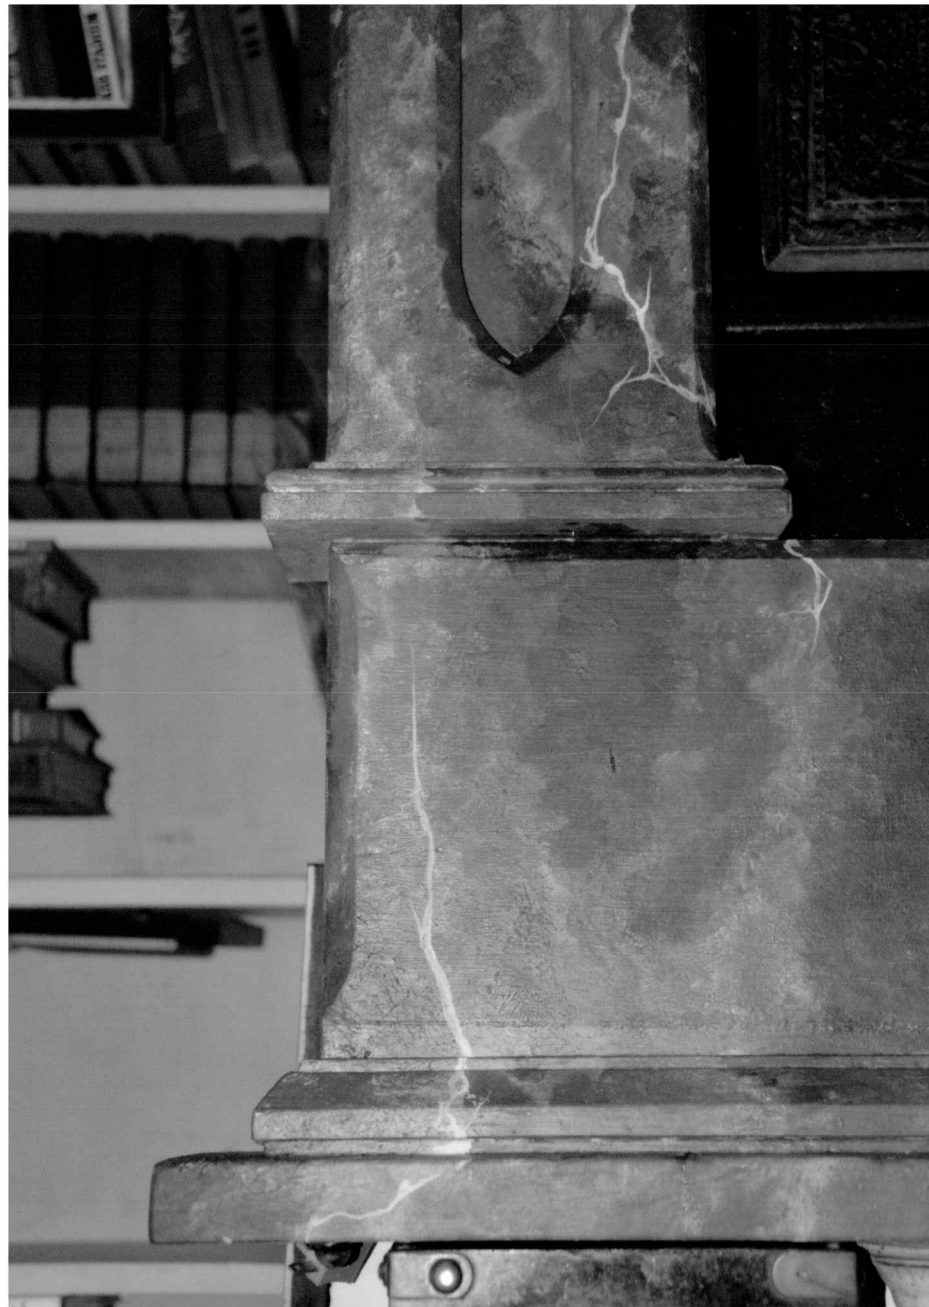
9 of 18

House, Southwest room, mantel detail

The southwest room flooring is mostly 3 ½-inch tongue and grooved pine that runs north-south. At the north end of the room is some random-width tongue-and-grooved pine that ranges between 3 ½ and 6 ½ inches, with most floorboards being around 5 inches wide. The walls are plaster and the baseboard and architrave match that in the passage. The window sash have Gothic lancet profiles to the muntins, 10-inch by 16-inch lights, and are mortised and tenoned and pinned at the corners and the muntins to the rails. There are parting beads and spring latches with long, thin barrels that are drilled through the rail, and the latch pulls out. There is a small wood cornice moulding around the room, with an ovolo over a cavetto. There is a chimney breast on the east that was originally just for a stove, but it has been opened up to create a fake fireplace. It has a wood mantel that has pilasters with sunken panels that have a lancet profile. The frieze is plain and the bed mould has a bevel and fillet. On the north elevation is a new pair of French doors added by the current owners. There is a ghost of a wall on the floor in the northeast corner of the room where a bathroom used to stand. It was added by a previous owner who subdivided the house into four rooms with bathrooms that were rented out to hunters in the 1920s and '30s, according to the current owners.

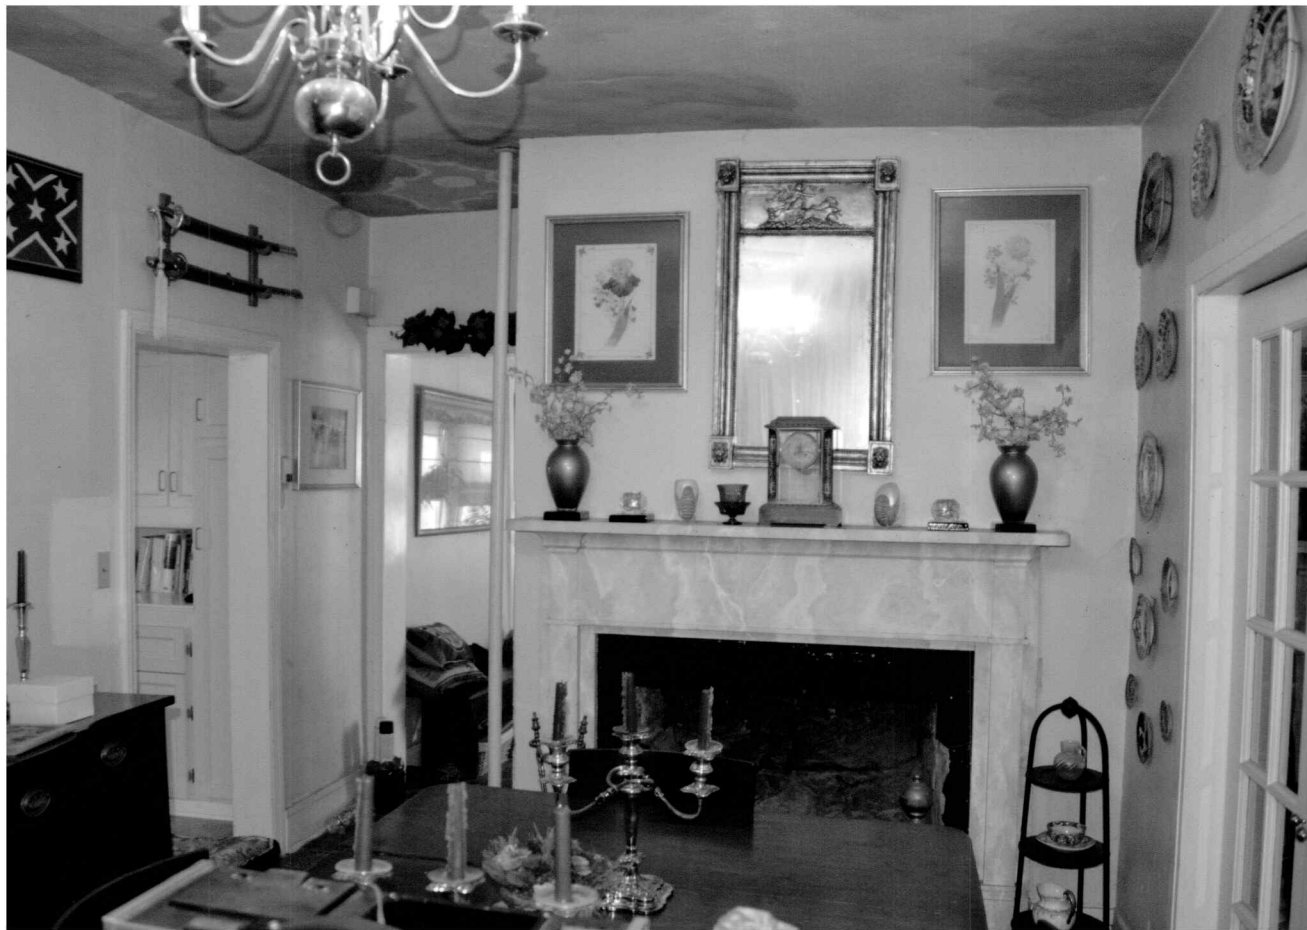
10 of 18

House, northwest room, view east

The northwest room flooring is random-width tongue-and-grooved pine that runs north-south and varies between 3 ½ and 6 ½ inches wide. The flooring runs through to the passage and the southwest room. The baseboard has a broken field, but the top field is larger here than it is in the passage. The architrave matches that in the passage. The south wall has a door to the passage, with another door to the west of it that leads to a closet under the stairs. the stair carriage is constructed with dressed lumber and cut nails, with no evidence of an earlier stair here. The closet door has four panels with sunken fields, no panel moulds, and is mortised and tenoned and pinned. It has plain cast iron butt hinges with five knuckles, and a plain cast iron rim lock with brass knobs, none of which is original. There was originally a small cabinet lock to this door. The sash match the southwest room but have 10-inch by 14-inch lights. There is a door on the north, set to the east, which leads to the north addition. It has modern trim. On the east is a fireplace with a brick hearth, a parged surround, and a firebox of roughly dressed rubble stone that is brought to course. The firebox has splayed jambs. There is a wood mantel with plain pilaster strips, a plain frieze, and a bed mould with a cavetto and bevel. To the north of the fireplace is a doorway to the wing, with typical architrave, but the door is missing.

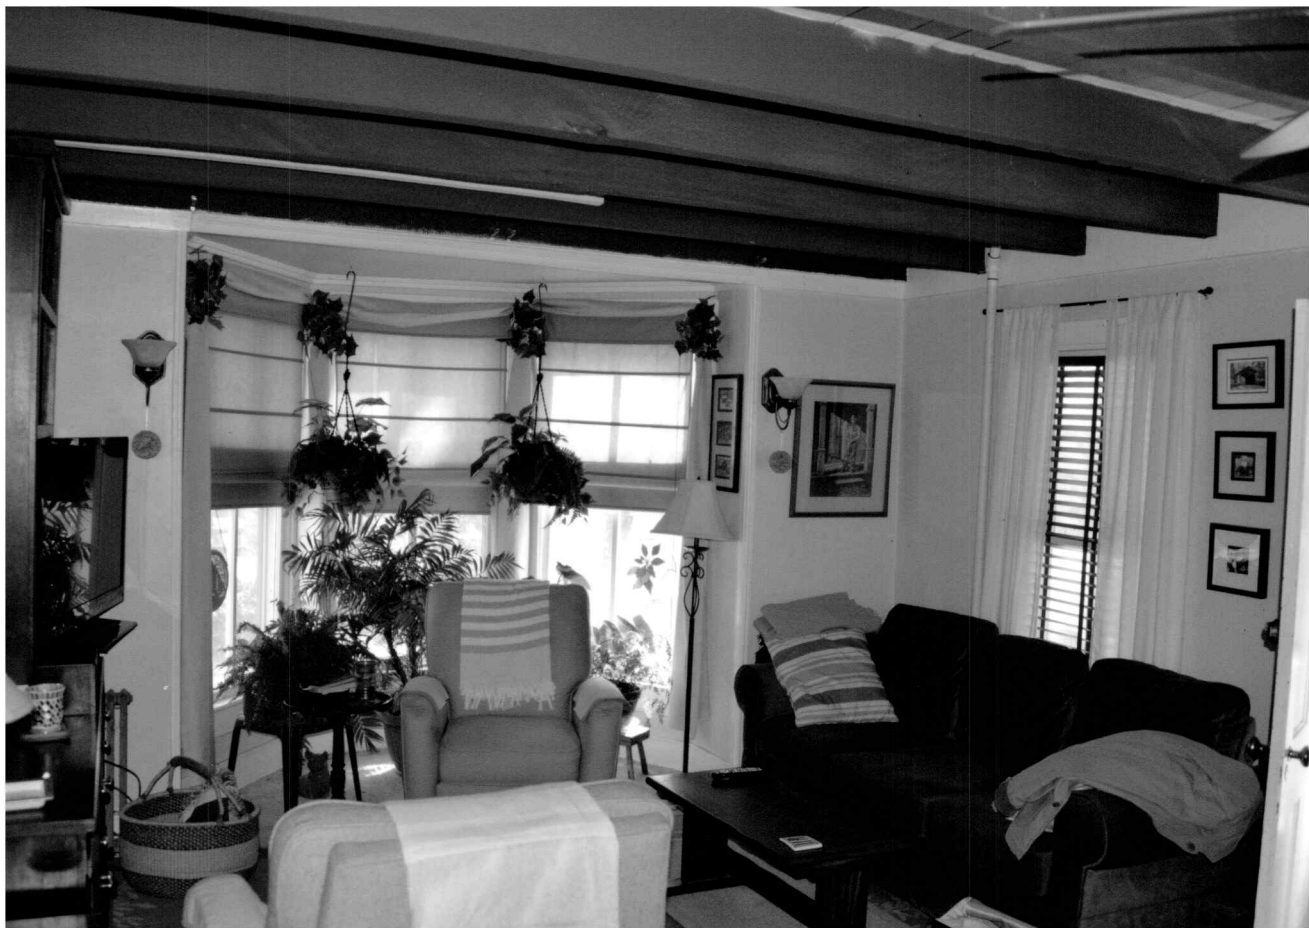
11 of 18

House, southeast room, view east

The southeast room in the wing has oak flooring that is butted and face-nailed with cut nails. It runs east-west and varies between 4 $\frac{3}{4}$ and 5 $\frac{1}{4}$ inches in width. The baseboard has a quirked bead on top. The architrave has a quirked bead on the inner edge only, and is mitered at the corners. The window sash have parting beads and spring latches that match the southwest room. There is a fireplace on the west that has been closed off for a wood stove. It has a wood mantel with chamfered pilaster strips, a plain frieze that has an arched cut on the bottom and chamfers on the bottom and sides, and a bed mould with a quirked ogee-and-bevel mould. The mantel shelf has a scallop cut on the edge. To the south of the fireplace is a vertical crack in the plaster, with a horizontal crack near the top, which could indicate an earlier window or door was located here. The existing baseboard does not have a break in it. The front door has four panels with sunken double fields and ogee panel moulds. It is mortised and tenoned and pinned, with small pins. It has a plain cast iron rim lock with a brass knob and cast iron foliate butt hinges with pendant finials. The second-story joists are exposed, are sash-sawn, are 2 $\frac{1}{2}$ by 6 $\frac{1}{2}$ to 7 inches, and are spaced 23 to 24 $\frac{1}{2}$ inches on centers. The bottom face contains lath nail holes. There is one joist at the east end that is added, with a short joist next to it. The original joist has an abandoned mortise on the east edge, where a stair header was probably attached. On the floor in this location, under the carpet, is a hatch to the basement, according to the owner. There is a bay window on the east side of the room, and the sash match the south windows. The north elevation has a doorway in the center, with typical architrave, but the door is missing.

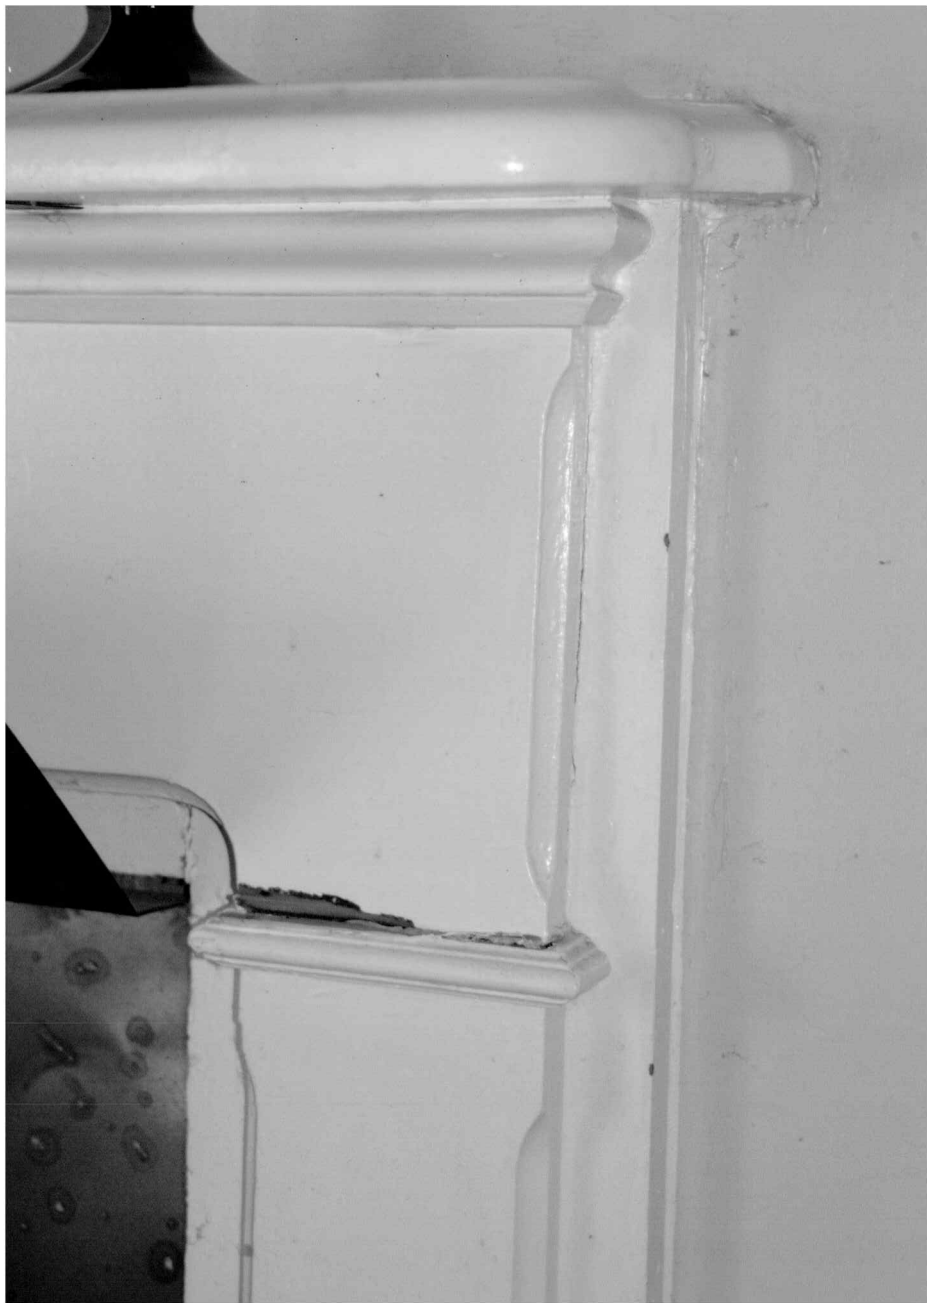
12 of 18

House, southeast room, mantel detail

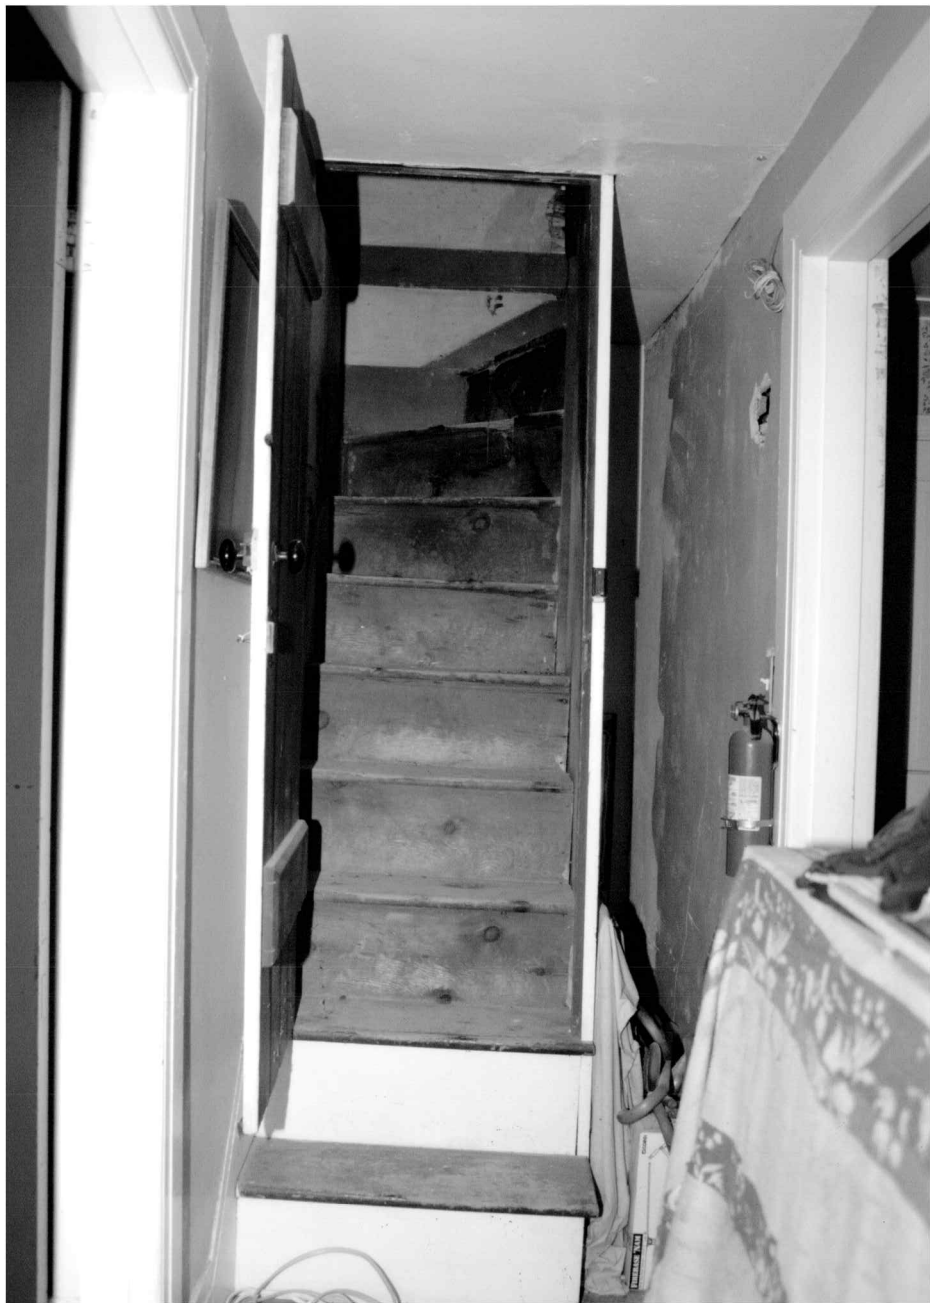
14 of 18

House, attic stairs

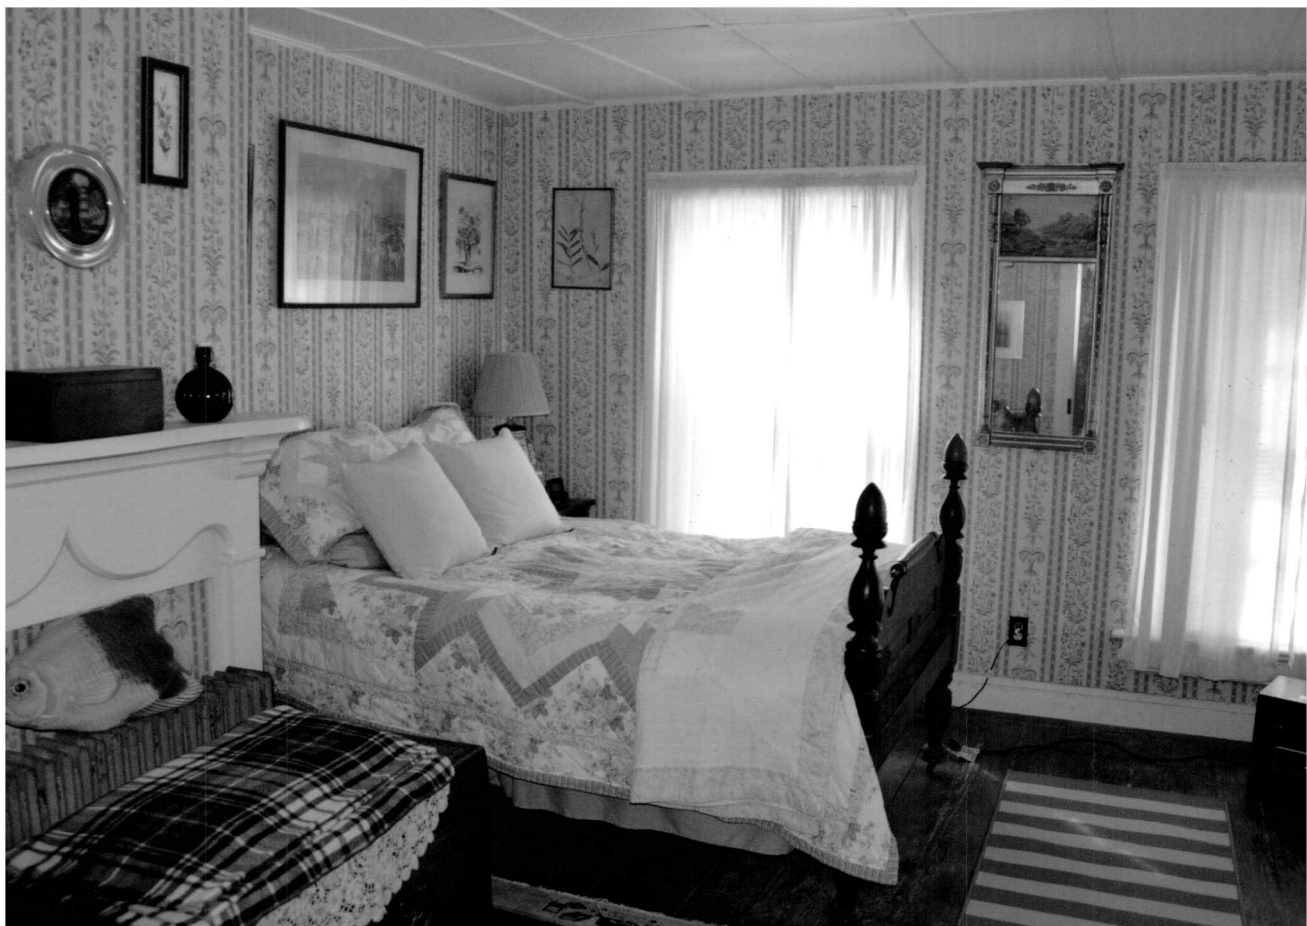
15 of 18

House, Southwest Chamber, view southeast

The southwest chamber baseboard matches that in the southeast room. The architrave is typical for the main block and the sash match those of the first story, with 10-inch by 14-inch lights. There is a new ceiling. The east elevation has a wood mantel with plain pilaster strips. The frieze has a bold double ogee cut on the bottom and the bed mould has a cavetto and bevel, with a small console on each end. There is a slight scallop cut to the edge of the mantel shelf. This was never a fireplace; rather, it has baseboard between the pilasters and a stovepipe hole above the mantel. A closet has been added to the north of the chimney. The west wall has a doorway set to the south that leads to a bathroom in the southwest corner, above the passage entryway. There is a typical four-panel door, with mineral knobs, and typical architrave. The bathroom has carpet and typical baseboard and architrave. There is a claw-foot tub, a cast iron sink with separate hot and cold faucets, and a water closet labelled "Crane – Hanover"; the date is illegible.

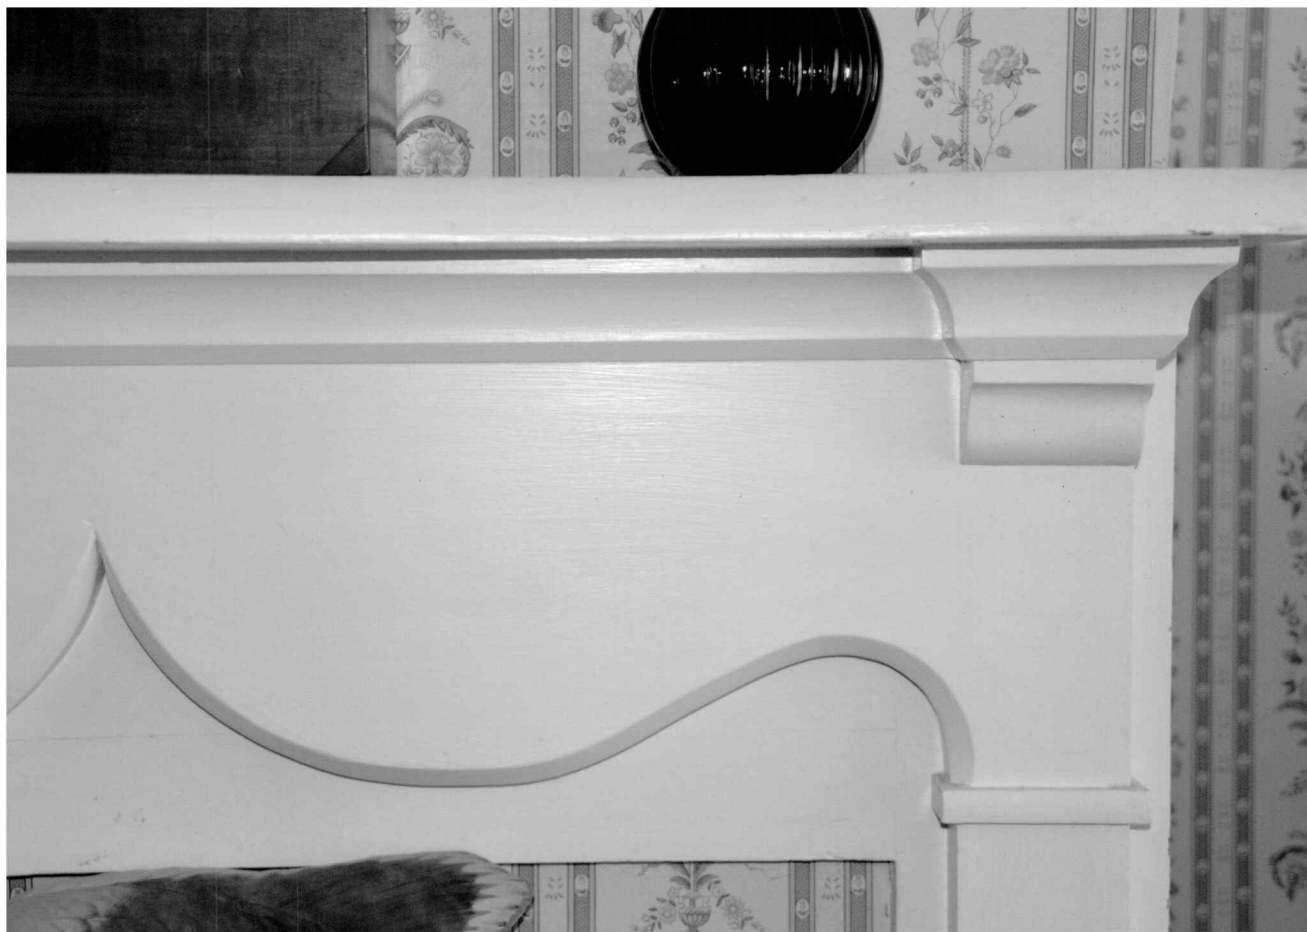
16 of 18

House, Southwest Chamber, mantel detail

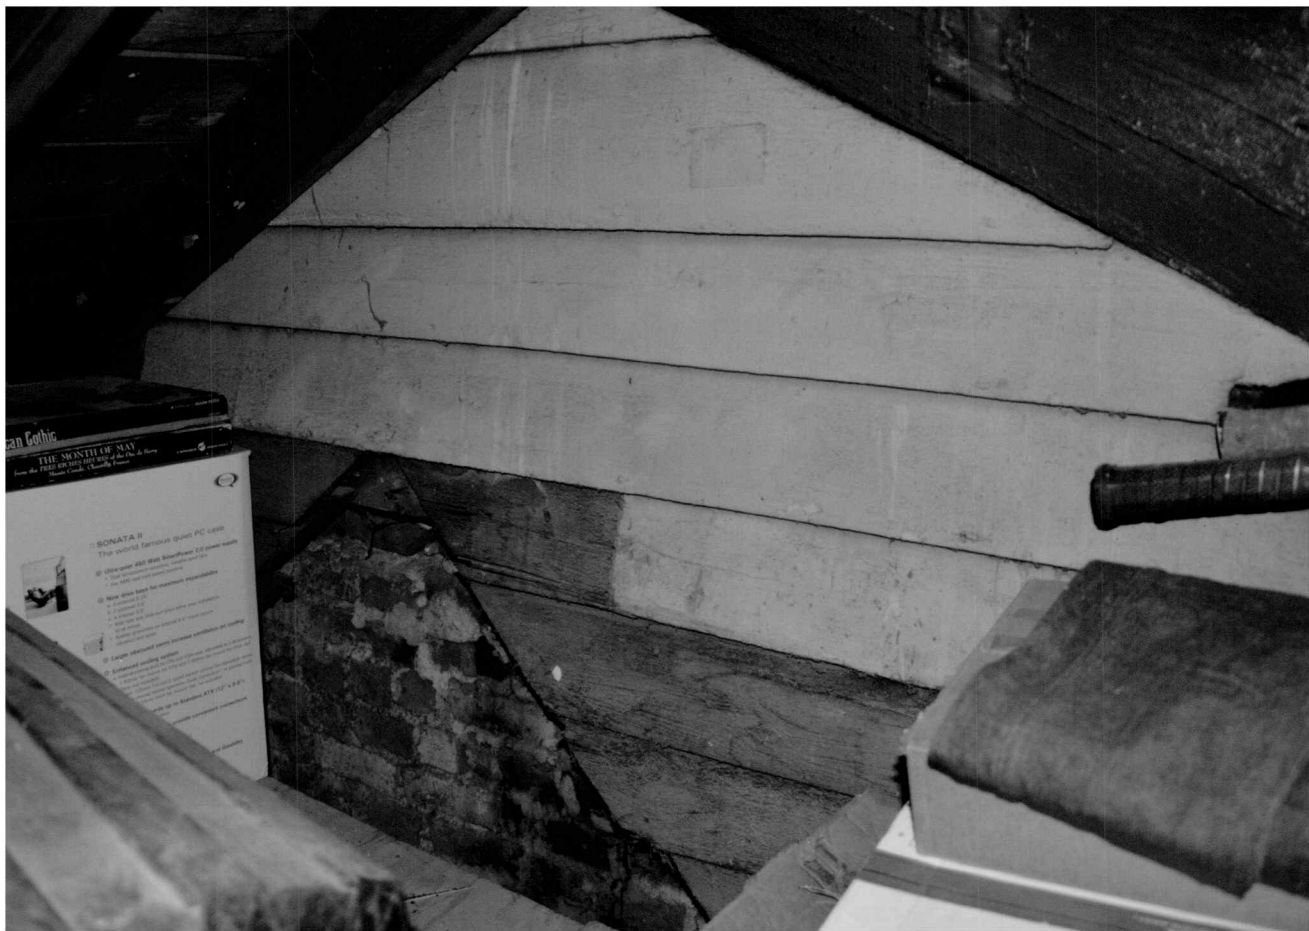
17 of 18

House, wing attic, view west to main block
east wall with original wing roof gable
and early paint on main block.

The wing attic has a plywood floor. The rafters are dimensional 2 by 6s with a ridge beam, and they are wire-nailed. According to the owner there were wood shingles, and he installed a metal roof over top of them. The west wall is weatherboards painted a yellow ochre or a cream color that has darkened. They have a weather of from 5 ¼ inches to 7 ½ inches. The rake board is 16 inches wide and painted dark brown, with the ghost of a bracket that has been removed. There is a triangular hole in the siding where the original gable of the wing roof was, and this exposes a brick chimney behind the siding. The weatherboards around this cutout are unpainted.
