HO-94

Patapsco Restaurant

8120 Main Street, Ellicott City

BASEMENT ELEVATIONS -- MEASURED BY HEATHER BARRETT, KEN SHORT, KACY ROHN, & JEN SPARENBERG -- DRAWN BY KEN SHORT -- SEPTEMBER 2016

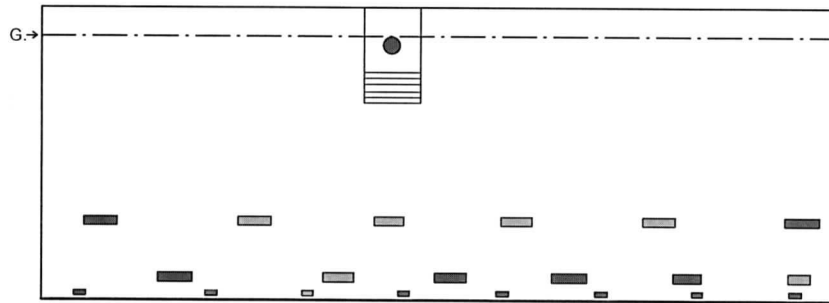
EAST ELEVATION

- A. SINGLE-LIGHT 19TH C. STOREFRONT WINDOW WITH PERIOD 2 JAMBS, SILLS & TRIM. TRIM REMOVED FROM POSTS.
- B. PERIOD 2 DOORWAY. DOUBLE DOORS REPLACED. NEW FRAMING AND TRIM NOT SHOWN.
- C. PERIOD 2 TRANSOM REPLACED. NEW TRANSOM NOT SHOWN.
- D. BRICK ROUGHLY BROKEN AGAINST MODERN FRAMING THAT IS ONLY DOTTED IN.
- E. CURRENT FLOOR LEVEL DOTTED IN.
- F. DOTTED LINE SHOWS BOTTOM OF SURVIVING TRIM, WHICH COVERS TOPS OF MOST POSTS AND MOST OF GIRT.
- G. PRESENT CEILING LEVEL.
- H. SPIKE DRIVEN INTO BRICK ABOVE GHOST OF VERTICAL FORMERLY ATTACHED TO WALL.
- J. FAINT PLASTER LINE MARKING BOTTOM OF ORIGINAL STAIR STRINGER.
- K. PLASTER COVERS AND CONCEALS NAILING BLOCK HOLES.
- L. BRICK ROUGHLY BROKEN TO CREATE WINDOW OPENING, WITH 19TH C. SASH.
- M. JOIST POCKETS, WITH ONE SURVIVING JOIST.

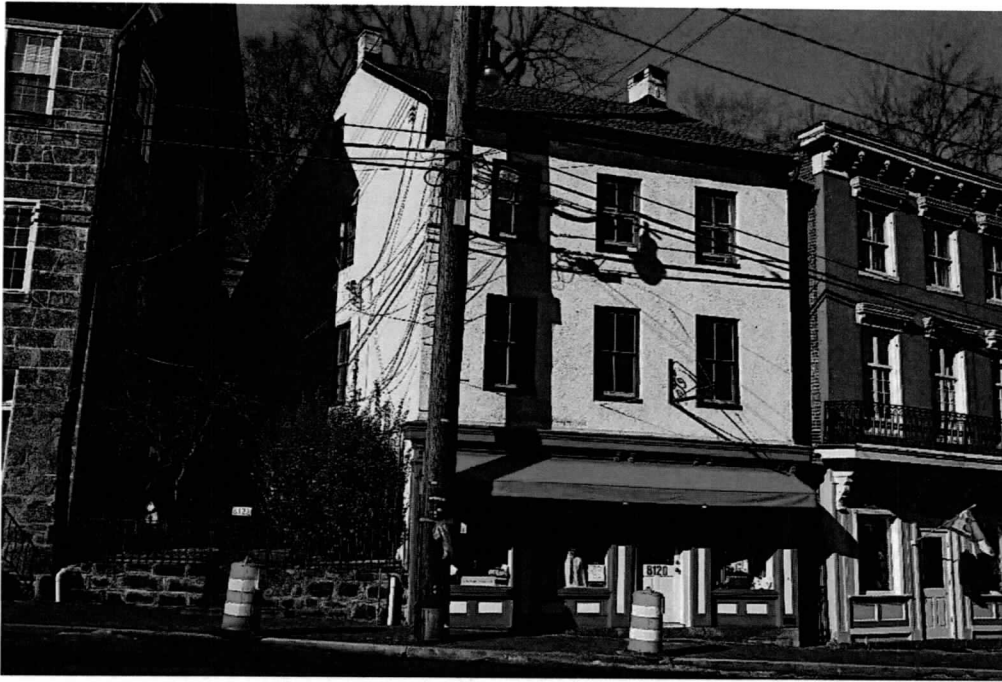
Photo 1 of 14: West & south elevations. 2/23/2021

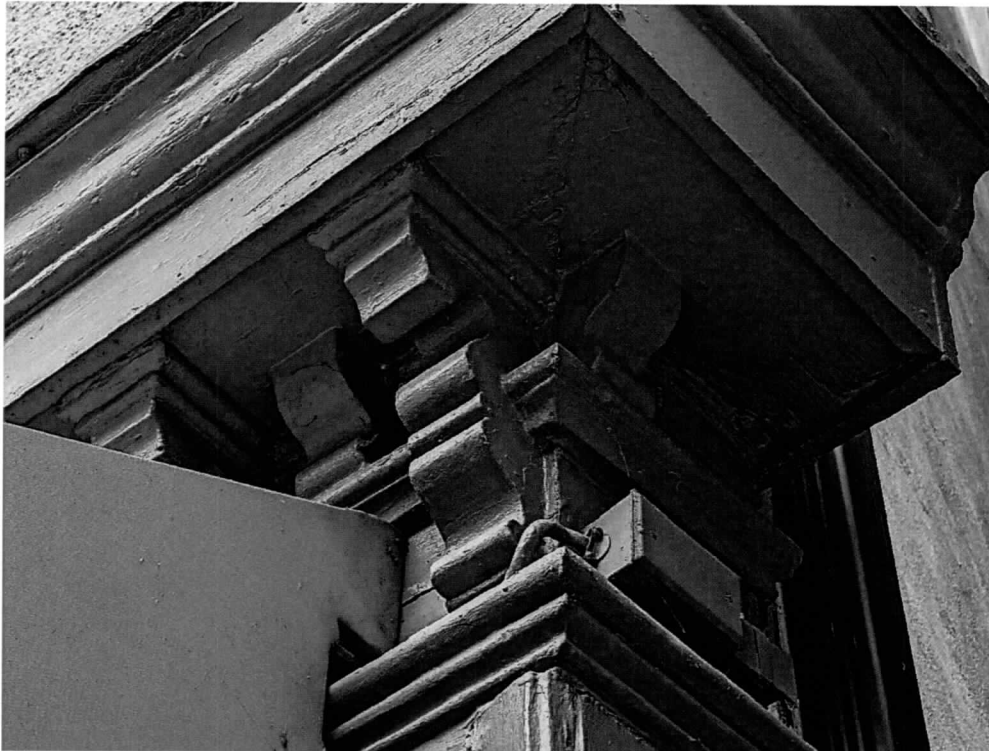
The bays are separated by paneled pilasters. There is a storefront cornice that has large, paired jig sawn scroll brackets over each pilaster, and they break into the frieze below. There are also smaller jig sawn scroll brackets between them. The cornice has an ogee and bead moulding. The first and second stories each have three two-over-two sash with wood sills. The cornice has a large fillet, probably in wood, serving as the bed mould, with a deep, plain wood frieze below it.

Photo 2 of 14: South elevation, storefront cornice. 11/15/2024

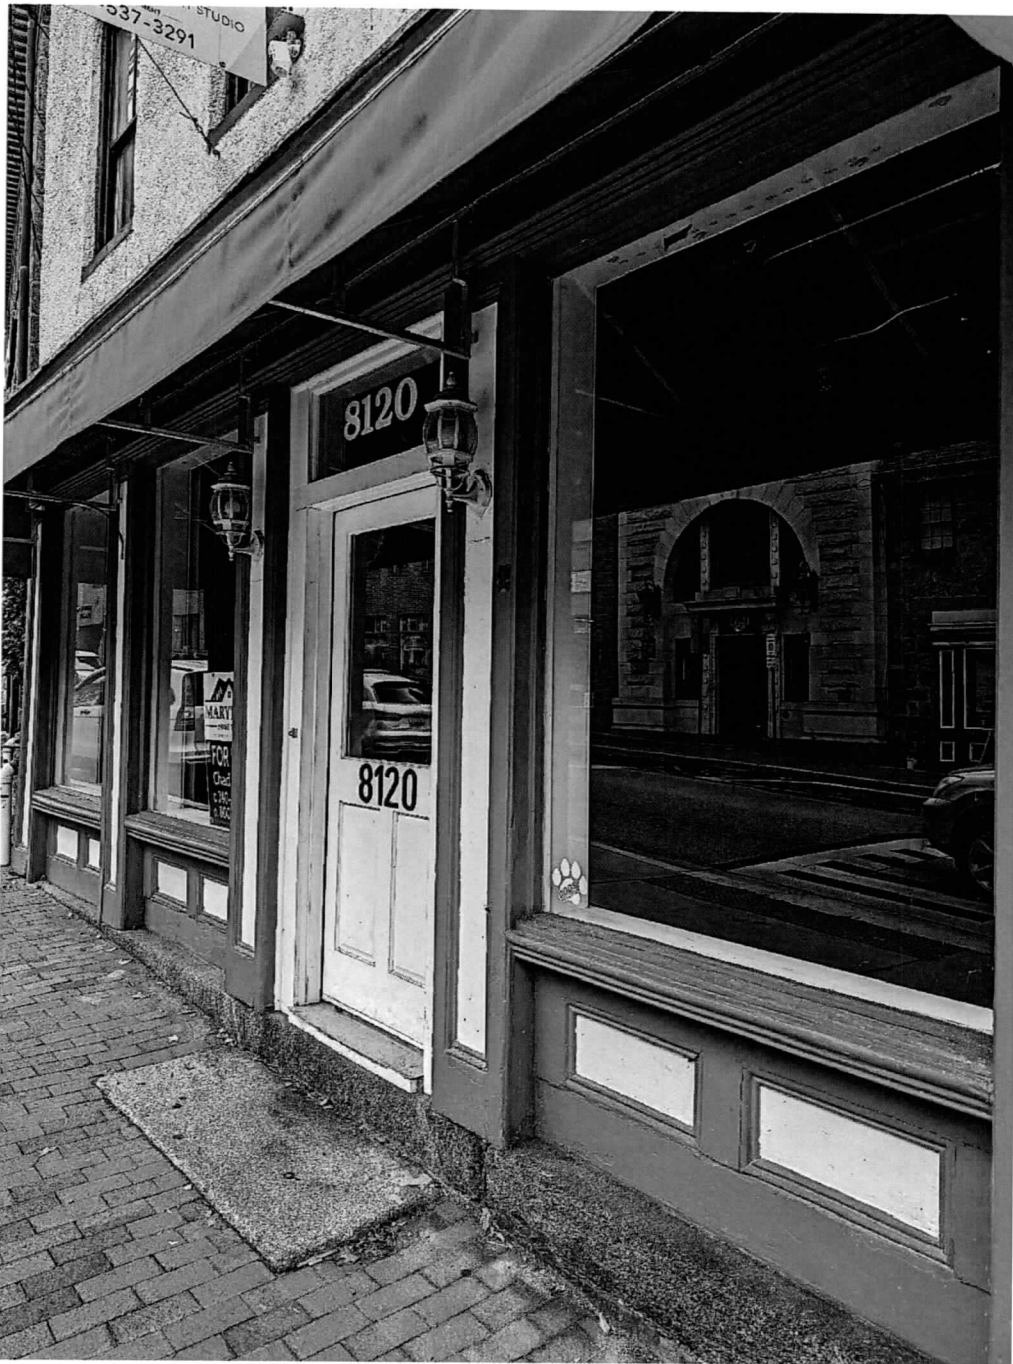
The south elevation has three storefront windows in the basement that each have a large single light above two lying panels that are flat and sunken, with ogee-and-bead panel moulds. The windowsill has a torus moulding with two beads below it. The east-center bay has a doorway with a door that has one light over two panels with sunken fields and no panel moulds. There is a one-light transom above it.

Photo 3 of 14: South elevation, storefront. 11/15/2024

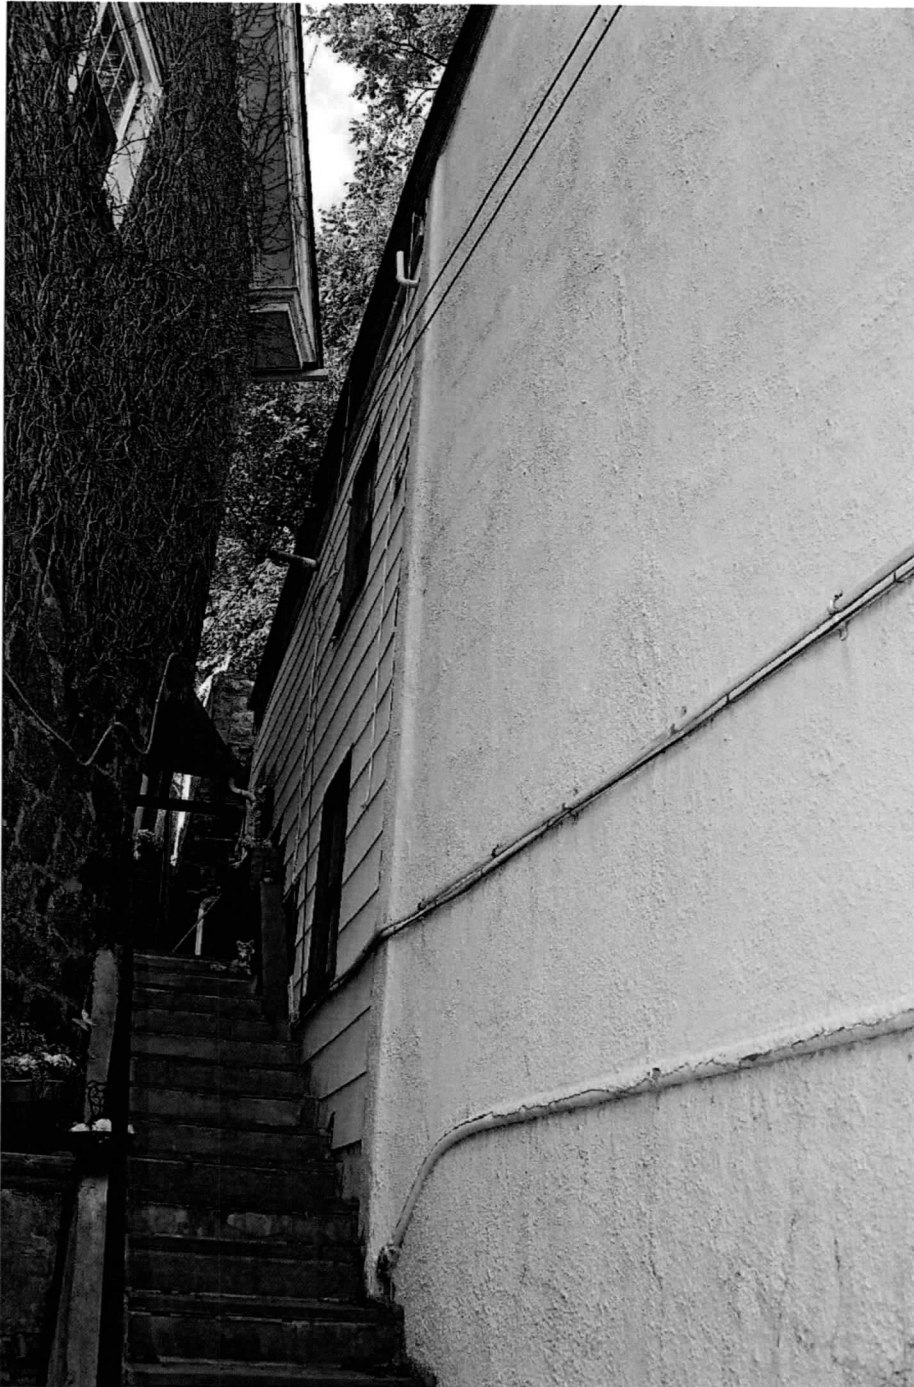
The west elevation of the main block has a full-size two-over-two window in the basement, set to the south, a full-size two-over-two window on the first story, and a short two-over-two on the second story. The gable end has a four-light sash set north of center. The addition is frame and is sided with asbestos shingles below the eave line, with the shed-end of the wall above this eave line covered with asphalt shingles. The addition has a two-over-two sash on both the first and second stories, in the south bay, and no openings in the north bay. The north bay at the first story level has a projecting concrete wall that steps down to the south.

Photo 4 of 14: West elevation, addition. 9/8/2016

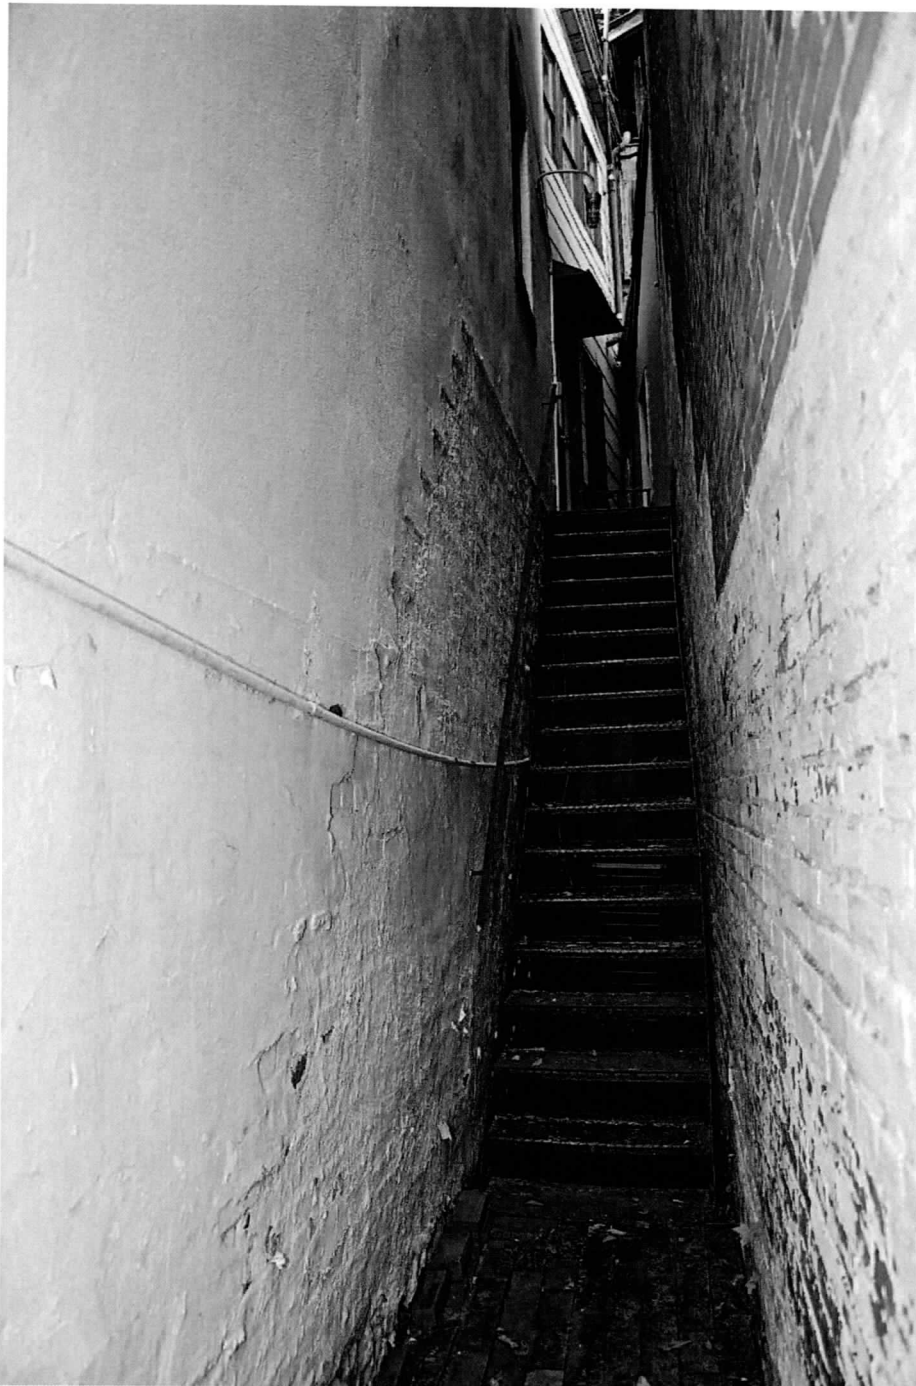
The east elevation has steel stairs ascending to the north and there is a ghost in the stucco of an earlier stair that was set closer to the street. There are pockets infilled on this wall where the landing joists were, with pockets cut into the neighboring building to the east, just across from the infilled pockets. The first story has a two-over-two sash set north of center, with a brick sill and patched parging on either side and above the opening, suggesting that it was cut in later. The brick wall ends at the north eave, where the interior brick wall is, and to the north of this corner the wall is frame, with asbestos shingle siding. The first story of this addition has a recessed doorway in the south bay that has a modern door and a wooden two-over-two sash. There is a window to the north. The second story has no openings in the main block and has triple two-over-two sash in the frame addition. The gable end of the main block has a window opening set north of center, but the sash is not visible from this oblique angle. The north end of the addition abuts a building on the lot to the east.

Photo 5 of 14: East elevation. 9/8/2016

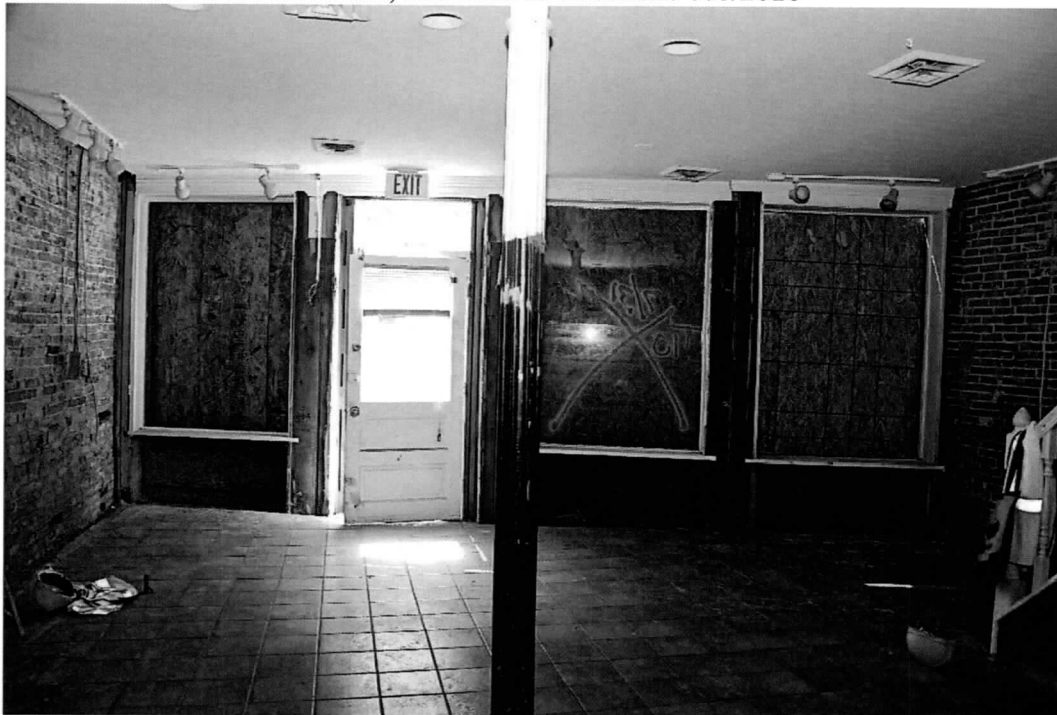
On the front, or south, wall, the east bay has a trim board on the eastern edge that has a beaded edge and is painted. To the west of this trim is a large window opening of one light, with most of the trim removed from around it, except at the top. This top trim has a quirked bead on the inner edge, a quirked ogee-and-bead backband, and is fastened with cut nails. The west jamb of this opening is a 9-inch-wide planed post with a 7/8-inch quirked bead on the west corner. This post has never been painted. The east corner of this post (the west jamb of the opening) could be cut back, so might also have had a bead. The east-center bay east jamb is a 3-inch-wide sash-sawn post set against the beaded post, with a 1-inch trim

Photo 7 of 14: Basement, south wall. 9/8/2016

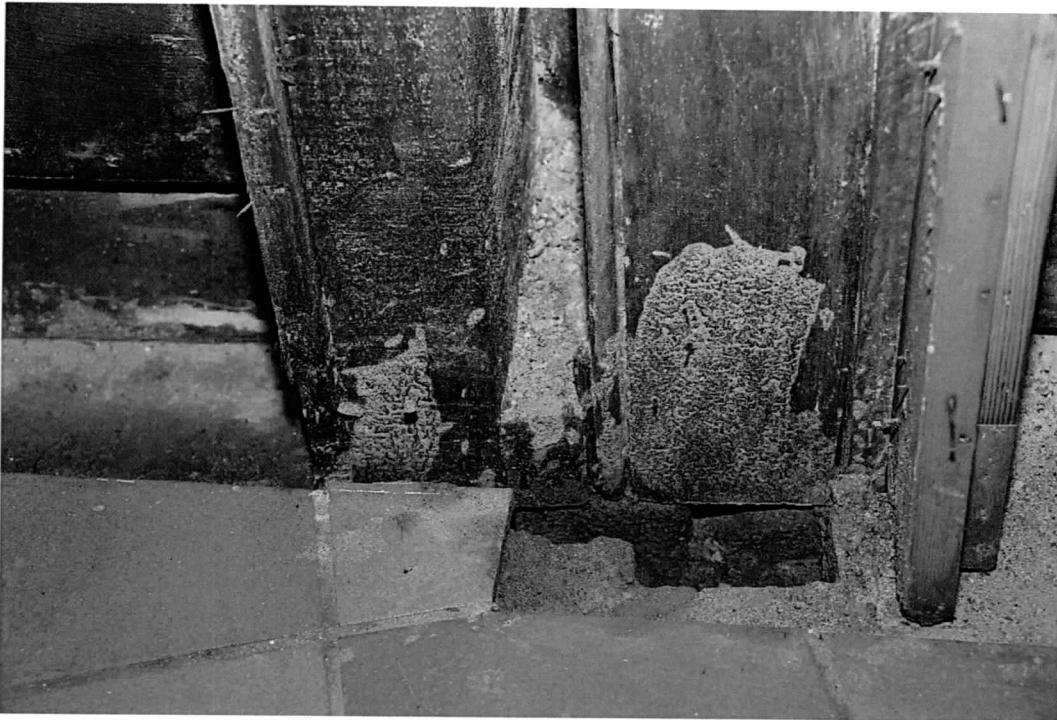
board nailed to the west side of this post with cut nails. This trim has a hinge mortise for a door and has the ghost of a transom bar that was original to the doorway and has been removed. Both of these two posts were covered by a 1-inch-thick trim board on their interior face, with a backband nailed to it; most of this trim has been removed recently due to flood damage. This bay now has a door with one light over two lying panels that have sunken fields and ovolo panel moulds. It is hung on three butt hinges with pins and has a new mortise lock. There is a new one-light transom. This doorway has new trim with blocking to fill in the gaps between it and the posts. The west jamb of this bay is a 3-inch-wide sash-sawn post added up against a 8 7/8-inch-wide planed post with a 7/8-inch-wide quirked bead on its east corner. The west side of this post may have been cut back, removing an original bead. The west jamb board of the doorway, on the east side of the door post, has hinge mortises, suggesting that there were double doors originally in this opening. The west-center bay has a 1-inch trim board nailed to the west face of the beaded post to the east. There is a large one-light commercial window in this bay. Below the wood sill are two horizontal boards set in the plane of the outer edge of this wall. The west jamb is a 1-inch-thick trim board nailed to a 4-inch-wide by 10-inch-deep post. This post is cut-nailed to spacer blocks that are attached to the east post of the west bay. The east post of the west bay is 6 1/8-inches wide by 10 1/4-inches deep, is planed on the north and east faces, and has a 7/8-inch quirked bead on the northeast corner. The west face of the post is only partially and obliquely visible but has several rough spots on it and may have been cut back. There is a 1-inch board on the west side of this post that is unpainted and was not a trim board; it was possibly added after the post was cut back. The west end of the north face has what appears to be plaster burns, indicating that there was probably a partition wall attached here that ran to the north and separated the west bay from the rest of the store. This bay has one large light with new trim, jamb boards, and new framing on the west side of the opening, plus new boards beneath the sill. The top trim sits proud of the trim of the other three bays by several inches. At the west end of the bay the brick on the south side is cut back.

Photo 8 of 14: Basement, south wall beaded post with later infill and stone sill. 9/8/2016

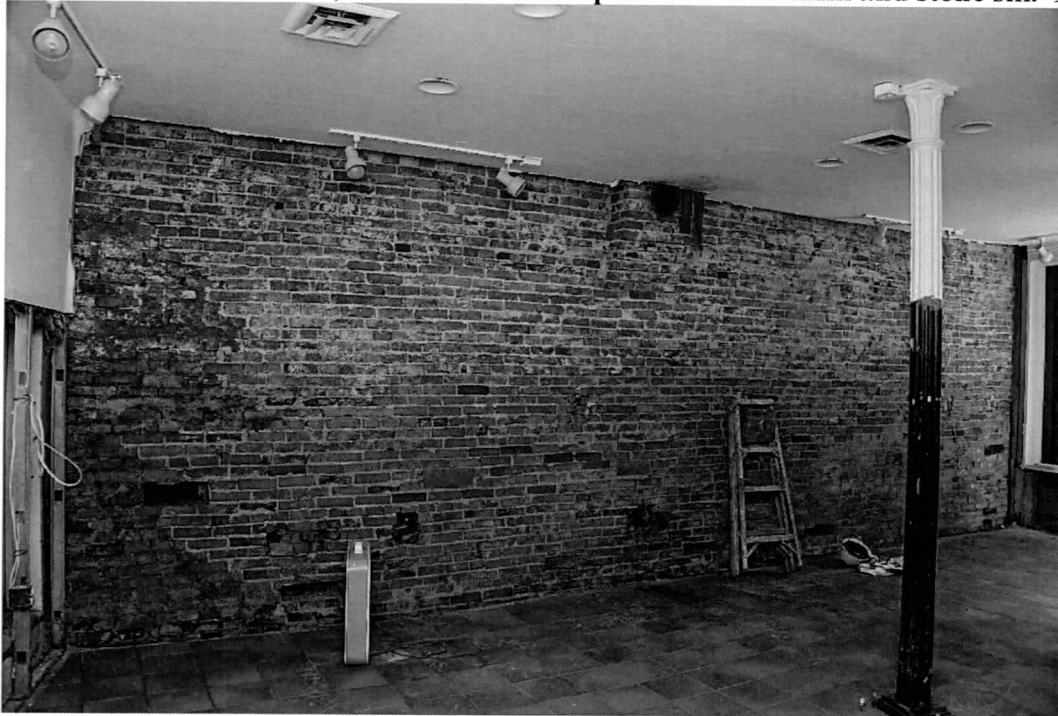
The east elevation is 7-1 common bond brick and at the bottom of the wall is a row of eight holes for missing nailers for baseboard. They are 4 1/2 to 5 inches long, are one course high, are set in the second course above the existing floor; one of these retains some rotten wood. The fourth course from the bottom has six holes, two of which still retain wood nailer blocks. These are 11 1/2 to 13 inches long and 1 1/2 courses tall. In the 13th and 14th courses from the bottom there are an additional six holes of the same size, four of which still retain wood nailers, but these do not align with the holes below. There are no nailers above this, though the top of the wall is hidden by the lowered ceiling. In the center of the wall, near the top, are six corbelled courses of brick, followed by straight projecting courses that create a stove flue with a thimble in it.

Photo 9 of 14: Basement, east wall. 9/8/2016

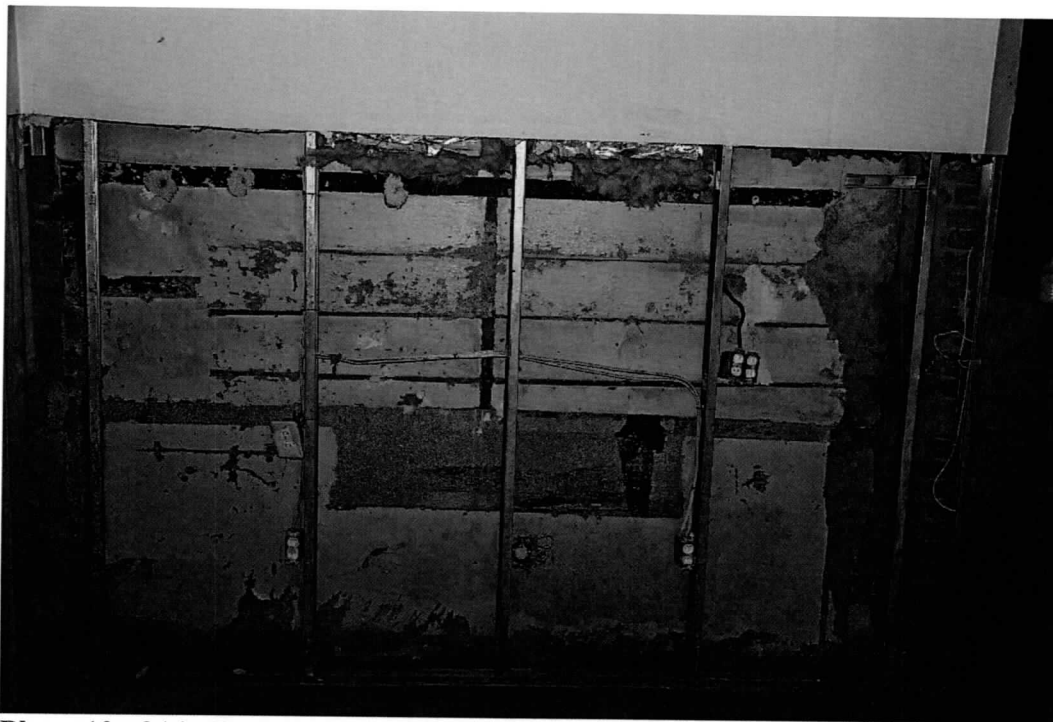
The north wall has a doorway at the west end that has wood nailing blocks in both jambs and appears to be original. There is a wood lintel with a rowlock course above. In the center of the wall is plaster with paint and the ghost of shelving that appears to be of two different eras. One of these eras perhaps had cabinets at the bottom, with a counter at about the same height as the top row of nailers on the east wall. A new doorway has been cut through to the east of center on this wall. There is also a doorway at the east end, with a bead-board door that has a cast iron rim lock with porcelain knobs. There are three courses of brick infill at the bottom of this opening. The south sides of the jambs are covered with plaster; the opening appears to be original but this is not certain. The north side of the opening only has a wood lintel, with no rowlock course. This wall was covered by metal studs and drywall, with the lower two-thirds of the latter removed due to water damage.

Photo 10 of 14: Basement, north wall in center, with shelf ghosts. 9/8/2016

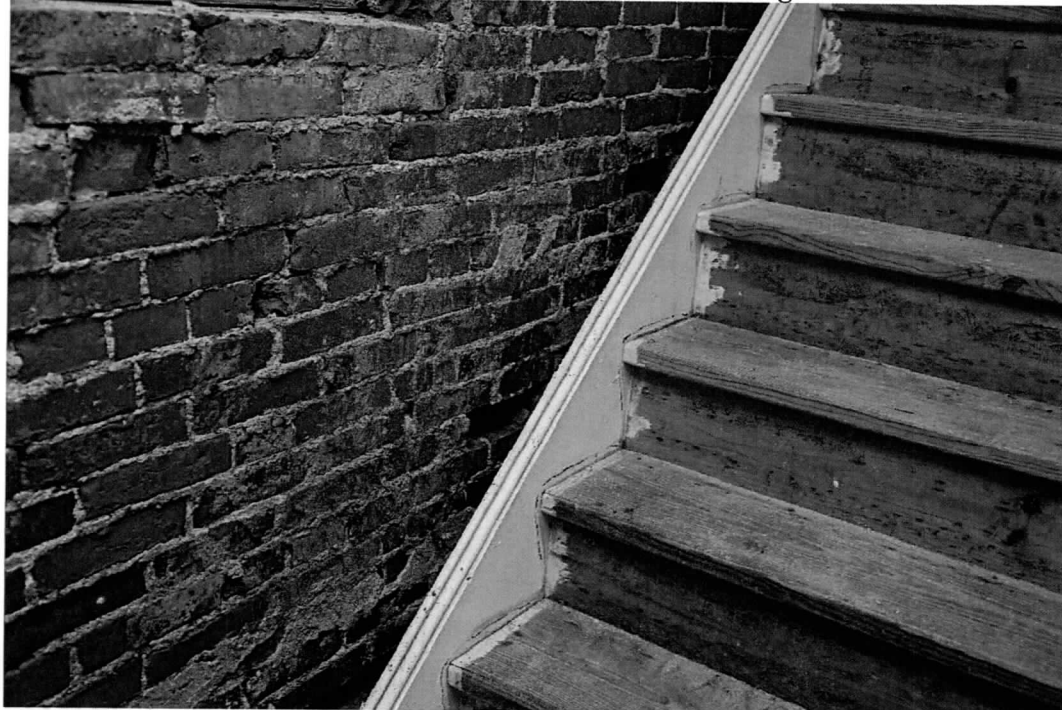
The west wall is also 7-1 common bond and has holes at the bottom of the wall for baseboard nailing blocks. The only other holes for nailers are behind the existing modern stair stringer and are staggered, ascending from about 7 feet 6 inches north of the south wall, at the bottom, to the top of the wall near the north end. There are five courses of brick between each pair of holes. There are also some holes

Photo 11 of 14: Basement, west wall showing nailing block holes behind existing stair. 9/8/2016

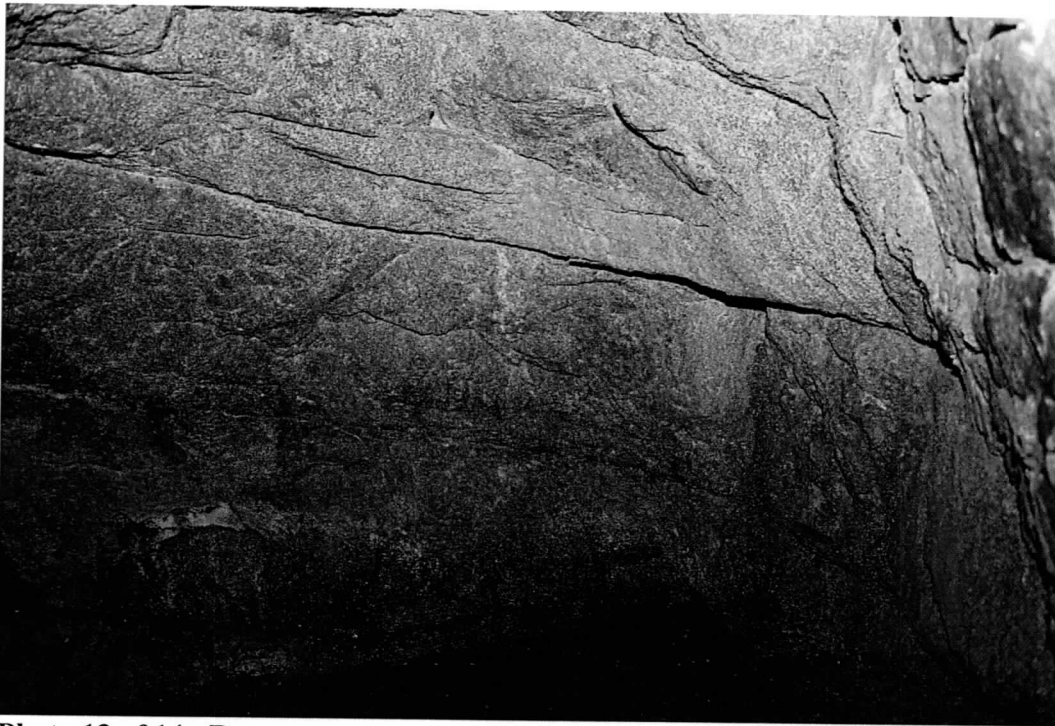
The rear cellar room has an uneven floor, part of which is concrete. There is a low stone wall on the north, set several feet inside of an upper stone wall which is of rubble and is battered. There are also several brick piers that support a circular-sawn timber beam under the joists, and this appears to be added. In the northeast corner is a low brick wall sitting inside the room, with two faces and with heavy whitewash. It has a hole in the southwest corner of it and inside it bedrock projects into the room. The east wall has a seam in the brick, about 18 inches south of the north wall. There is a doorway at the south end of this wall, with a segmental arch, the south end of which is set into the brickwork of the main block, suggesting that this is an original opening. The joists above are sawn, are about 2 by 6 inches, and are whitewashed. They run north-south and the pockets in the south wall appear to be original, not cut in. The joists at the west end pass through the wall and are exposed on the south side of this wall, flush with the wall. On the north wall, to the west, there is an opening in the low stone wall, with an opening in the north wall into a cave in the bedrock. There are brick piers on either side of the opening and a brick side wall on the west, on top of the low rubble stone wall. The cave ceiling slopes down to the north and the cave opens up wider to the east, with rubble stone at the south end around the mouth. The cave is 7 feet tall, 9 feet wide, and 10 feet deep at its largest measurements.

Photo 13 of 14: Basement, cave interior. 9/8/2016

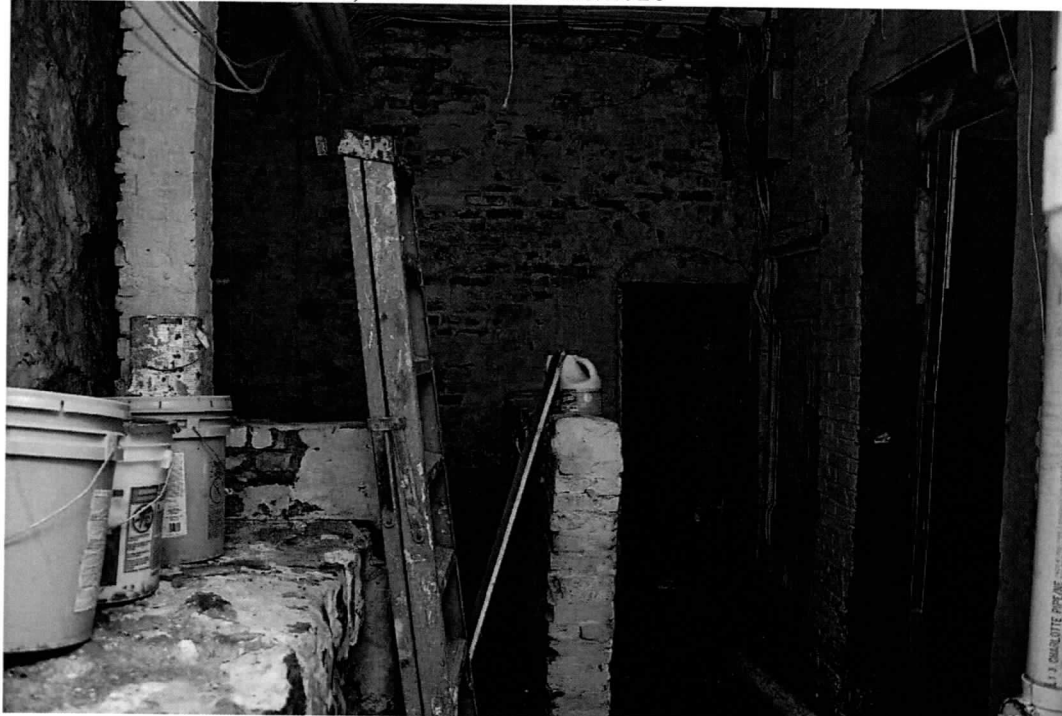
Photo 14 of 14: Basement, below addition, view east. 9/8/2016
