HO-993

St. Charles College

Architectural Survey File

Historic Properties Form

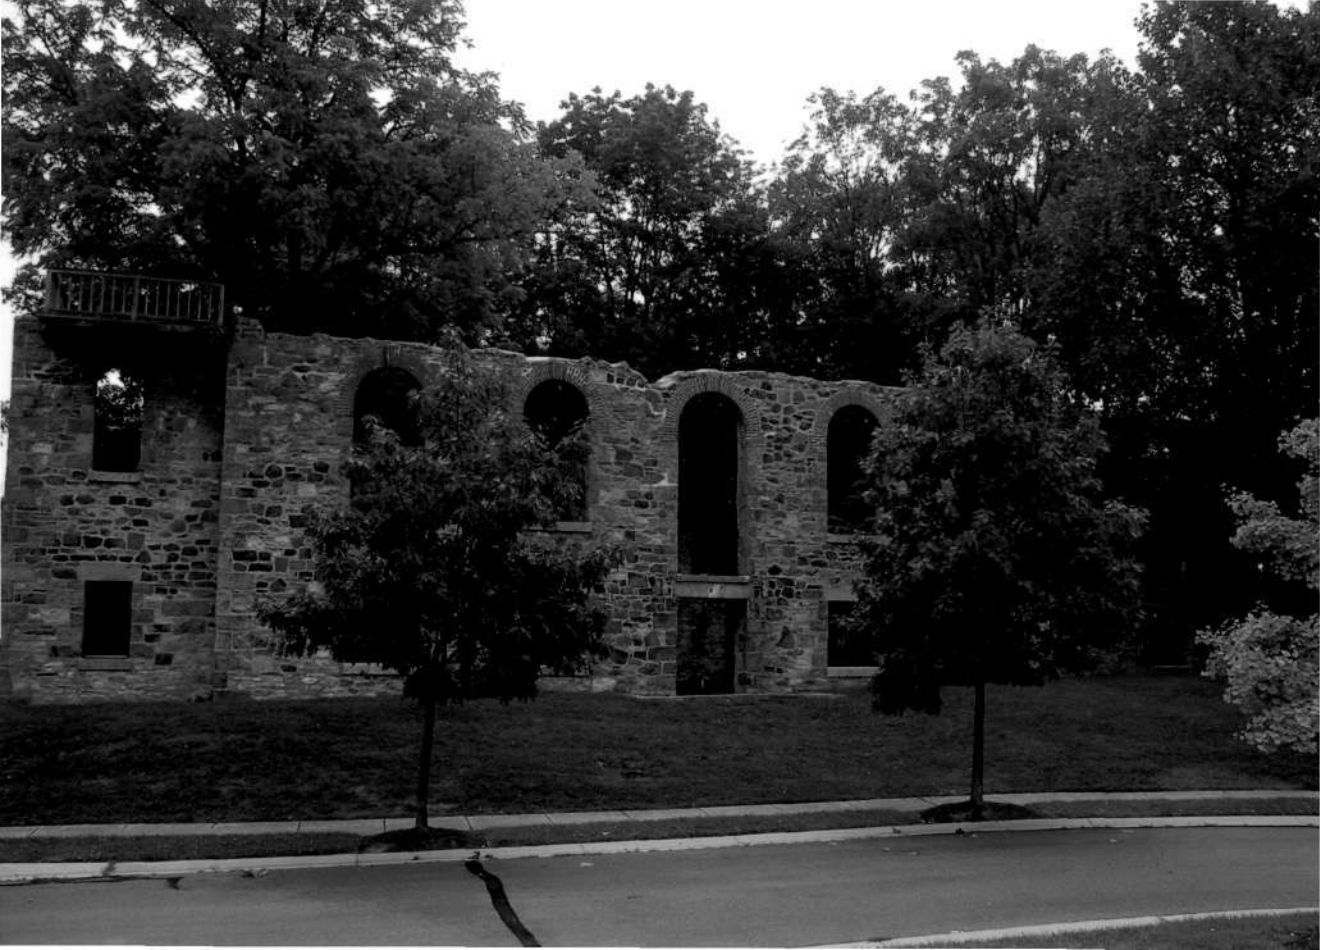
1/6

On the west elevation the five center bays project forward about two feet. On the first story, the north bay has a window opening with a sill that has a wash, and a granite lintel. There are the remains of a window frame that had sash weights and pulleys, and had parting beads. The window frame has a large three-quarter-round roll moulding on the outer side of the frame. Most of the window openings lack frames. The north-north-center bay has a wider window opening, as does the north-center bay. The center bay has a doorway that is set two steps below grade, with a brick paved porch in front that has a granite coping and granite steps. There is steel U channel in the wall flanking the lintel for a balcony landing that had piers that rested on the porch coping. The south-center, south-south-center, and south bays also had wider window openings. The south bay also had iron U channel flanking the lintel for a landing. There is a stone flush with the ground, with one hole on the top face of it, to take a post for the iron channel; it is in line with north side channel. The second story north bay has a round-arched opening for a window, with brick voussoirs. A pressure-treated wood deck cantilevers out from the wall above. The north-north-center and north-center bays have wider window openings that are round-arched and have brick voussoirs. The center bay has a wide doorway with a round arch and brick voussoirs. The south-center and south-south-center bays have wide window openings that are round-arched and have brick voussoirs. The south bay has a wide doorway with a round-arched opening and brick voussoirs. All of the brick arches have projecting brick keystones and flush end posts, except for the north bay, which has no keystone.

West Elevation

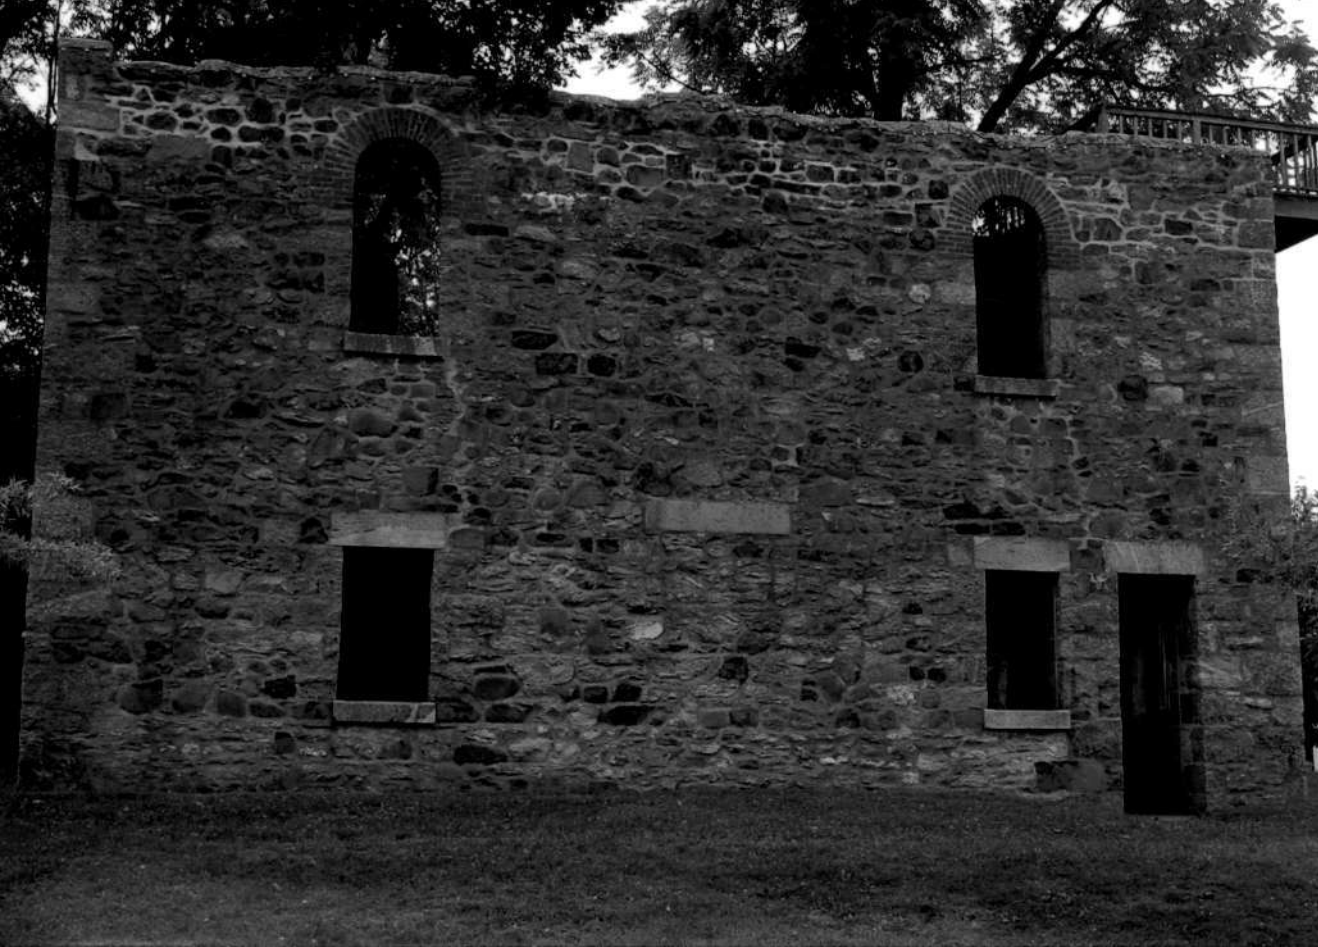
2/6

On the north elevation the first-story east bay has a typical first-story window opening with a charred wood lintel on the interior. The center bay has a granite lintel set slightly higher, with stone infill below

but no sill. The opening appears to have been short. The west bay has a typical first-story window opening, with a door to the west of it that has a typical lintel. The top of the frame has a roll moulding on the exterior, and has wire nails. The second-story east bay has a typical second-story window opening that is narrow. The center bay has no opening, and the west bay matches the east bay.

North Elevation

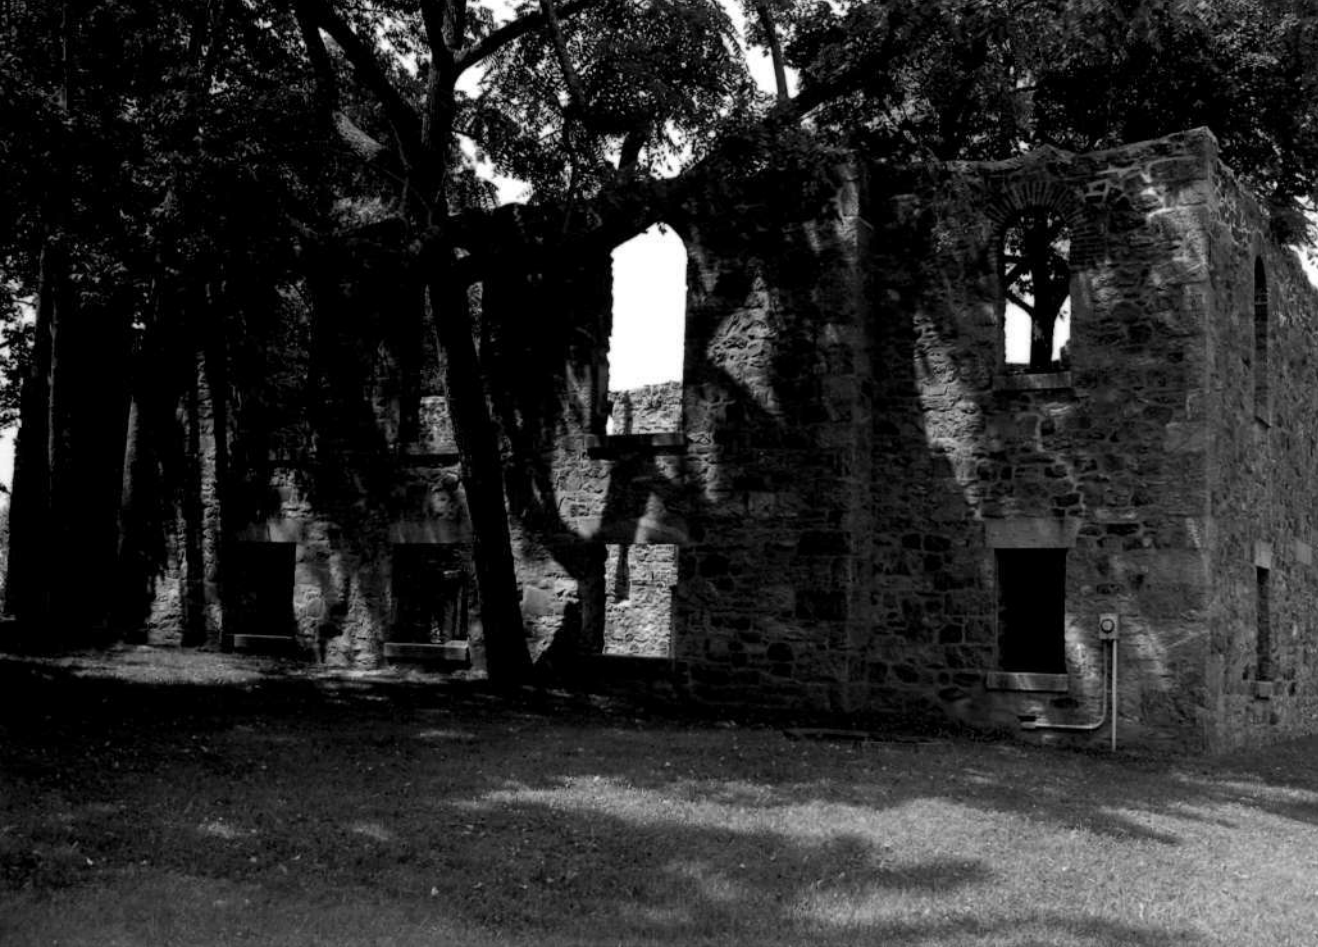
3/6

The east elevation, on the first story, has a typical first-story window opening in the north bay. The north-north-center, north-center, center, and south-center bays have typical wide first-story window openings. The south-south-center bay appears to have had one as well, though only trace remains of it are left because the wall has collapsed to the south. The south bay wall is recessed by one bay and has a window opening set to the north that has a granite sill with a wash and a granite lintel. The jambs have a recess on the interior. The door openings have flush jambs. On the second story the five bays to the north have typical second-story arched window openings; the north bay opening is narrow and does not have a keystone, while the others are wide and have a keystone. The south-center bay probably matched the three bays to the north of it but the wall has collapsed leaving little evidence remaining. The south bay, which is set back, has a typical second-story window opening that is wide and has a brick keystone.

East Elevation

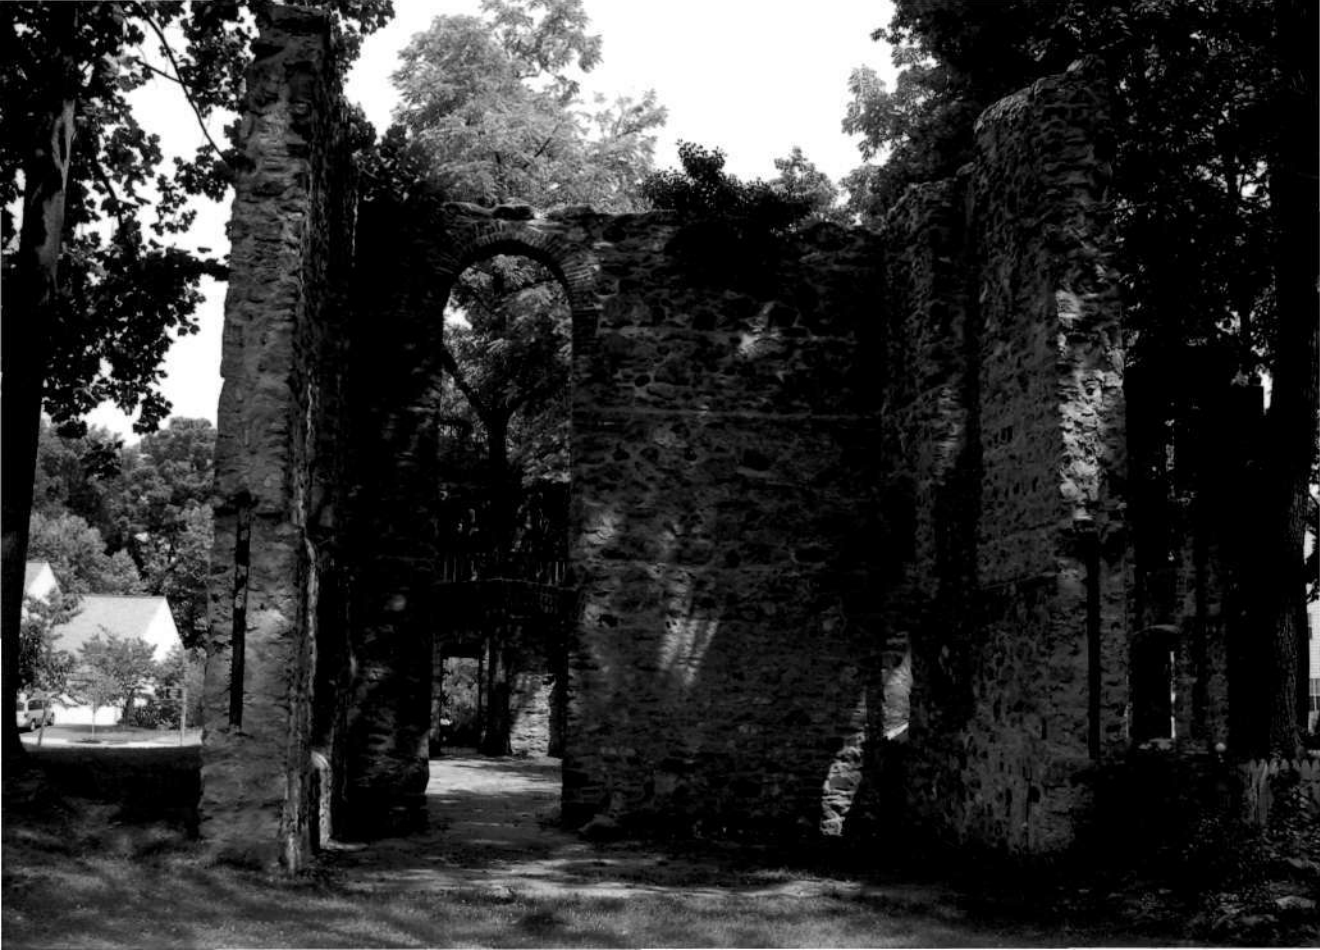
4/6

The south elevation east-bay wall collapsed but appears to have had a typical window on both the first and second stories. In the center and west bays the wall has completely collapsed. The first story has steel U channel in the wall with spikes coming from it, and the wall is recessed several inches and is flat on the first and second story; it appears that this wall was built to butt against a preexisting wall.

There are several trees growing up inside and near the walls on the outside that threaten to undermine the walls and foundations; one tree is growing on the wall where it collapsed in the southeast.

South Elevation

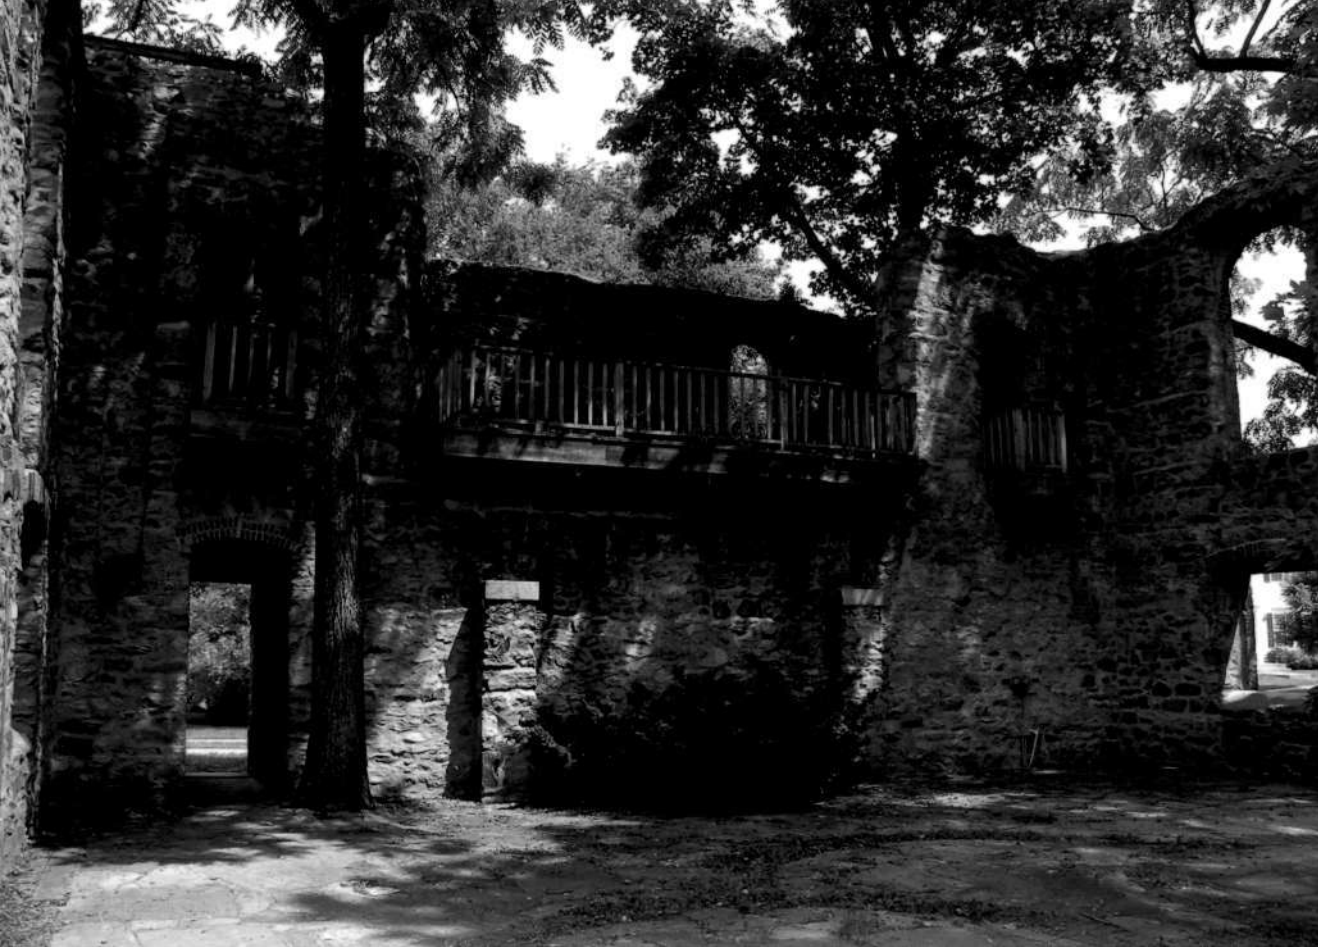
5/6

The interior is now three rooms with flagstone and brick paving. In the north room all of the openings have segmental brick arches with a wood lintel below them. The north wall has a brick arch in the center with stone infill below it and a short stone sill or lintel to each side, although it is not clear exactly what this is for. The south wall has the same short sills or lintels opposite those on the north wall, and this may have supported heavy beams at the floor level. The west bay has a doorway into the center room. A pressure treated floor was added for the second story, but the stairway up to it is now gone.

Interior, view north

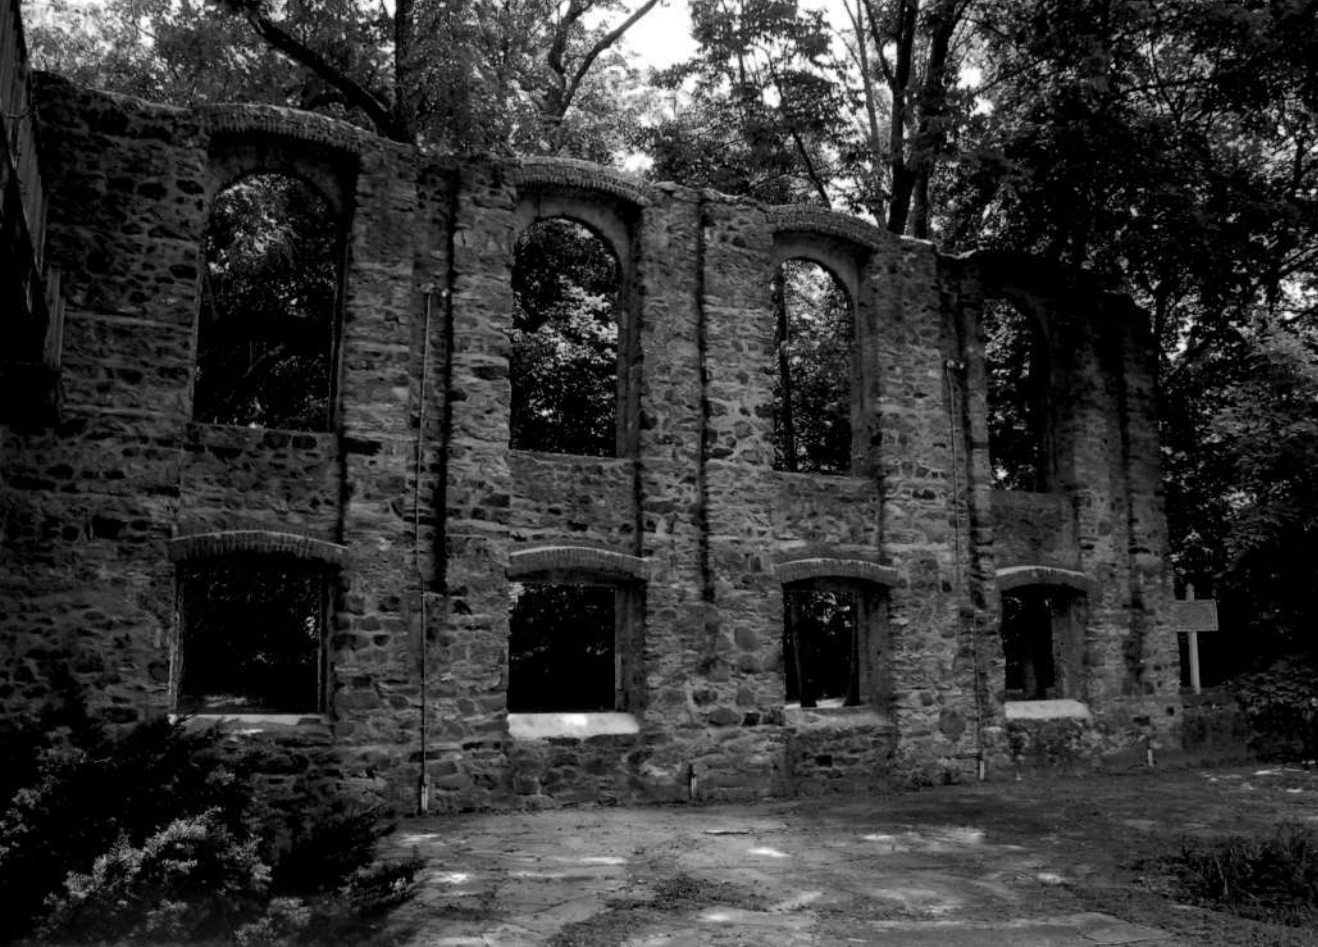
6/6

The center room has no second story, and there are iron straps projecting from the east and west walls at the floor level of what was the second story. On the east and west walls the second story windows have segmental brick arches on the interior. The west door is semi-circular arched. There are channels in the stone between each pair of openings and the walls are thinner from below the sills down to the first story brick arches. The north wall has two stone buttresses in the center bay of the first story. There is a wide opening in the center of the second story and the jambs here are splayed or rounded. The second story east and west bays have door openings set about two steps above the floor; these could have been window openings into the rooms. On the south wall the first story has two buttresses in the center bay. The second story has two channels in the wall. The west bay has a segmentally-arched doorway in the first story and a large semi-circular-arched doorway in the second story. The center bay on the first

Interior, view east
