## National Register of Historic Places Registration Form

historic name Hampton

other names Hampton Mansion; Hampton Hall; Hampton National Historic Site (preferred name) (BA-103)

street & number 535 Hampton Lane ☐ not for publication

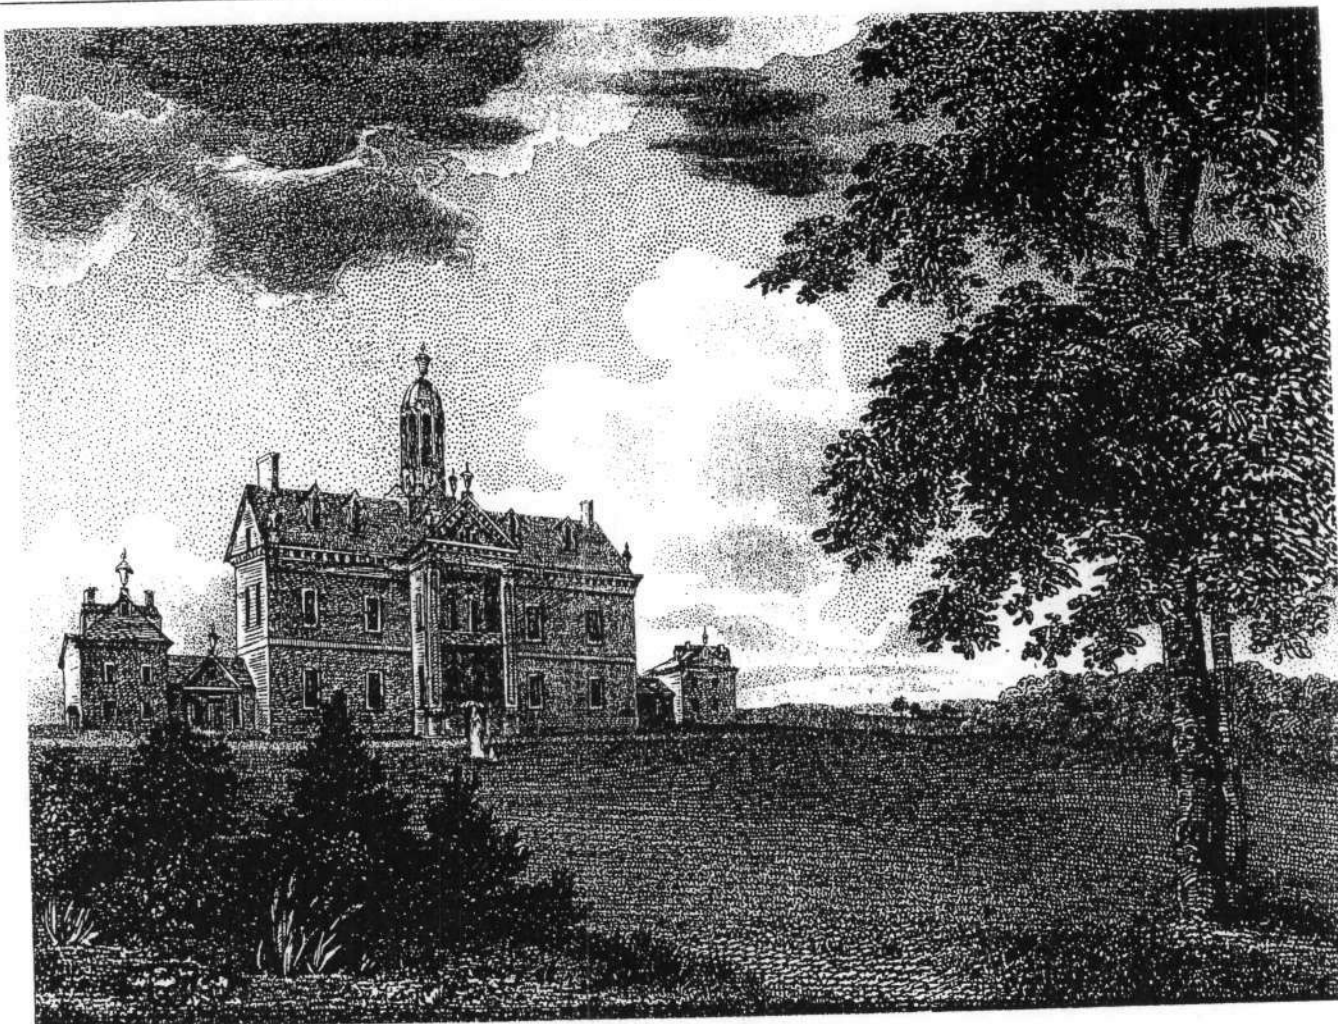
Fig. #4 Engraving of Hampton Mansion by William Russell Birch

*Hampton the Seat of Gen<sup>l</sup> Cha<sup>s</sup> Ridgley, Maryland. —*

Hampton Mansion, historically known as Hampton Hall, is an outstanding example of late Georgian architecture in America. Built between 1783 and 1790, it was probably designed in collaboration between Captain Charles Ridgely (1733-1790), the owner, and Jehu Howell (?-1787), a highly skilled builder and master carpenter referred to as "a very ingenious architect" in his obituary. Scholars have noted similarities between portions of Hampton's design with that of Castle Howard, a grand late 17th century estate, in Yorkshire. This is especially true when comparing the proportions and design of the two mansion's cupolas. No written record exists which indicates that Captain Ridgely used Castle Howard as his inspiration, though. As Captain Ridgely was connected to this family line through his mother it is possible that he made a visit while in England on one of his extended trips between 1750 - 1762. Images of Castle Howard were also readily available as prints.

The Mansion is situated at the top of a hill and dominates the surrounding landscape. It has a symmetrical five-part linear plan: a large central structure connected to two wings by hyphens. The house is constructed of gneiss-schist rubble stone covered with stucco, once scored to resemble fine coursed ashlar masonry. It is embellished with wood framed projecting porticoes, dormer windows, and a large cupola. The scoring in the original stucco was painted white. The original roofing material was fish-scale wood shingles, but it was replaced in 1841 with slate. The roof is decorated with carved wooden urns.

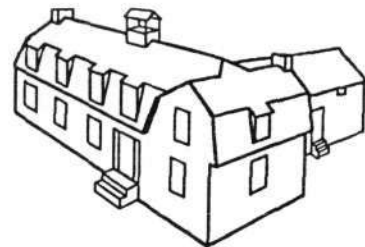
Fig. #17 Farm House Construction Phases

EVOLUTION OF THE  
HAMPTON FARM HOUSE  
c. 1725 to Present

The Farm House is an L-shaped, wood frame, two-story structure covered with wood weatherboards and rests on a stone foundation. The main section of the house is about 56'-0" by 20'-0". An addition to the north is approximately 25'-0" by 18'-0", and the east wing is about 28'-0" by 12'-0".

5) During the second half of the nineteenth century, the original link between the two earliest structures was replaced with a two-story connector with gambrel roof (Section C). Various cosmetic changes were made, such as plastering, replacing trim, changing fireplaces and their trim, repairing floors, and replacing a number of windows. A porch on the west wall of the house was added, c.1840-1850, and subsequently removed c.1930.

6) (Section E) In the twentieth century, plumbing and electricity were added and interior finishes were repaired and upgraded. In 1947-1948, a four-room addition, three bays long and one bay deep, was built on the north side of Section B. This addition was done to accommodate Jane and John Ridgely, Jr., who moved to the Farm House when Hampton became a National Historic Site. The addition was designed by Bayard Turnbull and built by Graham Cranston.
