National Register of Historic Places
Registration Form

historic name De La Brooke Tobacco Barn
other names SM-411

De La Brooke Tobacco Barn (SM-411)

Description Summary:

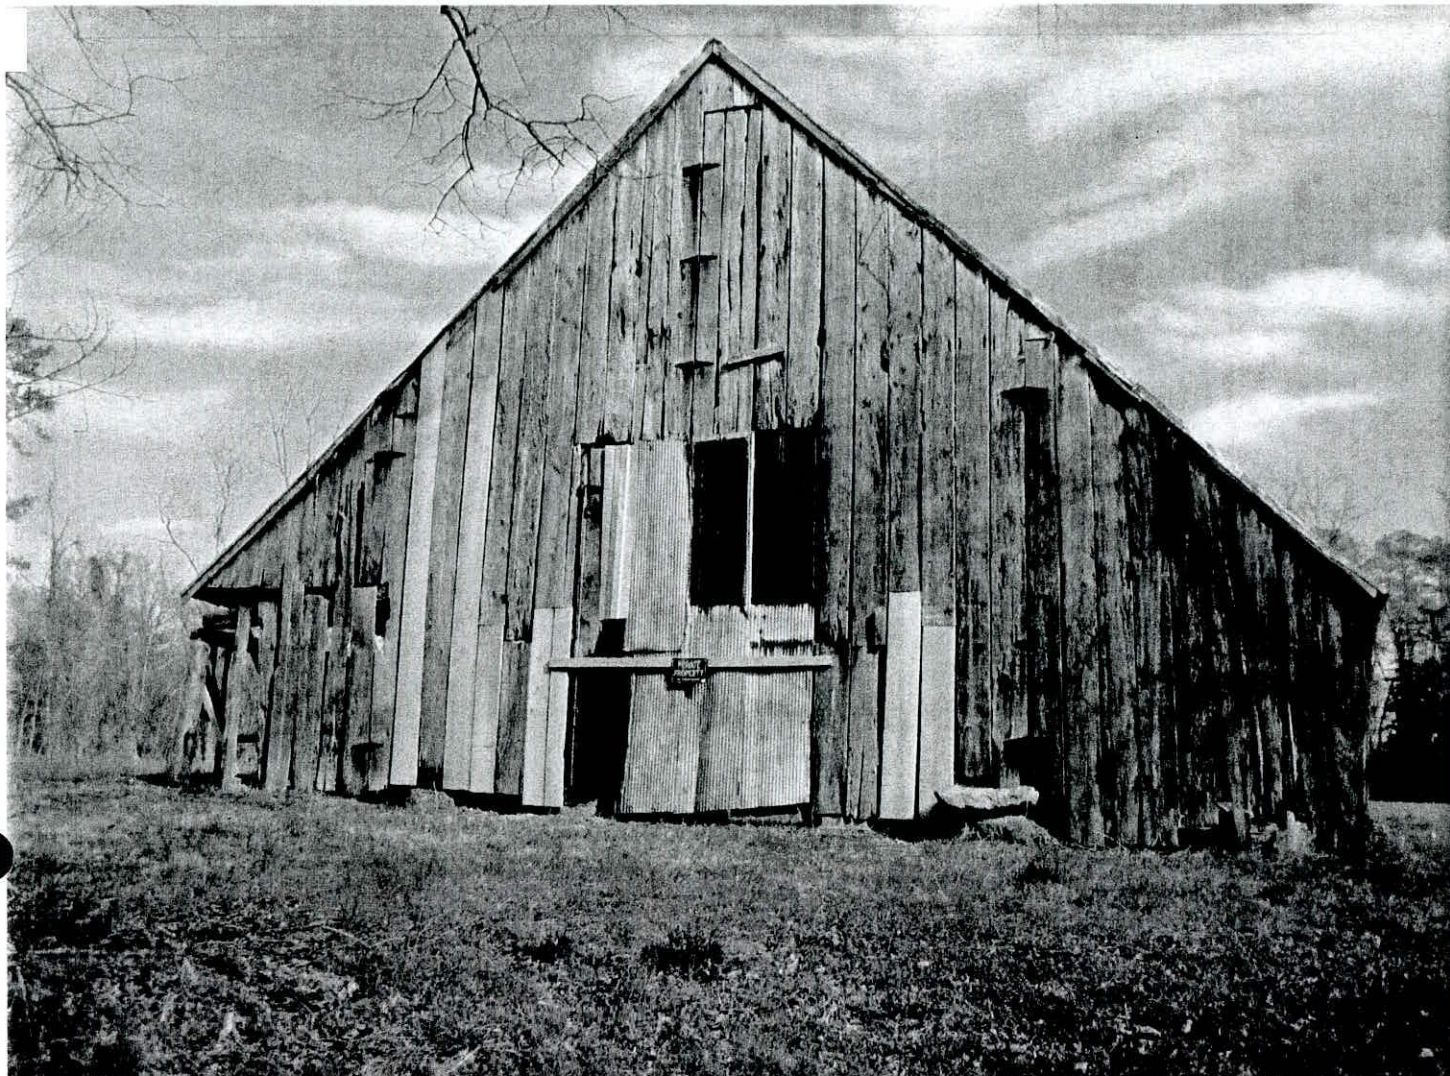
MD_StMarysCounty_DeLaBrookeBarn_001.tif

Barn exterior, view from west, 4/5/2014

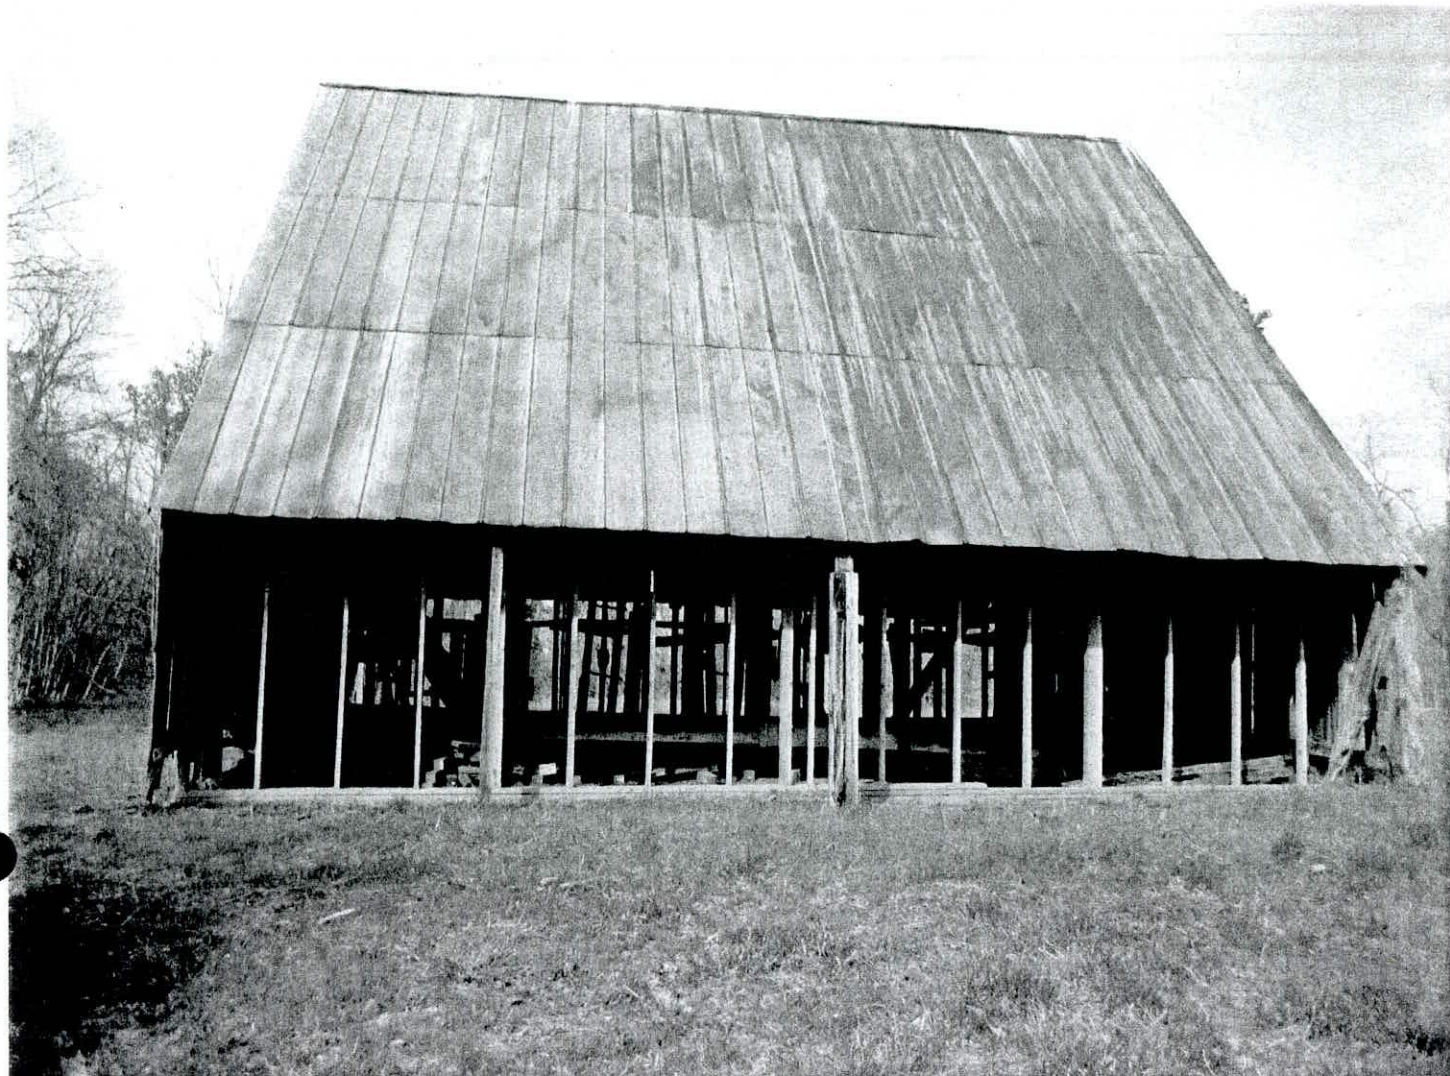
MD_StMarysCounty_DeLaBrookeBarn_002.tif

Barn exterior, view from south, 4/5/2014. Siding repair in progress.

The exterior of the barn is now sheathed in vertical board siding. The boards are non-uniform in width. Gaps between the boards help with air circulation. Additionally, each gable end wall exhibits three side-hinged ventilators, one on each side of the doorway and one above the doorway. The majority of the vertical board siding on the northeast and southwest walls (the outer walls of the sheds) is missing, but these two elevations also had two hinged ventilators at one time (Hughes 1994).

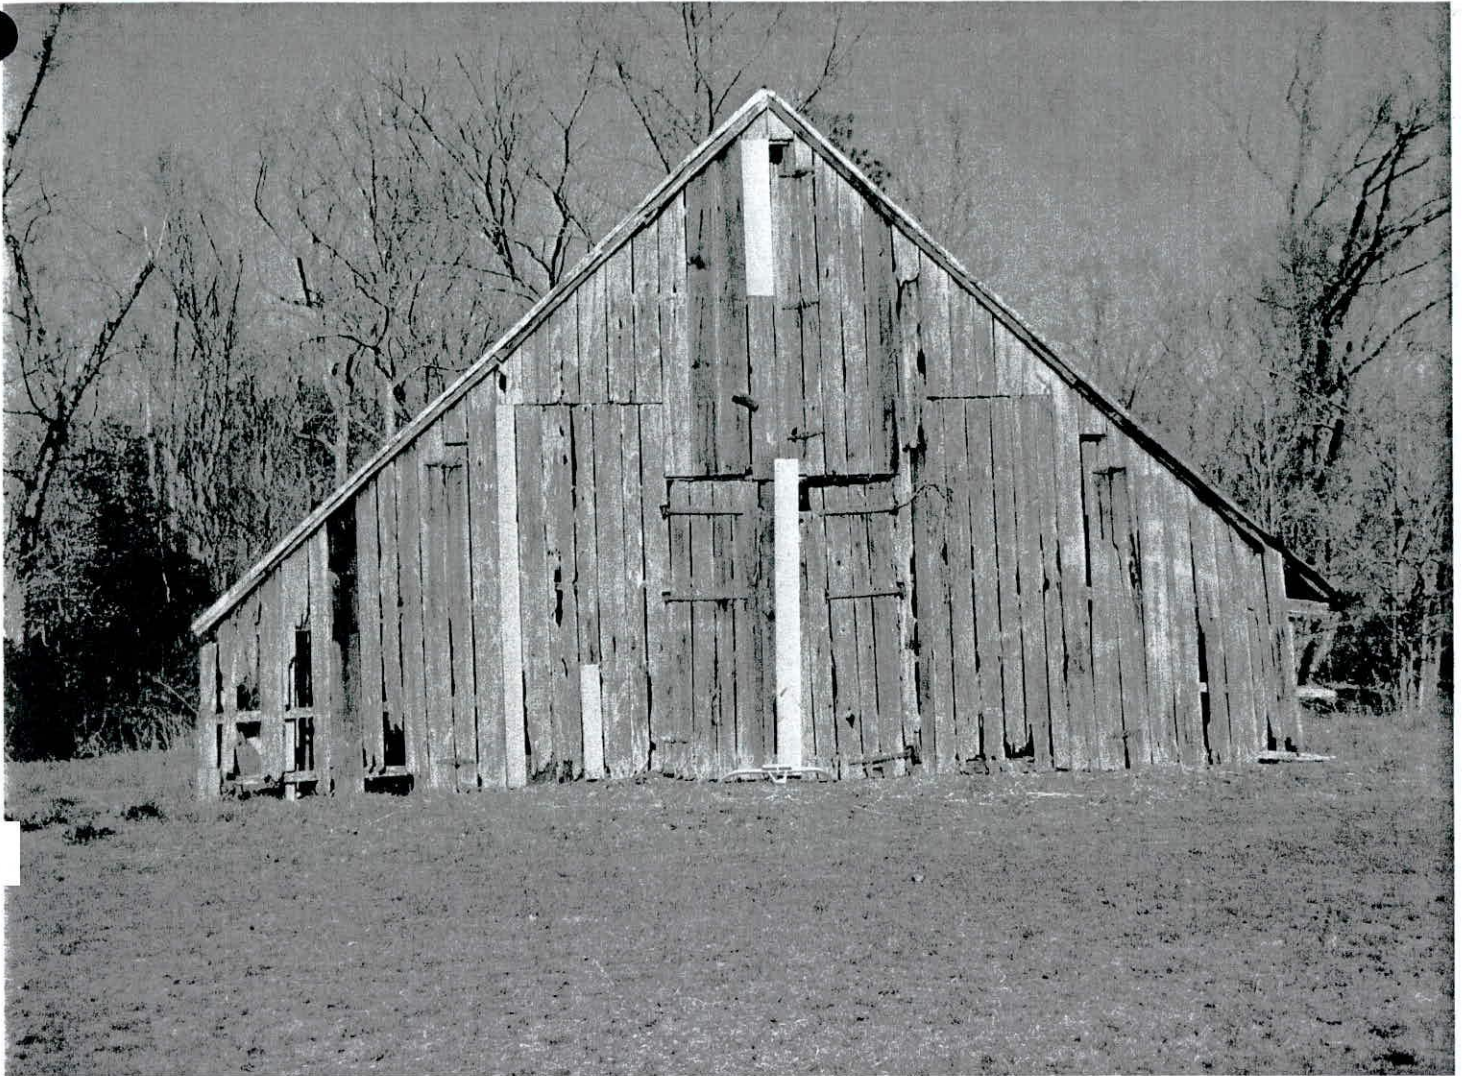
MD_StMarysCounty_DeLaBrookeBarn_003.tif

Barn exterior, view from east, 4/5/2014

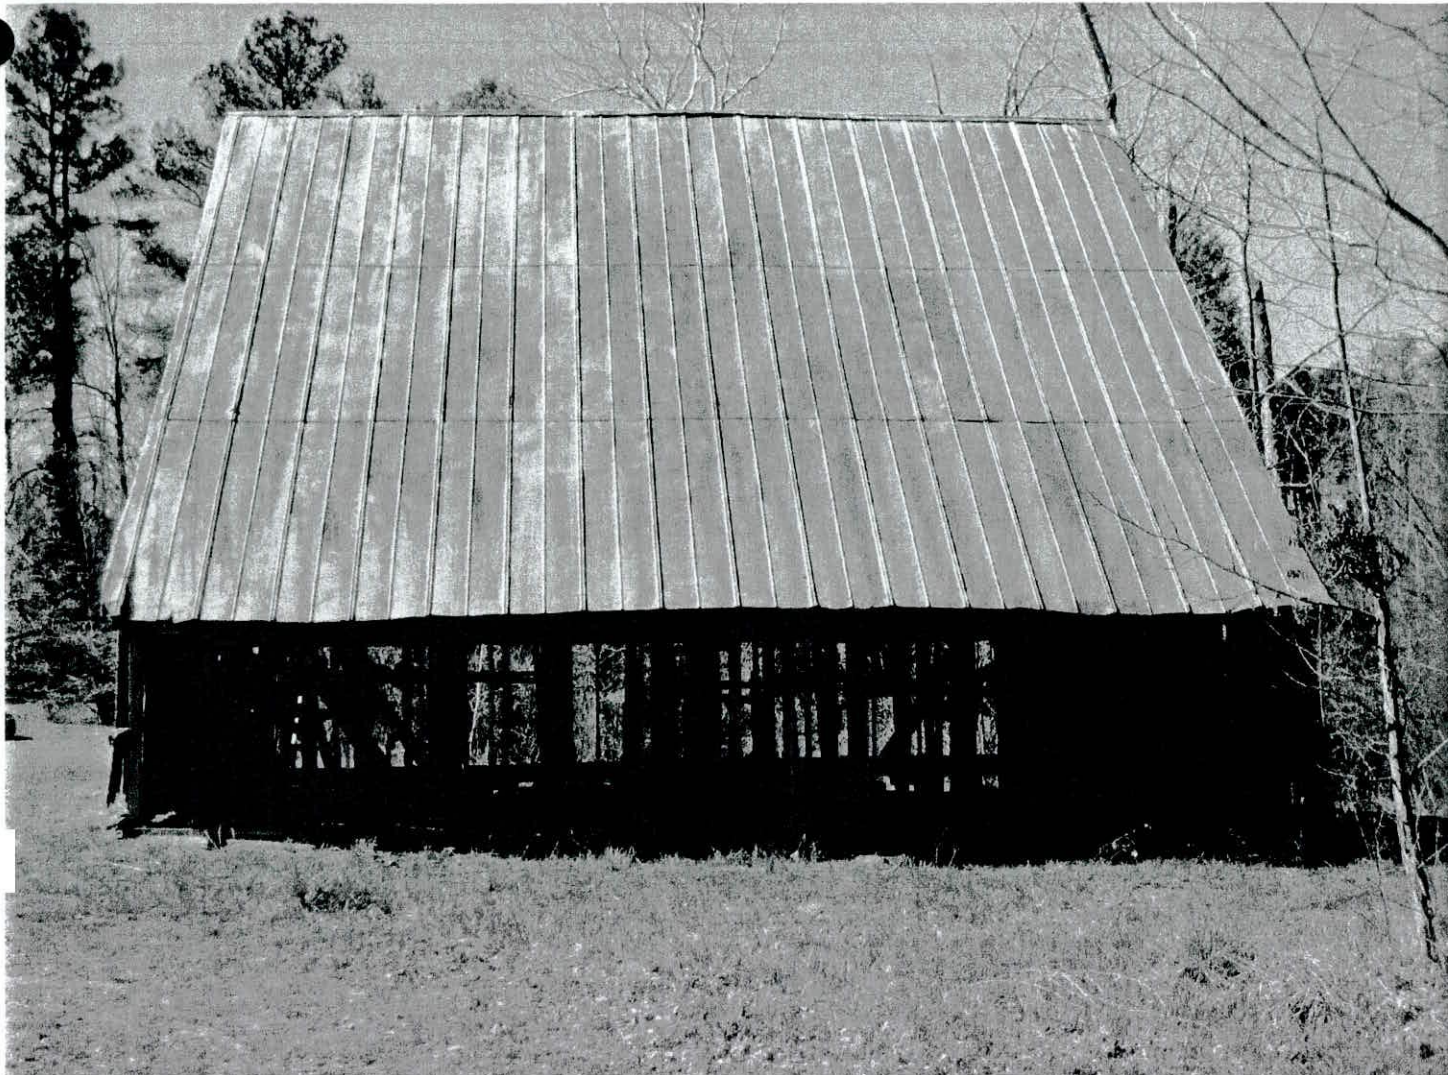
MD_StMarysCounty_DeLaBrookeBarn_004.tif

Barn exterior, view from north, 4/5/2014. Siding repair in progress.

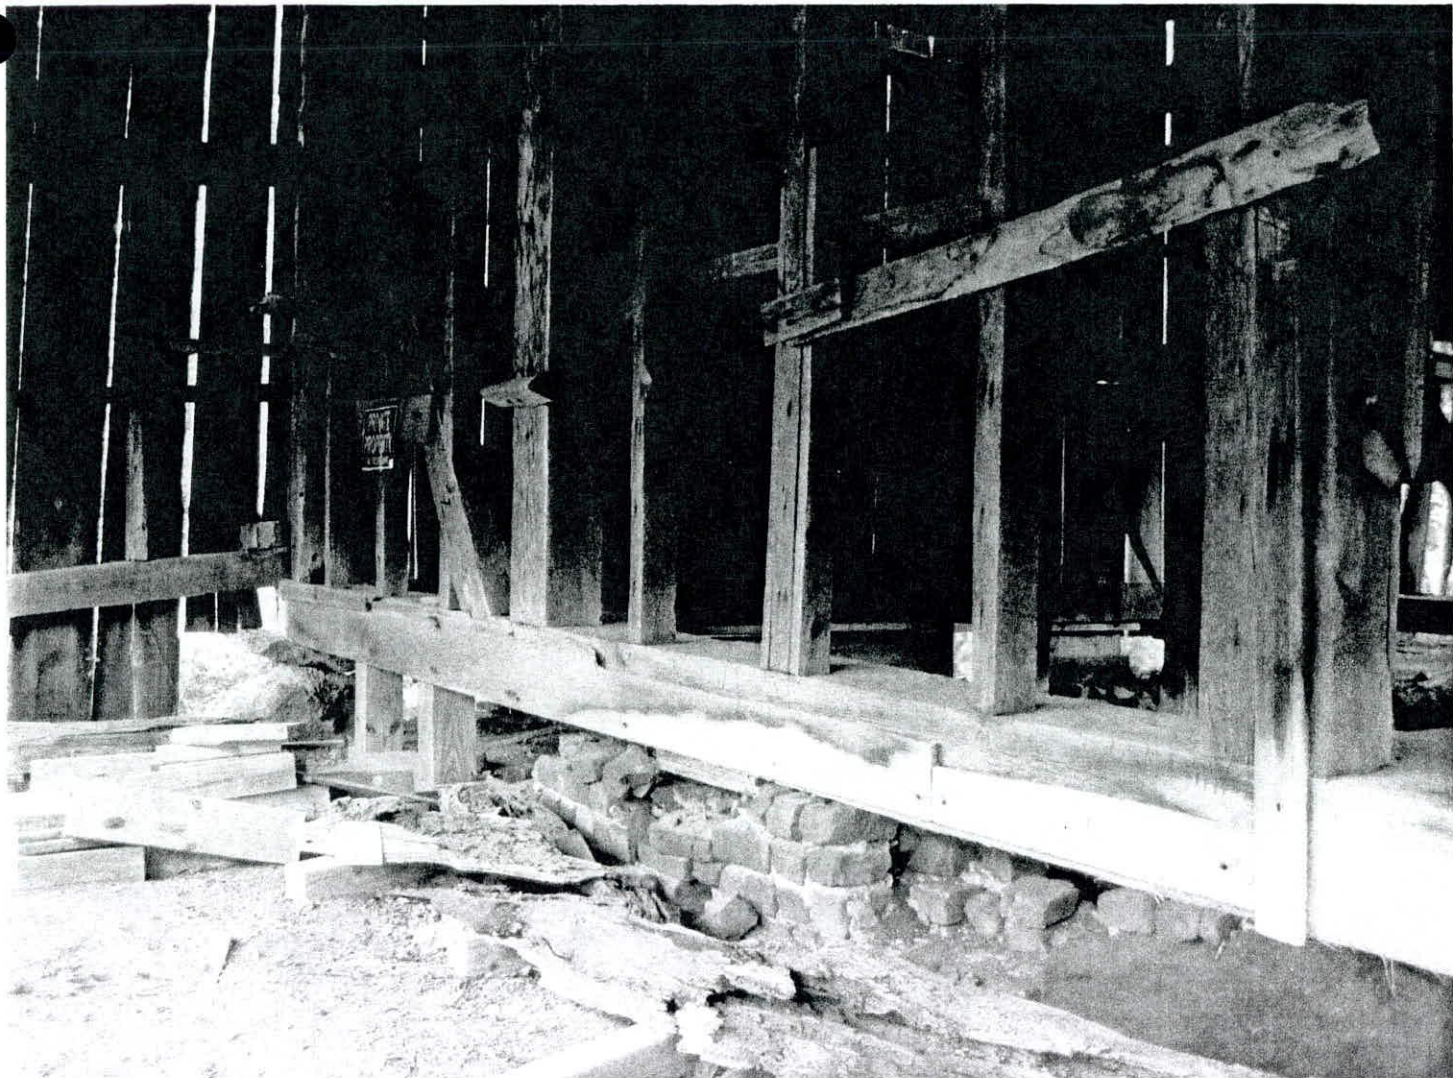
MD_StMarysCounty_DeLaBrookeBarn_005.tif

Interior framing and foundation detail, view from southeast, 8/11/2014

The barn has continuous sills with mortise and tenon corner joints secured by wood pegs. The sill on the northeast side has been replaced with a circular-sawn one of comparable size. This new sill was mortised to fit the tenons of the other sills, but it is secured to the framing members with machine cut nails. A sill bisects the barn from northeast to southwest. All the sills are raised above the dirt floor by ironstone, bricks, and wood blocks at various heights to level the sills. Ironstone is underneath the corners of the sill on the northwest side and where the additional sill joins the sill on the southwest side. Brick is positioned beneath segments of the sill on the southwest side of the barn, including at the south corner. Wood blocks prop up other segments of the sills. At present, the sill on the northeast side and the additional sill are underpinned just at the corners.

The framing system consists of hewn principal posts centered on eight-foot bays and pit-sawn studs on two-foot bays. Both the posts and studs are tenoned into the sills. Down braces reinforce the wall framing. The down braces are tenoned into the sills and corner posts and secured by wood pegs and wrought nails. The system of closely-spaced wall studs indicates the core section was originally clad in horizontal siding. In fact, one piece of weatherboard survives on the southwest wall. It is secured with wrought nails. Nail patterns on the two exposed longitudinal walls of the core also provide evidence that horizontal siding was once the exterior sheathing.
