Baltimore Lighthouse

Architectural Survey File

BALTIMORE LIGHT STATION

National Register of Historic Places Registration Form

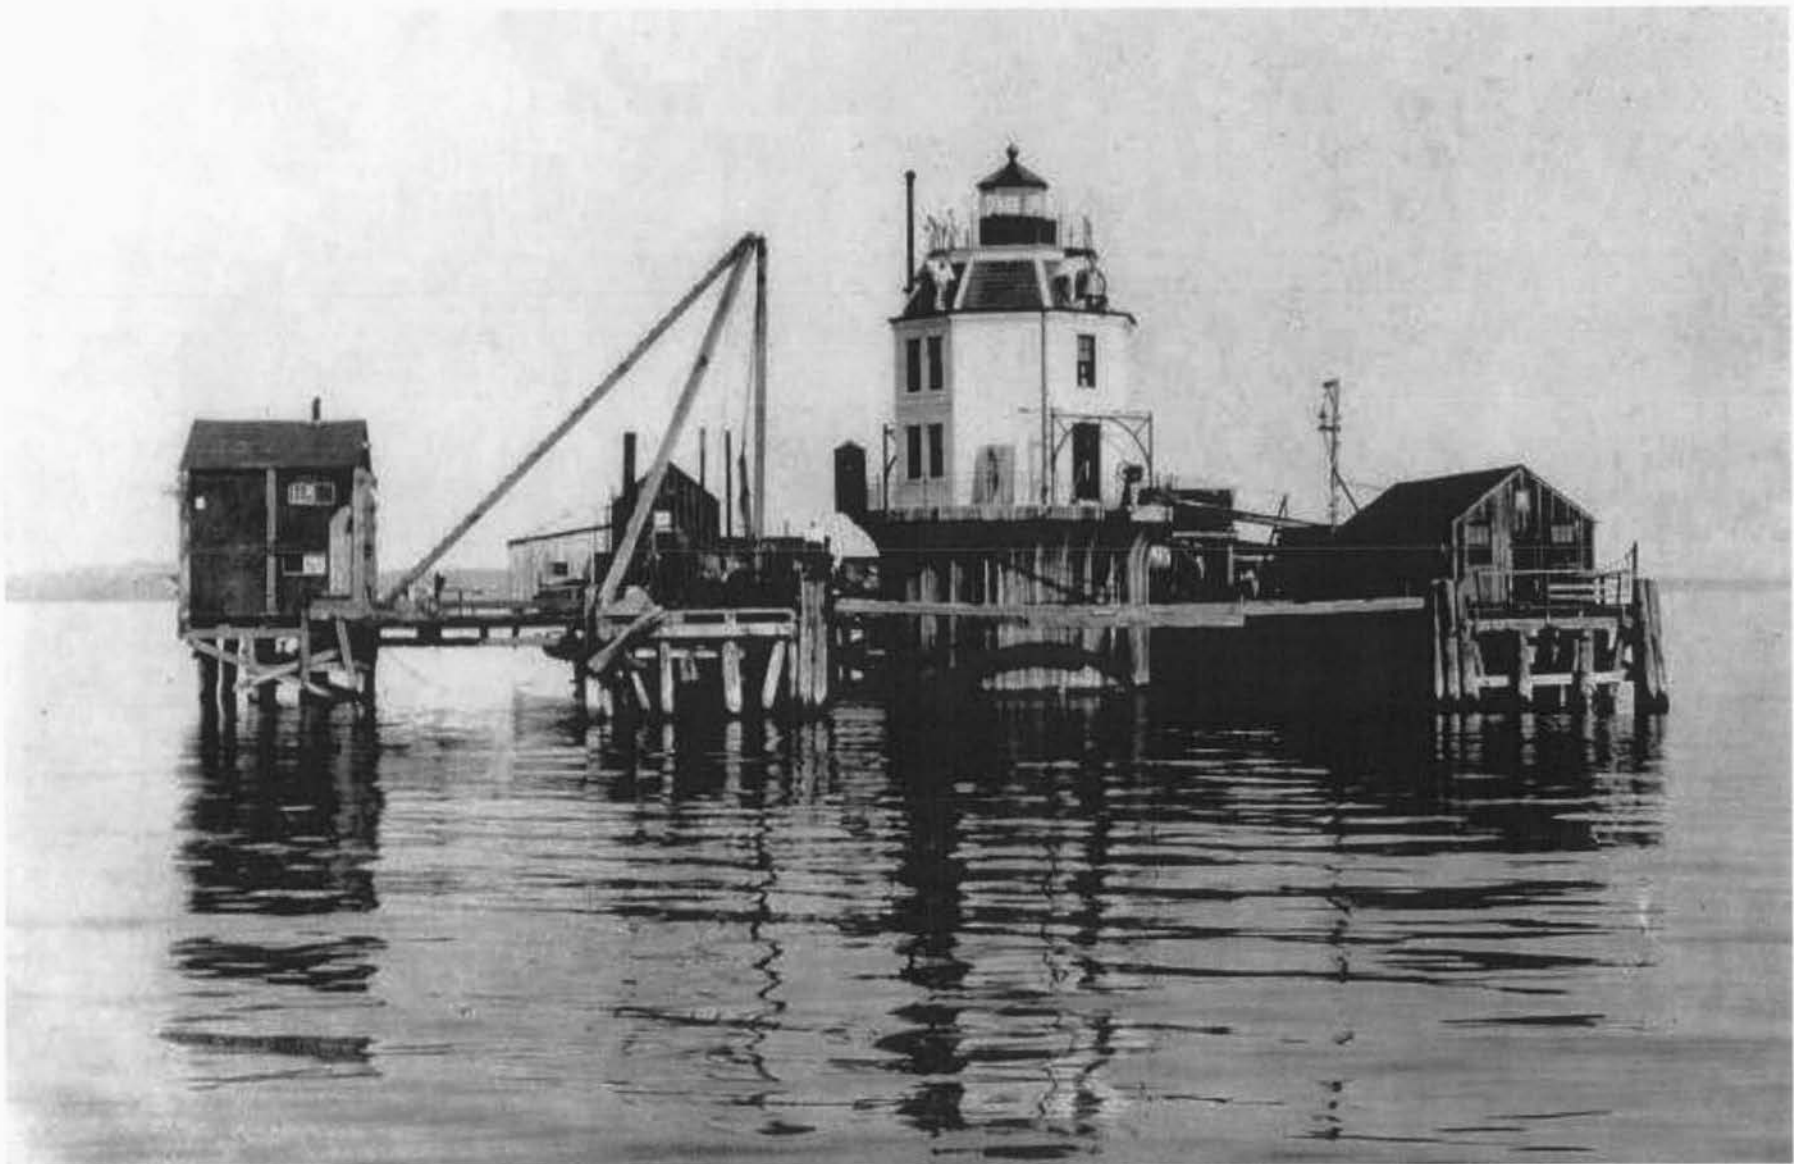
AA-945
Baltimore Light Station
1901

"Installation of 4,600 [pound] atomic generator SNAP-7B in Baltimore Light by U.S. Coast Guard buoy tender WHITE PINE," 20 May 1964.
