HO-451

## Hoogewerff-Donaldson Cottage (Elibank, Worthington House)

### **Architectural Survey File**

Hoogewerff-Donaldson Cottage  
6460 Elibank Drive, Lawyers Hill  
Howard County, Maryland

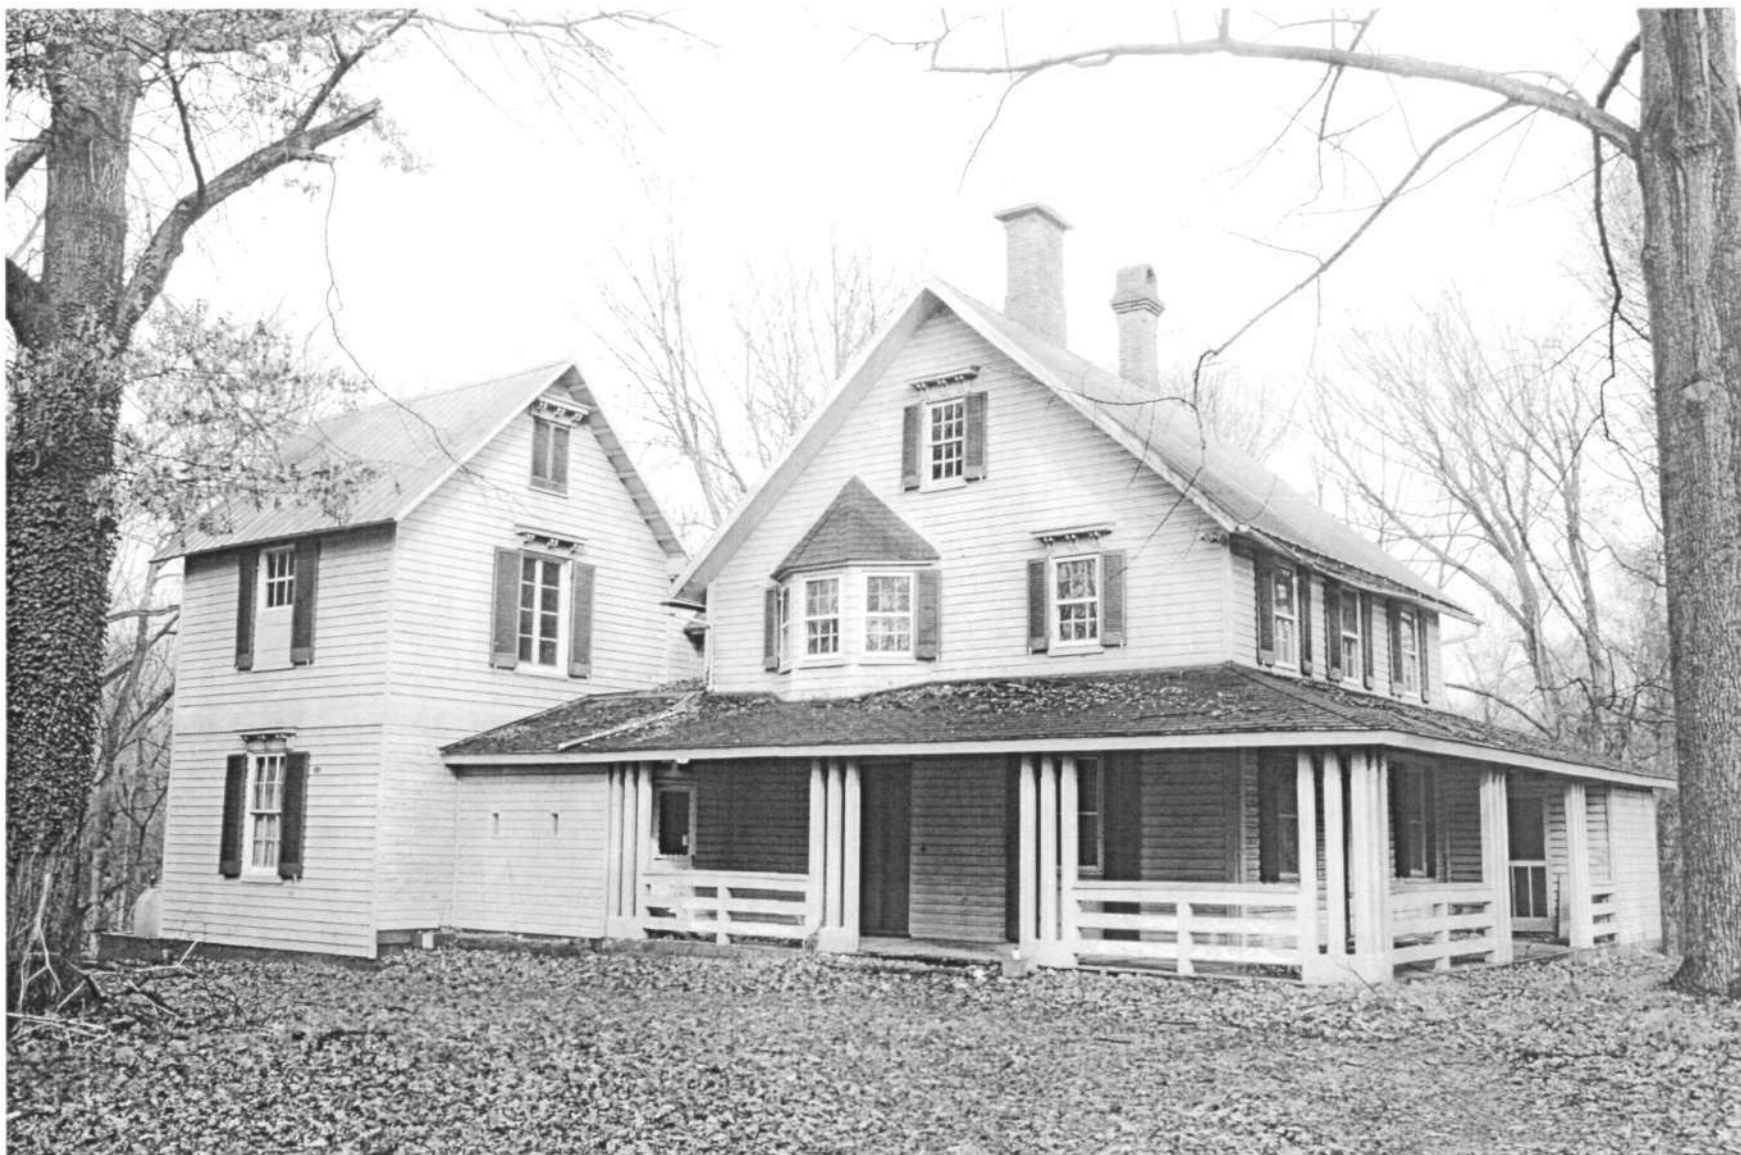
HO-451 Hoogewerff-Donaldson Cottage 6460 Elibank Drive South elevation  
Ken Short, December 2006 1/15

The house faces south toward the road and is a two-story, three-bay by two-bay frame structure with a rubble stone foundation, German siding, and a gable roof with an east-west ridge and inverted-V-seam metal. There is a two-story, one-bay-square wing attached to the northwest. This wing has a brick pier on the northwest corner with CMUs on the west side of the foundation. The wing is frame with weatherboards, but has German siding on the first story south elevation where the enclosed porch is attached. The rear porch of the main block was enclosed and an ell constructed that connected the main block to the northwest wing. This ell is two stories, is one bay square, has German siding, and has a gable roof with a north-south ridge. There is a second ell attached to this ell on the north. It is one story and one bay square, has a gambrel roof, and has German siding with weatherboards on the gambrel end.

HO-0451\_20061213\_01  
Hoogewerff-Donaldson  
Cottage  
6460 Elibank Drive  
Howard County, MD  
South elevation  
Ken Short  
December 2006  
1/15

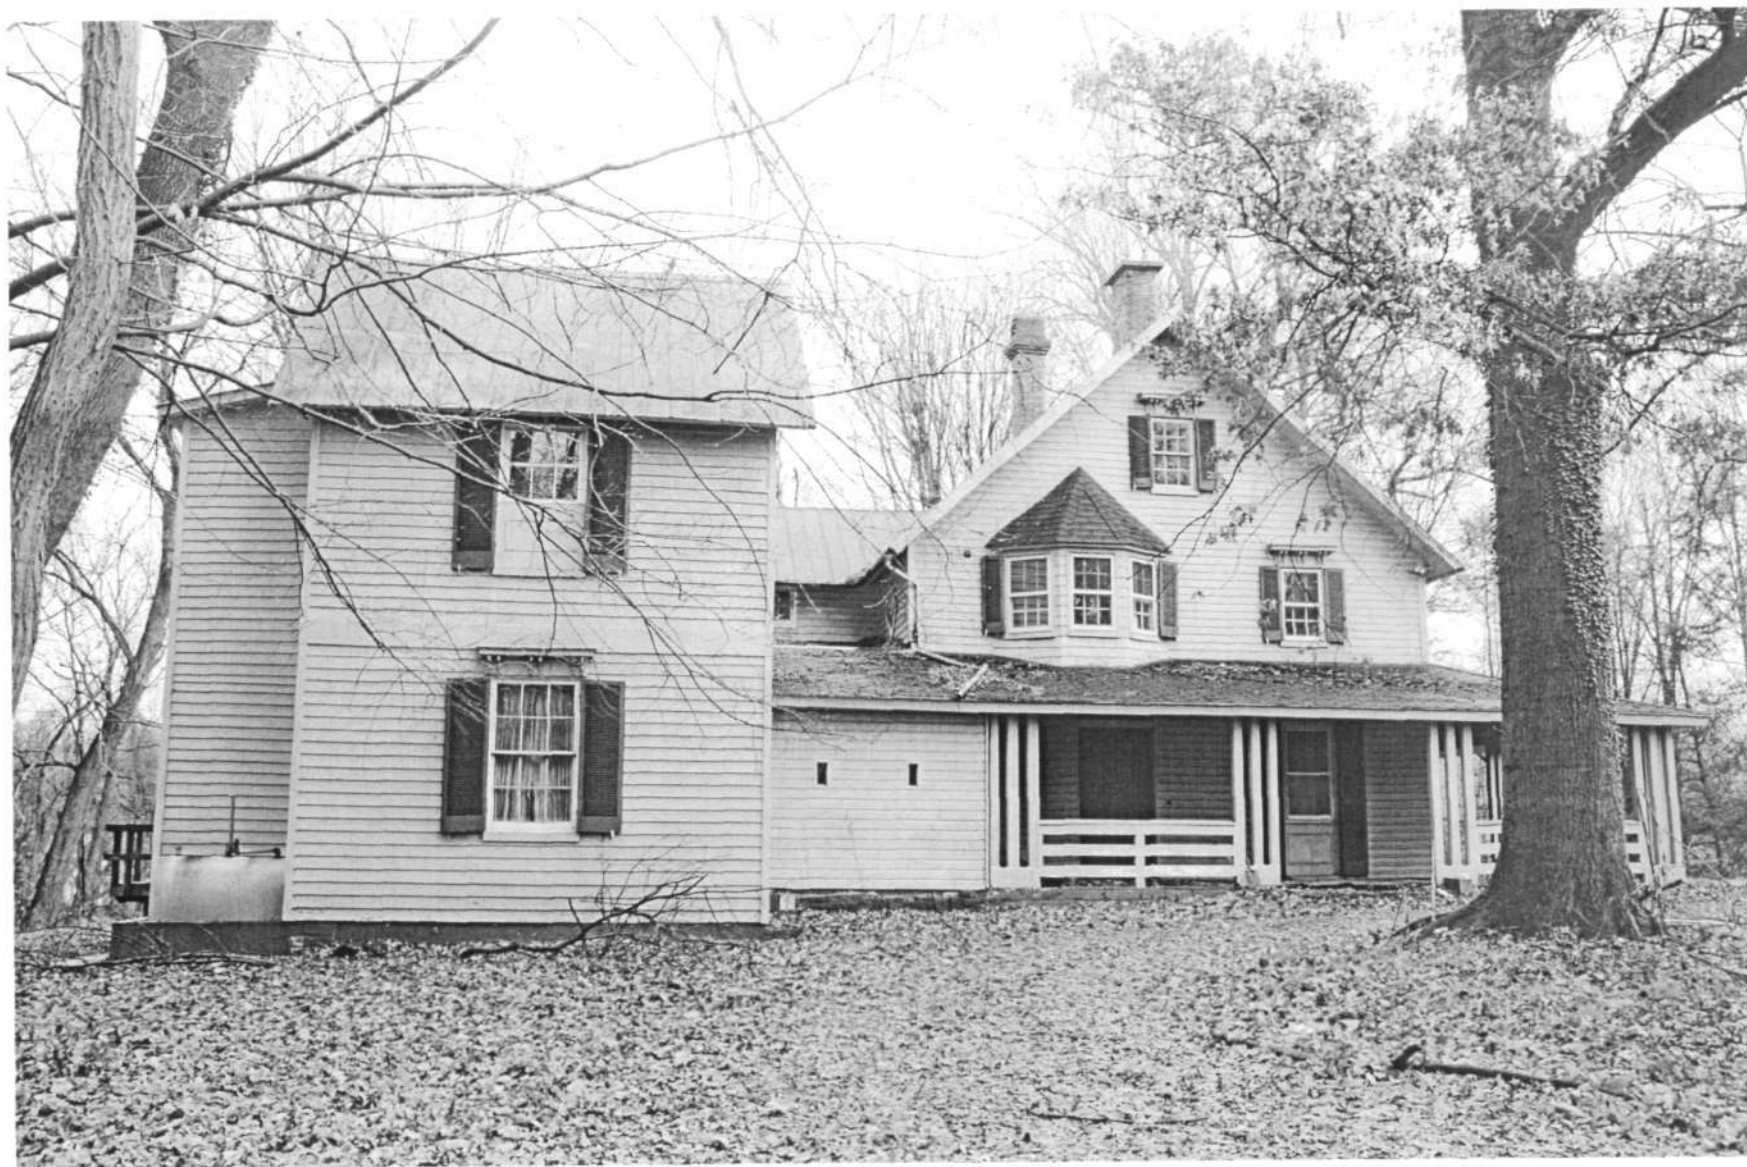
HO-451 Hoogewerff-Donaldson Cottage 6460 Elibank Drive West & south elevations  
Ken Short, December 2006 2/15

The west elevation of the wing has a six-over-six sash with typical frame, blinds, and cornice that matches those on the main block, on the first story. There is a plain board belt course above the cornice on the south and west elevations. The second story has a six-light sash above a panel that matches those added to the main block. The window also has a typical frame and blinds. The north elevation of this wing has a two-story projecting addition with weatherboards and has a brick pier on the northwest corner and CMUs for the foundation. This addition has a shed roof with corrugated metal and has a jalousie window on both the first and second stories of the north elevation. The east elevation, on the first story, has a door with panel moulds like those added to the main block. The east elevation of the wing is covered by the gambrel-roofed ell addition, and has a small six-over-six sash on the second story, north of that addition. There is an interior brick chimney on the wing that has chamfered corners and a concrete cap.

HO-0451\_20061213\_02  
Hoogewerff-Donaldson  
Cottage  
6460 Elibank Drive  
Howard County, MD  
West & south elevations  
Ken Short  
December 2006  
2/15

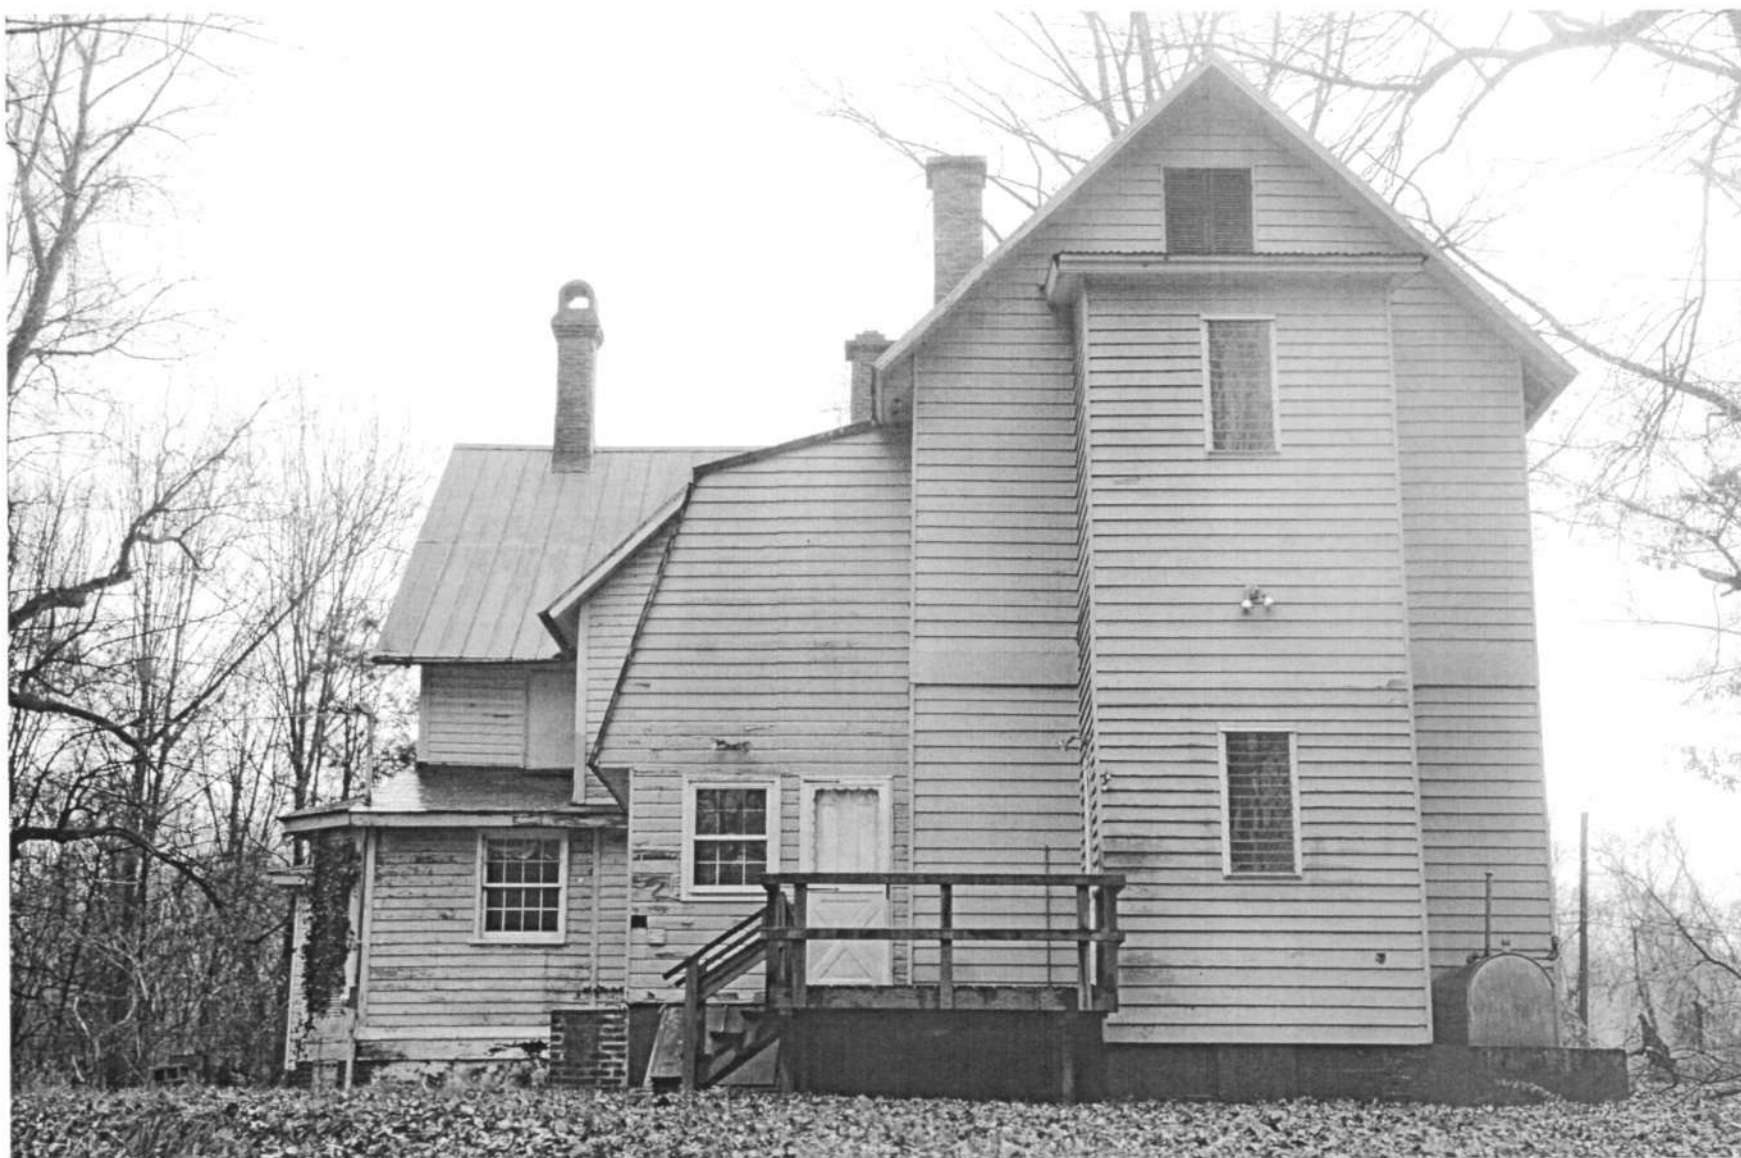
HO-451 Hoogewerff-Donaldson Cottage 6460 Elibank Drive West elevation  
Ken Short, December 2006 3/15

HO-0451\_20061213\_03  
Hoogewerff-Donaldson  
Cottage  
6460 Elibank Drive  
Howard County, MD  
West elevation  
Ken Short  
December 2006  
3/15

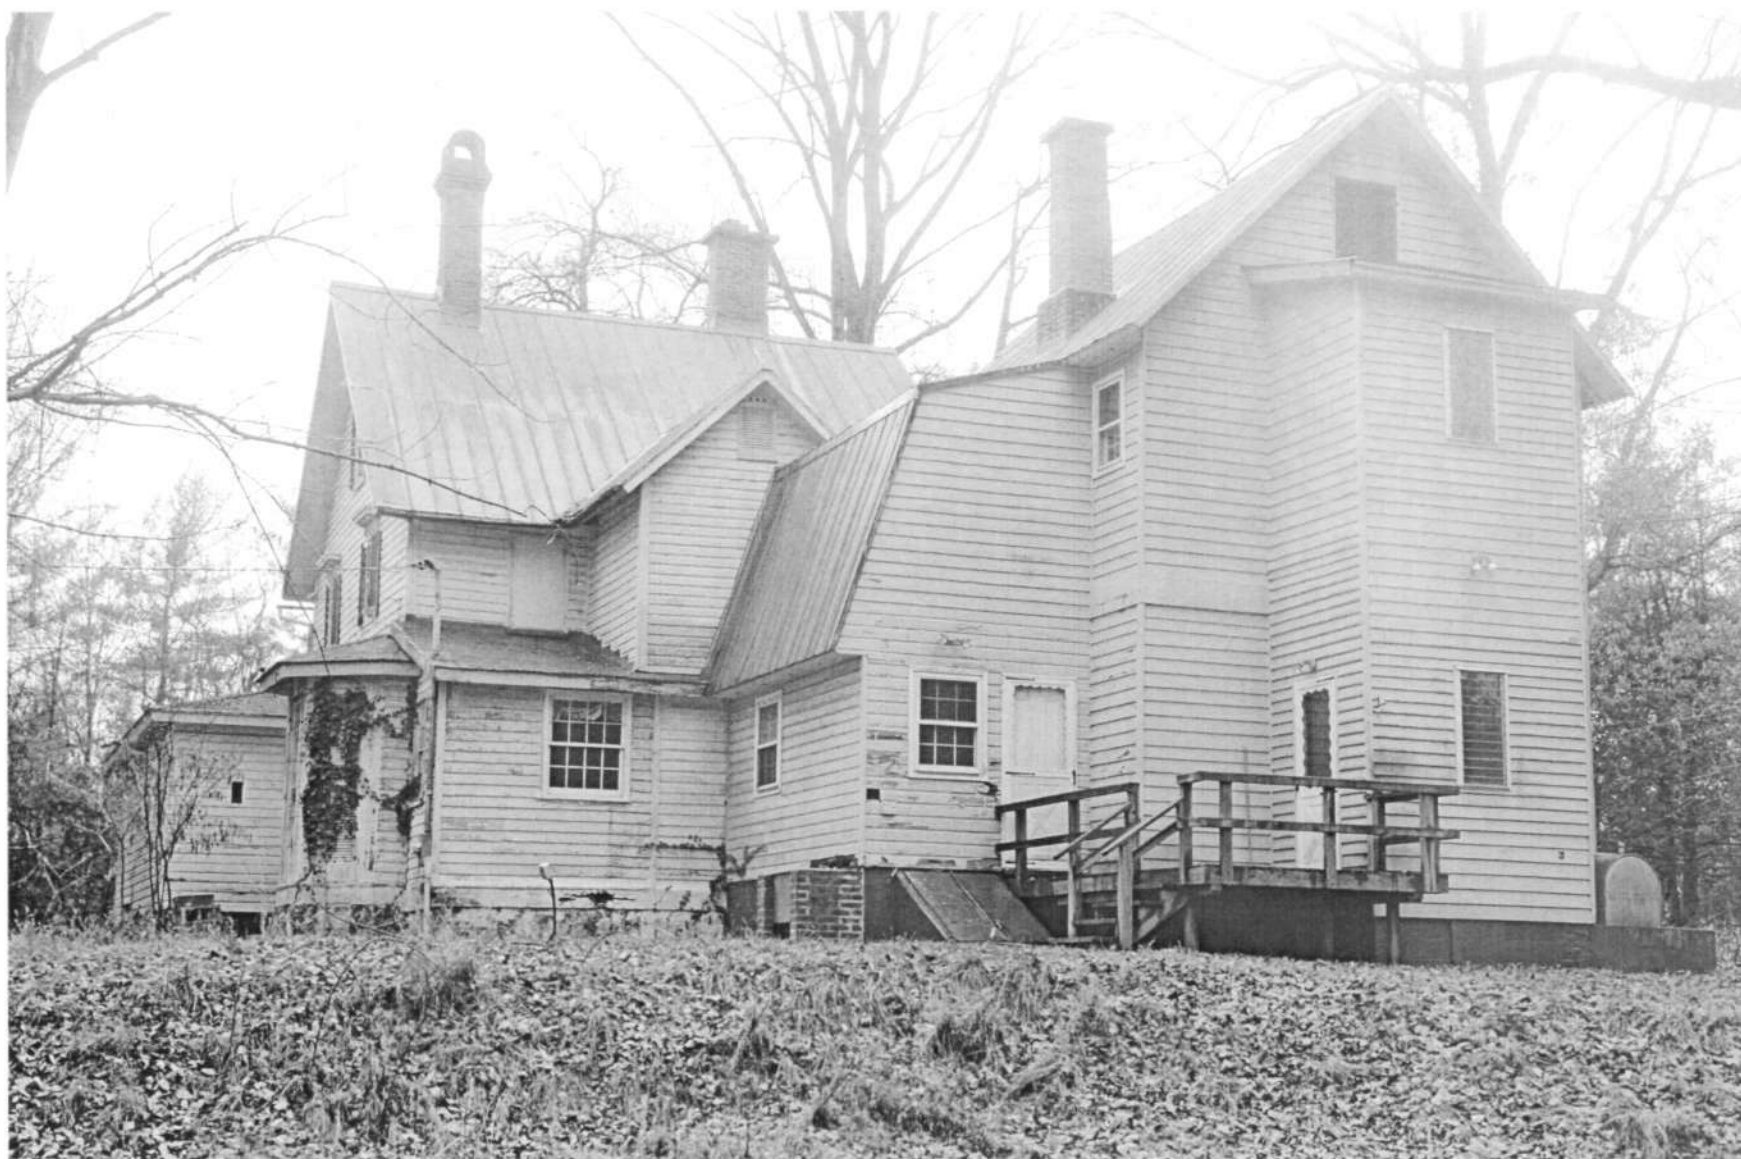
HO-451 Hoogewerff-Donaldson Cottage 6460 Elibank Drive North elevation  
Ken Short, December 2006 4/15

The north elevation of the main block, east of the gambrel addition, has the original rear porch enclosed on the first story with weatherboards and an eight-over-eight sash in a new frame. The foundation under the enclosed porch has brick piers with parged brick infill between them. The roof appears to have metal shingles. The second story east bay has a boarded-up window. The center bay on the second story has the first ell addition attached to it, with the gambrel addition to the north side of that. There is a vent in the gable end with three large holes drilled above it. This ell addition has no opening on the second-story east elevation.

HO-0451\_20061213\_04  
Hoogewerff-Donaldson  
Cottage  
6460 Elibank Drive  
Howard County, MD  
North elevation  
Ken Short  
December 2006  
4/15

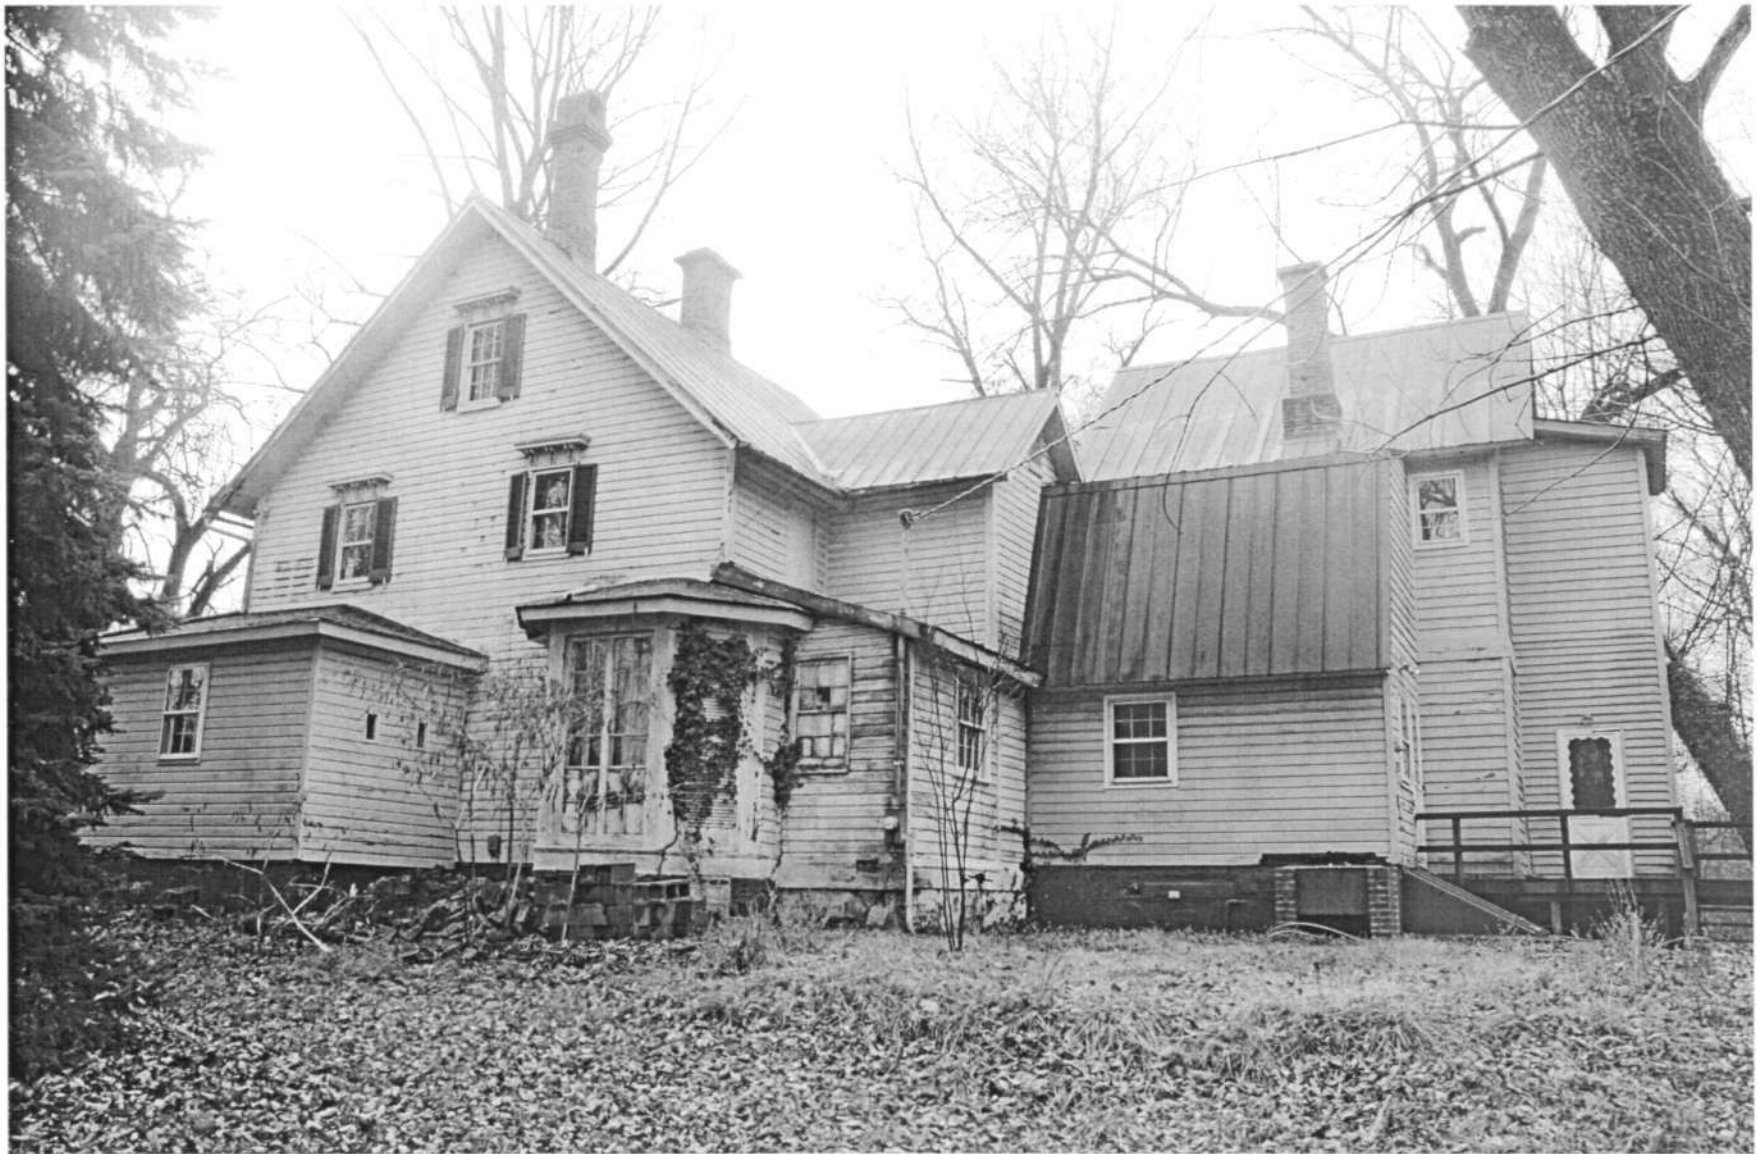
HO-451 Hoogewerff-Donaldson Cottage 6460 Elibank Drive East & north elevations  
Ken Short, December 2006 5/15

HO-0451\_20061213\_05  
Hoogewerff-Donaldson  
Cottage  
6460 Elibank Drive  
Howard County, MD  
East & north elevations  
Ken Short  
December 2006  
5/15

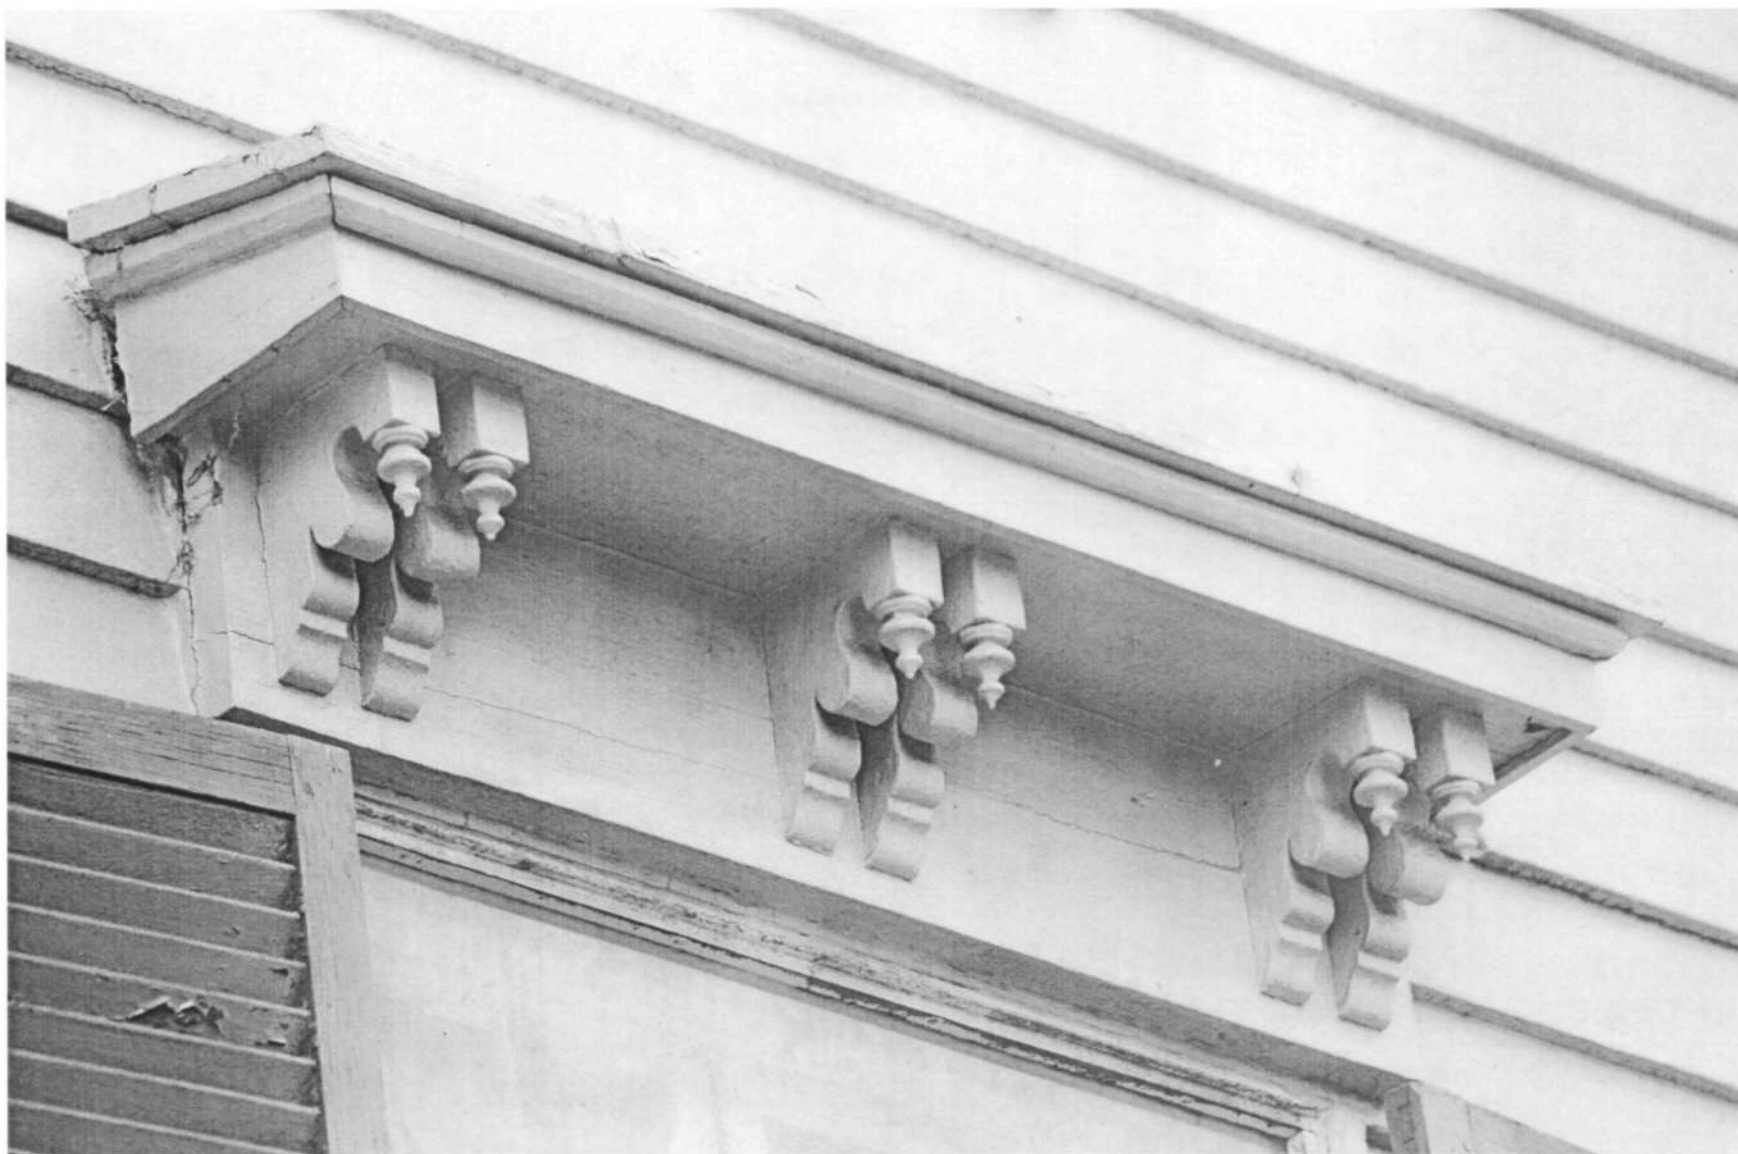
HO-451 Hoogewerff-Donaldson Cottage 6460 Elibank Drive East elevation  
Ken Short, December 2006 6/15

HO-0451\_20061213\_06  
Hoogewerff-Donaldson  
Cottage  
6460 Elibank Drive  
Howard County, MD  
East elevation  
Ken Short  
December 2006  
6/15

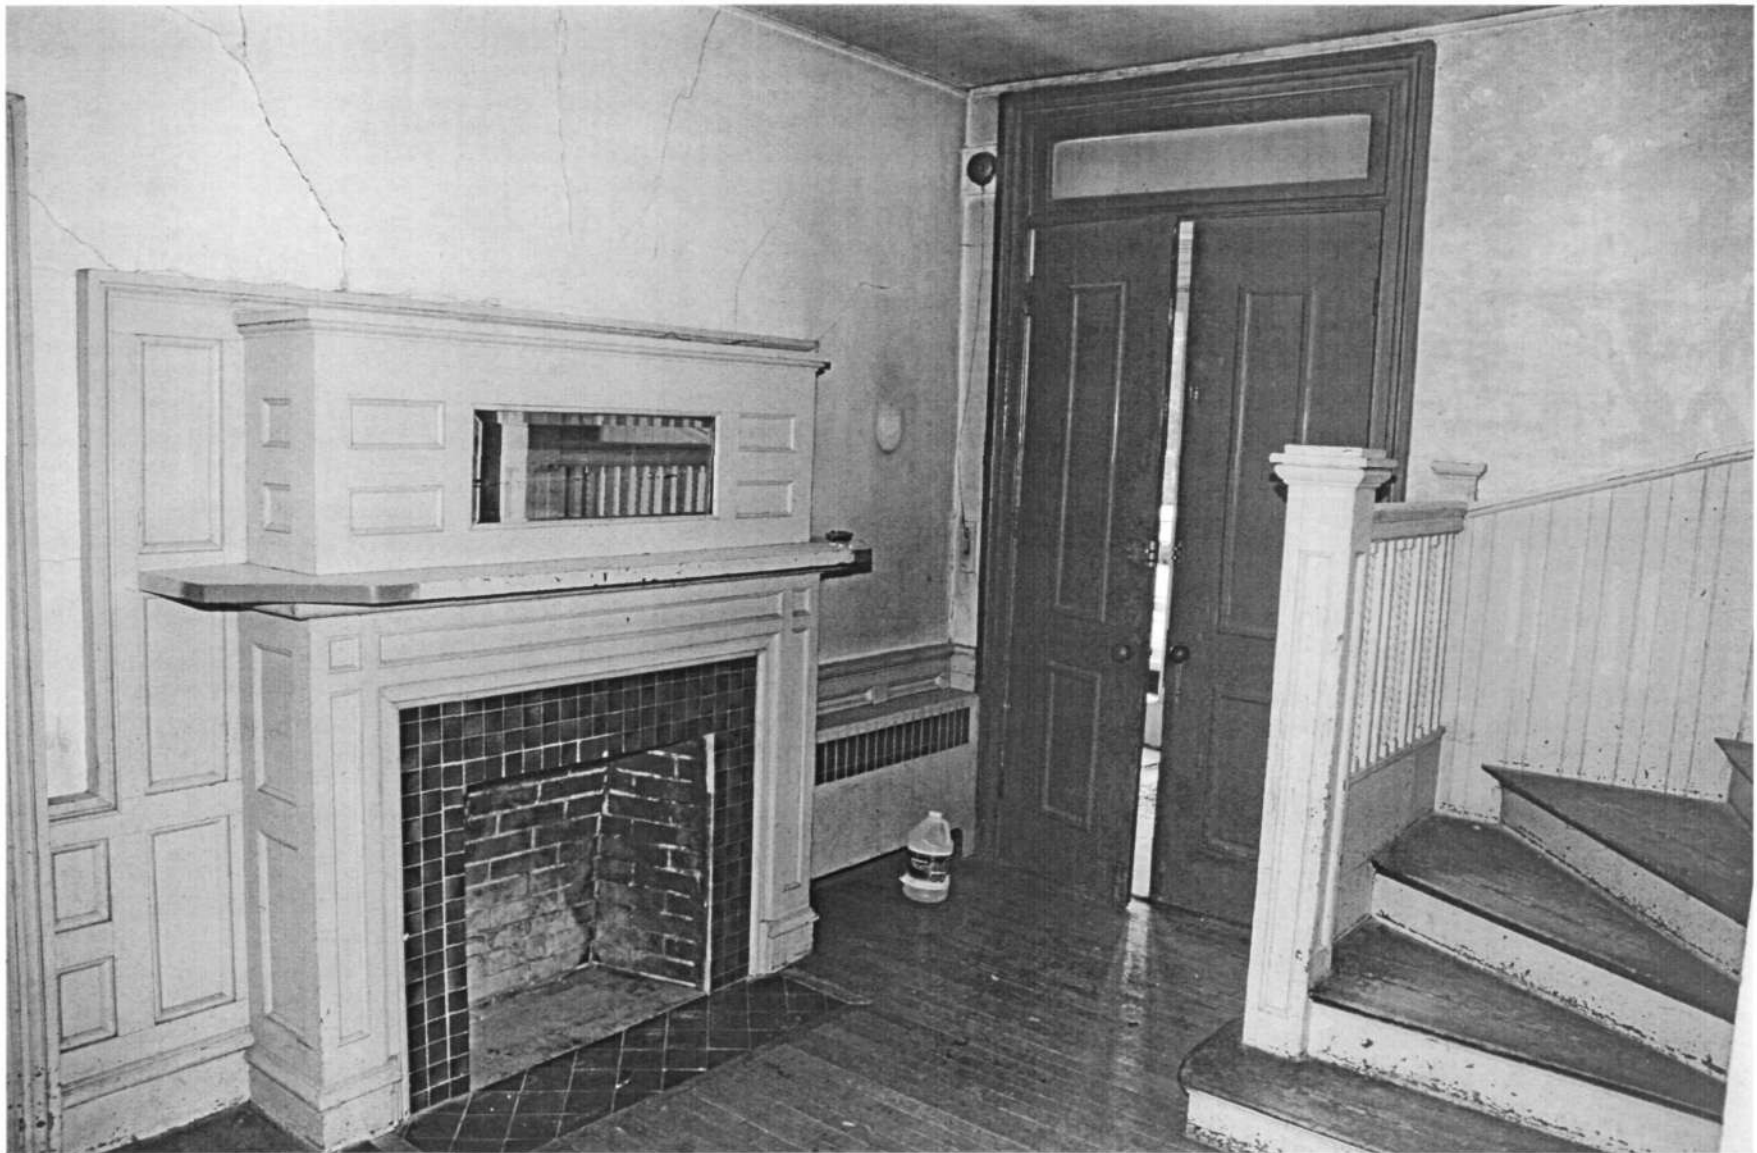
HO-451 Hoogewerff-Donaldson Cottage 6460 Elibank Drive Stair hall, view northwest  
Ken Short, December 2006 8/15

HO-0451\_20061213\_08  
Hoogewerff-Donaldson  
Cottage  
6460 Elibank Drive  
Howard County, MD  
Stair hall, view  
northwest  
Ken Short  
December 2006  
8/15

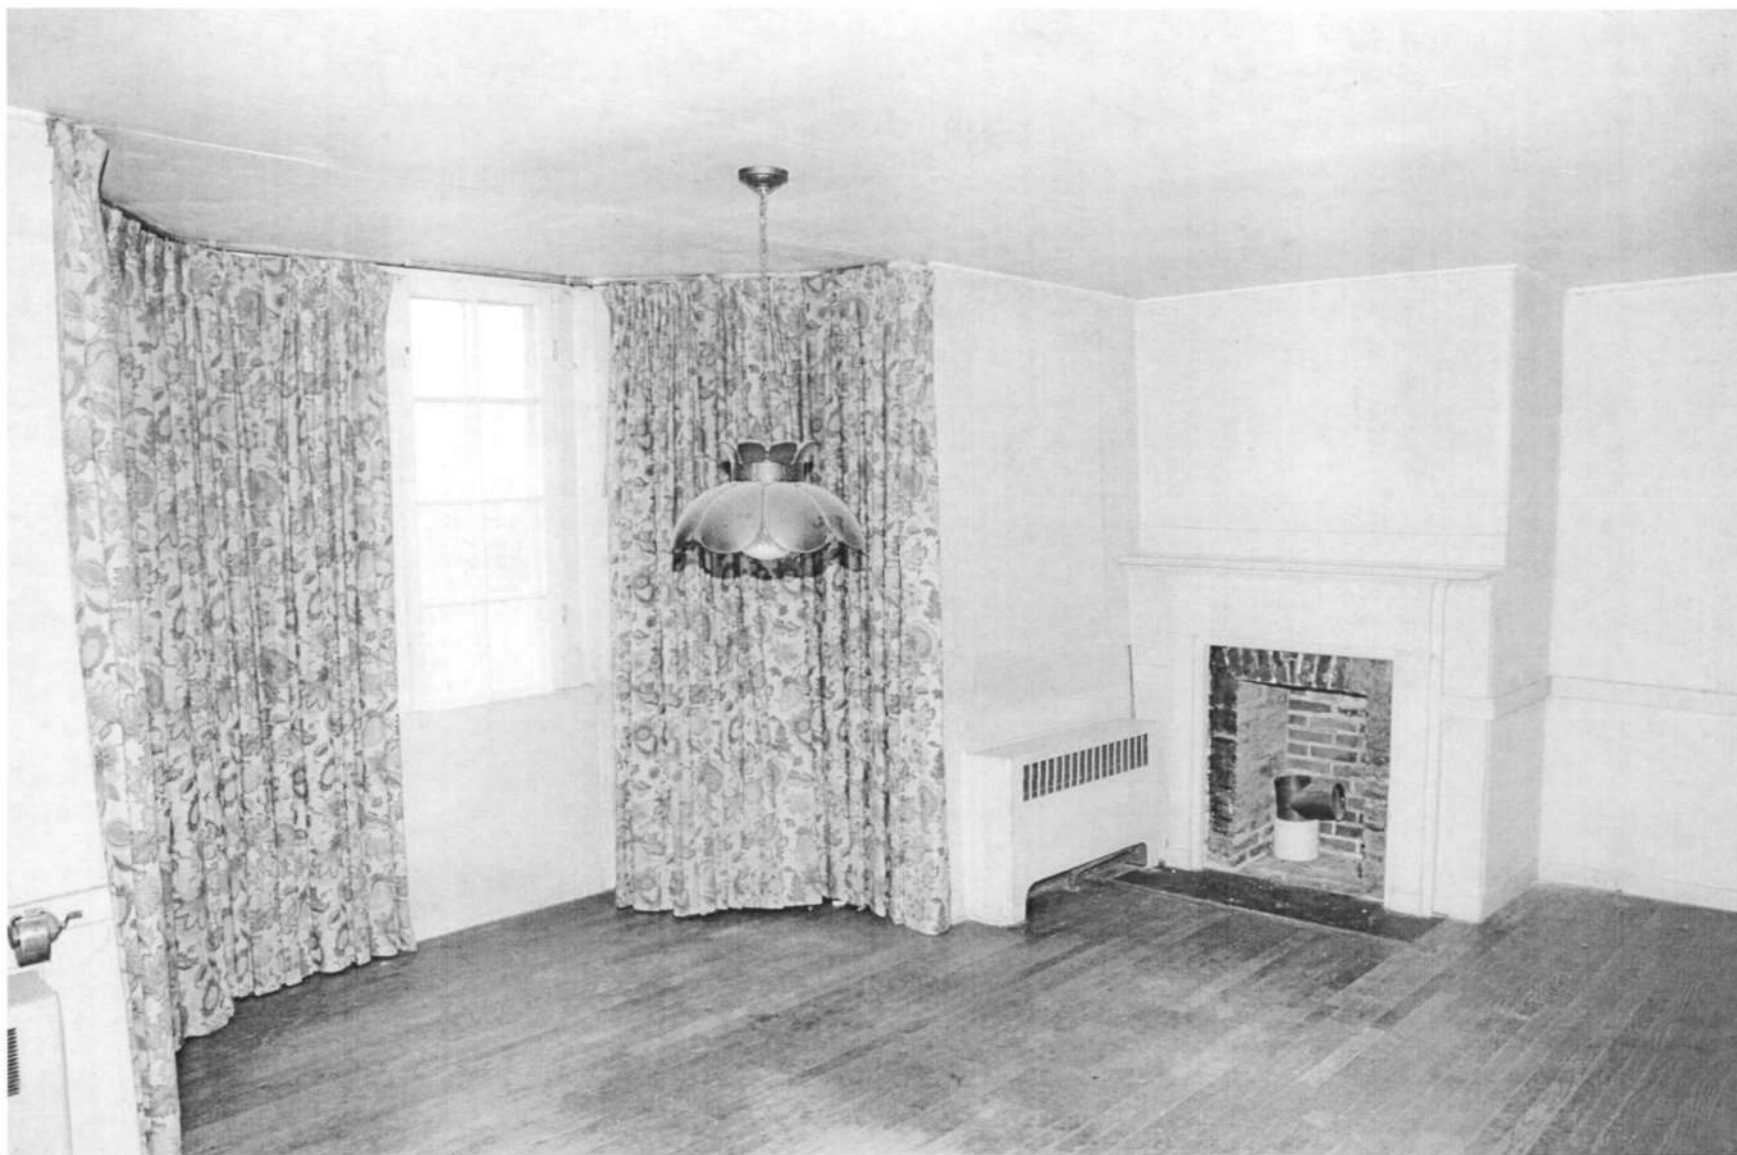
HO-451 Hoogewerff-Donaldson Cottage 6460 Elibank Drive South double parlor, view northeast  
Ken Short, December 2006 10/15

HO-0451\_20061213\_10  
Hoogewerff-Donaldson  
Cottage  
6460 Elibank Drive  
Howard County, MD  
South double parlor,  
view northeast  
Ken Short  
December 2006  
10/15

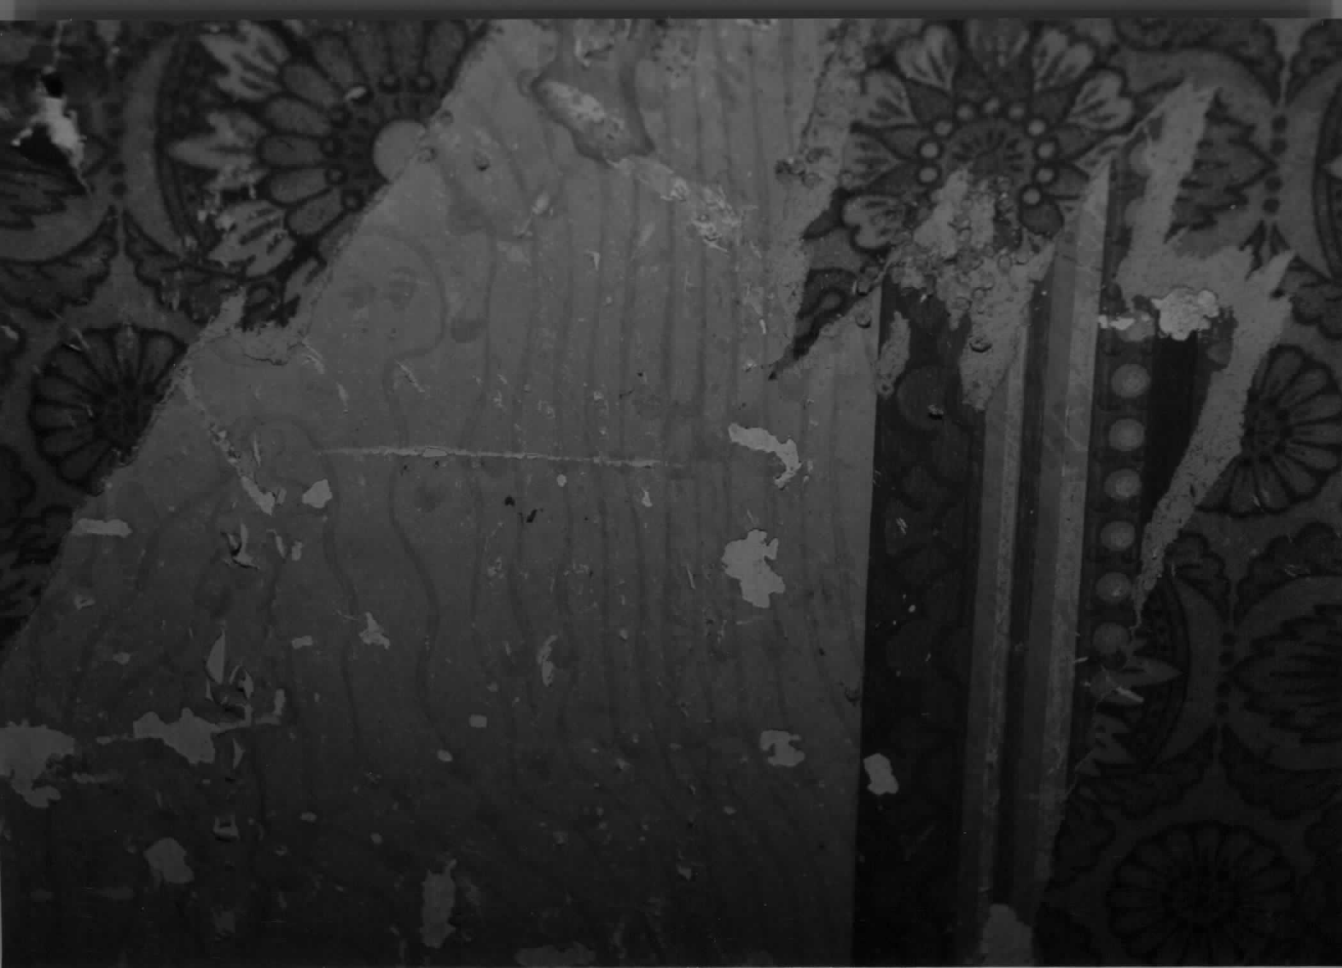
2 of 6

House, northwest room, east elevation,  
under layer of wallpaper beneath  
half-paneling

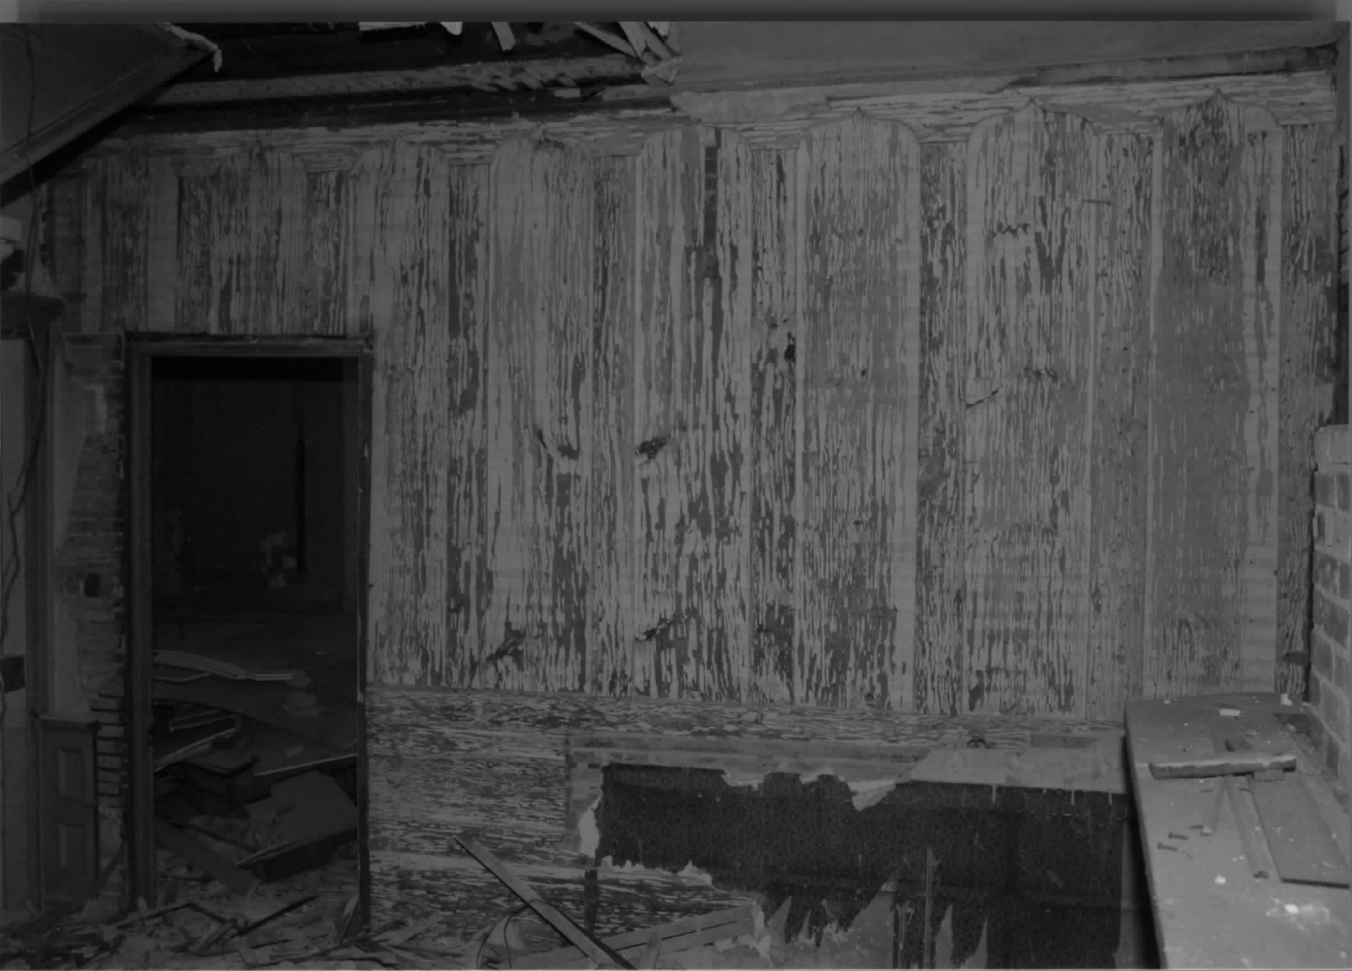
3 of 6

House, northwest room, east elevation,  
original paneled wall beneath lath  
and plaster and half-paneling

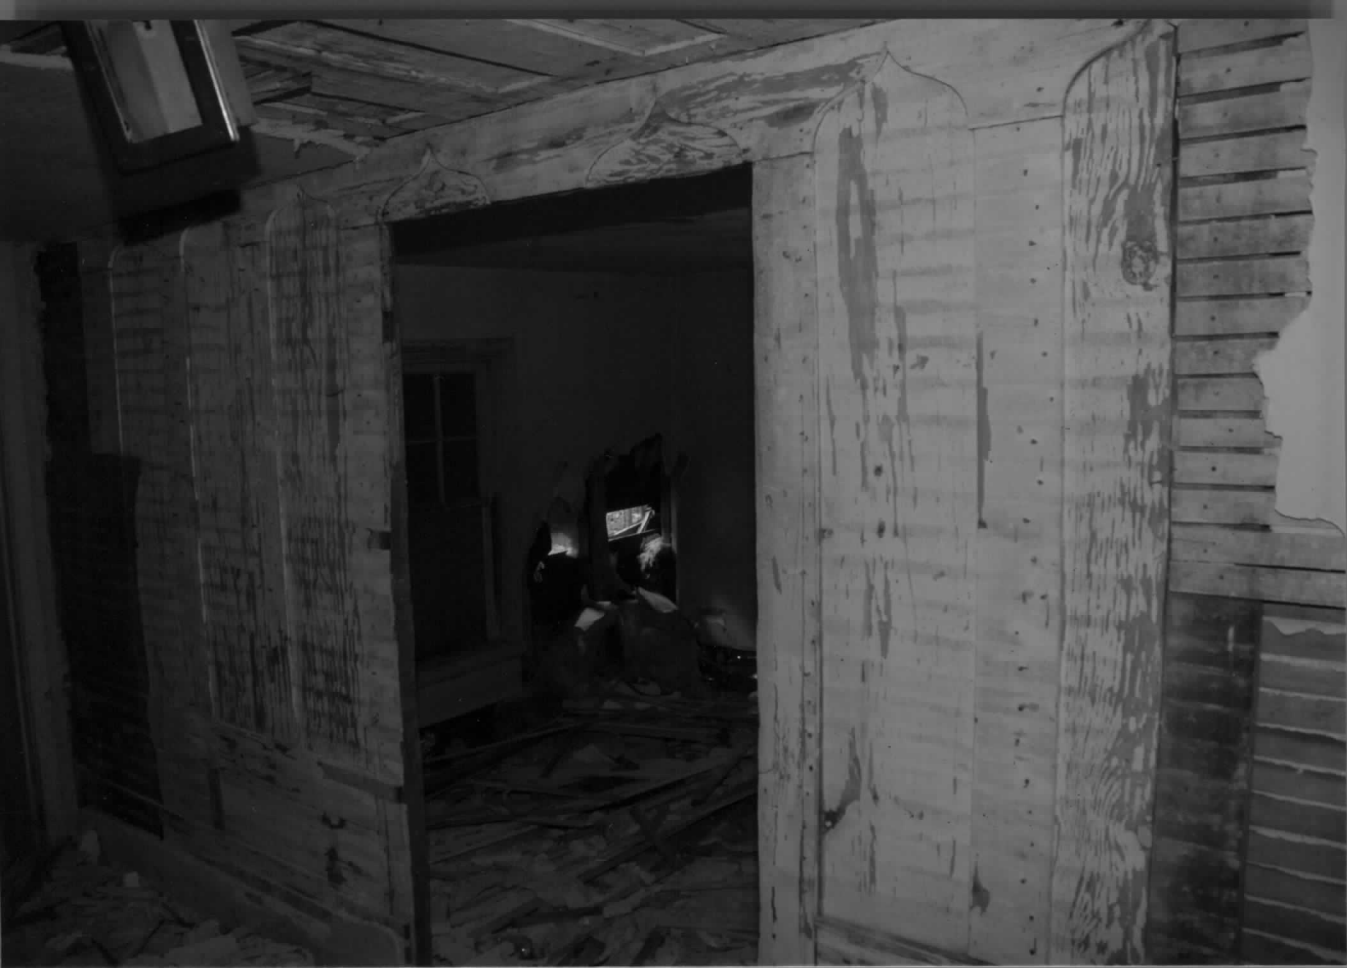
4 of 6

House, second-story passage, east  
elevation, original paneled wall  
beneath lath and plaster

HO-0451\_2011-09-02\_04  
House, second-story passage, east elevation,  
original paneled wall beneath lath and  
plaster

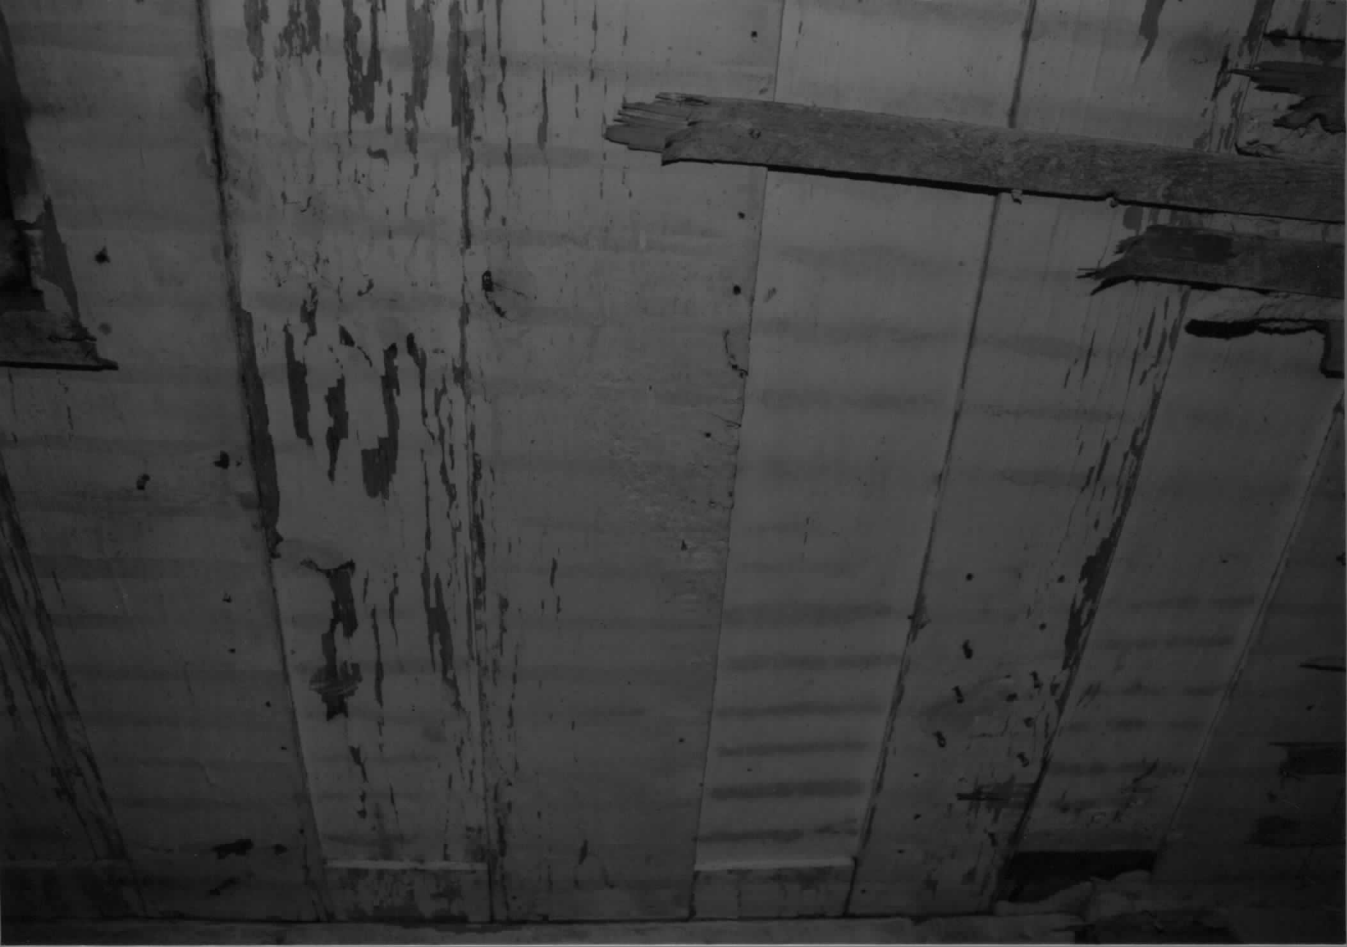
5 of 6

House, second-story passage, east elevation, original paneled wall beneath lath and plaster with ghost of chimney and mantel at north end
