National Register of Historic Places Registration Form

historic name Richland Farm
other names HO-907

street & number 4730 Sheppard Lane not for publication
city or town Clarksville vicinity
state Maryland code MD county Howard code 027 zip code 21042

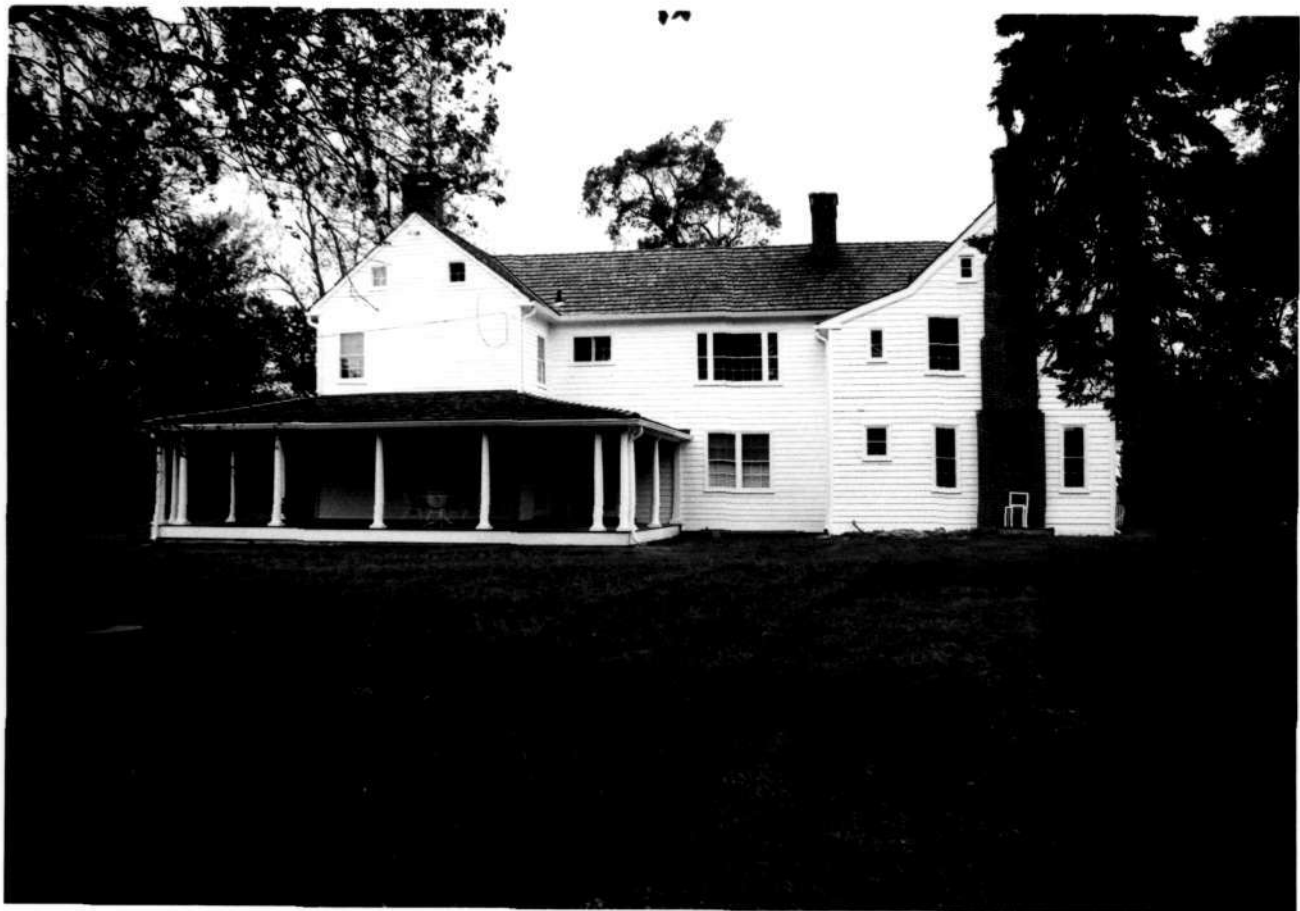
4 of 40

Main house - Northeast Elevation

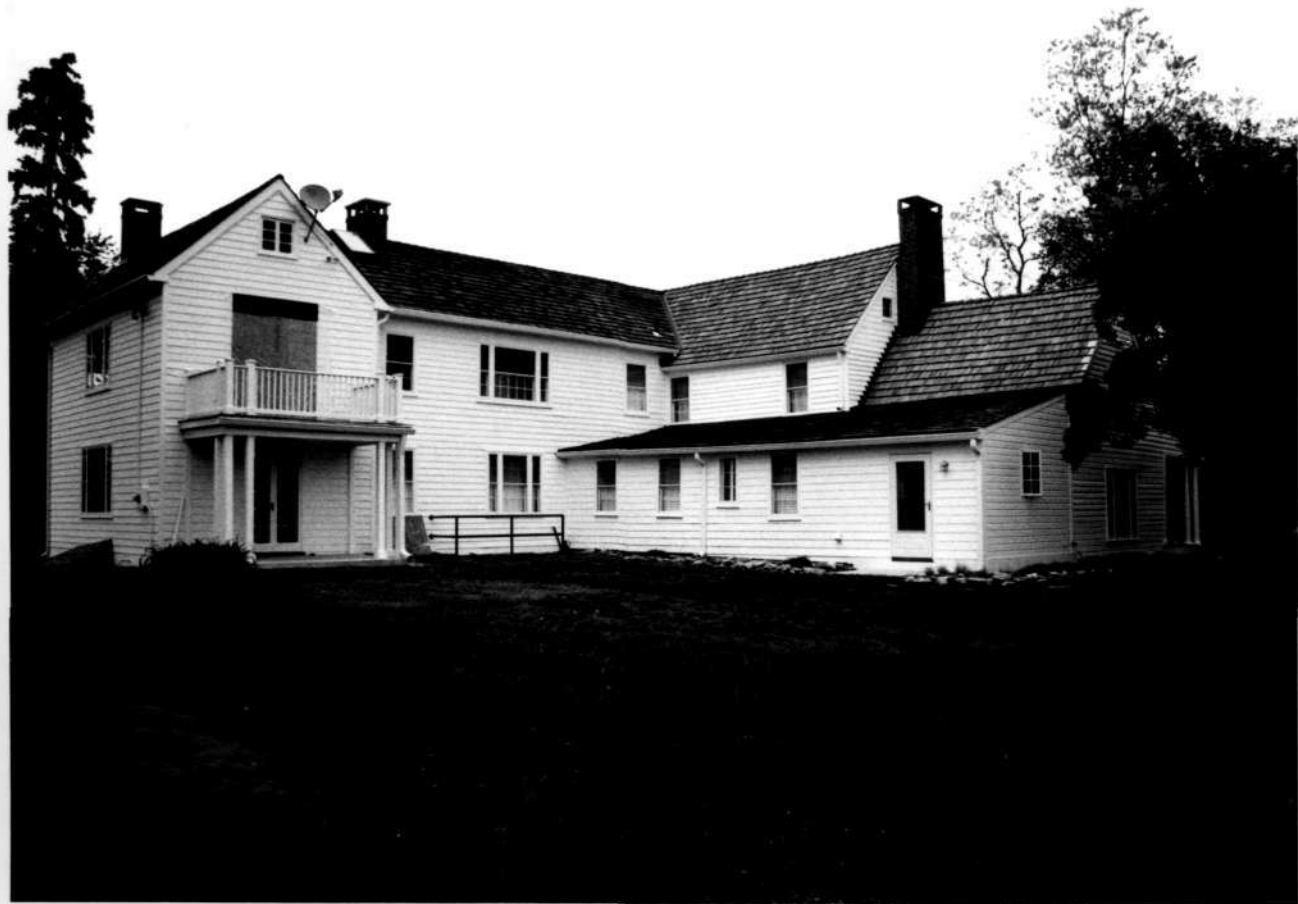
5 of 40

Main House - Southwest Elevation

The southwest elevation of the main block has a small opening with an iron grate in the south bay of the foundation. The first story has a six-over-six sash with a beaded-interior-edge frame and a wood sill in the west bay. The second story contains two typical six-over-six sash, and there is no opening in the gable end. The southwest elevation of the ell is set back slightly, and has German siding. The ground level is now above the bottom of the siding. On the first story, the west bay has a six-over-six sash with a plain frame and a narrow board sill. The south bay has a door like that on the northeast elevation of the ell. The door has a porcelain knob and is covered by a hood with a bracket and a board wall on the west. The hood has a flat-seam metal roof. On the second story, the west bay has no opening and the south bay has a typical six-over-six sash, but with a thin board sill. There is a box cornice with returns. The northwest elevation of the ell has a one-story CMU addition in the center, with a wood shingle roof laid over asphalt shingles. There is a typical six-over-six sash with a board sill both to the north and to the west of the addition. The second story has two typical six-over-six sash. There is a six-light sash in the gable end, and an interior brick chimney just west of the north bay.

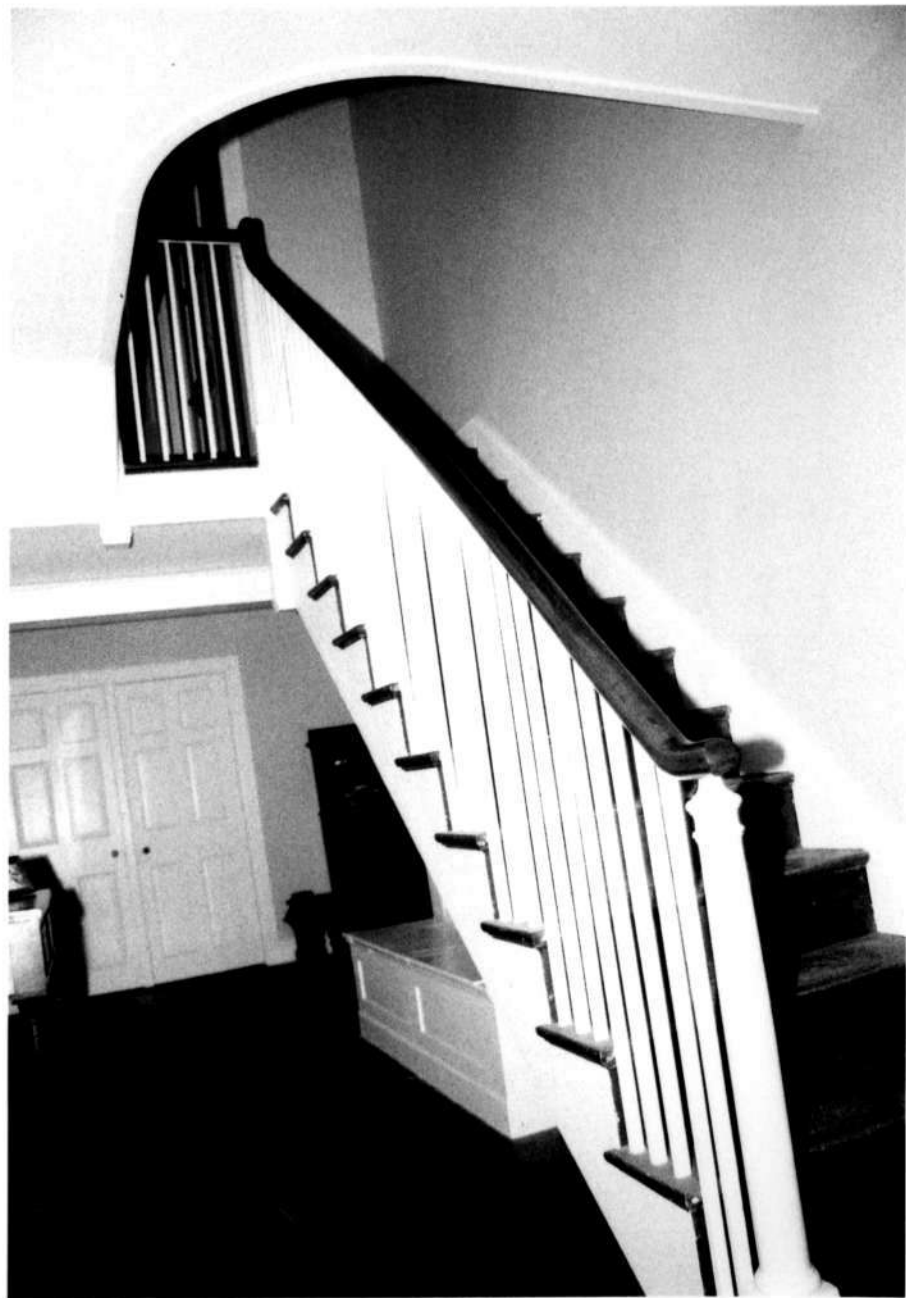
6 of 40

Main House - Front Staircase

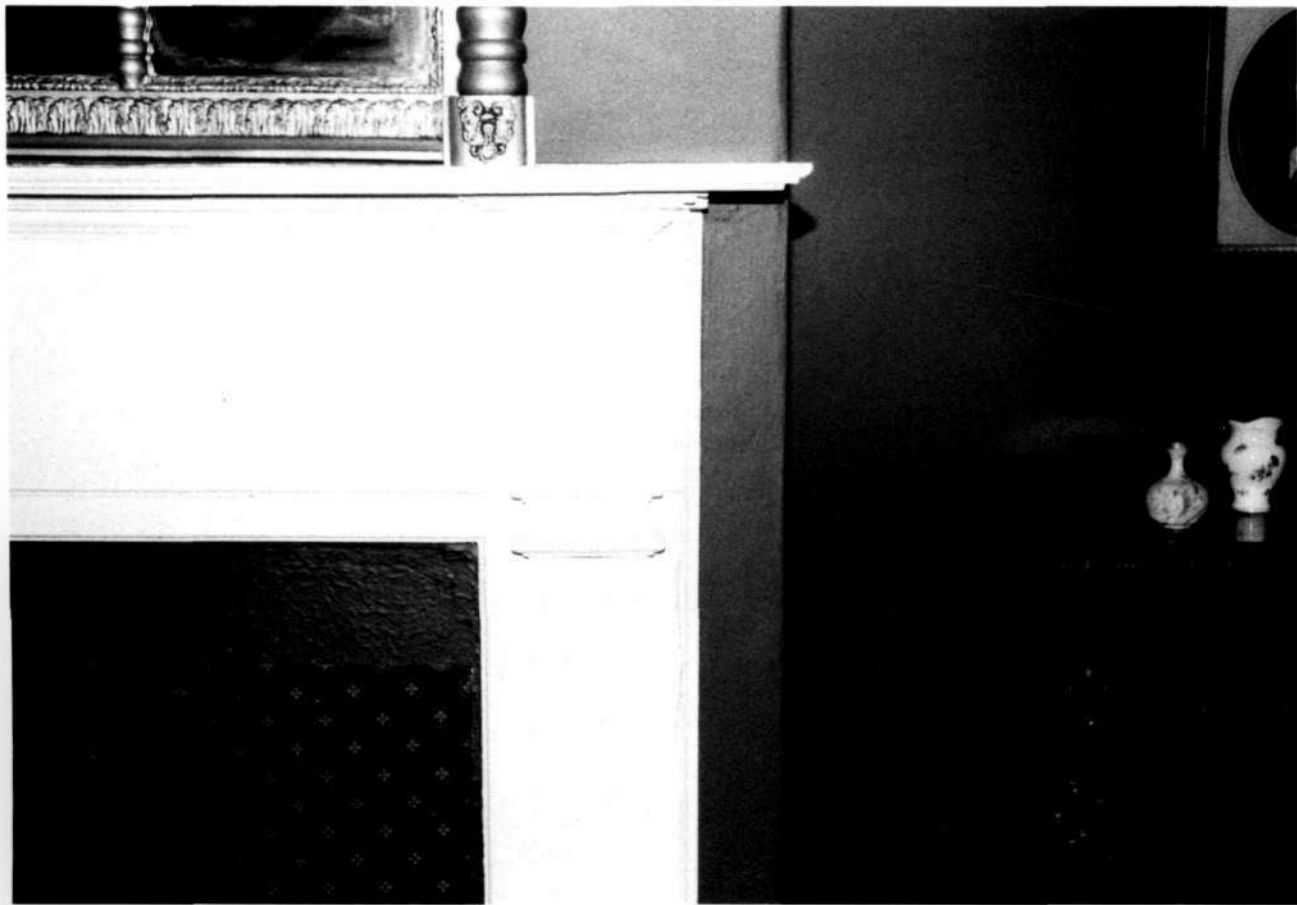
8 of 40

Main house - northeast parlor
mantel detail

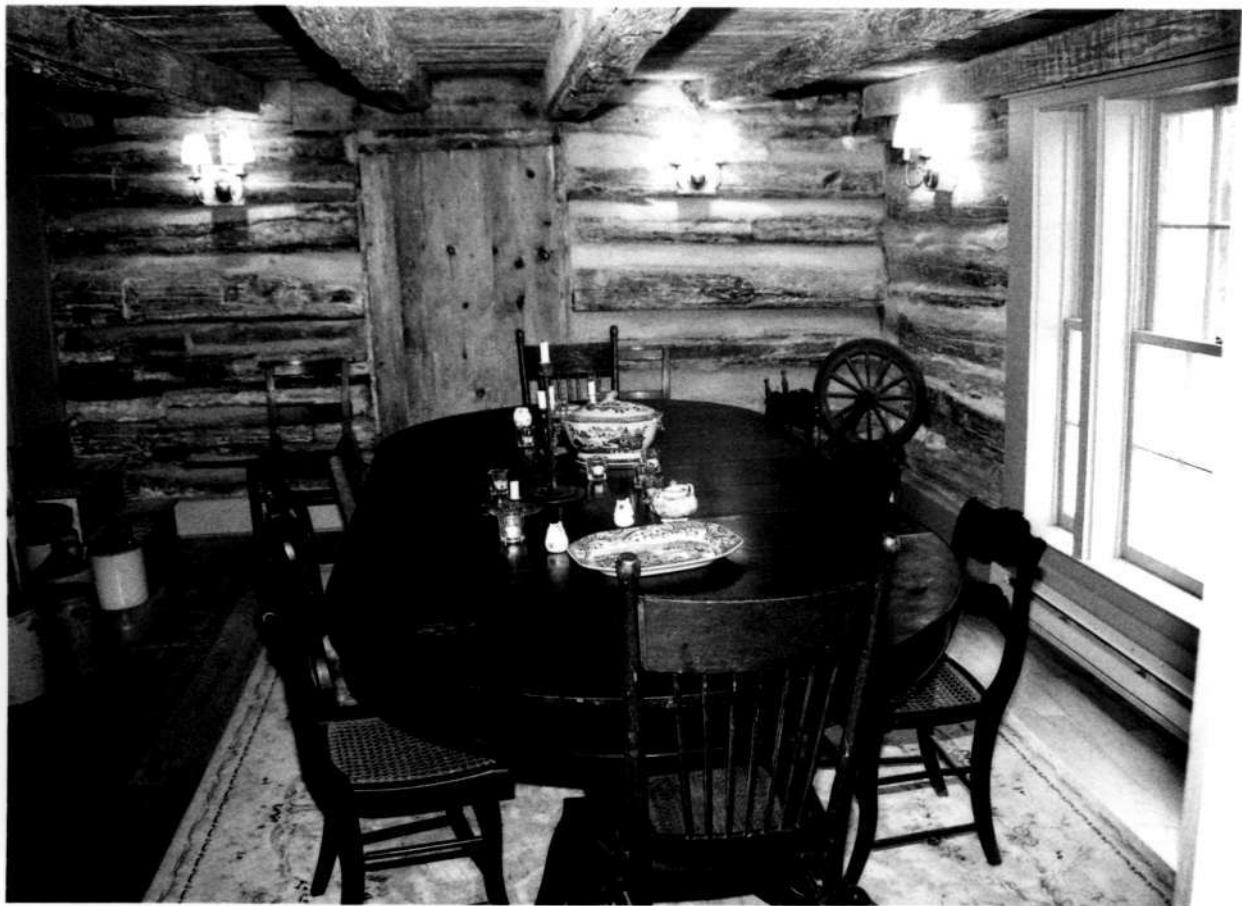
12 of 40

Main house - first floor southwest
log room (kitchen) taken from
northwest

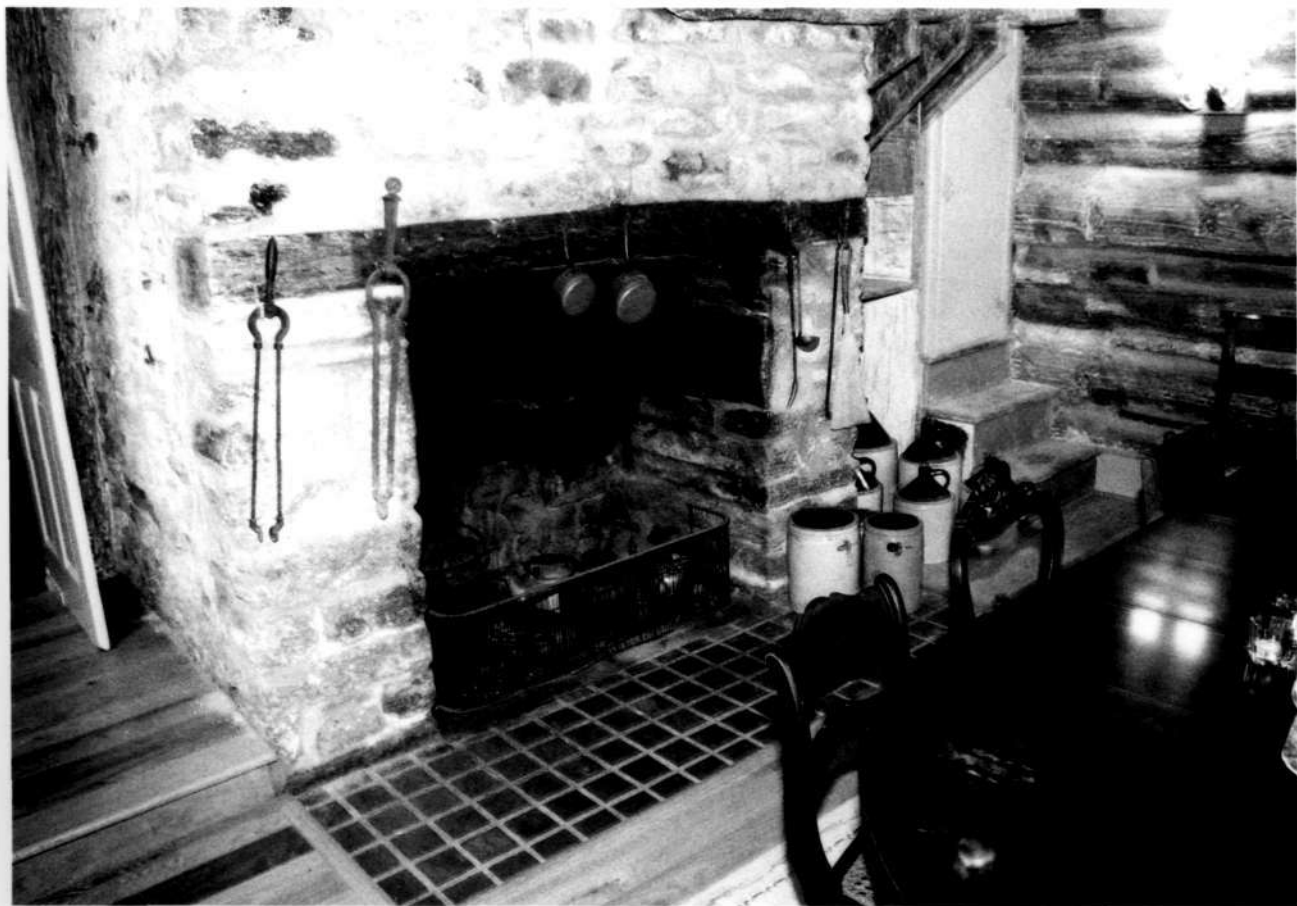
13 of 40

Main house - First floor southwest
log room (kitchen), hearth,
taken from west

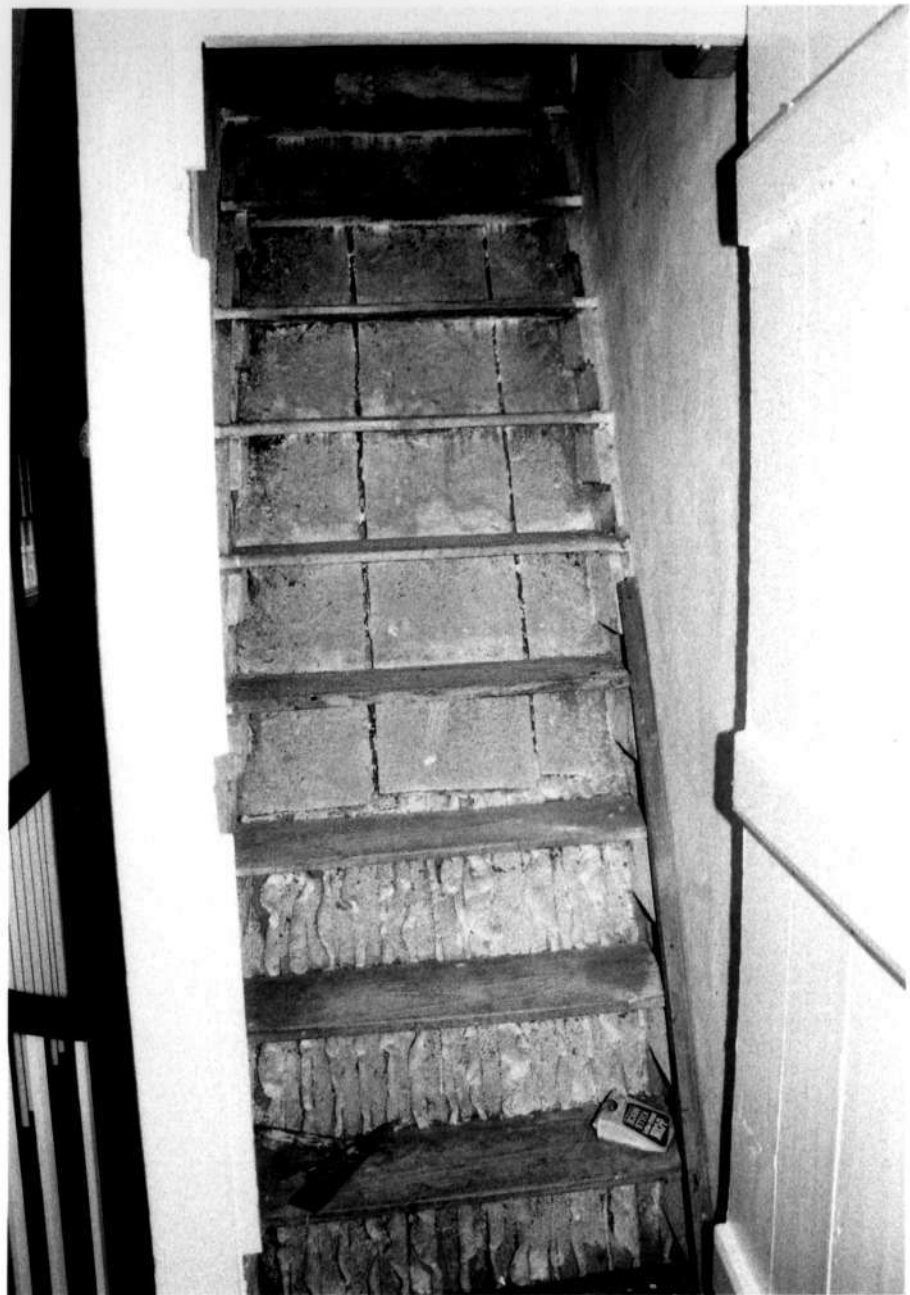
19 of 40

Main House - Second floor - old
stairs to attic taken from
southeast

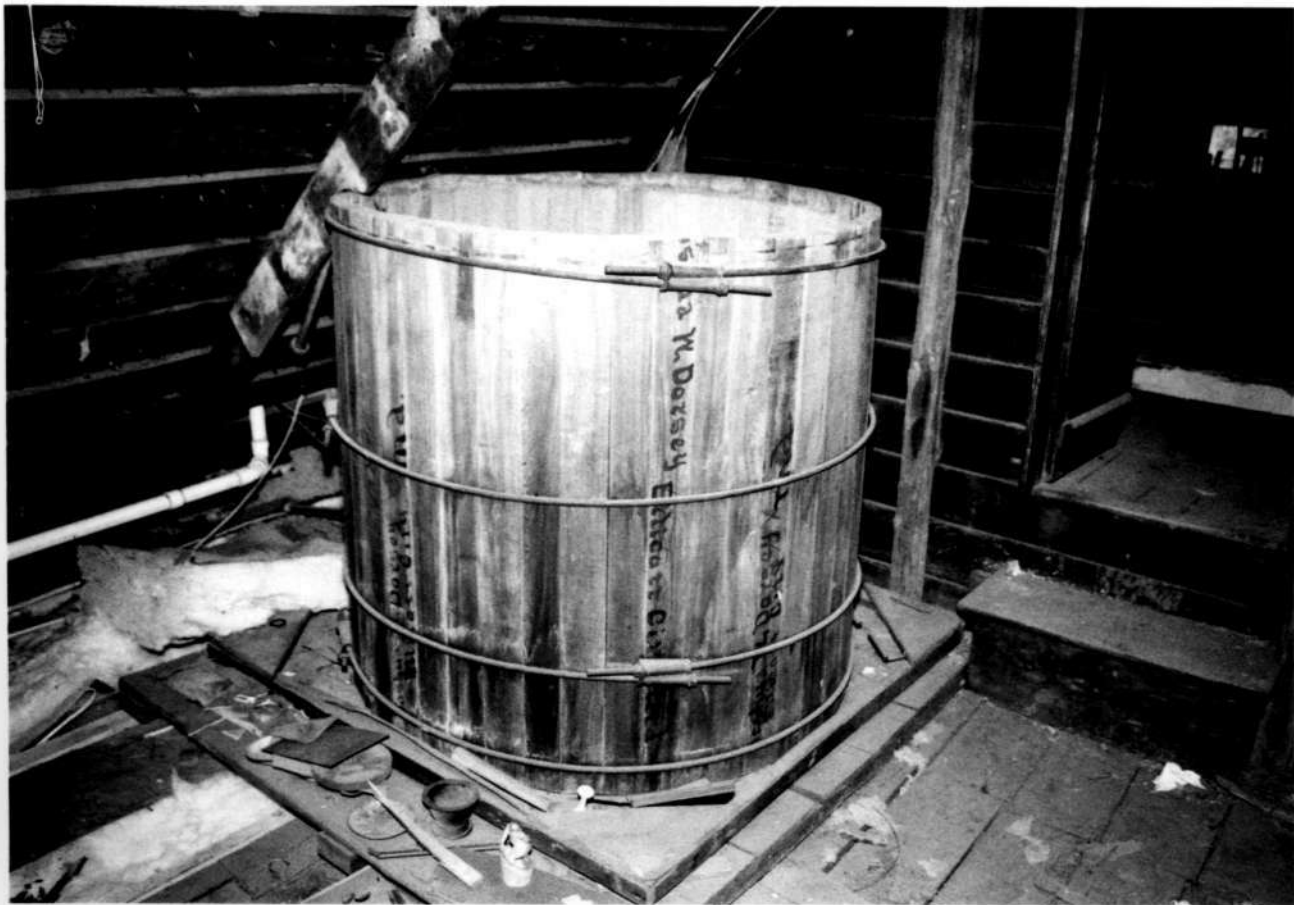
21 of 40

Main House - Cistern - old
section of attic

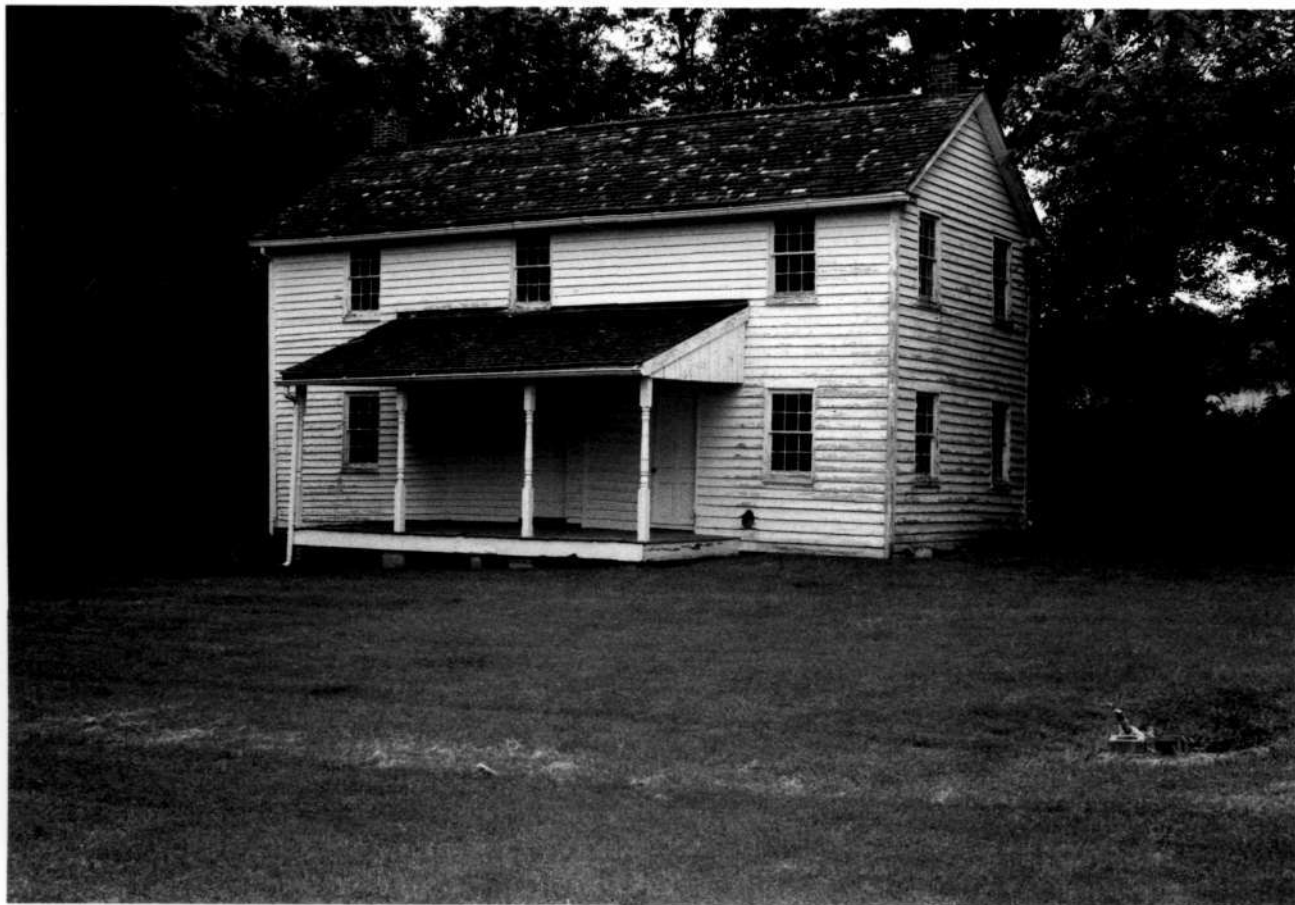
22 of 40

Superintendent's House -
Southeast facade taken
from east

About 150 feet west-southwest of the house is the Superintendent's House. It faces southeast and is a two-story, four-bay by two-bay structure with a rubble stone foundation, weatherboards, and a gable roof with wood shingles and a northeast-southwest ridge. There is an interior brick chimney on each gable end. The southwest half of the building is a log structure, and the northeast half is a frame addition. There is a two-story, two-bay by two-bay frame ell on the northwest that has German siding and a gable roof with a northwest-southeast ridge and wood shingles.

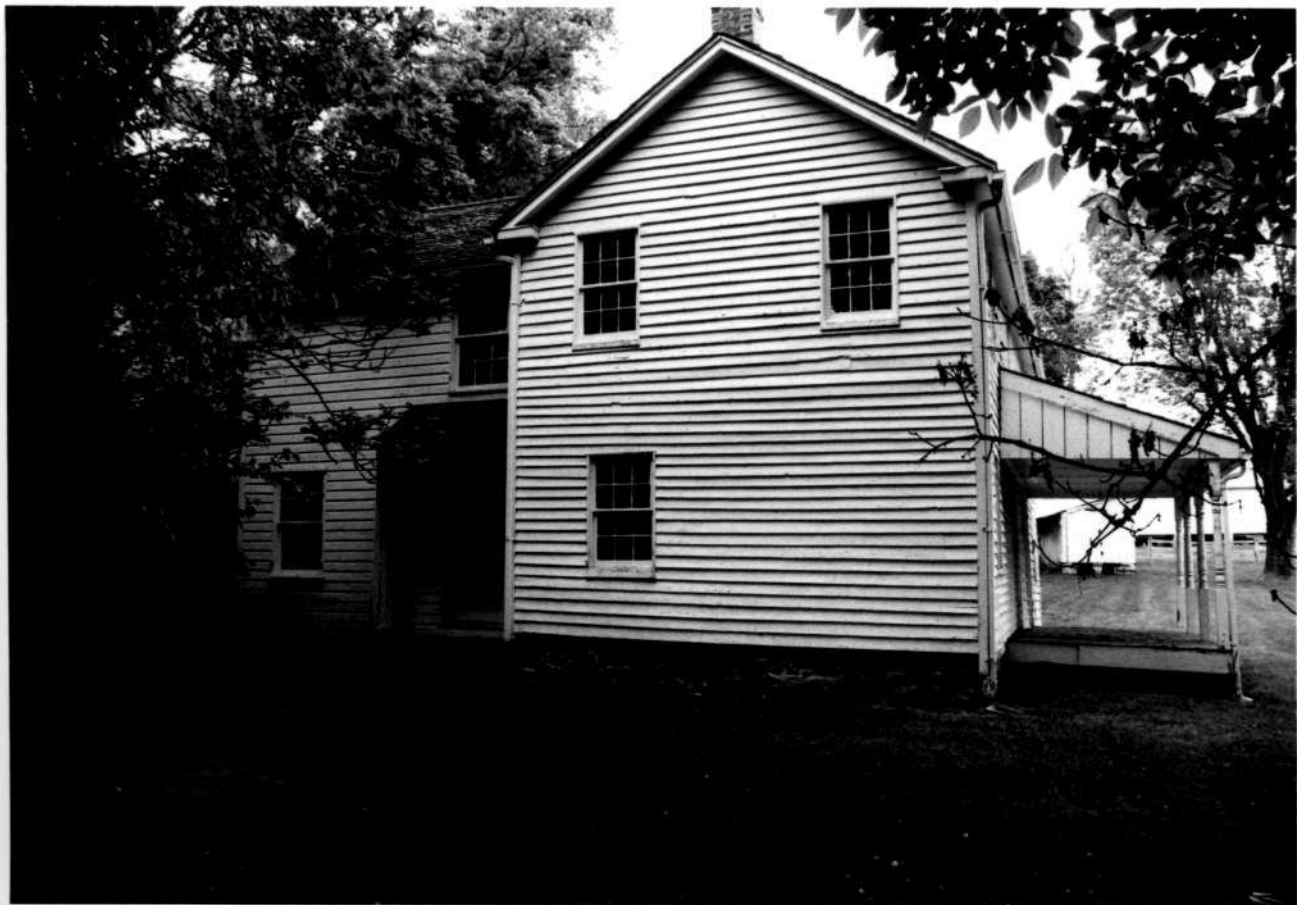
23 of 40

Superintendent's House -
Southwest Elevation

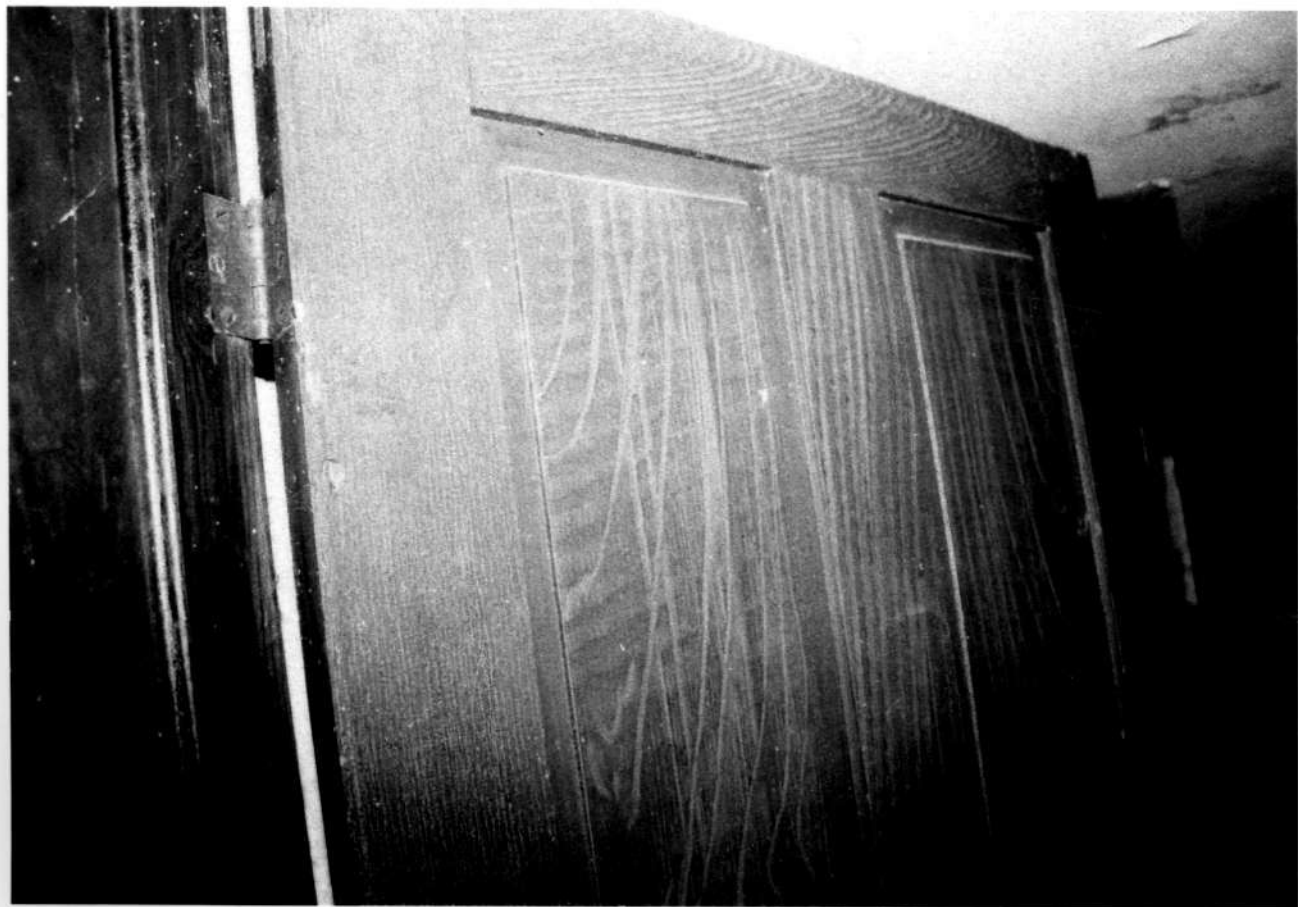
28 of 40

Superintendent's House - Second
Floor bedroom door detail

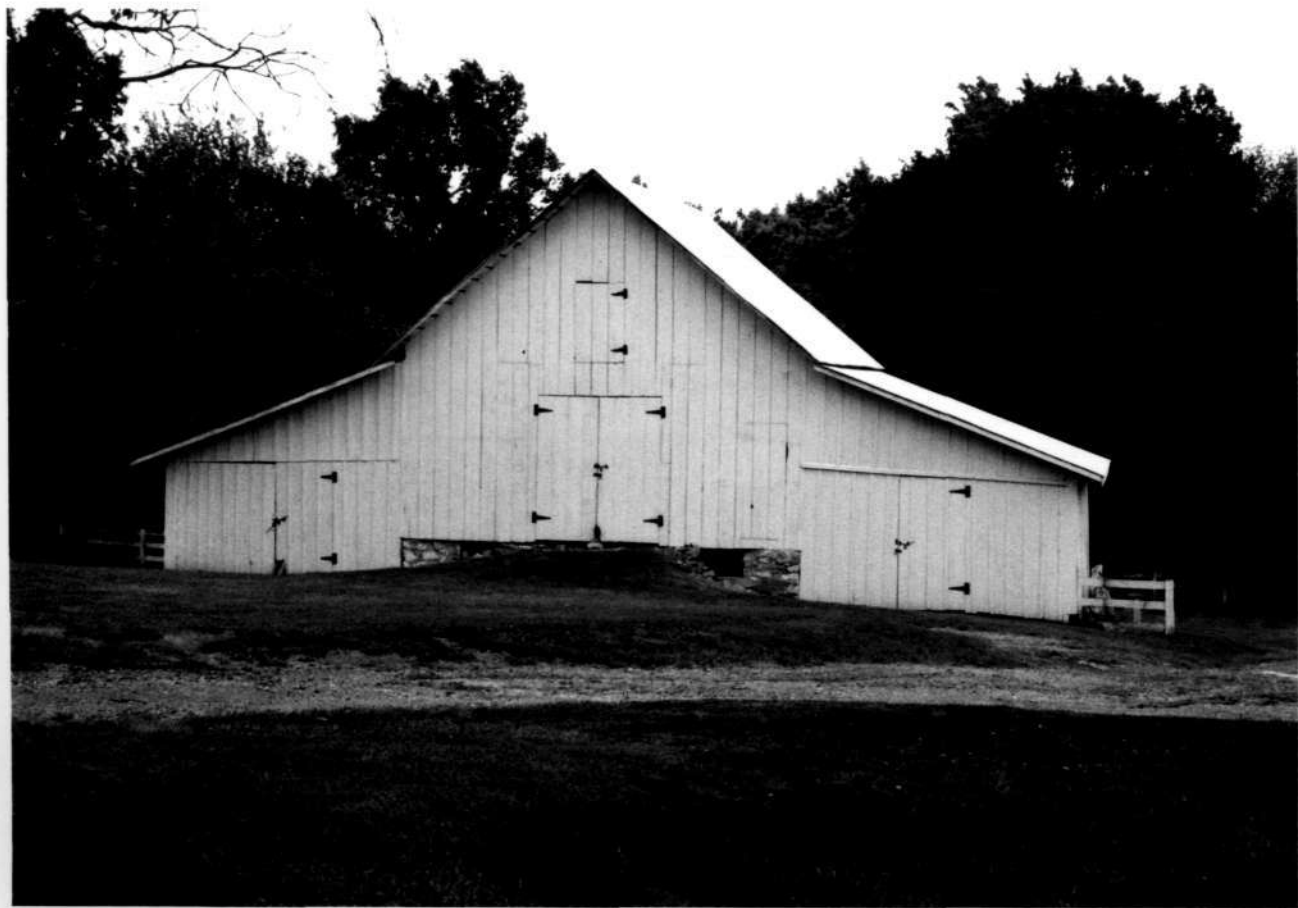
34 of 40

Bank barn northeast elevation

About 120 feet southwest of the house is a Barn that is banked into the hill on the northeast. It is a one-story, one-bay by one-bay structure with one-story, one-bay by one-bay shed-roofed additions on the northwest and southeast. The building has a gable roof with corrugated metal and a northeast-southwest ridge. The barn has a rubble stone foundation and vertical board siding, with board and batten siding on the additions. The northeast elevation has a ramp in the center with two-light sash to each side. The upper story has a pair of large doors on T-hinges, with a small door in the gable end on T-hinges. The additions have a door on T-hinges set between the lower and upper levels. There are no openings on the northwest or southeast elevations. The southwest elevation has two vertical-board Dutch doors on T-hinges on the lower story and one of them on the upper story. The gable end also has one of these. The northwest addition has a vertical board-Dutch door on T-hinges, while the southeast addition is open on the southwest. The lower story of this elevation has vertical boards between the stone end walls of the

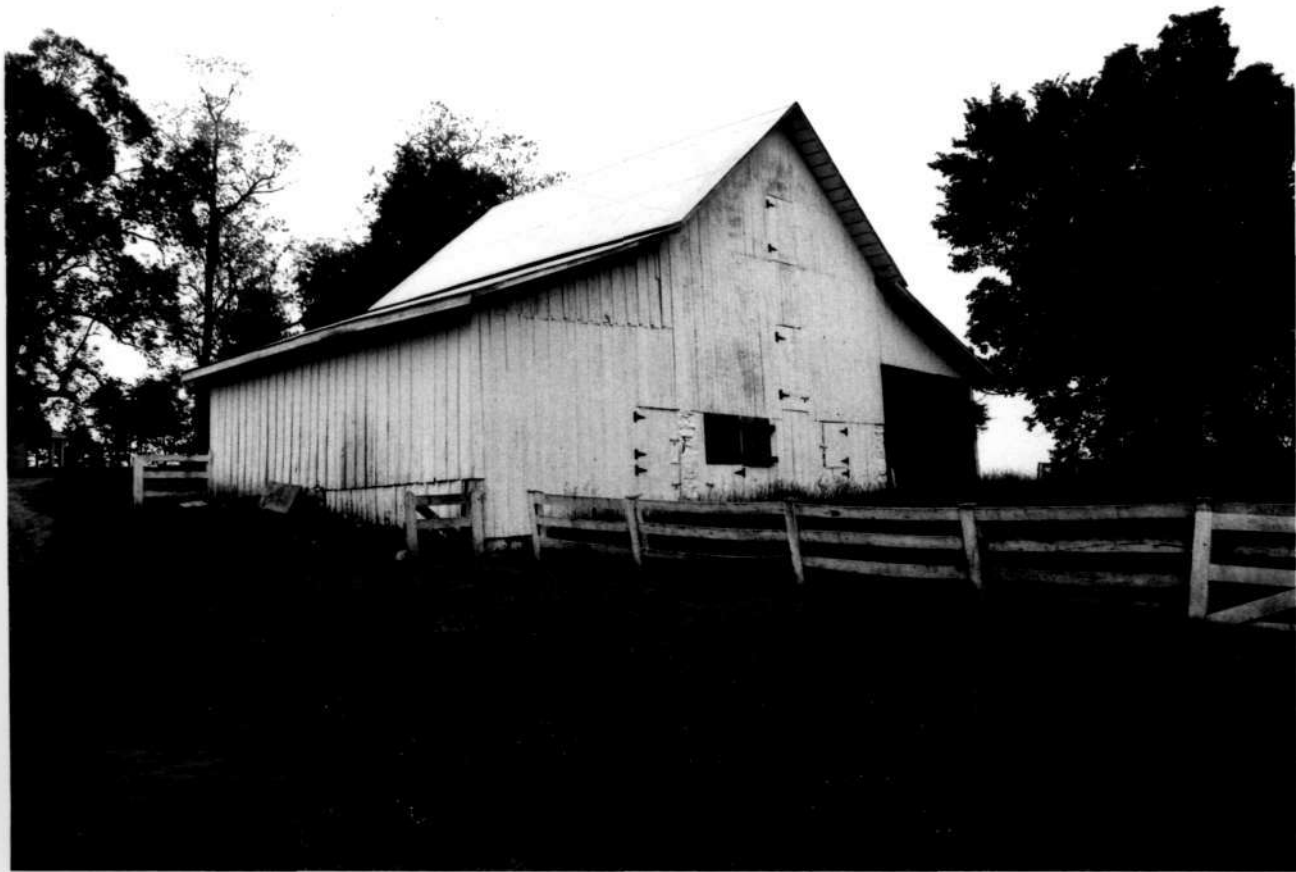
35 of 40

Bank barn southwest elevation

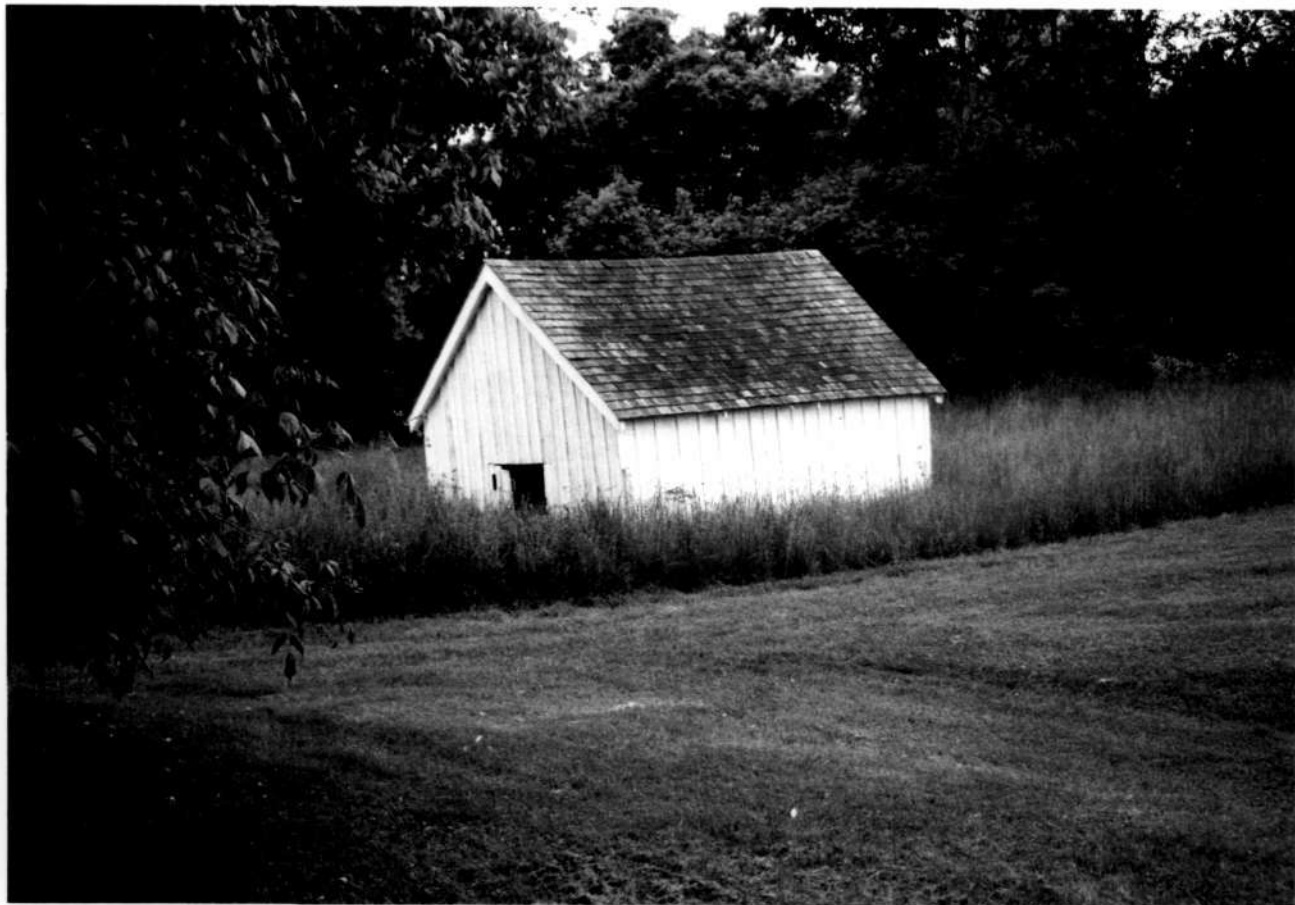
36 of 40

Smokehouse taken from
northeast

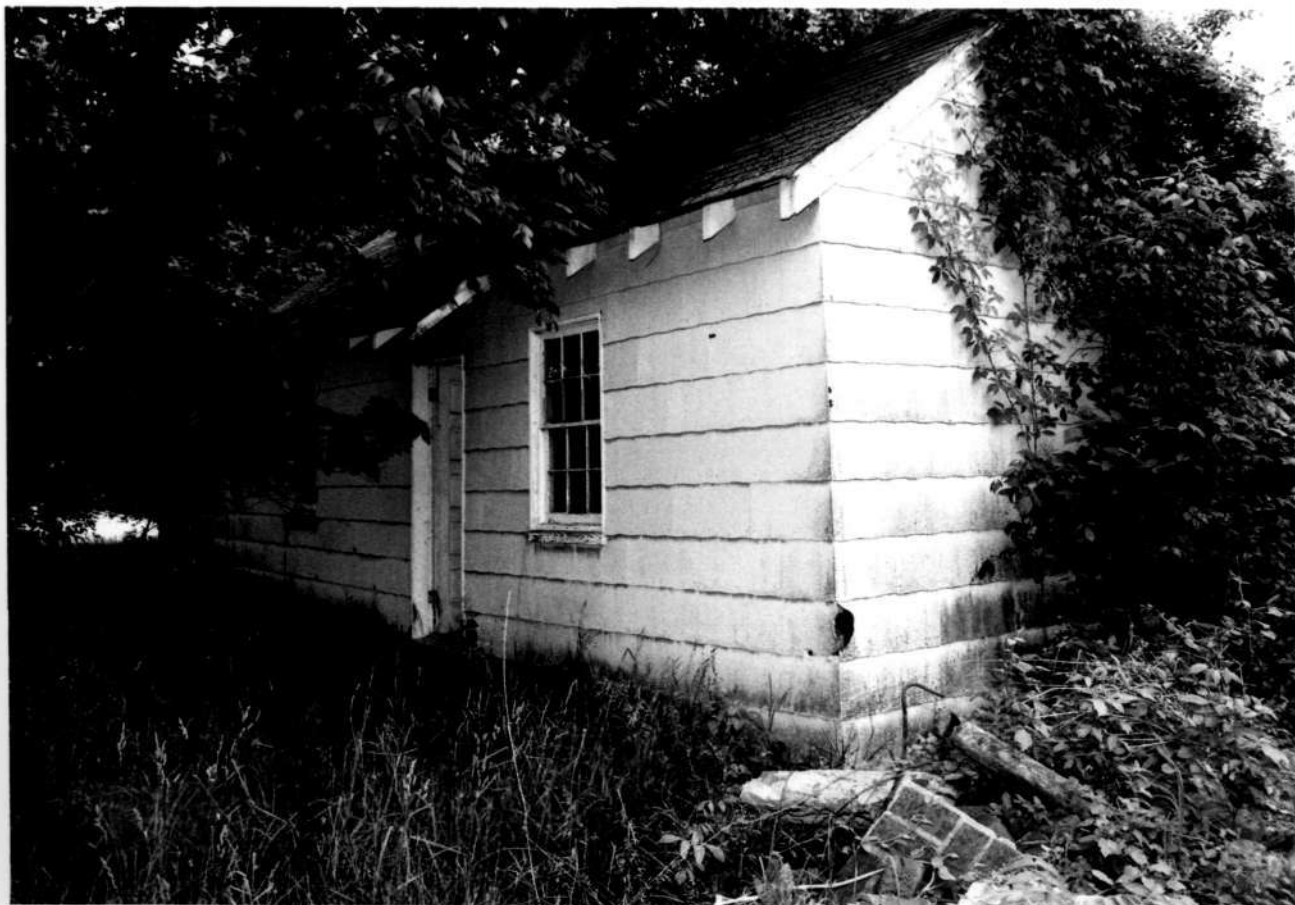
37 of 40

Gardener's cottage taken from
northwest

southeast. The cottage has a concrete foundation, asbestos shingle siding over wood shingles, and a gable roof with asphalt shingles and a northwest-southeast ridge. There is a brick chimney in the center, and the roof has open eaves. The northeast elevation has a central doorway with a door that has five lying panels and a beaded-edge interior frame. There is a six-over-six sash to each side with a beaded-interior-edge frame. The northeast elevation of the addition has a boarded-up window opening. The southeast elevation of the addition has a doorway to the northeast, but the door is missing. The northwest elevation has no openings. The southwest elevation has a six-over-six sash in both the south and west bays, and there is a window opening in the addition.

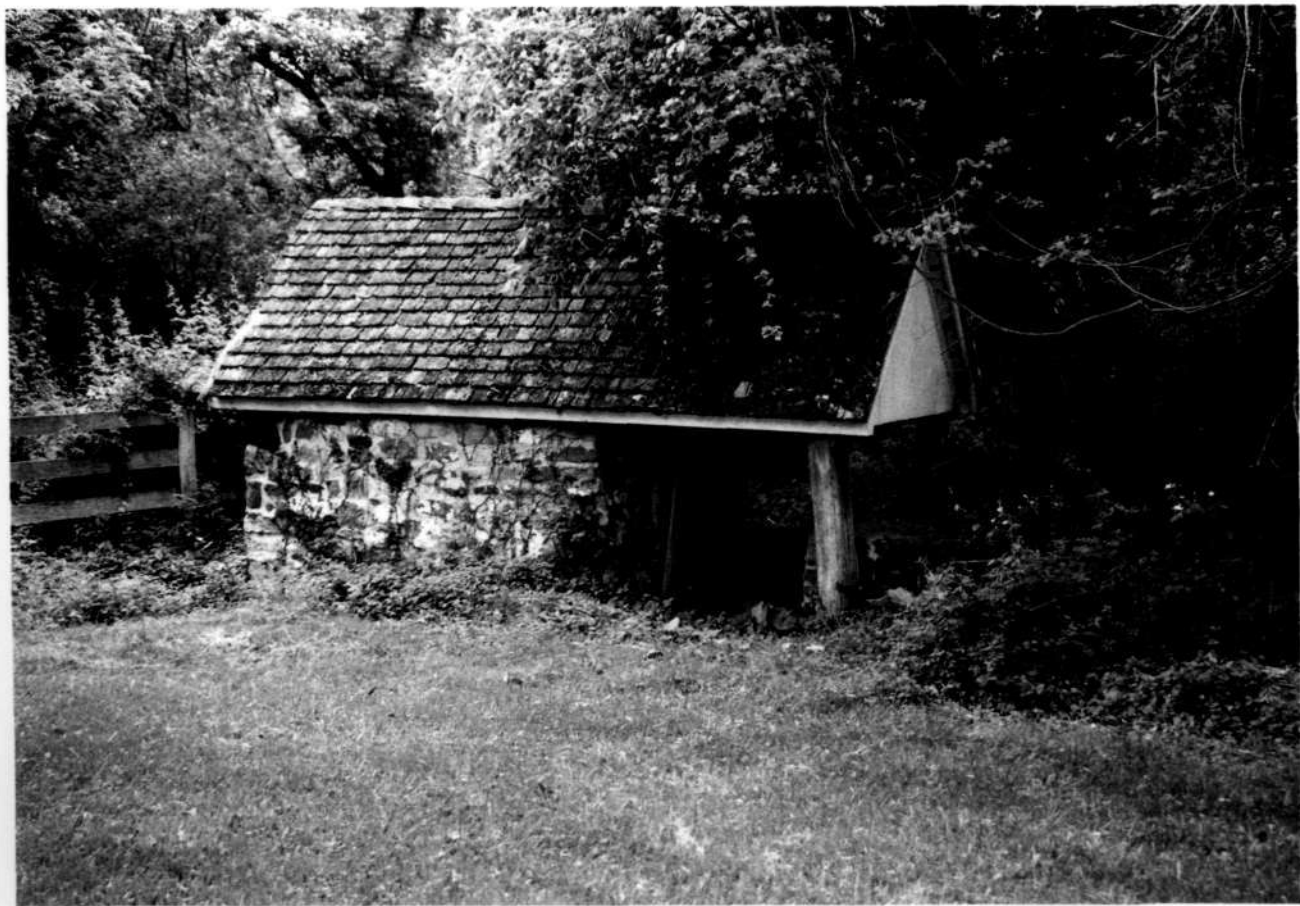
38 of 40

Springhouse taken from east

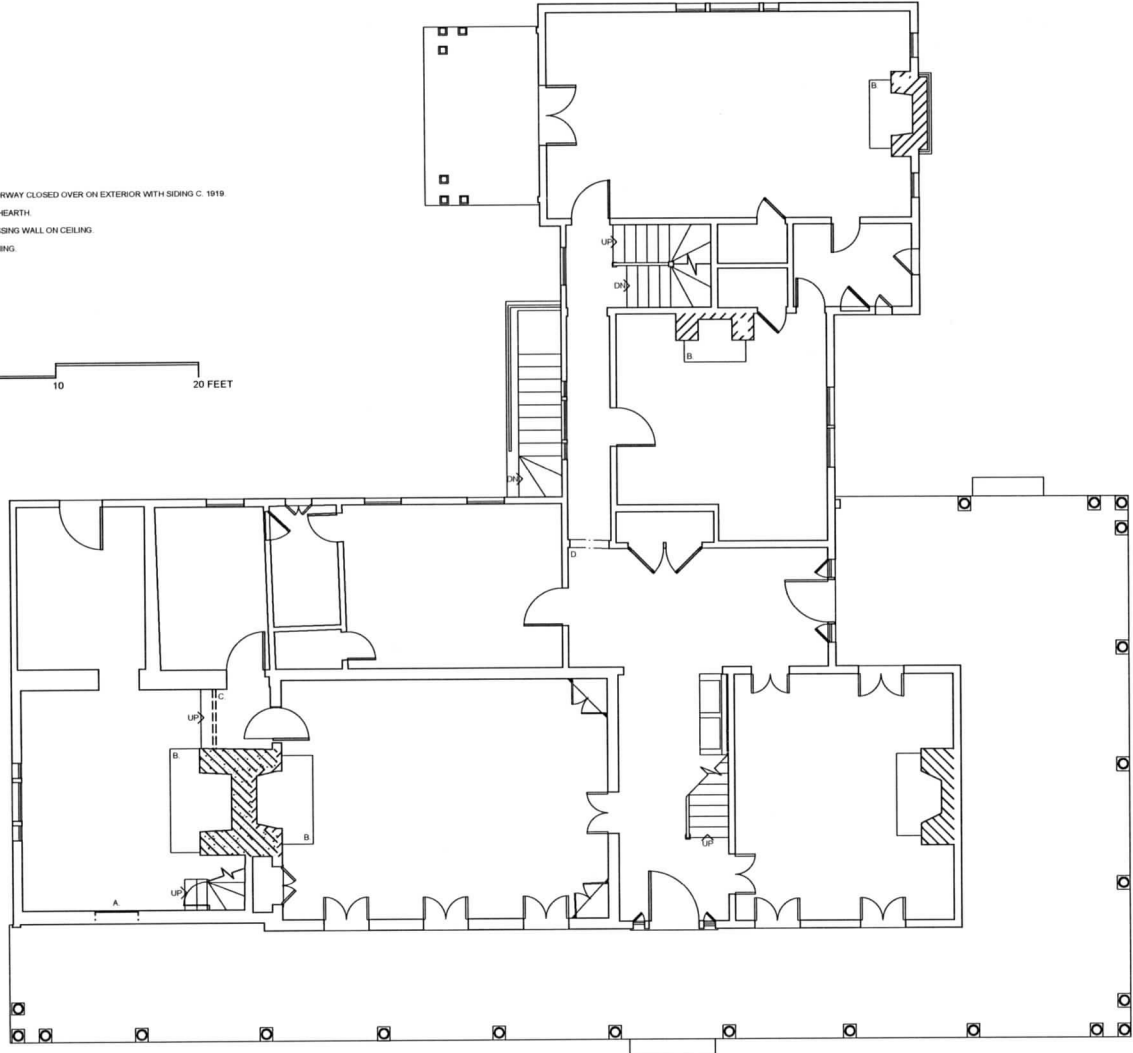
FIRST STORY PLAN -- MEASURED BY KEN SHORT & PETE MORRILL -- DRAWN BY KEN SHORT -- APRIL 2023

- NOTES:
- A. ORIGINAL DOORWAY CLOSED OVER ON EXTERIOR WITH SIDING C. 1919
 - B. QUARRY TILE HEARTH
 - C. GHOST OF MISSING WALL ON CEILING
 - D. ARCHED OPENING

HO-907 RICHLAND 4730 SHEPPARD LANE

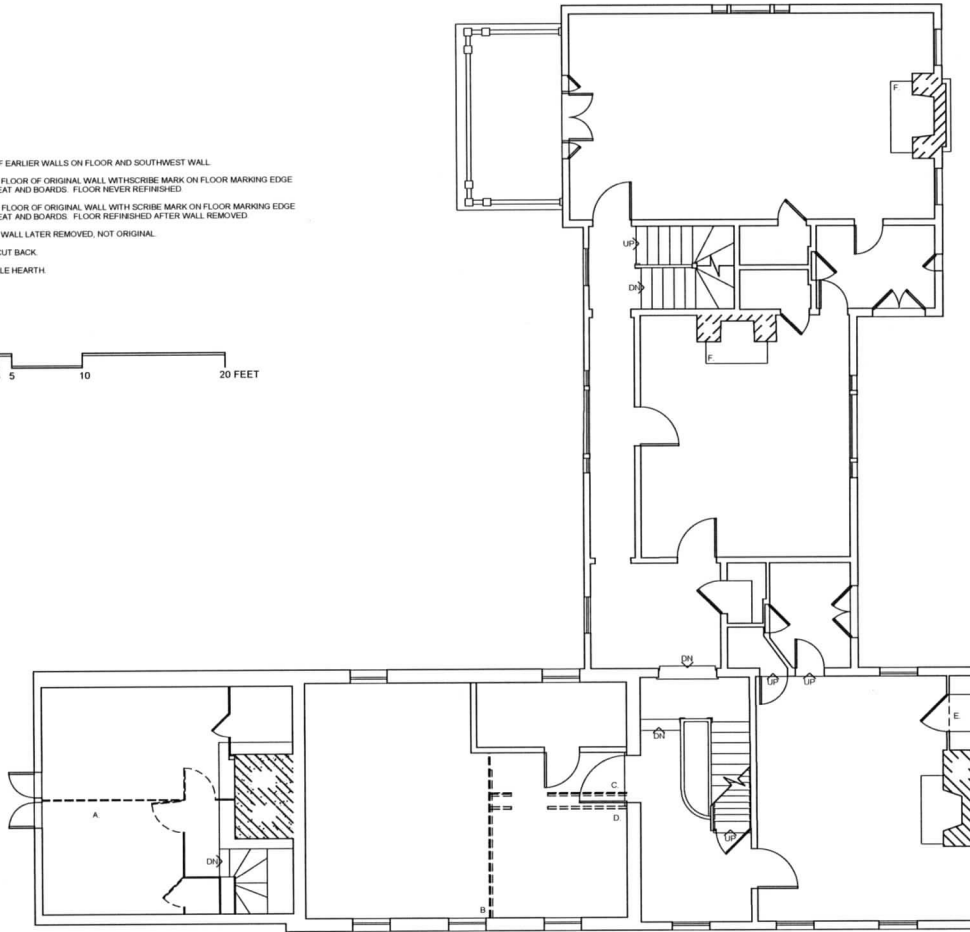
SECOND STORY PLAN -- MEASURED BY KEN SHORT & ALLISON LUTHERN -- DRAWN BY KEN SHORT -- APRIL 2023

- A. GHOSTS OF EARLIER WALLS ON FLOOR AND SOUTHWEST WALL
- B. GHOST ON FLOOR OF ORIGINAL WALL WITH SCRIBE MARK ON FLOOR MARKING EDGE BETWEEN CLEAT AND BOARDS. FLOOR NEVER REFINISHED
- C. GHOST ON FLOOR OF ORIGINAL WALL WITH SCRIBE MARK ON FLOOR MARKING EDGE BETWEEN CLEAT AND BOARDS. FLOOR REFINISHED AFTER WALL REMOVED
- D. GHOST OF WALL LATER REMOVED, NOT ORIGINAL
- E. SHELVES CUT BACK
- F. QUARRY TILE HEARTH

HO-907 RICHLAND 4730 SHEPPARD LANE

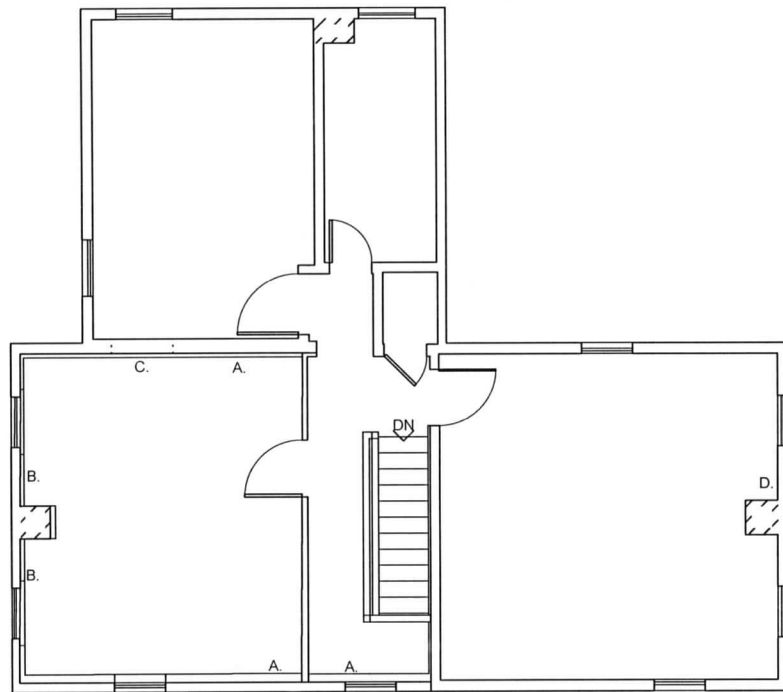
OVERSEER'S HOUSE -- SECOND STORY PLAN -- MEASURED BY KEN SHORT, PETE MORRILL & DAVE DELL -- DRAWN BY KEN SHORT -- MAY 2023

- A. SHELF SET ABOVE WINDOW SILL LEVEL, APPARENTLY MARKING CHANGE FROM LOG BELOW TO FRAME ABOVE IN WALL.
- B. SHELF SET JUST BELOW WINDOW SILL LEVEL, APPARENTLY MARKING CHANGE FROM LOG BELOW TO FRAME ABOVE IN WALL.
- C. GHOST IN WALL OF PROBABLE EARLIER WINDOW OPENING, NOW CLOSED OVER.
- D. BRICK CHIMNEY STACK PREDATES FIREPLACE ALTERATIONS ON FIRST STORY.

HO-907 RICHLAND 4730 SHEPPARD LANE
