National Register of Historic Places Registration Form

historic name Richland Farm
other names HO-907

street & number 4730 Sheppard Lane not for publication
city or town Clarksville vicinity
state Maryland code MD county Howard code 027 zip code 21042

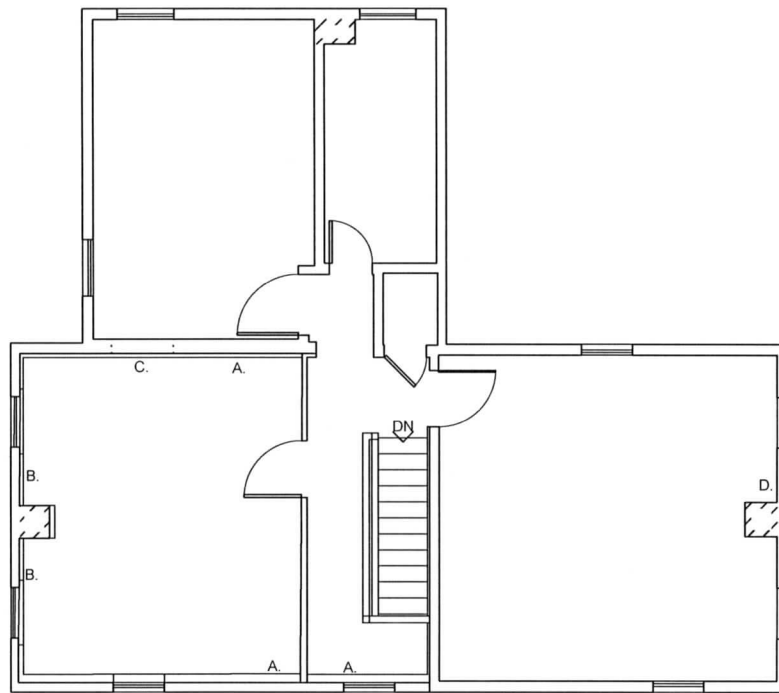
OVERSEER'S HOUSE -- SECOND STORY PLAN -- MEASURED BY KEN SHORT, PETE MORRILL & DAVE DELL -- DRAWN BY KEN SHORT -- MAY 2023

- A. SHELF SET ABOVE WINDOW SILL LEVEL, APPARENTLY MARKING CHANGE FROM LOG BELOW TO FRAME ABOVE IN WALL.
- B. SHELF SET JUST BELOW WINDOW SILL LEVEL, APPARENTLY MARKING CHANGE FROM LOG BELOW TO FRAME ABOVE IN WALL.
- C. GHOST IN WALL OF PROBABLE EARLIER WINDOW OPENING, NOW CLOSED OVER.
- D. BRICK CHIMNEY STACK PREDATES FIREPLACE ALTERATIONS ON FIRST STORY.

HO-907 RICHLAND 4730 SHEPPARD LANE

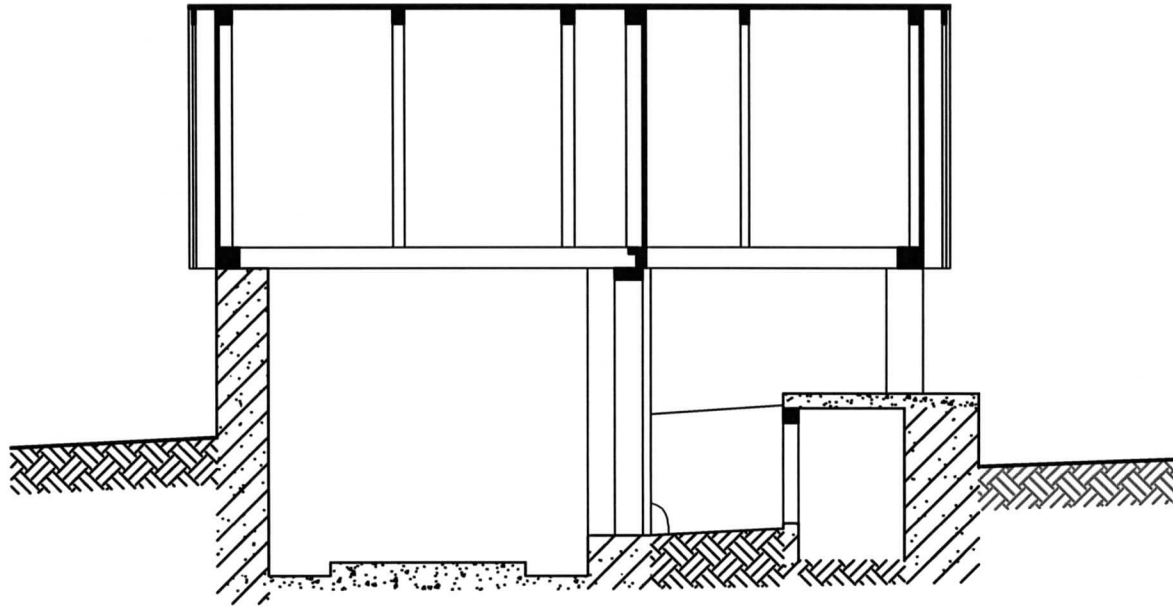
SPRINGHOUSE SECTION -- MEASURED BY PETE MORRILL, KEN SHORT & ALLISON LUTHERN -- DRAWN BY KEN SHORT -- JUNE 2023

HO-907 RICHLAND 4730 SHEPPARD LANE

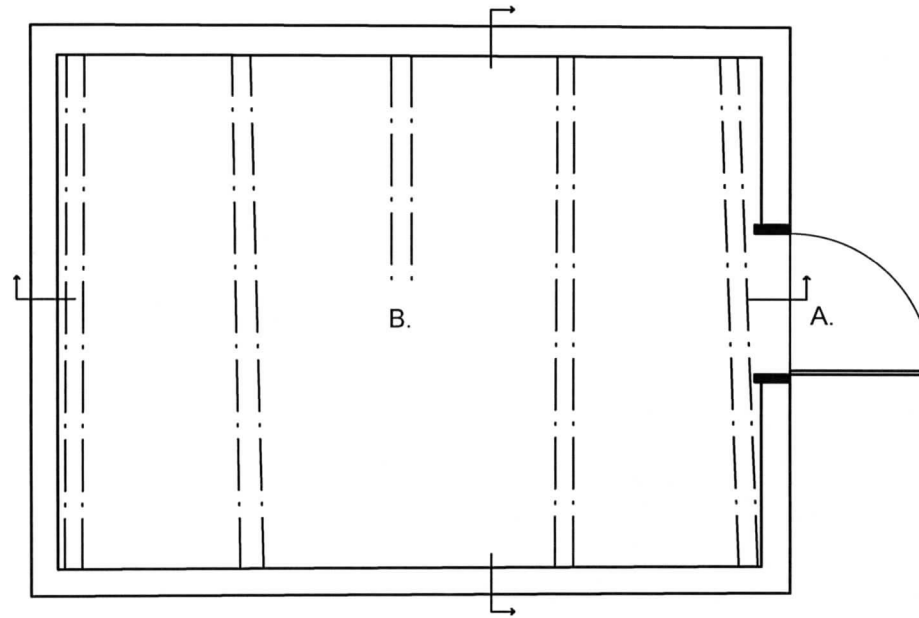
SMOKEHOUSE PLAN -- MEASURED BY KEN SHORT, ALLISON LUTHERN & PETE MORRILL -- DRAWN BY KEN SHORT -- JUNE 2023

A. CONCRETE FLOOR
RAISED TO TOP OF
REBUILT STONE
FOUNDATION.

B. THREE CENTER
BEAMS TO HANG MEAT
CUT OUT. END OF THIS
BEAM DOES NOT
SURVIVE IN
SOUTHWEST WALL.

HO-907 RICHLAND 4730 SHEPPARD LANE

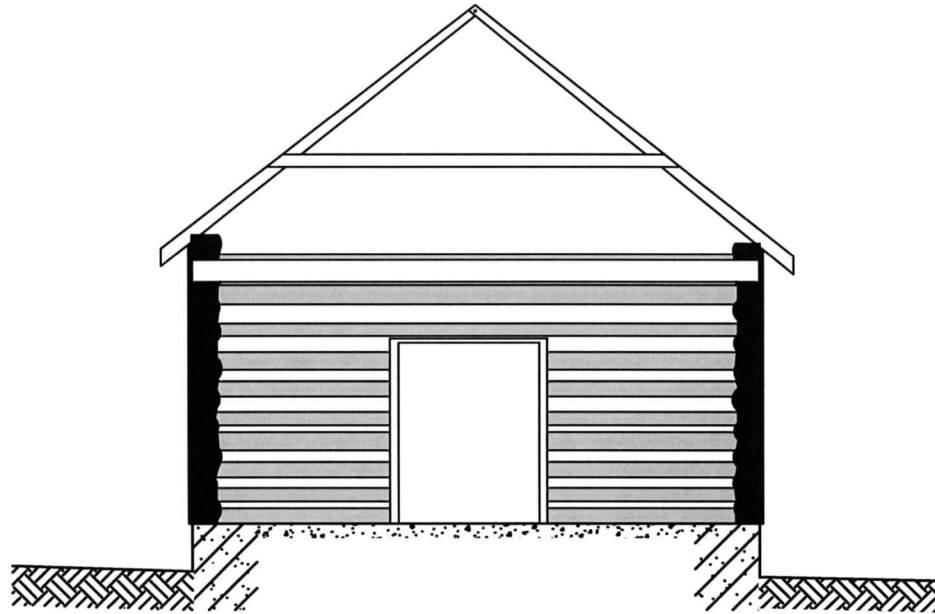
SMOKEHOUSE TRANSVERSE SECTION-- MEASURED BY KEN SHORT, ALLISON LUTHERN & PETE MORRILL -- DRAWN BY KEN SHORT -- JUNE 2023

HO-907 RICHLAND 4730 SHEPPARD LANE

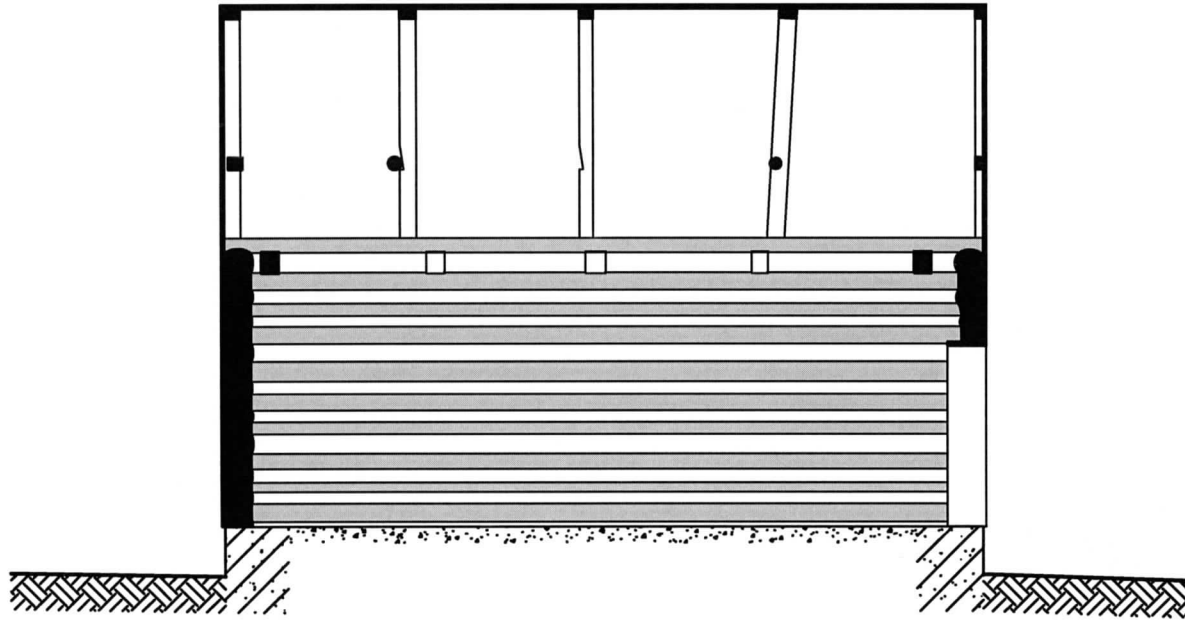
SMOKEHOUSE LONGITUDINAL SECTION-- MEASURED BY KEN SHORT, ALLISON LUTHERN & PETE MORRILL -- DRAWN BY KEN SHORT -- JUNE 2023

HO-907 RICHLAND 4730 SHEPPARD LANE

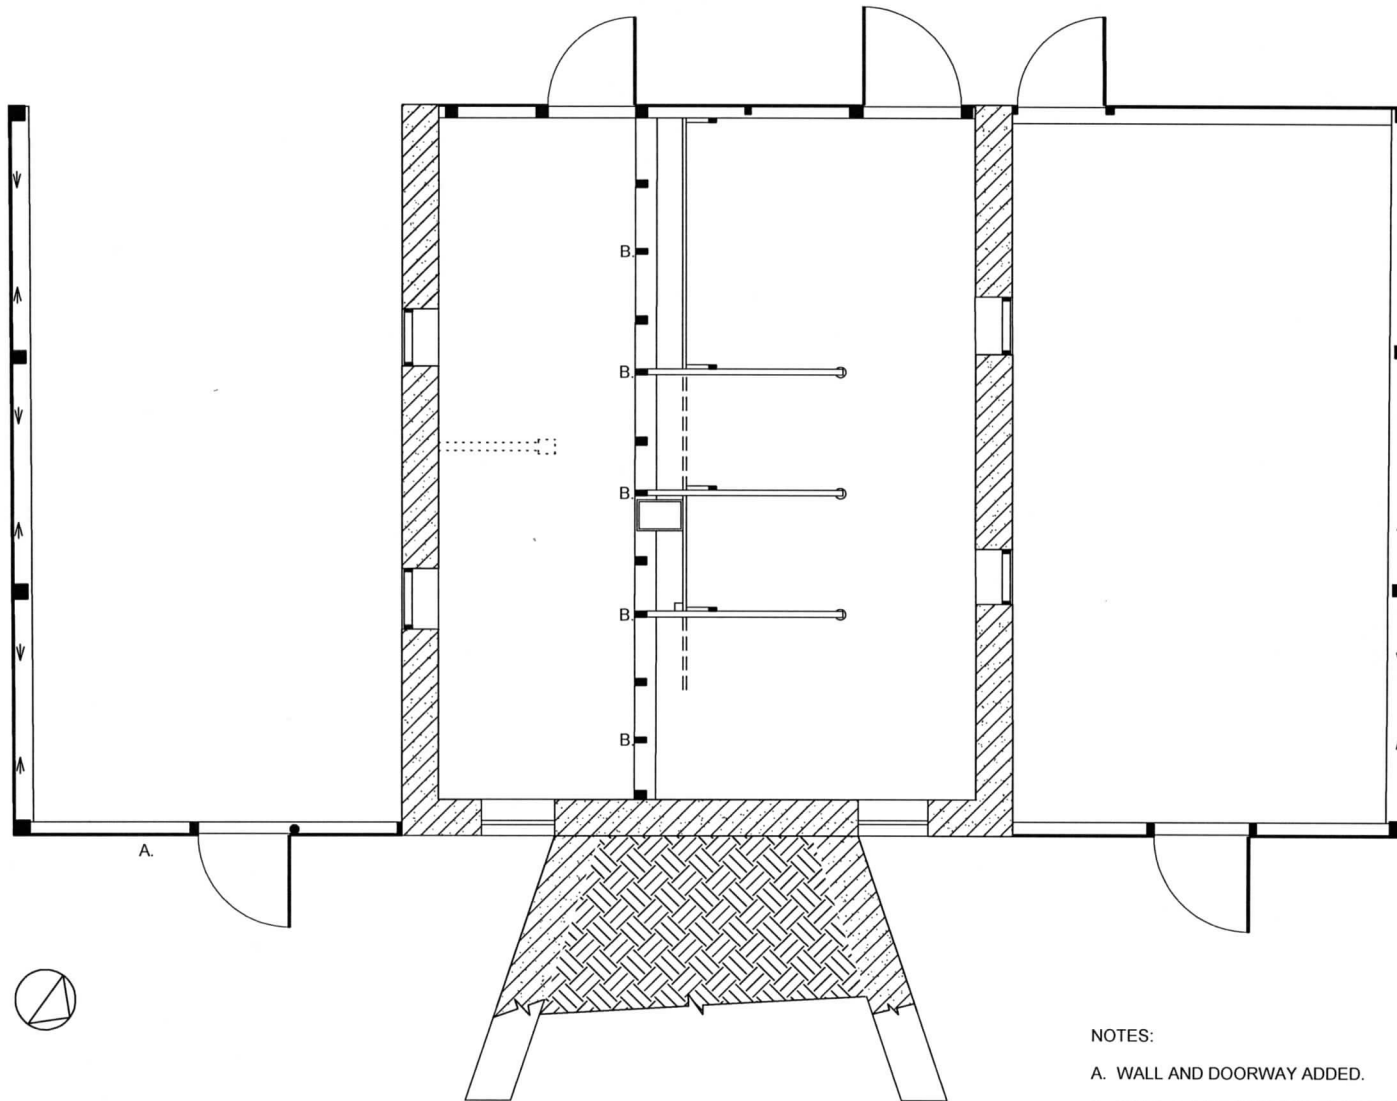
BARN -- LOWER STORY PLAN -- MEASURED BY KEN SHORT, ALLISON LUTHERN, & PETE MORRILL -- DRAWN BY KEN SHORT -- JUNE 2023

- A. WALL AND DOORWAY ADDED.
- B. STALL PARTITIONS AND INTERMEDIATE POSTS ADDED.
- ▲ LOCATION OF DOWN BRACE TOE.

HO-907 RICHLAND 4730 SHEPPARD'S LANE

About 120 feet southwest of the house is a Barn that is banked into the hill on the northeast. It is a one-story, one-bay by one-bay structure with one-story, one-bay by one-bay shed-roofed additions on the northwest and southeast. The building has a gable roof with corrugated metal and a northeast-southwest ridge. The barn has a rubble stone foundation and vertical board siding, with board and batten siding on the additions. The northeast elevation has a ramp in the center with two-light sash to each side. The upper story has a pair of large doors on T-hinges, with a small door in the gable end on T-hinges. The additions have a door on T-hinges set between the lower and upper levels. There are no openings on the northwest or southeast elevations. The southwest elevation has two vertical-board Dutch doors on T-hinges on the lower story and one of them on the upper story. The gable end also has one of these. The northwest addition has a vertical board-Dutch door on T-hinges, while the southeast addition is open on the southwest. The lower story of this elevation has vertical boards between the stone end walls of the

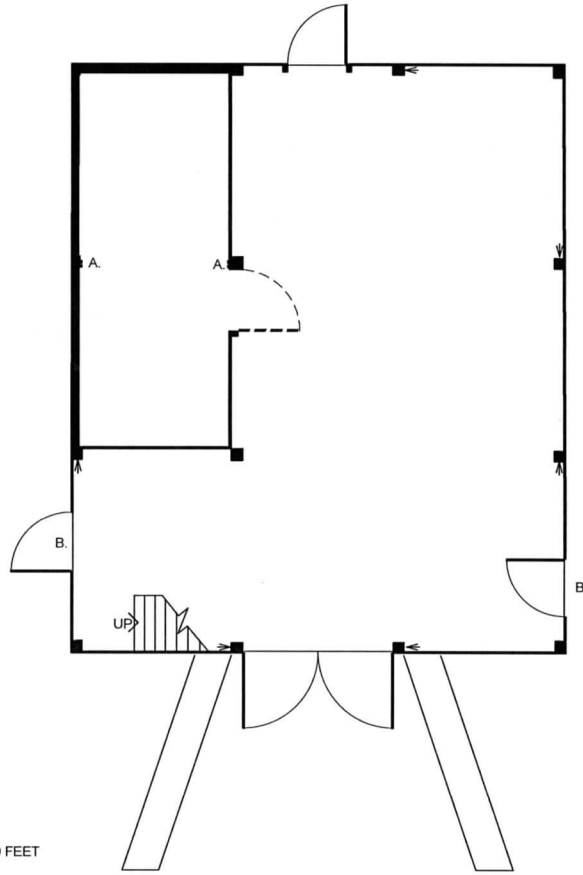
BARN -- UPPER STORY PLAN -- MEASURED BY KEN SHORT, PETE MORRILL, & ALLISON LUTHERN -- DRAWN BY KEN SHORT -- JUNE 2023

- NOTES:
- A. CLEATS ON WALL TO SLIDE BOARDS INTO.
 - B. DOOR CUT THROUGH LATER.
 - ▲ LOCATION OF DOWNBRACE TOE.

HO-907 RICHLAND 4730 SHEPPARD'S LANE

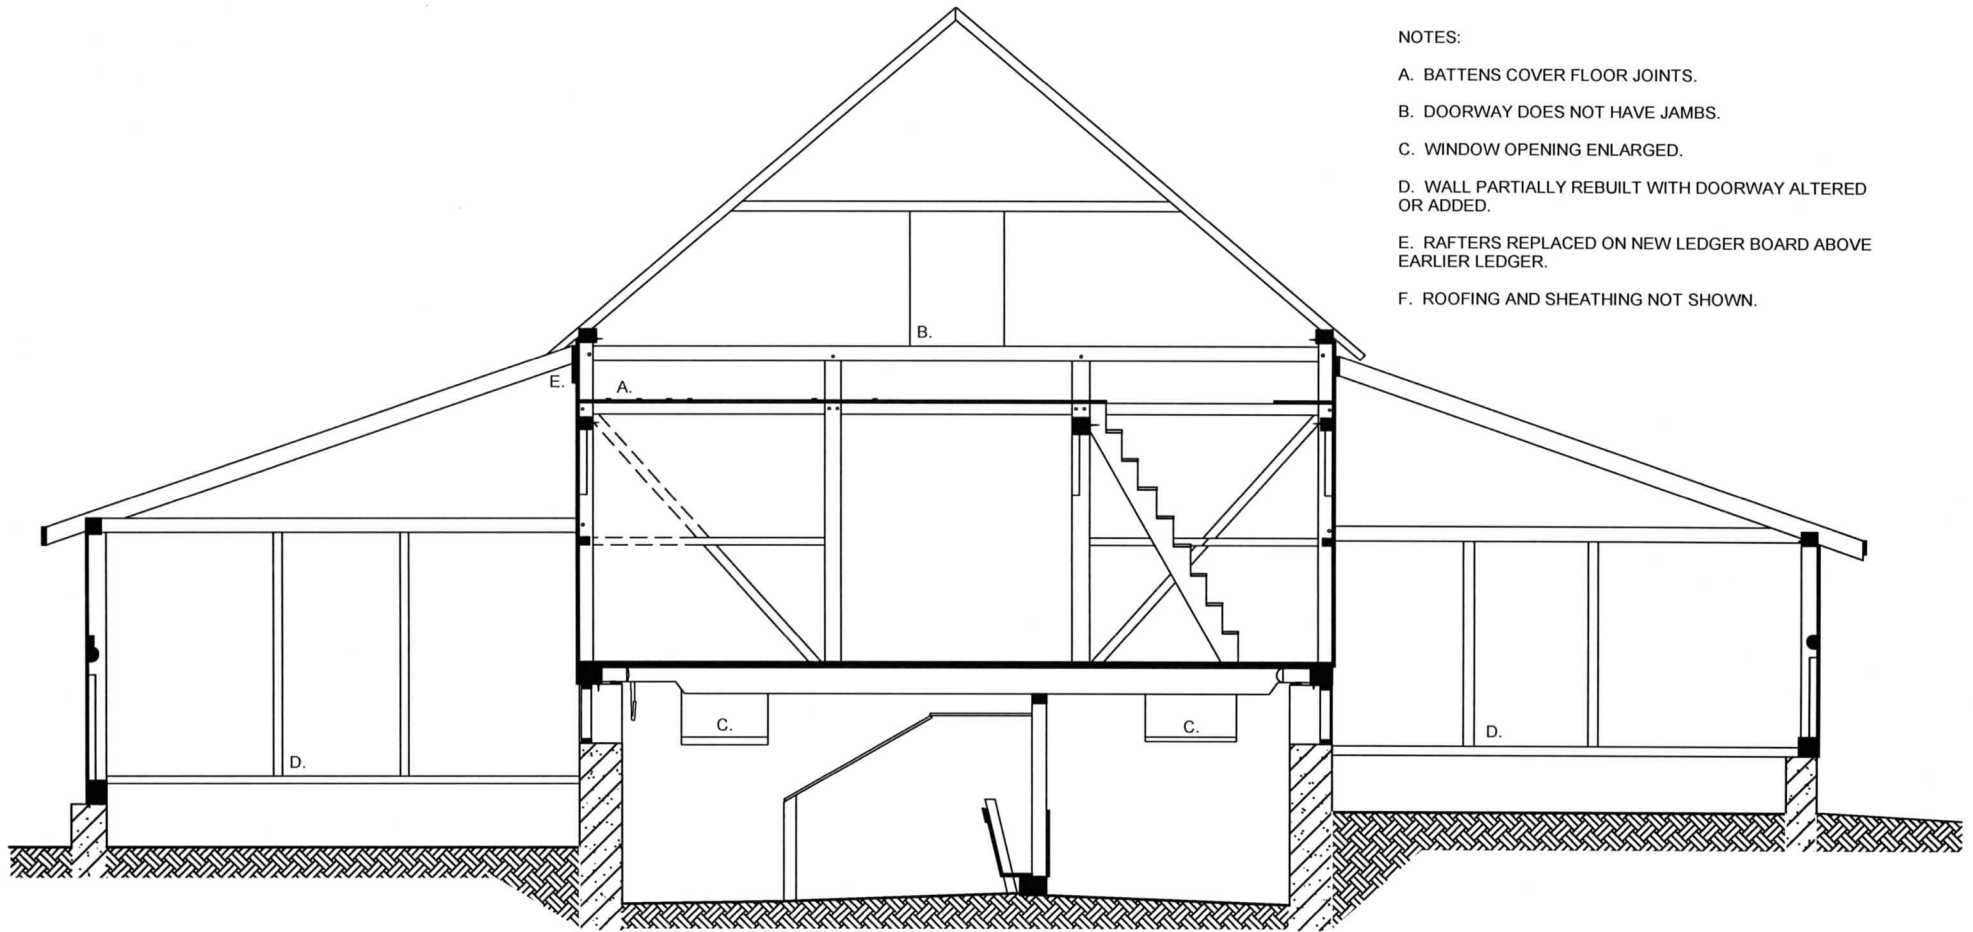
BARN -- TRANSVERSE SECTION -- MEASURED BY KEN SHORT, PETE MORRILL, & ALLISON LUTHERN -- DRAWN BY KEN SHORT -- JULY 2023

- A. BATTENS COVER FLOOR JOINTS.
- B. DOORWAY DOES NOT HAVE JAMBS.
- C. WINDOW OPENING ENLARGED.
- D. WALL PARTIALLY REBUILT WITH DOORWAY ALTERED OR ADDED.
- E. RAFTERS REPLACED ON NEW LEDGER BOARD ABOVE EARLIER LEDGER.
- F. ROOFING AND SHEATHING NOT SHOWN.

HO-907 RICHLAND 4730 SHEPPARD LANE

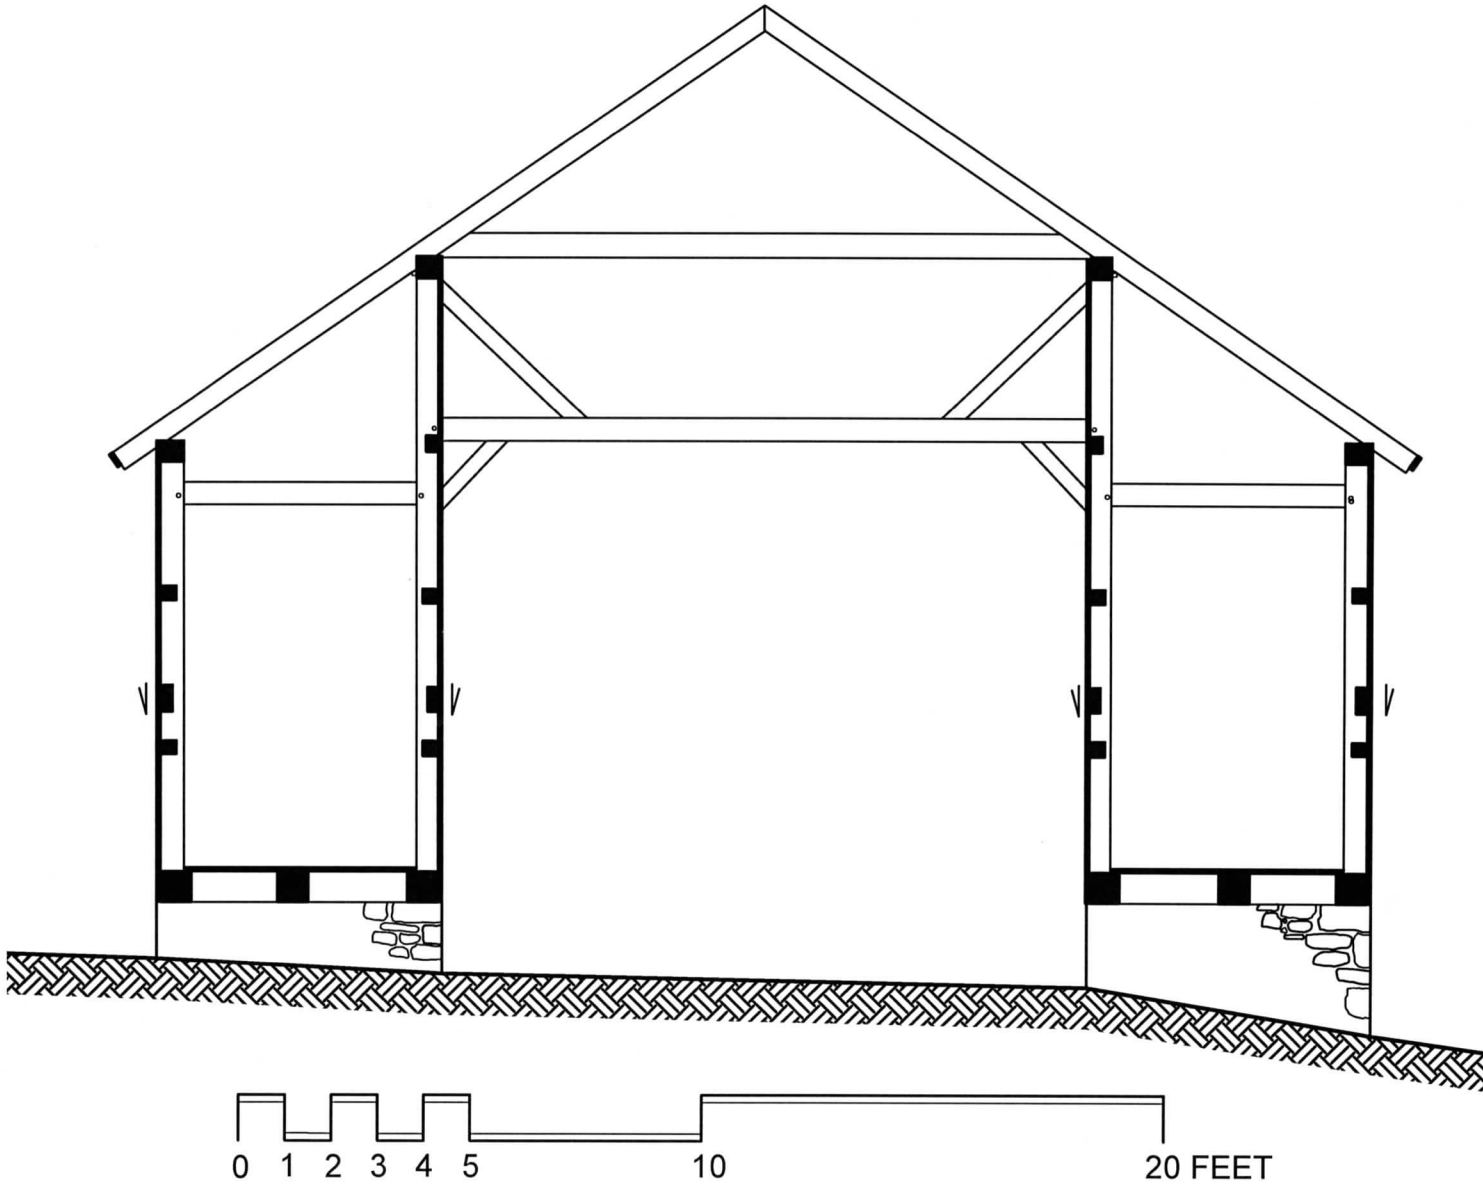
WAGON SHED -- TRANSVERSE SECTION -- MEASURED BY PETE MORRILL & KEN SHORT -- DRAWN BY KEN SHORT -- JULY 2023

HO-907 RICHLAND 4730 SHEPPARD LANE

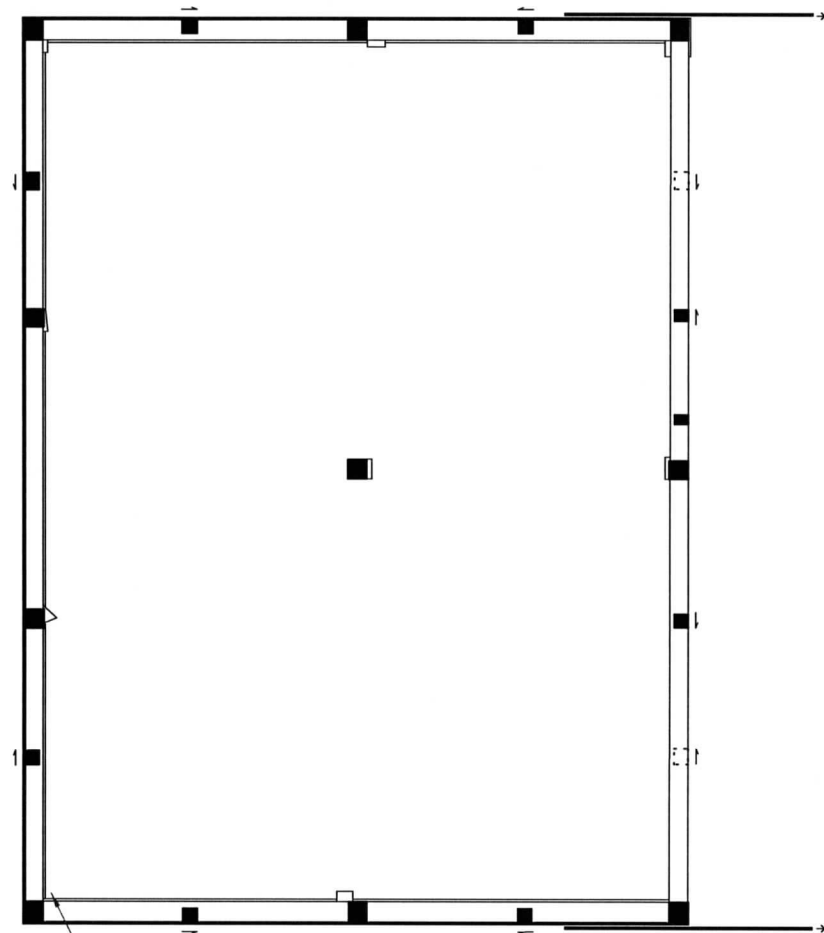
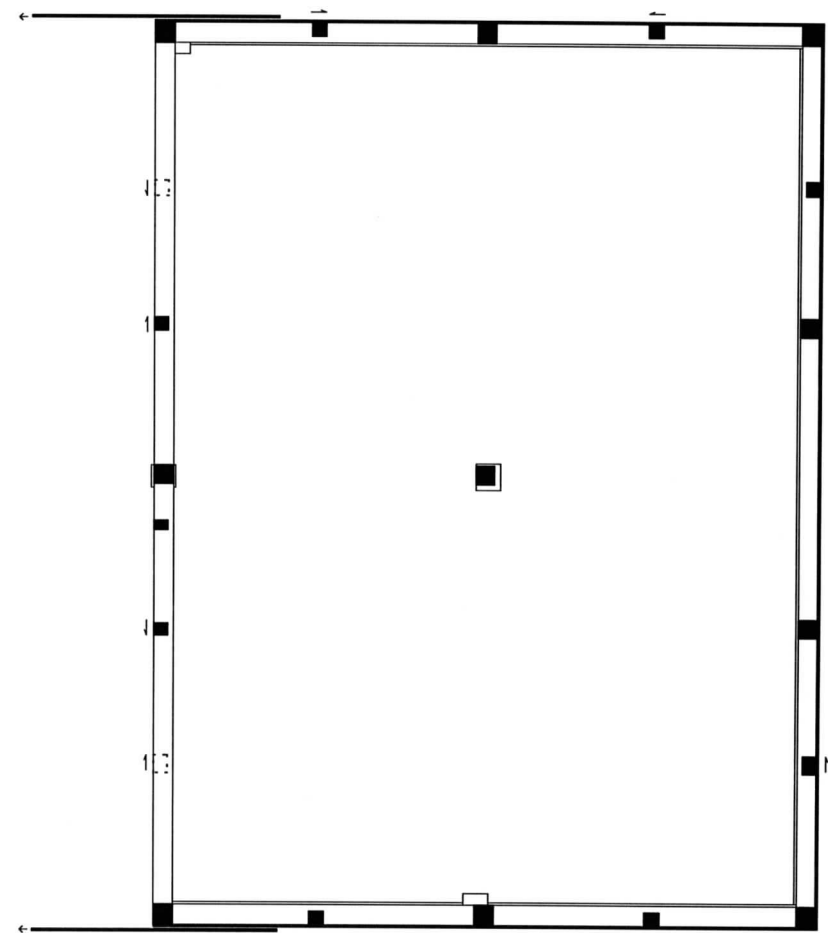
BARRACK -- PLAN -- MEASURED BY KEN SHORT & PETE MORRILL -- DRAWN BY KEN SHORT -- SEPTEMBER 2023

CORNER PIER
BURIED

HO-907 RICHLAND 4730 SHEPPARD LANE

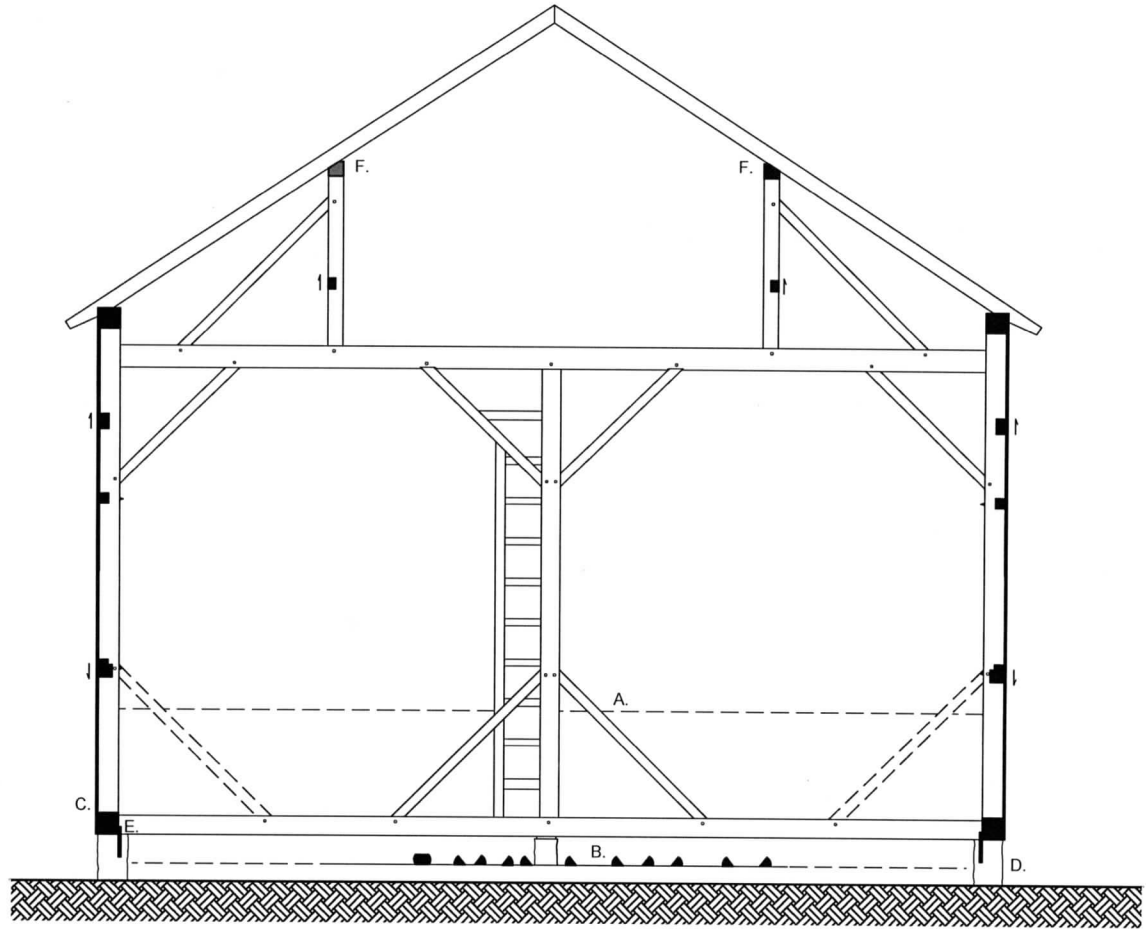
- NOTES:
- A. NAIL EVIDENCE INDICATES A LOW BOARD WALL FLANKING THE CENTER AISLE.
 - B. LOOSE LOGS, MOSTLY QUARTERED, AND SET ON SLEEPERS ON THE GROUND IN THE MOW. PORTIONS MISSING OR BURIED UNDER DEBRIS.
 - C. THE JOINT FOR THIS POST ROTTED AND THE POST NOW PUSHED OFF THE SILL. EXISTING CONDITION NOT SHOWN.
 - D. PIERS ARE MONOLITHIC GRANITE, ROUGHLY SQUARED AND BURIED DEEP INTO THE GROUND.
 - E. WIDE BOARD NAILED TO SILL TO CLOSE GAP BETWEEN PIERS.
 - F. RAFTERS ARE LET INTO THE PURLINS.
 - G. ROOFING AND SHEATHING NOT SHOWN.
