## Upton Mansion, (Dammann Mansion, David Stewart Residence)

### **Architectural Survey File**

United States Department of the Interior  
National Park ServiceNational Register of Historic Places  
Registration Form

historic name UPTON  
other names/site number Stewart, David, Residence; Dammann Mansion

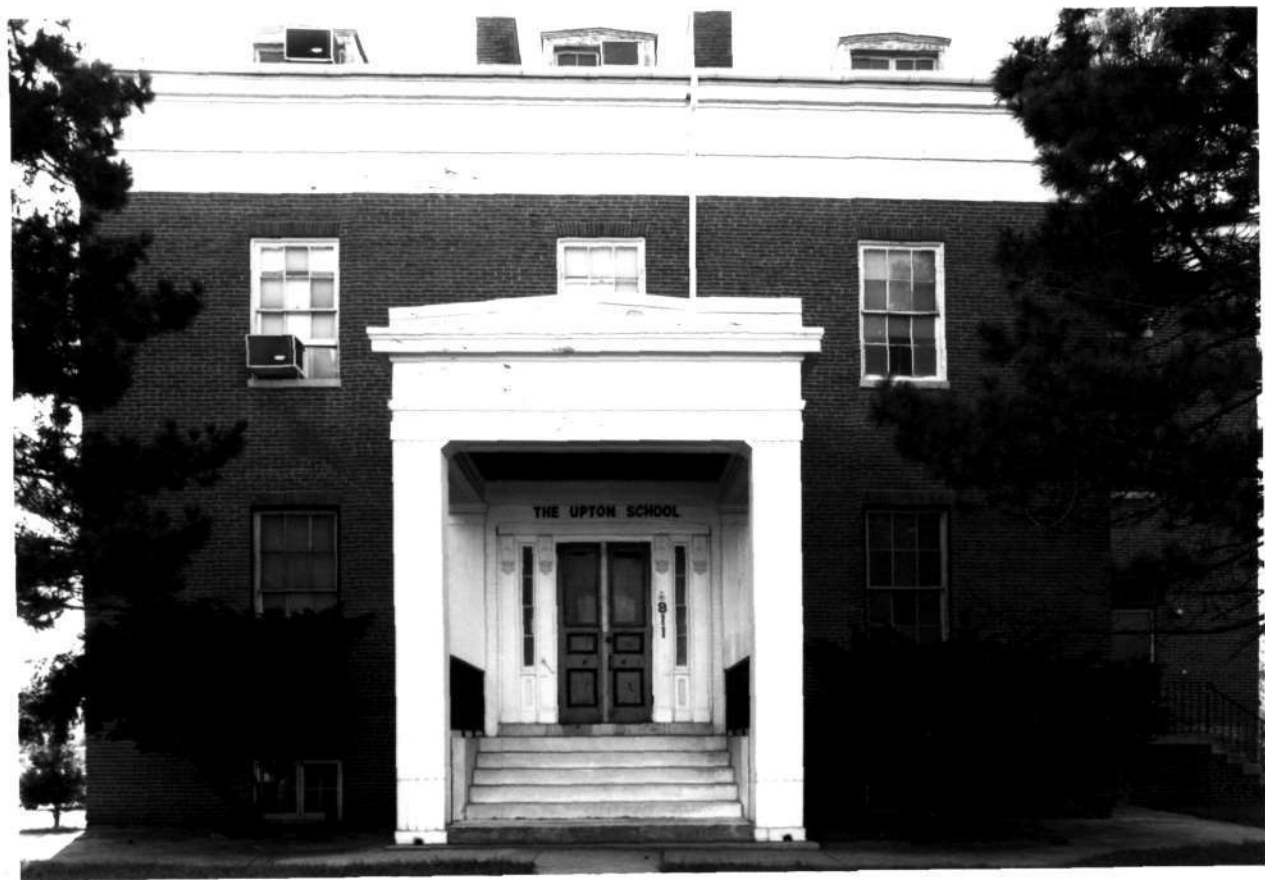
# 1 / 8

The north facade faces West Lanvale Street, and is three bays wide. A portico shelters the central entrance; square columns (encased in grooved plywood) support an entablature and cornice employing Classical molding profiles surmounted by a shallow pediment. Above a granite apron, a flight of five marble steps rises to a marble platform with an iron rail featuring a rose and thistle motif derived from the Stewart family arms. The cheek walls flanking the steps are carved on their outer faces, each with a large stylized flower centered in a stepped recessed panel. The entrance comprises double-leaf doors with three flat fielded panels framed with quirk ogee panel molds (the upper panels have been replaced with glazing). The doors are flanked by four-pane sidelights above a paneled spandrel. The doors and sidelights are defined by four pilasters with stepped plinths and richly carved consoles with acanthus leaves at the capitals. The frontispiece is slightly recessed within a segmental-arched opening. The portico has a paneled ceiling.

NORTH FACADE -

The entrance bay is flanked by large 9/6 windows on the first floor; at the second floor level, the three bays are defined by 6/6 sash. The basement is lighted by paired casement windows; three shallow gabled dormers with paired casements light the attic on the north slope of the roof. The window sash throughout the building was replaced in the 1957-58 rehabilitation, but the original frames were retained. Windows on the first and second stories throughout the building have splayed jack arches and marble sills. The first-floor windows have cast iron grilles with rose-and-thistle decoration. This window configuration and detailing is consistent throughout the building.

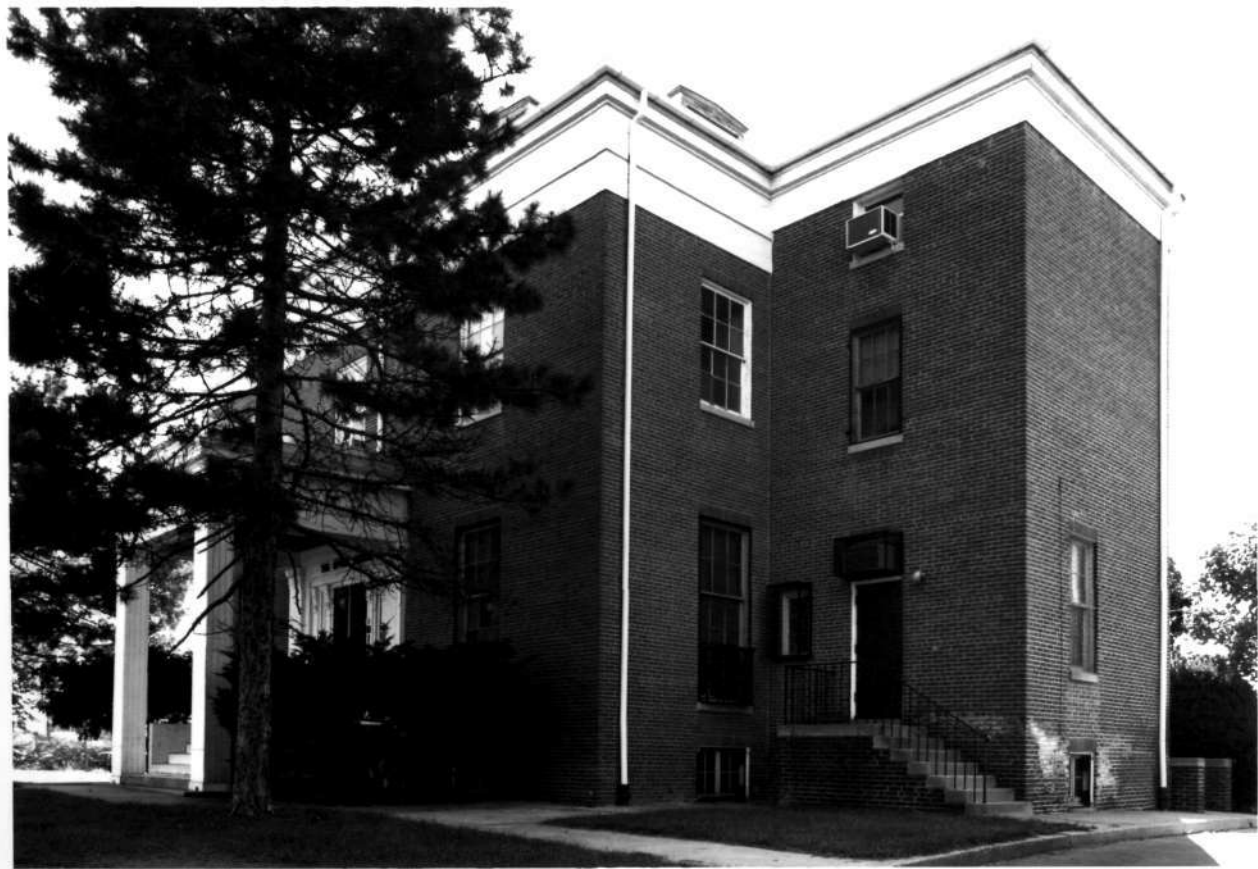
#2/8

The west elevation originally mirrored the east, with a three-sided projecting bay on its southern half. A service wing one bay wide by one bay deep and rising the full height of the building was added in the third quarter of the 19th century; it is not mentioned

VIEW FROM NORTHWEST

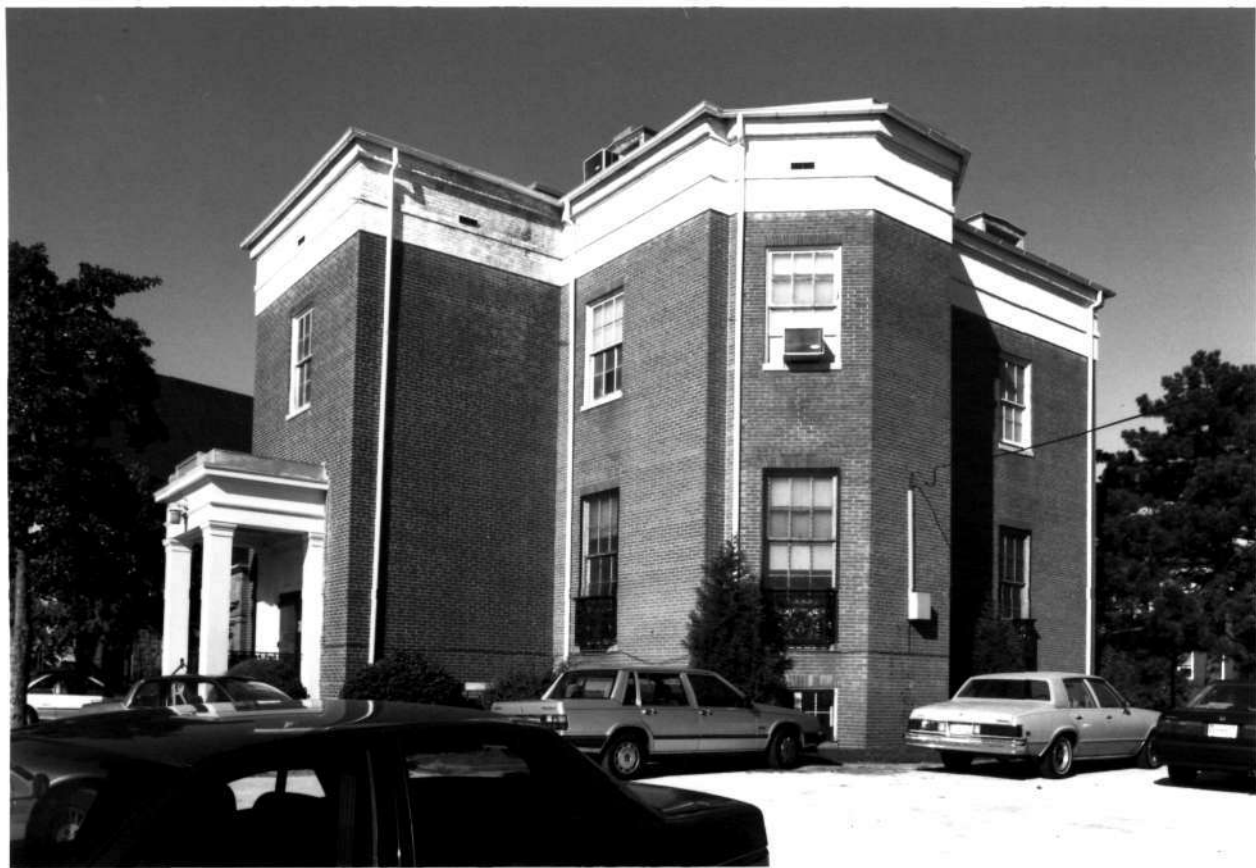
# 3/8

On the east elevation, a three-sided projecting bay occupies the southern half of the facade; there are windows in the angled facets of the projecting bay, and a single window centered in the northern portion of the facade, on both the first and second stories.

The south elevation originally was the garden facade; its symmetrical three-bay composition and detailing mirror the north elevation with the exception of a two-story porch which formerly occupied the central bay and which was replaced with a brick stair tower in the 1957-58 rehabilitation. This tower is constructed of concrete block faced in brick laid in running bond, with a two-brick belt course at the level of the entrance. A Classically-detailed portico serves the entrance, which comprises double-leaf, three panel doors. The granite steps and cheek wall bases of the original south porch were reused in the new portico. Original entrance enframements, similar to that described on the north facade, survive in the south wall within the stair tower. The basement on the south side is lighted by 6/6 windows opening into an areaway. In the 1957-58 rehabilitation, the cast iron railing with rose-and-thistle decoration was salvaged from the first level of the south porch and incorporated into a new brick wall protecting this areaway (historic photographs show a simpler geometrical railing in this location).

VIEW FROM SOUTHEAST

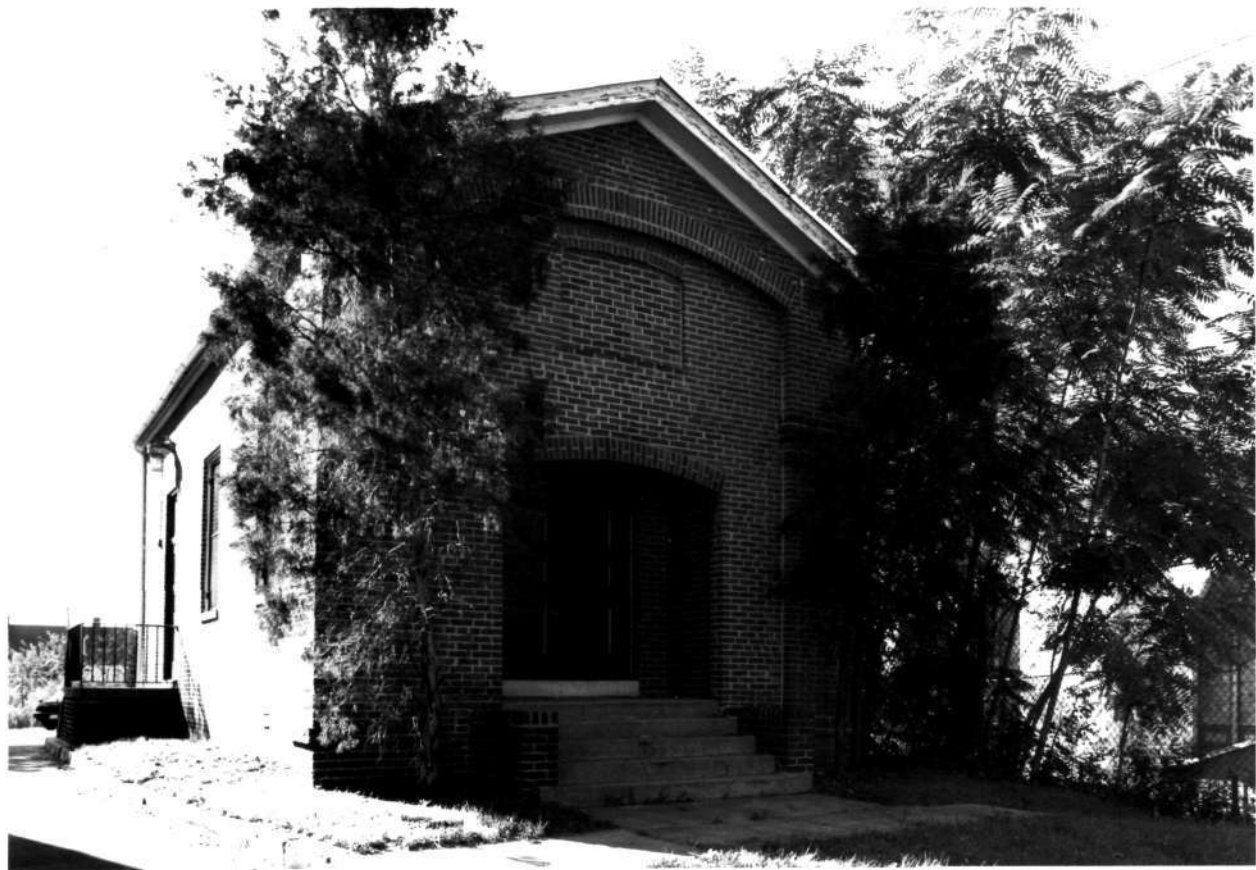
# 5/8

The carriage house is located to the west of the building; this is a rectangular, one-story brick building with a broad segmental arched opening in its north gable end. It was remodeled extensively in 1957-58 to serve as a school assembly room. A 19th-century photograph shows a one-story, hip-roofed building located to the west of the existing carriage house; this presumably was the stable mentioned in David Stewart's inventory, and was demolished in the late 19th century for the construction of the church at the corner of Lanvale and Fremont streets. According to the inventory, the stable and carriage house accommodated two family carriages (one large, one small) and tack, a pair of carriage horses, a red-and-white cow, and a stepladder.

CARRIAGE HOUSE, VIEW FROM NORTHEAST

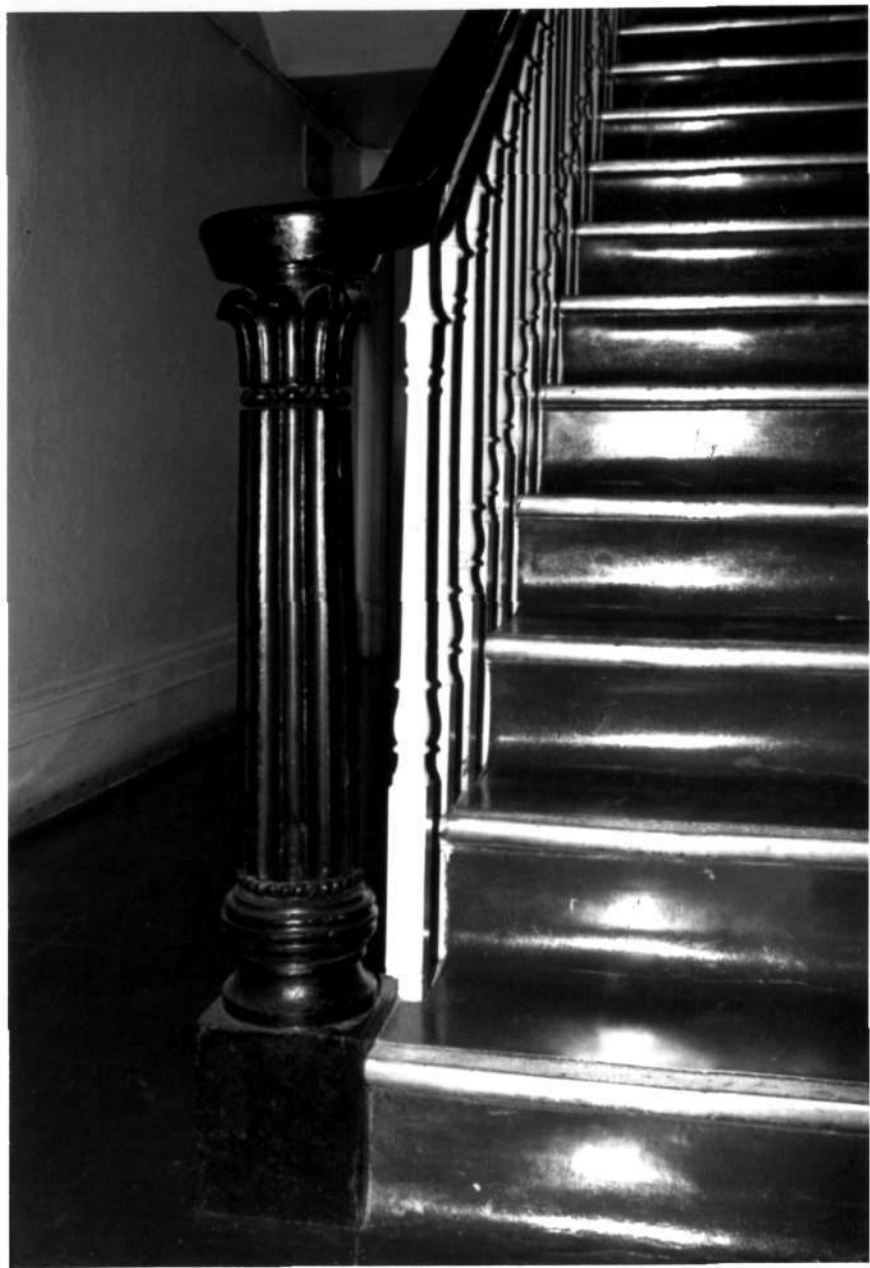
# 6/8

The open-string stair has a fluted mahogany newel, turned balusters (two per tread), and scrolled step ends. At the landing between the first and second floors, an opening provides access to the second level of the service wing. The detailing of this opening is consistent with that in the main hall. As described in a newspaper article of 1929, the wing housed a service stair which joined the main stair at this landing. The landing between the second and third floors has an entrance to the upper level of the wing, detailed in a manner similar to the second floor of the main block.

STAIR DETAIL

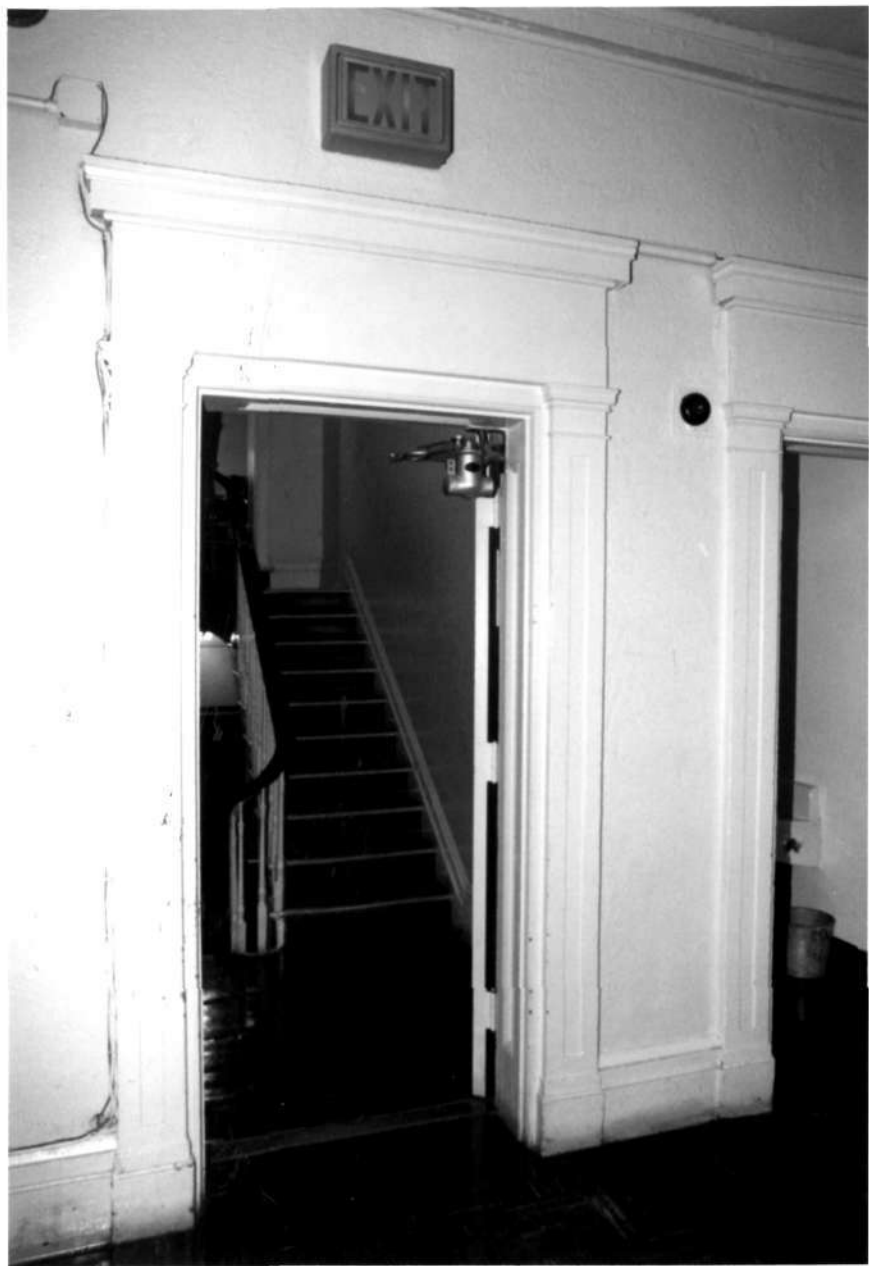
#7/8

On the interior, Upton retains the vast majority of original door, window, and baseboard trim intact. A clear hierarchy of finish is evident in this decorative detailing. In the most formal, public areas of the first floor--the entrance hall, stair passage, and east parlors--door and window openings are framed by stepped-paneled pilasters with carved capitals incorporating greek key and patera motifs; these support a plain entablature, with architrave and cornice outlined by egg-and-dart and bead-and-reel moldings. Door jambs are paneled, and windows have paneled blinds which fold flush with the openings. The southwest room, presumably the library, is treated similarly, but the greek key and patera elements are absent from the window frames. [Trim in the northwest room was removed in the conversion of this space to toilet facilities.] A complex baseboard with multiple Classical molding profiles is found throughout the first floor and continues the full height of the stair to the attic. On the second-floor openings, the pilasters have a simpler recessed panel without a step, and the architraves are less bold and lack the egg-and-dart and bead-and-reel moldings; baseboards are also less elaborate, with a beaded step and a quirk ovolo cap. On the third floor, openings have beaded casings, plain frames with a single step near the inner edge, and plain corner blocks; baseboards are treated with a single step.

TYPICAL TRIM, 2ND FL. HALL

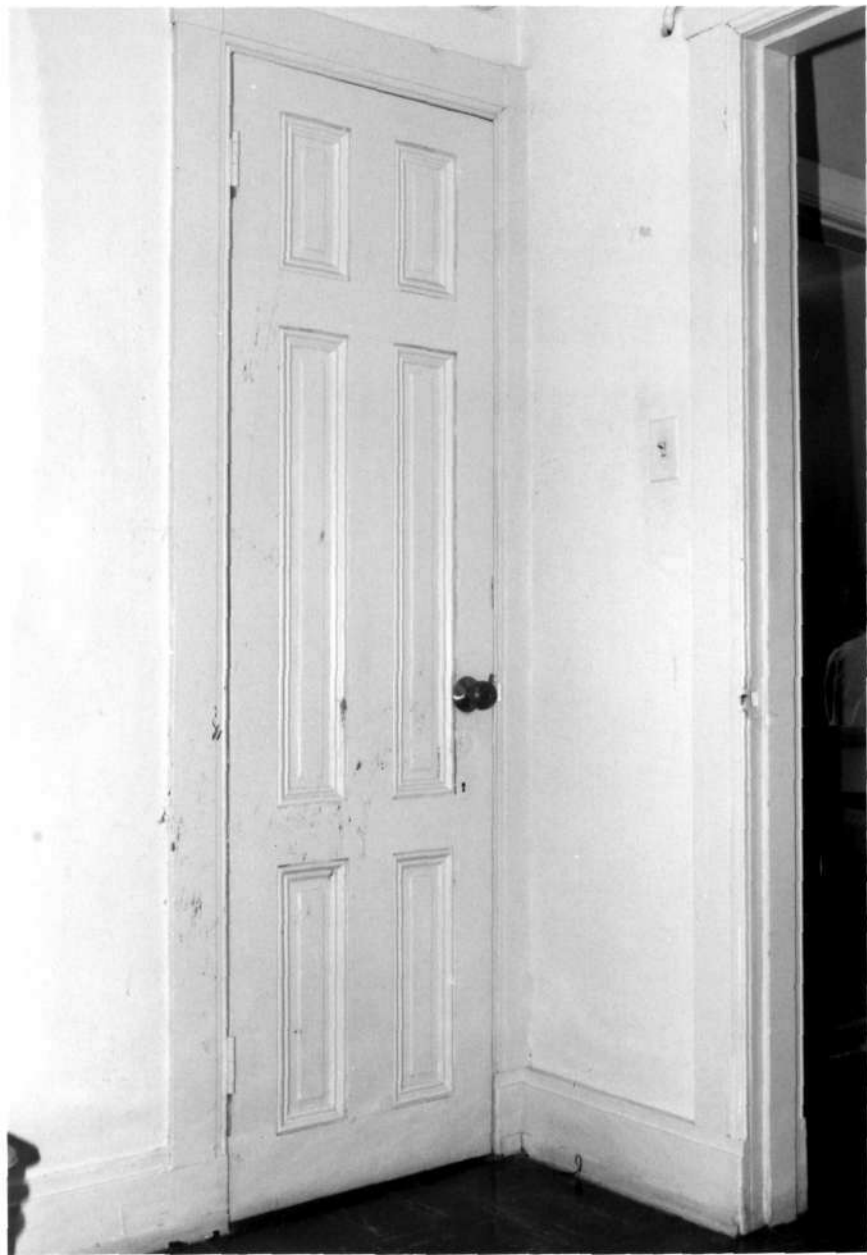
# 8/8

DOOR AND TRIM, 3RD FL.
