QA-492

## Bridge (SHA 17021)

### **Architectural Survey File**

SHA Bridge No. 17021 Bridge name MD 213 over Old Mill Stream Branch

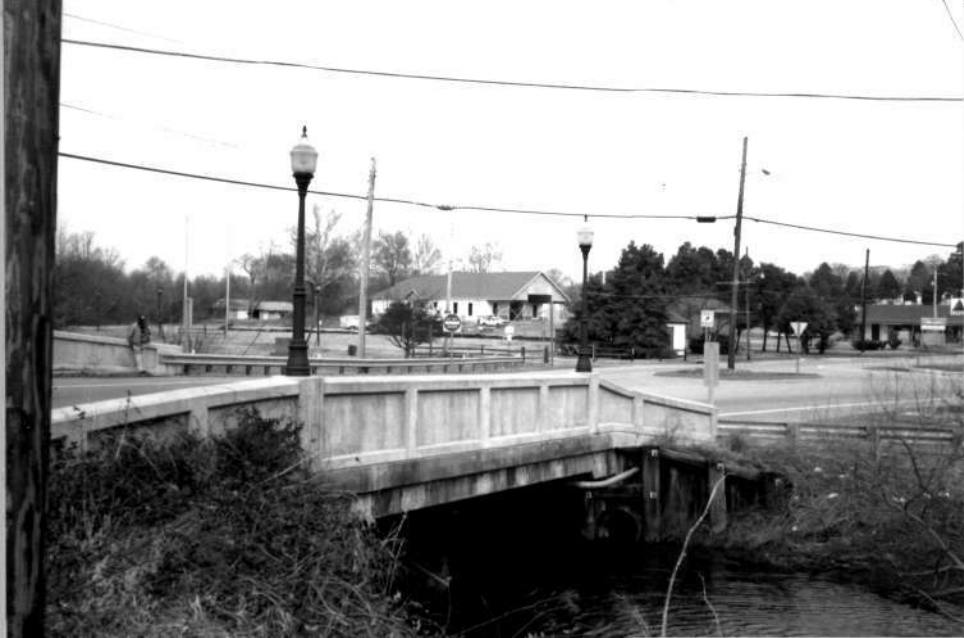
1. QA-492
2. MD 213 over Old Mill Stream Branch
3. Queen Anne Co., Md (17021)
4. Caroline Hall
5. 3/97
6. MDSHPO
7. east side
8. 1 of 6

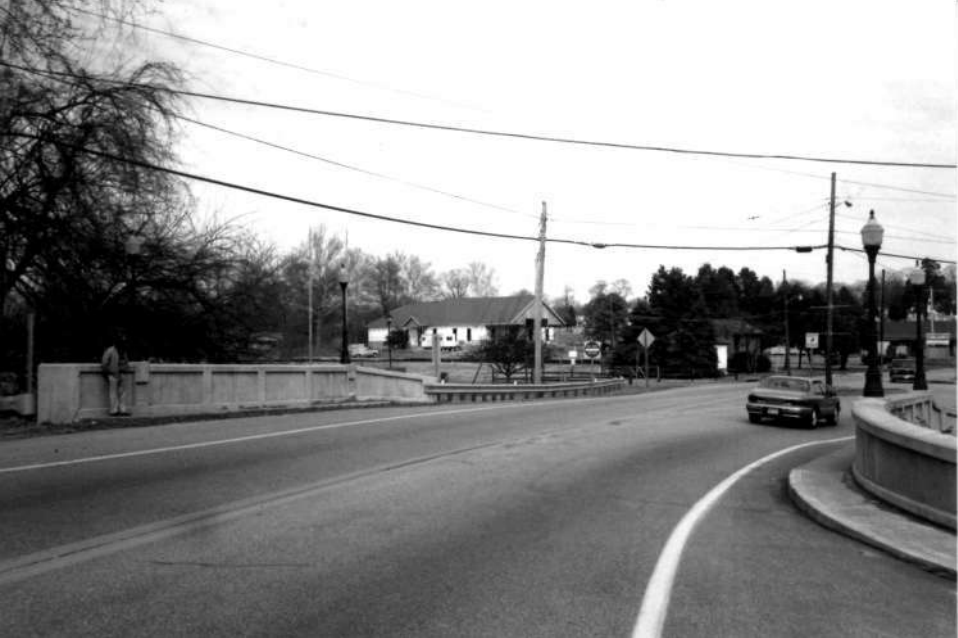
1. QA-492
2. MD213 over Old Mill Stream Branch
3. Queen Anne Co., Md. (17021)
4. Caroline Hall
5. 3/97
6. MDSHPO
7. roadway approach
8. 2 of 6

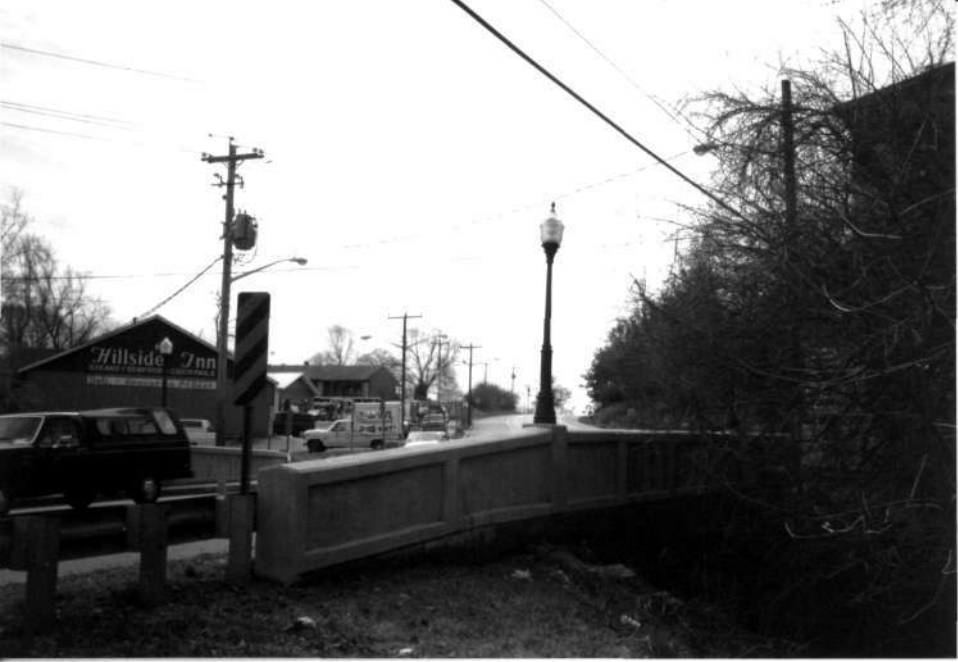
1. QA-492
2. MD 213 over Old Mill Street Branch
3. Queen Anne Co., Md (1702-1)
4. Caroline Hall
5. 3/97
6. MDSHPO
7. west side
8. 3 of 6

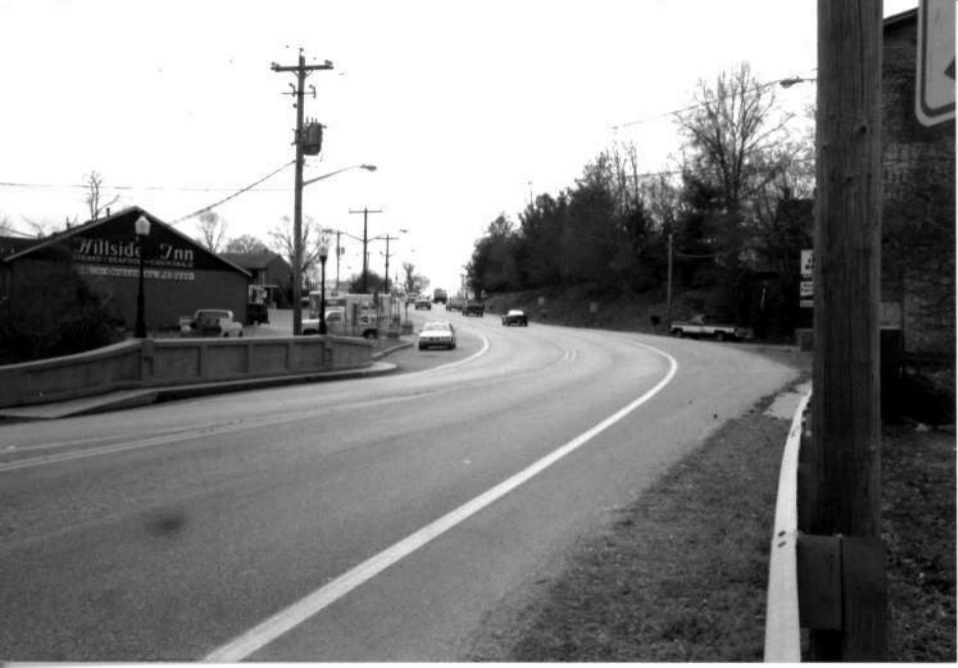
1. QA-492
2. MD 213 over Old Mill Stream Branch
3. Queen Anne Co., Md (17021)
4. Caroline Hall
5. 3/97
6. MDSHPO
7. roadway approach
8. 4 of 6

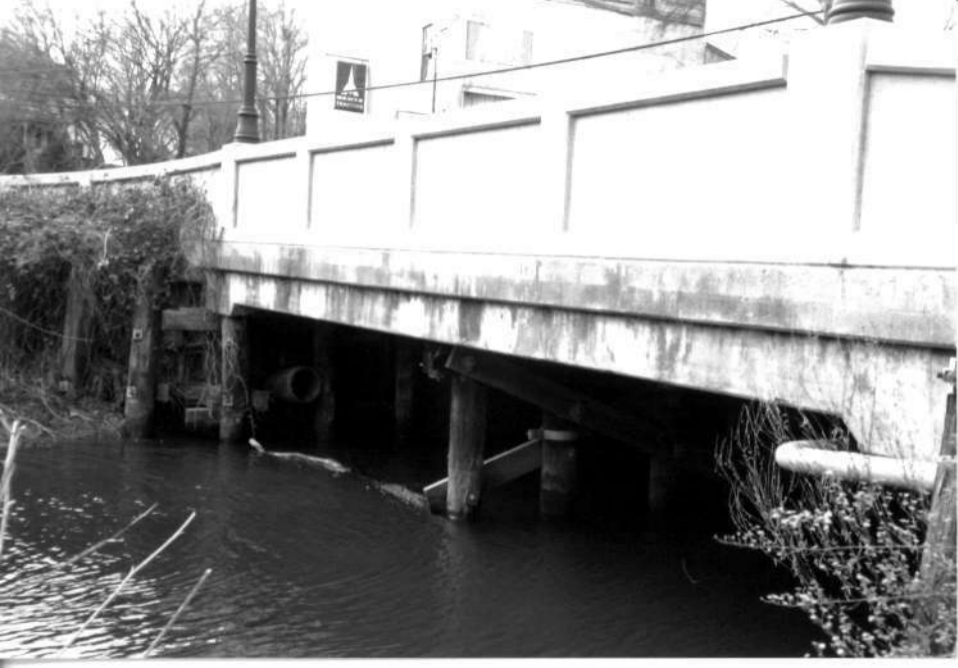
1. QA-492
2. PID 213 over Old Mill Stream Branch  
(17021)
3. Queen Anne Co, Md
4. Caroline Hall
5. 3/97
6. MDSHPD
7. detail of substructure
8. 5 of 6

Bridge No. 17021 is a 2-span, 2-lane, concrete slab bridge. The bridge was originally a two-cell box culvert, widened with a concrete slab in 1945. The structure is 32 feet long and has a clear roadway width of approximately 44 feet; there are two (2) sidewalks, each measuring 2 feet, 10 inches wide. The out-to-out width is approximately 47 feet. The concrete slab has a bituminous wearing surface. The structure has decorative concrete parapets with recessed panels and metal light posts. Both ends of the west parapet wall, and the north end of the east parapet wall, flare away from the roadway approaches. The south end of the east parapet wall curves away from the roadway approach. A date impression on the parapet indicates that bridge was constructed in 1945. The substructure consists of two (2) timber abutments, timber bents and cross-bracing, and timber wing walls. The bridge has a sufficiency rating of 78.2.

According to the 1995 inspection report, this structure was in fair condition. The timber piles had checks, cracks and delamination and the timber cross-bracing was in good condition. The timber abutments had some rotted areas with delamination and section loss. The timber wing walls had areas of rot and checks, splits and delamination. The concrete culvert had concrete erosion and cracking and the concrete slab was in good condition with no defects. The parapets were in good condition, as were the lights on the bridge.
