## St. Michael's Roman Catholic Church Complex, (St. Michael's Boys School)

### **Architectural Survey File**

# National Register of Historic Places Registration Form

historic name St. Michael the Archangel Roman Catholic Church  
other names/site number St. Michael's Church Complex (preferred) B-4208

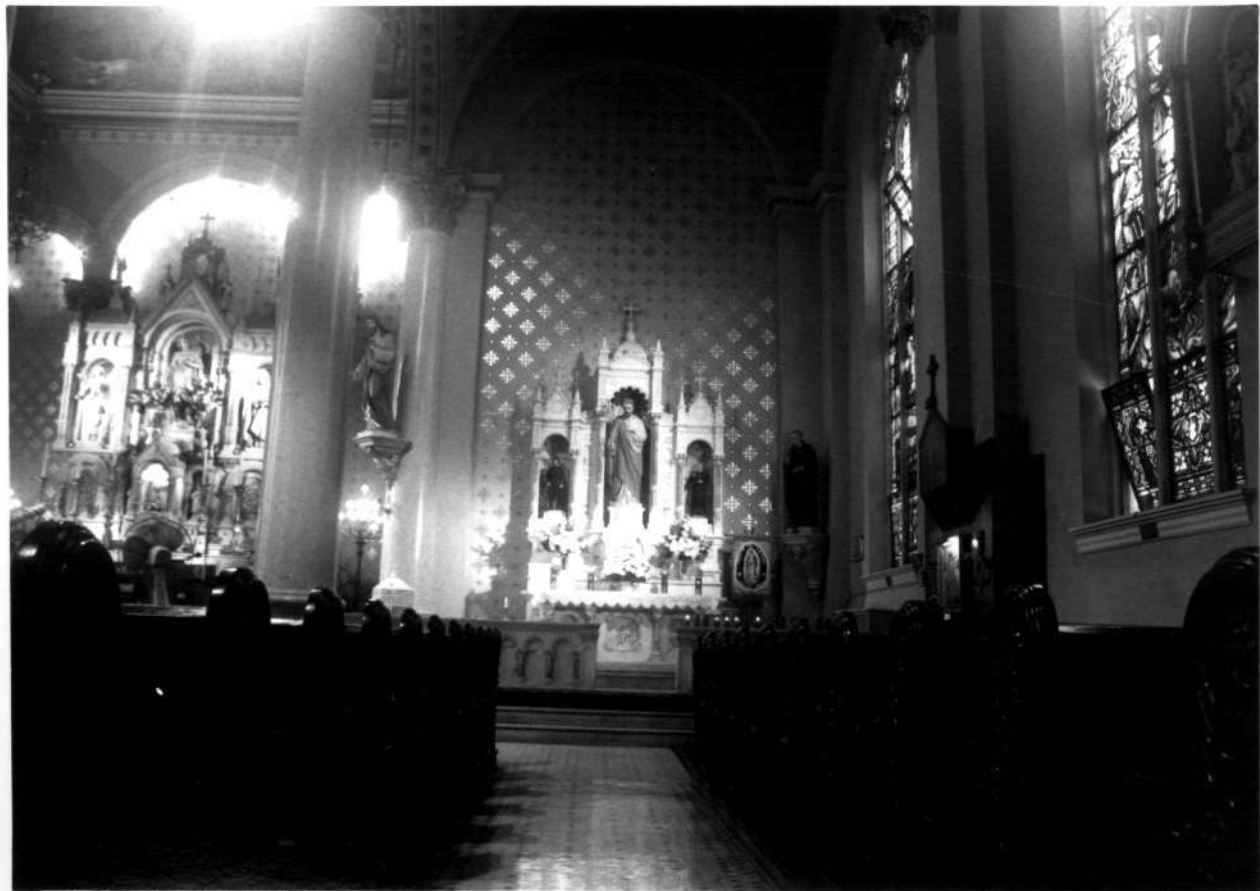
4/57

Interior-side altar east

Repairs on the side altars and the rebuilding on the High altar began in the summer of 1881. A marble statue of St. Michael took the place of the mural in the High Altar and the altar was rebuilt in marble and white pine (Refer to Photos 4,5,6).

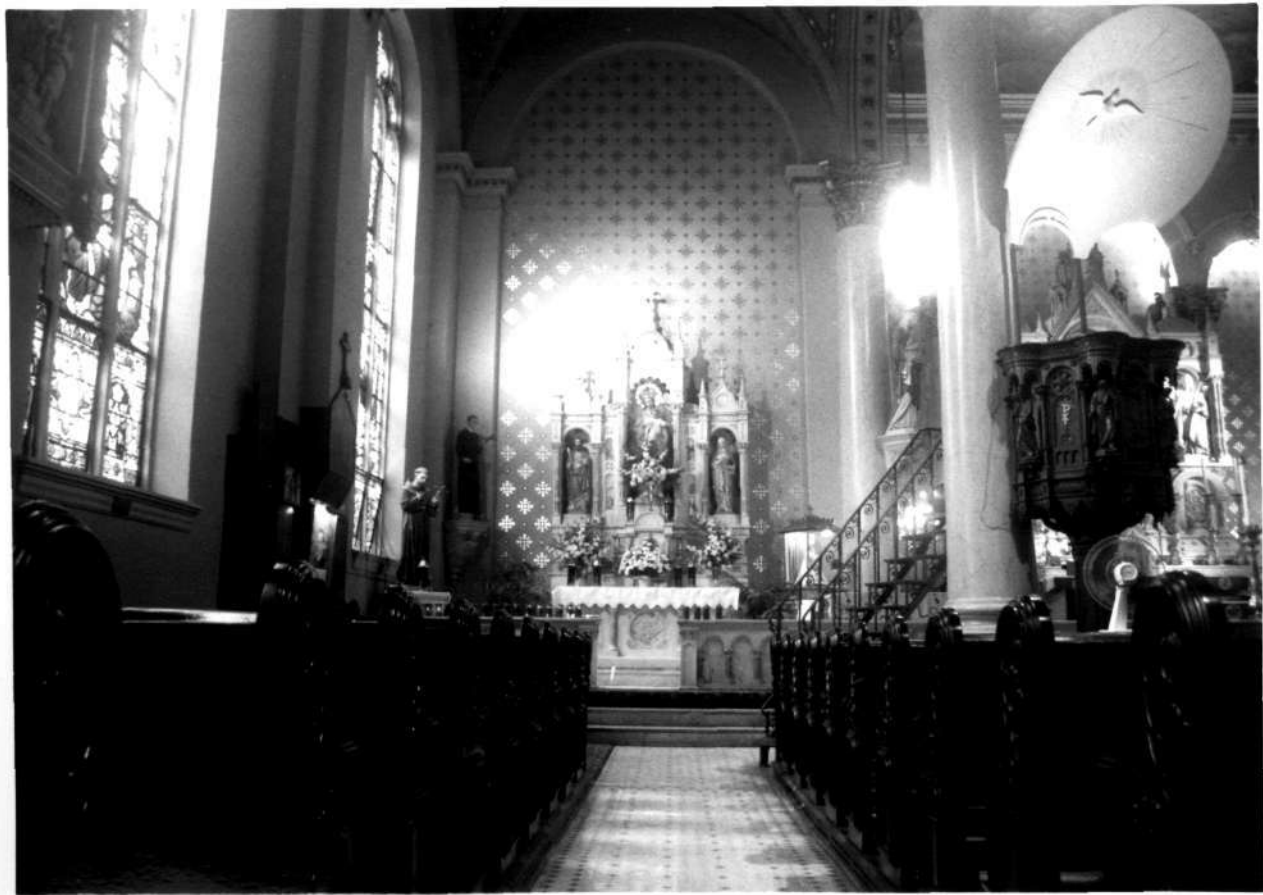
5/57

Interior - side altar west

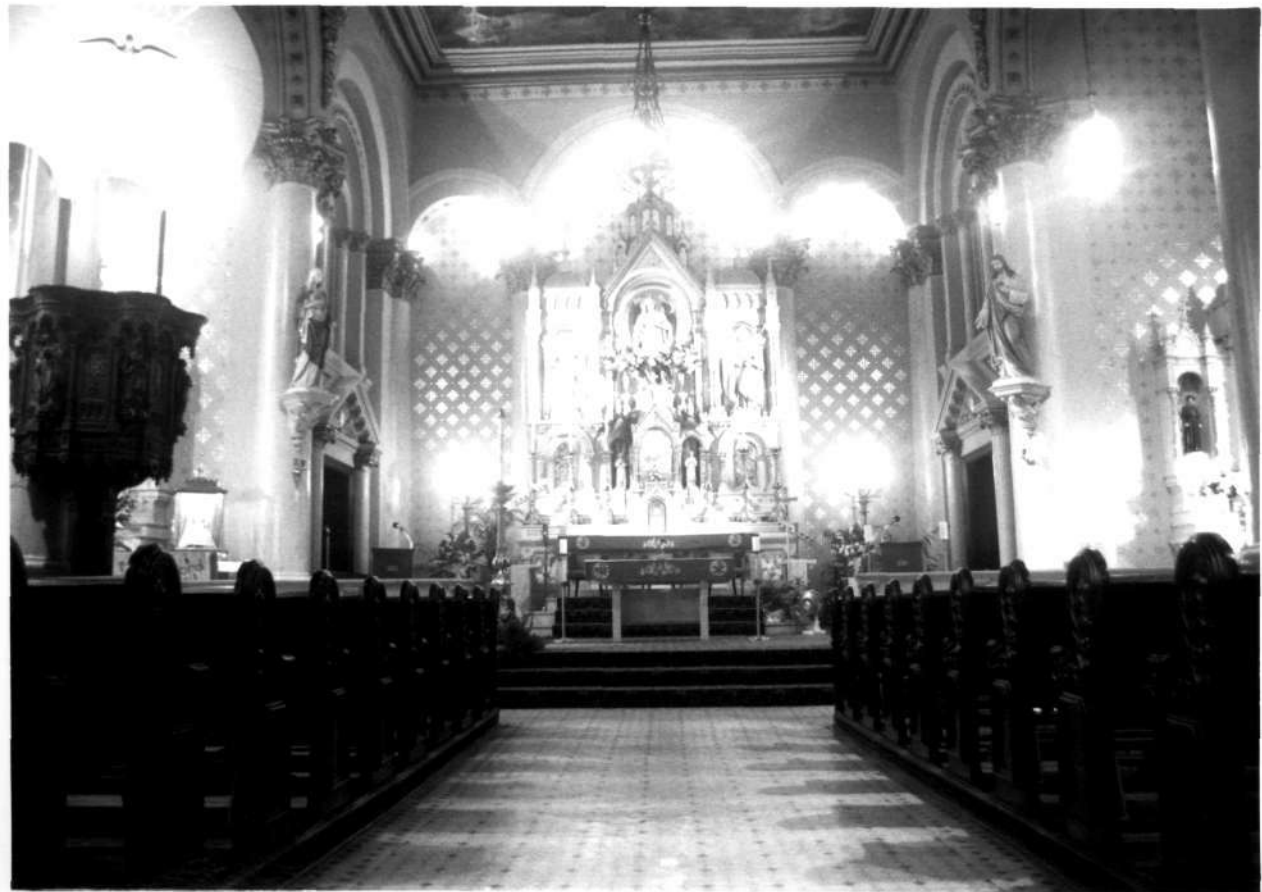
6/57

Interior - Sanctuary - view north

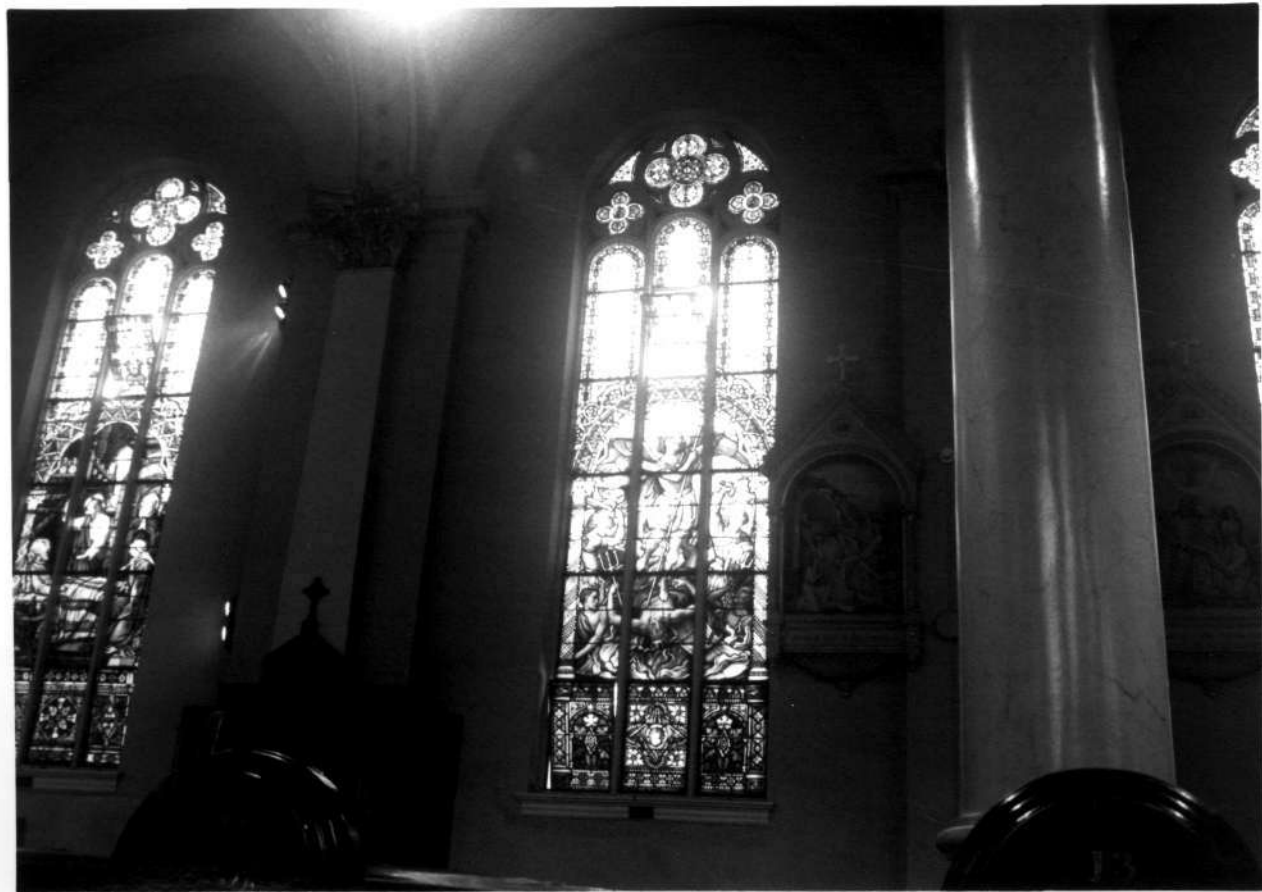
15/57

Interior - Detail stained glass

Future renovations continued throughout the rest of the 19th century. The new stained glass windows with a different design were installed by Ketteler of Munich in 1893 (Refer to Photos 14,15). The vestibule of the church was extended and new inner glass doors were installed dividing the vestibule from the nave of the church. Presently the vestibule still

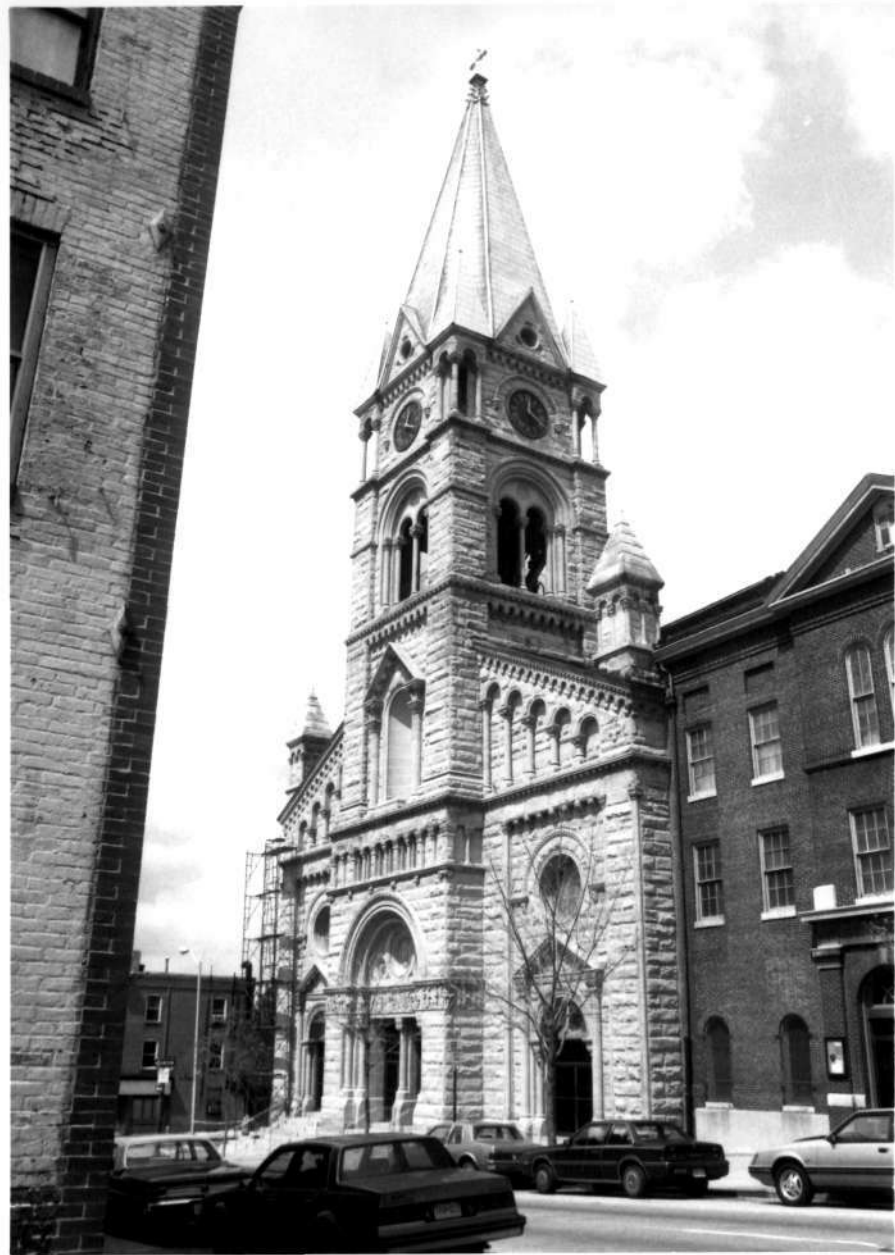
18/57

SE elevation

The main south front elevation of St. Michael's Church has a granite base and facade divided into three bays; a central bay flanked by side bays (Refer to Photo 18). The central contemporary double doors are set in a compound arch flanked by coupled engaged columns and a central column between the sets of doors (Refer to Photo 19). Flanking the main entrance are similar entrances set in pediments with circular stained glass windows above (Refer to Photo 20). There are blind arcades directly above the main entrance and above the circular windows of each side bay. The square tower intersects the gabled roof which has a corbel table for a cornice line. A spire or bell turret with a small cross caps the clock tower. Square parapets with pyramid roofs flank the tower in the southwest and southeast corners of the front facade (Refer to Photo 21). Each parapet is decorated by blind arcades.

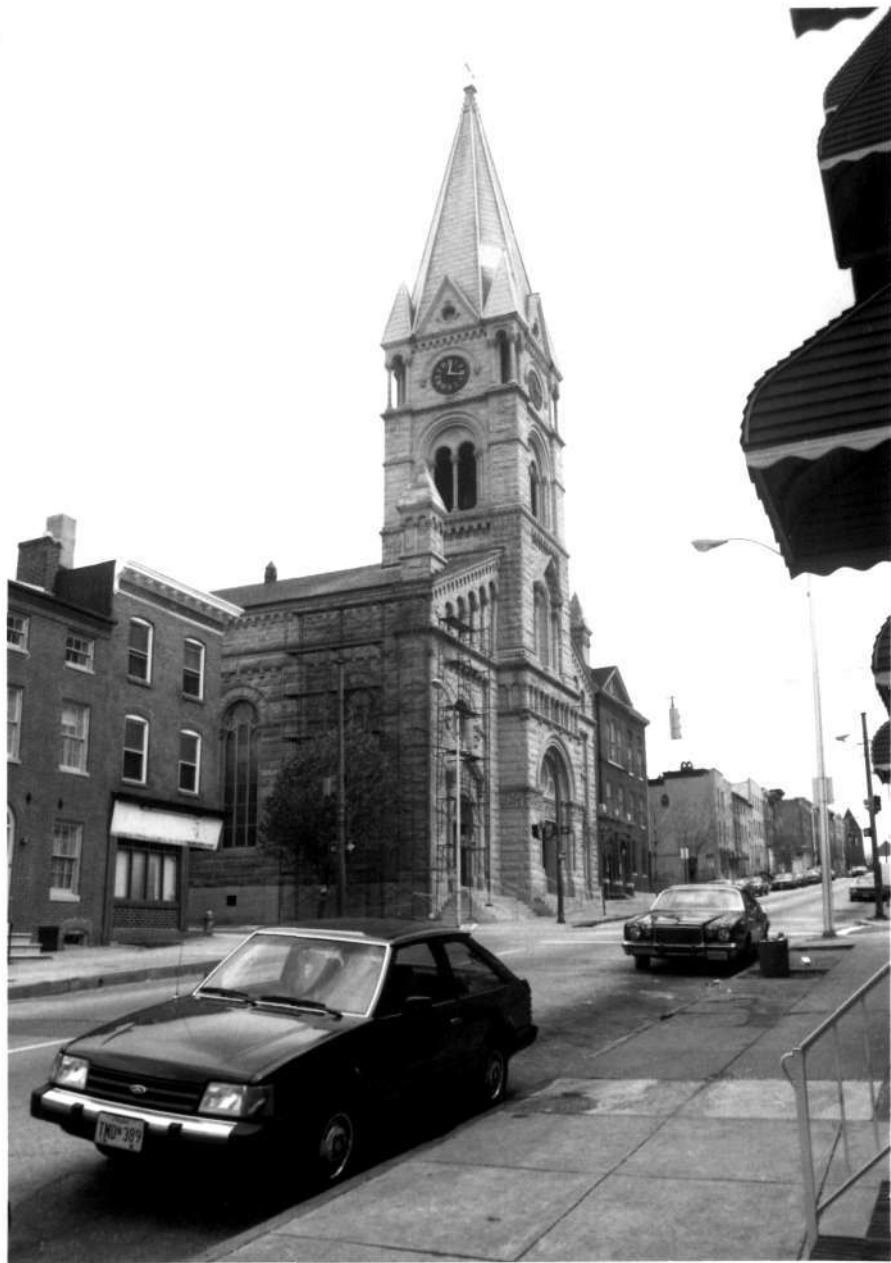
21/57

SW elevation - looking east

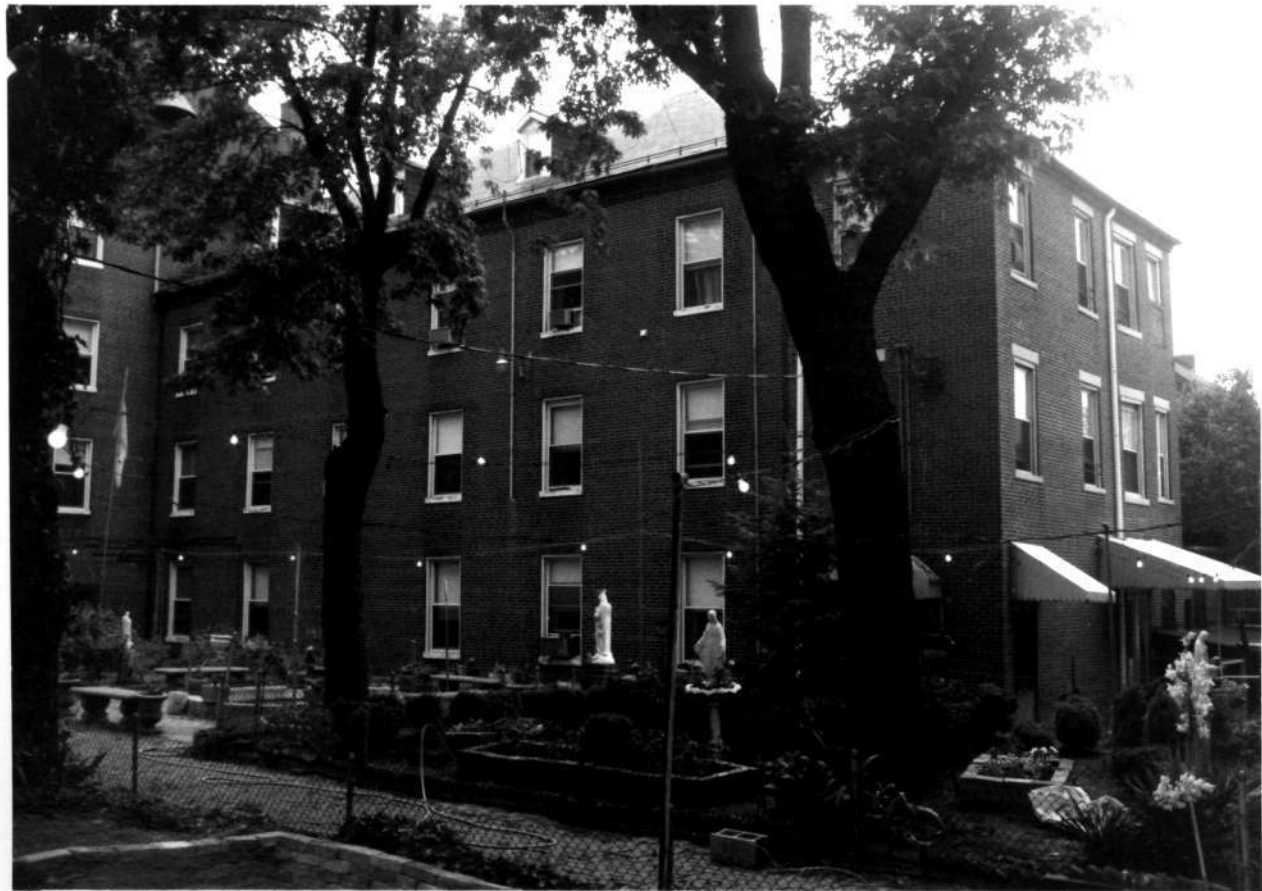
29/57

NE elevation

The east rear elevation is three and a half stories with a basement and measures seven bays wide with 1/1 white aluminum replacement windows with painted stone sills and flat brick arches above each window. The seventh bay at the northwest corner of this elevation is an early 20th century addition to the Rectory. The roofline of this bay is lower than the rest of the building and the windows of this bay are narrower with unpainted stone lintels and sills. Three small gabled dormers, the same as those at the front elevation line the roofline (Refer to Photo 29).

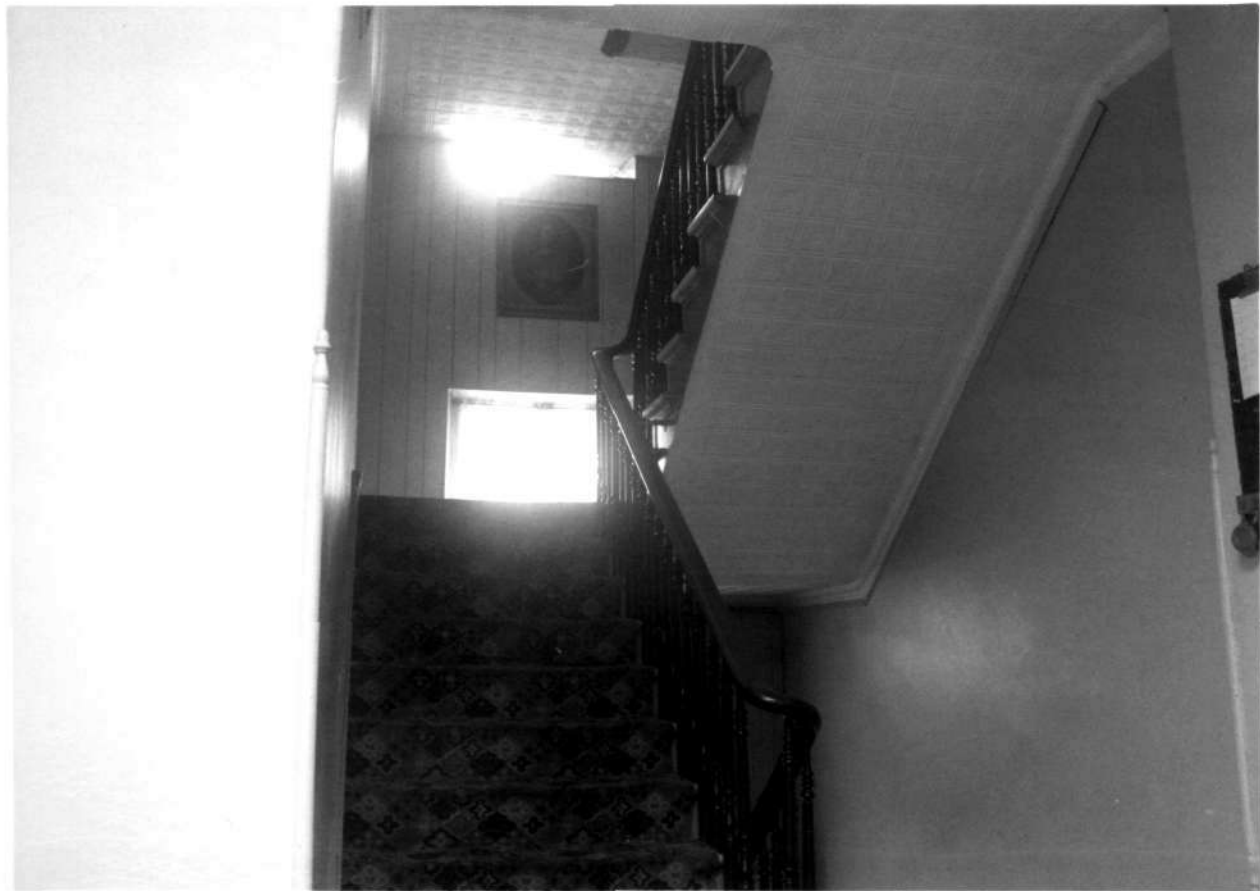
30/57

Typical stairway - view east

Improvements were made to the interior of the Rectory in 1898 when the parlors in the Rectory were altered to create a corridor for better access throughout the building including the interior connection to the church. The interior has experienced significant alterations such as wood paneling on the walls, dropped ceilings, carpeting and new contemporary doors. Some of the original tin ceilings and original woodwork can be seen in some of the rooms. Fortunately the integrity of this structure has not been significantly damaged due to the fact that most of the changes are reversible (Refer to Photos 30,31).
