HO-1165

Treakle Farm

Architectural Survey File

**MARYLAND HISTORICAL TRUST
DETERMINATION OF ELIGIBILITY FORM**

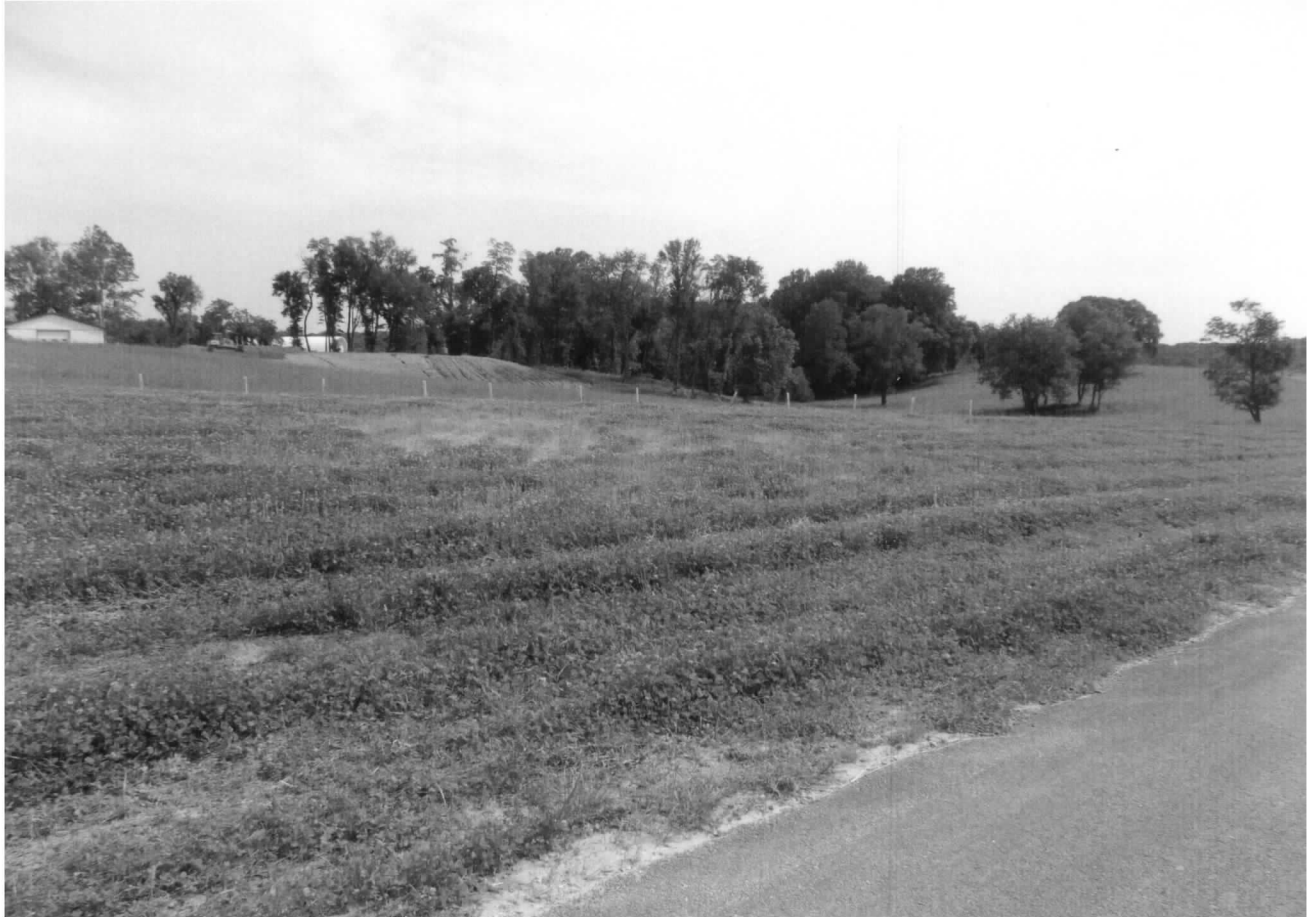
HO-1165-2018-06-11-01

ENTRY TO PROPERTY LOOKING EAST

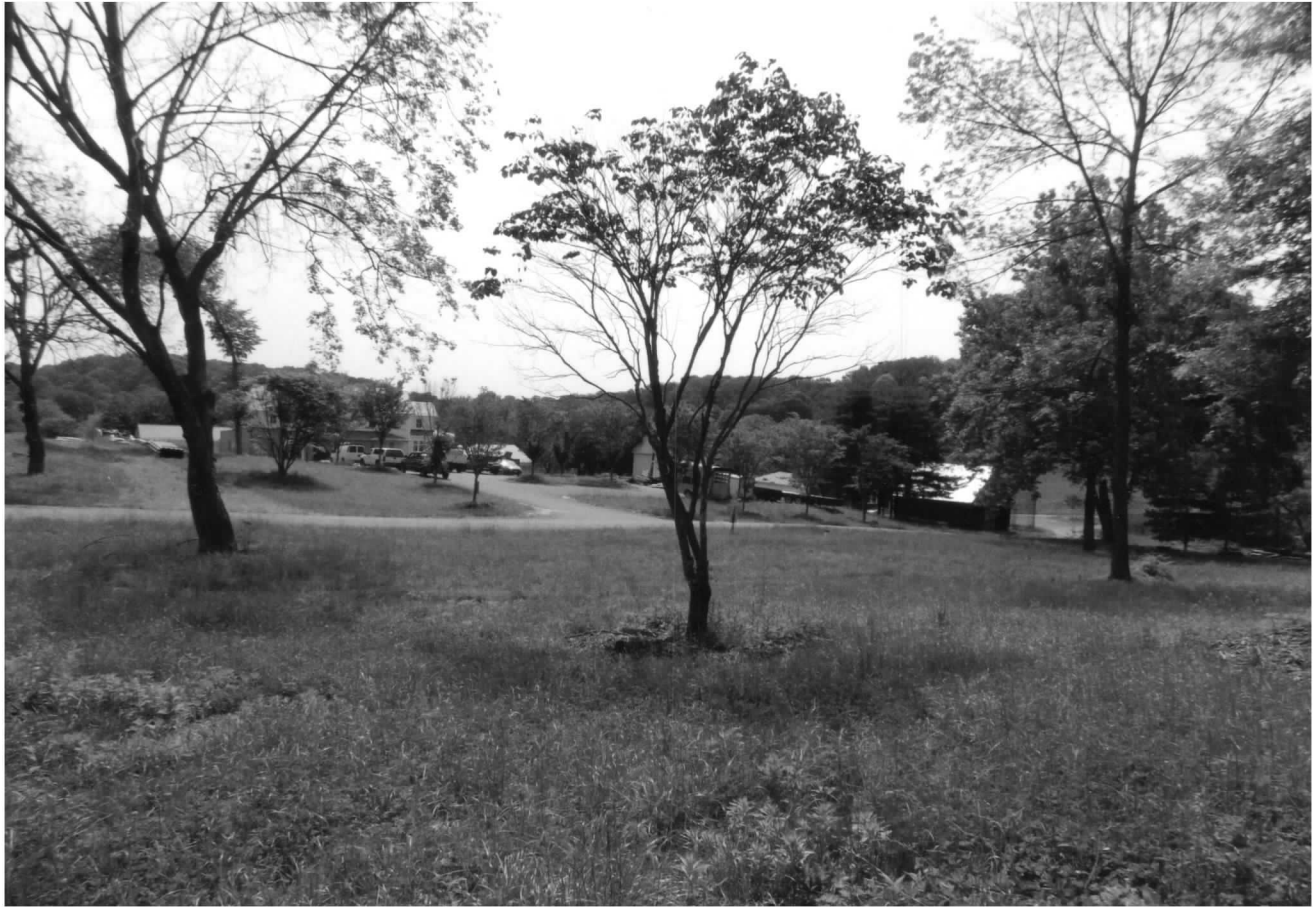
HO-1165-2018-06-11-02

Original 58' long x 24' deep 2-1/2 story roof house with basement is constructed of original 2x4 stud walls w/ diagonal board sheathing and wood joist floors w/ areas of original wood flooring. All framing is exposed to view during a renovation into a

BUILDING 1 LOOKING EAST

Although in the process of being renovated, the main house still retains integrity with its original massing, wood structure, workmanship, and main stair.

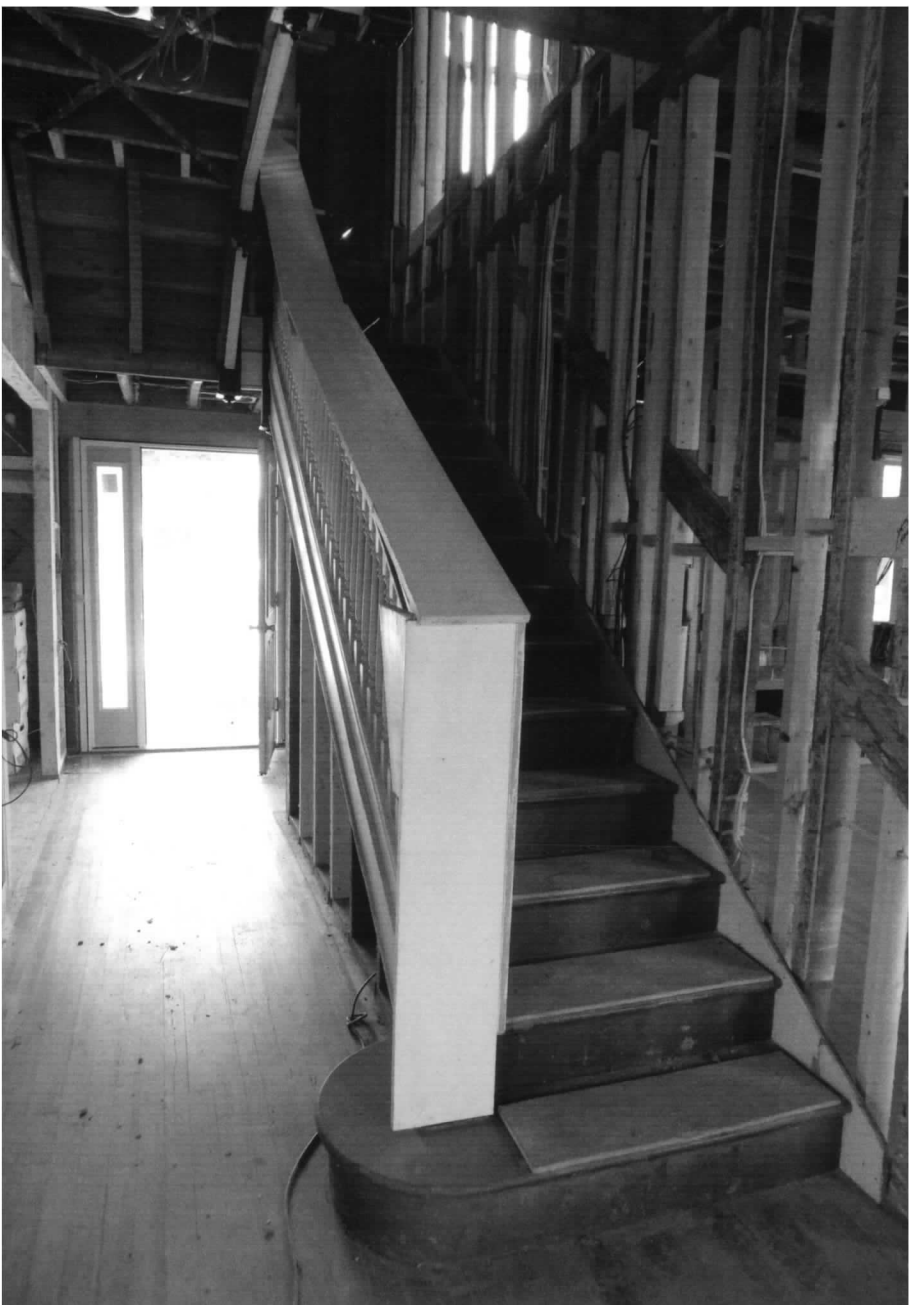
HO-1565-2018-06-11-14

BUILDING 1 - 1ST FLR STAIR HALL

original building are sensitively done. The new rear fieldstone foundation wall on the south is also in character. The subdivision of the first floor maintains the living and dining room spaces that flank the stair hall.

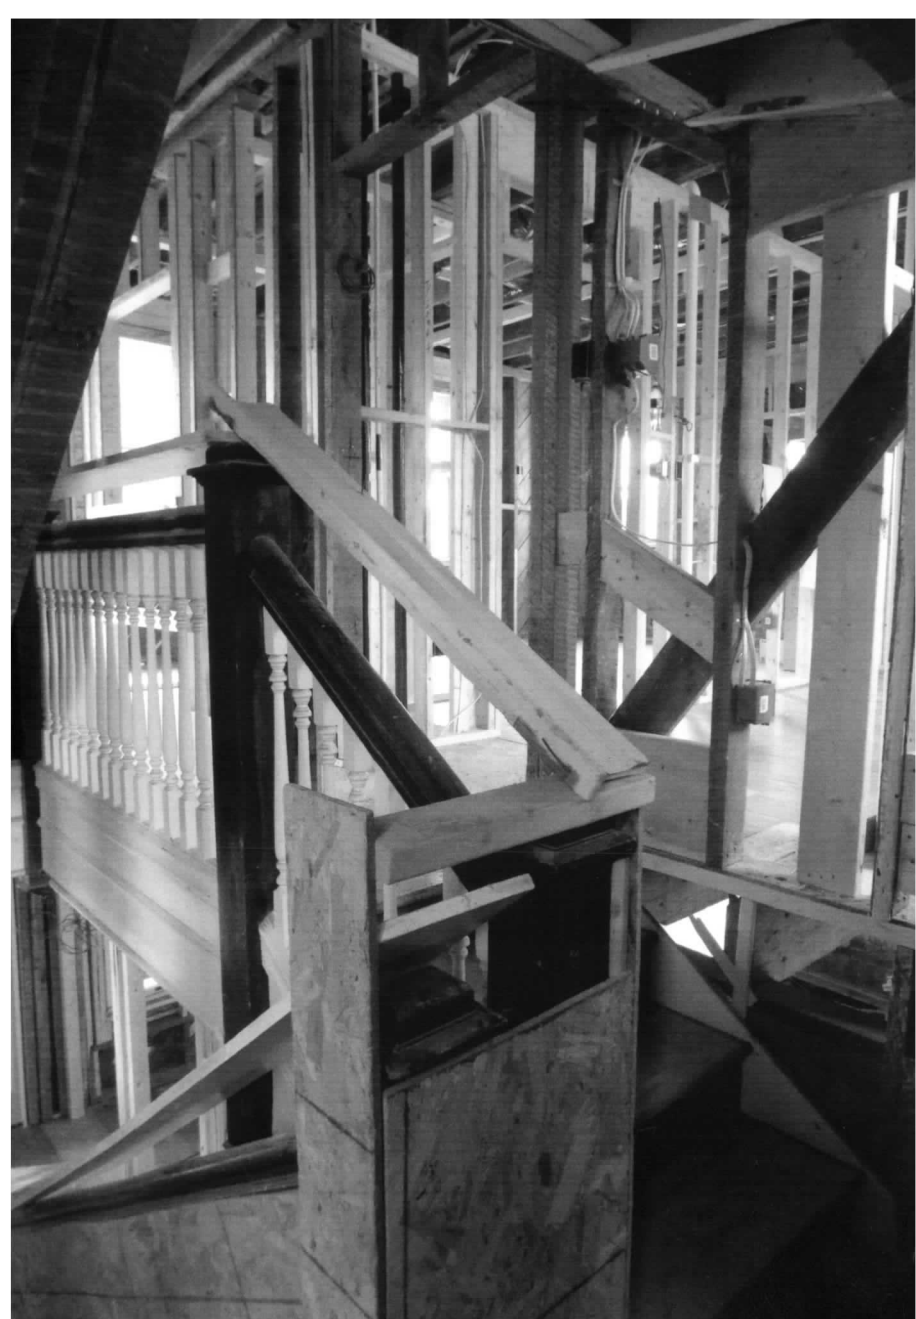
HO-1165-2018-06-11-27

BUILDING 1 - 2ND FLY STAIR

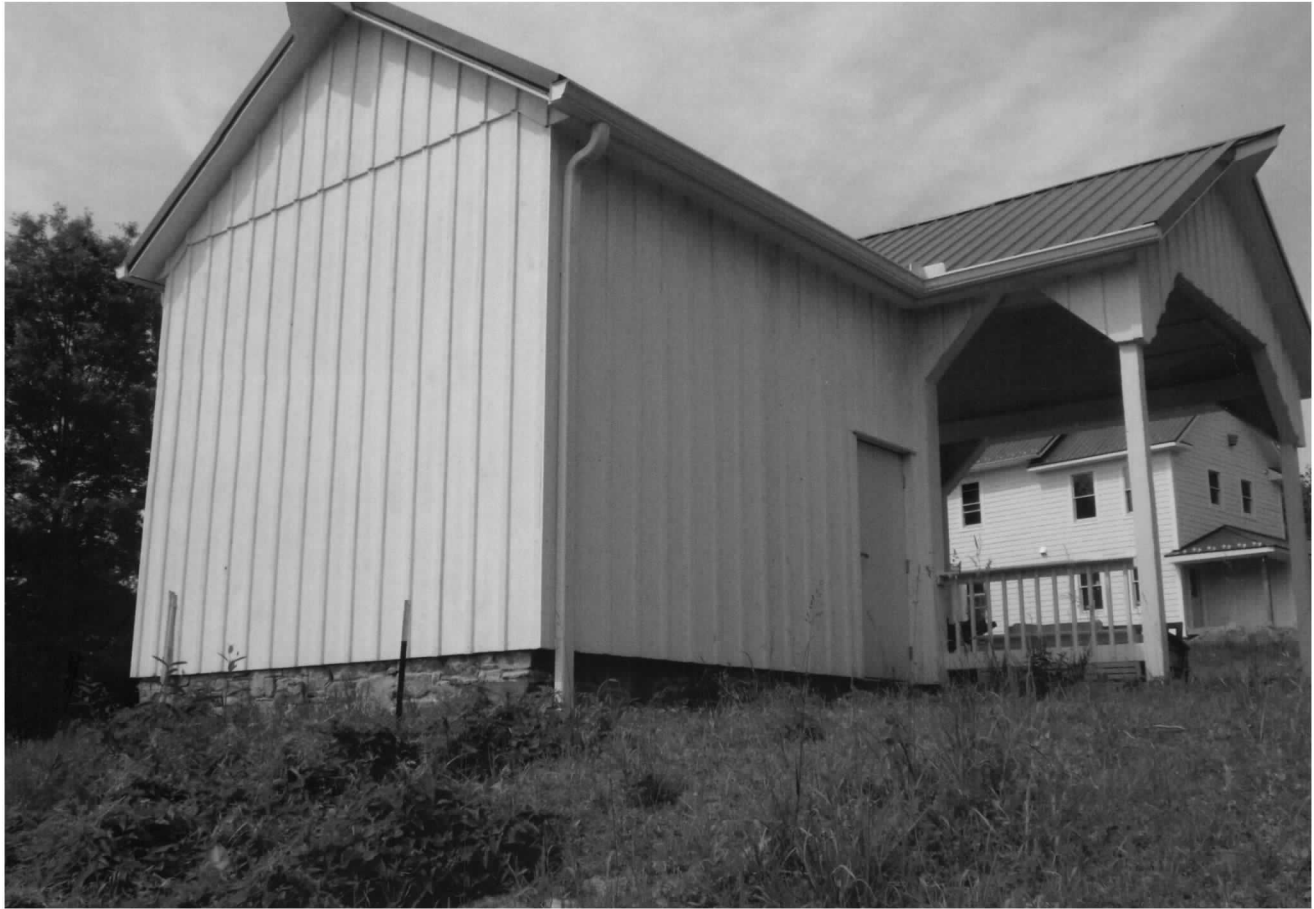
HO-1165-2018-06-11-18

Original ice house fieldstone foundation walls surrounding a 6' diameter, 12' deep hole for ice storage (no building remained on top of walls). Foundation walls were repaired leaving hole intact with new shed built on top of existing foundation walls with a gable roof clad with corrugated metal and walls clad in wood board and batten with a new gable roof extension covering an outdoor area. The interior of the shed has been clad with horizontal wood boards. Stone floor surrounding hole reconstructed with a wood floor infilling the diameter of the hole with a trap door to allow access down into ice hole.

BUILDING 2 - ICE HOUSE

Originally an ice house, the building has retained its integrity because of its stone foundation walls surrounding an original 12' deep ice hole showing its original function of preserving ice before the invention of mechanical refrigeration. The outline of the hole is visible in the interior and accessible through a trap door. The gable roof shed building built atop the original foundation walls is in character with what might have been originally there.

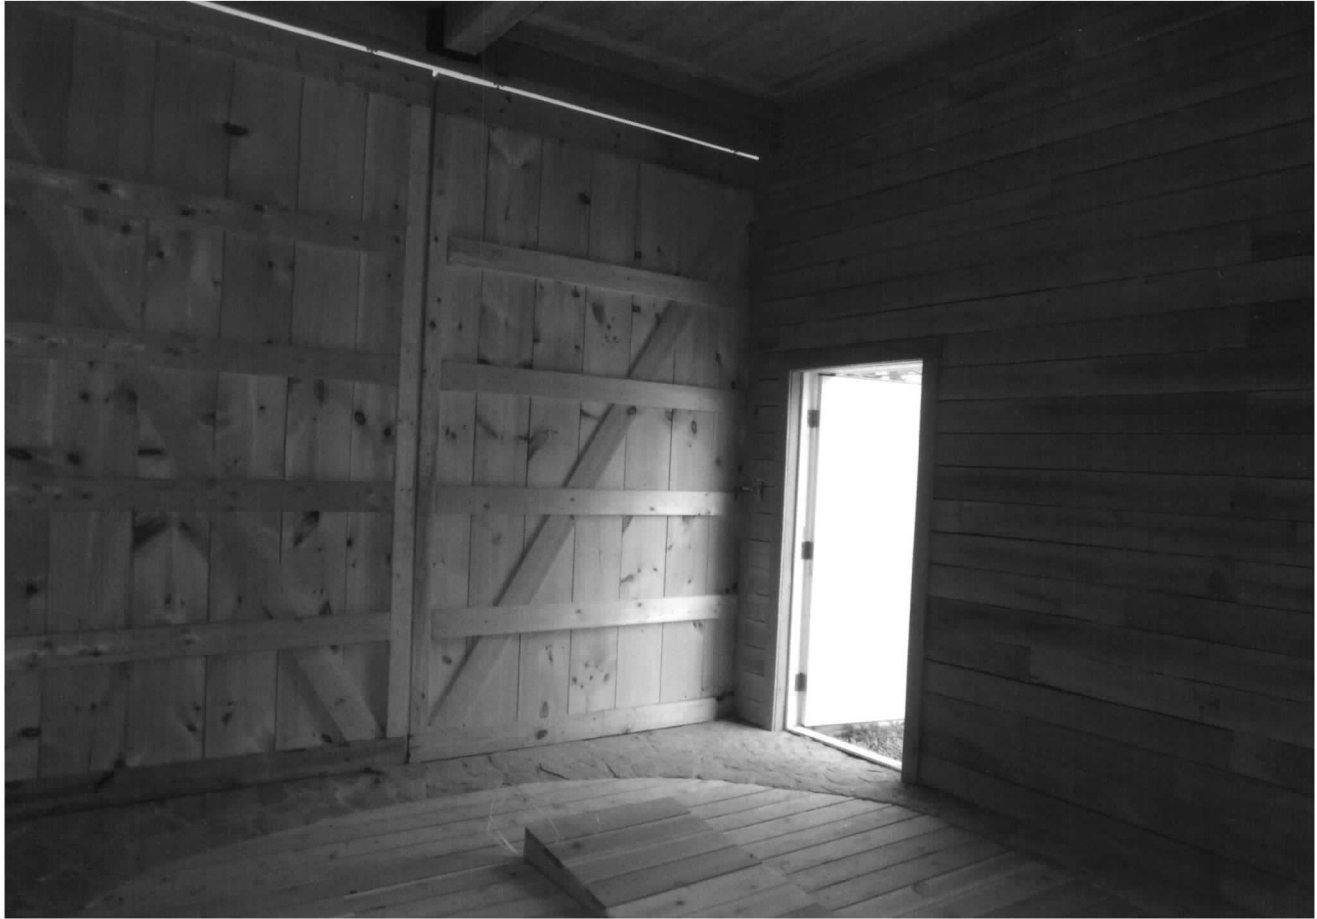
HO-1165-2018-06-11-49

BUILDING 2 - ICE HOLE

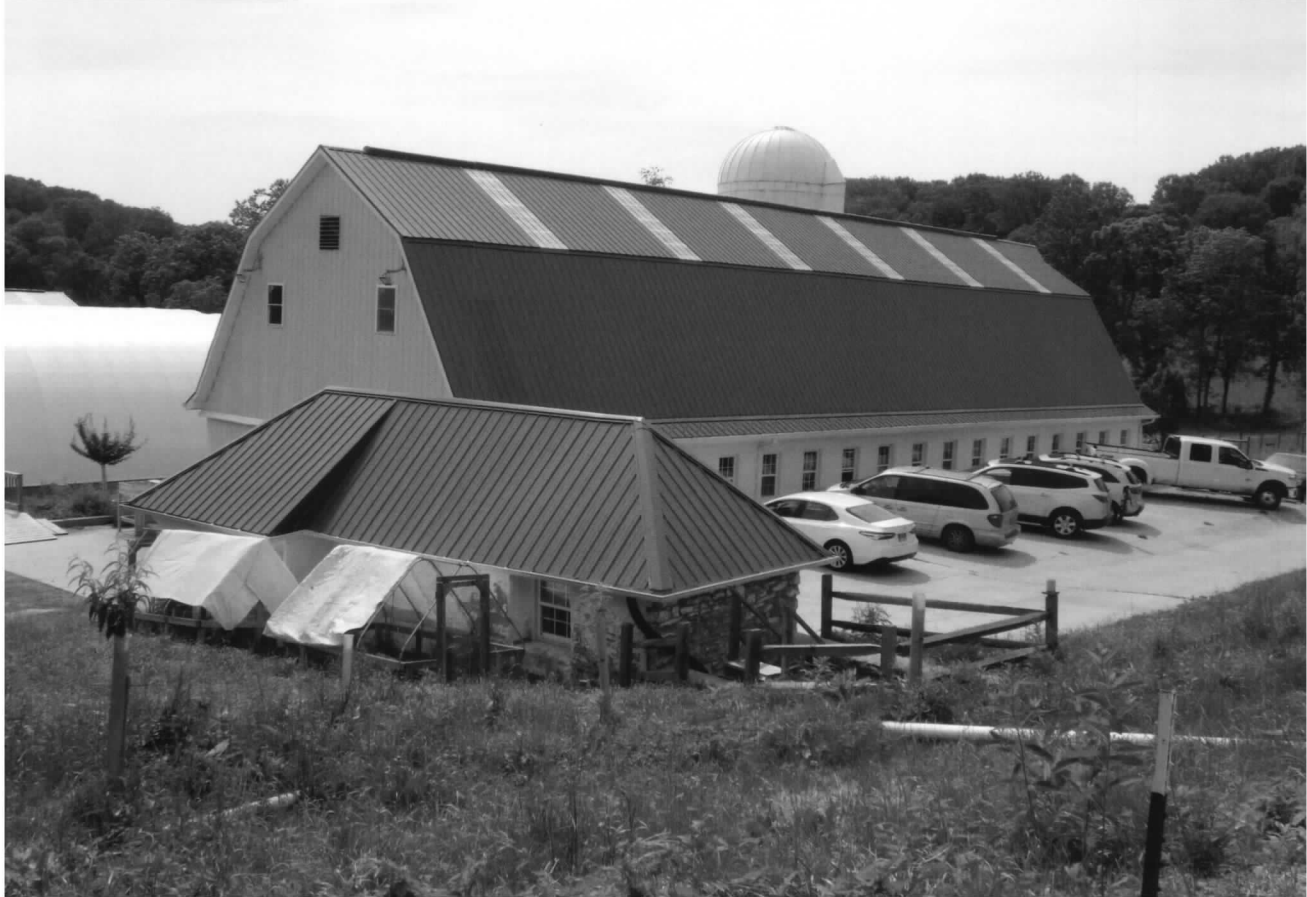
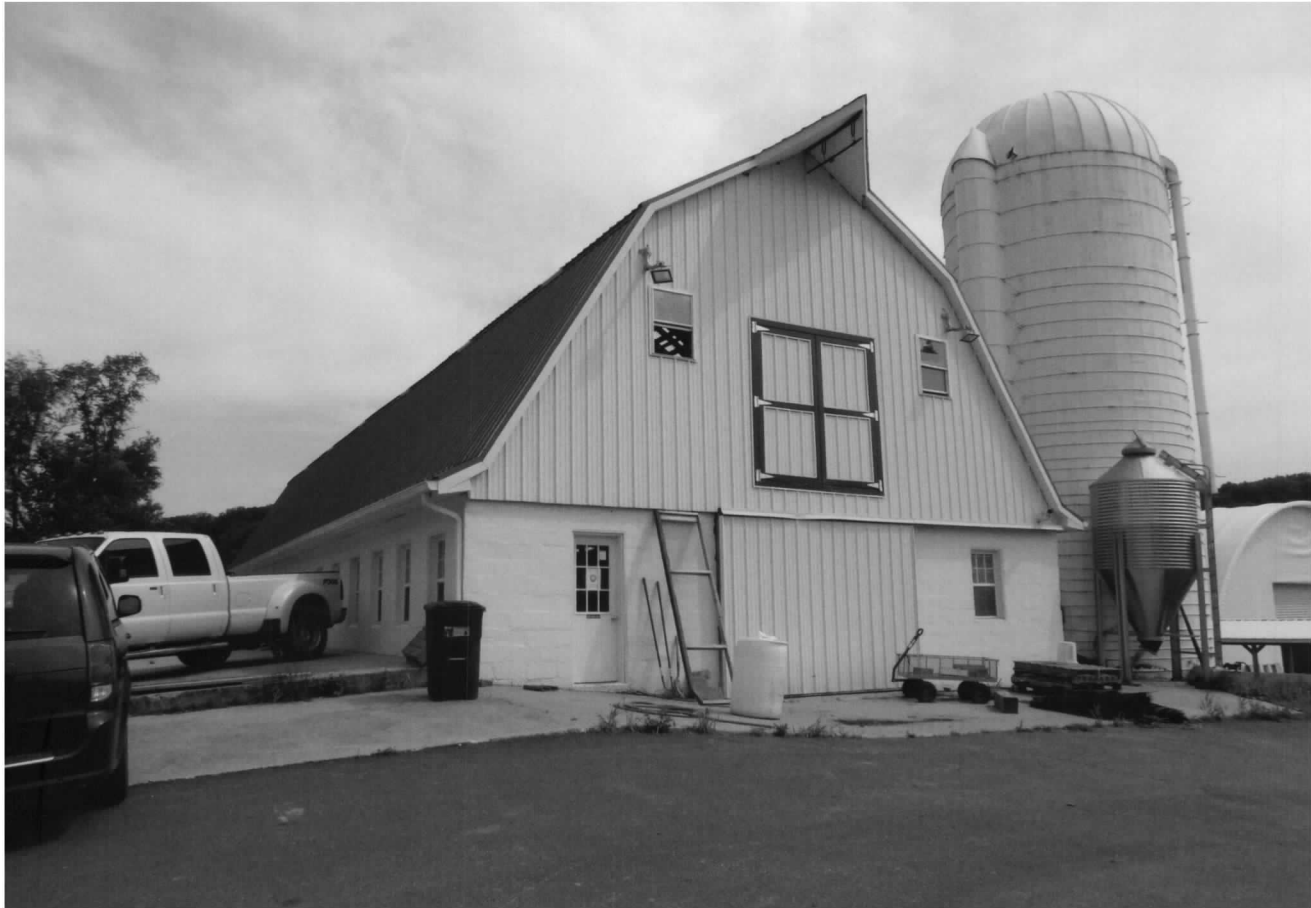
HO-1165-2018-06-11-52

A 1-story with loft barn structure constructed in 1950 of concrete block and wood floor and roof framing with a gambrel roof profile clad with a metal corrugated roof with plexi-glass skylight panels. Metal replacement double-hung windows are installed with sliding barn doors and a double loft door with a covered hoist on the south end of the building. The wall surfaces above the concrete block at the north and south gambrel roof ends are clad in metal corrugated panels. The silo at the southeast corner of the barn is constructed of metal framing with banded metal vertical paneling. The building has a concrete floor with a section of the 1st flr. for chicken breeding. The interior partitions are clad in horizontal board and the loft floors which are insulated are supported by wood beams and pipe columns.

BUILDING 3

Built in 1950, the gambrel roof barn constructed of concrete block and wood roof framing, re-clad in metal board & batten siding with metal silo has retained its integrity for a 68-year-old structure. It is a contributing structure to the farm complex because it is an example of the evolving physical development of the farm's historic function.

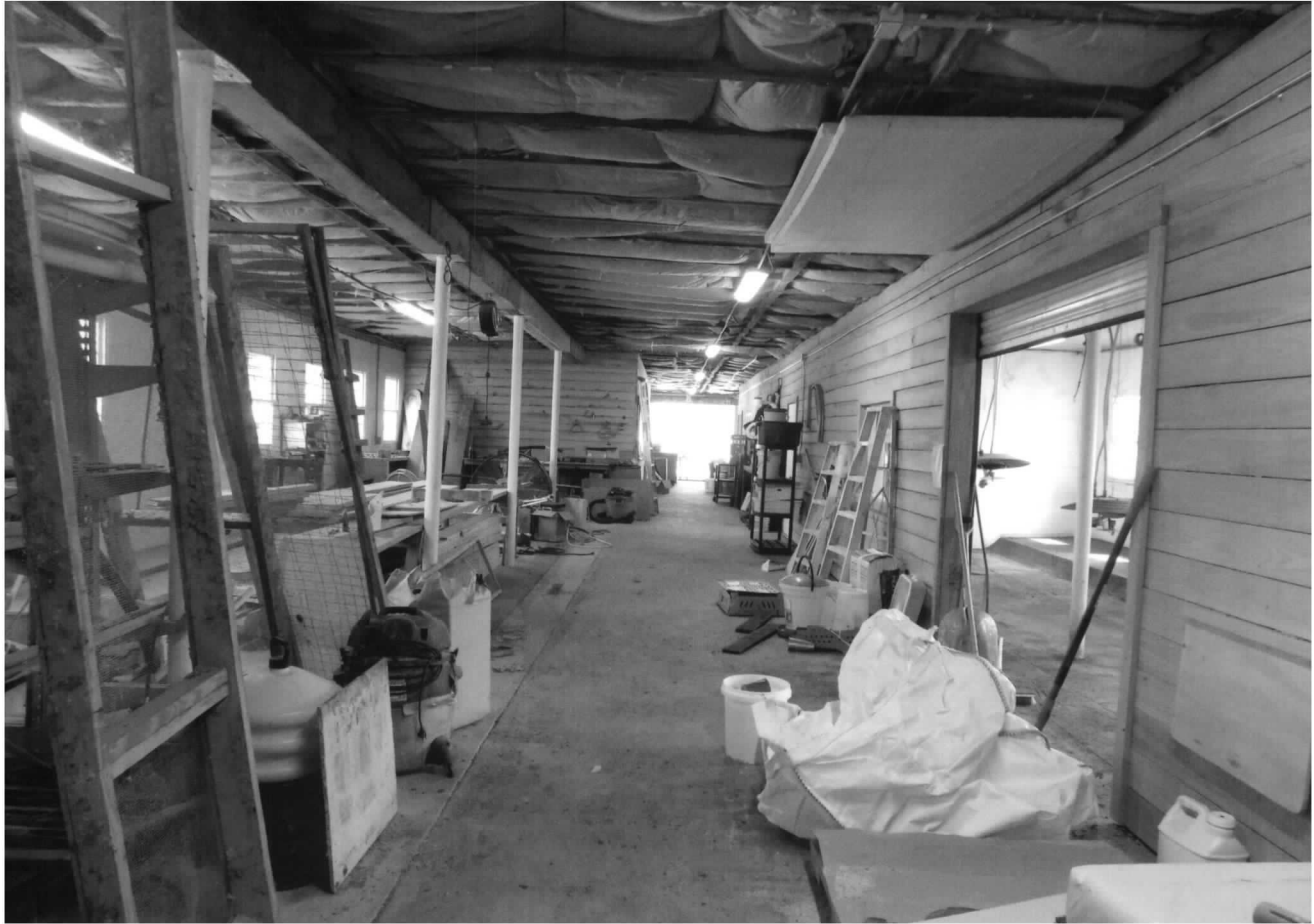
HO-1165-2018-06-11-5f

BUILDING 3 - TYP. INTERIOR

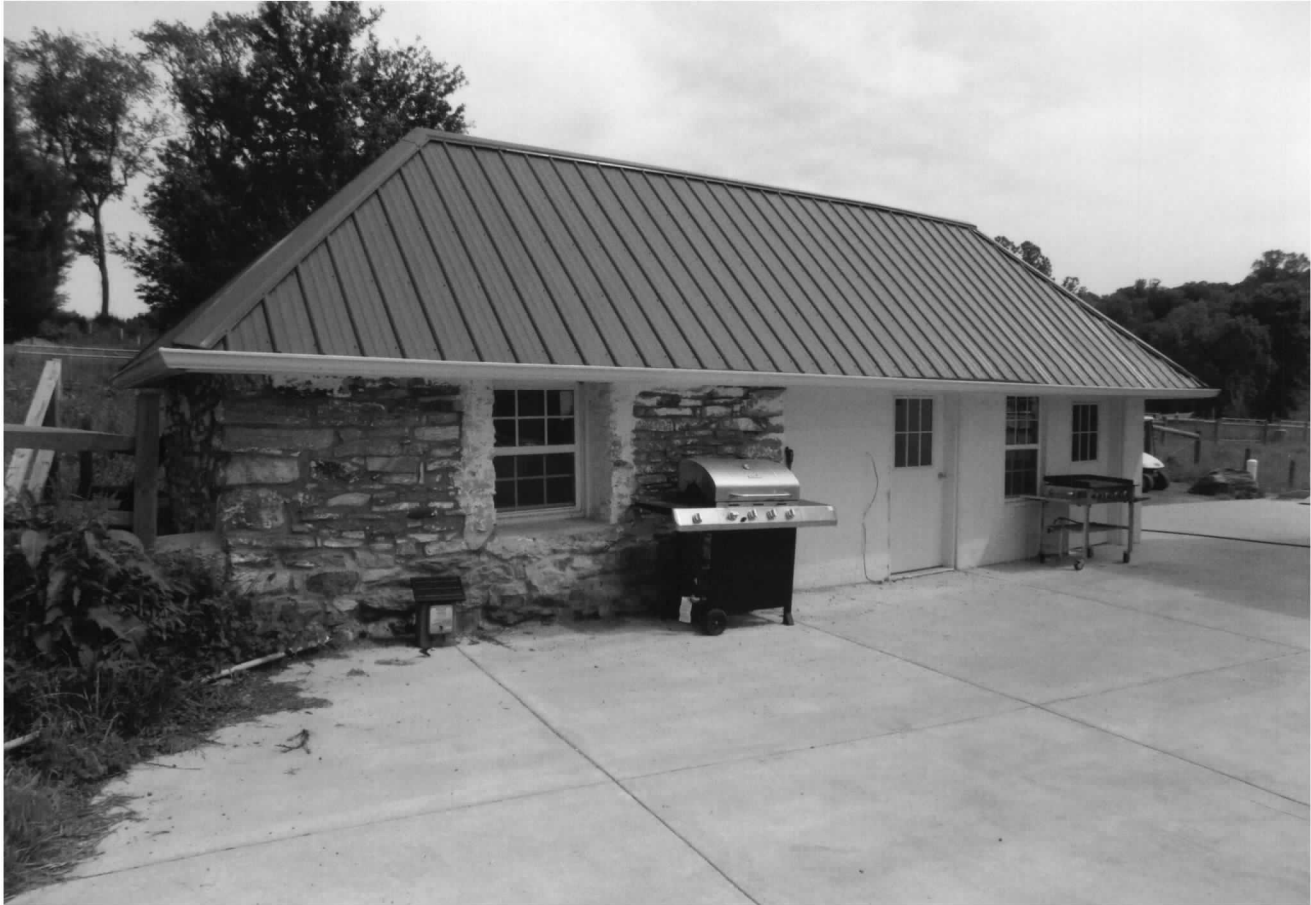
HO-1165-2018-06-11-59

Original 1-story spring house with active spring flow near northwest corner of barn with original fieldstone walls with metal replacement double hung windows. Original exposed roof framing with hipped roof clad in corrugated metal. One-story concrete block addition with metal replacement windows and half-lite metal door at east end of building extending hipped roof profile. Interior of stone walls have been parged and painted. The floor is concrete.

BUILDING 6 - SPRINGHOUSE

Original springhouse with active spring and concrete block extension has retained its integrity because of its original masonry structure, roof structure and roof profile. It also retains its original function for collecting and protecting spring water from leaves, debris and animals.

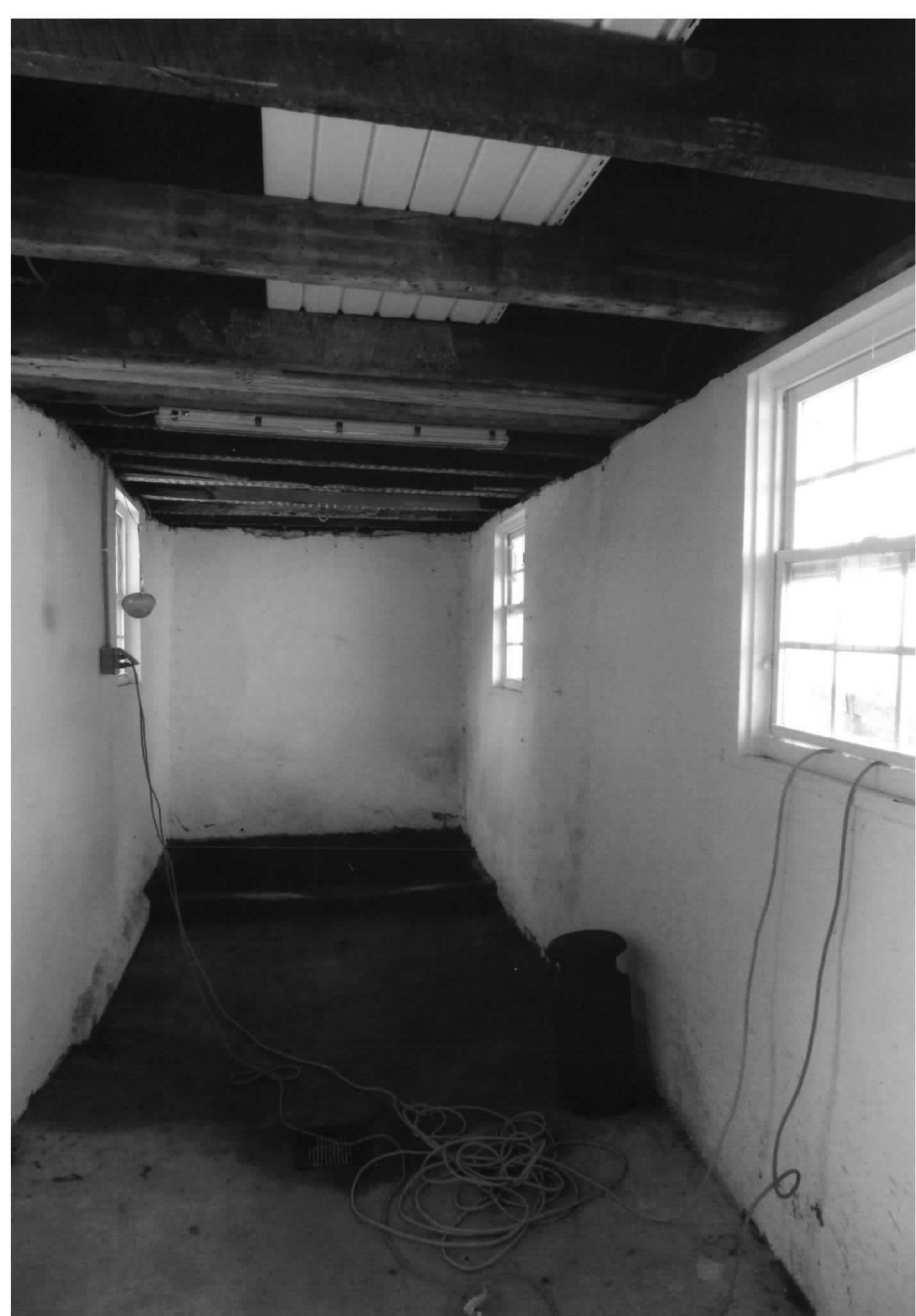
Ho-1165-2018-06-11-21

BUILDING 6 - TRF. ING W/ SPRING POOL

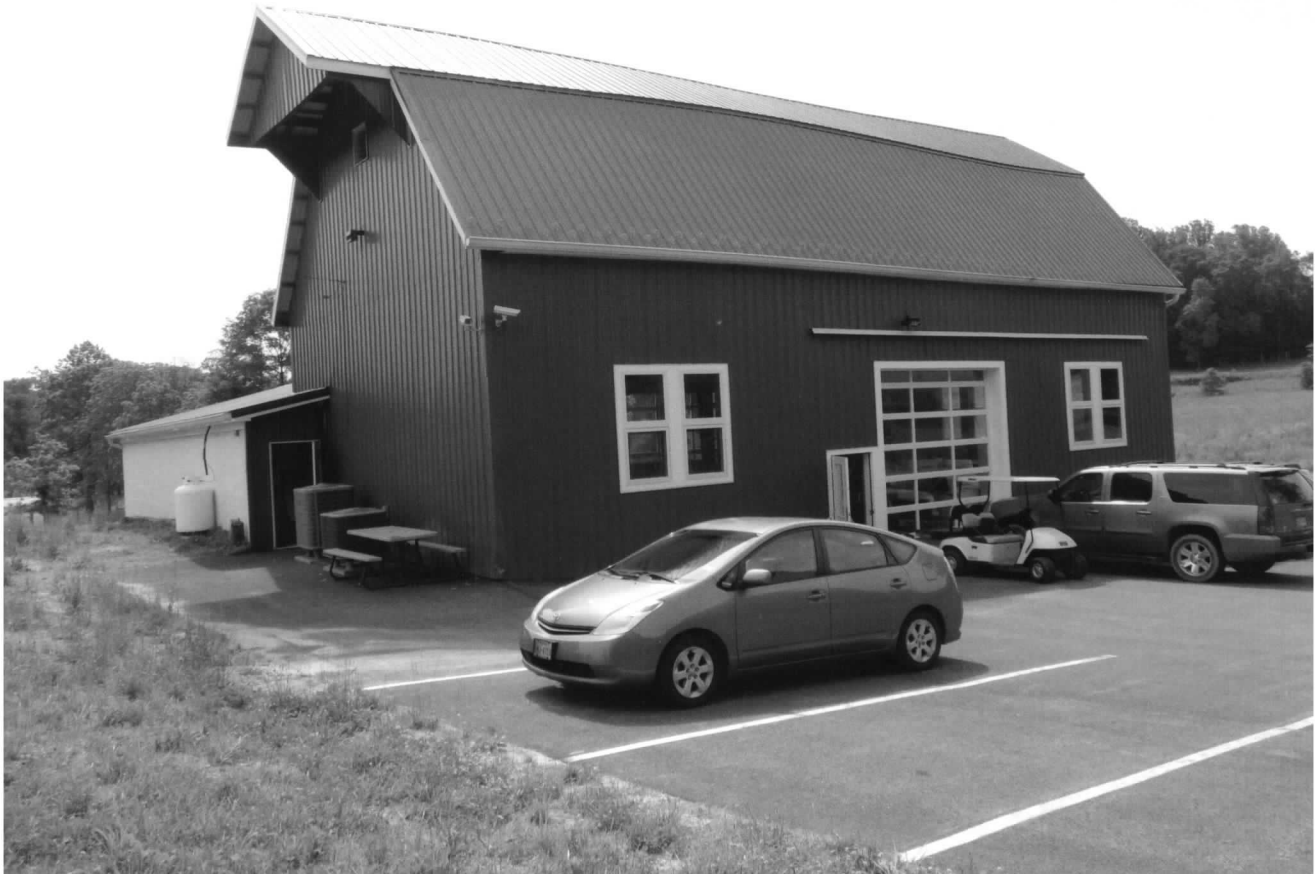
HO-1165-2018-06-11-68;

Original gambrel roof profile barn with original exposed structure with new concrete floor, interior of exterior walls and ceiling clad in horizontal wood boards and non-original awning windows and 2 glazed overhead garage doors. Exterior of building clad in board & batten pattern metal siding with gambrel roof and covered hoist clad with a metal corrugated roof. There is a concrete block addition with wide openings perpendicular to barn at north east corner with an offset gable profile clad with a metal corrugated roof and skylights and gable end metal siding.

BUILDING 7

Although altered, the original barn with addition has retained its integrity with its original, massing, roof profile, hoist roof extension, and heavy timber structure with mortise & tenon connections. Re-cladding of board & batten pattern metal siding, standing seam metal roof, interior board finish, and poured concrete floor are in character with the building. Although the loft was removed, the barn retains a sense of its original interior space. New window and garage door openings are not in character but are an example of evolving development of farm as an education center & store.

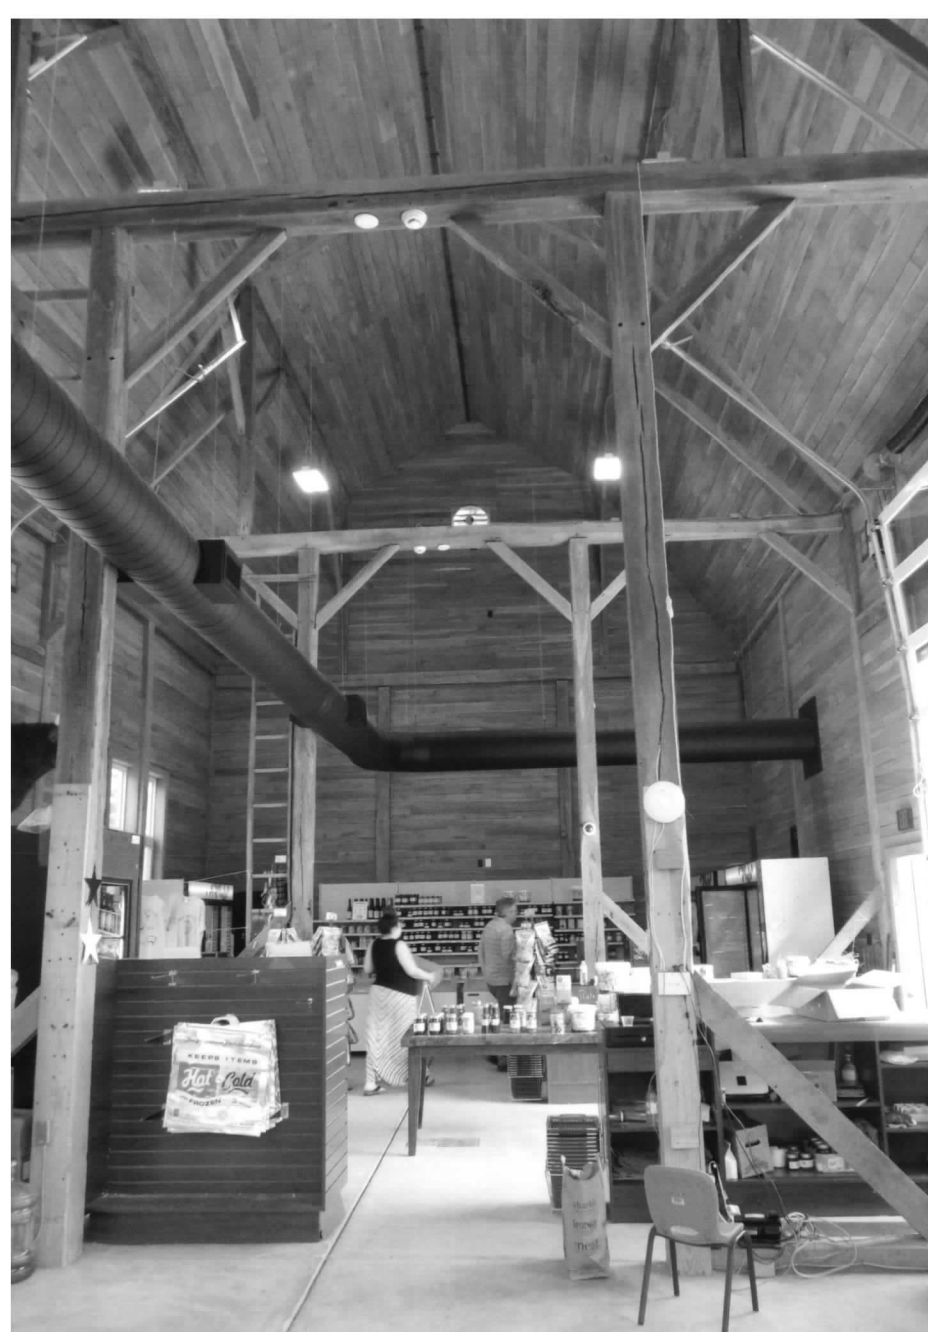
HO-1165-2018-06-11-71

BUILDING 7 - TYP. INTERIOR

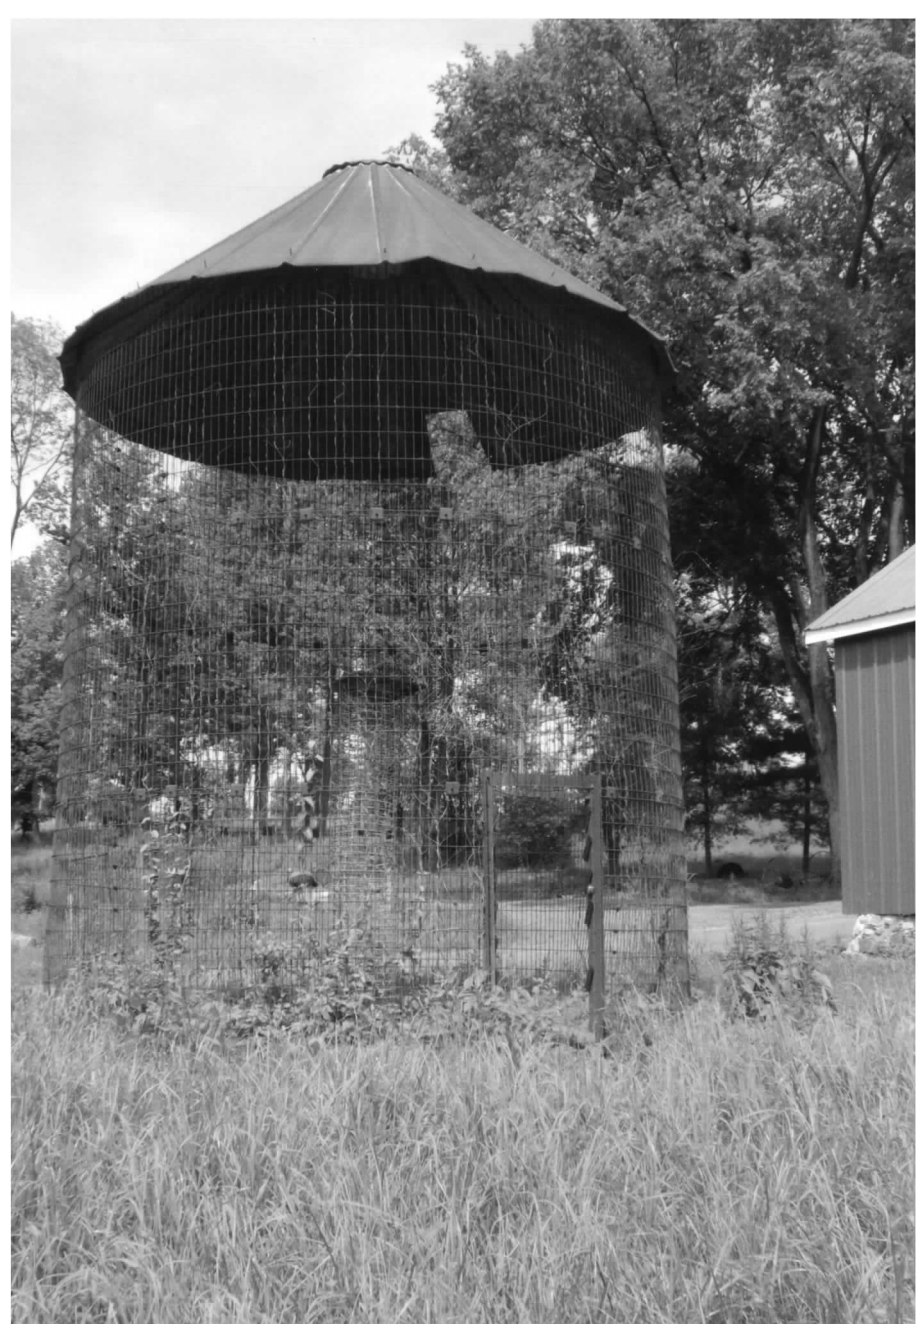
Ho-1165-2018-06-11-77

Original metal wire corn crib with metal domical roof in fair condition.

BUILDING 8 - CORN CRIB

Original metal corn crib has retained its integrity because it is completely intact showing its original storage function.

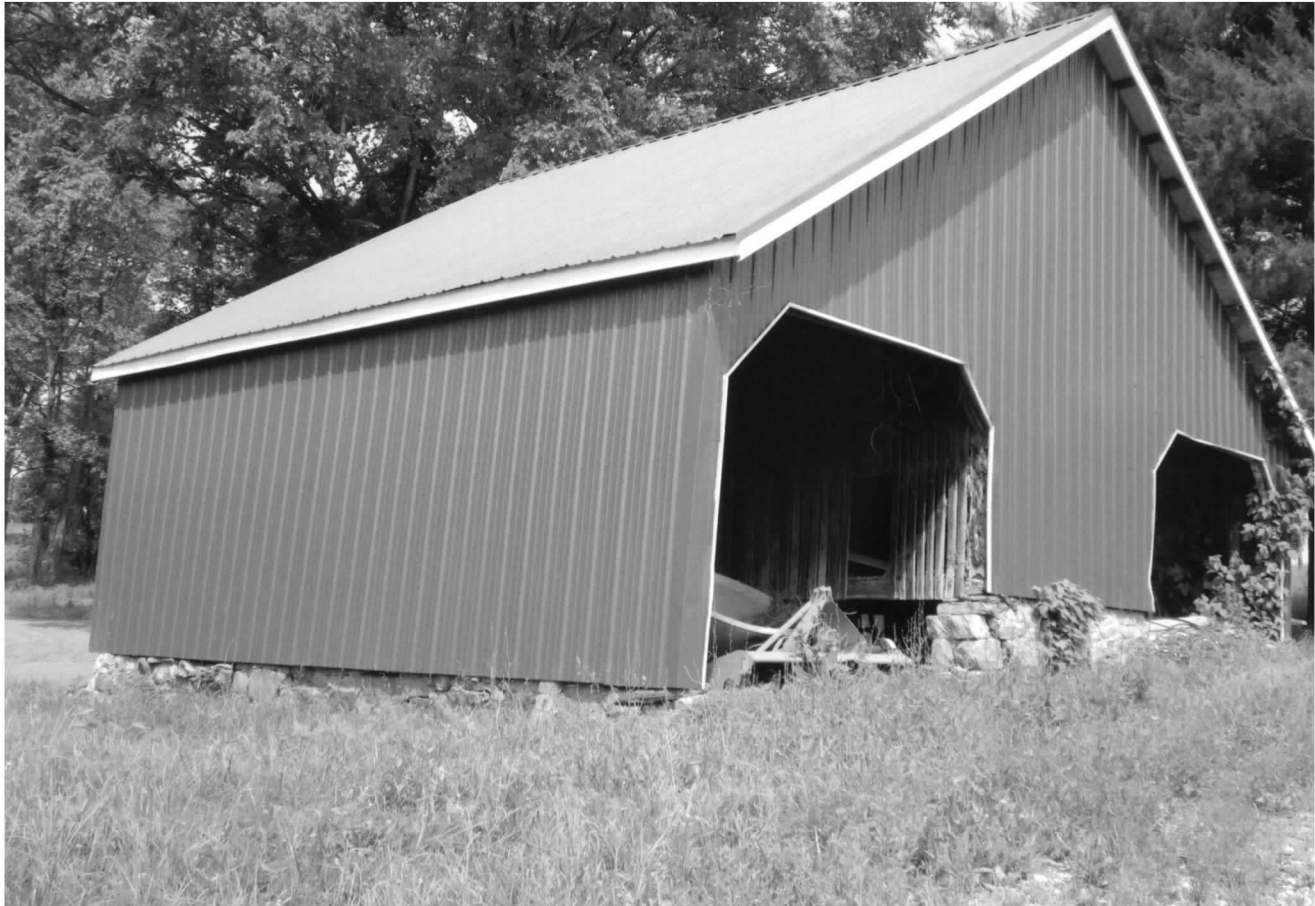
HO-1165-2018-06-11-78

Original 2-bay farm implement shed with loft, original stone foundation walls, dirt floor, exposed heavy timber wall and roof framing. Gable roof is clad in corrugated metal with original exterior board sheathing clad in board & batten pattern metal siding. Bays remain intact with raised enclosed storage space between them.

BUILDING 9- FARM IMPLEMENT SHED

Original 2-bay farm implement shed has retained its integrity with its original massing, bays, roof profile, wood structure, rough board cladding and fieldstone foundation walls. Re-cladding with metal board & batten pattern siding and standing seam metal roof are in character with the structure.

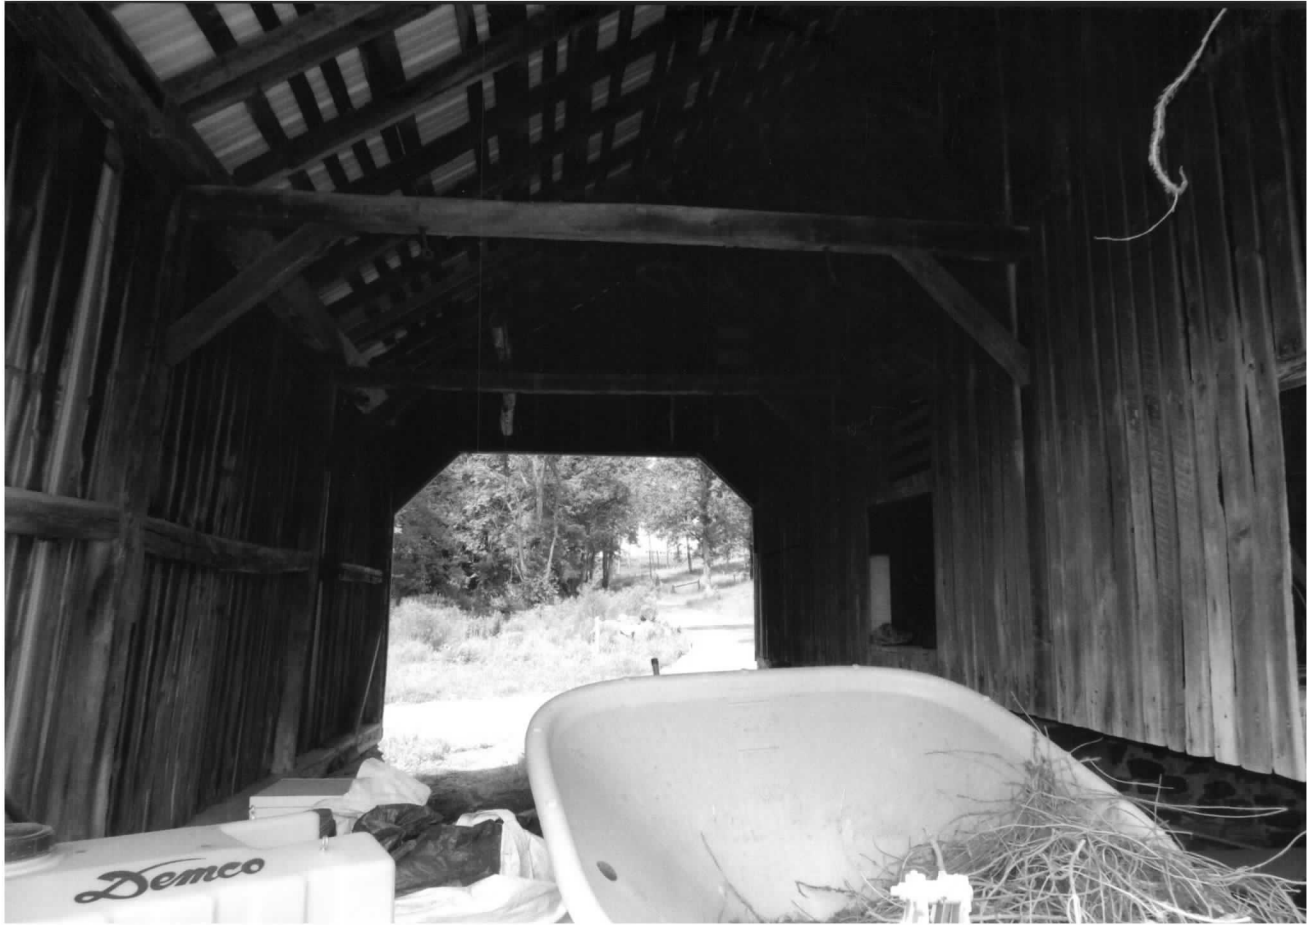
^{MHT}
HO-1165-2018-06-11-84

BUILDING 9 - TRP. BAY

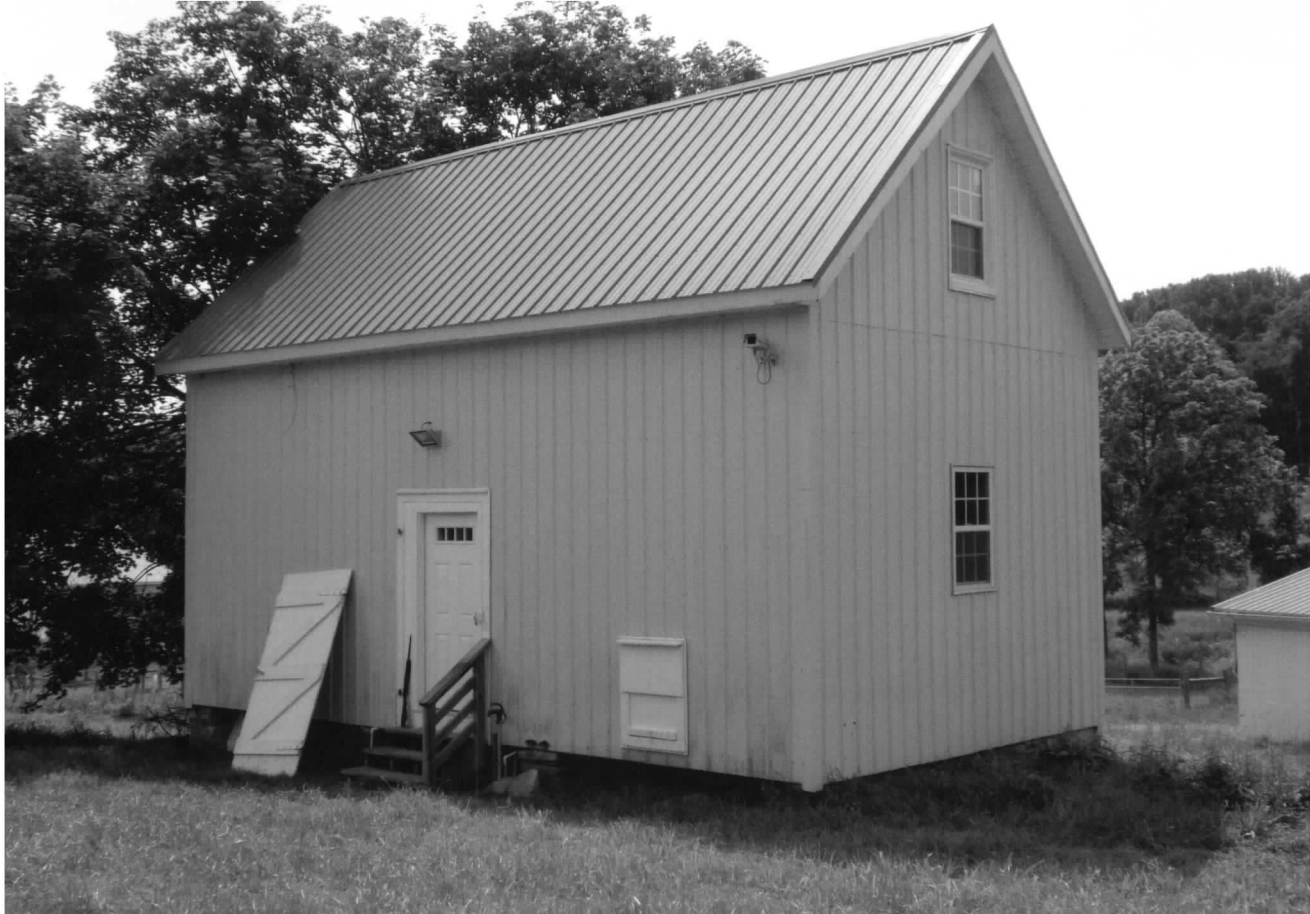
HO-1165-2018-06-11-88

Original 1-story with attic storage structure with original fieldstone foundation piers, exposed heavy timber floor and roof framing converted to bunk house for farm hands. Gable roof is clad in corrugated metal with exterior clad in board & batten pattern metal siding. New metal double hung metal windows have been installed. Interior of exterior walls and attic ceiling is clad with wood boards. A non-original wood stair accesses the attic level where the original wood flooring remains.

BUILDING 10

Original gable roof shed has retained its integrity with its original massing, roof profile, most of its original wood structure, and fieldstone piers. Re-cladding with wood board & batten pattern siding, corrugated metal roof, and interior board finish is in character with the structure.
