HO-1165

Treakle Farm

Architectural Survey File

**MARYLAND HISTORICAL TRUST
DETERMINATION OF ELIGIBILITY FORM**

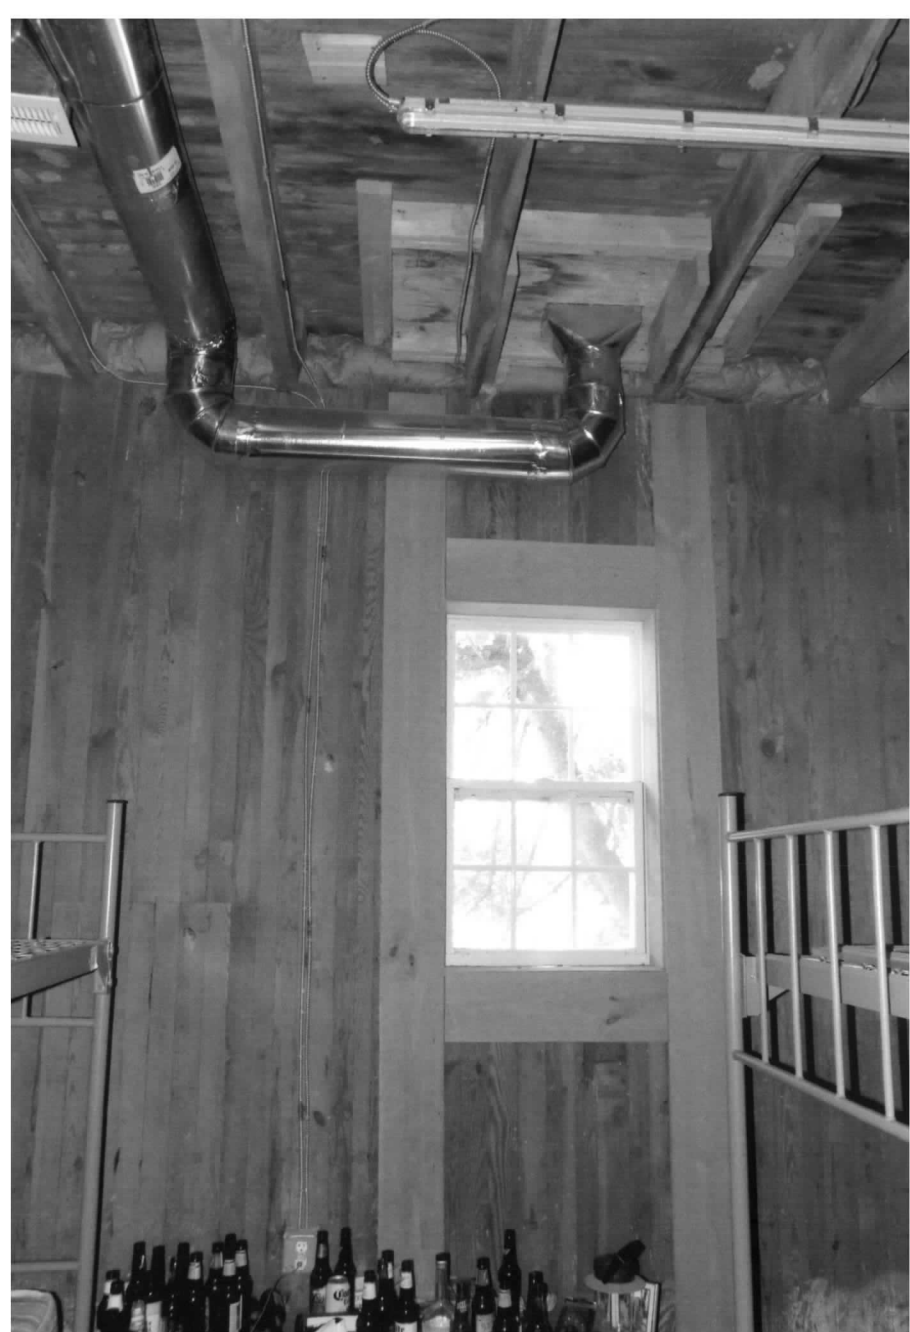
Ho-1165-2018-06-15-92

Original 1-story with attic storage structure with original fieldstone foundation piers, exposed heavy timber floor and roof framing converted to bunk house for farm hands. Gable roof is clad in corrugated metal with exterior clad in board & batten pattern metal siding. New metal double hung metal windows have been installed. Interior of exterior walls and attic ceiling is clad with wood boards. A non-original wood stair accesses the attic level where the original wood flooring remains.

BUILDING 10 - TYP. INT.

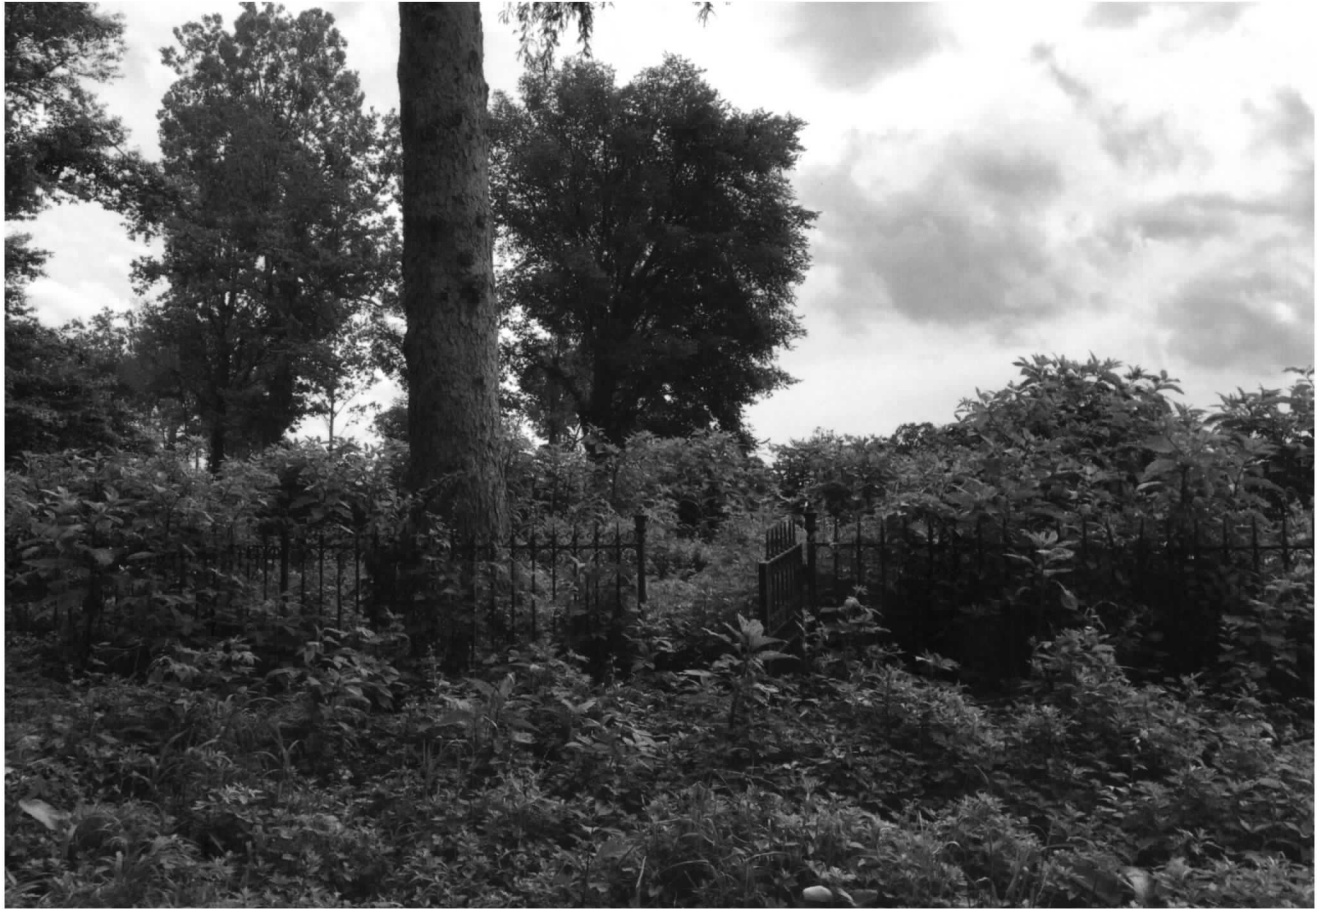
HO-1165-2018-06-11-101

Treacle family graveyard located approx. 500' from west elevation of Building 1. An ornamental wrought iron fence with gate encloses the graveyard that contains seven granite obelisk tombstones bearing the names of:

The tombstones are weathered and leaning but in good condition. The graveyard is overrun with vegetation.

TREXLE FAMILY GRAVEYARD

The Treacle family graveyard has retained its integrity because it is an intact example of a family graveyard from the 19th century with granite tombstones and ornamental wrought iron picket fencing that were frequently found on farms.
