HO-551

## Oakland Manor Washhouse and Icehouse (The Eye of the Camel, Rose Price Cottage)

### **Architectural Survey File**

'Oakland Manor' Washhouse and Icehouse ('Eye of the Camel'; Rose Price Cottage)  
5432 Vantage Point Road  
Columbia

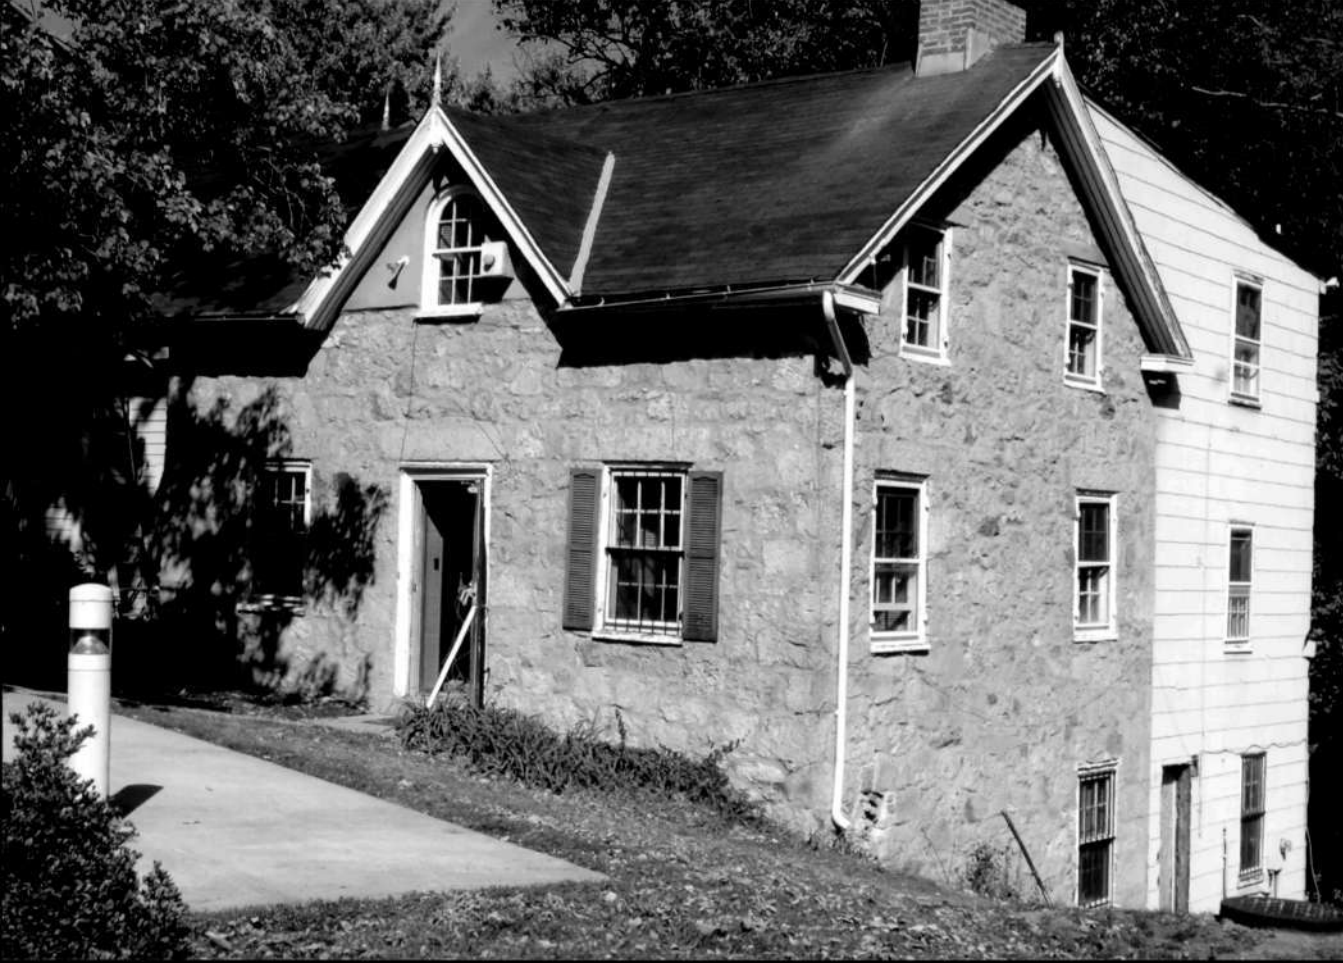
1/4

The west elevation has a new door in the center bay with a cut stone sill and lintel. The door has a beaded-interior-edge frame. To either side is a six-over-six sash with a beaded frame with a wood sill and a cut stone lintel. The cross gable is parged and has a round-arched six-over-six sash with a wood sill. There is a wood box cornice with returns, and the soffit of the cornice has three slats with gaps between them. The south elevation foundation has a six-over-six sash in the east bay with a plain frame and a wood sill. The first story has two six-over-six sash with wood sills, beaded frames, and cut stone lintels. The gable end has two six-over-six sash with wood sills and parged lintels. The sills are set below the eave line. There is a wood finial at the ridge with a drop pendant, and the top of this is broken off. The north end of the ridge also has a drop pendant. On the south elevation of the addition, the foundation has a boarded-up door and a six-over-six sash in a plain frame to the east. Both the first and second stories have a six-over-six sash in a plain frame in the center. The east elevation of the addition has German siding on the basement and first story and raw wood sheathing on the upper story. There is a boarded-up window opening in the south bay of both the first and upper stories, with no other openings. The north bay of the stone building has a boarded-up opening in the foundation and the first story.

Washhouse, west + south elevations

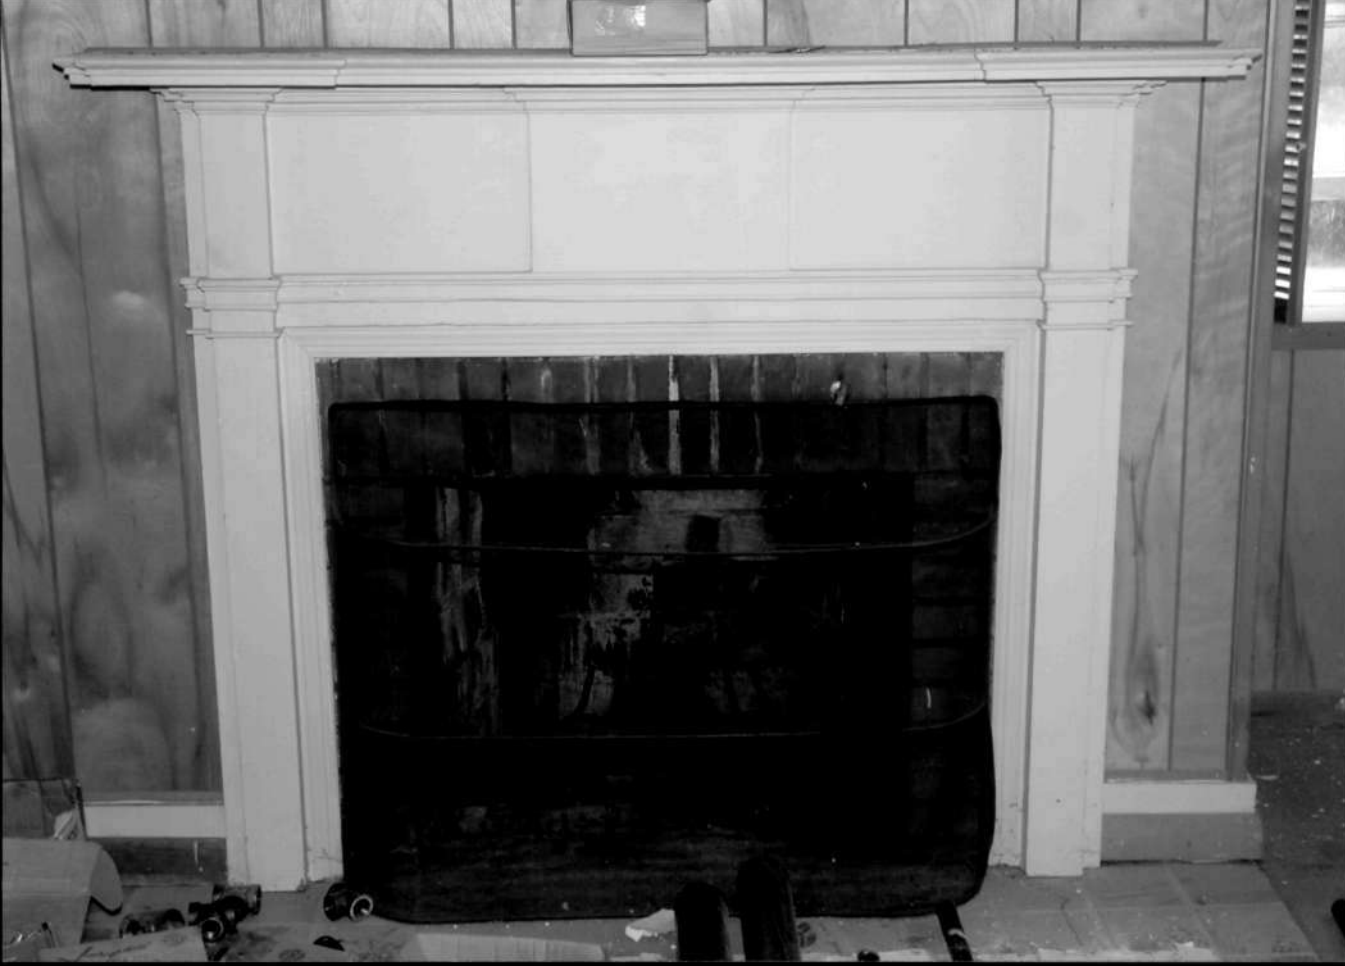
2/4

The interior of the washhouse has one room in the stone section on the first story, with carpeting, paneling, and drywall on the ceiling over top of some sawn lath. The attic joists are sash sawn and run east-west, and the flooring above them is also sash sawn. The south elevation has a fireplace with a firebrick firebox, a tile hearth, and a modern brick surround. There is a wood mantel that has plain pilasters and plain raised impost blocks. The bed mould has a bead at the top, a quirked Greek ogee with a lip to it, and a cavetto below it that is very similar to the attic baseboard. The mantel shelf is squared off above the imposts and is bowed between the imposts. The edge of the shelf has a Greek ovolo and bead. This mantel was probably reused from somewhere within the house. The frame addition has modern partitions and a stairway to the basement.

Washhouse, mantel  
1

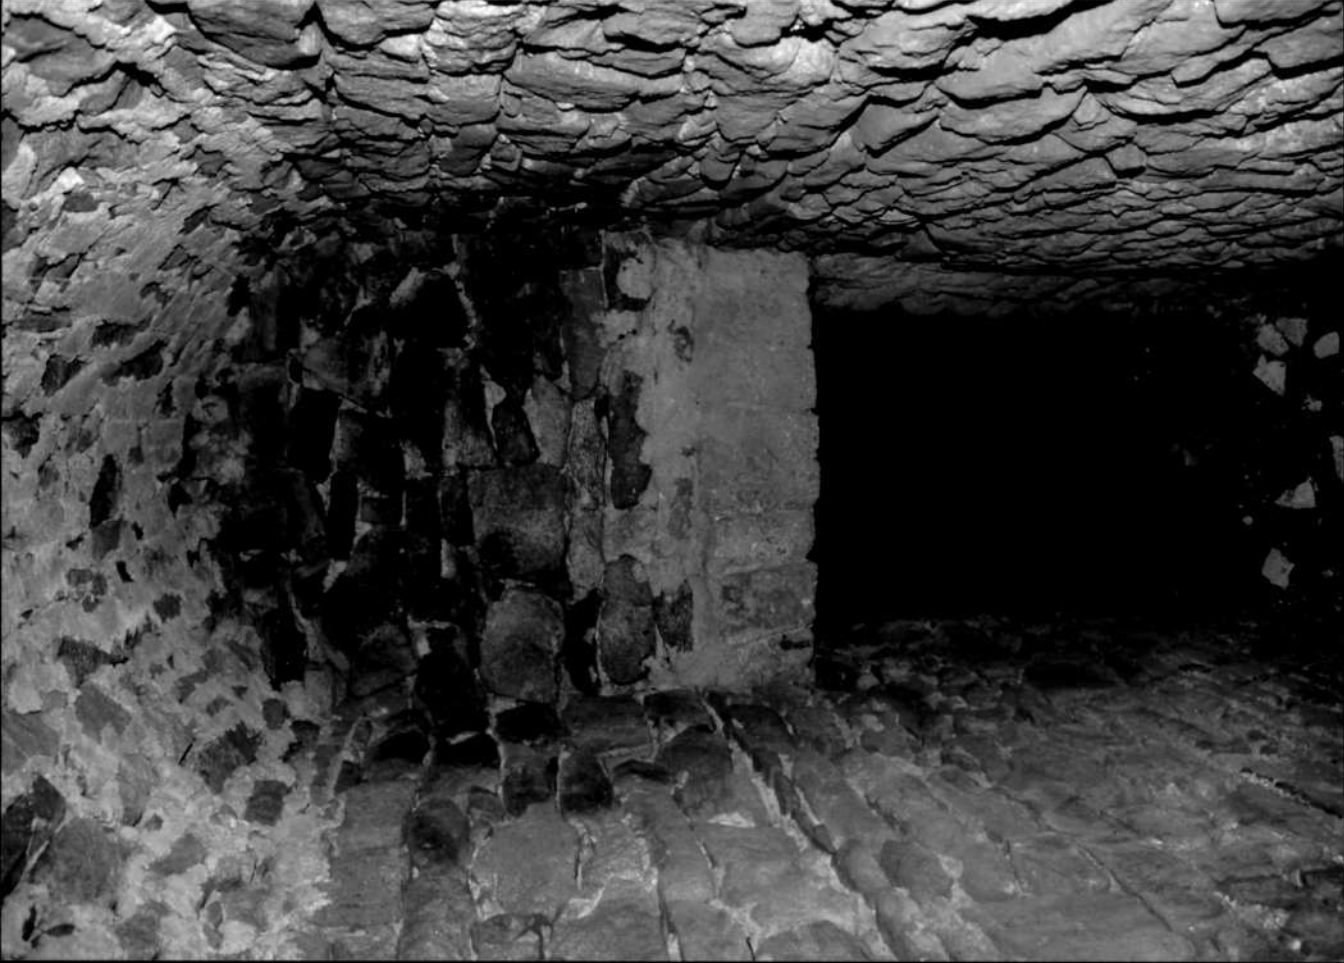
3/4

The icehouse is located between the mansion house and the wash house, is completely underground, and has no part of its structure visible above ground (and apparently never did). The CMUs closing off the doorway to the icehouse were broken out, revealing a barrel-vaulted tunnel built of rubble stone that is several feet below the floor of the washhouse basement and slopes down to the west. At the west end of the tunnel is an opening with a cut stone lintel that gives access to the icehouse proper. The icehouse is a circular, domed, rubble stone structure with several feet of debris on the floor (including bottles and china), which is several feet below the level of the tunnel. The icehouse is approximately 18 feet in diameter and approximately 25 feet high, with a square opening at the top of the dome that has been closed off.

Icehouse entrance

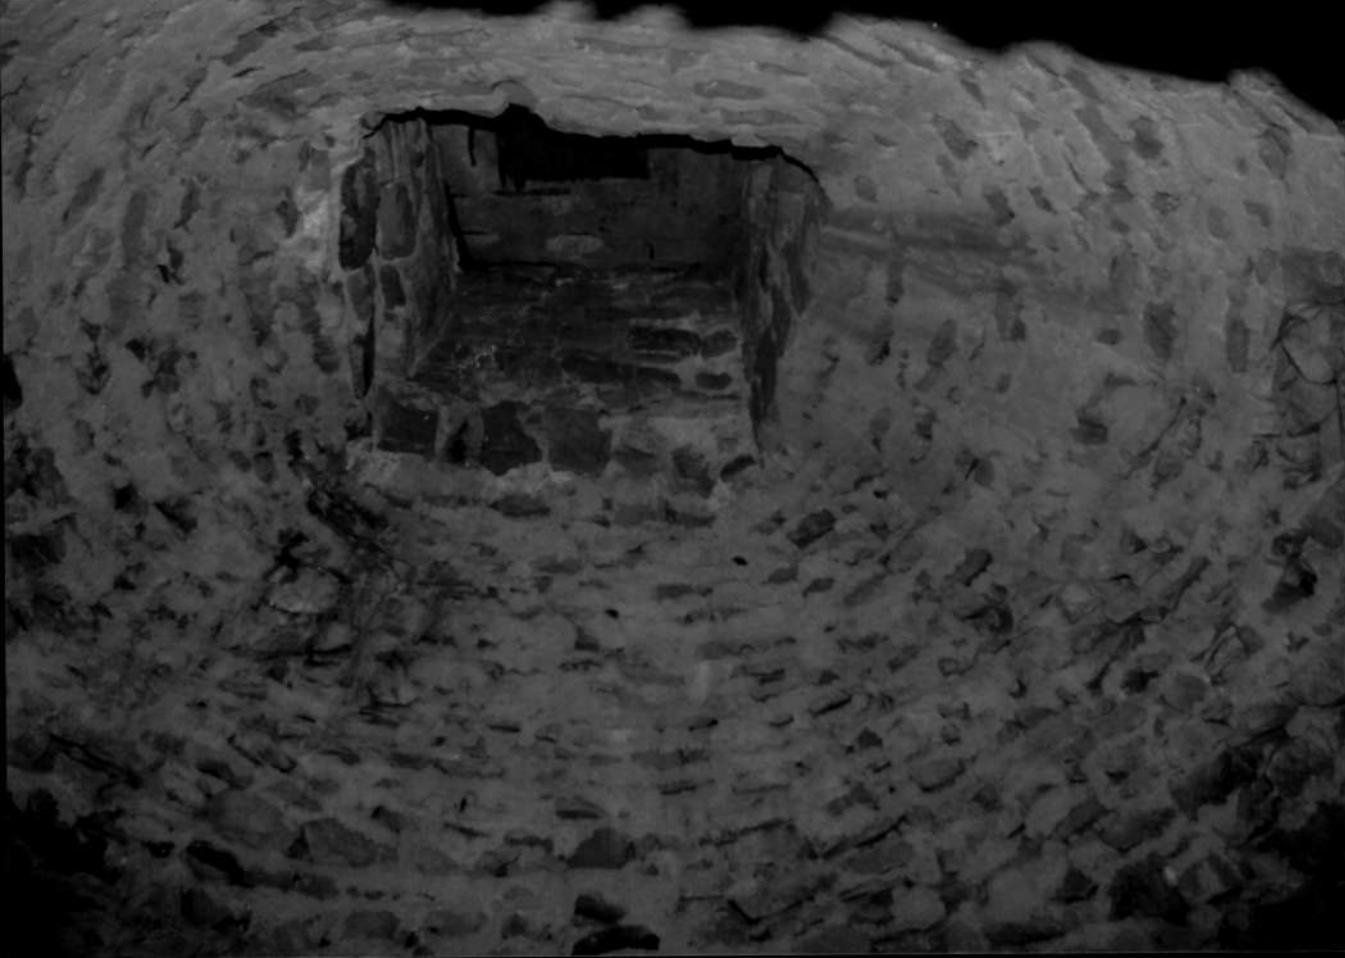
4/4

Icehouse done

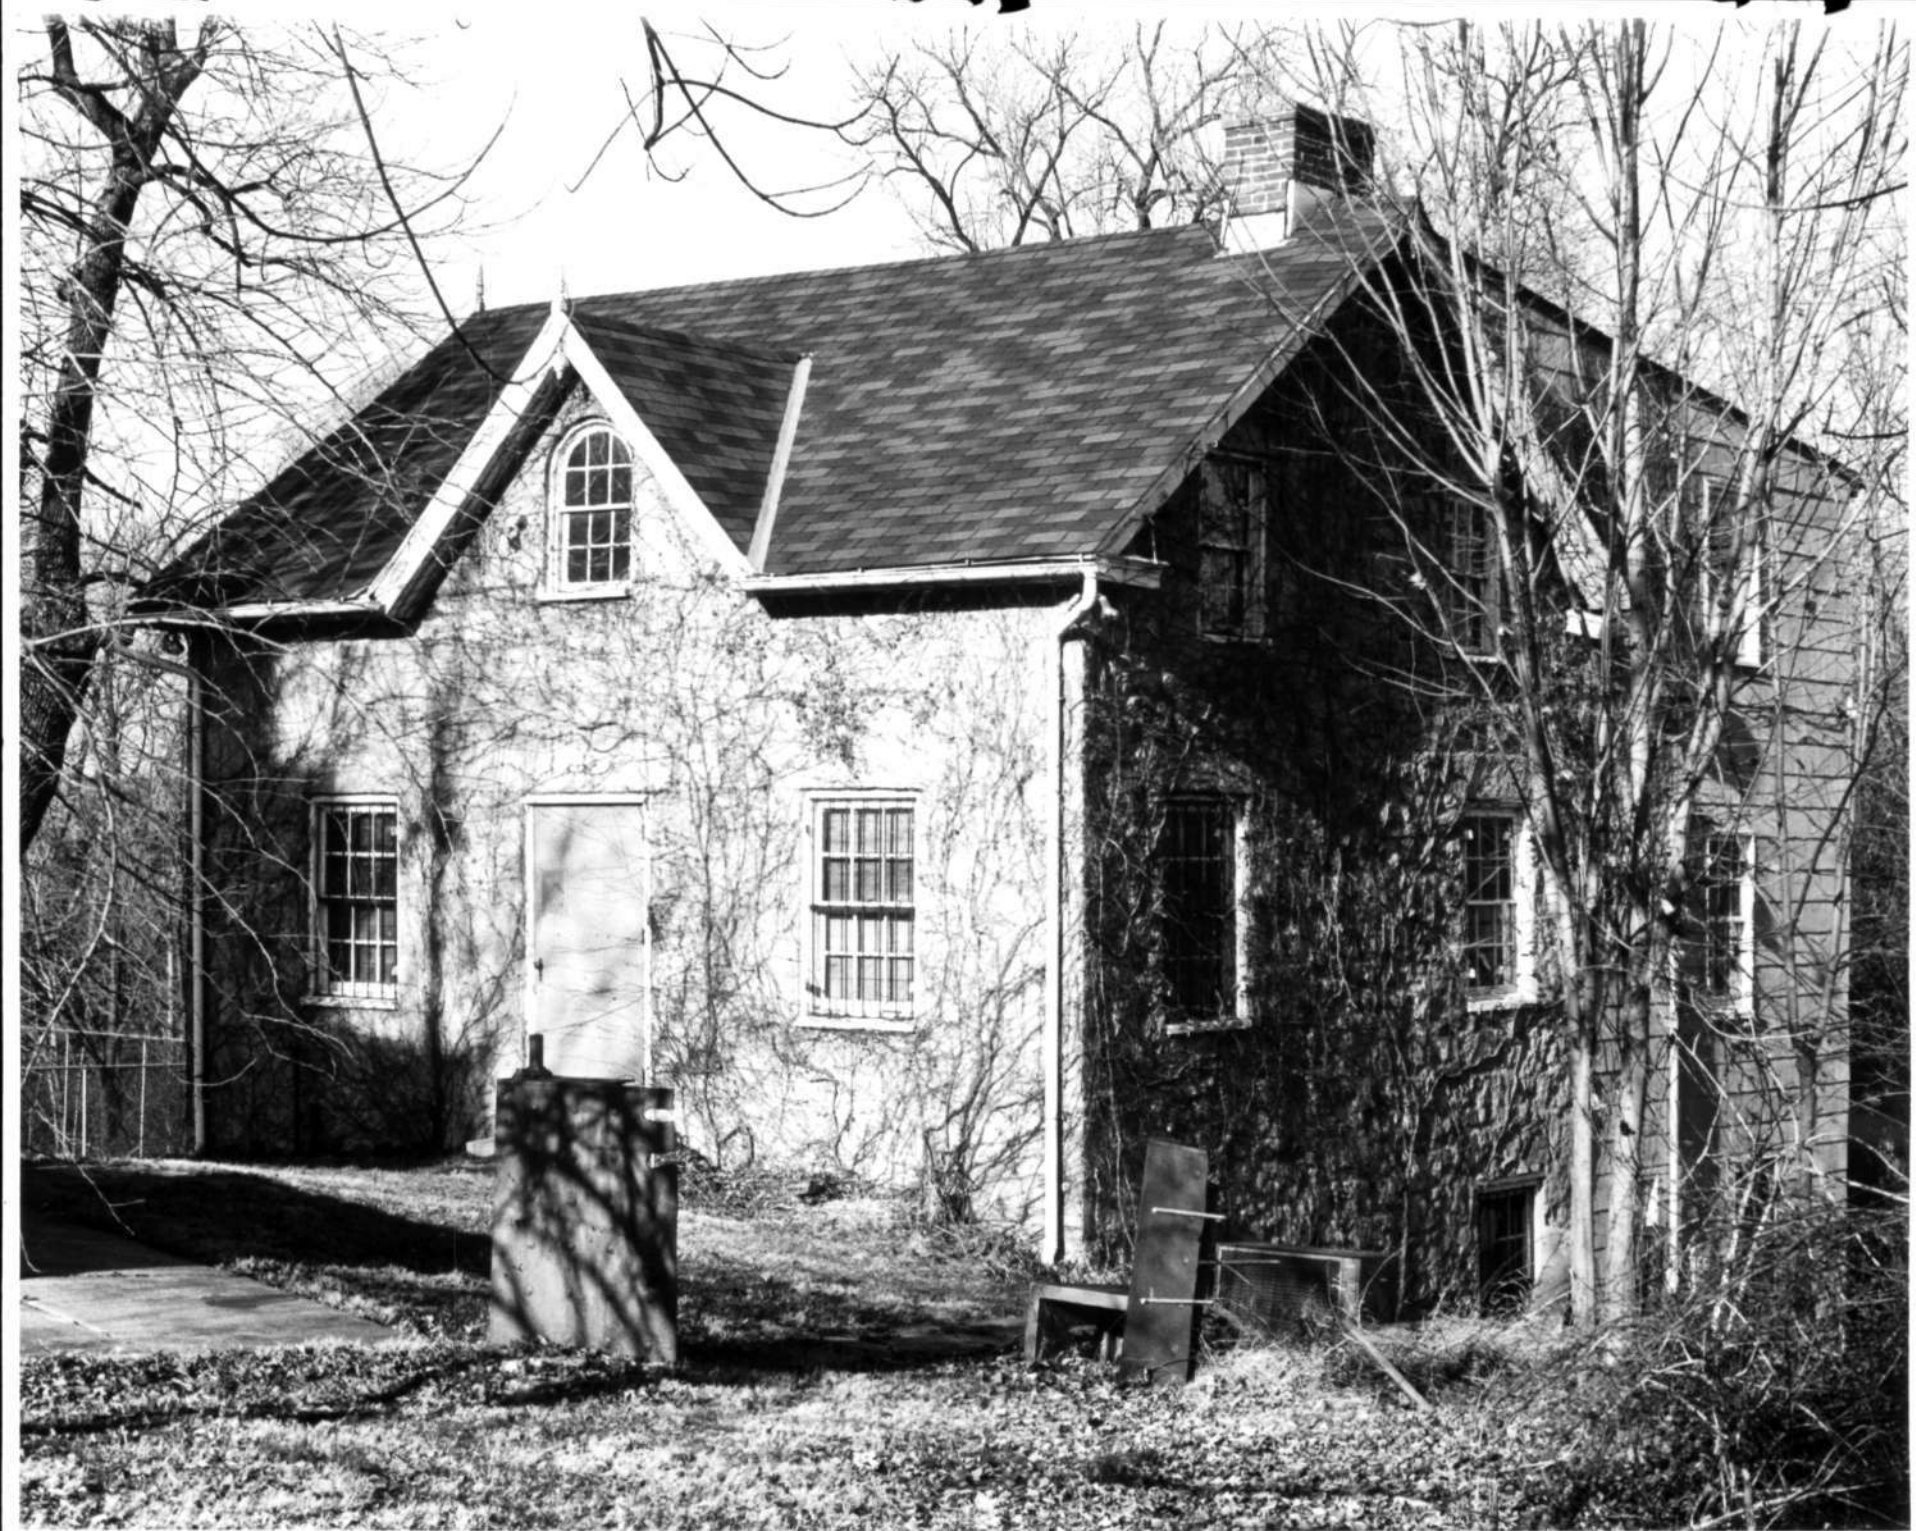
Name: HO-551  
The Eye of the Camel  
Location: 9879 Vantage Point Road  
Columbia, Maryland 21044  
Photographer: Cleora B. Thompson, A.I.C.P.  
Date of photograph: April, 1980  
Negatives in possession of the Maryland Historical Trust  
View: Southeast  
Photographer looking: Northwest  
Photograph number: 1 of 1
