HO-576

Wilde Lake Barn (Oakland Manor Barn)

Architectural Survey File

Oakland Barn (aka Wilde Lake Barn)

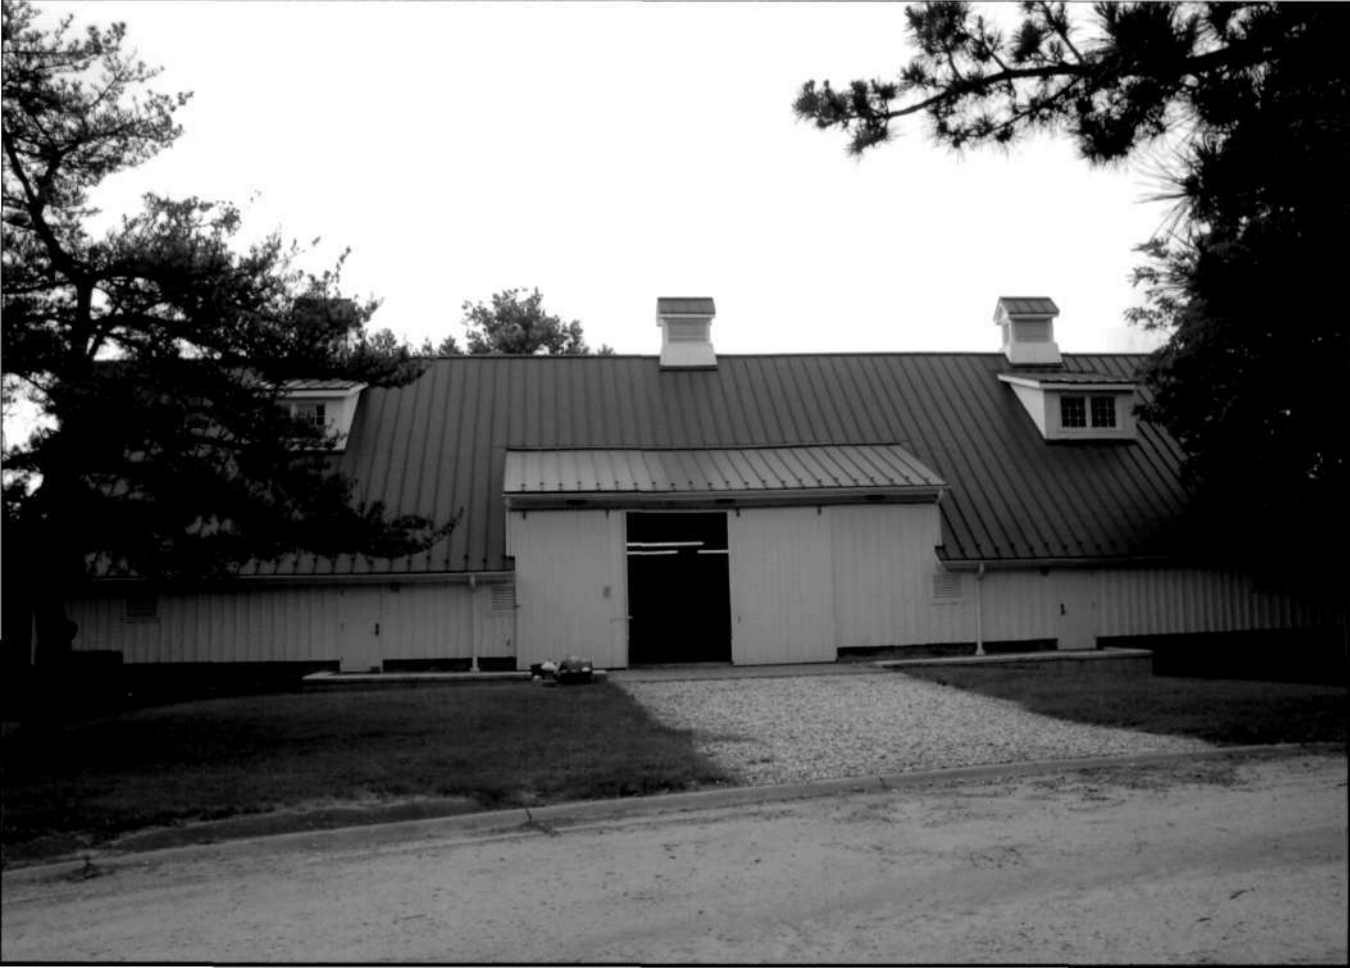
1/8

Barn, North Elevation

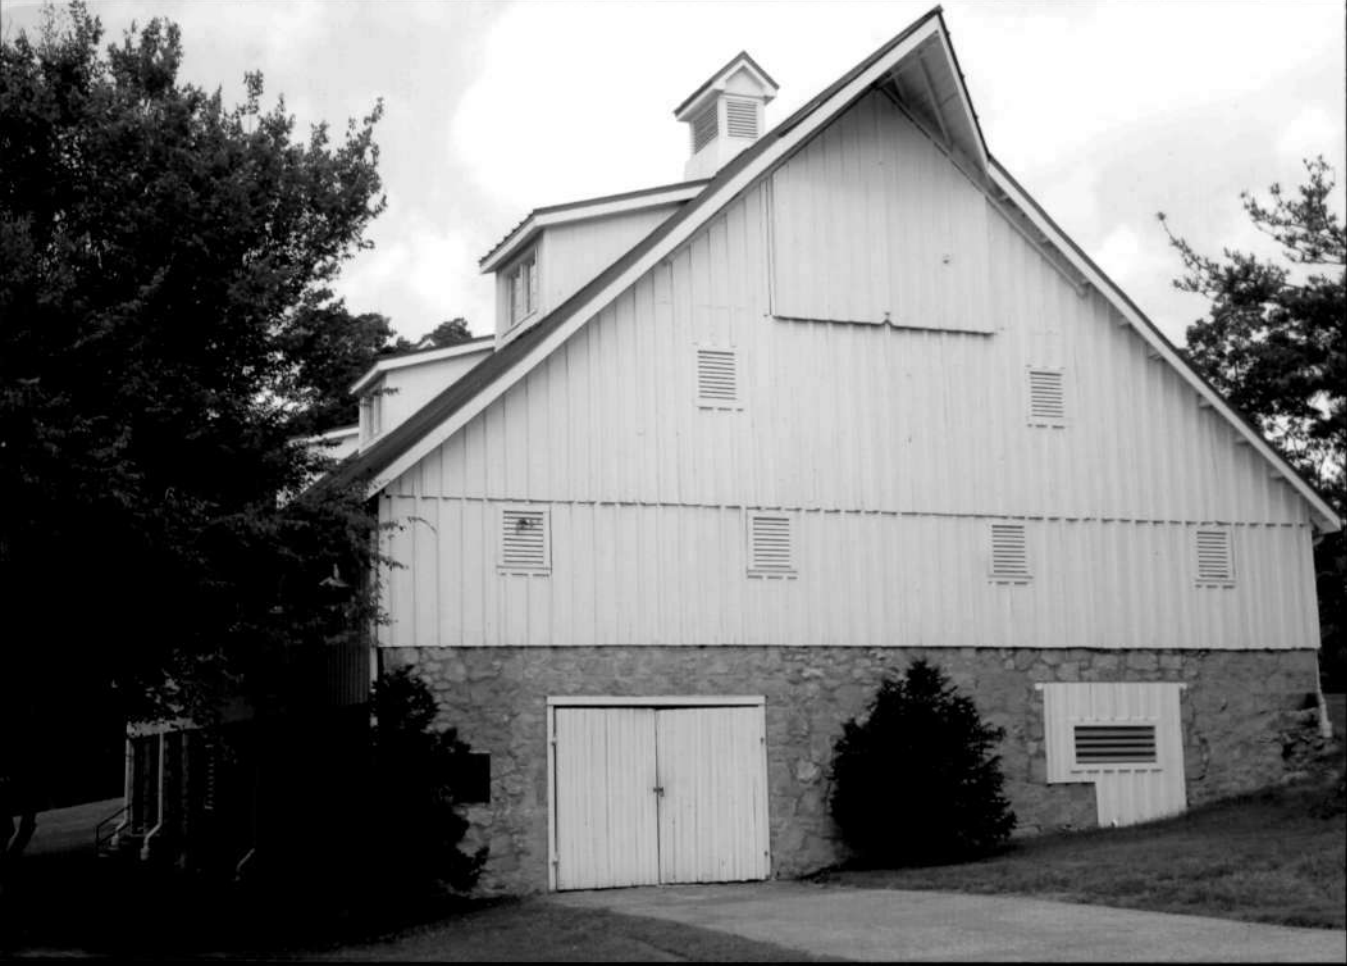
2/8

On the east elevation the lower story has board-and-batten doors hung on strap hinges in the south bay. The north bay has an opening that is closed off with board-and-batten siding and a large metal vent, and has patched stonework around the opening. The south bay opening has been altered with the stonework patched on both sides of the door and over it. There is a seam in the center of the building, with quoins and earlier stonework to the north; it appears that this was an earlier barn foundation that was enlarged to the south when the existing barn was built. The upper story has four vents, with two vents above it, and double doors in the gable end that are made with boards and battens. There is a triangular pent roof

Barn, South & East elevations

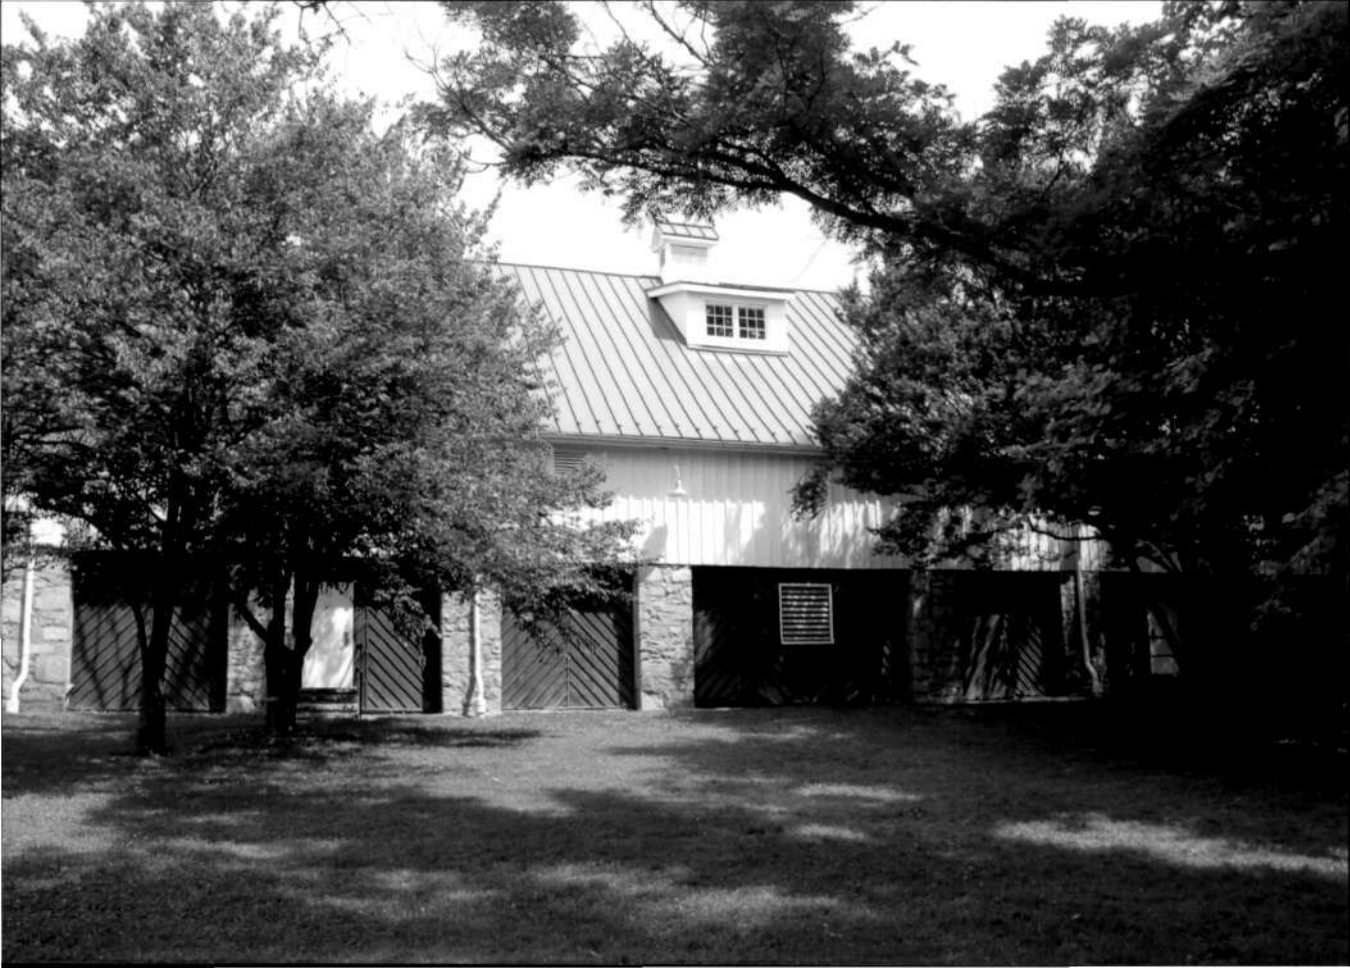
5/8

On the south elevation the lower story has eight stone piers with herringbone board-and-batten infill in each bay. Two bays have fire doors added, and the center has an aluminum vent; all of this infill has been added. The upper story has one vent in each bay except the center bay. There are three typical dormers.

Barn, South Elevation

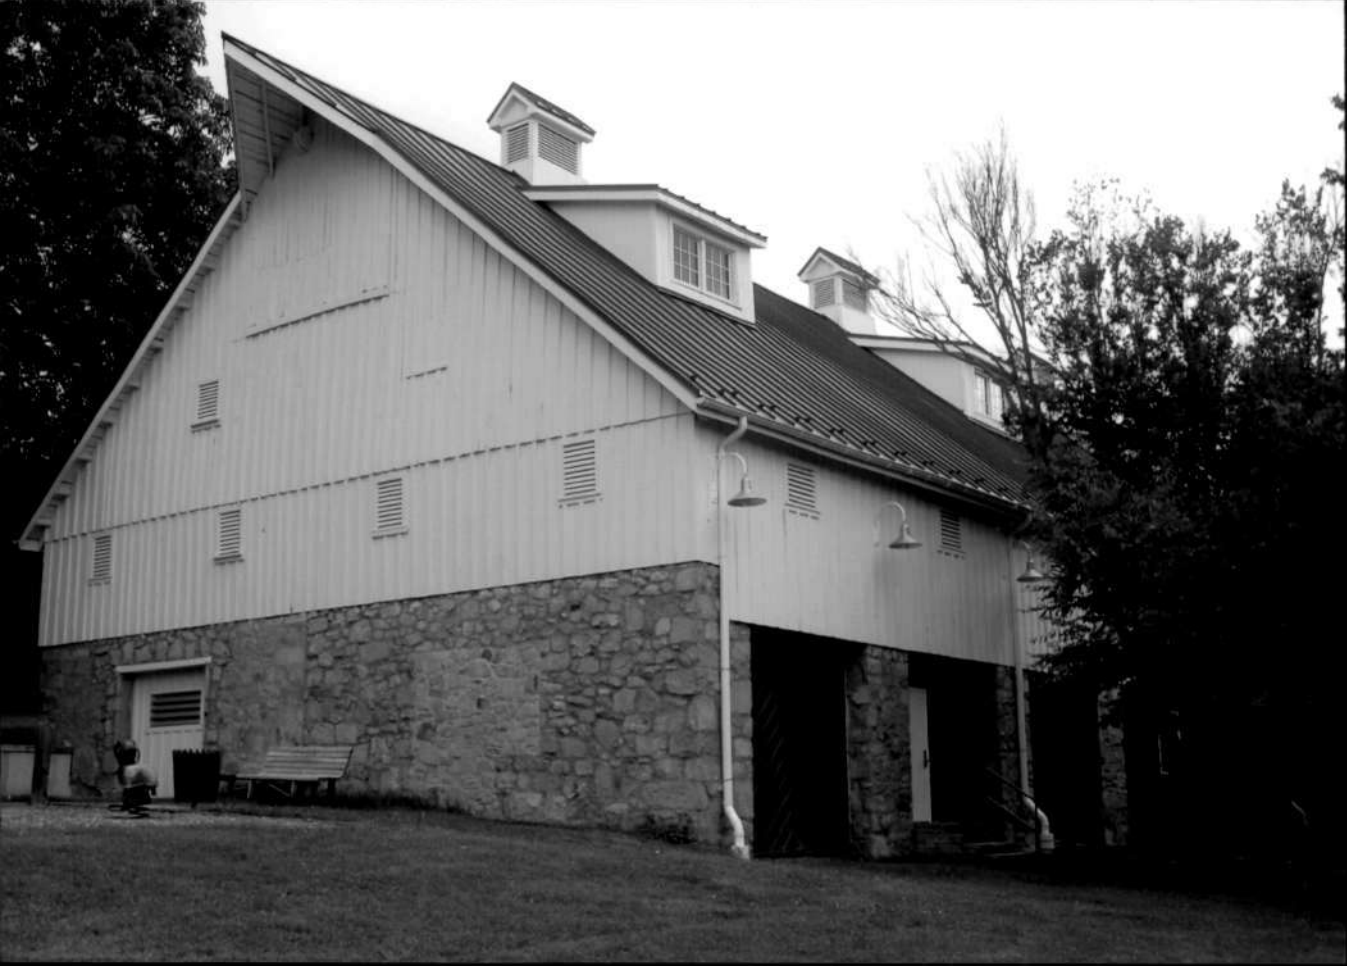
4/8

On the west elevation the lower story has a stone-infilled opening in the south bay. The north bay has a wide opening with board-and-batten infill and aluminum vent. There is patching around the opening that indicates it is a later alteration. There is a seam down the center of the foundation with quoins on the north side of the seam, like that on the east elevation. The stones on both sides of the seam have drill holes. The upper story has four vents, and had two above that, but the south one has been infilled. The gable end door opening has been closed off and has no rollers. The hay track extends outside, with a triangular pent roof covering it, and there is a pulley next to it with a hole in the siding next to the pulley.

Barn, West & South elevations

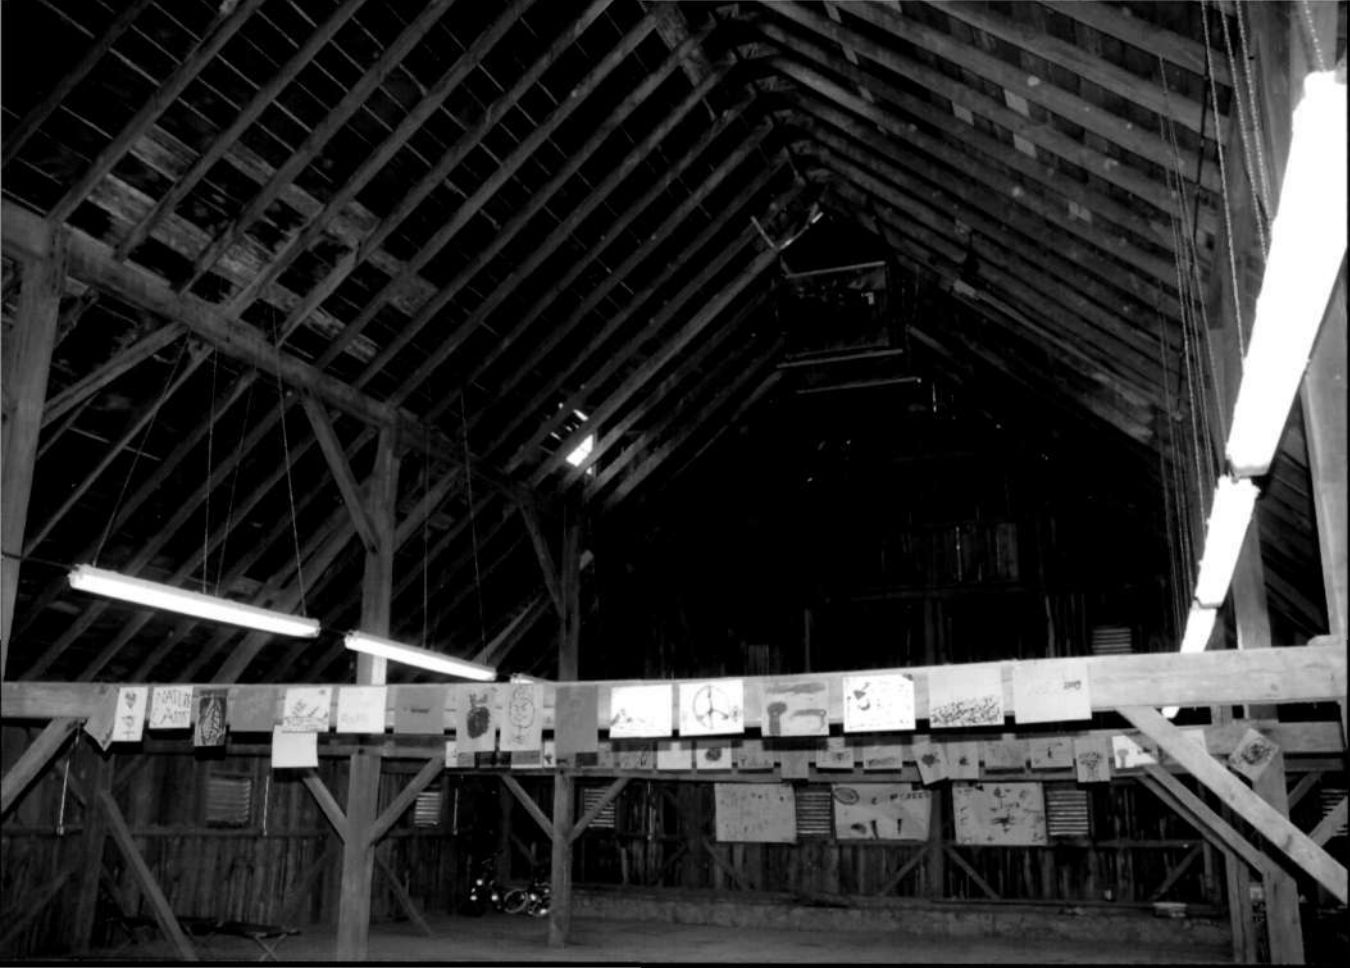
5/8

The interior of the barn has a heavy-timber braced frame of circular-sawn timber that is mortised and tenoned and bolted, with braces that are wire-nailed. There are six bents in the center that consist of queen posts that support purlins that are ganged together two-by-eights. The center girts cut across the center floor and have beveled half-lapped scarf joints with four bolts. The framing creates an aisled building, and there are down-braces from the end posts into the aisles. The queen posts have up-braces to the girts, and have down-braces from just below the purlins down to the girts near the end posts. There are also up-braces from the queen posts to the purlins. The gable end bents have additional posts and braces and horizontal nailers for the siding. The rafters are circular-sawn 2-by-6s that support solid board sheathing and have gussets at the ridge. The foundation is raised above the floor level about 15 inches and the sill consists of two 2-by-10s that are ganged together. The floor is mostly plywood, with some 4-inch tongue-and-grooved boards in the center where the main doors are. There is a hay track that runs down the gable ridge for the whole length of the barn. The east end of the barn is closed off with a plywood wall and a partial floor. The rafters are two pieces and are lapped at the purlins. The west gable end has two wooden reels on the wall just below the hay track. The rafters were not cut through where the dormers are built. The purlin in the center bay, where the wagon doors are, are 2-by-12s because this is a longer span.

Barn, interior, view West

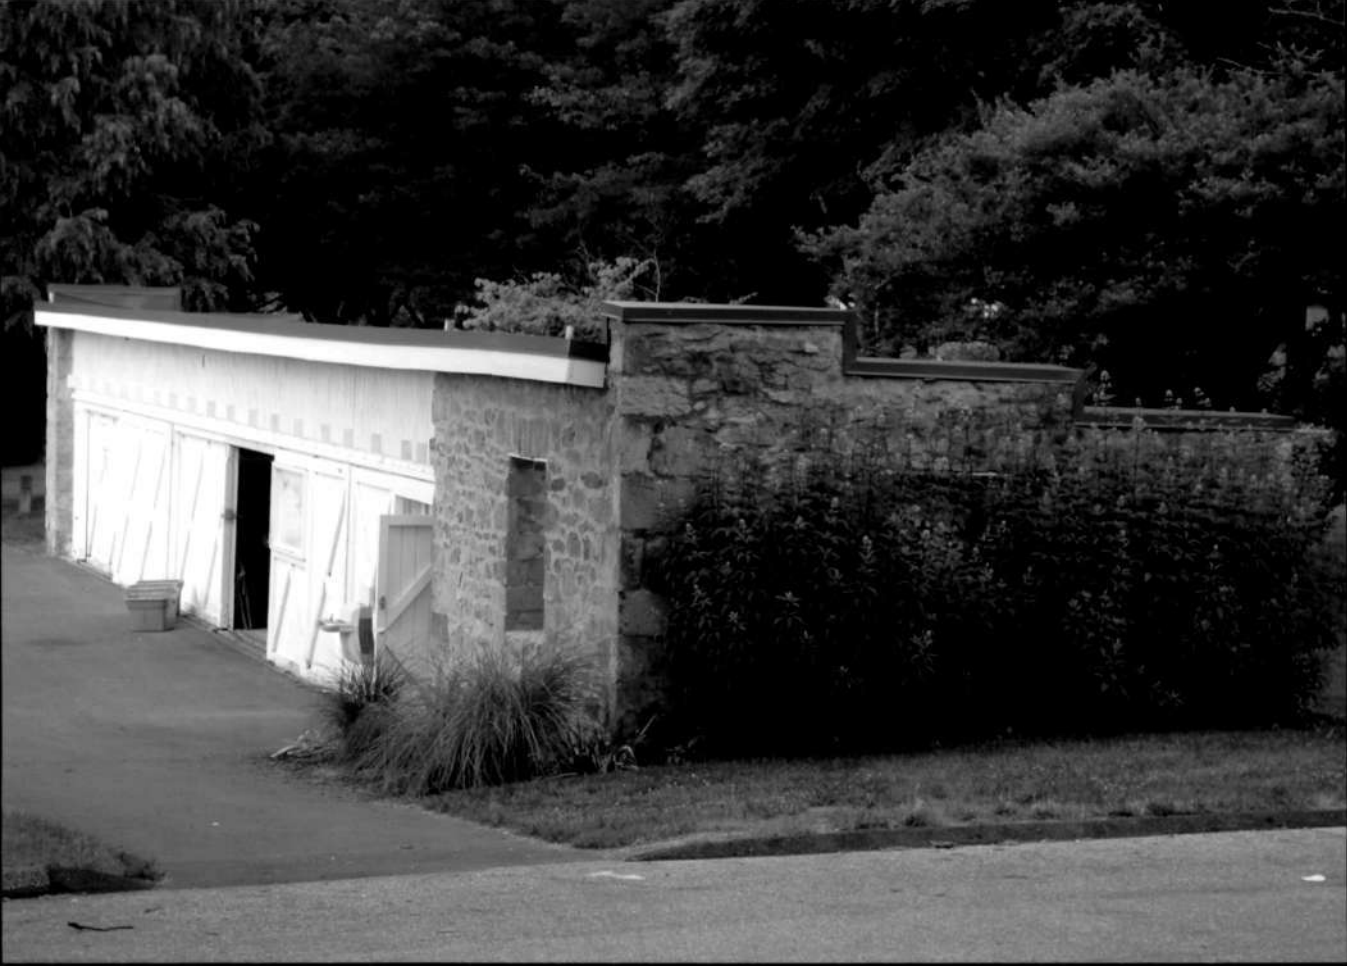
6/8

Several hundred feet to the east of the barn is a rubble stone banked foundation that appears to be from another barn. It is banked slightly into a hill on the north and is close to Wilde Lake on the south, and it has new framing to support a shed roof of standing seam metal that slopes to the north; there are stepped parapet walls on the east and west in stone. The south elevation has a boarded-up window opening to the east with a steel lintel under a stone jack arch. Most of this elevation has infill with cross-buck doors below board-and-batten siding. The east elevation has a boarded-up window opening with a steel lintel beneath a stone jack arch. The north elevation has a boarded-up opening in the east bay that is full height, and must have been for a door. The west elevation has a boarded-up window opening set to the north with a steel lintel under the stone jack arch. This building is now used as a boat house.

Shed, South & East Elevations

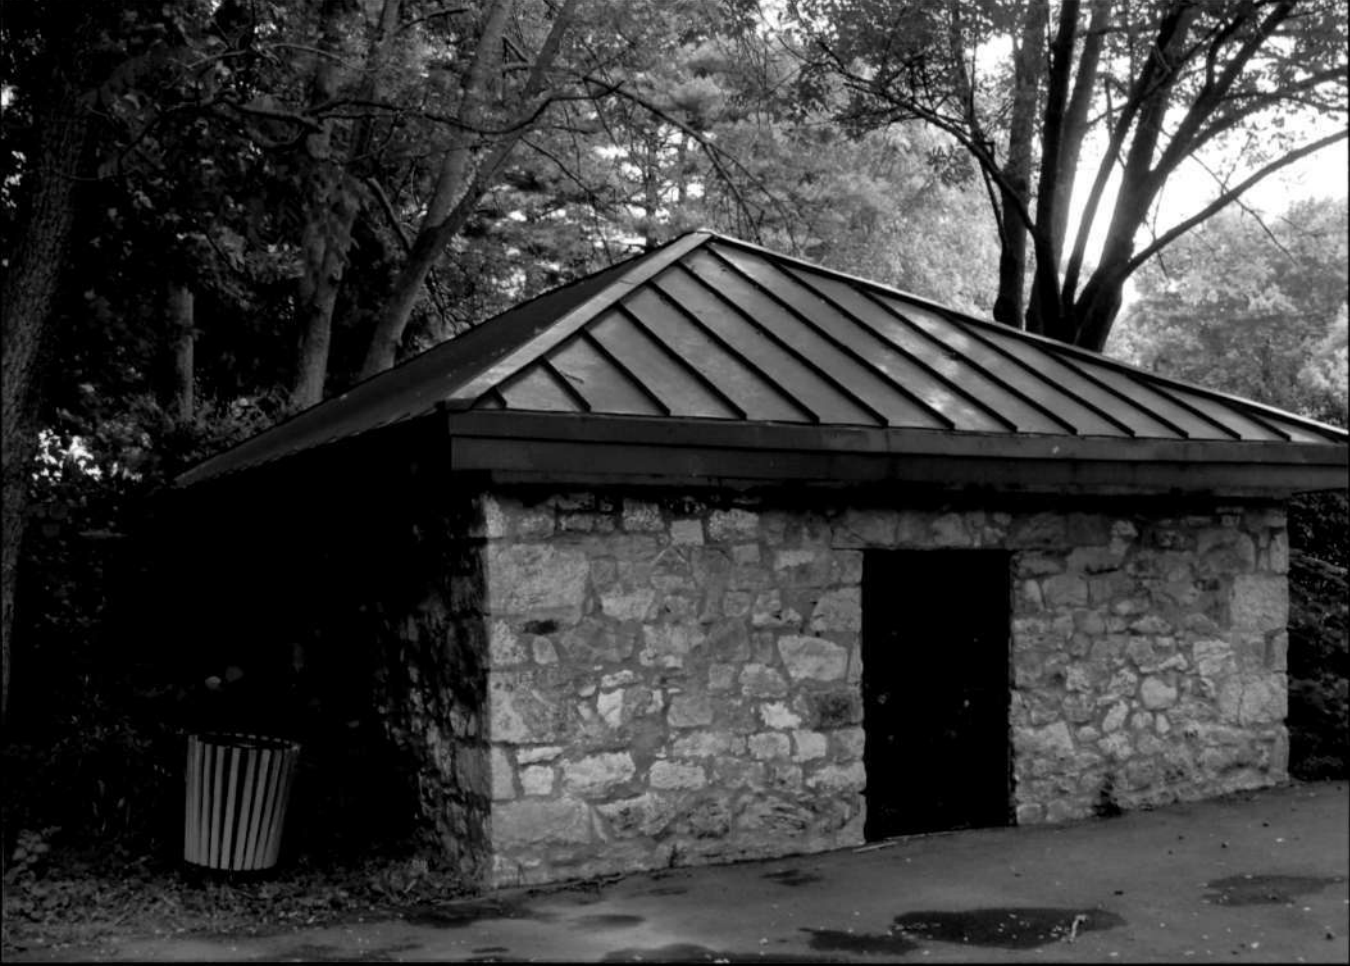
7/8

To the east of the foundation/boat house, at the east end of Wilde Lake, is a springhouse. It is a one-story, one-bay square rubble stone structure with a hipped roof that has new standing-seam metal. The roof cantilevers on the north side and is supported on a stone retaining wall on the north end, with the east and west sides of this cantilevered section open. The south elevation has a new vertical-board door on T-hinges and has a steel lintel. The east elevation has a boarded-up opening with a steel lintel. The stone has been repointed and has a waterproof coating that is now peeling off. The roof has boxed eaves. The west elevation has a boarded-up opening with no lintel. The north elevation is open beneath the cantilever and has a doorway in the center off the north wall, with a new door. The opening has been raised, with the wood lintel cut through. The rafters are sawn, but there are no clear tool marks. The original plate spans the openings on the east and west, and the bottom face of the plate has half-dovetailed half laps to connect it to the north plate. The inner edge of the plate has a series of seven mortises for horizontals that ran east-west. The bottom face below each mortise has a nail hole in the center and a sawn roman numeral. The west side has "XXIII, XXIII, XX/, XX/I, XX/II, and XX/III." The last Roman numeral is over top of the north wall and cannot be seen. The north wall has a segmentally-arched opening for a spring head, and it has cut stone voussoirs. Some of the rafters have plaster burns. The roof framing at the north end of the cantilever has a sole plate set about 18 inches south of the north wall, and the sole plate runs east-west. There are outriggers and dragon pieces nailed to the north side of the sole plate, and they run to the north and support a plate on which the rafters are toe-nailed. The rafters have a bird's-mouth cut at the foot. None of the nails could be examined. The bottom face of the sole plate has plaster burns. The east plate only has four mortises, none of them close to the building, and the ones that are here align with those on the west side. The Roman numerals are either not legible, or are missing. The plate is sash-sawn and has no half-lap joint on the bottom face. There is a lap cut into the outer edge, but it is not clear what this is for.

Springhouse, West & North Elevations

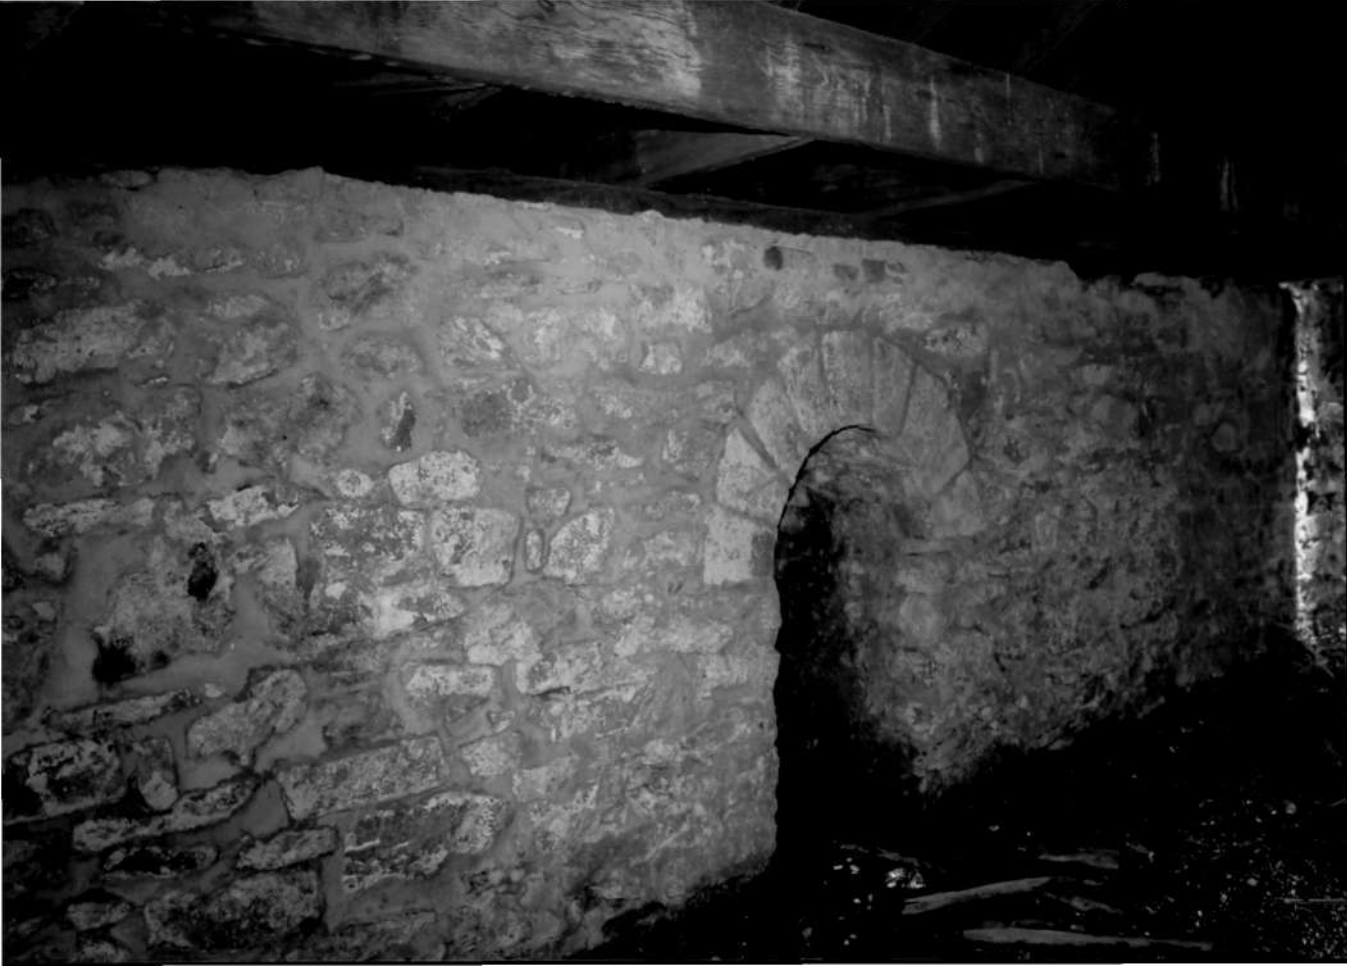
8/8

East and west of the building are sloped cheek walls of rubble stone attached to the north wall.

Springhouse, North Embankment Wall

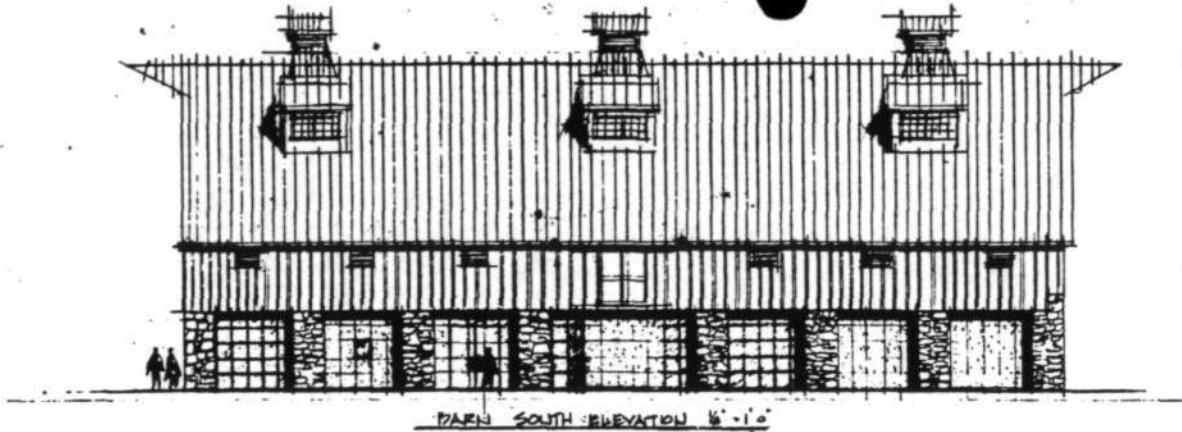
BARN SOUTH ELEVATION 1/8" = 1'-0"

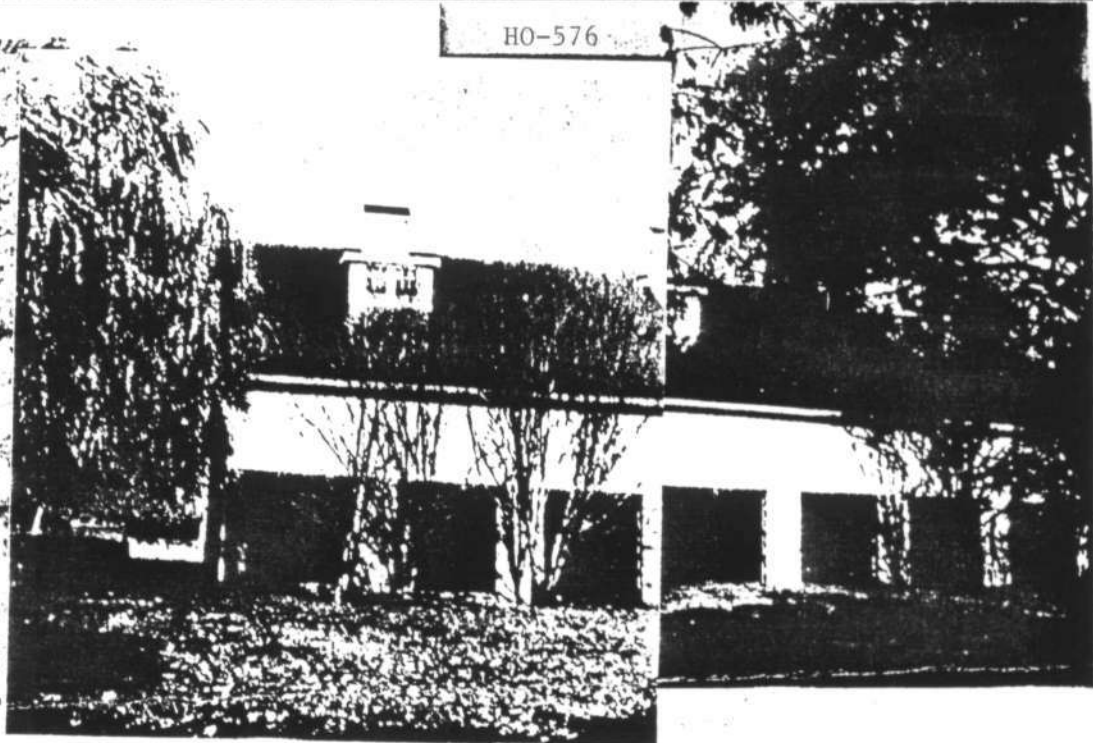
LAKE VIEW - SOUTH

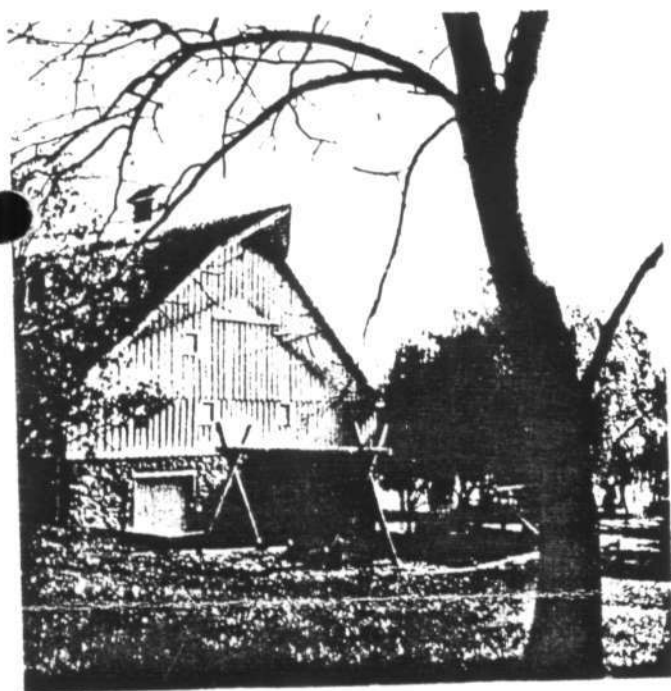
WEST SIDE

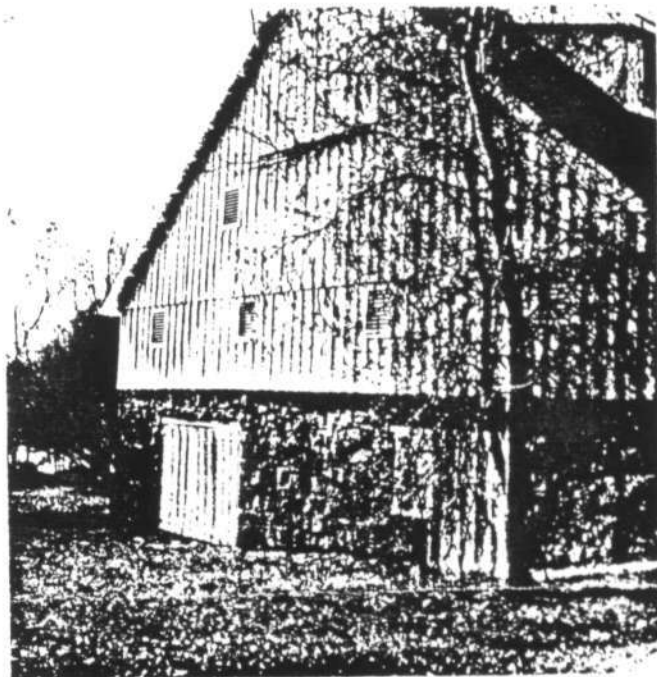
EAST SIDE
