HO-709

Architectural Survey File

Property/District Name: 10756 Scaggsville Road Survey Number: HO-709

CAPSULE SUMMARY
10756 Scaggsville Road
(HO-709)

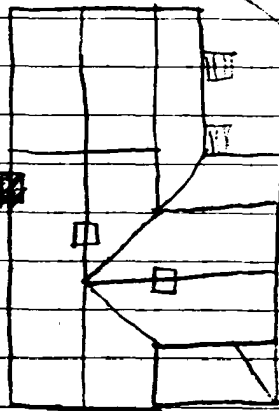
1910s-20s
frame
barn

A large wood frame barn is located to the east of the main dwelling. The original portion of this hay barn dates to circa 1920. The original building sits on a stone foundation and has vertical board siding. The entire building is covered with a metal gable roof. A frame addition on the northeast side sits on a concrete block foundation.

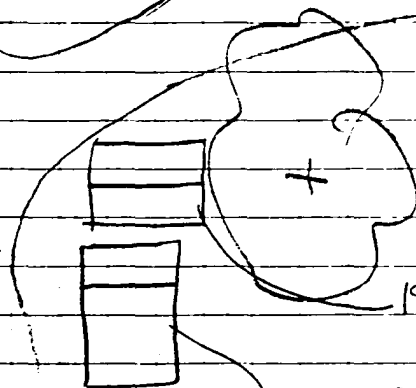
1920s frame
shed

To the southeast of the main house stand two circa 1920, wood frame sheds. The larger shed is set on a stone pier foundation. It has a gable roof with metal sheathing and wood vertical board siding. The smaller shed is also set on a stone pier foundation and has a gable roof, but it clad in board and batten siding.

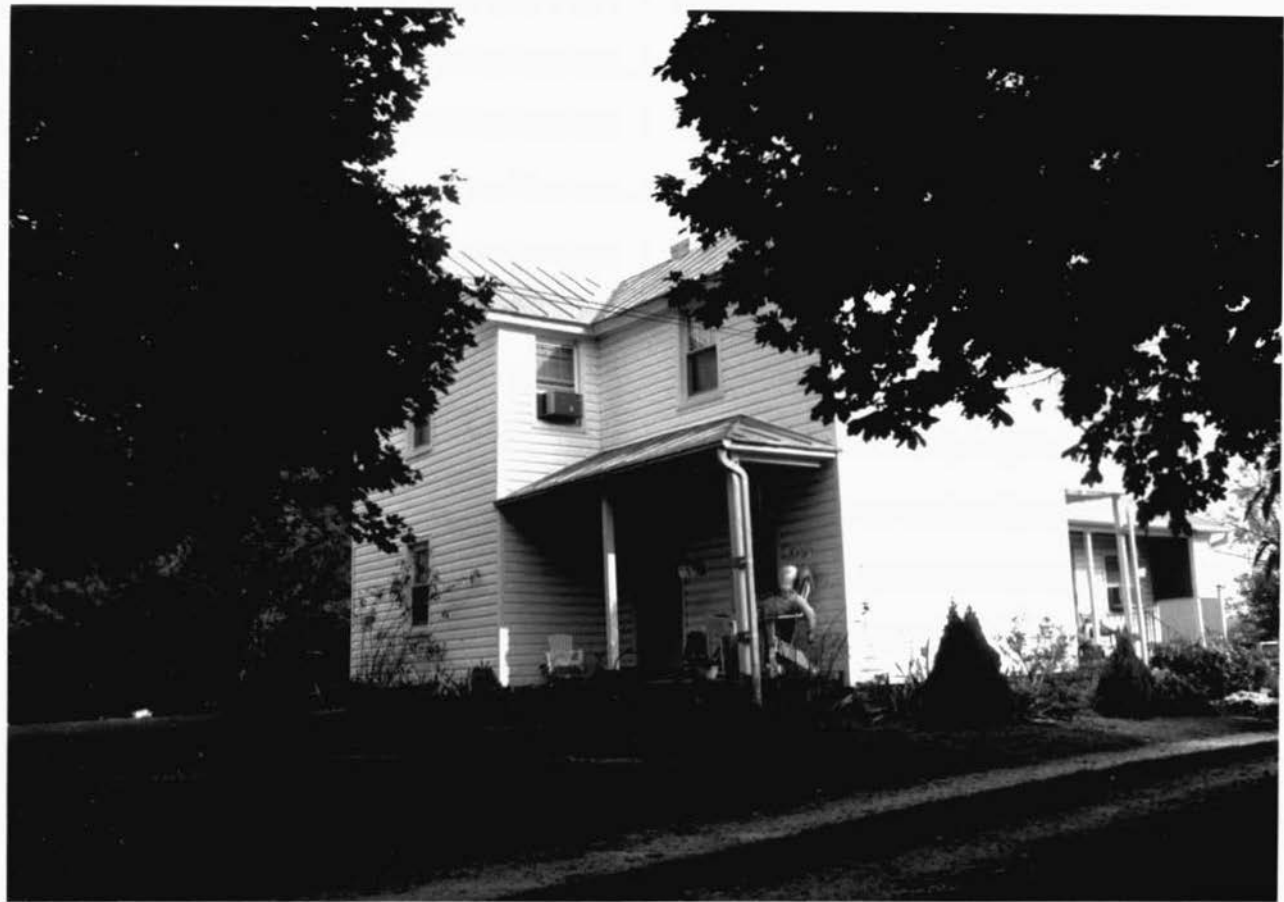
1 OF 11

HOUSE, SOUTH CORNER

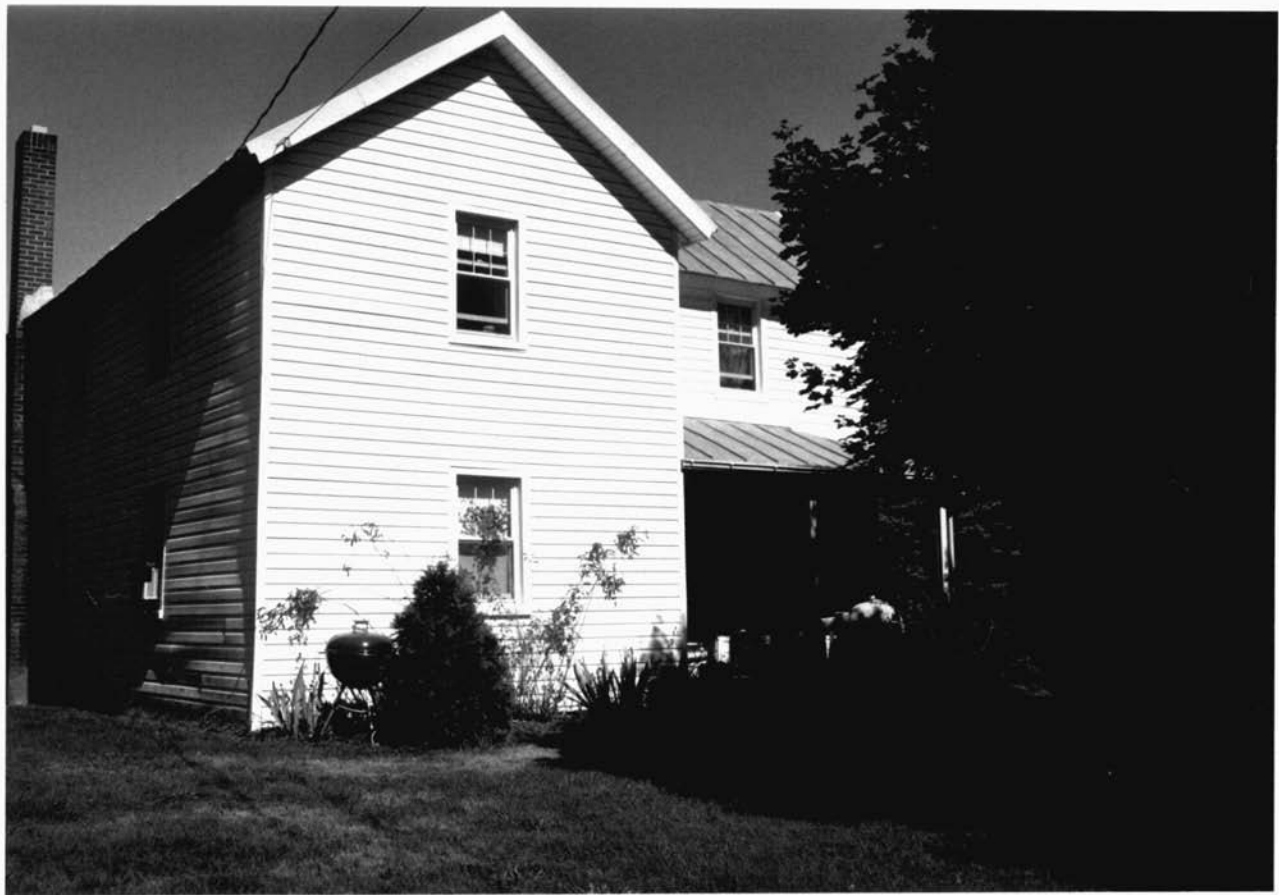
2 OF 11

House, W Corner

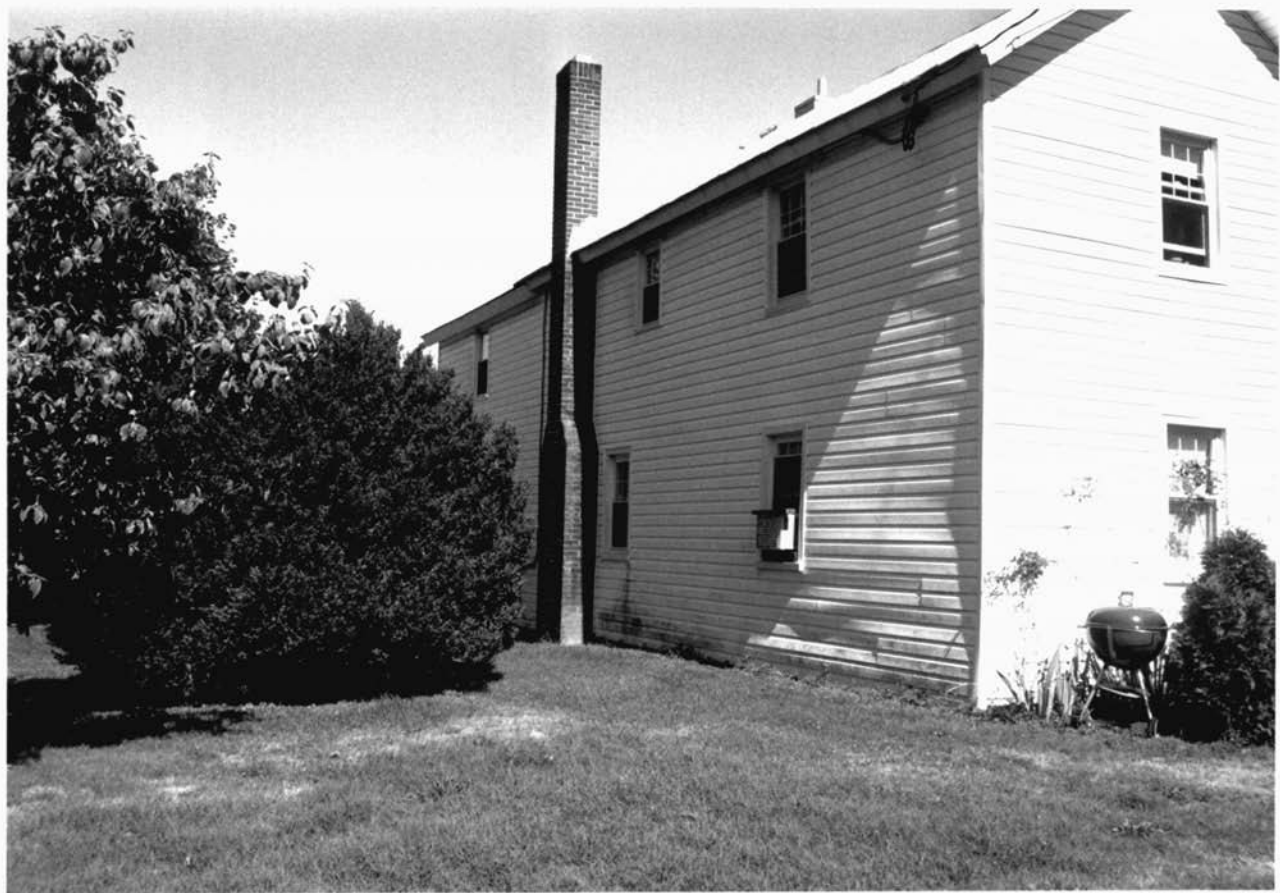
3 of 11

The northwest elevation consists of the original house with the large, two-story addition to the north. The exterior brick chimney, laid in stretcher bond, rises at the north of the original section of the house. The first story of the original house is pierced by two non-original, 6/1 metal sash windows, and the second story is pierced by two non-original, 6/1 metal sash windows. The first and second stories of the addition are each pierced by a single 6/1 metal sash window.

House, NW Elevation

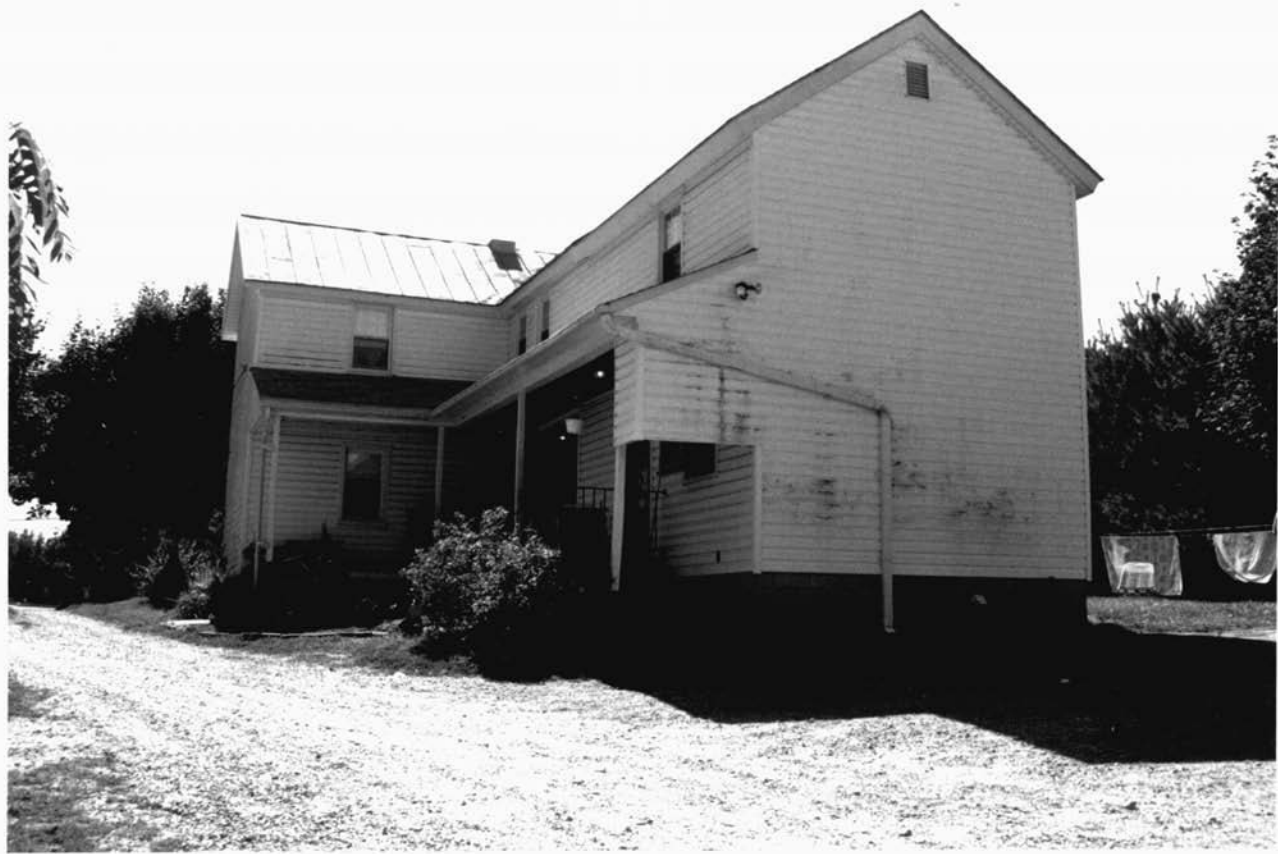
4 of 11

The northeast elevation consists of the gable end of the rear ell and the rear wall of the original side gable portion of the house. On the northeast elevation, the first story of the original house is entirely covered by the one-story, L-shaped porch with a shed

=====
roof with asphalt shingles. Beneath the porch, on the first story, is an original, single leaf, wood paneled door with lights. The first story is also pierced by one non-original, 6/1 metal sash window. The second story is pierced by one non-original, 6/1 metal sash window.

House, NE // Elevation

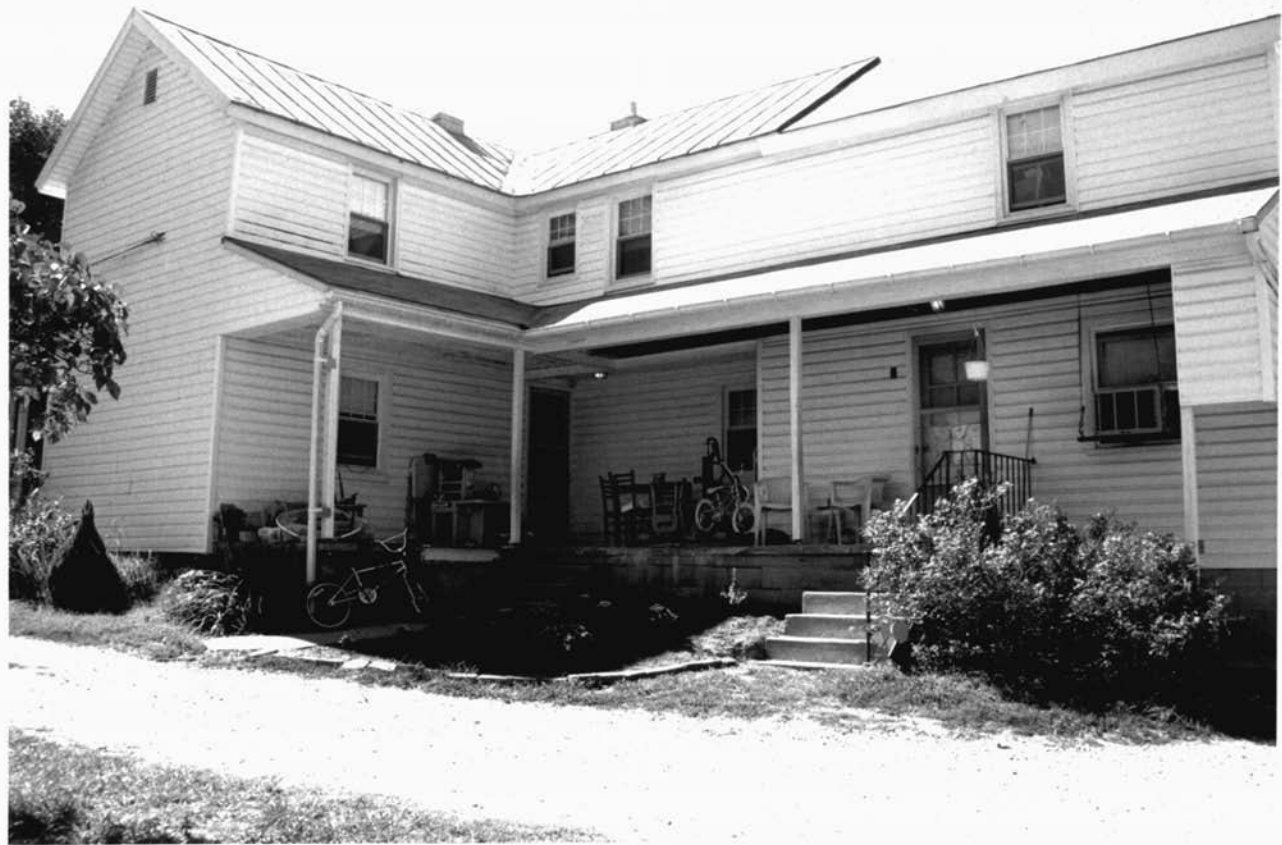
The first story of the southeast elevation is entirely covered by the one-story, L-shaped porch with an asphalt shingled shed roof. Beneath the porch, on the first story, is a salvaged, single leaf, wood paneled door with lights. The first story of this elevation is pierced by two non-original, 6/1 metal sash windows. The second story, is marked by three non-original 6/1 metal sash windows of varying sizes, two within the original rear ell, and one in the addition.

HO-709
10756 Scaggsville Rd.
Howard County, MD
Tracenes
September 1997
Maryland SHPO
House, SE Elevation
5 of 11

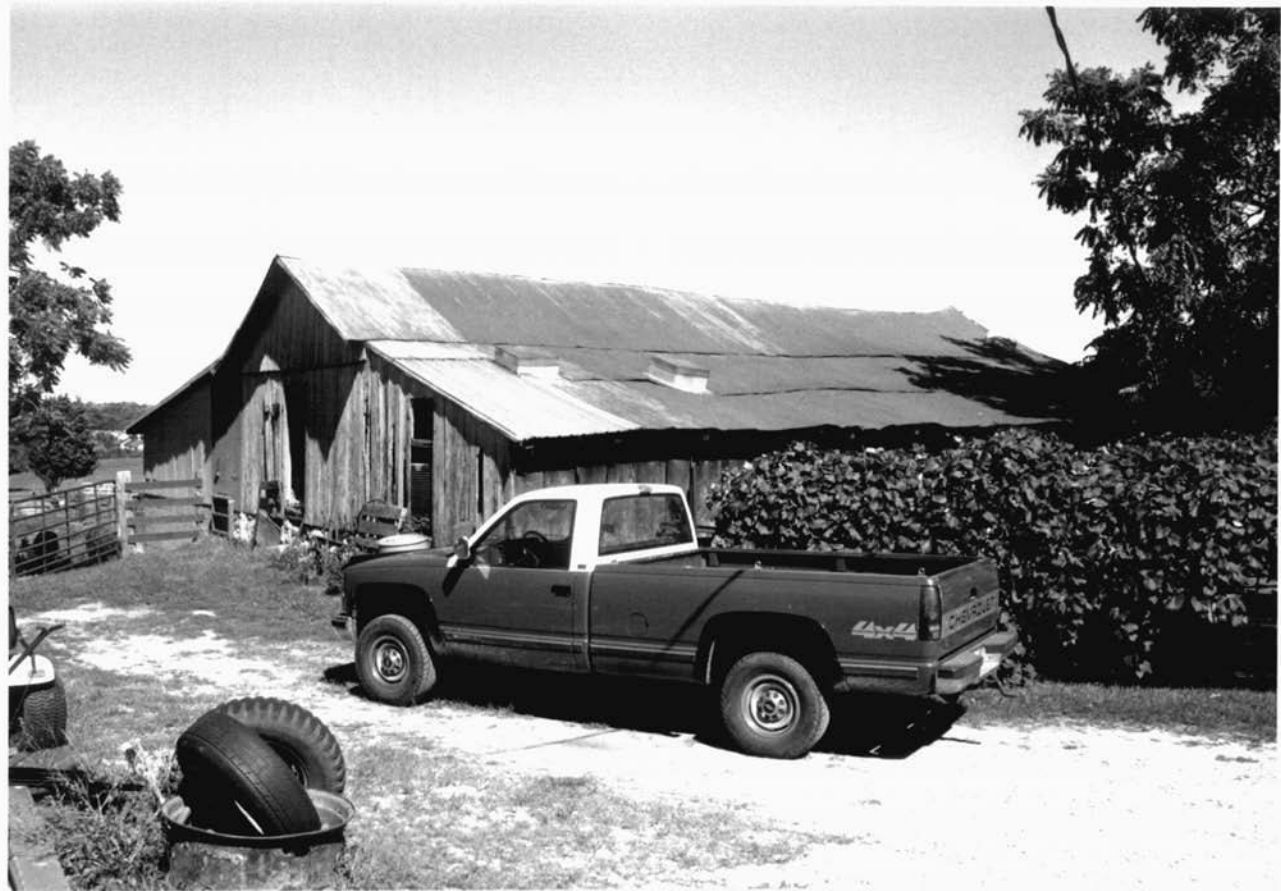
6 of 11

Barn, W corner

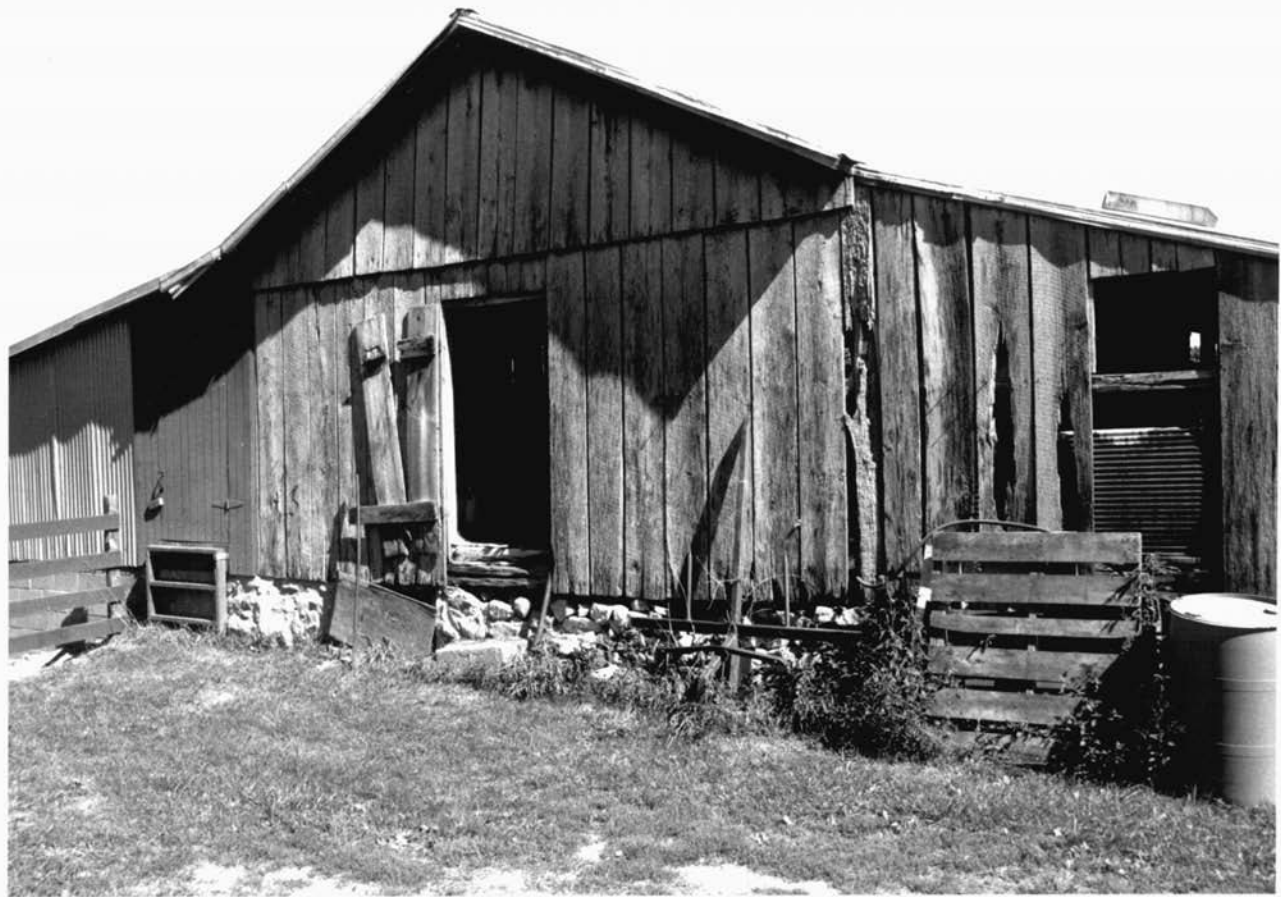
7 of 11

Barn, NW Elevation

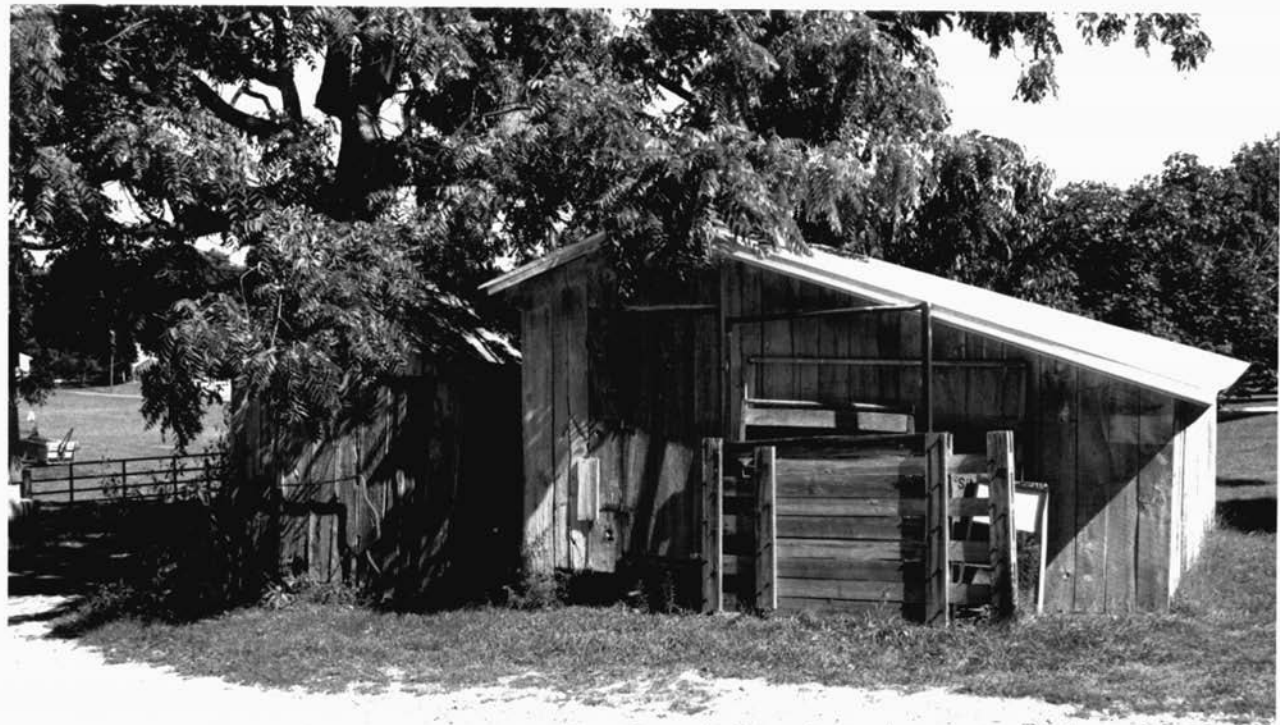
8 of 10

Sheds, NW Elevation

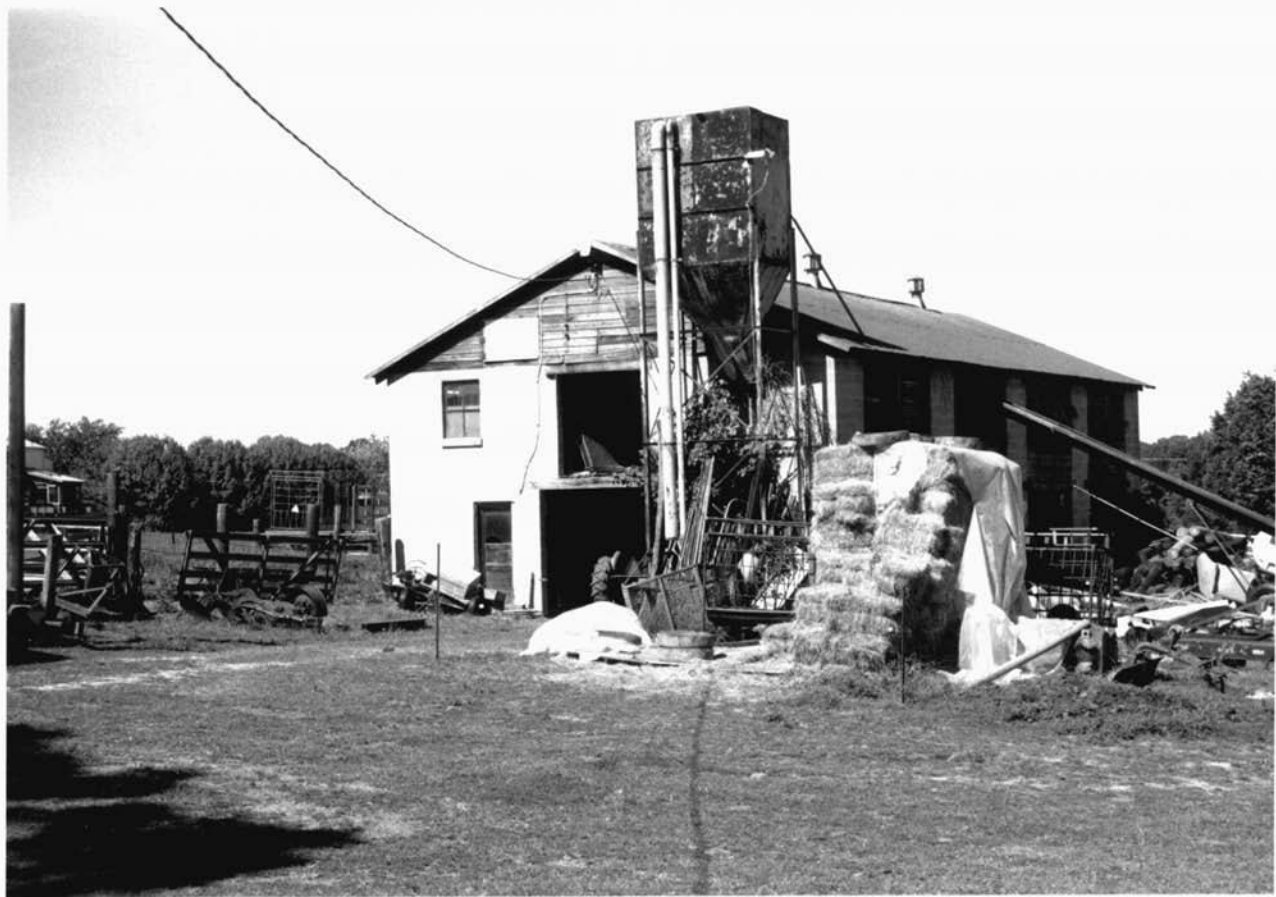
9 of 14

A two-story concrete block barn is also located to the east of the main house. This 1950s building has a metal gable roof and allows vehicles to pass through the interior structure.

Barn, W corner

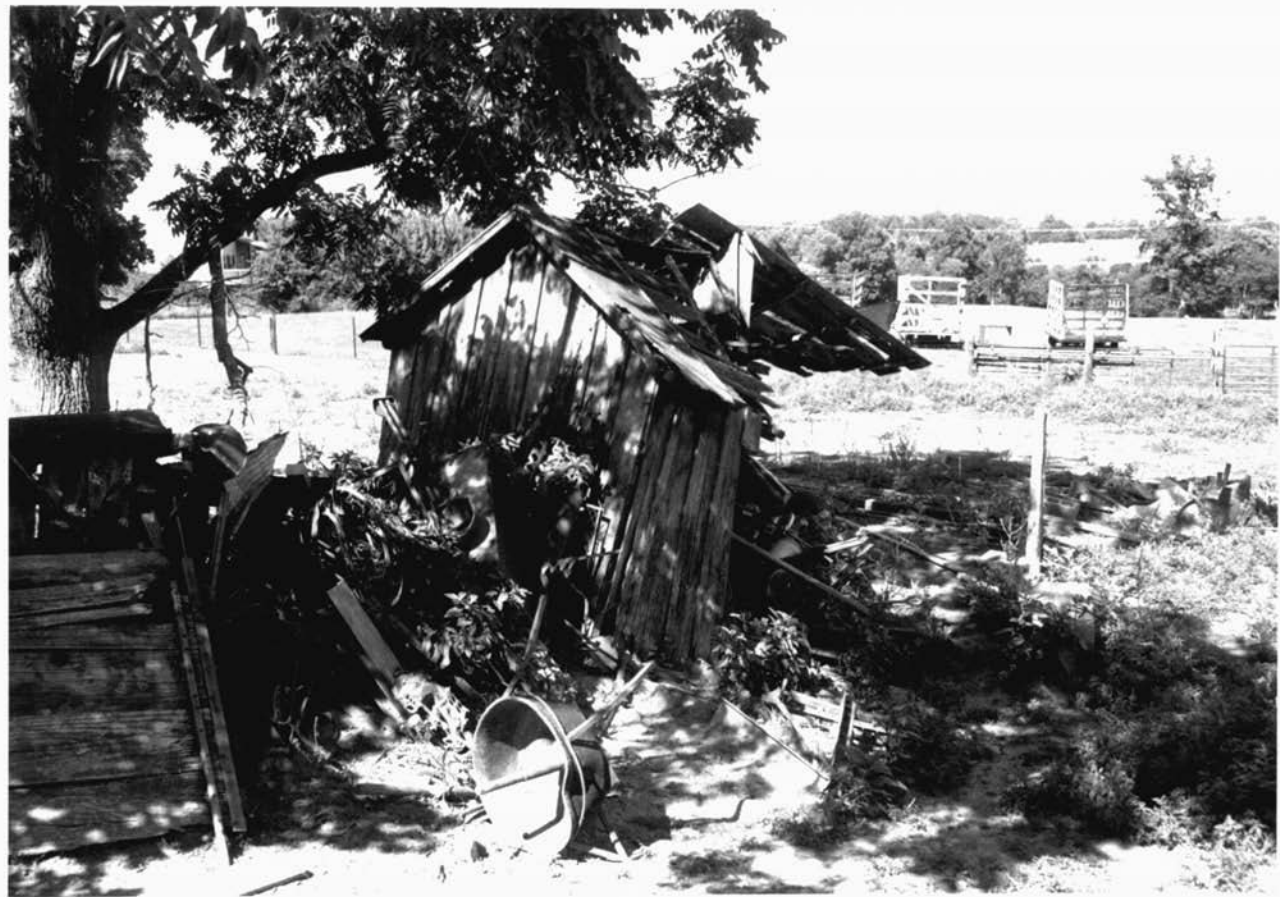
10 of 10

A 1930s dilapidated wood frame shed lays to the northeast of the main dwelling. The shed has board and batten siding and a gable roof.

Shed, SS corner

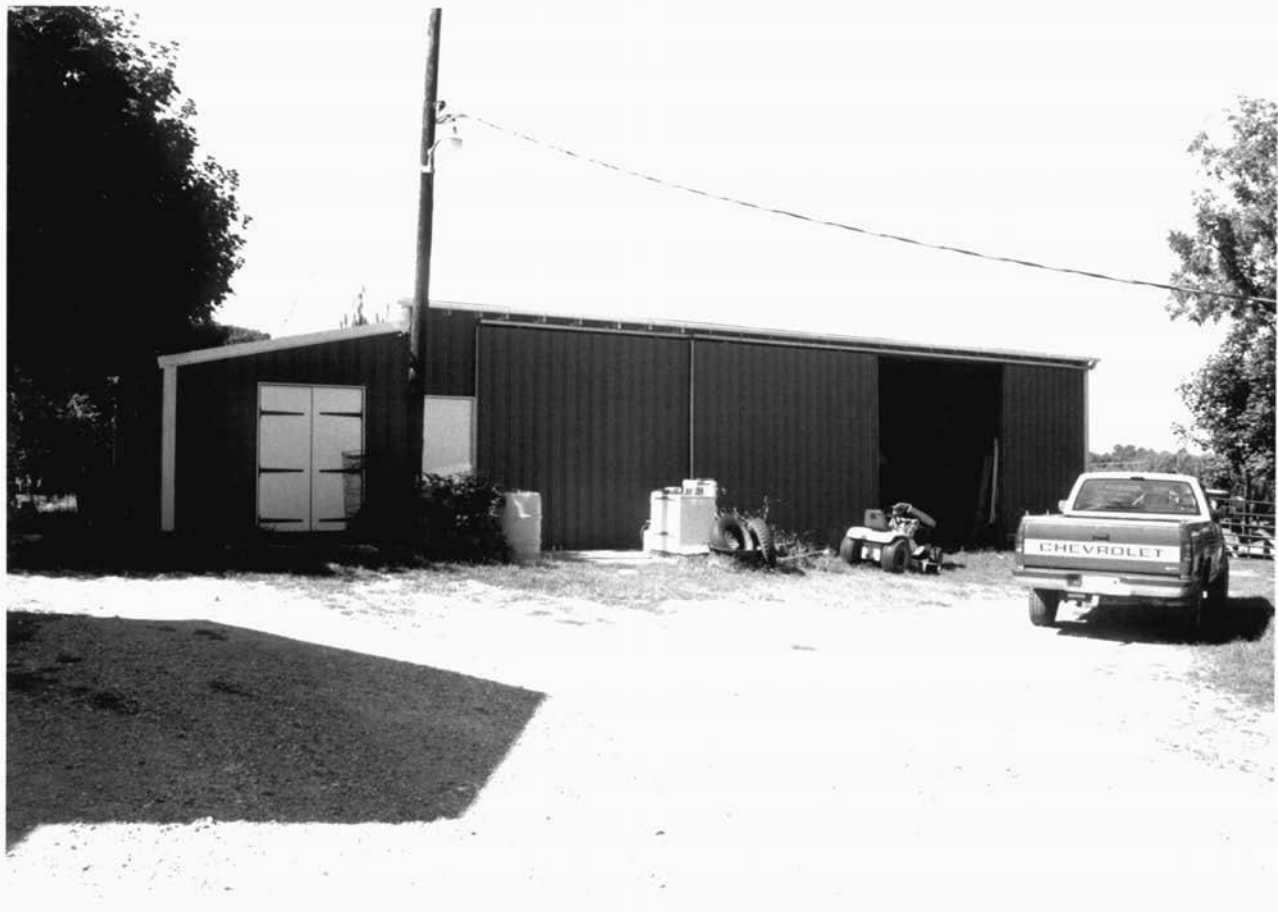
11 of 11

A 1980s wood frame, machine shed is located to the north of the main building. The shed is covered with metal siding and has a gable roof.

Machine Shed, SE Elevation
