## Montrose Farm

### **Architectural Survey File**

National Register of Historic Places  
Registration Form

historic name "Montrose"

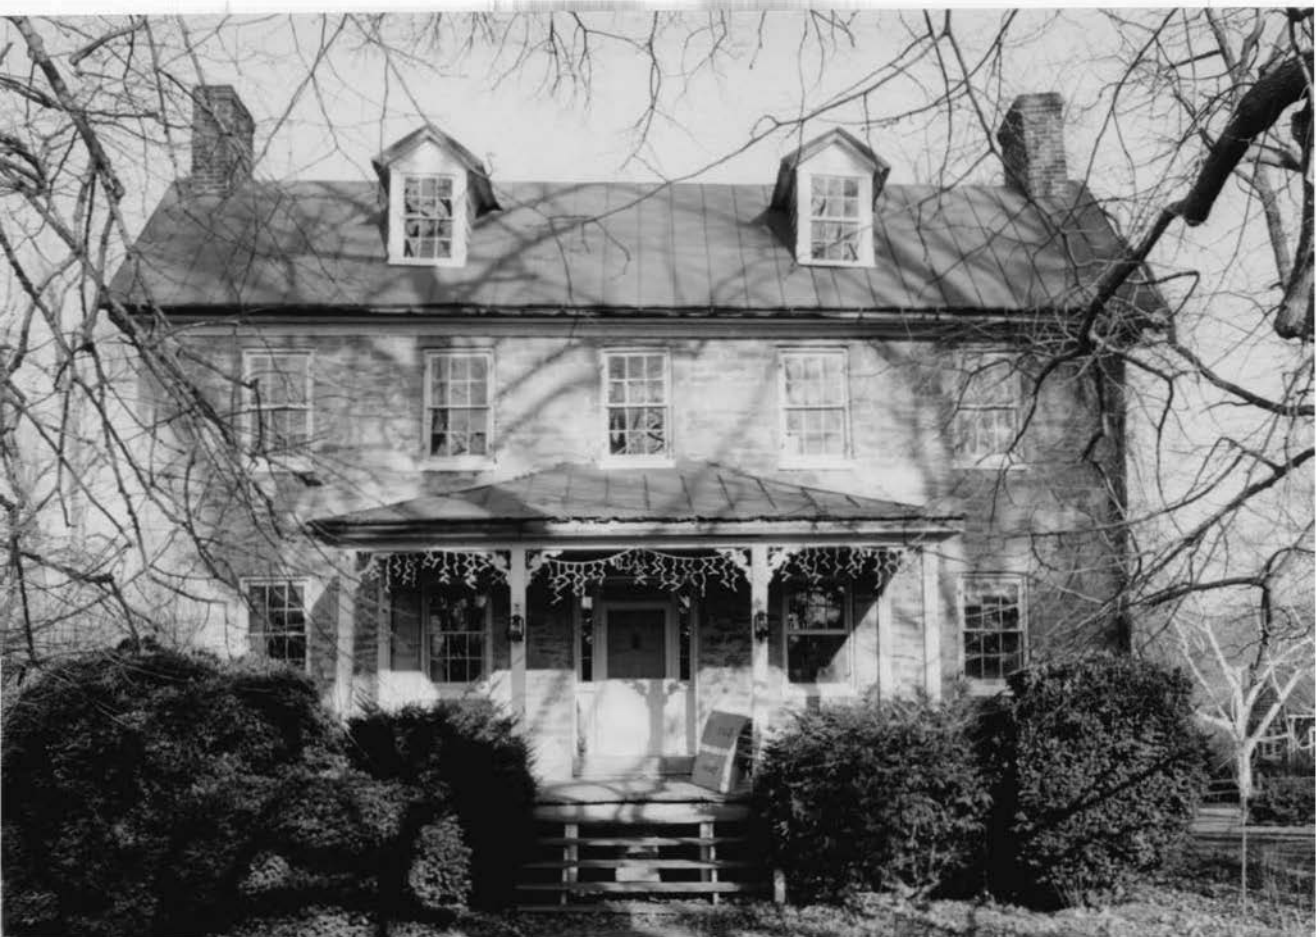
1/21

House. S. elev

On the south elevation of the stone house, all of the openings have large stone lintels. In the foundation, the west bay has a six-over-three double hung sash in a beaded-interior-edge frame. The west-center bay has a three-over-three double hung sash, and the east-center bay has in-fill of vertical boards set inside of the window frame. The east bay has a six-light sash. The first story has a center entrance with a stone sill that has a wash. The door has six small panels over two tall panels, and the panels have sunk fields and quirked Greek ogee panel moulds. There is a porcelain knob. The entrance has a three-light transom and side lights with four lights over one panel. The soffit and jambs have one panel each, with the same moulds as the door. The doorway has a bullnose-moulded frame and a large stone lintel. There are two six-over-six double hung sash to each side of the opening. They are set in bullnose-moulded frames, with wood sills and cast iron shutter hardware. These sash are typical for the stone portion of the house. There is a three-bay, one-story, hipped roof porch with standing seam metal roofing. The porch is supported by three stone piers. The west elevation of the west pier is parged and contains traces of red paint. The east pier is parged on the east elevation and painted white. The porch has a wood deck, four chamfered posts, jig-sawn balusters and brackets, and a wood box cornice with two Greek ovolo mouldings. The second story has five typical six-over-six sash, and there is a wood box cornice. There are dormers over the west-center and east-center bays, with six-over-six double hung sash, architraves with two fillets, and gable roofs with a north-south ridge and standing seam metal. The sides of the dormers have wood shingles. There are two lightning rods on the ridge.

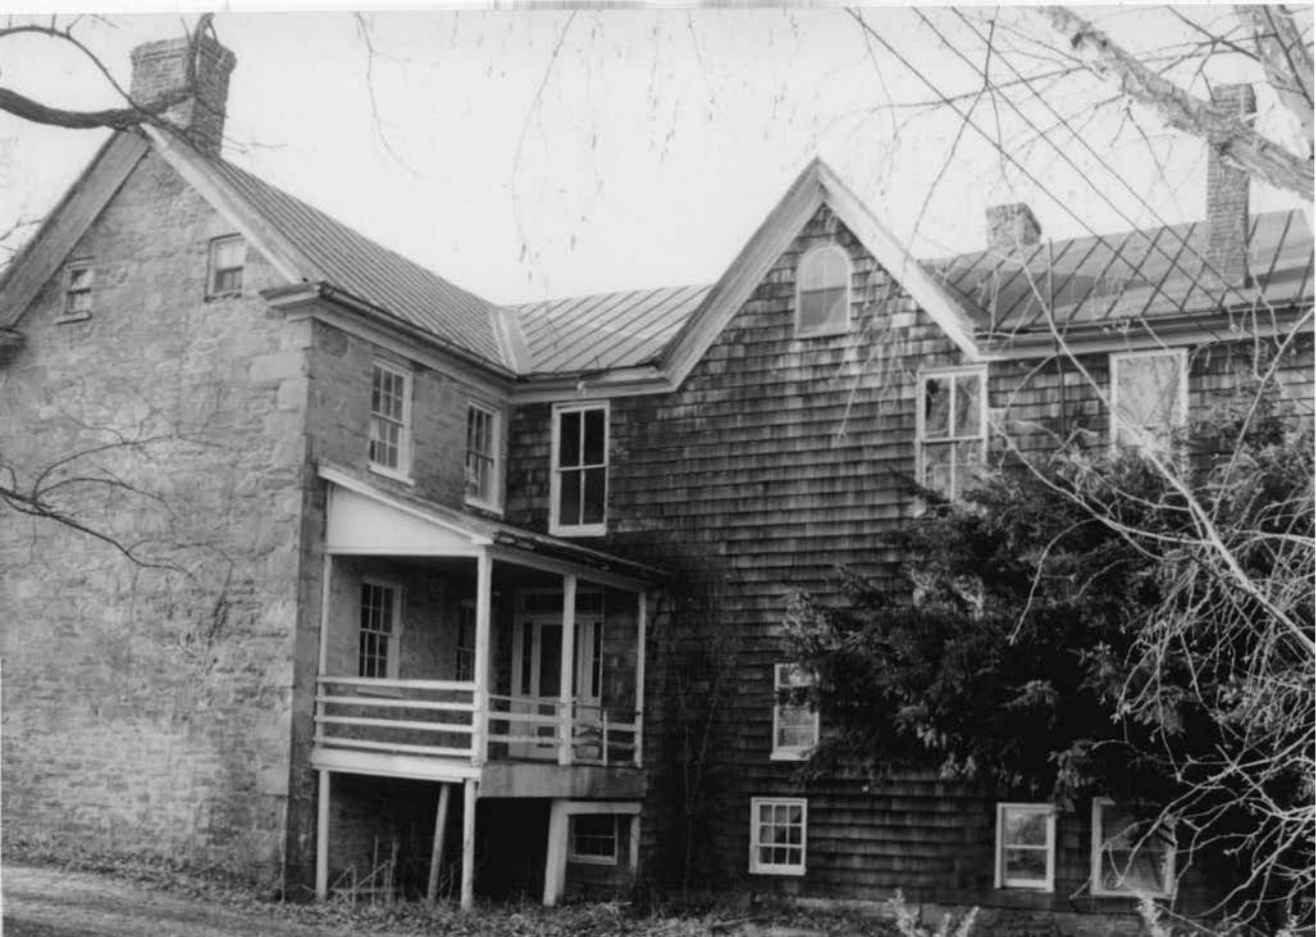
3/21

House - E. elev

The east elevation of the large addition, at the basement level, has two six-over-three double hung sash to the south, a later one-over-one sash just north of center, and two windows, each with paired four-light casements and plain head-cut trim, to the north. The first story has a door in the south bay that has four panels with sunk fields and ogee-and-bevel panel moulds. There are sidelights with two lights over one panel, and a three-light transom. The south-center bay has a small two-over-two double hung sash set lower on the wall than the other openings. There are two two-over-two sash to the north. The second story has three typical two-over-two sash, with no opening in the south-center bay. There is a cross gable over the south-center bay that has a semi-circular arched two-over-two sash. There is a box cornice with returns.

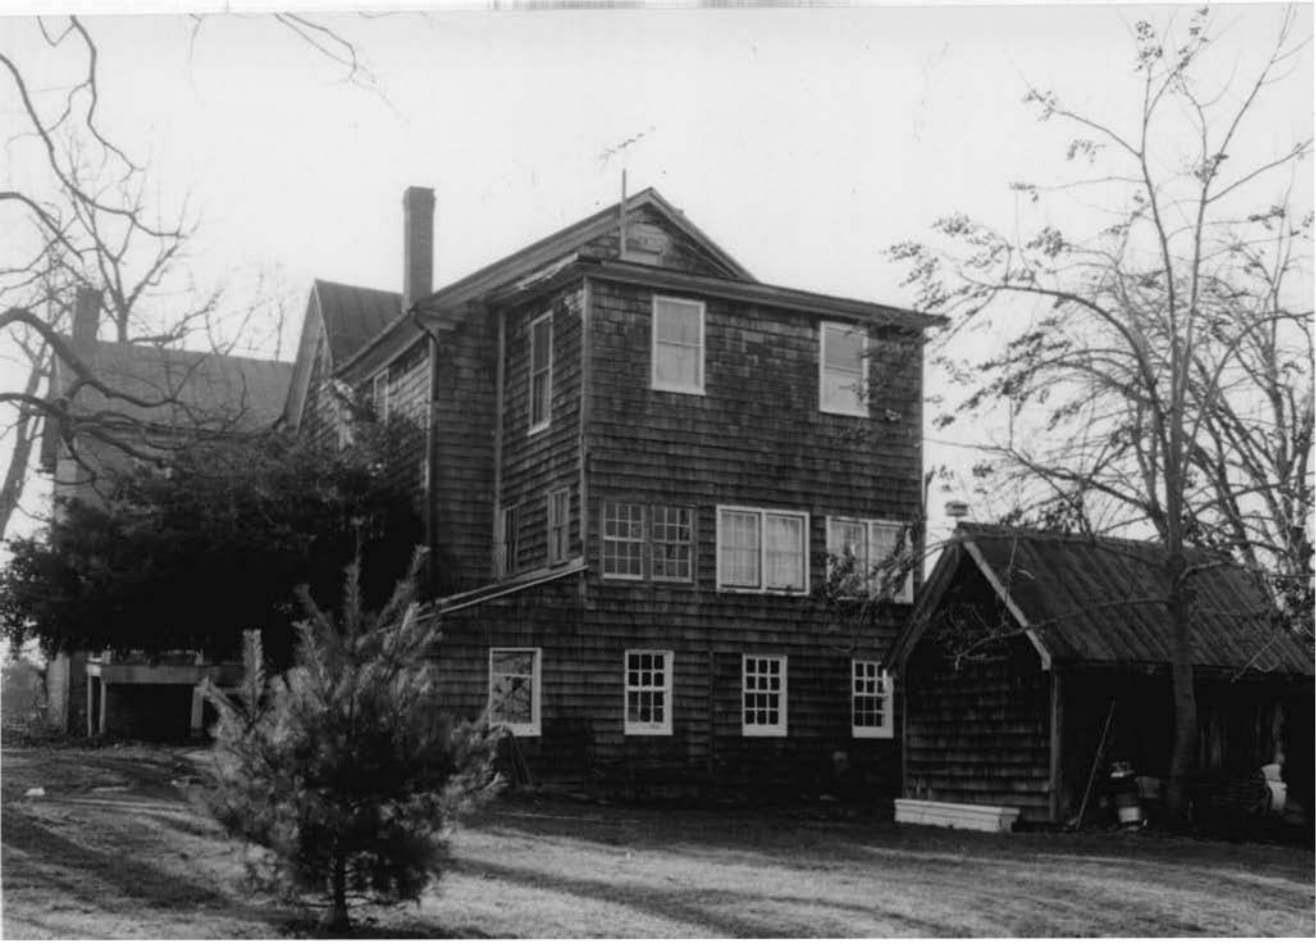
4/21

House - N. elev.

The north elevation of the stone section retains traces of whitewash over traces of red paint on the basement. The first story has two typical six-over-six sash, with traces of whitewash on the walls and traces of red paint beneath the window sill level. There is a one-story, shed-roof porch with

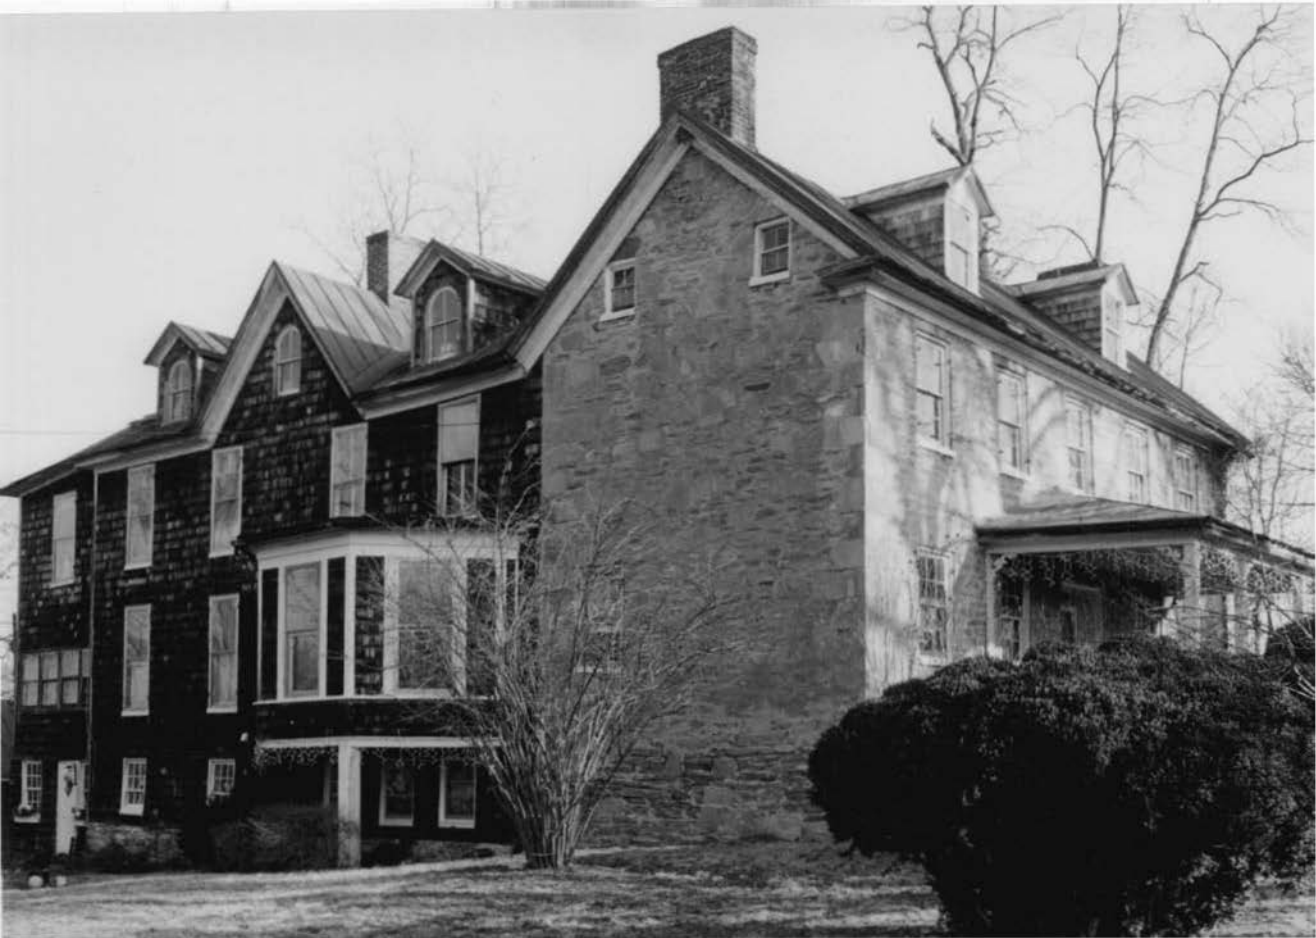
5/21

House - W & S elevs

The west elevation of the stone section has a typical six-over-six sash in the north bay of the first story, with no opening in the south bay. The second story has no openings. The gable end has two two-over-two double hung sash in bullnose-moulded frames, with wood sills. There is a boxed raking cornice. The west elevation of the wood section has a basement story consisting of a low

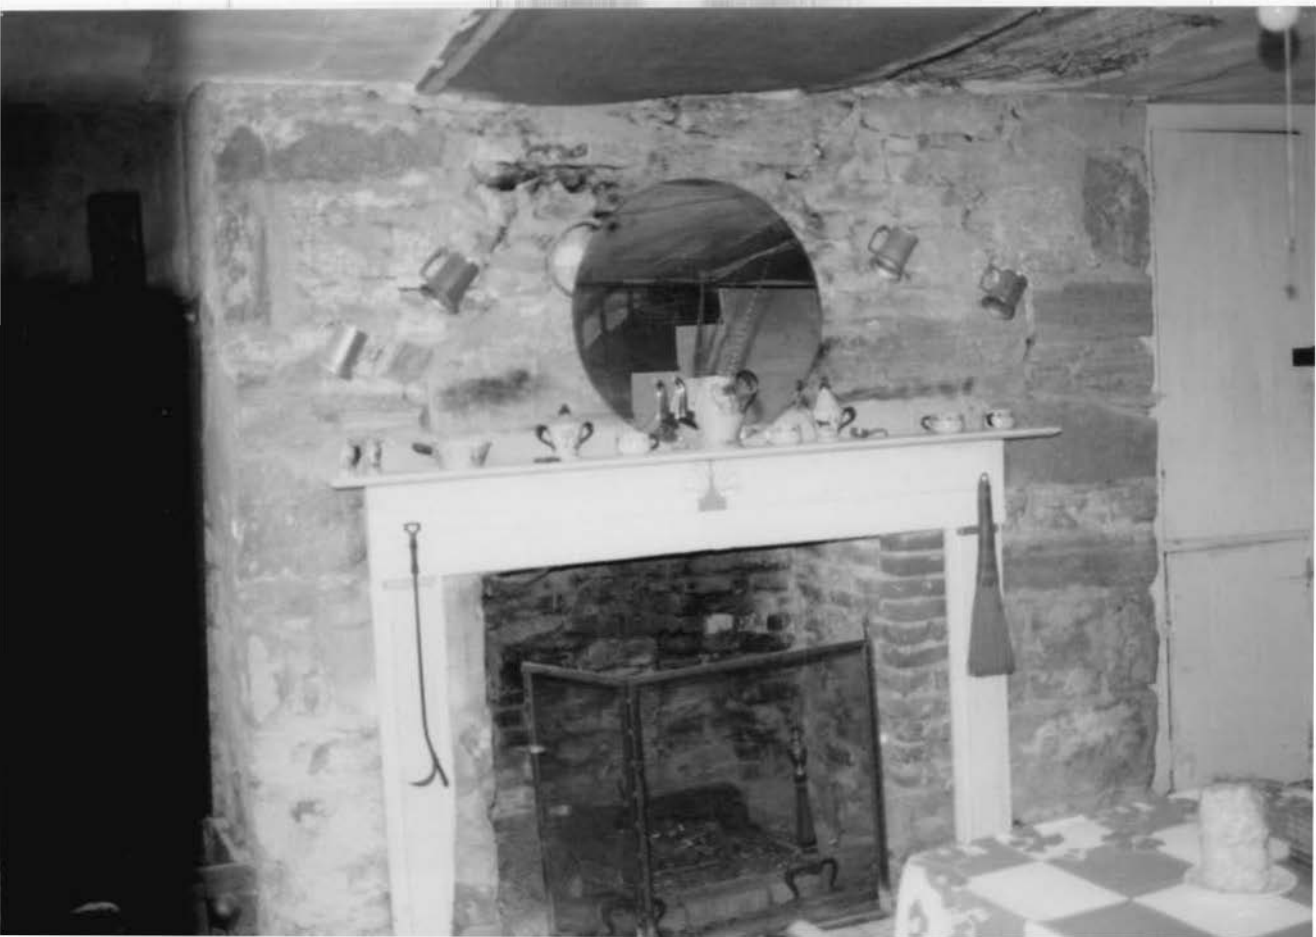
6/21

SW Cellar Rm - w elev

The southwest cellar room has random-width pine flooring 3 ½ to 4 ½ inches wide. The flooring runs east-west, is set on sleepers, and is very deteriorated. The walls have plaster on stone, and the ceiling is plaster on circular sawn lath that is fastened with cut nails. The east elevation has a straight run, open stringer stair to the first story. It has square-in-plan balusters, a three-quarter-round handrail, and a square, chamfered newel post. There is a beaded-edge vertical-board door beneath the stair that leads to a closet. The door has a wood stock lock that is stamped with the number "3" on the end. The doors are hung on cast iron butt hinges marked "N. ENG. BUTT C<sup>o</sup>" both the lock and hinges are fastened with gimlet screws. The partition wall has circular sawn lath and the door frame is constructed with cut nails. The door has two plugged holes for earlier latches; these holes are blocked by the present lock. South of the stairs is a beaded-edge vertical-board door leading to the southeast cellar. The door is constructed with three wide boards and has a cast iron box lock with a mineral knob. The door is hung on cast iron butt hinges that are marked "W. H. CARR<sup>sm</sup>" and "PATENT." The south elevation has a ghost of a window to the east that has been lathed and plastered over. To the west is a window with splayed, plastered jambs, mortised and tenoned and pegged sash, and a wood sill. The sash do not have parting beads. The west elevation has a fireplace with splayed jambs. The south jamb is stone, but the north jamb has brick in-fill to narrow the opening. The fireplace has a segmentally-arched brick lintel with two iron bars supporting the brick. Above the brick is a large stone lintel that spans the original opening width. There is a wood mantel with plain pilaster strips, a broken frieze, and no bed moulding. The mantel fits the current opening size, not the original size of the fireplace. There is a stove pipe hole with a terra cotta lining above the stone lintel. North of the fireplace is a built-in cupboard with beaded-edge vertical-board doors consisting of a single door set above a smaller single door. The cupboard has beaded-interior-edge architrave. The top door has a small cast iron rim lock, and is hung on plain cast iron butt hinges fastened with gimlet screws. The north elevation has the ghost of a window, which has been lathed and plastered over, to the west. The east bay has a circular-sawn vertical-board door.

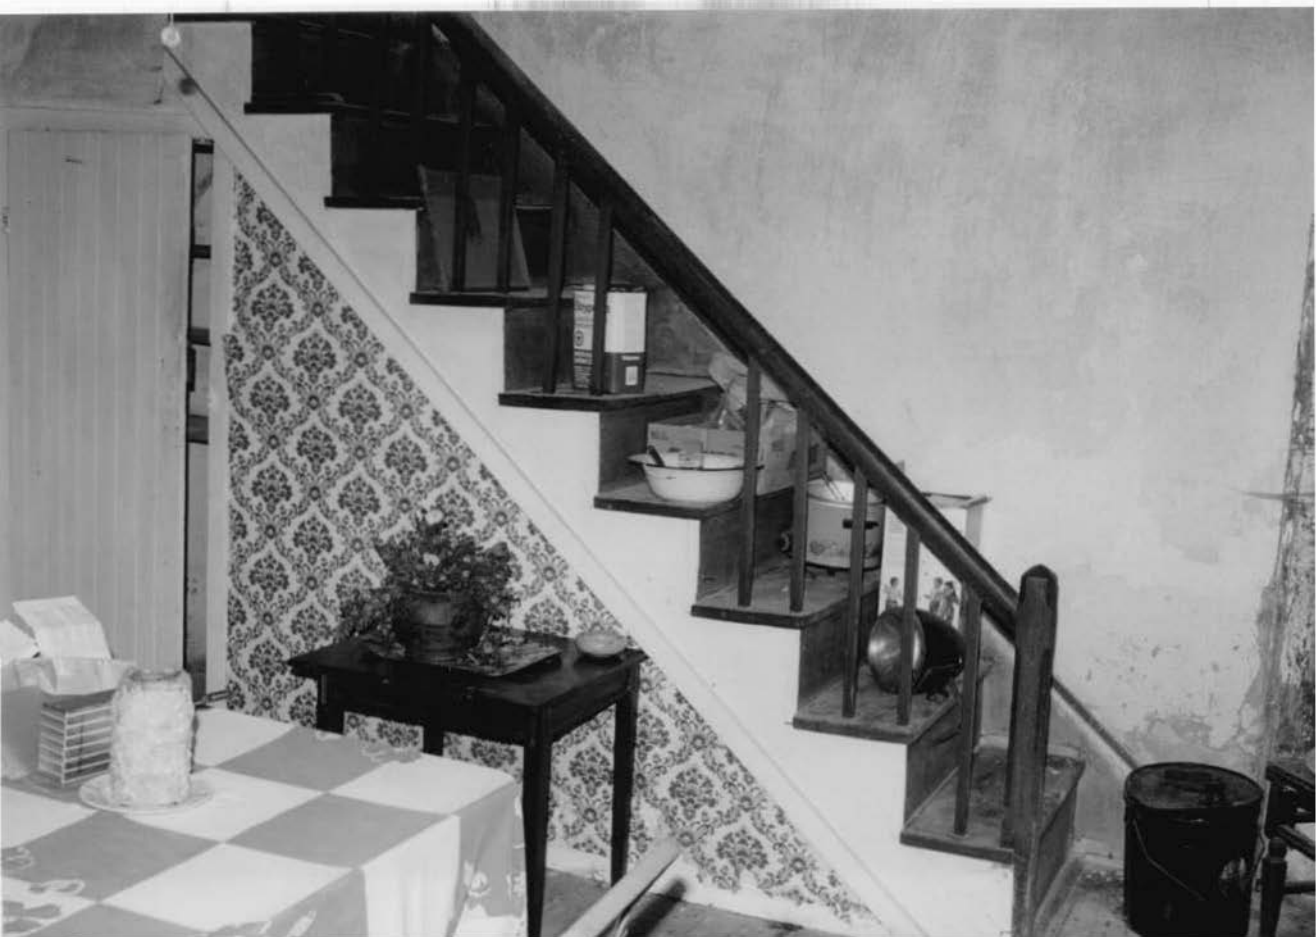
7/21

SW Cellar Rm. E. elev.

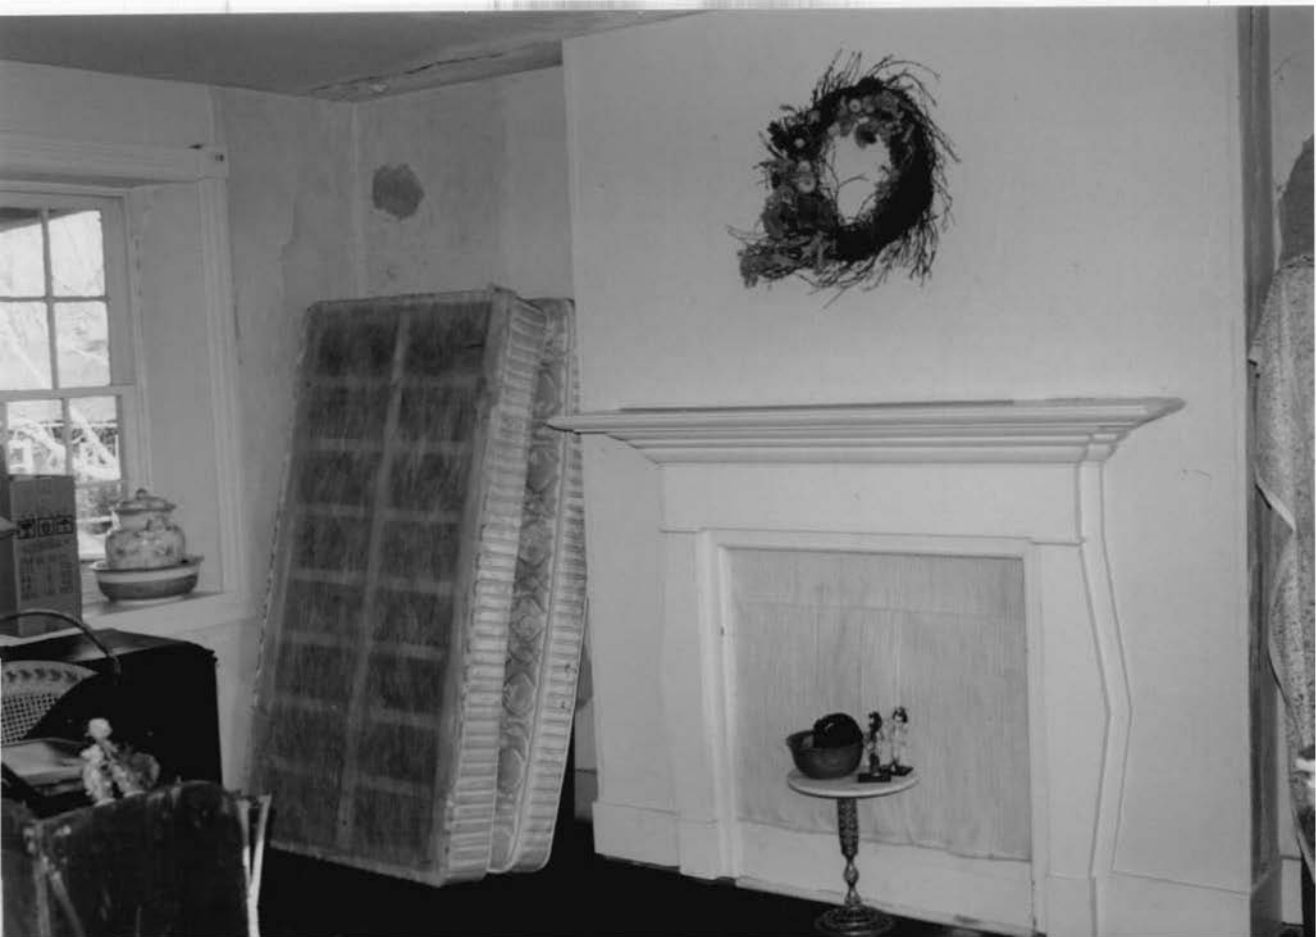
8/21

SE Rm - vw NE

The southeast room has random width oak or chestnut flooring that is 4 ¾ to 7 ½ inches wide, and runs east-west. The windows have splayed jambs with mortised and tenoned and pegged sash that have parting beads. The architrave in this room matches that of the front door. The baseboards are plain, and are rather wide and deep. There is a fireplace on the east elevation that is closed off and has no hearth. It appears that this was never a functional fireplace, but was always meant for a stove. The wood mantel has plain pilaster strips that are angled outward on the outer edge, as if meant to be exaggerated entasis. It has a plain frieze and a bed mould with three Greek ovolos. There is also a Greek ovolo moulding on the edge of the mantel shelf. The mantel has been pulled off the wall and re-fastened.

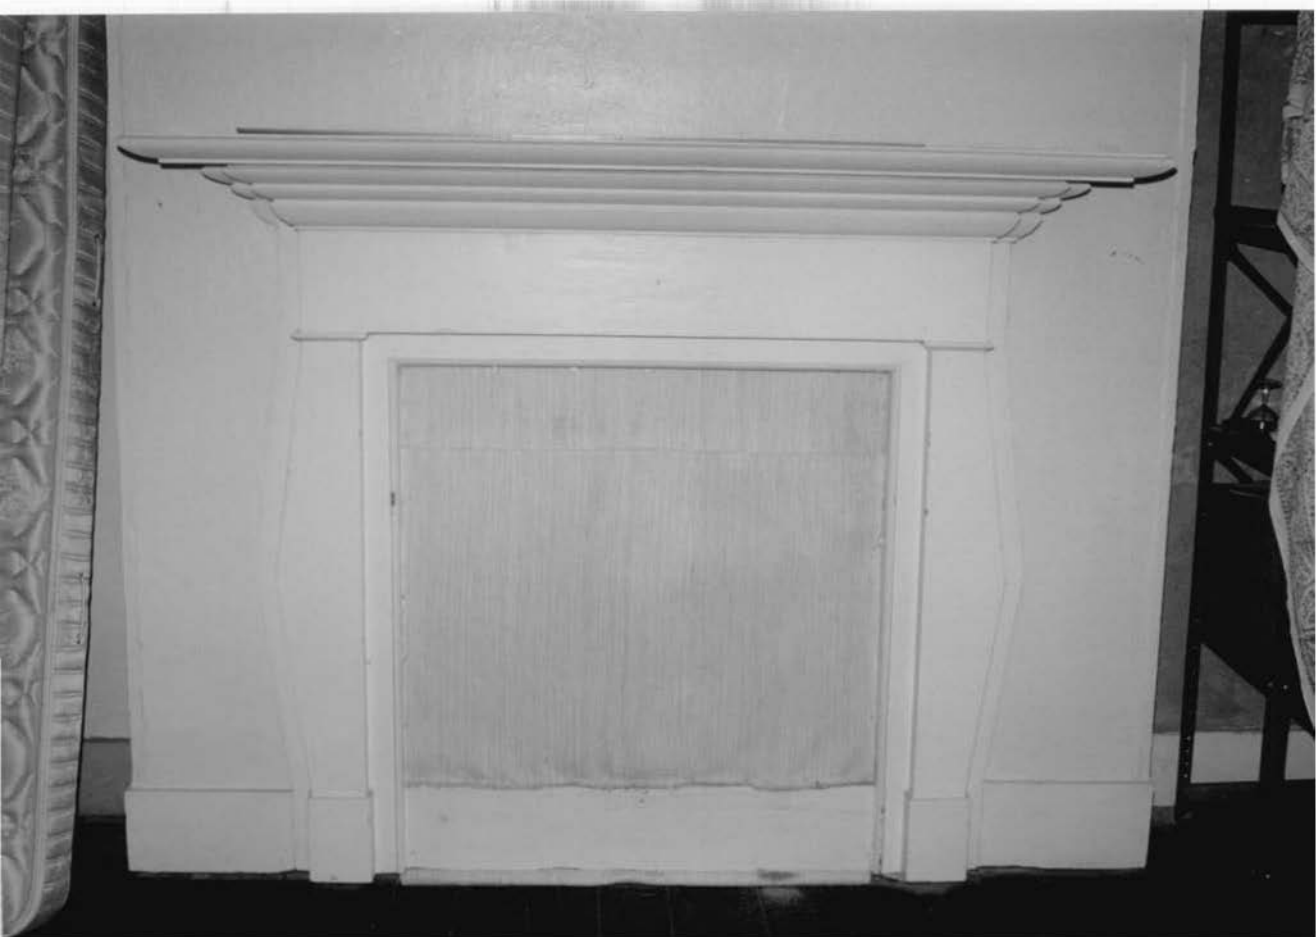
9/21

SE Rm mantel

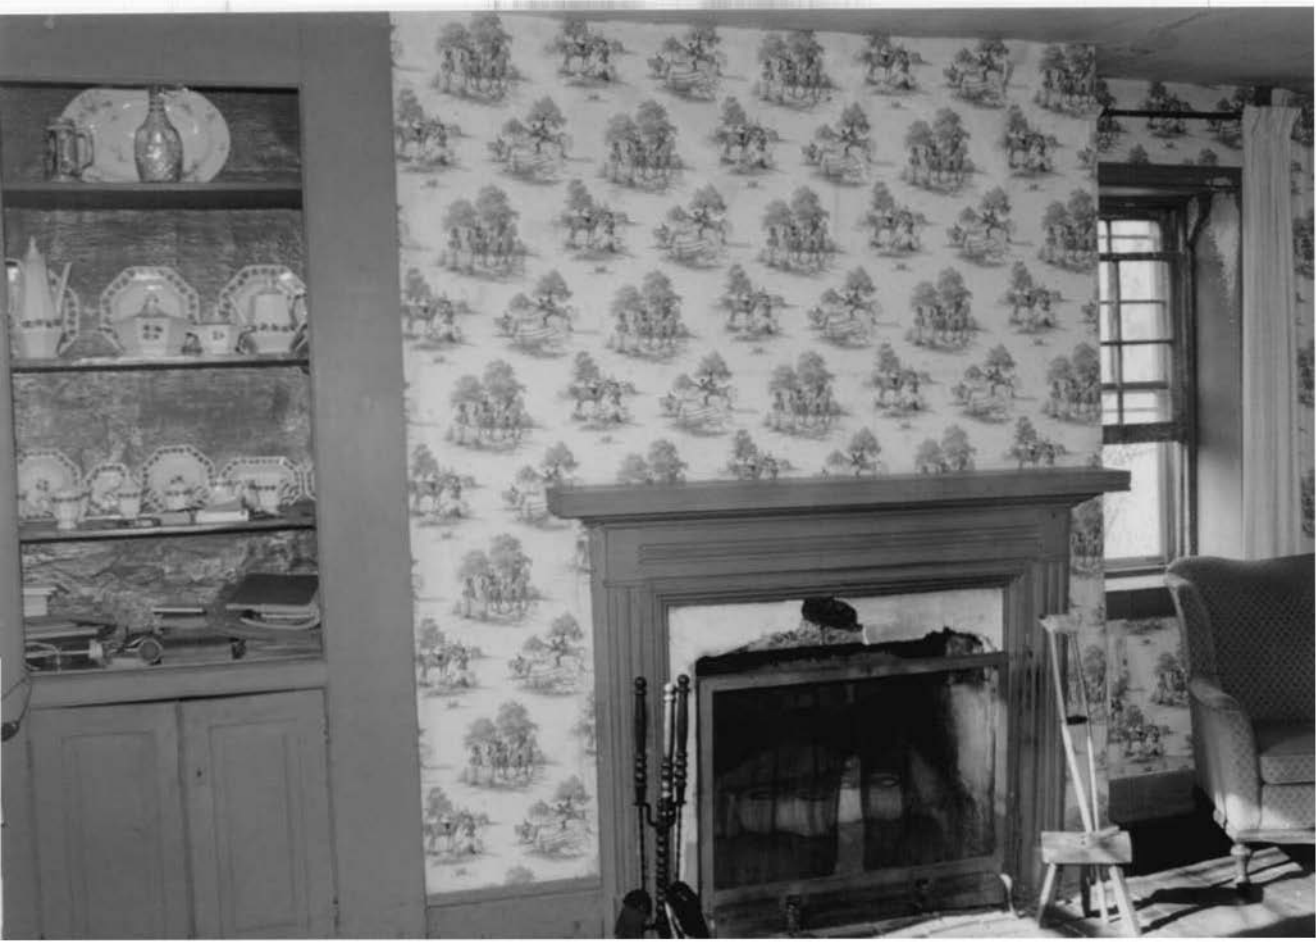
10/21

SW Rm. W. elev

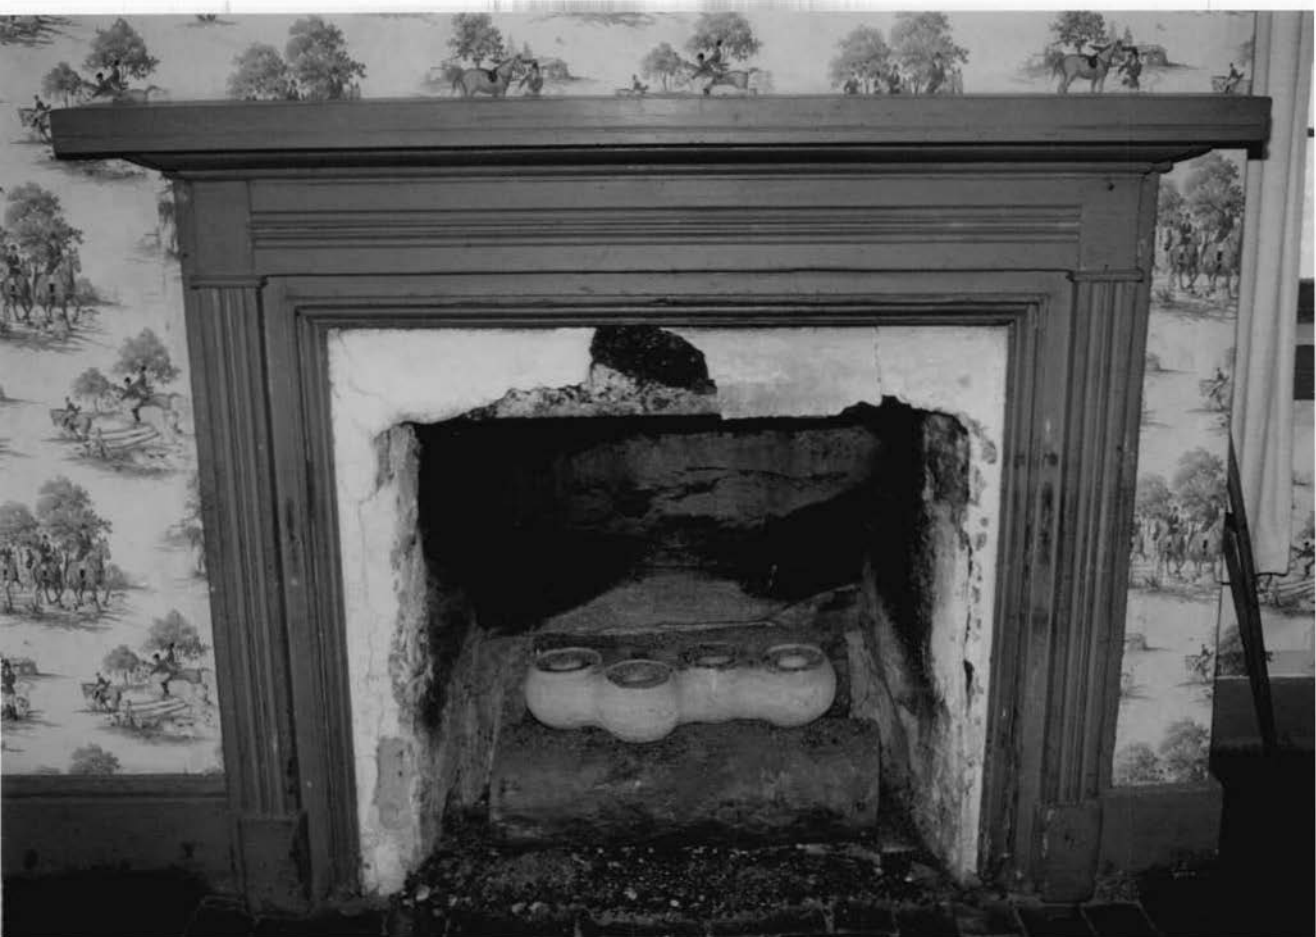
11/21

SW Rm. mantel

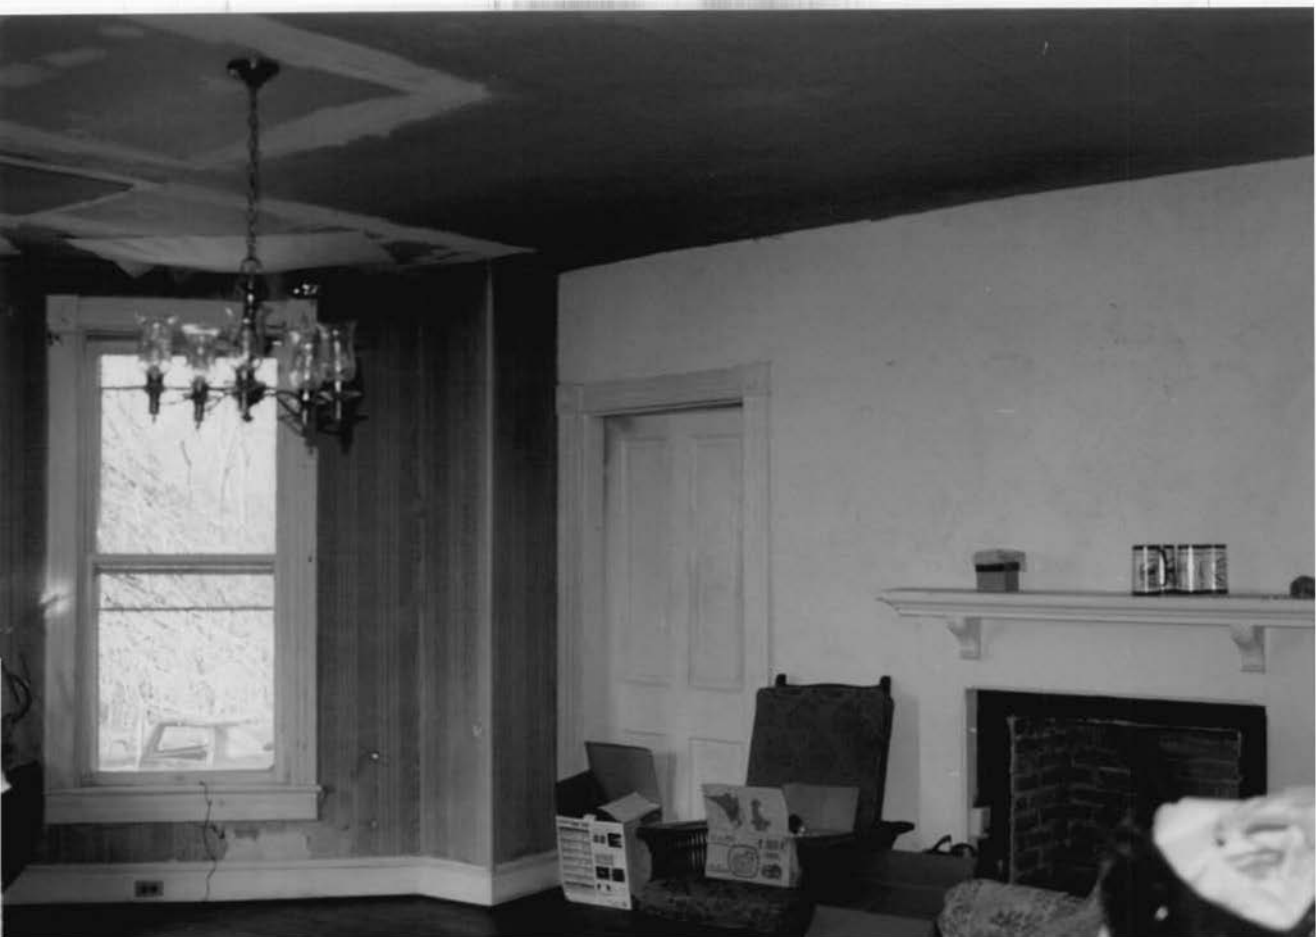
12/21

West-center rm - vw NW

The west-center room has 2 inch wide oak flooring that runs east-west and is laid on top of earlier flooring. There is a large three-sided bay window on the west elevation that has the same architrave as found in the passage and stair hall. The ceiling at the juncture where the bay window meets the house is very deteriorated, with much plaster missing or replaced by various patches. On the north elevation, to the east, is a fireplace with a brick hearth, straight brick jambs, and plastered surround. According to the Randalls, there was originally a coal-burning insert here. The wood mantel has two scroll brackets with acanthus leaves, and an egg and dart moulding on the mantel shelf. It appears that this mantel was applied later, or has been removed and re-fastened, as it abuts the plaster wall rather than having the plaster applied up to it.

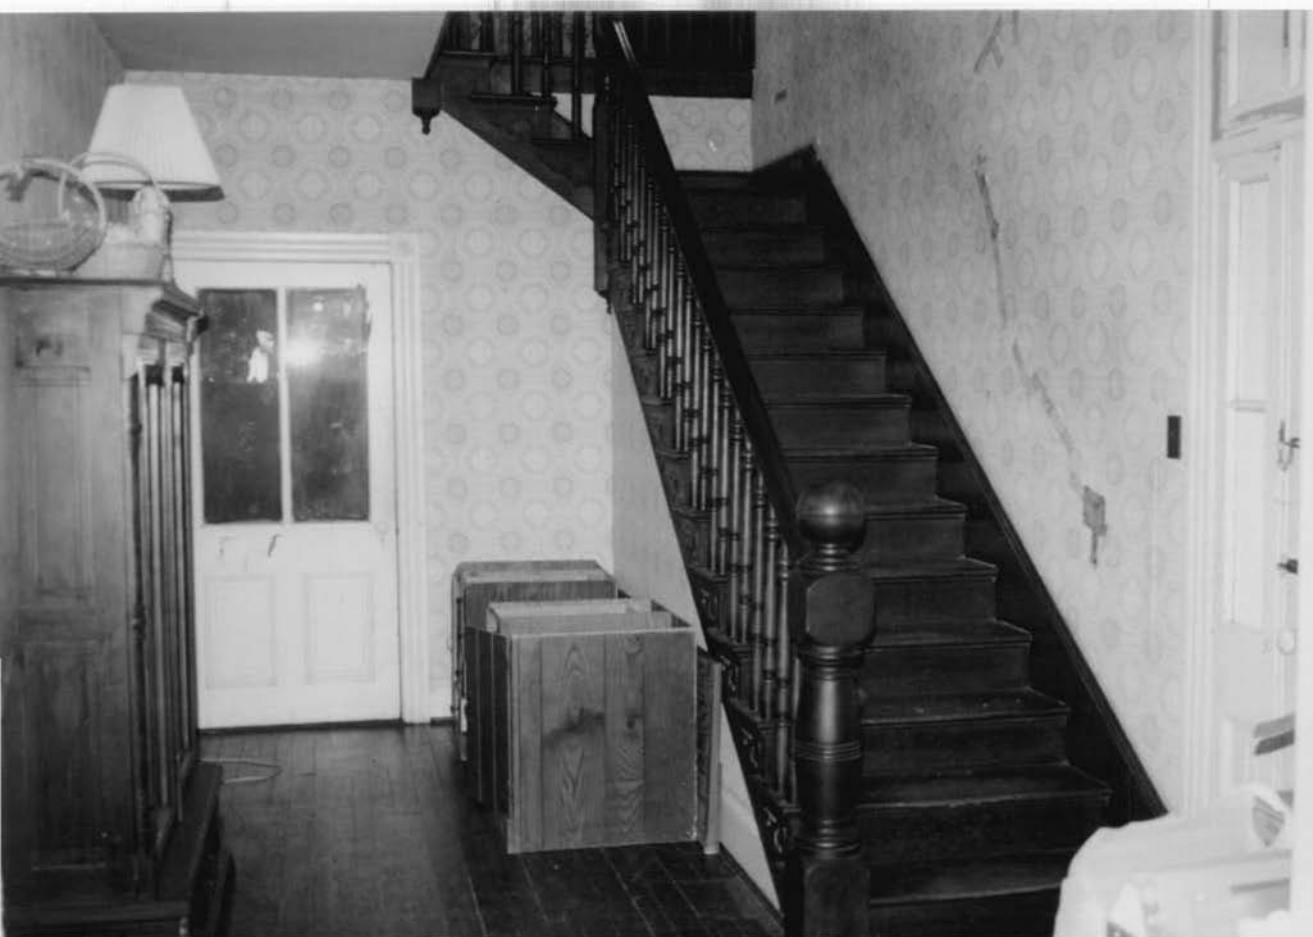
13/21

Passage - vw N.

The north wall of the passage is opened up almost as wide as the passage itself, and the opening contains the same architrave as is found on the interior doorways of the passage. The jambs of this wide opening each have a sunk, flat panel. There is a dog-leg stair on the east that has a large turned walnut newel post, a moulded walnut handrail, and turned oak balusters. It has an open stringer with sawn brackets, and the baseboard matches that of the front passage. On the east

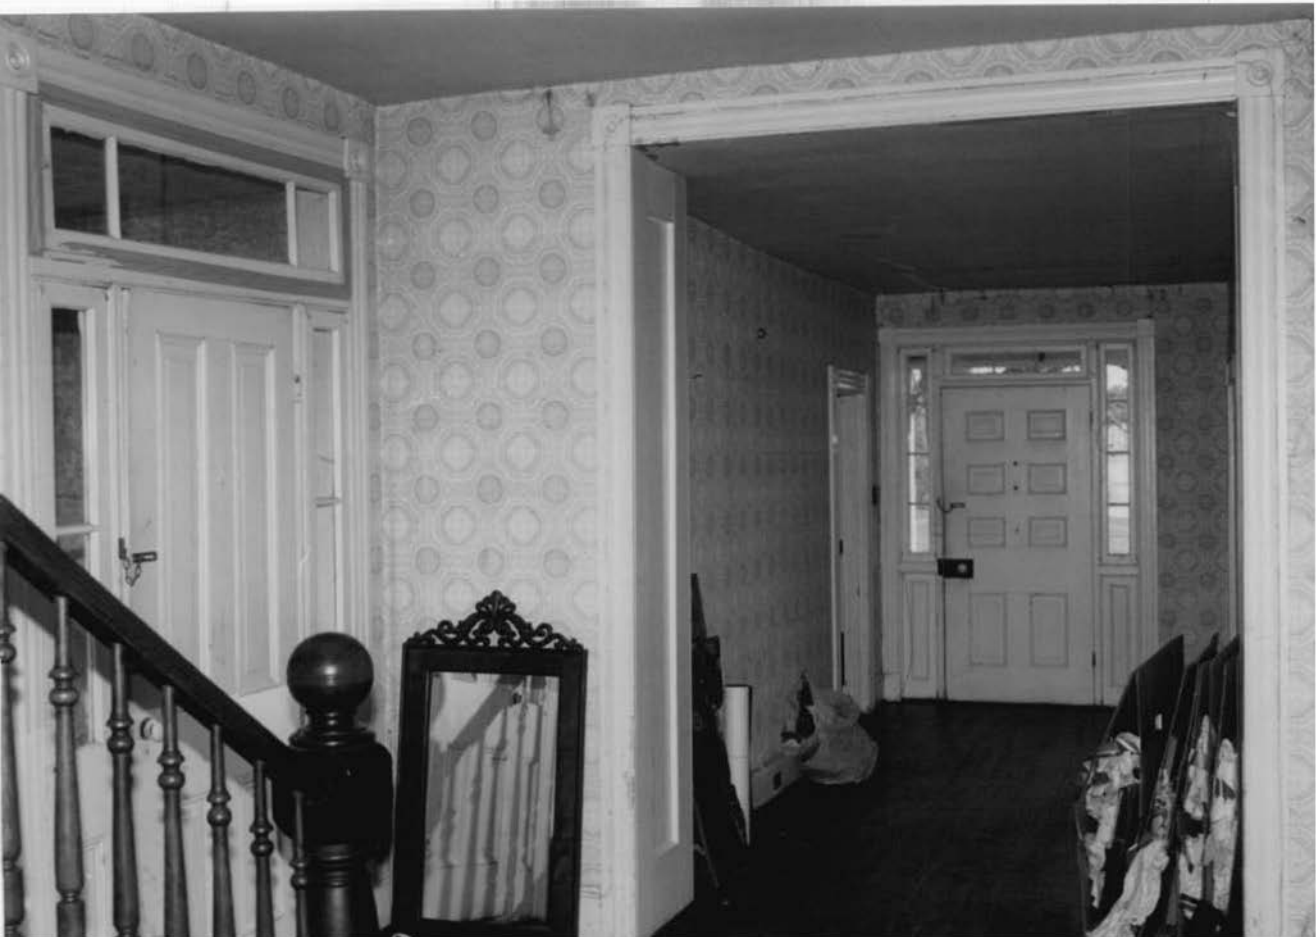
15/21

Center Passage, 1<sup>st</sup> sty, UW SE.

the west and two small rooms and a winder stair to the east of the passage. The passage has 2 ½ to 3 ¼ inch wide pine flooring throughout it that runs north-south. The baseboard has a quirked Greek ogee and bevel on the top of it. The front door has quirked Greek ogee moulds, and a large, plain cast iron rim lock with a porcelain knob. This lock may be a Carpenter lock, but it is missing a seal. The architrave here has two fillets and a beaded interior edge. There are plain corner blocks. The doors to the southeast and southwest rooms have two tall panels with sunk fields and no panel moulds. The architrave here has two reeds on either side of a pulvinated frieze, with a beaded interior edge. Here there are bull's-eye corner blocks. The cast iron butt hinges are heavily painted. There is a cast iron rim lock with porcelain knob that is marked "D. M. & C<sup>o</sup> New Haven" on the east door, while the rim lock on the west door is unmarked. Neither one of these locks is original, as there are ghosts of earlier, larger locks.

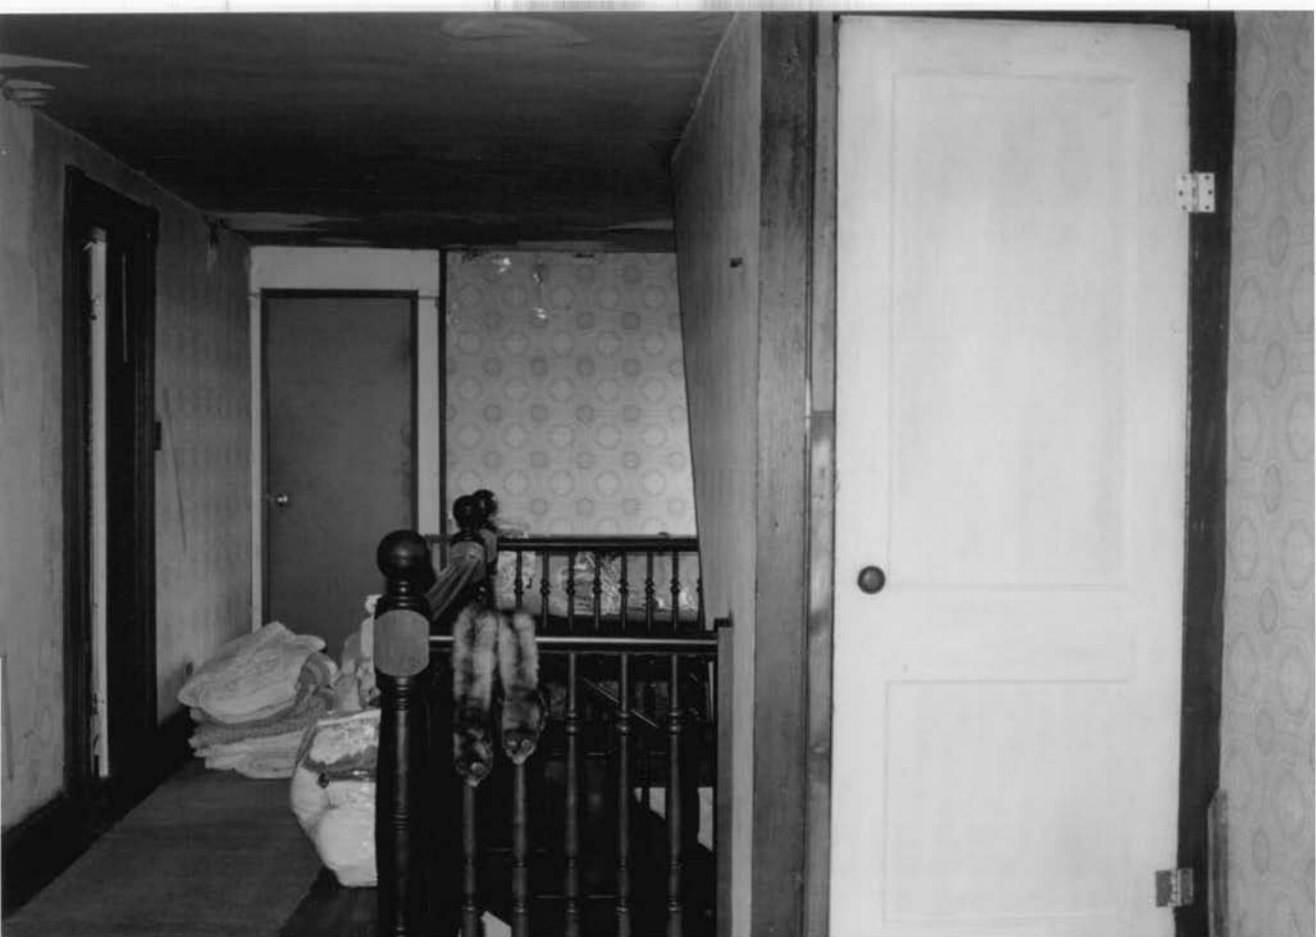
17/21

Passage - 2nd sty - VW N

The second story floor plan is identical to the first story. The south passage has plain baseboard, and the architrave has a broken field with a beaded interior edge and plain corner blocks. The doors have two tall panels like those to the rooms below. The cast iron rim locks have porcelain knobs, and are not original to the doors, as there are ghosts of earlier locks. There is an enclosed winder stairway to the attic along the west wall. The stairway ascends from the north to the south. The doorway to the stairs has plain, mitered architrave with a beaded interior edge. There is one step set below the opening, and this opening never had a door. At the south end of the stairway is a closet with a door that has two tall panels. This door has been cut down on the bottom. It is hung on cast iron butt hinges that are heavily painted. The door framing is of reused material but the architrave is not. It is plain, mitered trim with a beaded interior edge, and does not have old mortises for hinges, while the door frame does. The stairway here originally ascended from the south to the north, and the floor at the southeast corner of the stairway enclosure has mortises for two rectangular-in-plan balusters that were originally located here. When the stairway was altered, most of the floor at the north end was replaced, and there is new flooring in the closet as well. The stairway is built with wire nails.

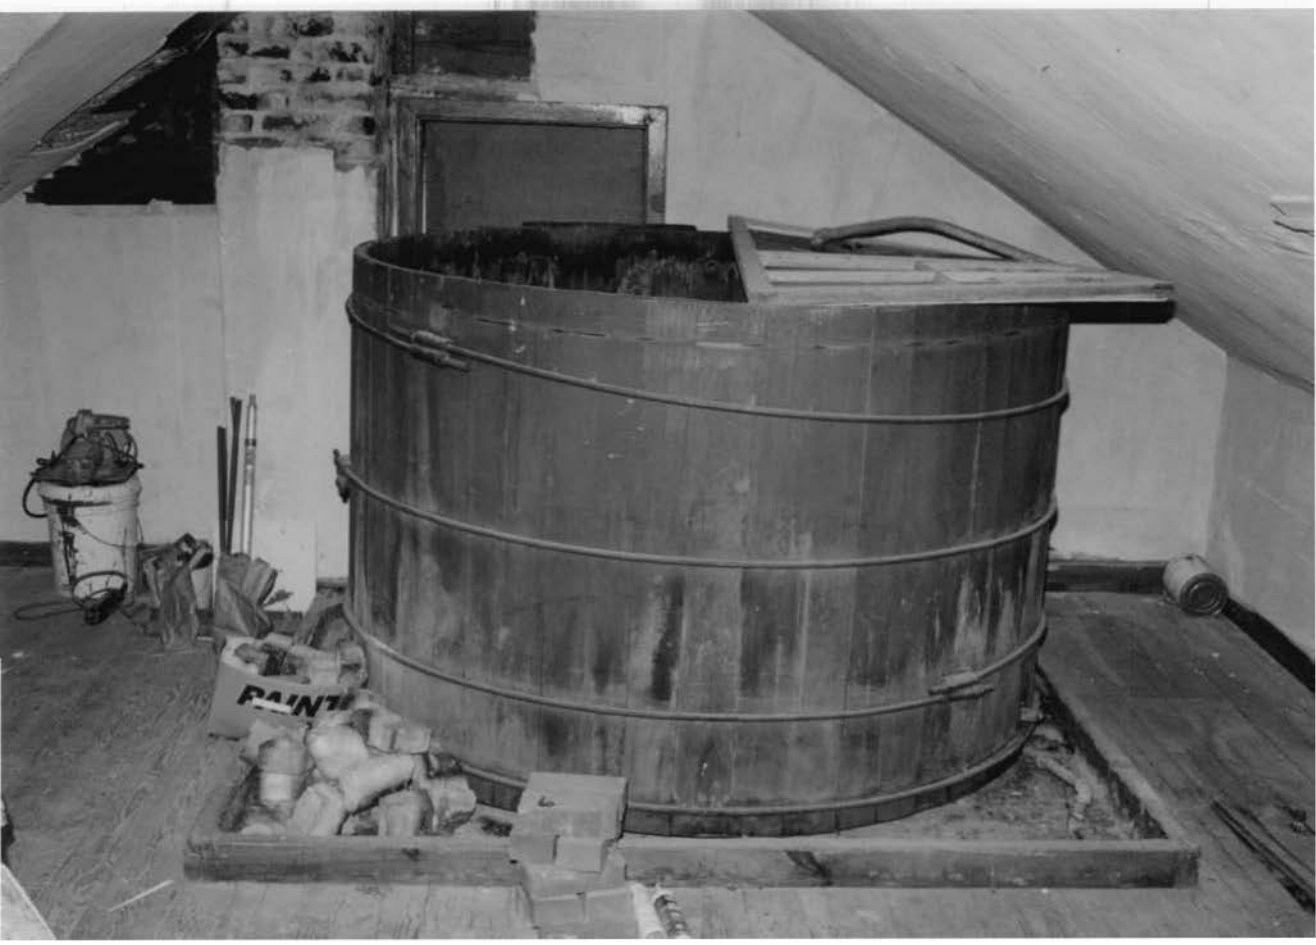
18/21

Attic cistern in N. end

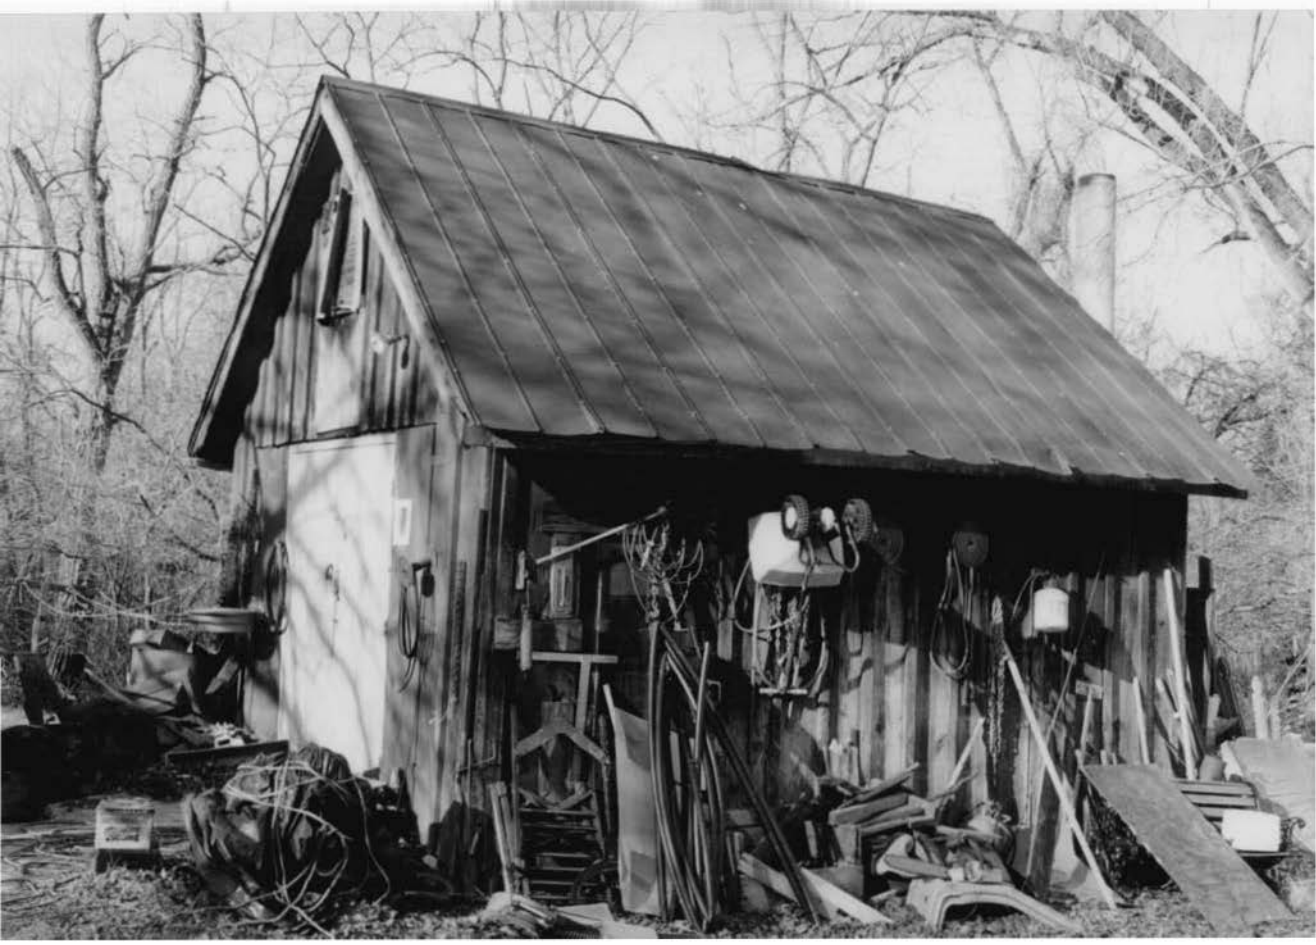
19/21

Wagon Shed - S&E elevs

About 38 feet northwest of the house is a wagon shed. It is a one-story, one-bay by one-bay structure with a rubble stone foundation, board and batten siding, and a gable roof of inverted-v-seam metal with a north-south ridge. The south elevation has two new metal doors and plywood in-fill in an original opening, and a boarded-up opening in the gable end. The east elevation has a door, hung on butterfly hinges, set to the south. The north elevation has been patched with corrugated metal and it is not possible to tell if there were ever any openings here. The west elevation has a new window cut into it. The interior has sheetrock on the ceiling and walls, and a plywood floor.
