## Montrose Farm

### **Architectural Survey File**

National Register of Historic Places  
Registration Form

historic name "Montrose"

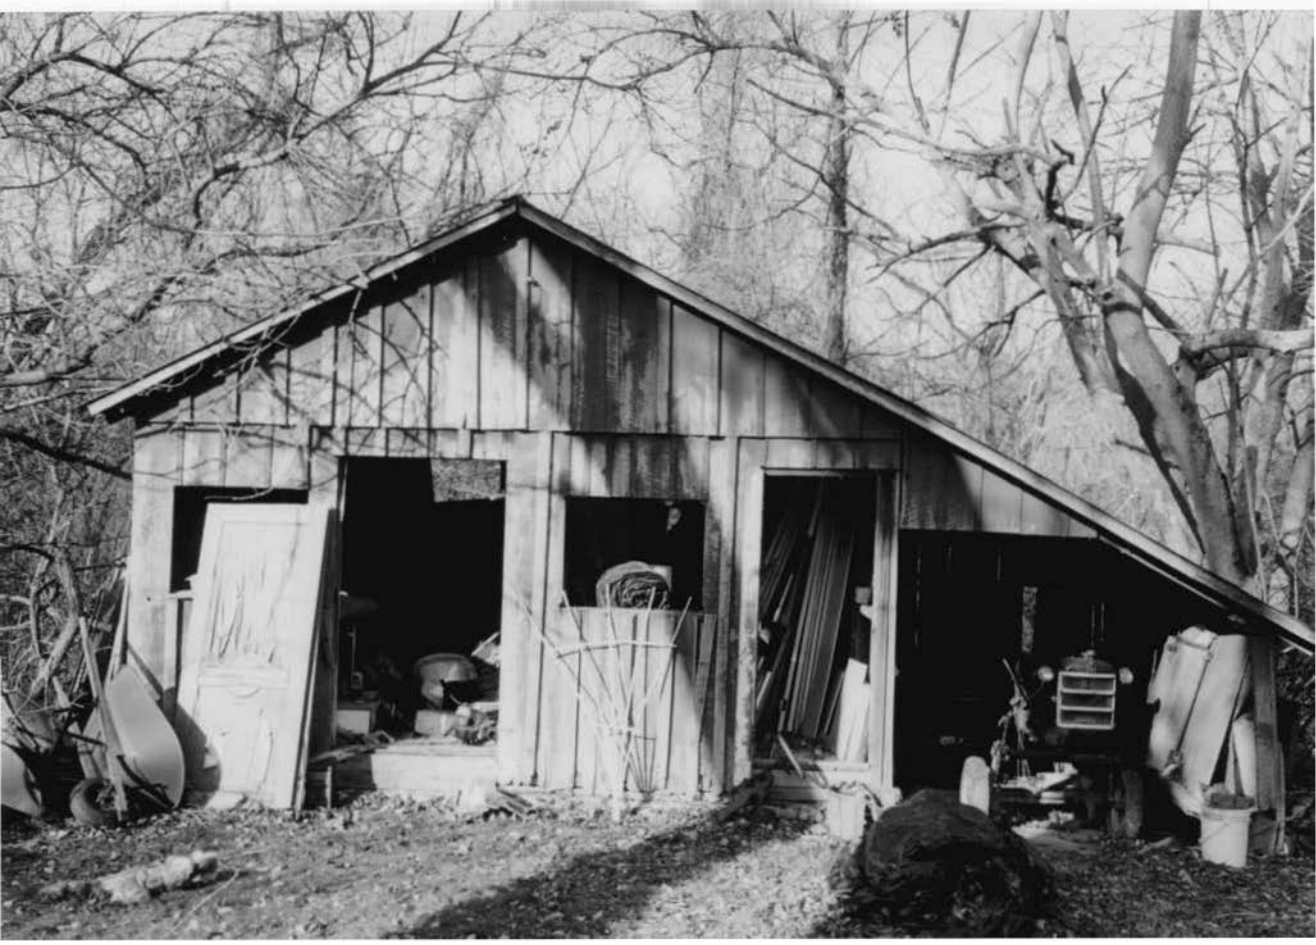
20/21

Granary, E. elev

There is a granary about 100 feet northwest of the house that is a one-story, four-bay by one-bay frame structure on a rubble stone foundation. The board and batten siding is circular sawn and fastened with wire nails, and the gable roof has inverted v-seam metal with a northwest-southeast ridge. The southeast elevation, from south to east, has a window opening, a door opening, a window opening, and another door opening. There are no openings on the southwest and northeast elevations. There is a shed roof addition on the northeast that is open on its southeast. The northeast wall of this addition is collapsing. The northwest elevation has two window openings. On the interior, the northwest two-thirds of the building is divided in half by a horizontal board and batten half wall, creating two bins. The northwest, northeast, and southwest elevations of the bins have horizontal board and batten siding that is about four-and-a-half feet high. The southeast ends of the bins would have been closed off with loose boards that slid down in grooves on each side of the bin, stacking one board on top of the other. There is a tongue-and-grooved wood floor that runs northwest-southeast. Beneath it is an ice house.
